# PROPERTY APPRAISER OF MIAMI-DADE COUNTY

PROPERTY INFORMATION	
Folio	03-4117-006-0010
Property Address	2 CORAL WAY CORAL GABLES, FL 33134-0000
Owner	NNN TRS INC
Mailing Address	4440 ROSEWOOD DR PLEASANTON, CA 94588
Primary Zone	5004 MIXED-USE 2
Primary Land Use	1111 STORE : RETAIL OUTLET
Beds / Baths /Half	0 / 0 / 0
Floors	1
Living Units	0
Actual Area	31,977 Sq.Ft
Living Area	31,977 Sq.Ft
Adjusted Area	30,155 Sq.Ft
Lot Size	32,705 Sq.Ft
Year Built	1994

2 Coral Way

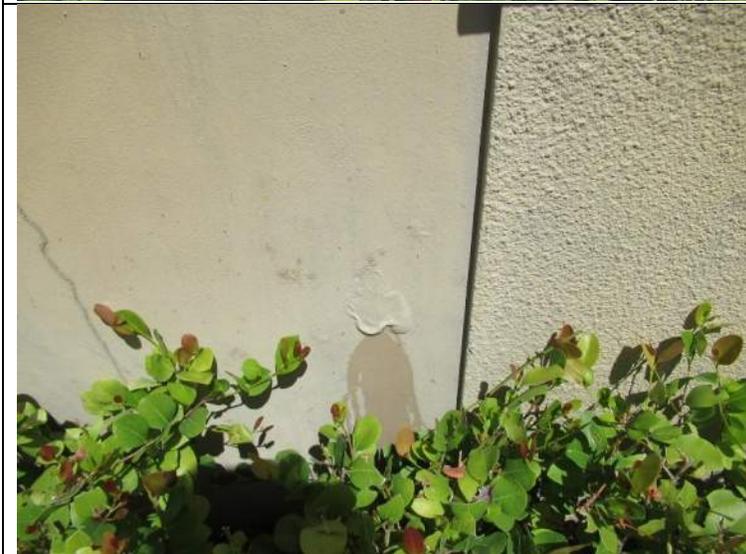
**Photograph No. 18.**

Wall paint bubble filled with water along with a hairline crack to the left in the stucco surface.

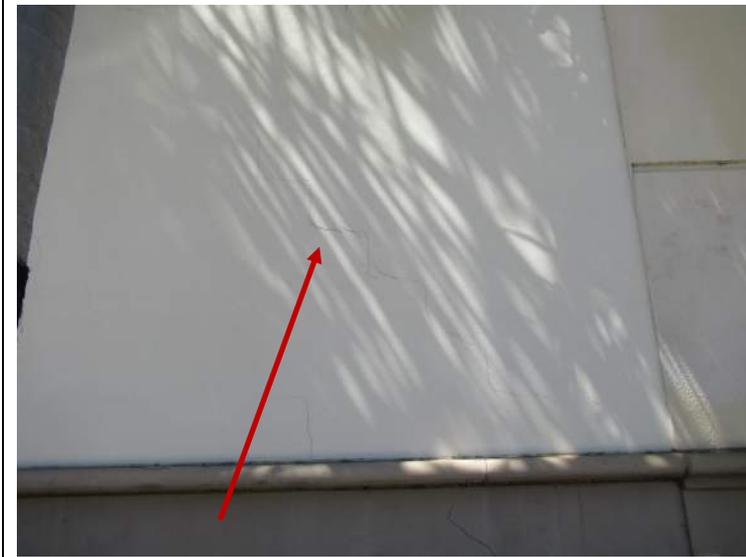
**Photograph No. 20.**

Stairstep mortar joint telegraphing cracks in stucco surface on the east elevation along Douglas Road. The cracks appear to have been present for a significant amount of time based on dirt in cracks. The cracks need to be properly treated and sealed when the building is painted. These are typical storm related movement cracks. The building is structurally sound.

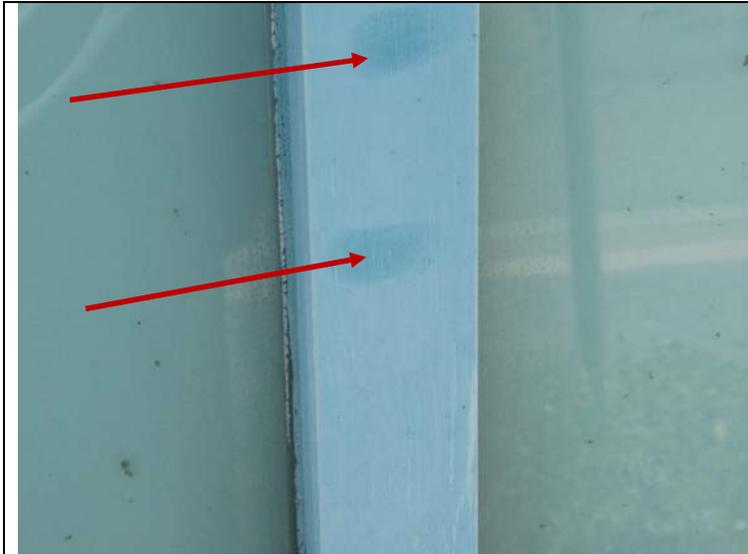
**Photograph No. 35.**

Paint peeling off frame and glass gasket shrinkage observed.

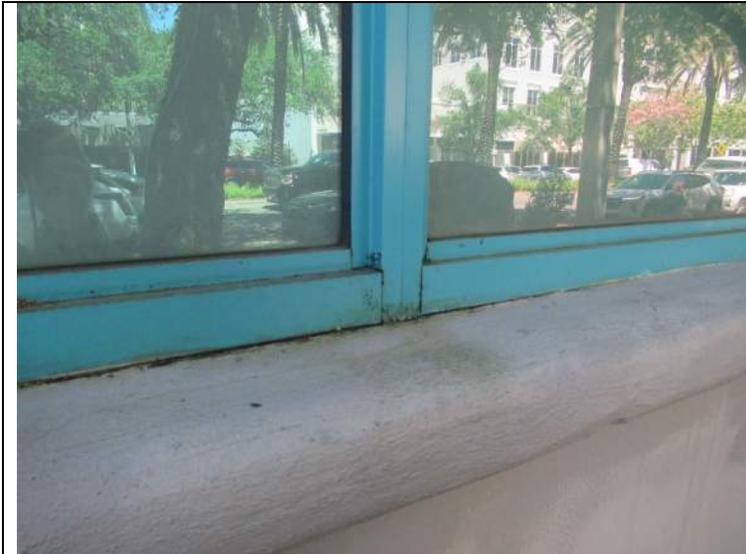
**Photograph No. 43.**

Water stains on exterior wall sill showing trapped water leaking out of frame. This is an indication that the glass gasket is leaking excessive water into the frame. The glass to frame should be wet sealed with sealant.

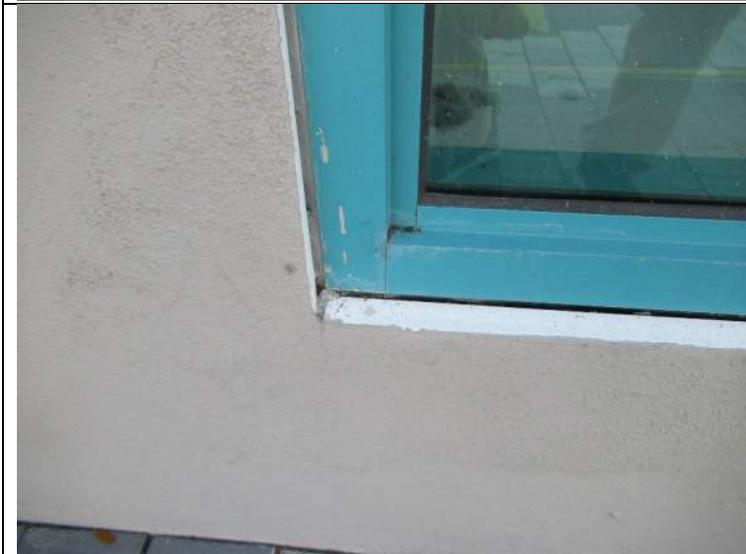
**Photograph No. 44.**

Water stains on exterior wall sill showing trapped water leaking out of frame. This is an indication that the glass gasket is leaking excessive water into the frame. The glass to frame should be wet sealed with sealant.

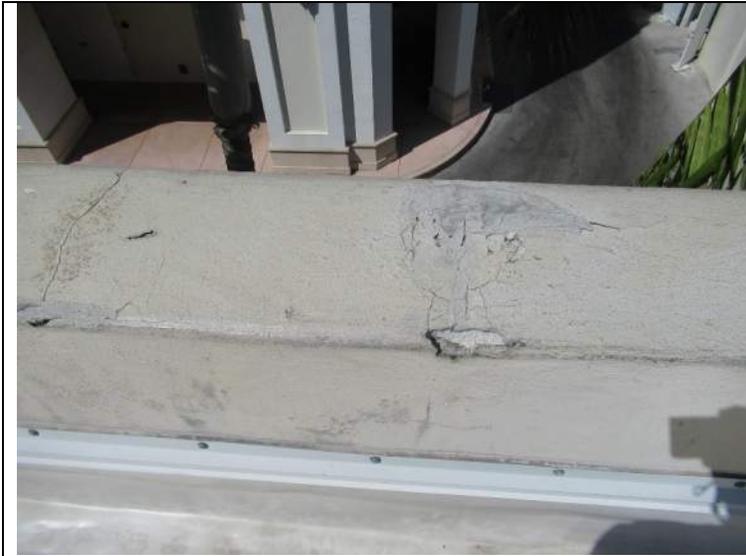
**Photograph No. 11.**

The parapet wall along the west elevation of the building. The top of the wall is a rounded EPS foam/EIFS cap that is adhered to the concrete tie beam. The cap has impact damage from prior storms.

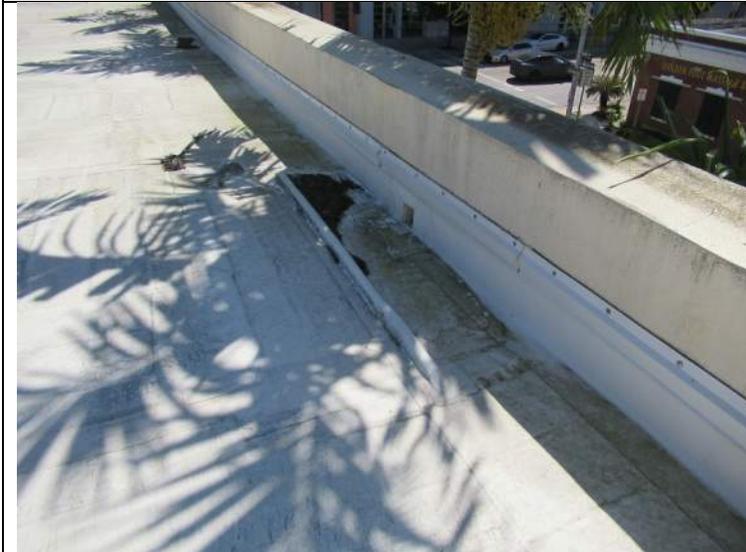
**Photograph No. 12.**

Close up of prior picture (arrow) showing EPS foam under EIFS acrylic stucco and top of concrete tie-beam. Spider radial cracking from impact damage can be seen. The exposed EPS foam needs to be covered, and the cap painted.

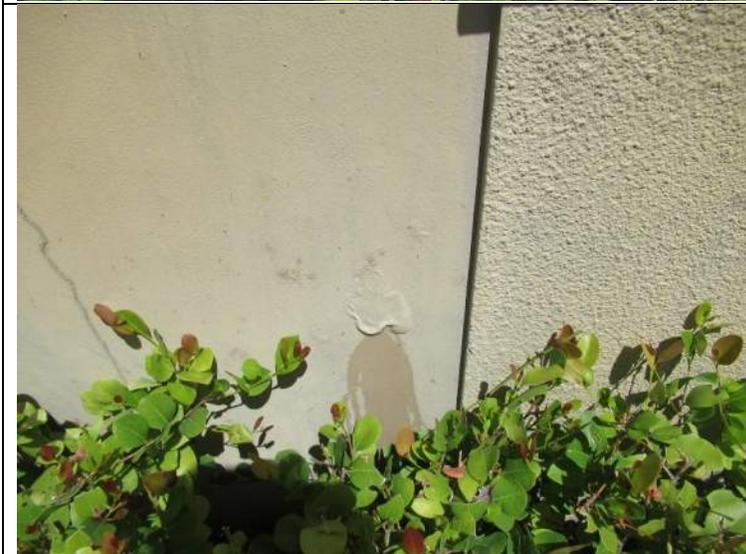
**Photograph No. 18.**

Wall paint bubble filled with water along with a hairline crack to the left in the stucco surface.

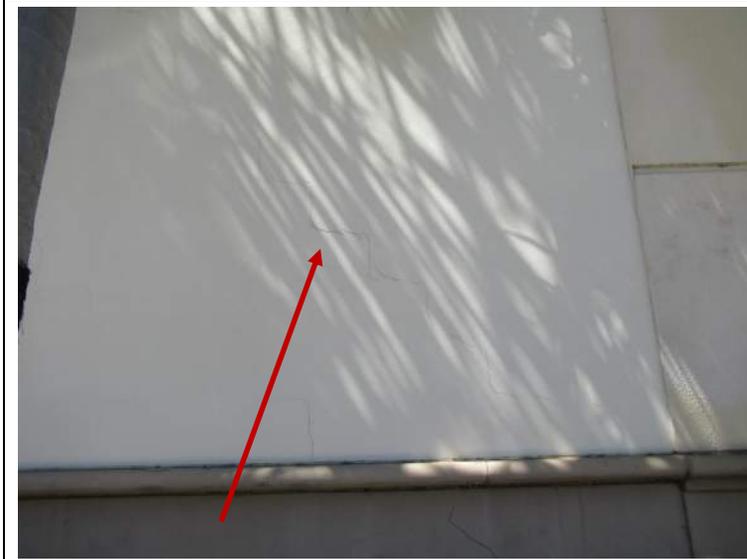
**Photograph No. 20.**

Stairstep mortar joint telegraphing cracks in stucco surface on the east elevation along Douglas Road. The cracks appear to have been present for a significant amount of time based on dirt in cracks. The cracks need to be properly treated and sealed when the building is painted. These are typical storm related movement cracks. The building is structurally sound.

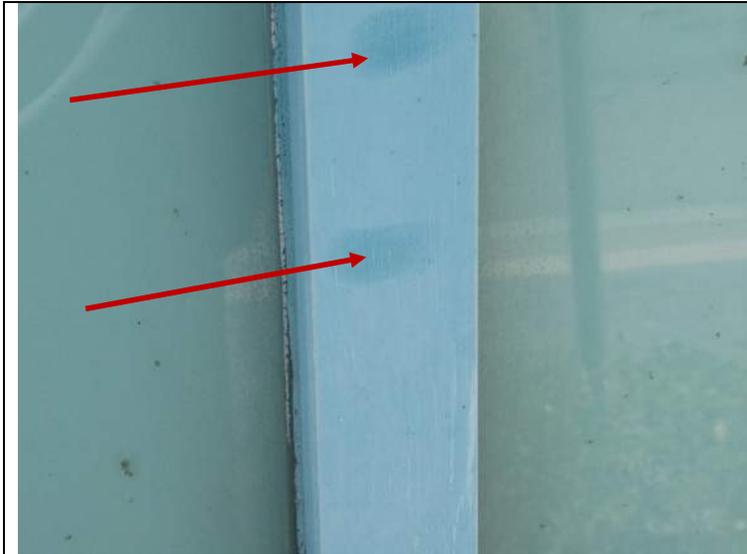
**Photograph No. 35.**

Paint peeling off frame and glass gasket shrinkage observed.
