BILTMORE II CONDOMINIUM BUILDING

FORTY-YEAR INSPECTION

**Biltmore II Condominium Building
600 Biltmore Way
Coral Gables, FL 33134**

Project No. 06-269-L

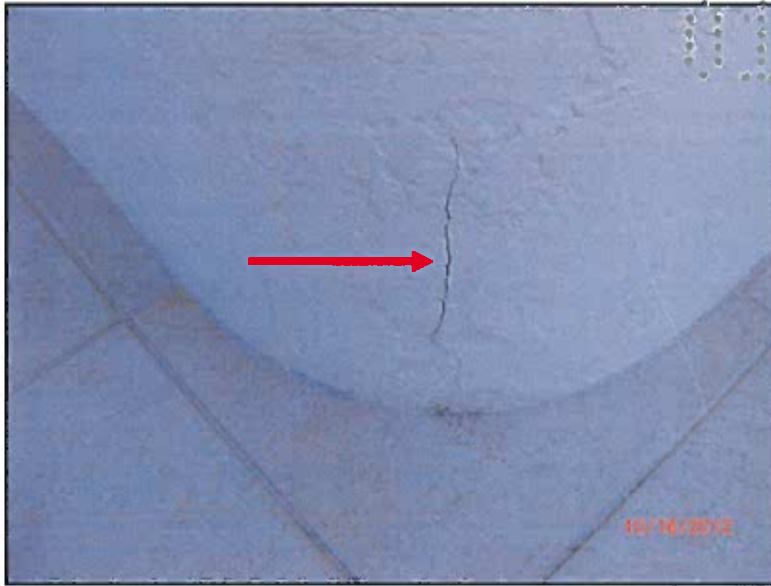
1. The building structure is generally in good condition.
2. The interior walls of balconies are in good condition overall. Minor cracking was observed on interior balcony wall and building wall (photo #1, photo #2 and photo #3) location.

PHOTO # 1: Vertical cracking on building wall located at balcony Unit #219

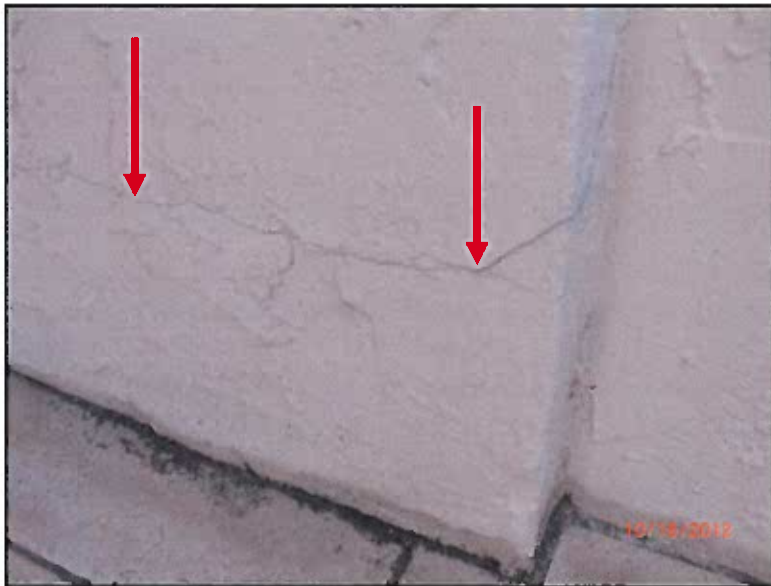
PHOTO # 2: Horizontal cracking/delaminated stucco at balcony wall Unit #219

The walls of the balcony slabs are typically in good condition, the inspected residential units' exhibit cracking at balconies. This is an indication of moisture intrusion into the block wall, with subsequent delamination of stucco. If left unabated, the stucco at the balcony block wall will eventually spall off, creating a falling debris and life safety hazard for residents and pedestrians below. We recommend the balcony walls be repaired where there are sign of cracking and

delamination. In addition, we also recommend that all balcony block walls be surveyed to document similar conditions.

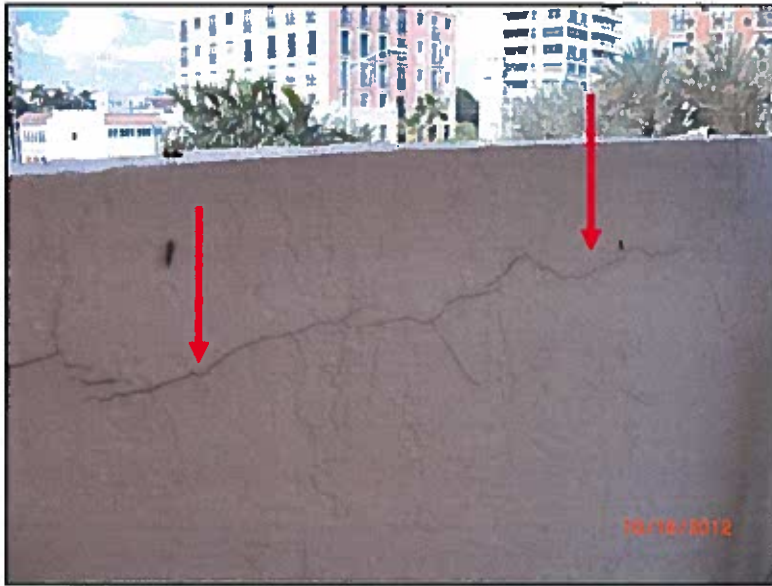
PHOTO # 3: Horizontal cracking on balcony block wall concrete cap at Unit #219

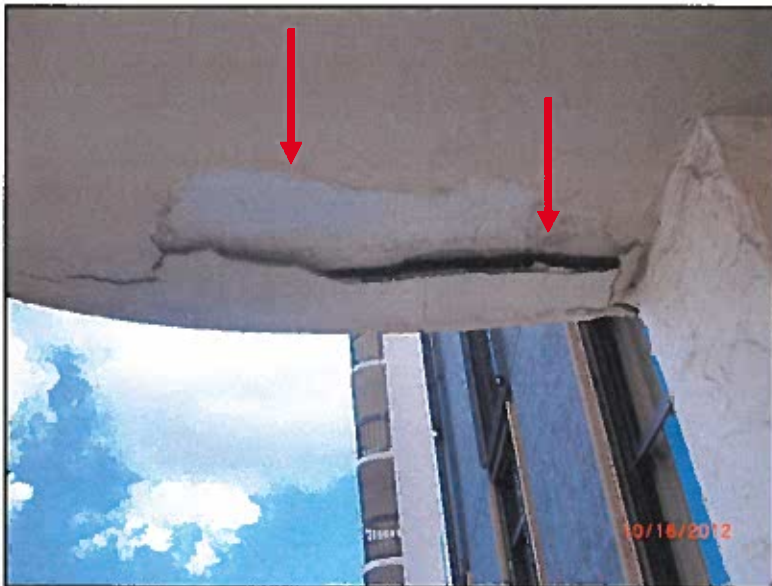
3. The balcony slabs are in fair condition. Spalled concrete with corroded reinforcing steel was noted on the balcony ceilings of Units 219 and 416 (photo #4 and photo #5).

PHOTO # 4: Concrete spalling/exposed steel rebar at balcony ceiling at Unit #219

Although the edges of the balcony slabs are typically in fair condition, some units exhibit cracking and concrete spalling at the slab edge and at the underside of slab above. This is an indication of moisture intrusion into the concrete, with subsequent corrosion of the reinforcing steel. If left unabated, the concrete at the edges of balconies will eventually spall off, creating a falling debris and life safety hazard for residents and pedestrians below. It's recommended that balcony edges be repaired where there are signs of cracking and concrete spalling. In addition, we also recommend that all balconies be surveyed to document similar conditions.

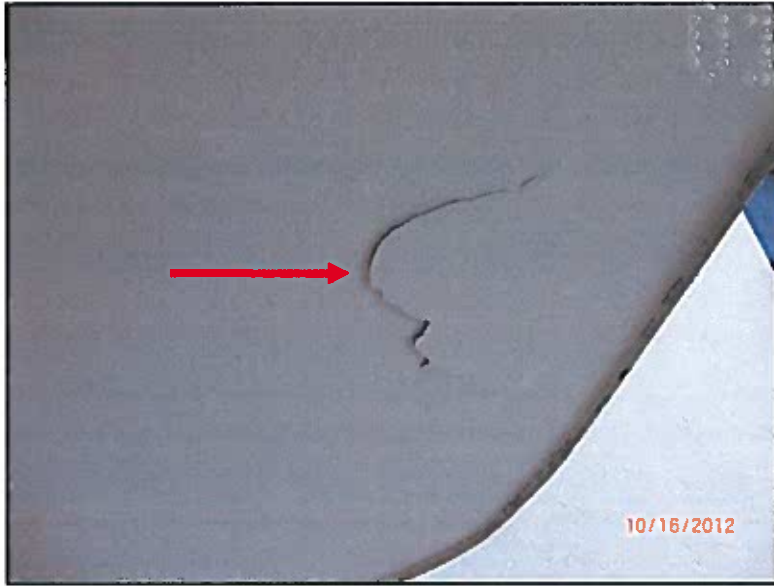
PHOTO # 5: Concrete spalling at balcony ceiling at Unit #416

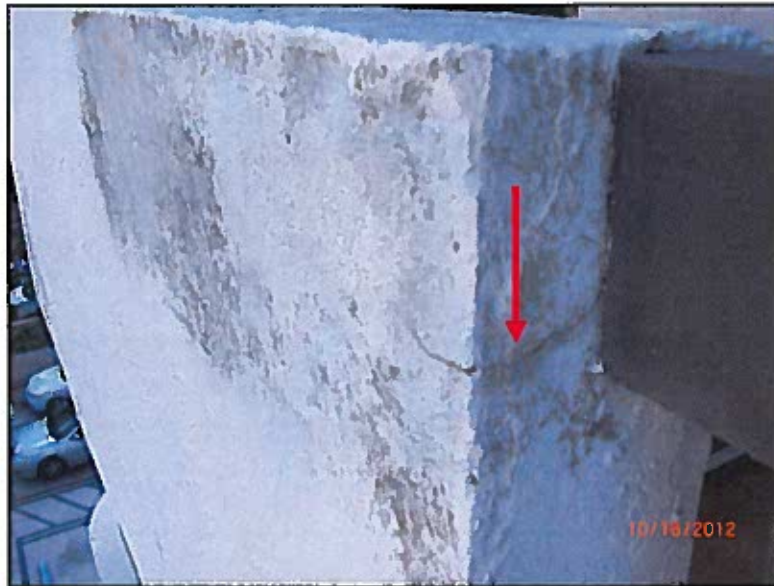
4. Minor stucco cracking at balcony railing connection to block wall of Unit 407 (photo #6).
5. We observed stucco cracking along balcony's edge of Unit 407 (photo #7) and connection between block wall and building column of Unit 219 (photo #8).

PHOTO # 6: Cracking stucco at balcony railing connection at Unit #407

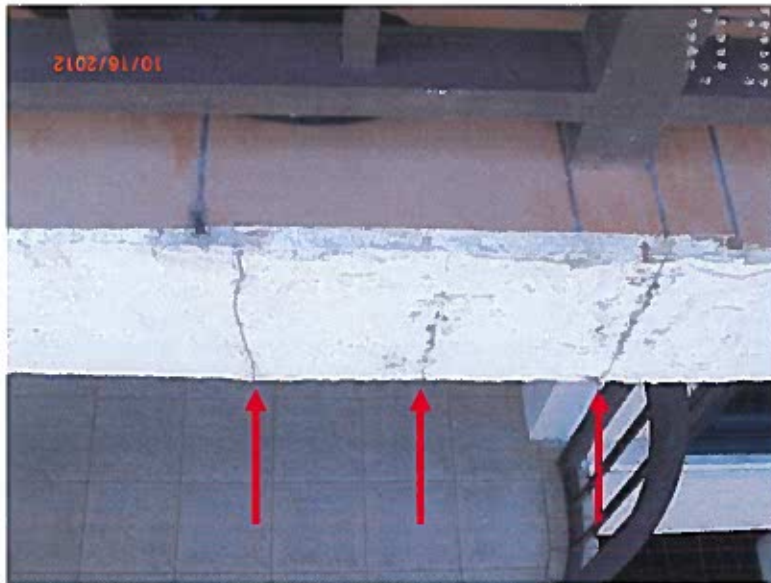
PHOTO # 7: Cracking/delaminated stucco on balcony slab edge at Unit #407

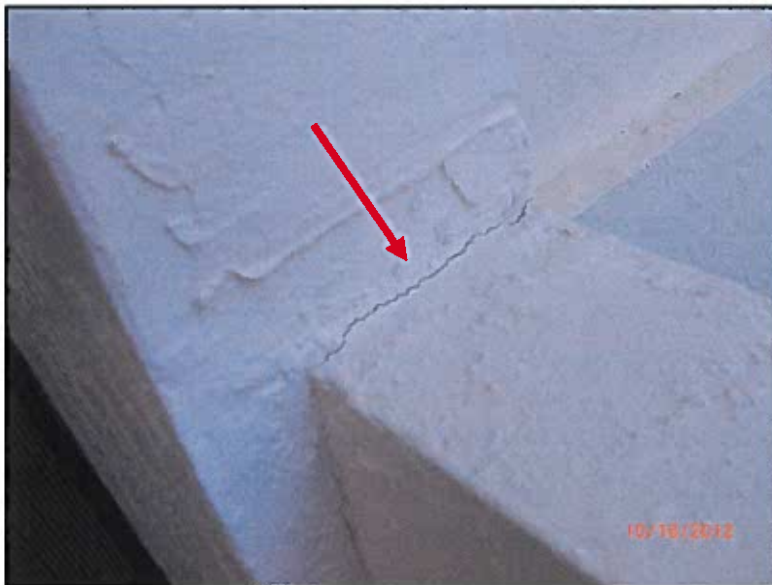
PHOTO # 8: Cracking at connection between balcony wall and bldg. column at Unit #219

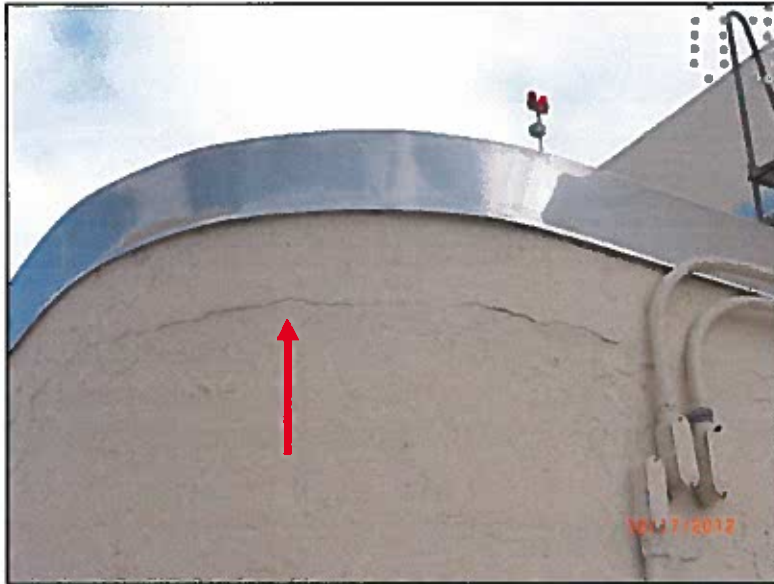
6. The roof edges of the Generator Room (photo #9) and East Elevator Machine Room (photo #10) at Roof Area have fine horizontal cracks which exhibit signs of water infiltration.

PHOTO # 9: Delaminated/cracking stucco at exterior of Generator Room at roof area

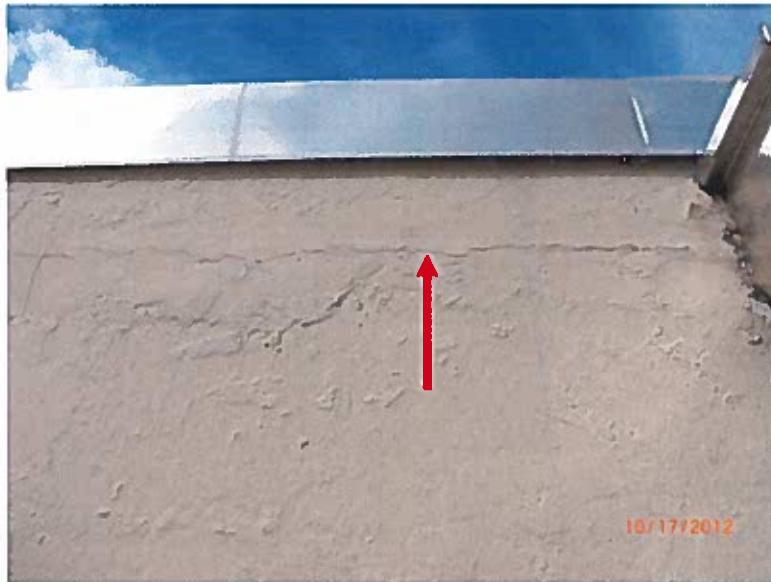
PHOTO # 10: Delaminated/cracking stucco at exterior of east Elevator Machine Room at Roof Area

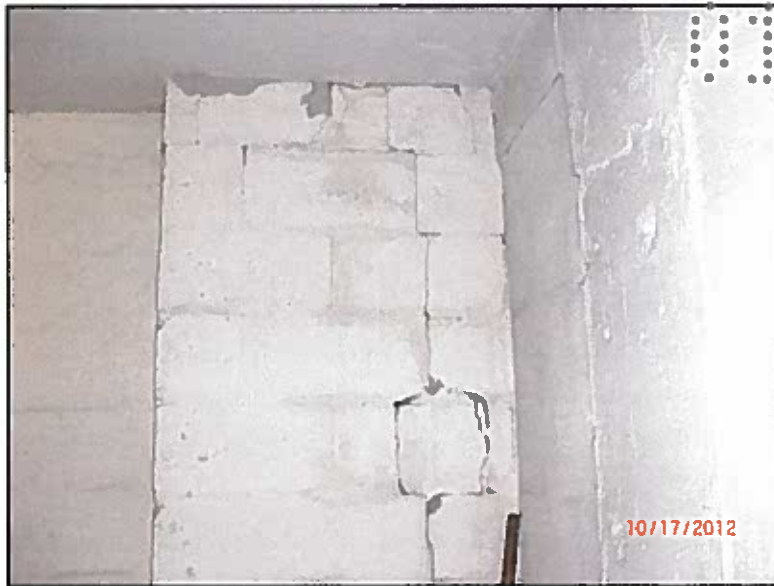
7. The interior block wall at the east side of the Elevator Machine Room at the Roof Area was observed with step cracking (photo #11).
8. The roof edge of the Penthouse exterior wall (photo #12) was noted with fine horizontal cracks which exhibit signs of water infiltration.

PHOTO # 11: Step cracking at corners of east side Elevator Machine Room

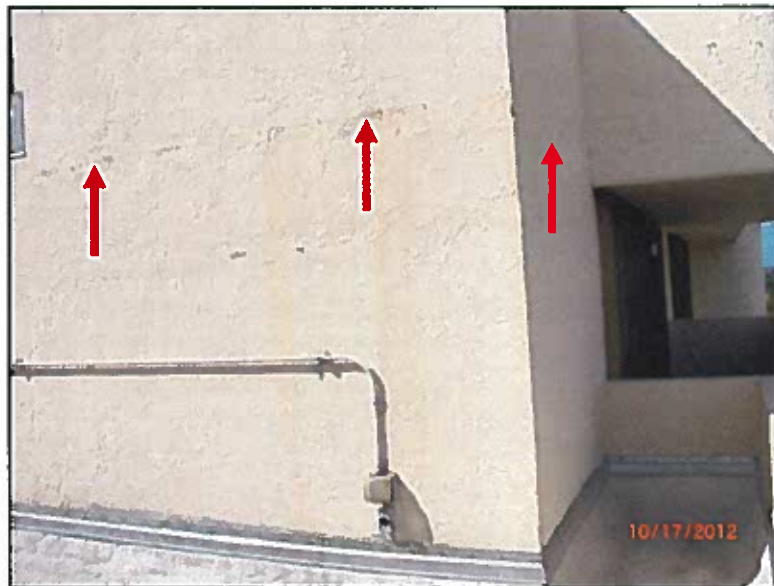
PHOTO # 12: Horizontal cracking at PH exterior wall

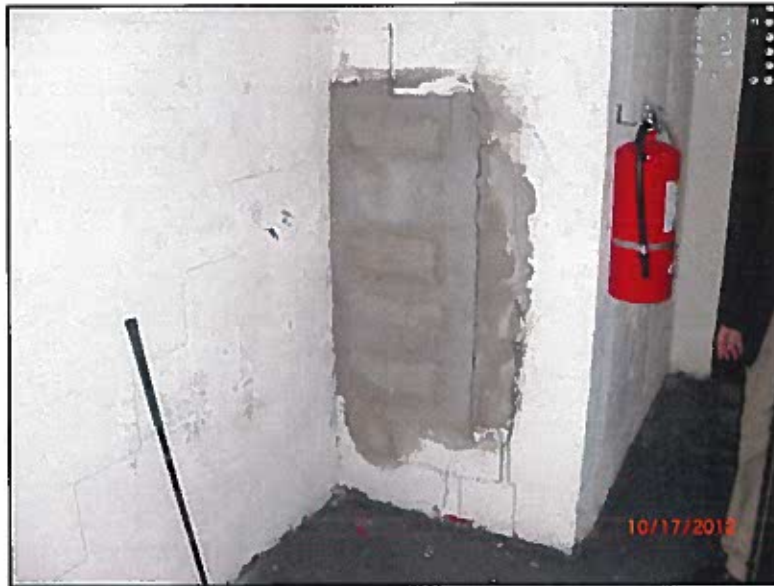
9. The interior block wall at the West Elevator Machine Room is not mortared properly at patched area (photo #13).
10. Hair Line cracking across column drop panel next to Parking Space No. 267 (photo #14 and photo #15).

PHOTO # 13: Cracks on block wall at inside of West Elevator Machine Room

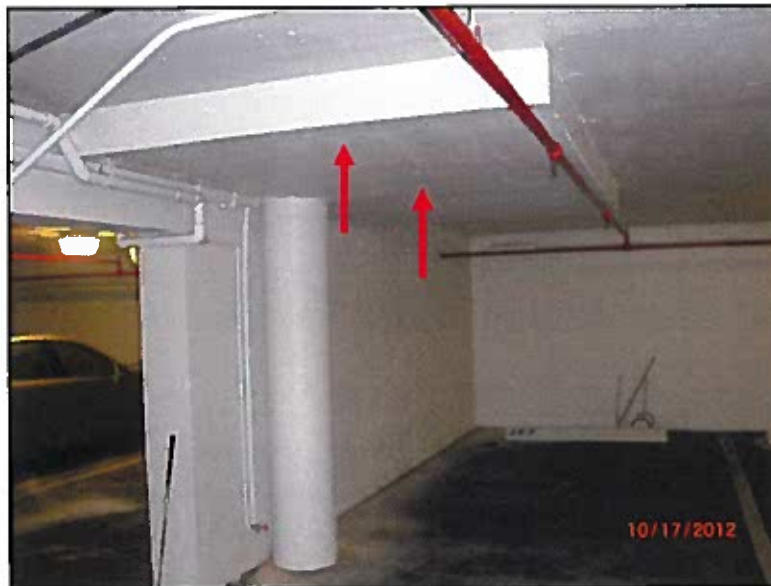
PHOTO # 14: slab cracking at column drop panel next to Parking Space No. 267

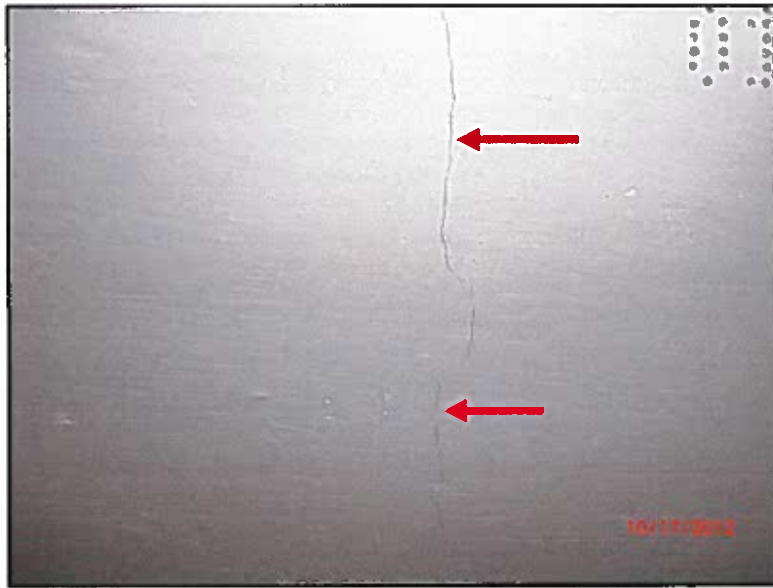
PHOTO # 15: slab cracking at column drop panel next to Parking Space No. 267

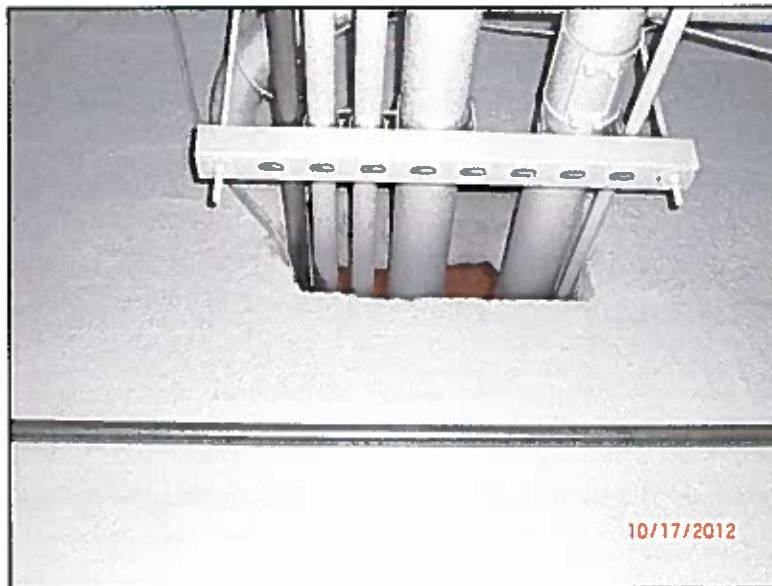
11. Unsealed wall pipe penetration at fire rated separation (2hr Fire rate assembly) (photo #16).
12. Hair line cracking on slab and beam was noted next to Parking Space No. 210 (photo #17 and photo #18).

**PHOTO # 16: Unsealed wall, pipe penetration at Fire rated assembly (2hr fire rated assembly)
Paint Storage Room**

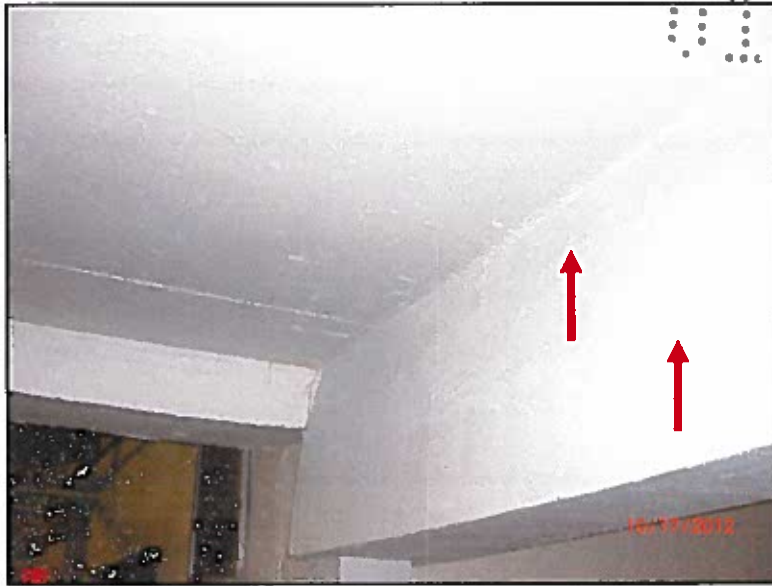
PHOTO # 17: slab cracking and beam cracks next to Parking Space 210

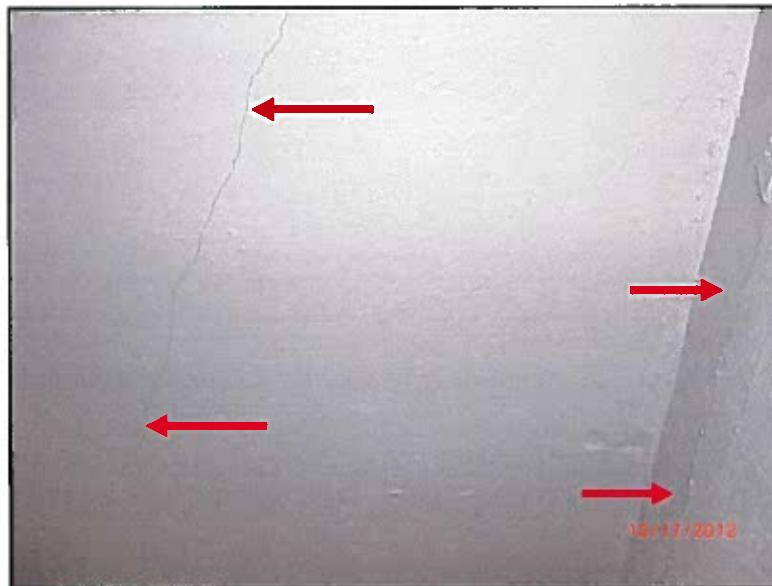
PHOTO # 18: slab cracking at column drop panel next to Parking Space 210

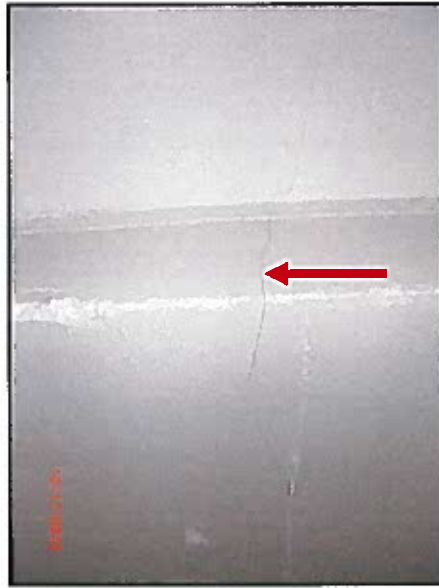
13. Hair line cracking across column drop panel between Parking Space No. 248 & 249 (photo #19).
14. Hair Line cracking at column drop panel corner between Parking Space No. 245 & 246 (photo #20).

PHOTO # 19: slab cracking at column drop panel between Parking Spaces 248 & 249

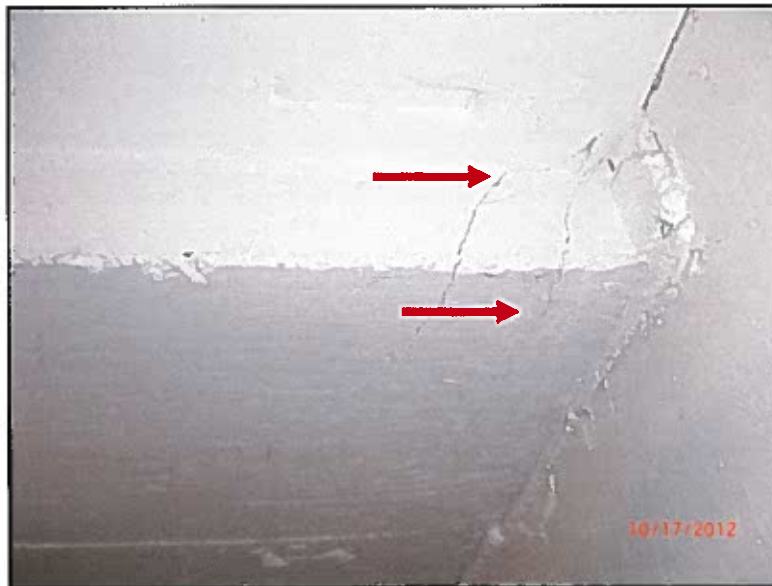
PHOTO # 20: slab cracking at column drop panel between Parking Spaces 245 & 246

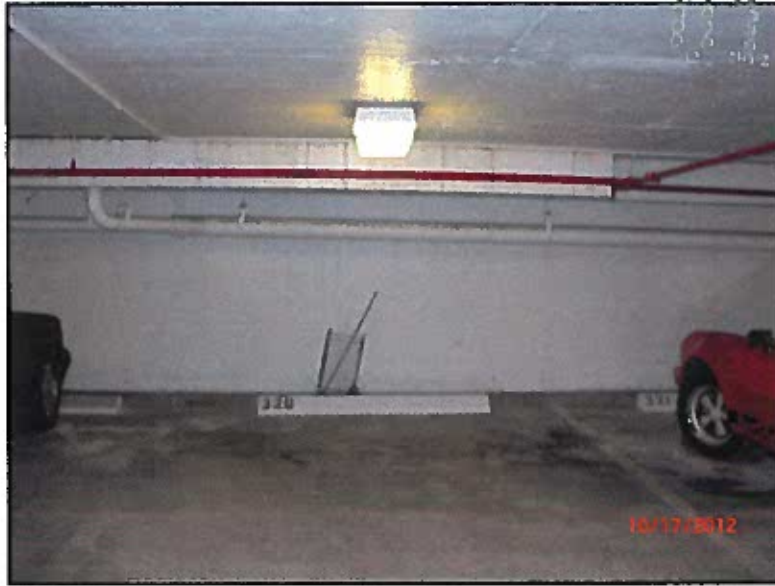
15. Trench drain drop ceiling opening over flows at opening between Parking Spaces No. 314 & 327 (photo #21 and photo #22).
16. Surface cracking and water intrusion was noted at underside of ramp on front of Parking Space No. 61 (photo #23).

PHOTO # 21: trench drain drop ceiling between Parking Spaces 314 & 327

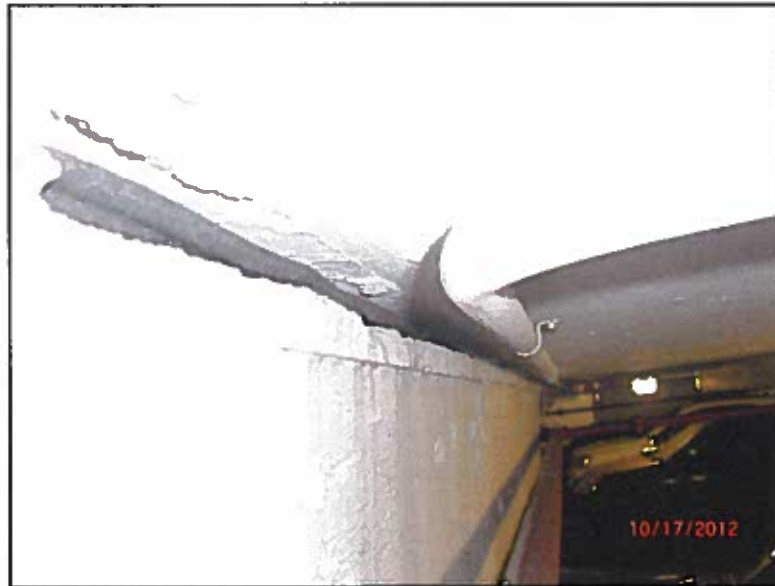
PHOTO # 22: trench drain drop ceiling opening between Parking Spaces 314 & 327

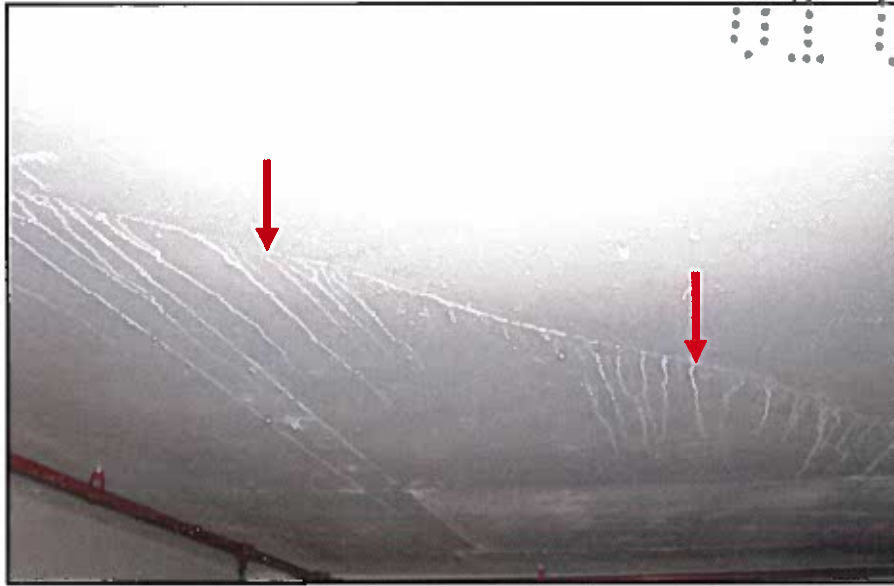
PHOTO # 23: cracking and water intrusion at underside of ramp in front of Parking Space 61

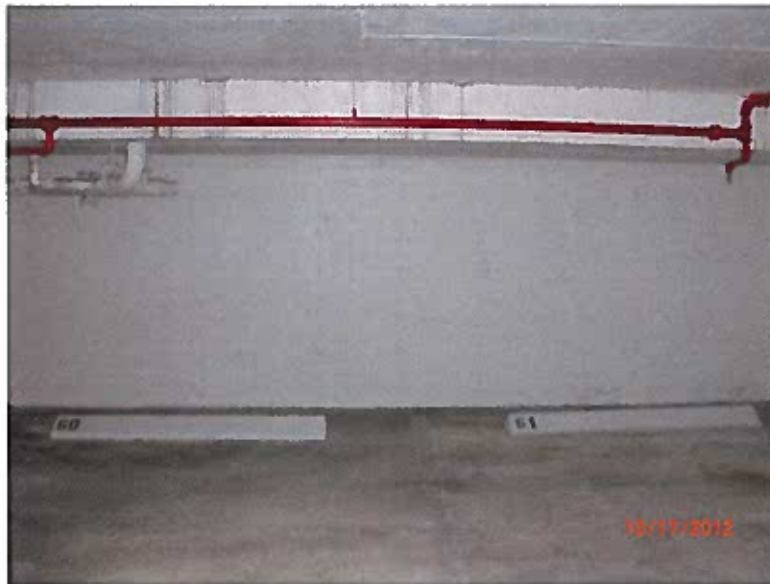
17. Trench drain drop ceiling opening over flows at opening between Parking Space No. 52 & 61 (photo #24 and photo #25).
18. The East end of the Parking Garage wall exhibits hair line cracking next to Parking Space No. 51 (photo #26).

PHOTO # 24: trench drain drop ceiling between Parking Spaces 52 & 61

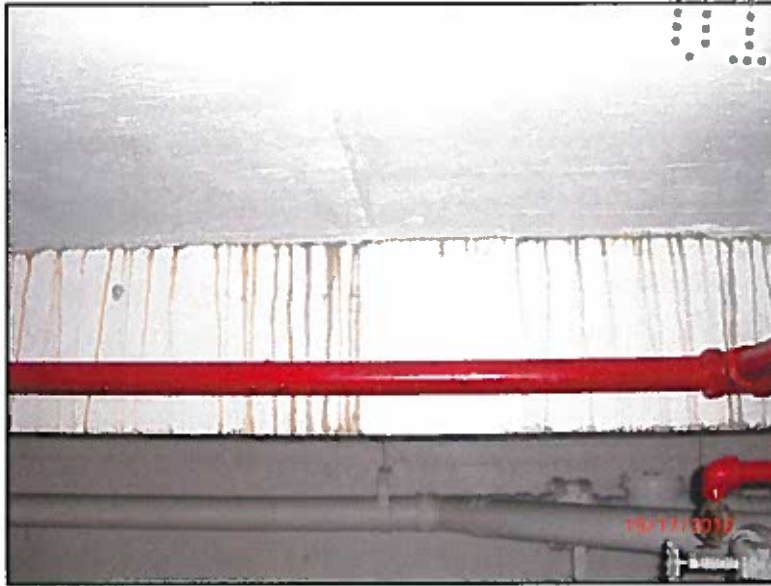
PHOTO # 25: trench drain drop ceiling between Parking Spaces 52 & 61

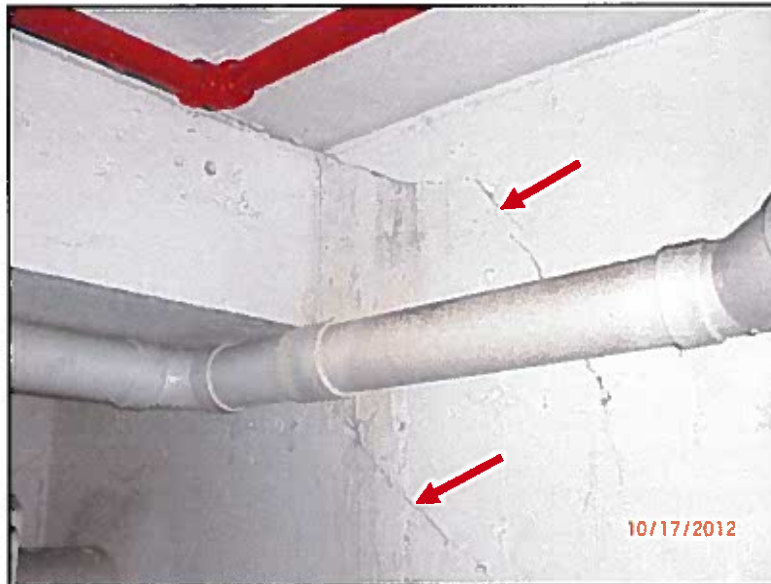
PHOTO # 26: cracking on wall next to Parking Space 51

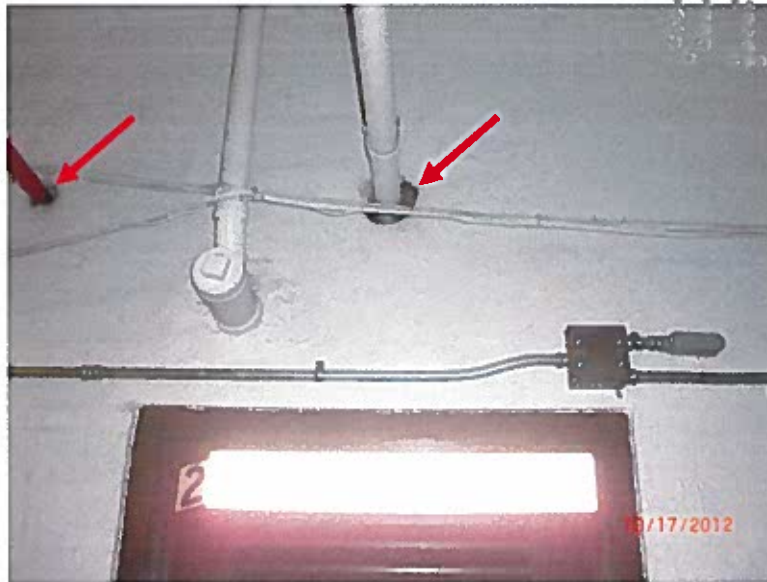
19. Unsealed wall pipe penetration at fire rated separation (2hr Fire rate assembly) above Fire Pump Room door (photo #27).
20. Hair Line Cracking on Overhang at West side (photo #28).

PHOTO # 27: Unsealed wall, pipe penetration at Fire rated assembly (2hr fire rated assembly)
Paint Storage Room

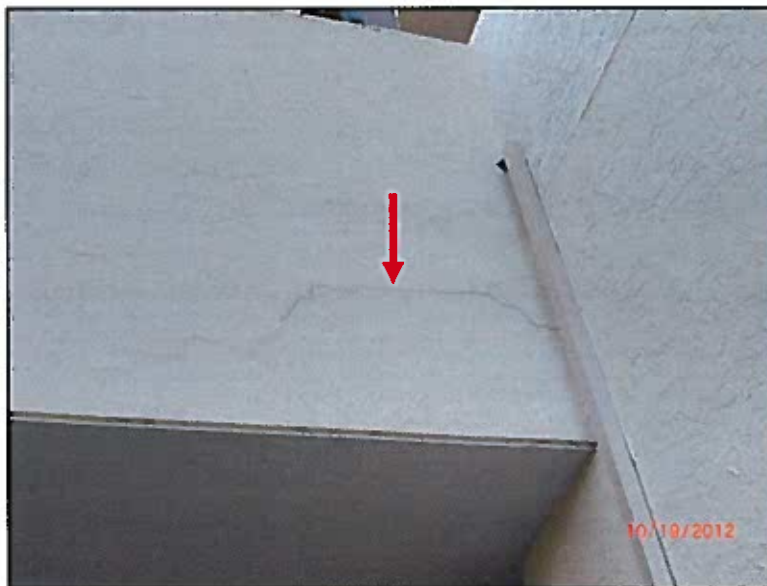
PHOTO # 28: cracking on overhang at West side

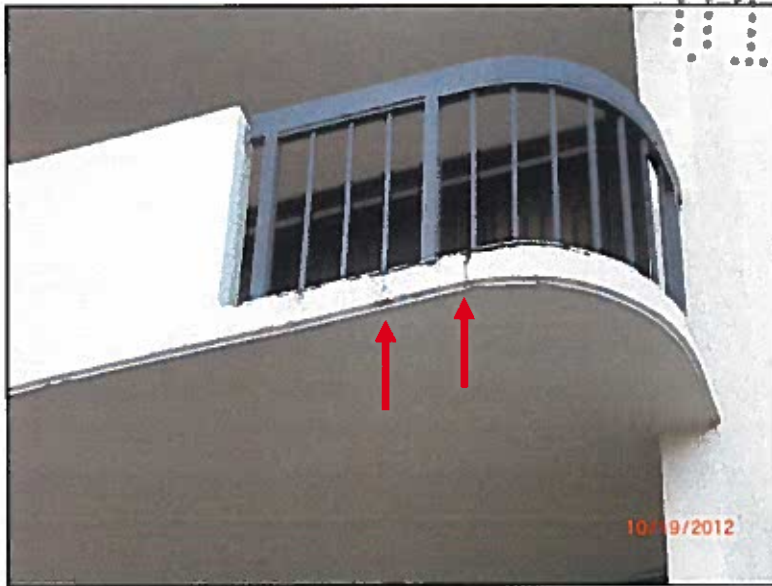
21. Hair Line Cracking and staining on balcony edge at Third level on north side (photo #29).
22. Blistering and underside cracking was observed at Overhang (photo #30).

PHOTO # 29: cracking and staining on balcony edge

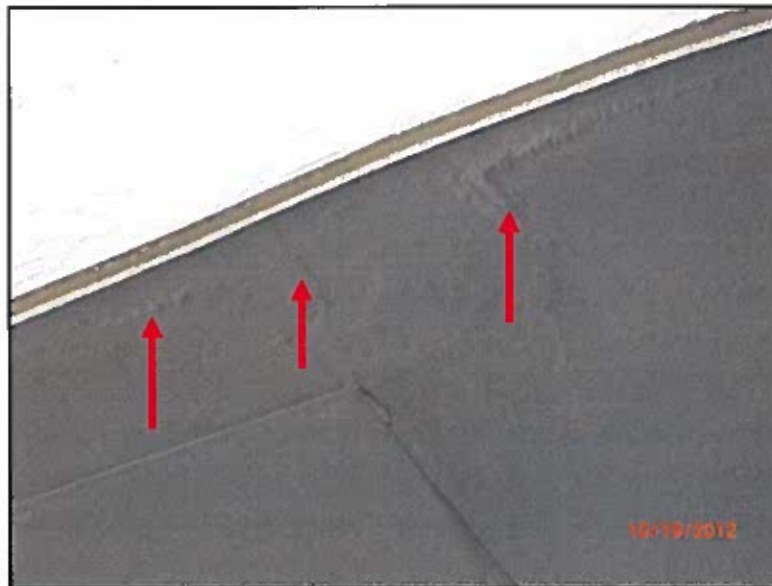
PHOTO # 30: cracking & blistering at underside of overhang edge

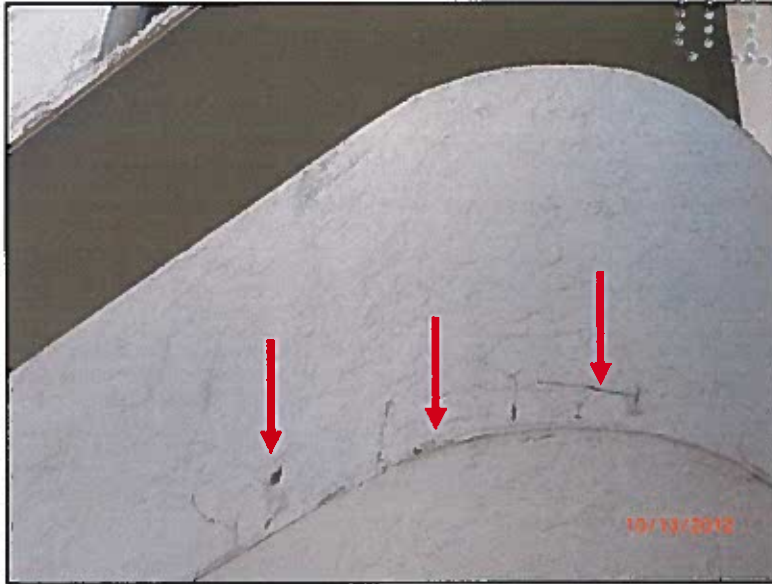
23. Cracking at bottom of balcony wall was noted (photo #31).
24. Crack along tiled pedestrian ramp east of main entrance was observed (photo #32).
25. Delaminated stucco and cracking at bottom of fourth floor balcony wall on east (photo #33).

PHOTO # 31: stucco cracking at bottom of third floor balcony wall on East side

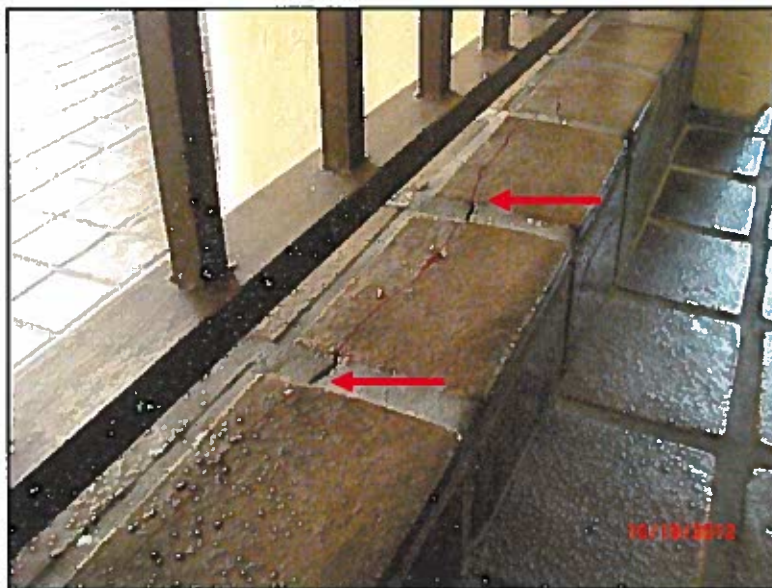
PHOTO # 32: crack along tiled ramp east of main entrance

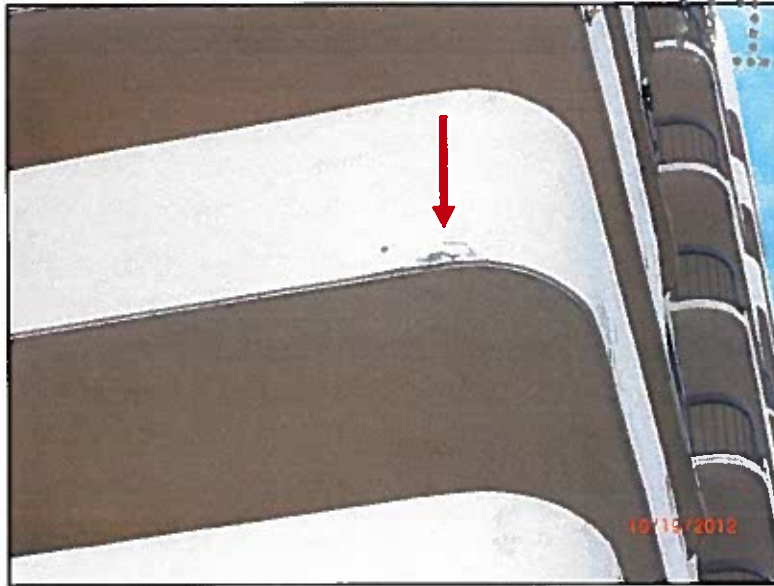
PHOTO # 33: cracking and staining at bottom of fourth floor balcony wall on east

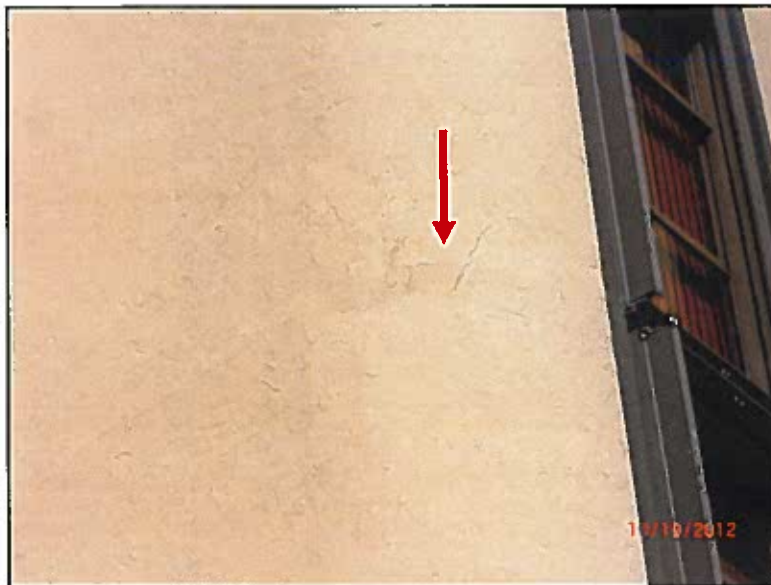
26. Surface cracks on building shear wall next to window shutter next to east stairs tower (photo #34).
27. Spider web cracking on exterior face at first balcony on East side (photo #35).

PHOTO # 34: stucco cracking on building wall next to east stairs tower

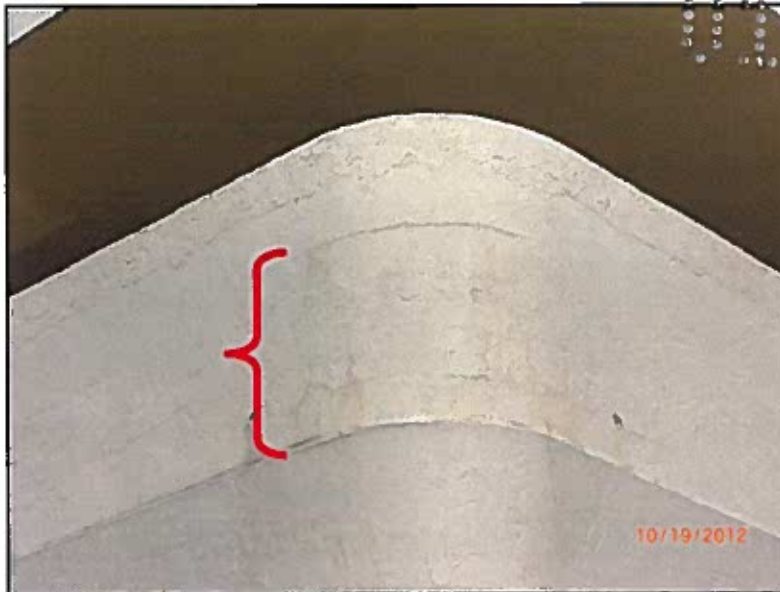
PHOTO # 35: spider web cracking on exterior face at second floor balcony on East side

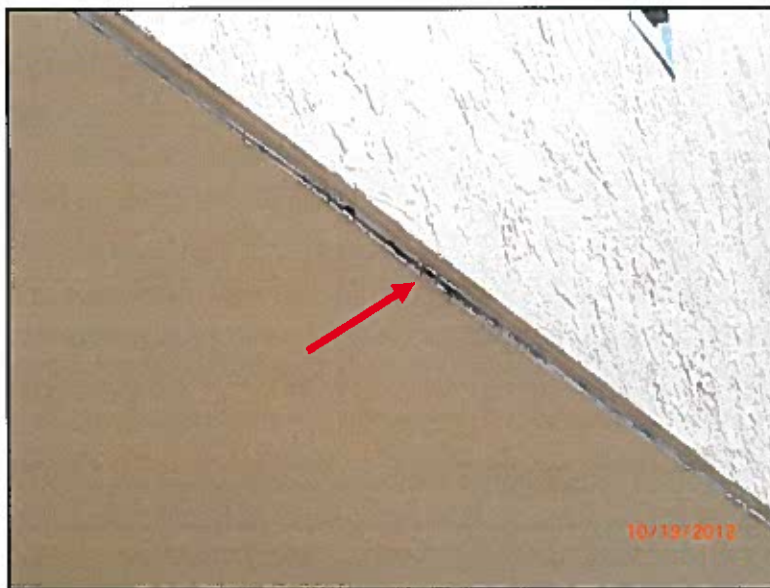
28. Ceiling panel separation at edge of South overhang (photo #36).
29. Stucco cracking on East side of building corner at Pool Deck Area (photo #37).

PHOTO # 36: ceiling separation at edge of South overhang

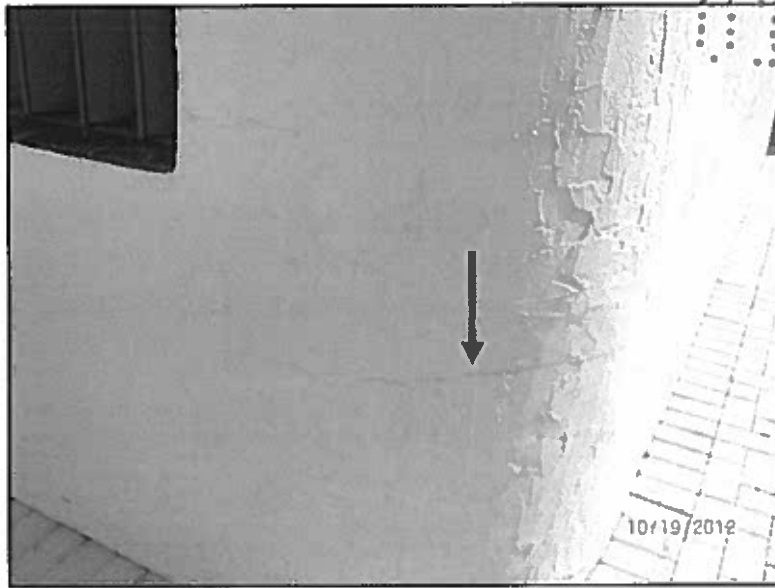
PHOTO # 37: stucco cracking on East side of building corner at pool deck area
