AFTER PHOTOS

EXTERIOR ARCHITECTURAL FEATURES

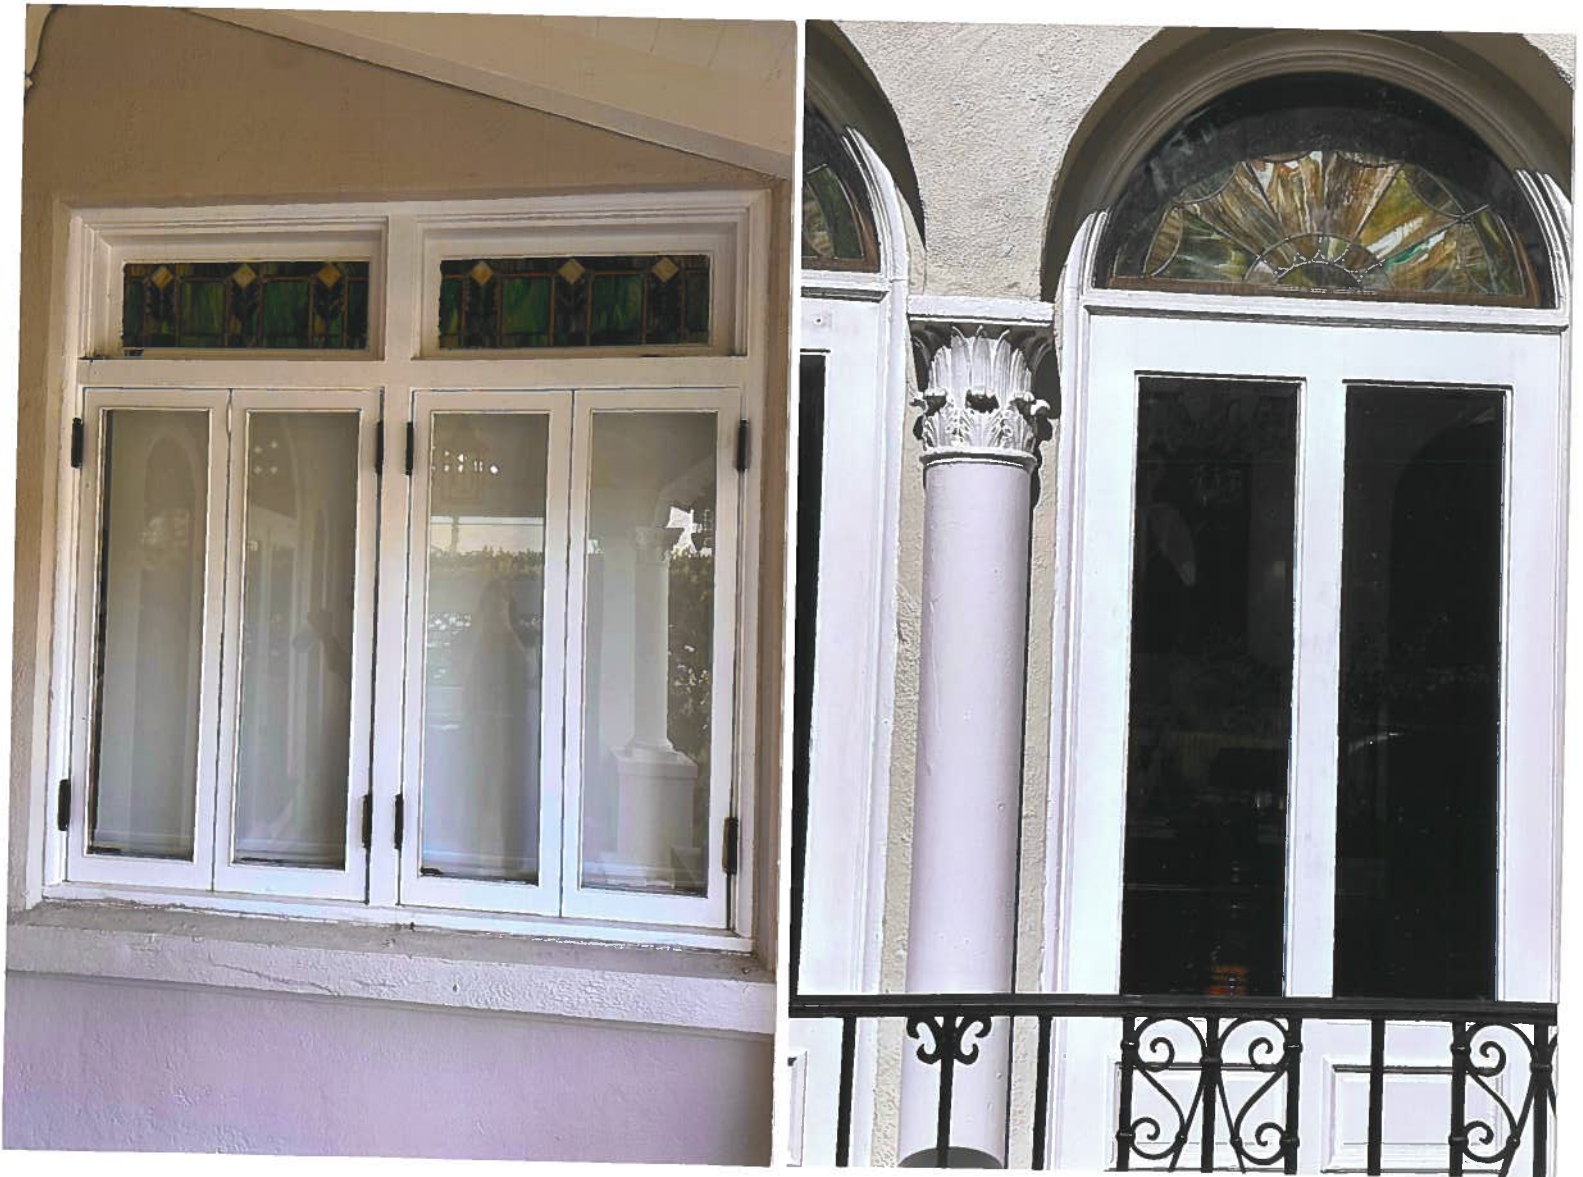
FEATURE # 1: ORIGINAL WINDOWS WITH STAINED GLASS -
REPAIRED & RESTORED

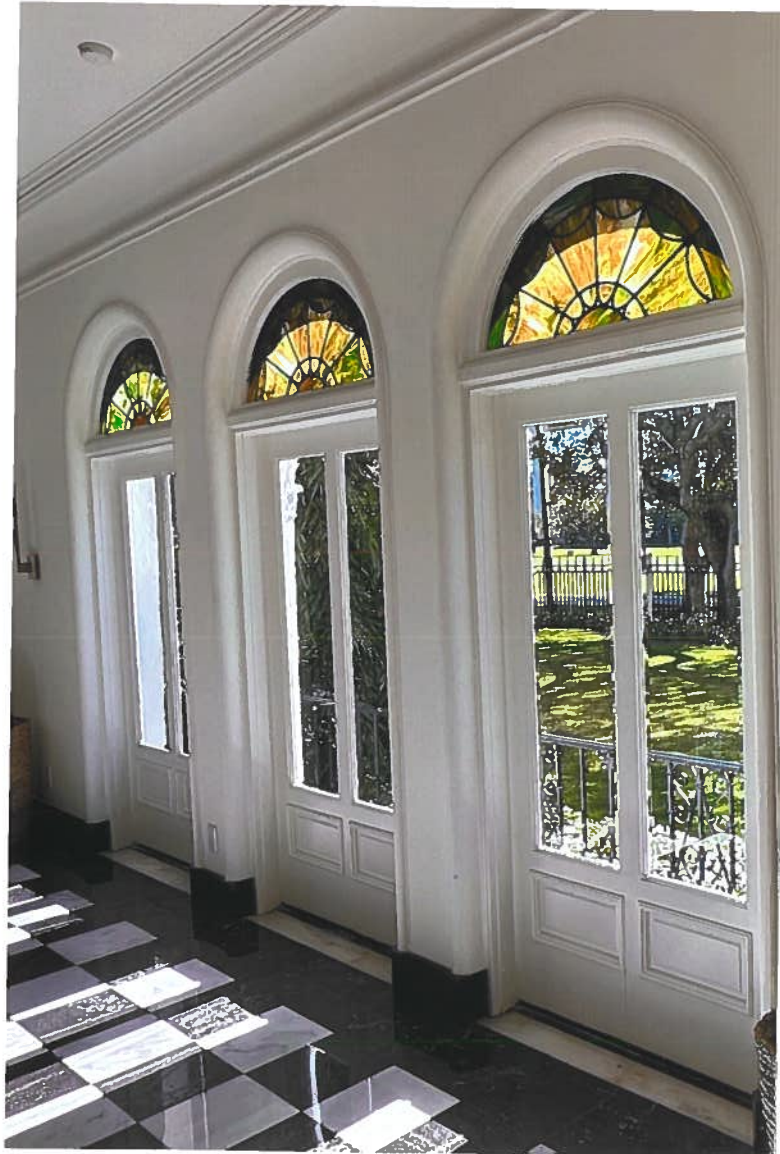
FEATURE # 1: ORIGINAL WINDOWS WITH STAINED GLASS -

REPAIRED & RESTORED (CONTINUED)

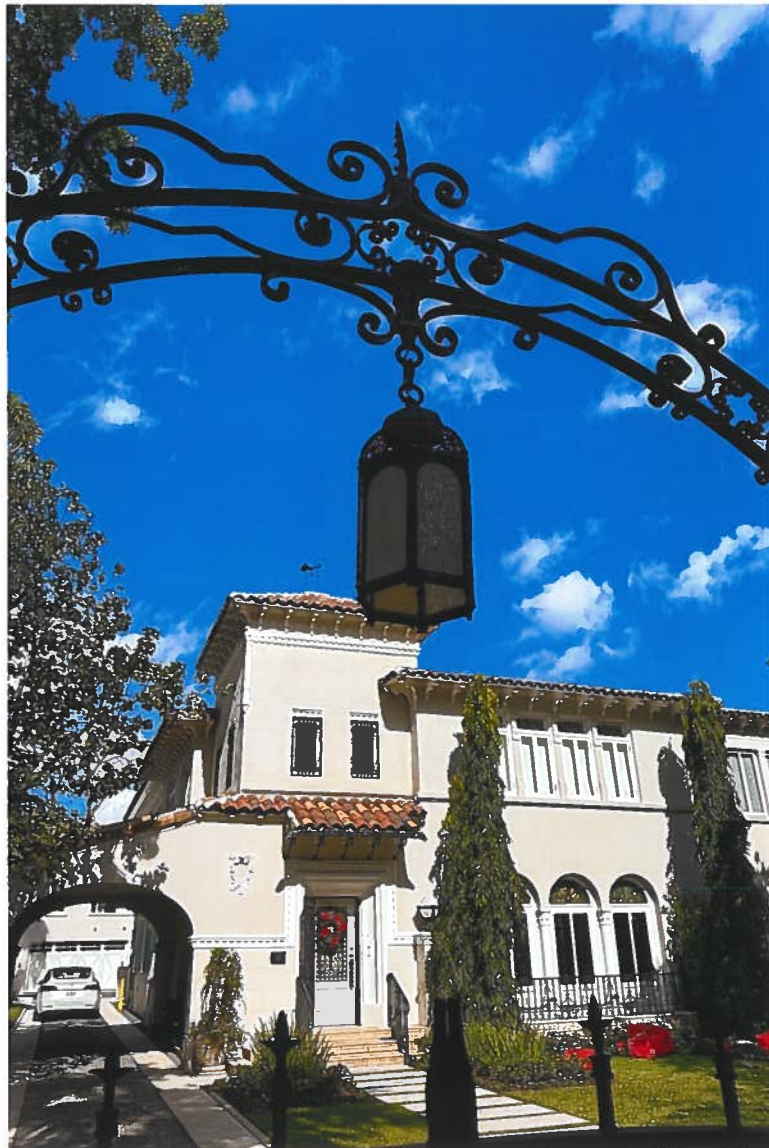
FEATURE # 2: ORIGINAL WROUGHT IRONWORK -

REPAIRED & RESTORED

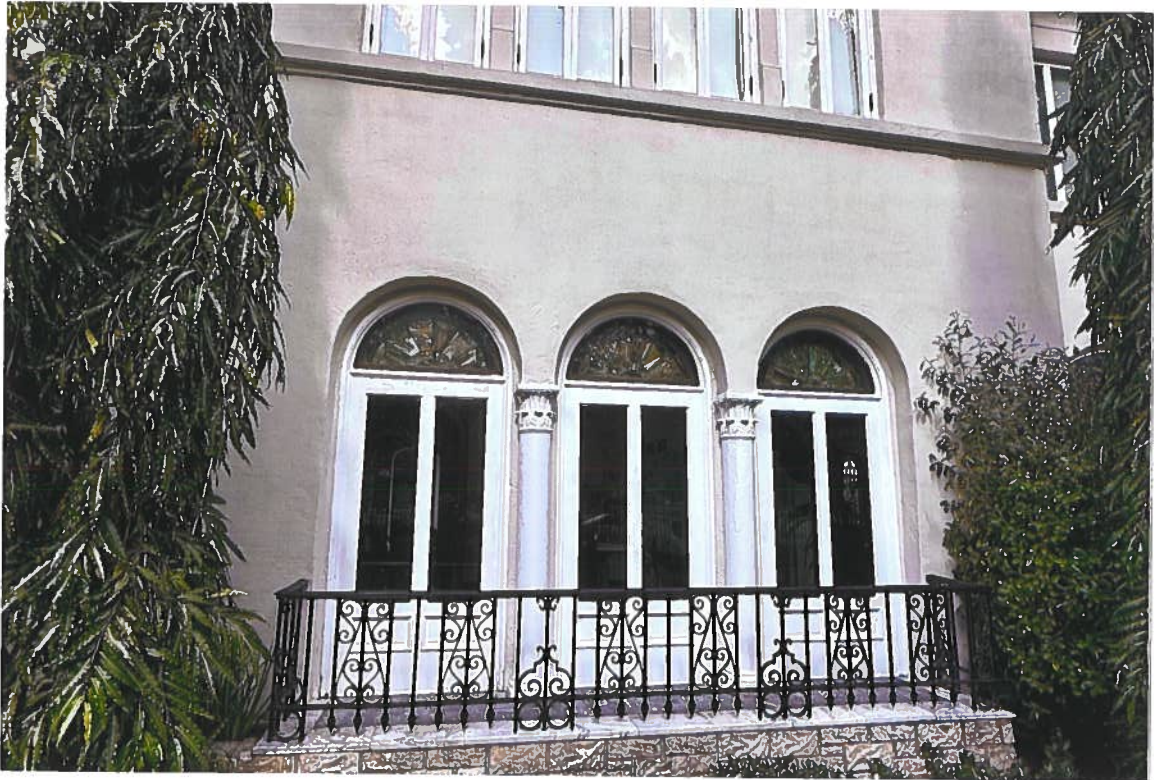
FEATURE # 2: ORIGINAL WROUGHT IRONWORK -

REPAIRED & RESTORED (CONTINUED)

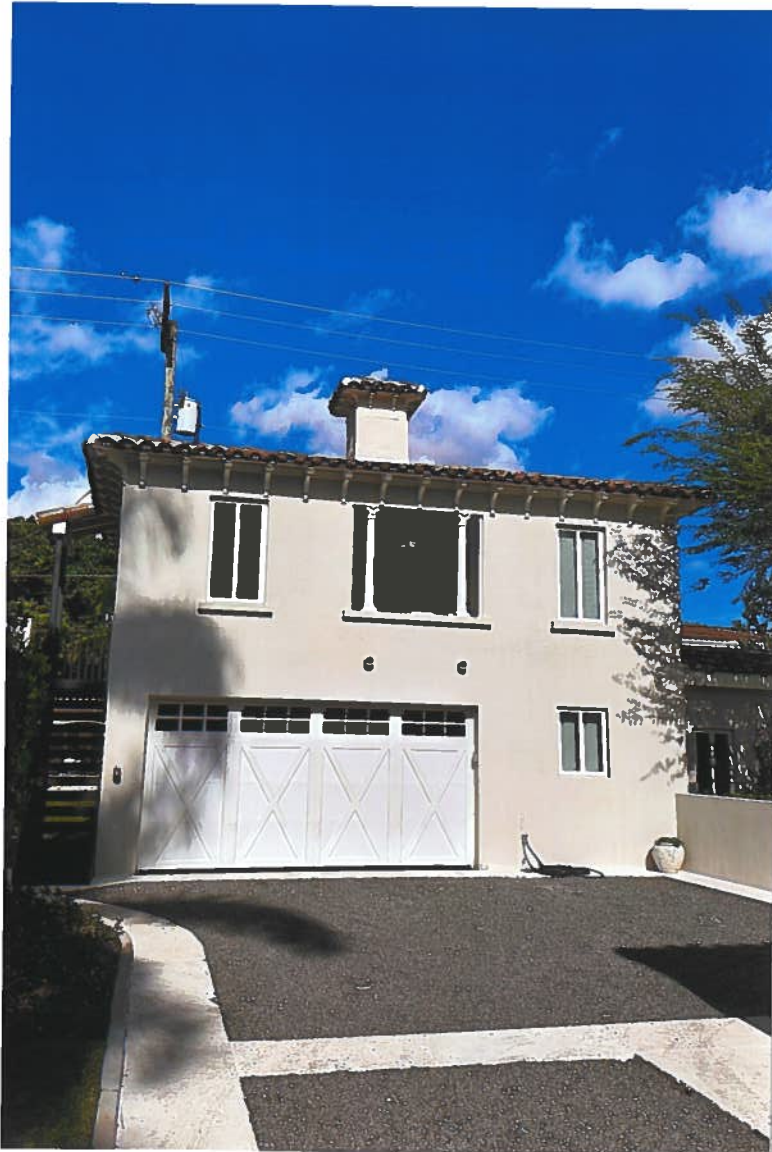
FEATURE # 3: RE-ESTABLISHING ORIGINAL GARAGE

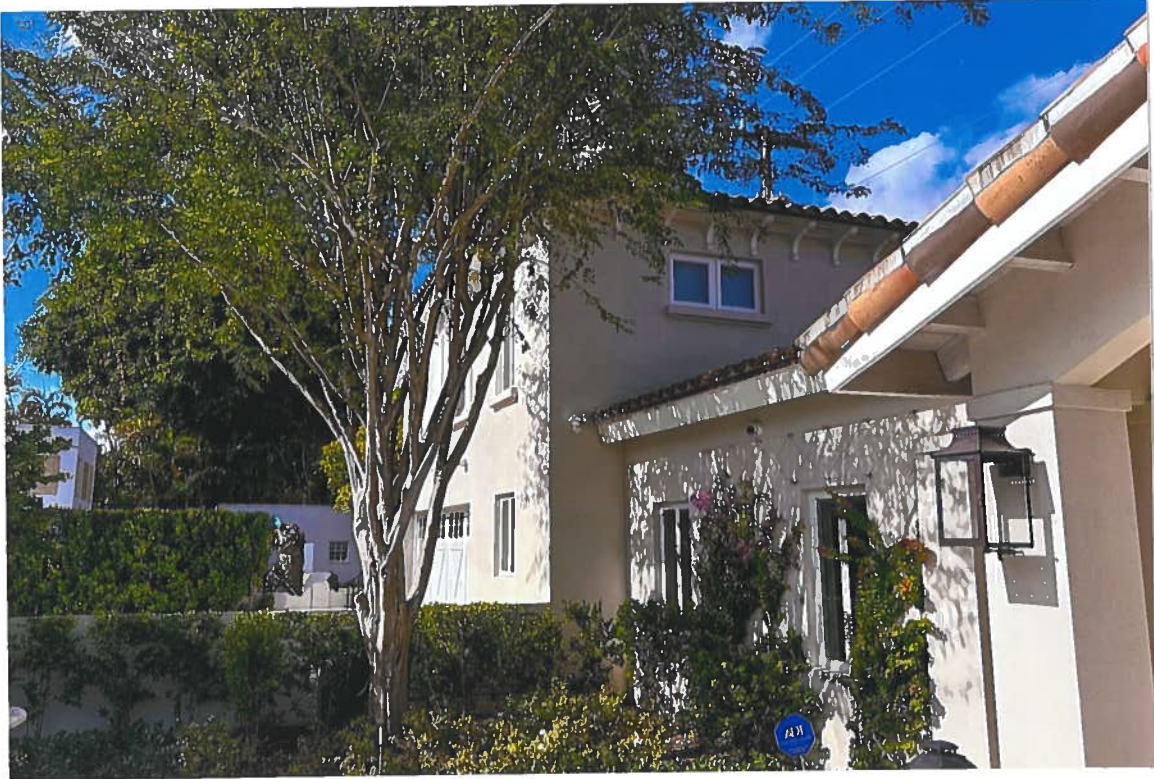
FEATURE # 6: ACCESSORY BUILDING (CONTINUED)

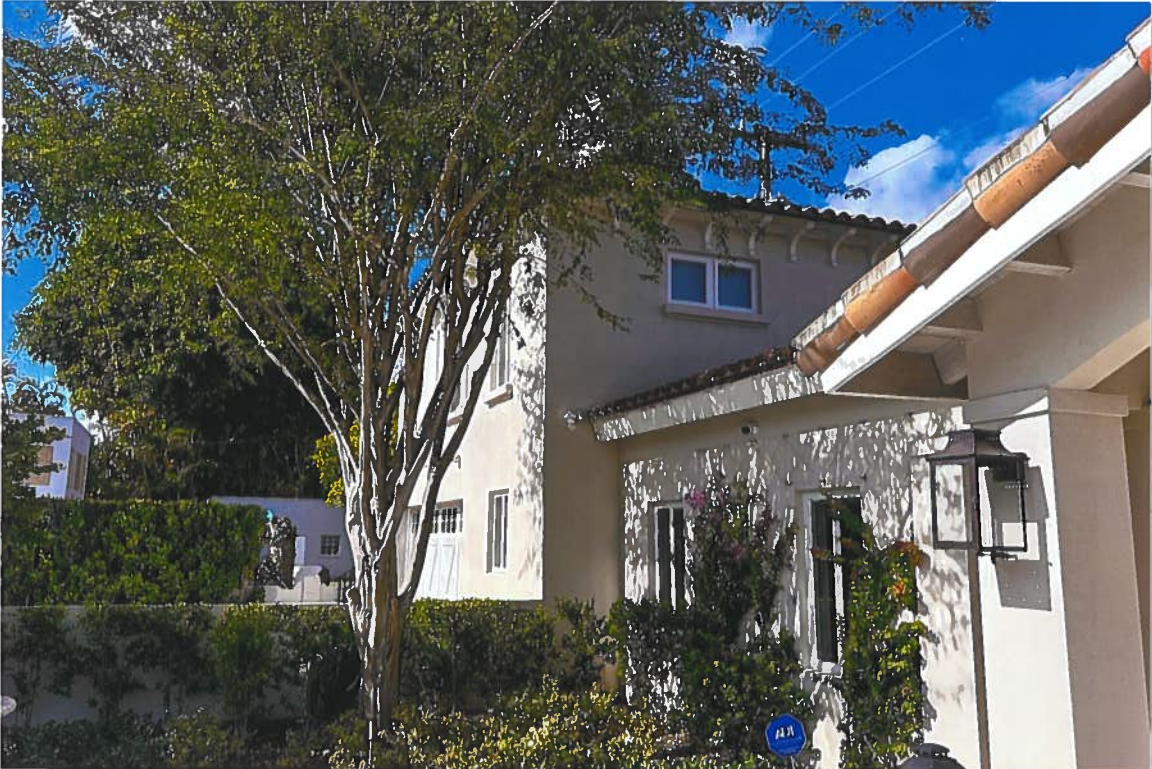
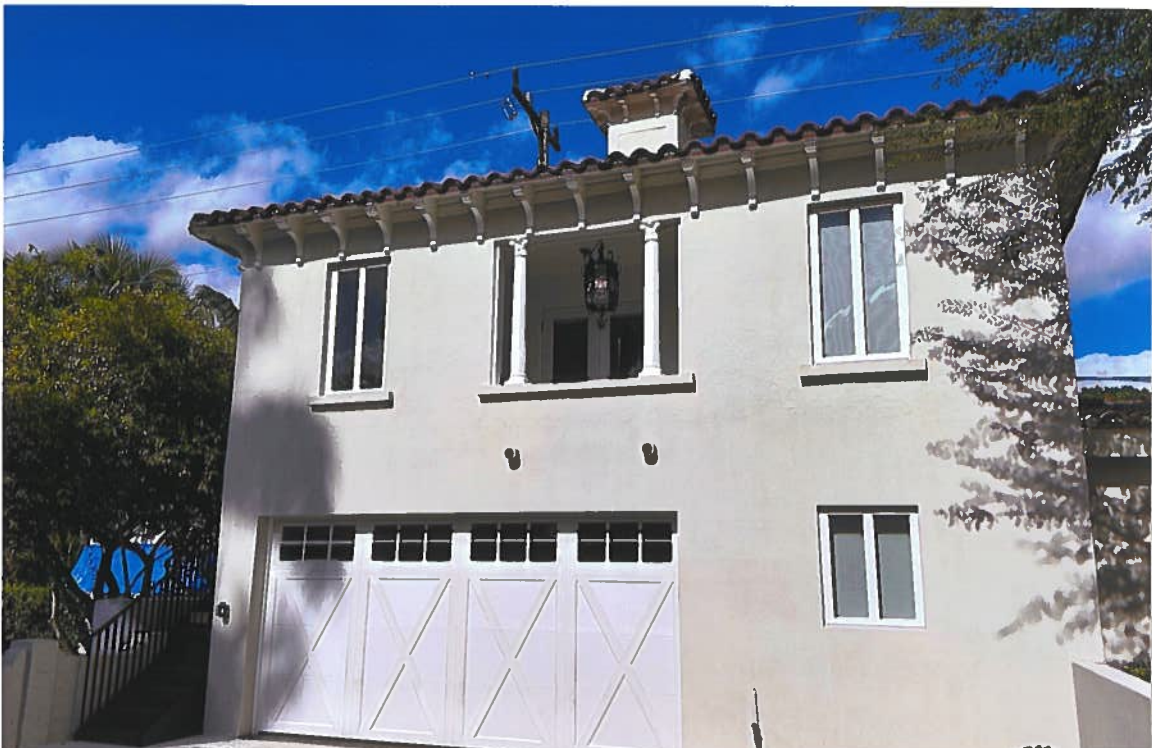
FEATURE # 3: RE-ESTABLISHING ORIGINAL GARAGE -

(CONTINUED)

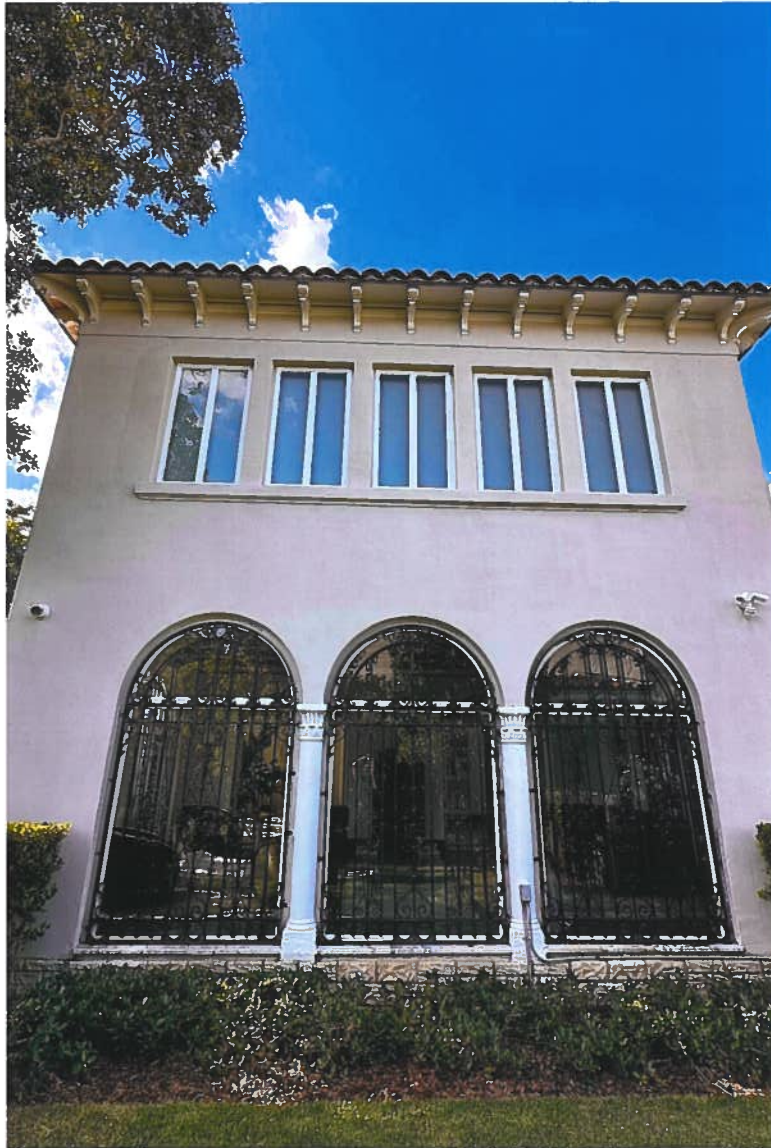
FEATURE # 4: RE-ESTABLISHING REMOVED WINDOWS

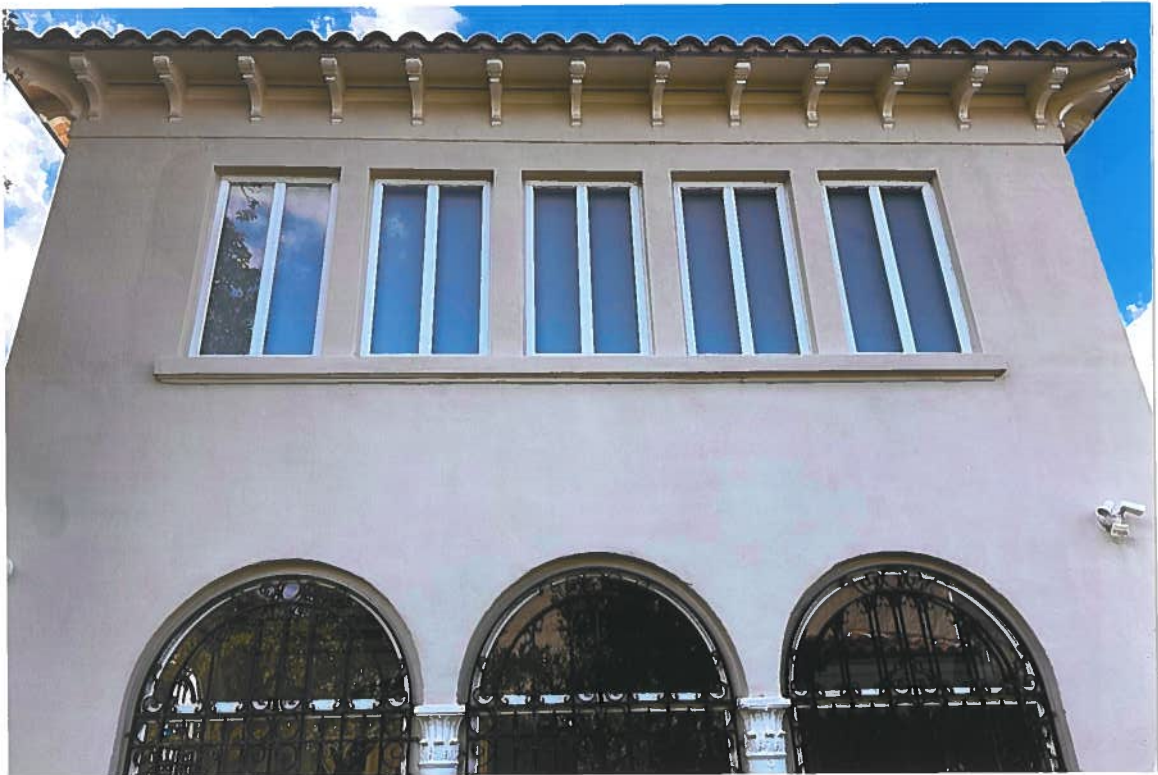
FEATURE # 4: RE-ESTABLISHING REMOVED WINDOWS

(CONTINUED)

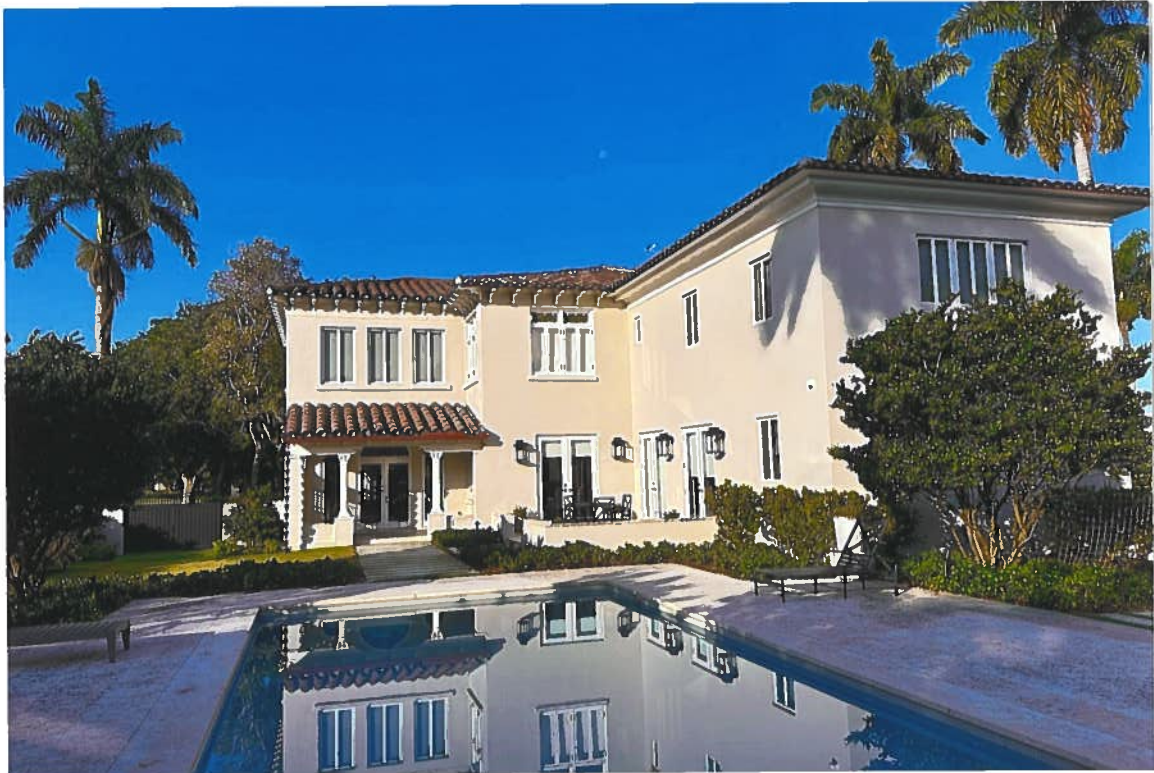
FEATURE # 5: EXTERIOR - REAR OF HOME

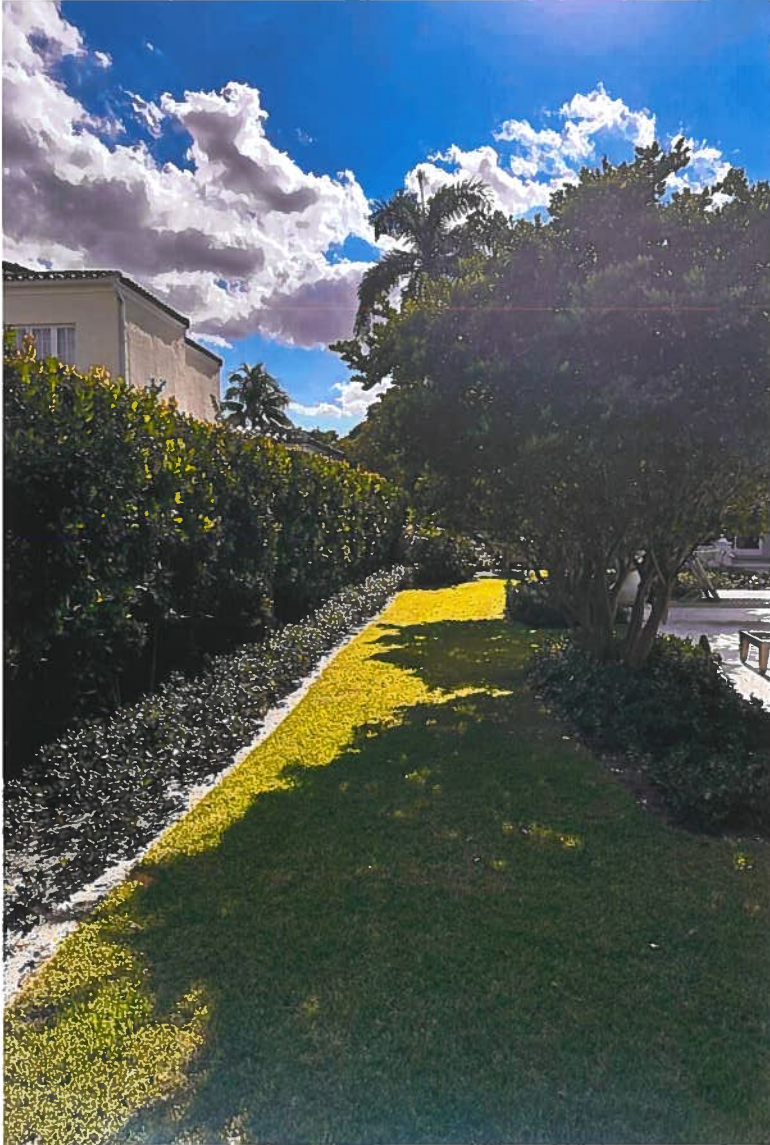
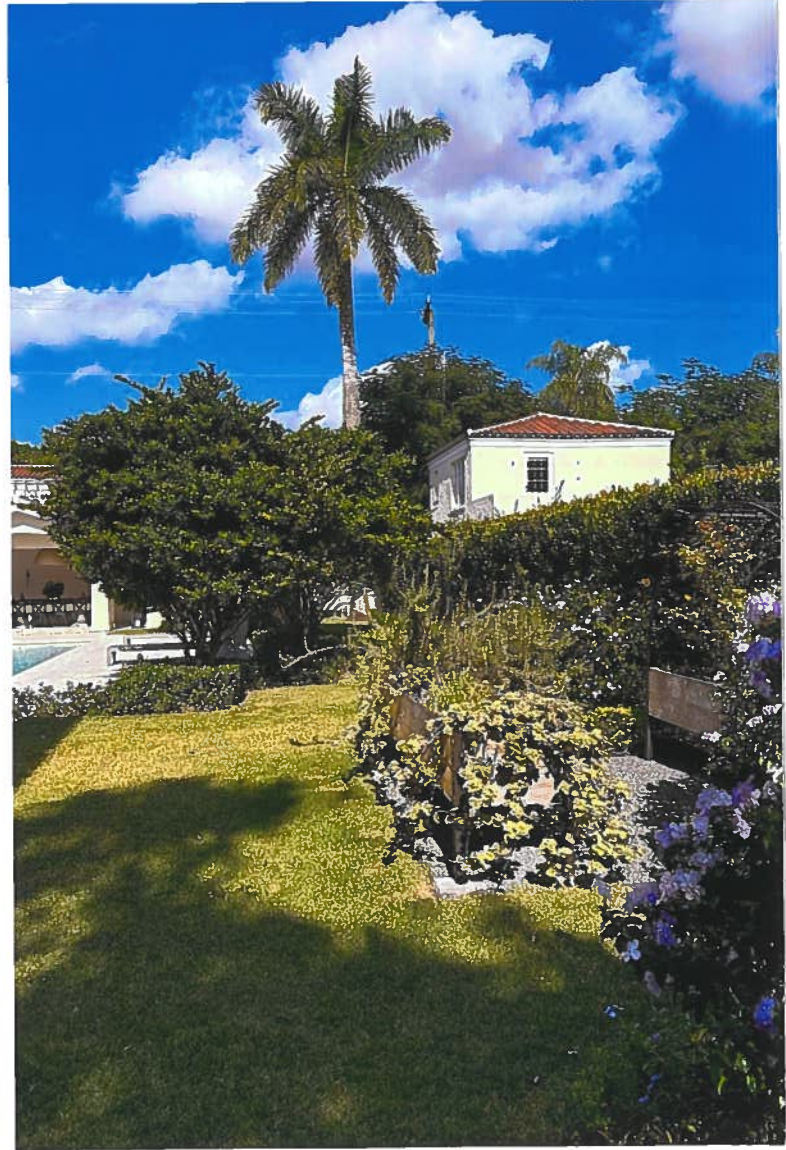
FEATURE # 5: EXTERIOR - REAR OF HOME

(CONTINUED)

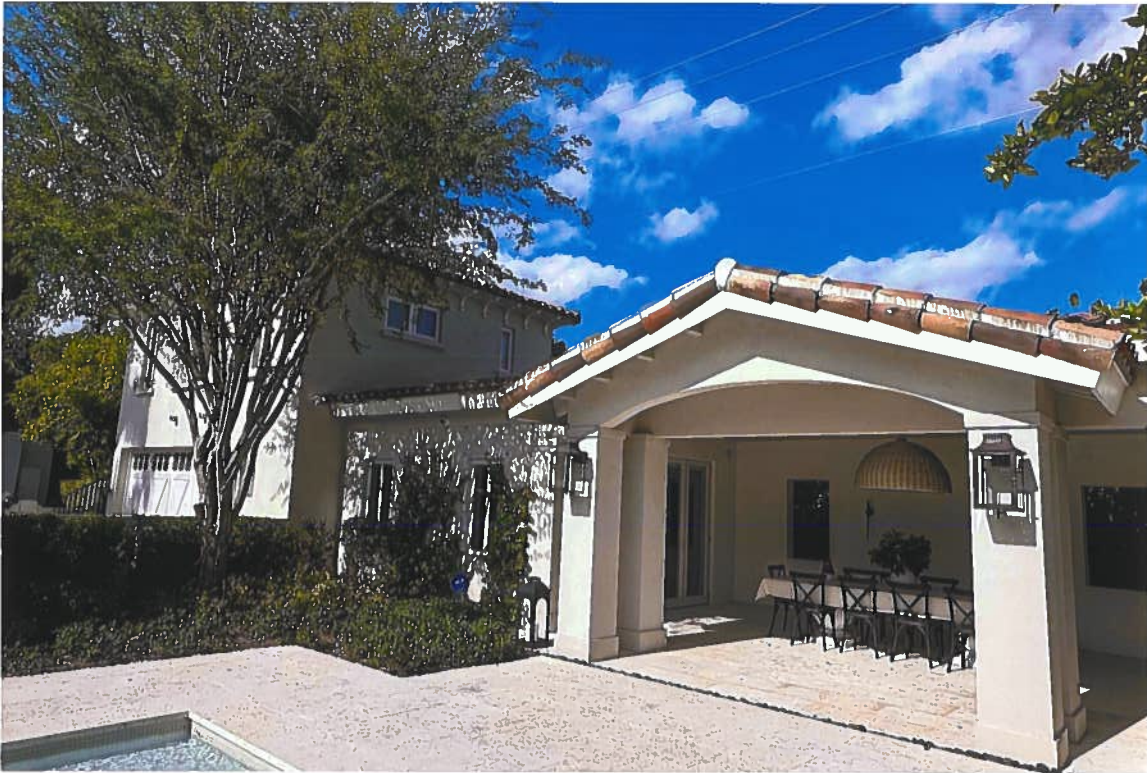
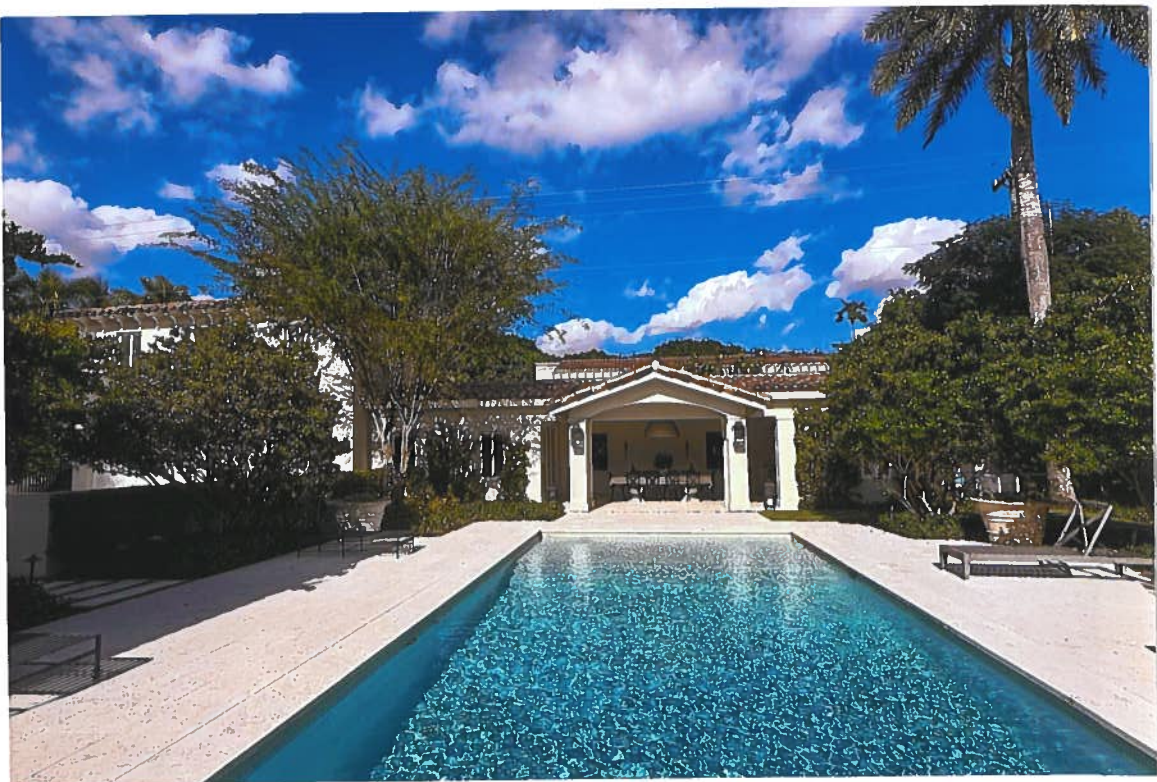
FEATURE # 6: ACCESSORY BUILDING
