Please find below my Tree Risk Assessment report for five Black Olive trees on north and east sides of property, on the right of way.

#### SUMMARY

DOCUMENTATION OF TREES 9/26/23

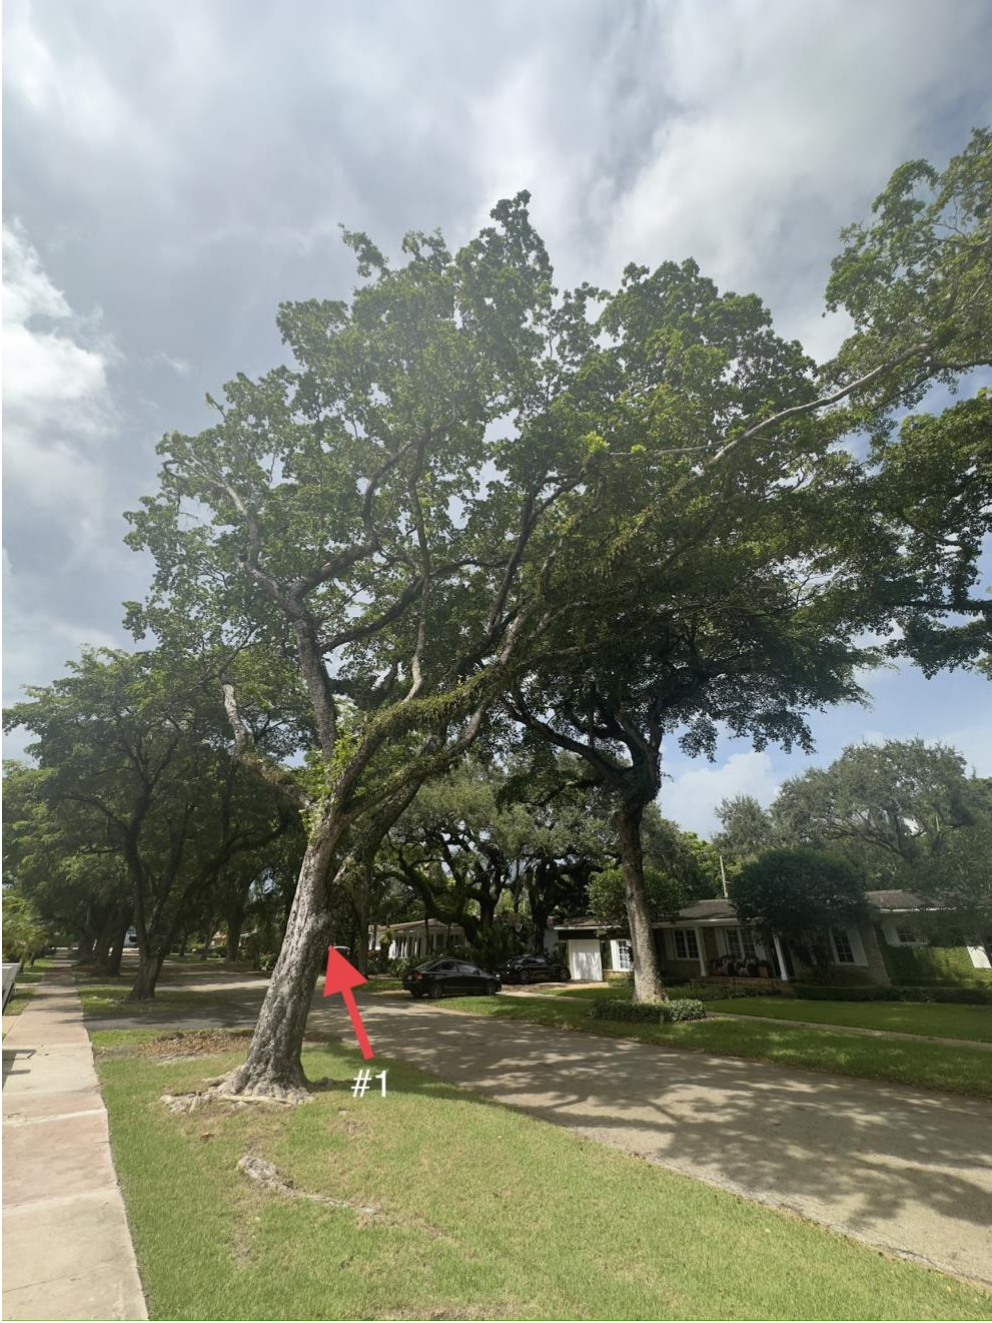
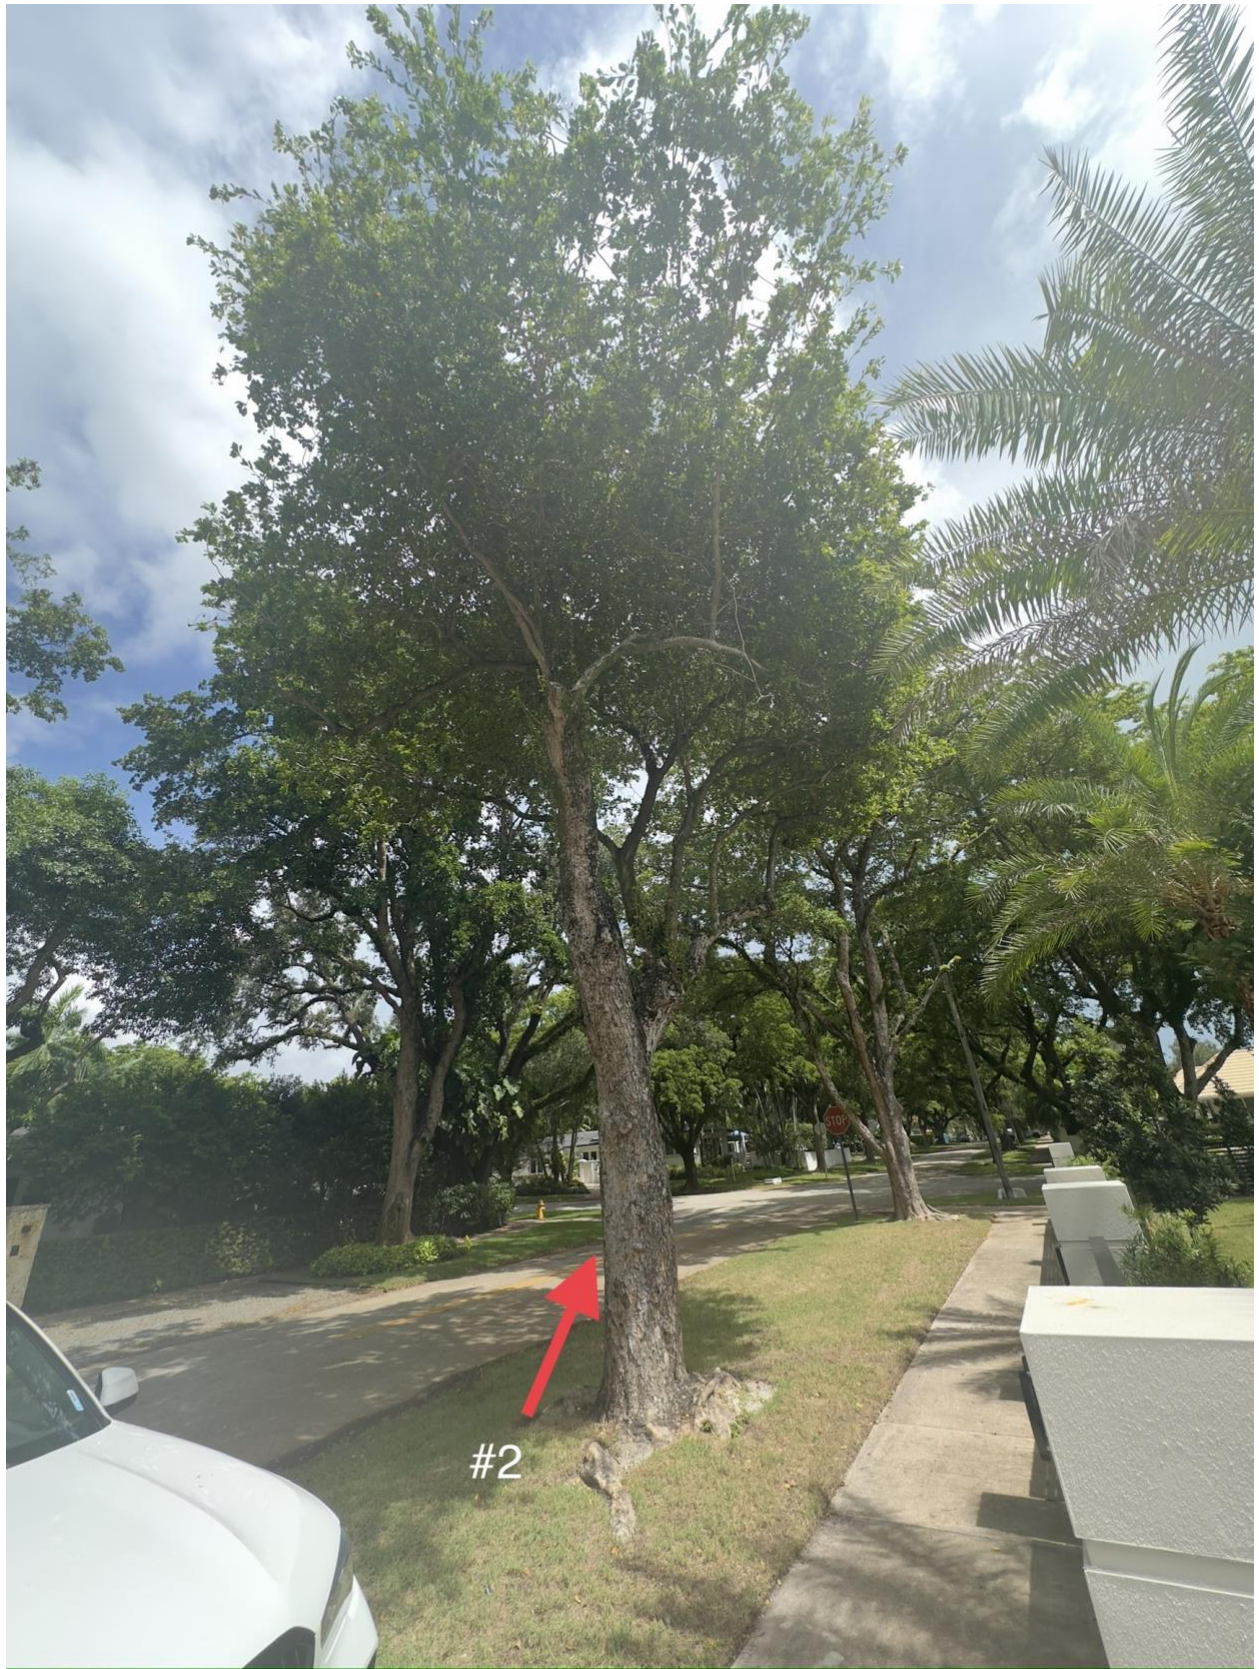
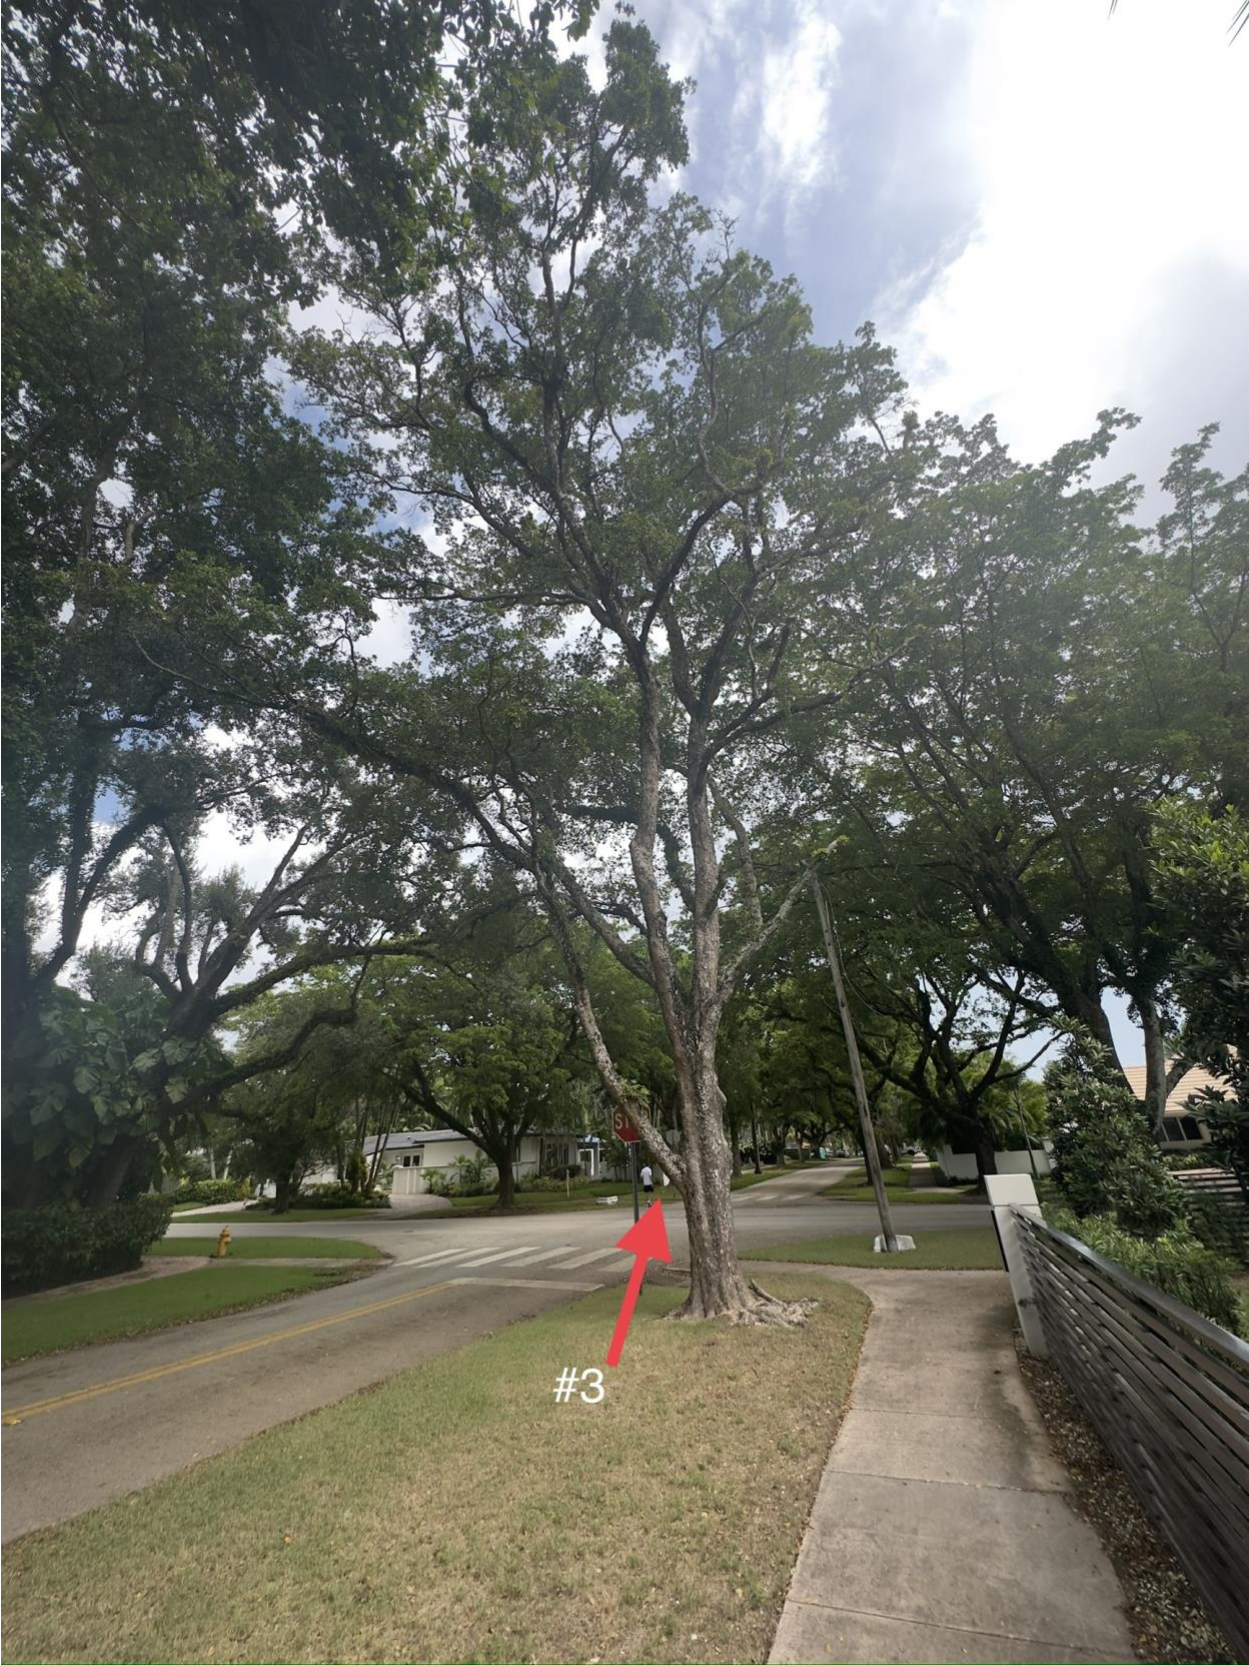
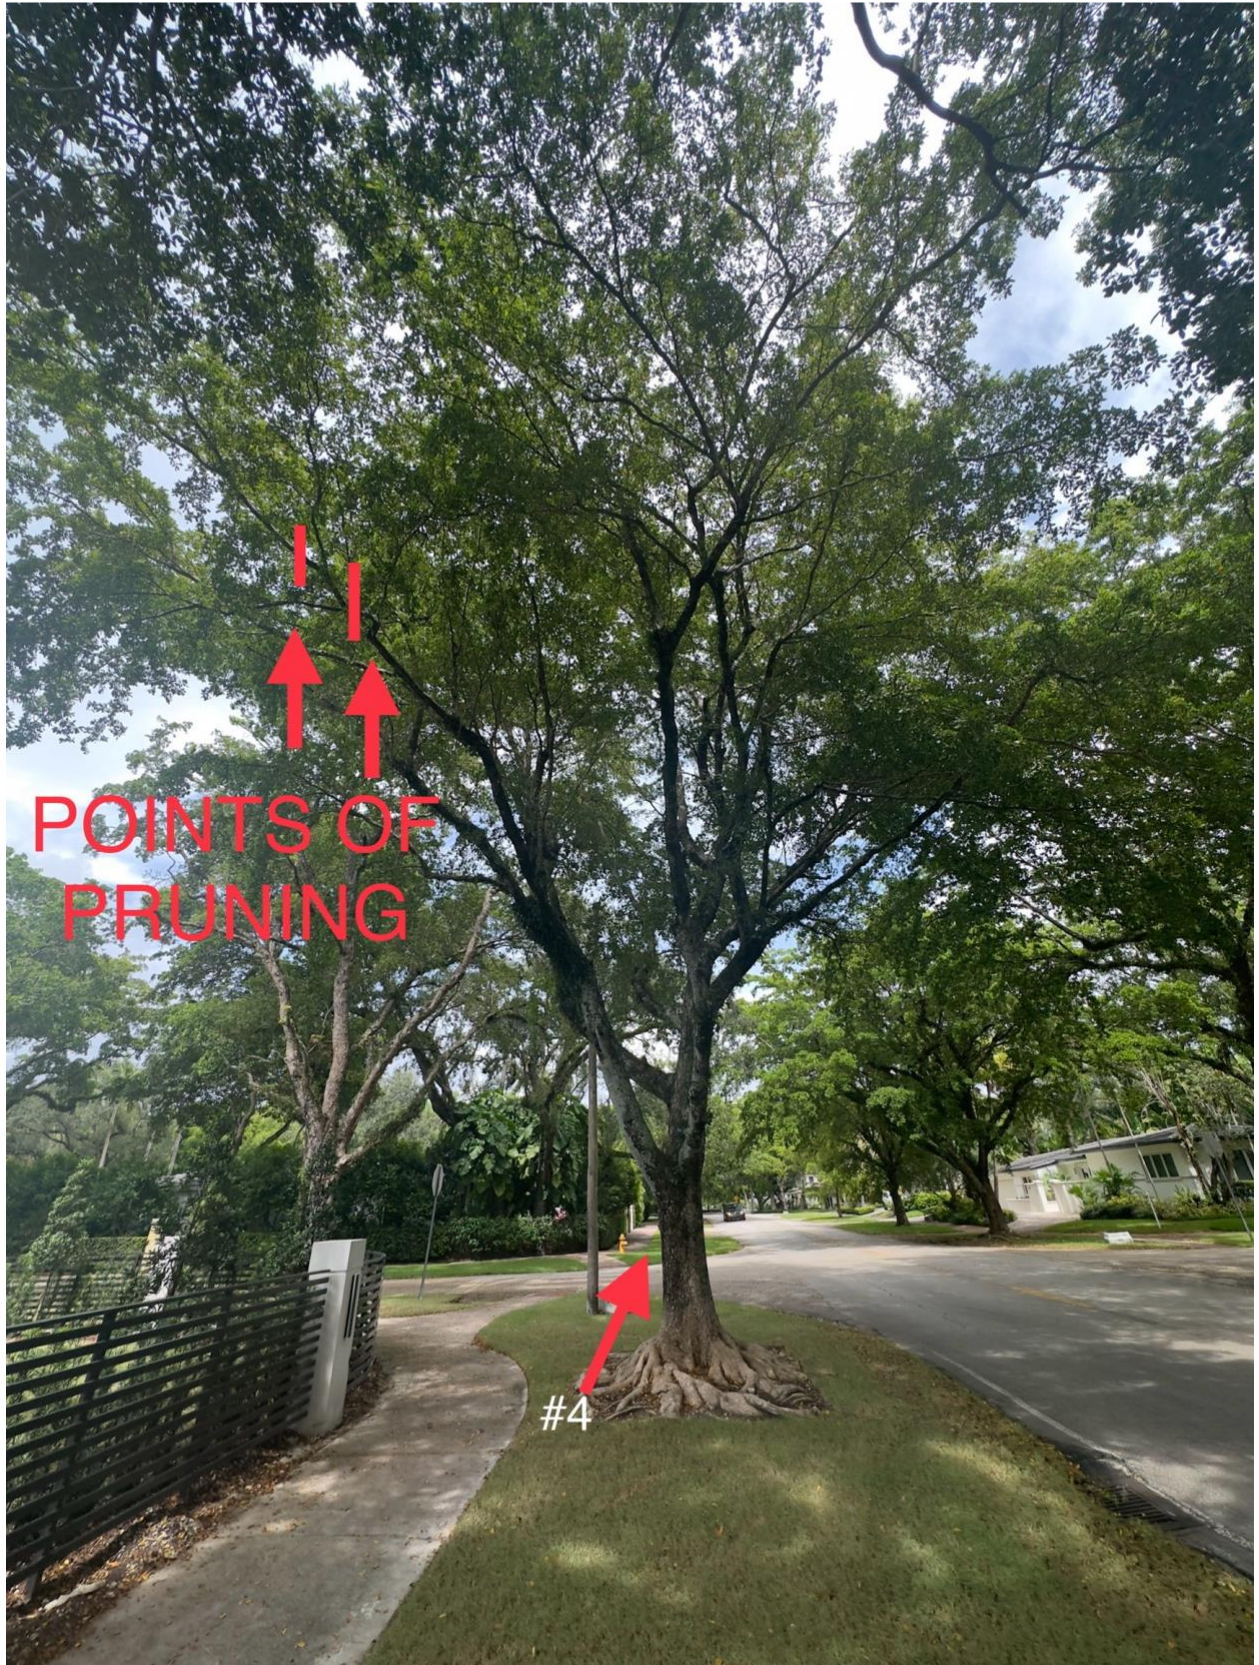
1. Bucida buceras (Black Olive tree) DBH 25.5", SPREAD 45', HEIGHT 45' (TREES CONDITION IS MODERATE Class B, Condition 70%) The tree is located on the right-of-way on the north side of property, on the right of way. It appears that canopy is asymmetrical, this is due to a lack of canopy on the south side from a mature tree that was previously removed under permit during the new construction on this property.

2. Bucida buceras (Black Olive tree) DBH 20", SPREAD 32', HEIGHT 40' (TREES CONDITION IS MODERATE Class B, Condition 70%) The tree is located on the right-of-way on the north side of property, on the right of way. It appears that canopy is asymmetrical and live crown ratio should be a focus of improvement in future pruning. Several areas of improper pruning in canopy need correcting.

3. Bucida buceras (Black Olive tree) DBH 23.5", SPREAD 47', HEIGHT 40' (TREES CONDITION IS FAIR Class B, Condition 80%) The tree is located on the right-of-way on the northeast corner of property, on the right of way. It appears that canopy is symmetrical is average. Several areas of improper pruning in canopy need correcting.

A visual inspection of trees revealed an apical canopy with very little lateral growth on south side for tree #1-3. The areas headed off in canopy should be monitored to unsure decay or dieback does not in-sue

RESTORE CANOPY – For the the first two to three years allow canopy to flush out as much auxiliary growth and spouts in canopy, no pruning is required in this phase. Once canopy has flushed out sufficiently, prune no more than twenty percent of these sprout back to collar or parent branch to allowing compartmentalization. When selecting these sprouts for removal the objective should be to restore a canopy that is promoting lateral branches and good taper. Two years after sprout management prune, the next phase would be to subordinate any of the remaining auxiliary growth spouts or sprouts from old pruning cuts that have dominated and are over extended, and to cut back old pruning stubs to only to nearest unions of branches that are at least one third in diameter of specific stub.
