SHORT LEGAL DESCRIPTION	
THE BILTMORE REGENT CONDO	
CORAL GABLES BILTMORE SEC	
LOTS 24 THRU 32 BLK 1 PB 20-28	
F/A/U 03-4117-008-0200

**NOTICE OF UNSAFE STRUCTURE VIOLATION FOR FAILURE TO RECERTIFY
AND NOTICE OF HEARING**

The Falcon Group (Falcon) conducted a 30-Year **Electrical** Recertification of the referenced building in accordance with the requirements of section 8-11(f) of Miami Dade County and City of Coral Gables “General Considerations & Guidelines” for the building safety inspections. In summary, in accordance with the above regulations and guidelines, the recertification is not approved since repairs are required to meet current standards of safety.

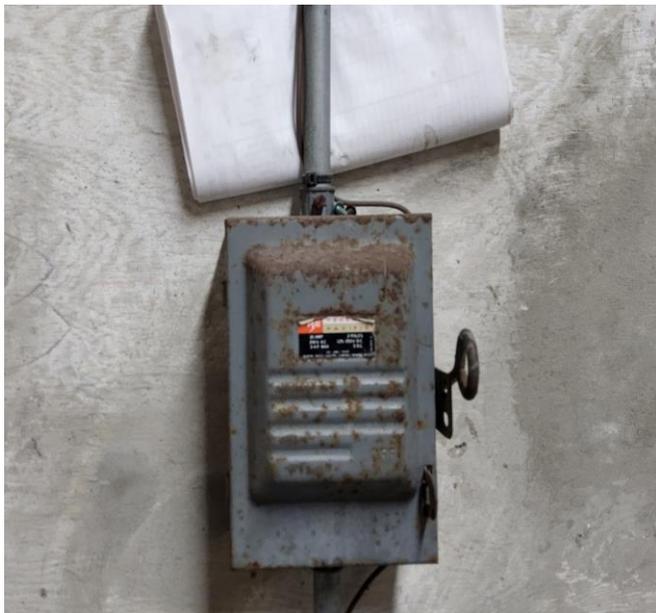
Photo # 24. Item 26.a. Pool equipotential bonding: Failed test between pumps and metal parts.

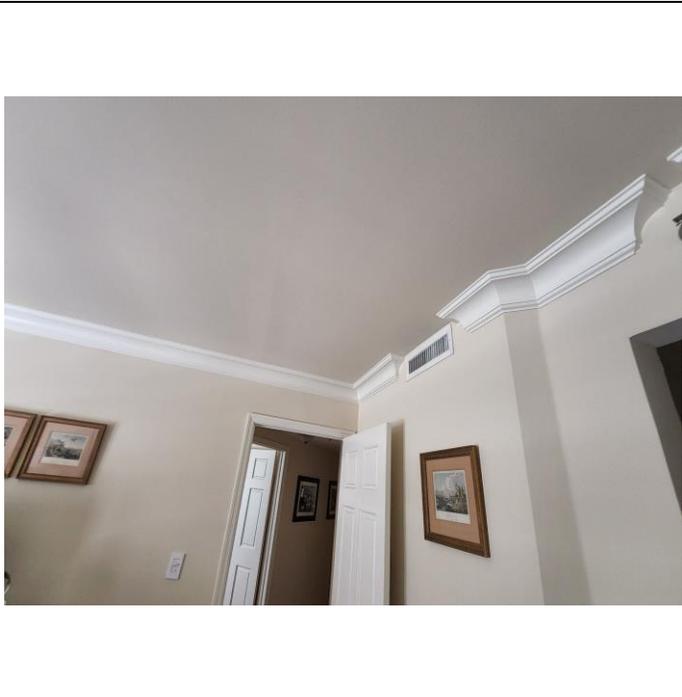
Photo # 36. Item 28.5. Missing smoke alarm inside the sleeping rooms.

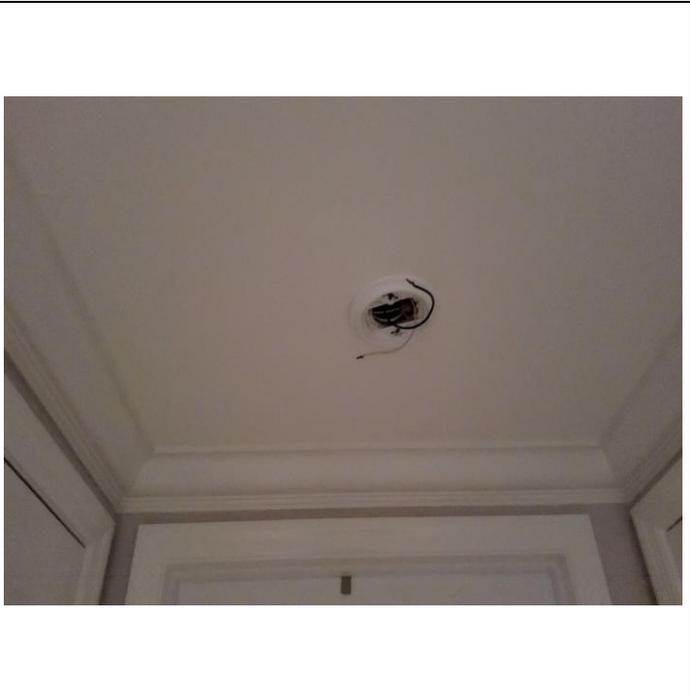
Photo # 37. Item 28.3. Missing smoke alarm inside the sleeping rooms.

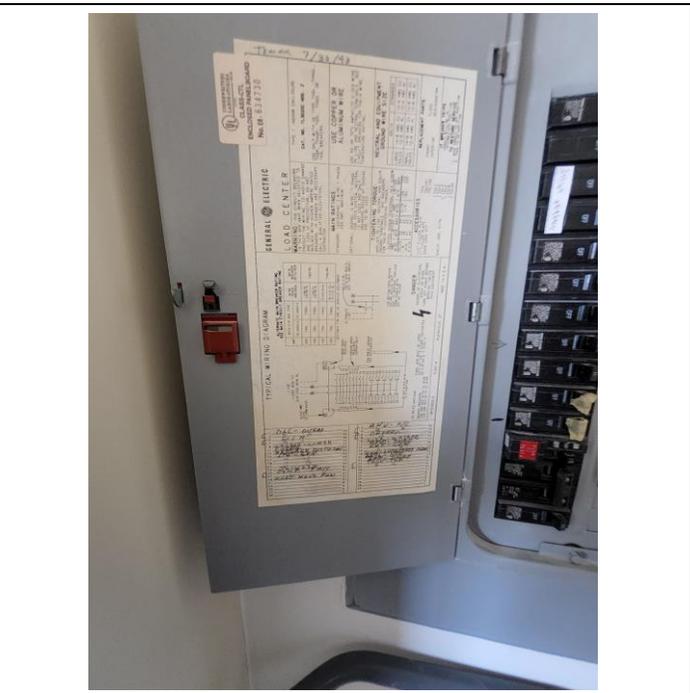
Photo # 39. Items 28.7. Electrical panel missing or incomplete proper circuit directory.

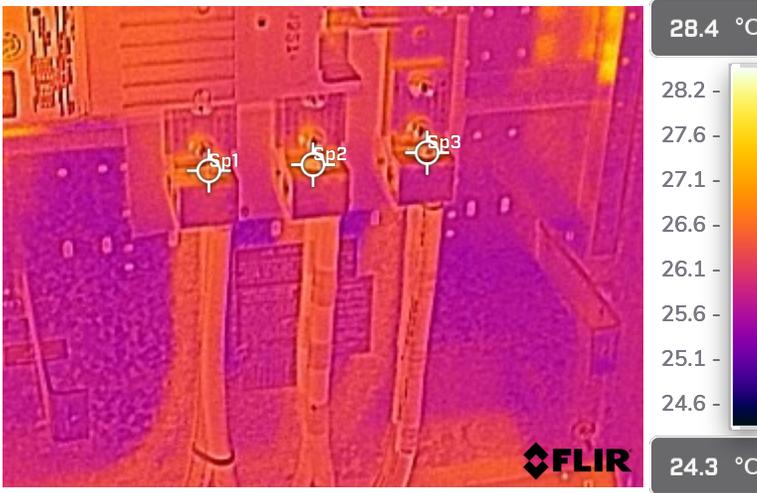
THE BILTMORE REGENT CONDO	
Date	04/10/2024
Location	Electric meter room
Equipment	EDP
Component	Panelboard-busbar
File name	FLIR1409.jpg
Condition	NORMAL

Sp1	26.6 °C
Sp2	26.7 °C
Sp3	26.5 °C

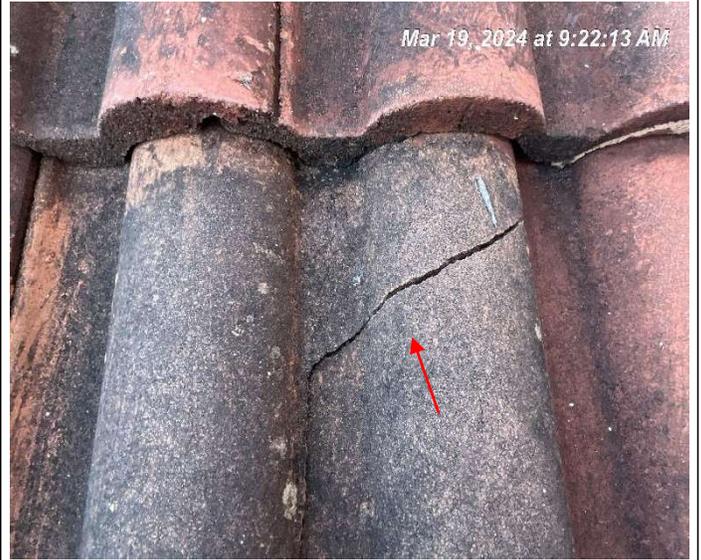
Photo # 21. Chipped clay barrel tile at the PH floor roof.

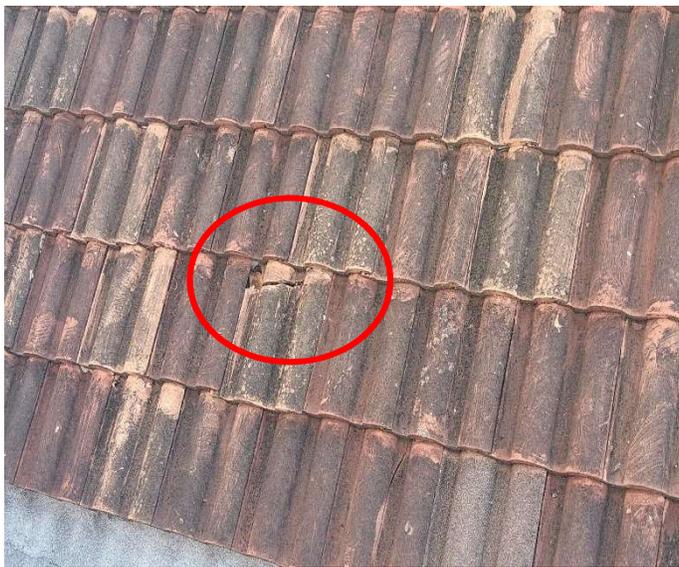
Photo # 22. Cracked clay barrel tile at the PH floor roof.

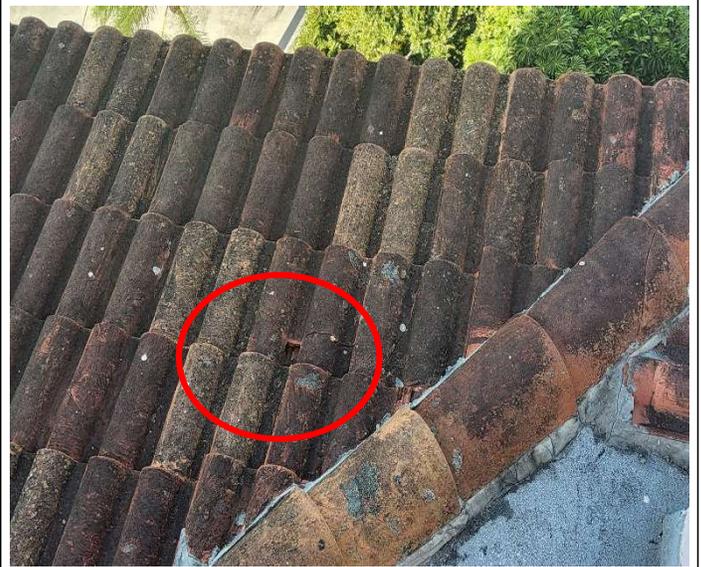
Photo # 23. Cracked clay barrel tile at the PH floor roof.

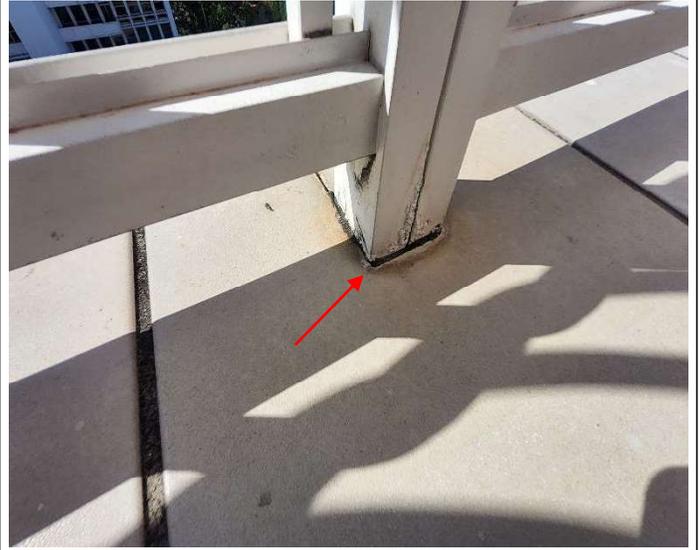
Photo # 29. Cracked tile at the balcony and missing sealant/grout at the railing post throughout.

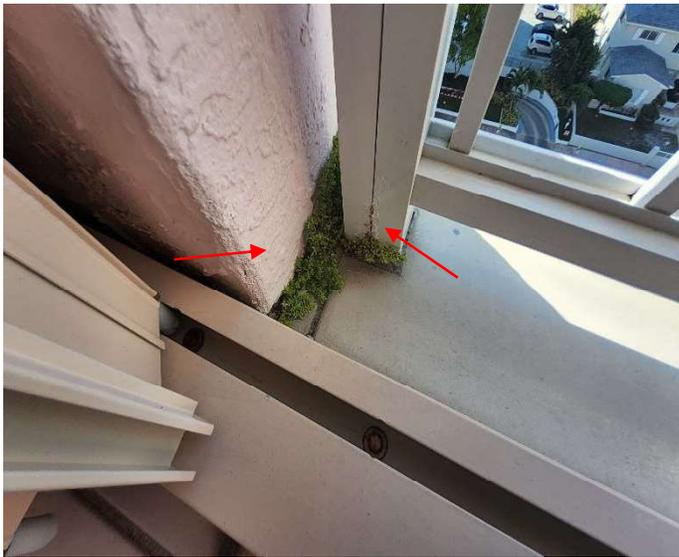
Photo # 30. Pitting corrosion at the balcony railing post throughout.

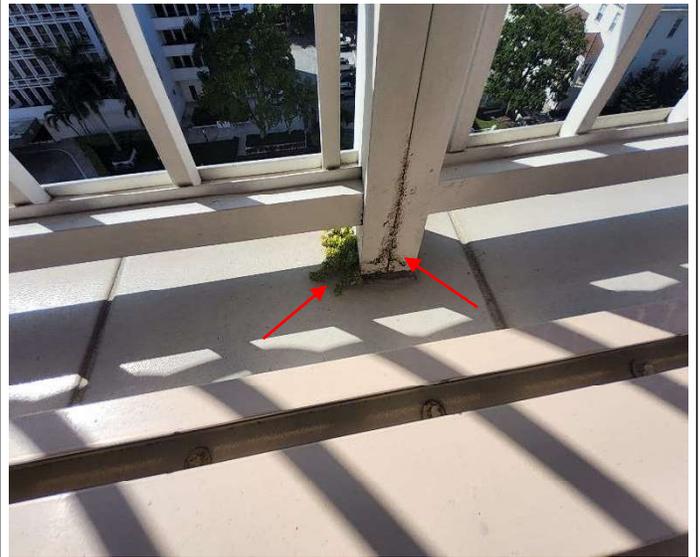
Photo # 31. Biological growth and pitting corrosion at the balcony railing post.

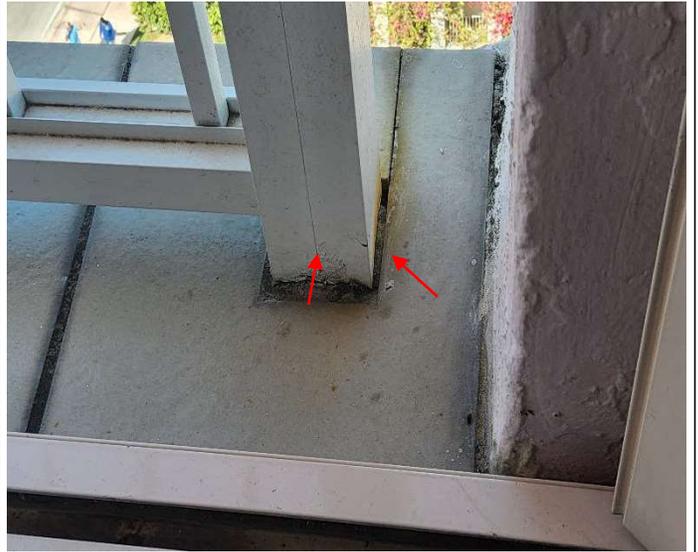
Photo # 33. Cracked tile around the railing post.

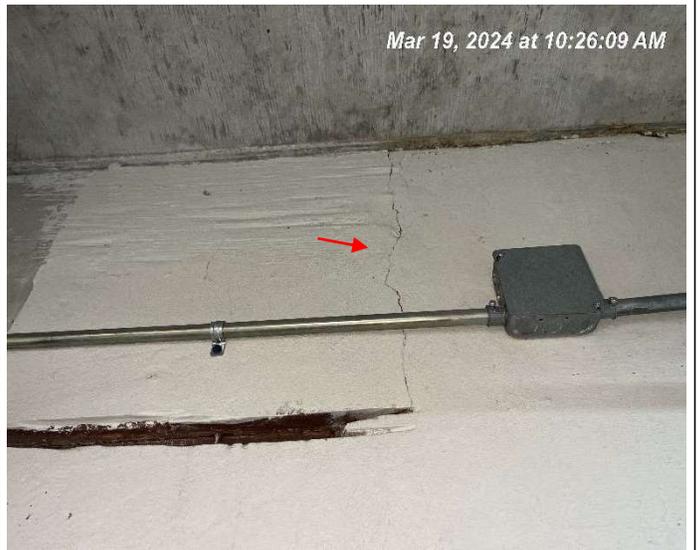
Photo # 35. Concrete crack at the ceiling slab of the basement garage.

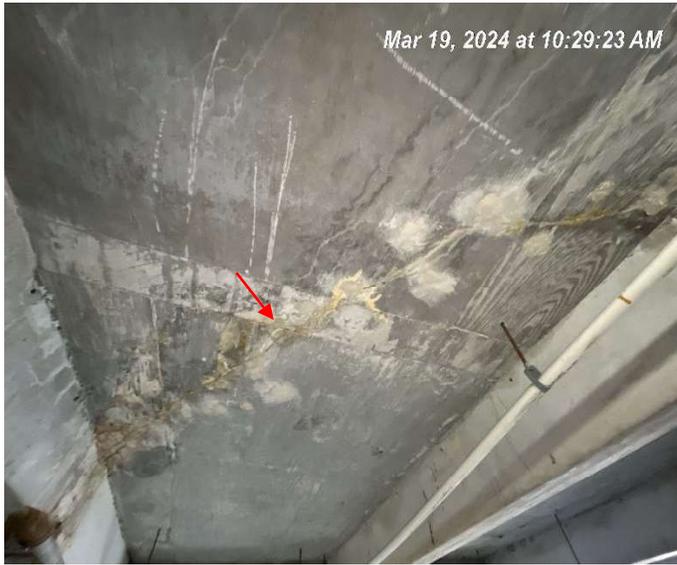
Photo # 36. Concrete crack at the wall of the basement garage.

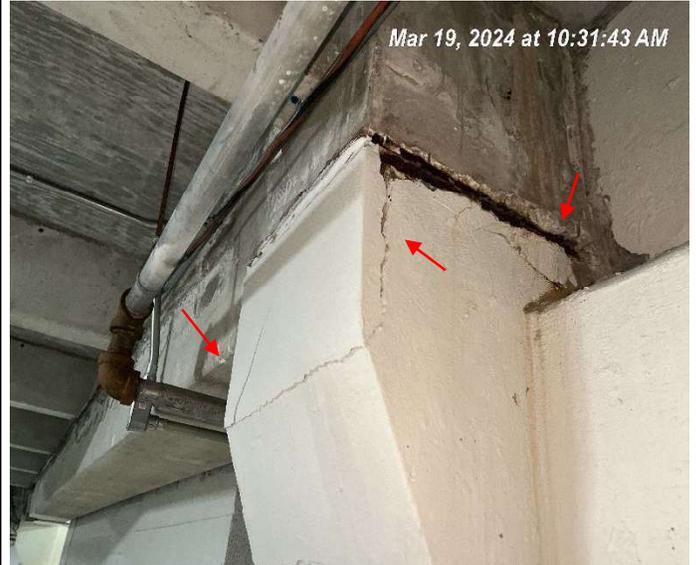
Photo # 37. Concrete crack with water stains and efflorescence at the ceiling slab of the basement garage.

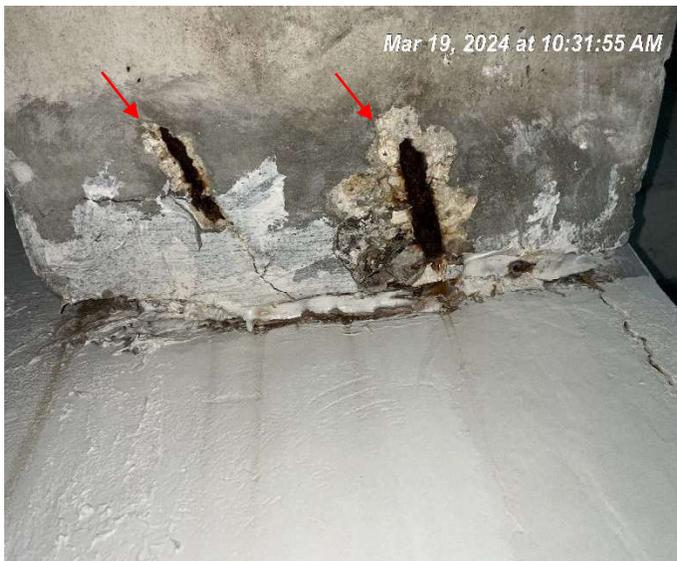
Photo # 38. Cracked and delaminated concrete at the column of the basement garage.

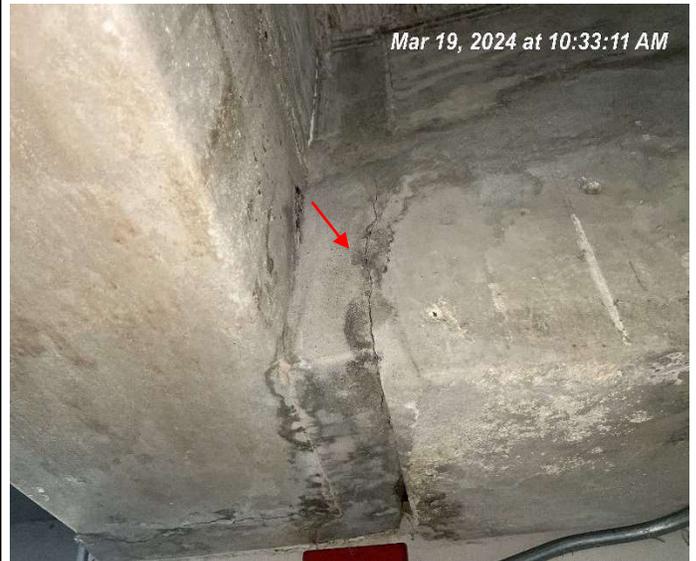
Photo # 39. Spalled concrete with exposed corroded rebar at the beam of the parking garage.

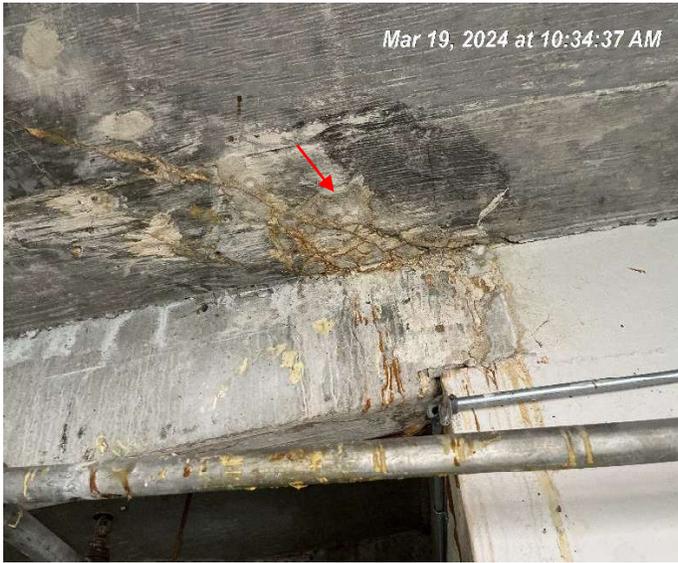
Photo # 40. Concrete crack at the beam of the basement garage.

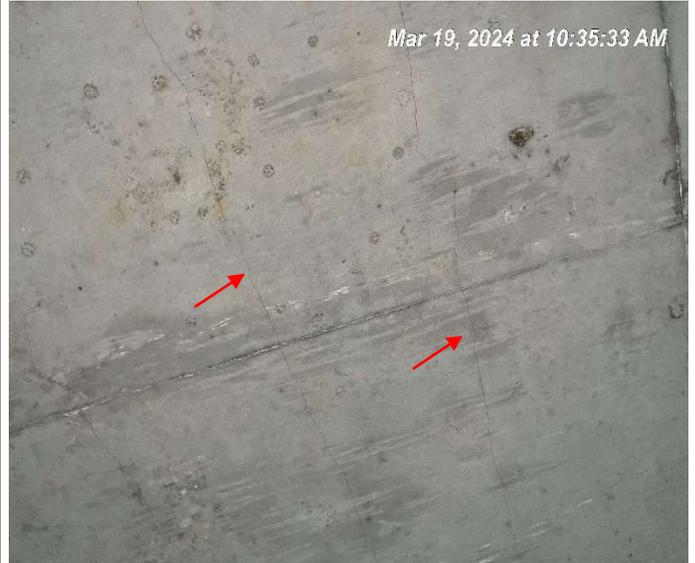
Photo # 41. Concrete crack with water stains and efflorescence at the ceiling slab of the basement garage.

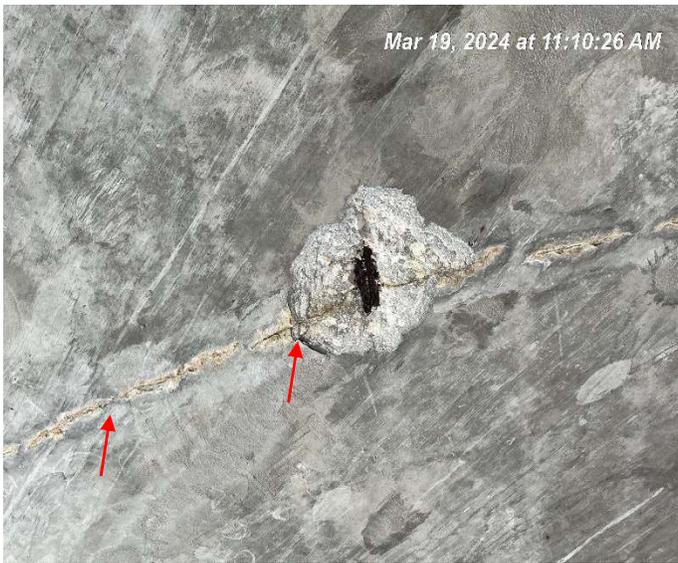
Photo # 42. Concrete cracks at the ceiling slab of the basement garage.

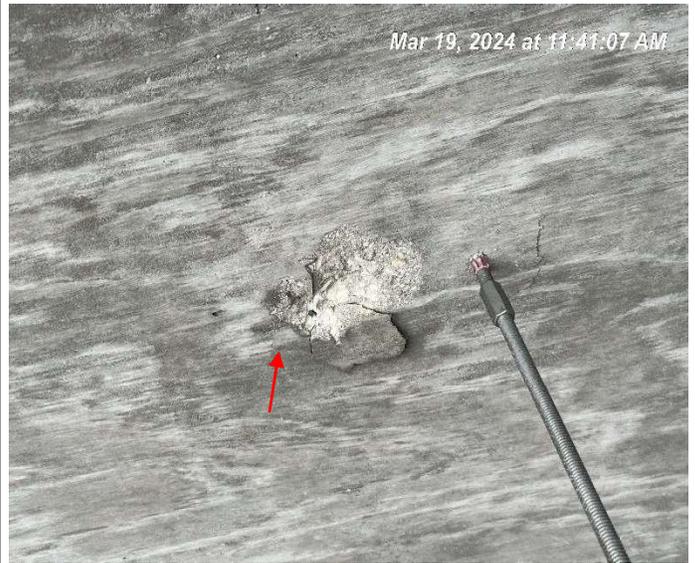
Photo # 43. Cracked and spalled concrete with exposed corroded rebar at the ramp ceiling slab (East Side)

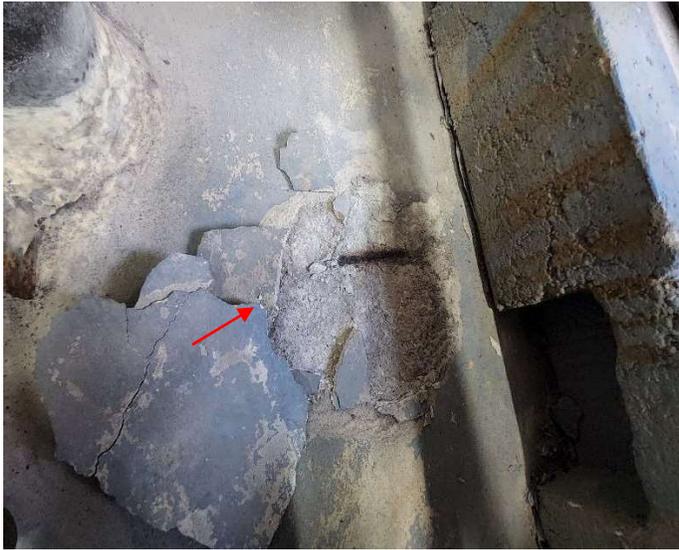
Photo # 44. Cracked and spalled concrete at the ramp ceiling slab (West Side)

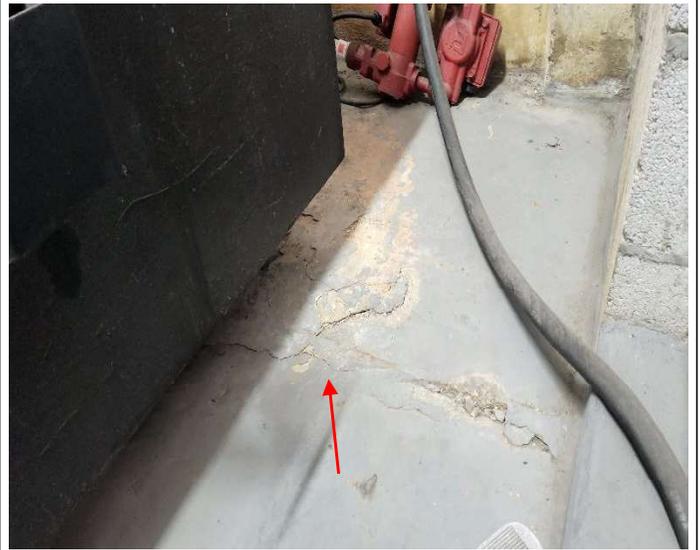
Photo # 45. Cracked and spalled concrete with exposed corroded rebar at the Generator & Fire Pump Room.

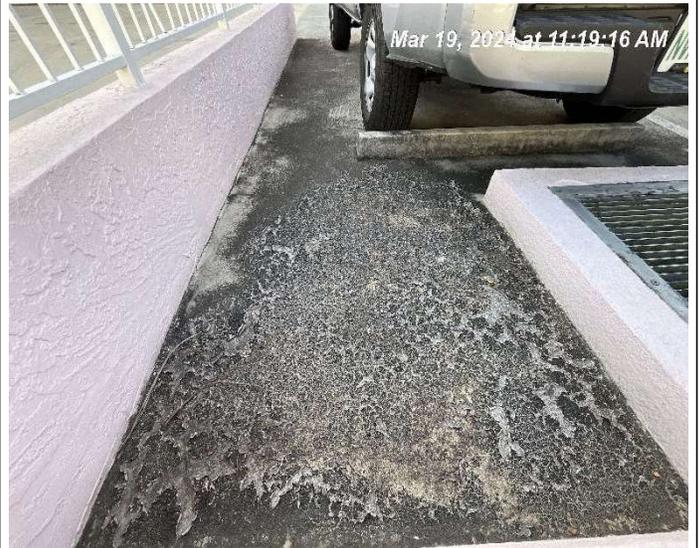
Photo # 47. Delaminated waterproofing coating at the parking deck.
