**Almeria Park Condominium
357 Almeria Avenue
Coral Gables, FL 33134**

Testing Report

Re: Moisture Scanning

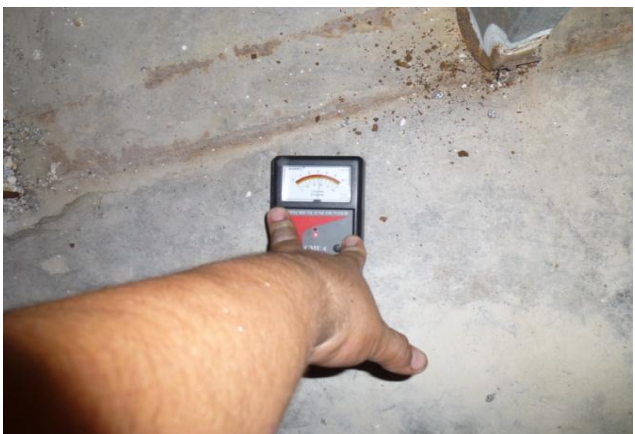
Picture 12

12	Bathroom Shower Floor	Dial shows 60 % of moisture on the shower's floor.

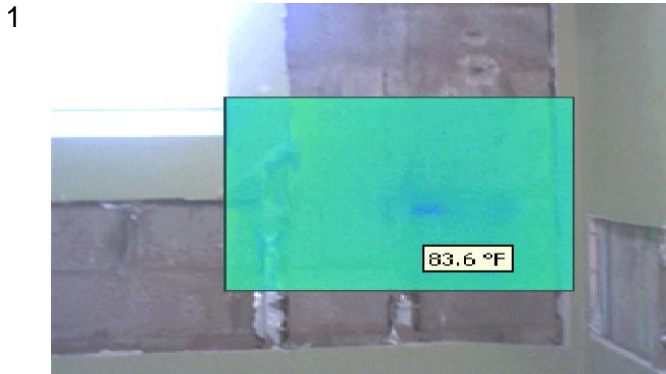
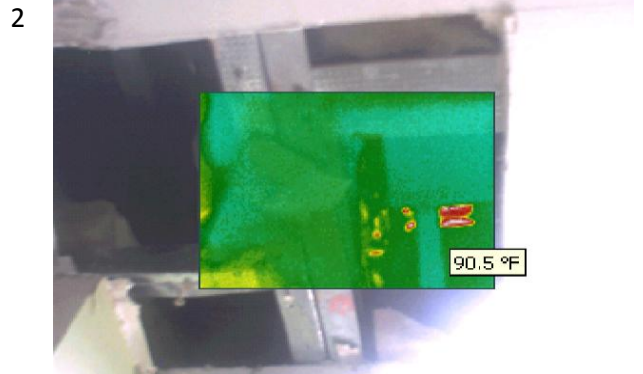
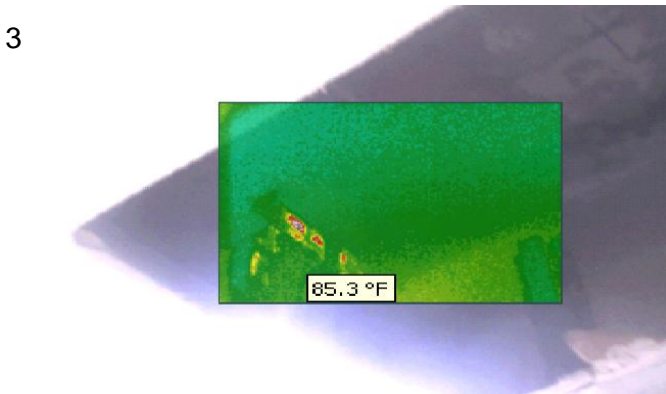
TEST N*	1	2	3	Comments
Dimention SF	2	2	2	
Relative Humidity %	60	60	60	
Temperature *F	83.6	90.5	85.3	
Exterior temperature*F	81	81	81	
Exterior Humidity %	85	85	85
