ITEMS HANDED OUT TO
HISTORIC PRESERVATION BOARD
BY OWNER'S ATTORNEY
AT 03/15/23 HPB MEETING

Document for:
Inspection Report

Local Historic Designation Number:
LHD 2022-13

Subject Property:
517 Aragon Avenue
Coral Gables, FL

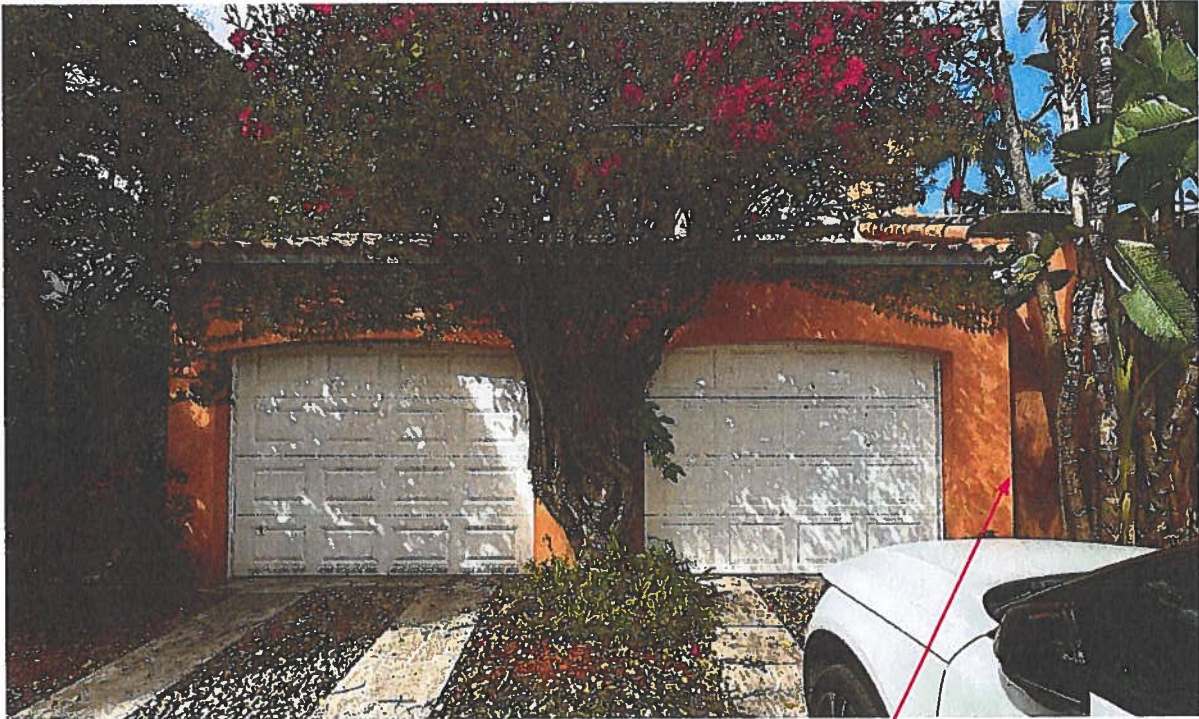
GARAGE ADD-ON

Garage extension removes original carport, changing intention and facade significantly.

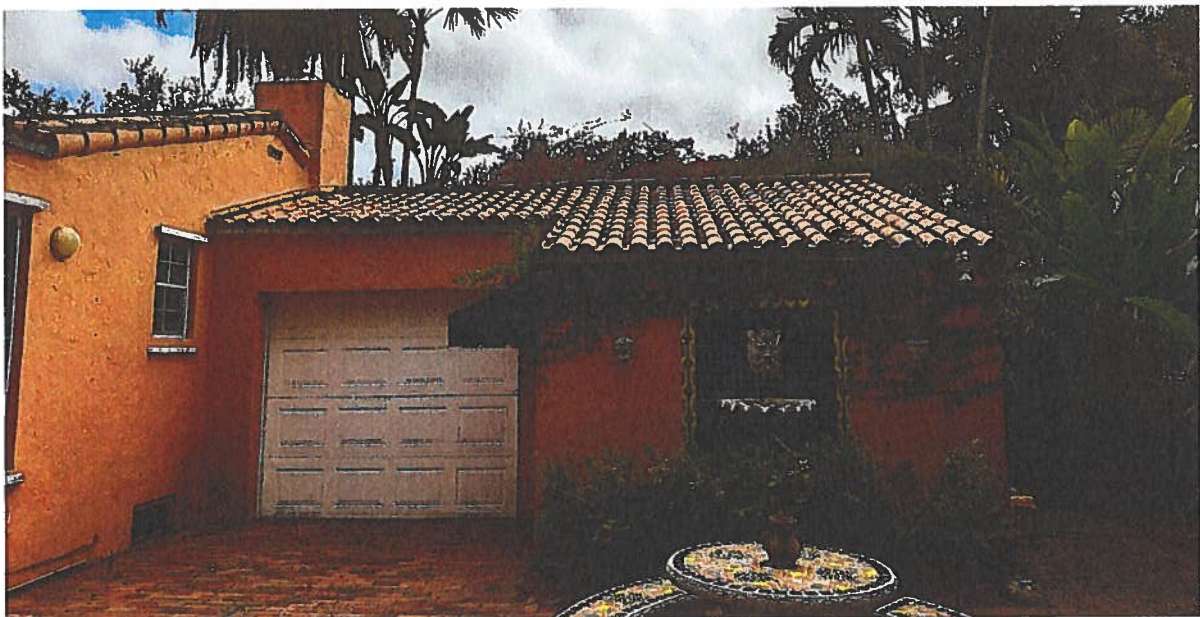
Garage protrudes from original facade

New addition removes transparency of facade, and openness to backyard.

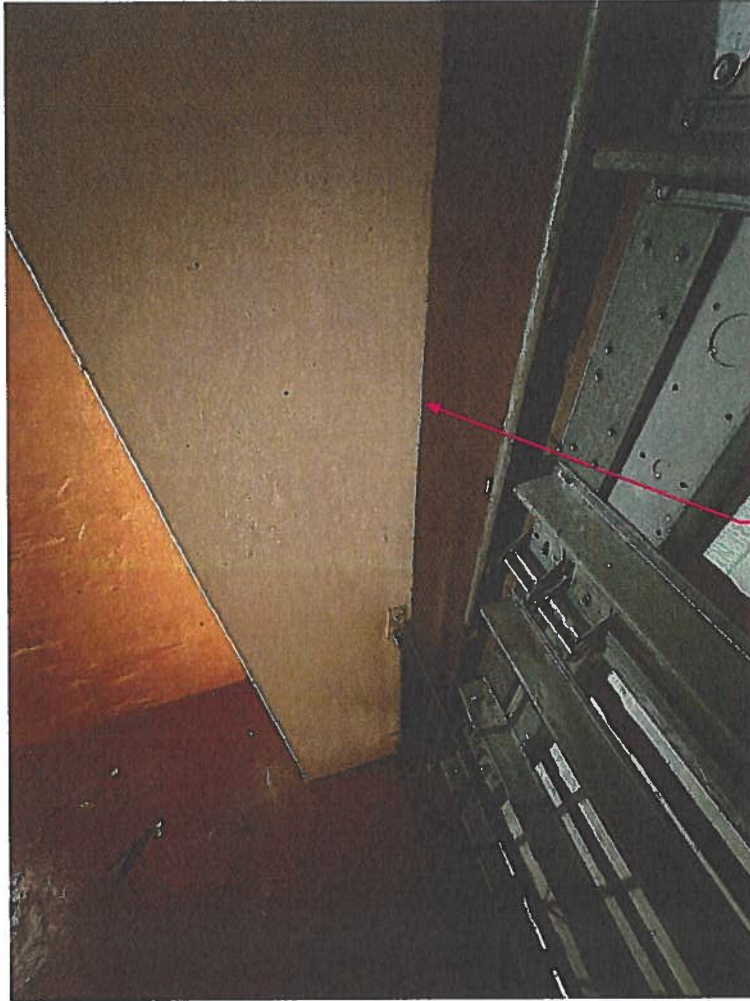
New column and wall tied into original column with rebar and cannot be separated without extensive cutting, reconstruction, and cost.

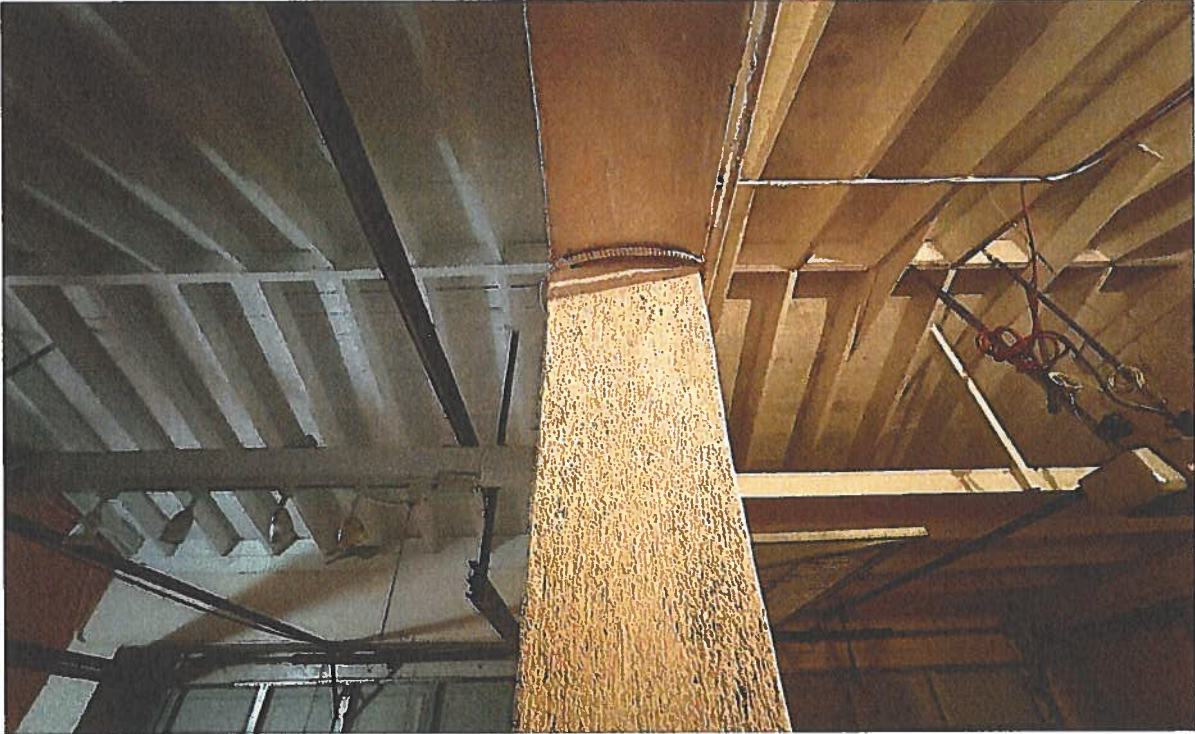
Both garages share center roof joist and roof system. If tried to reverse, most likely entire roof would need to be replaced at extensive cost to client.

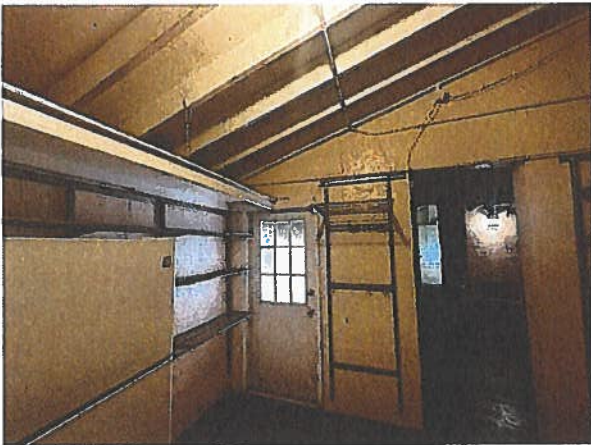
Rear of new garage extension.

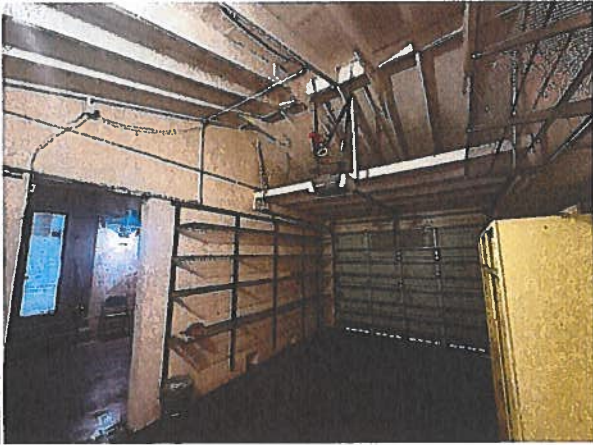
Front of new garage extension.

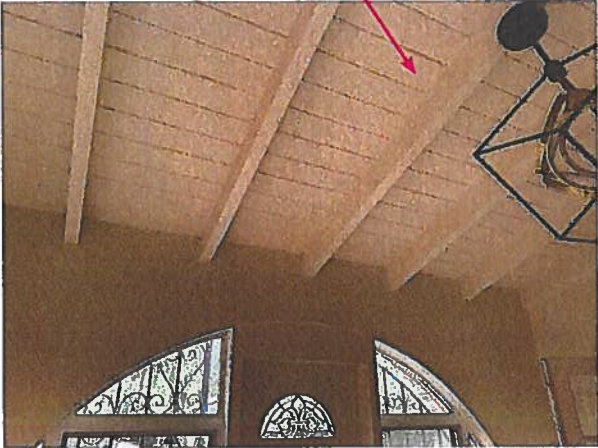
Roof area missing any insulation when enclosed

Entry courtyard was originally screened in, and now is interior.

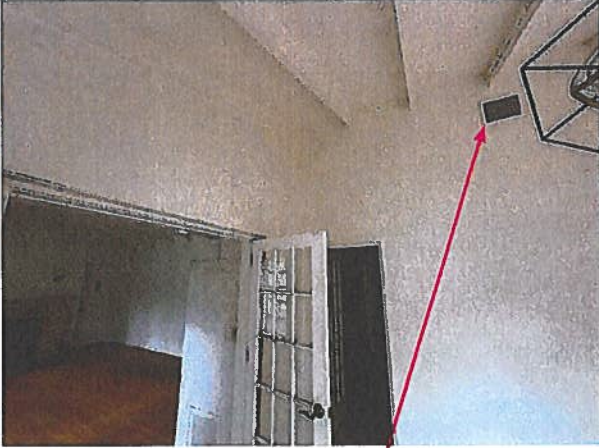
Air vents added when porch enclosed.

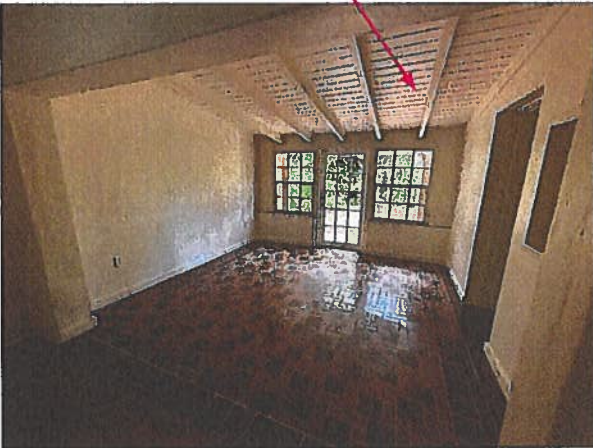
Roof area missing any insulation when enclosed

Rear courtyard originally screened in, and now opened into the home. New tile looks laid, and AC added in room.

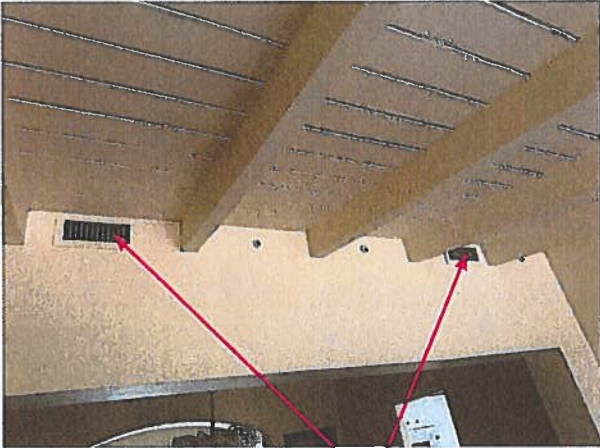
Air vents added when porch enclosed.

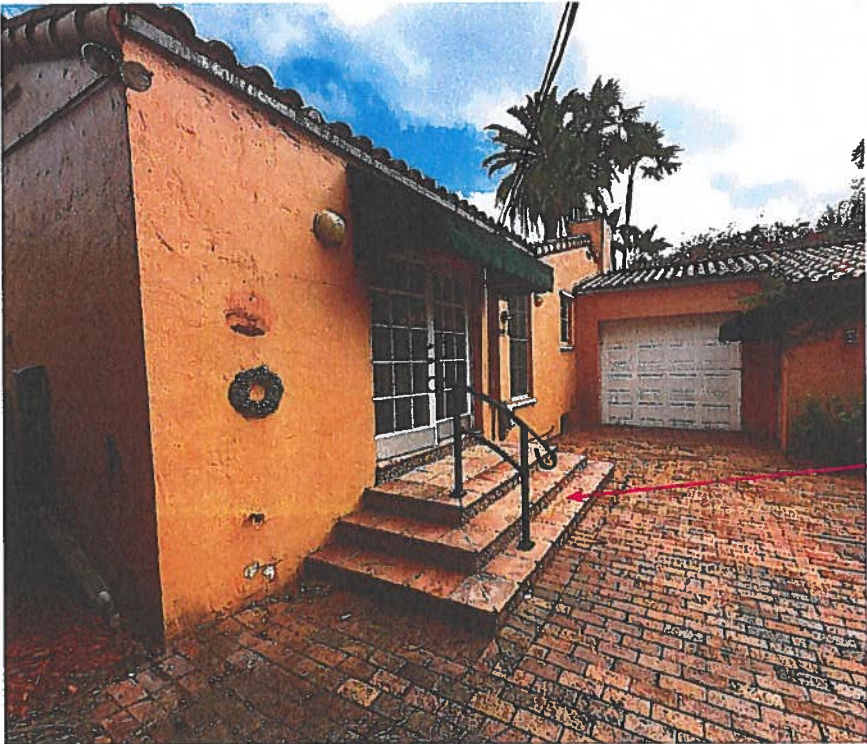
Openings on Kitchen remodel changed West facade extensively. Openings cannot be reversed without extensive concrete work and cost.

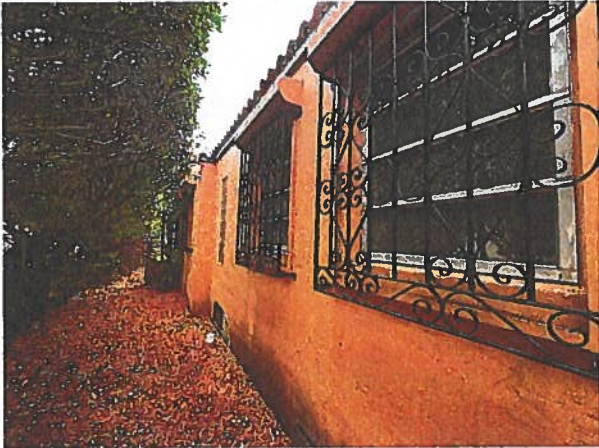
Openings on East wall changed over renovations. Openings cannot be reversed without extensive concrete work and cost.

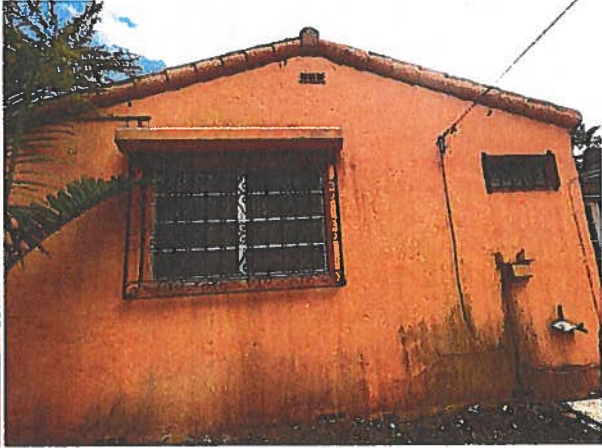
Openings on rear wall changed extensively. Openings cannot be reversed without extensive concrete work and cost.

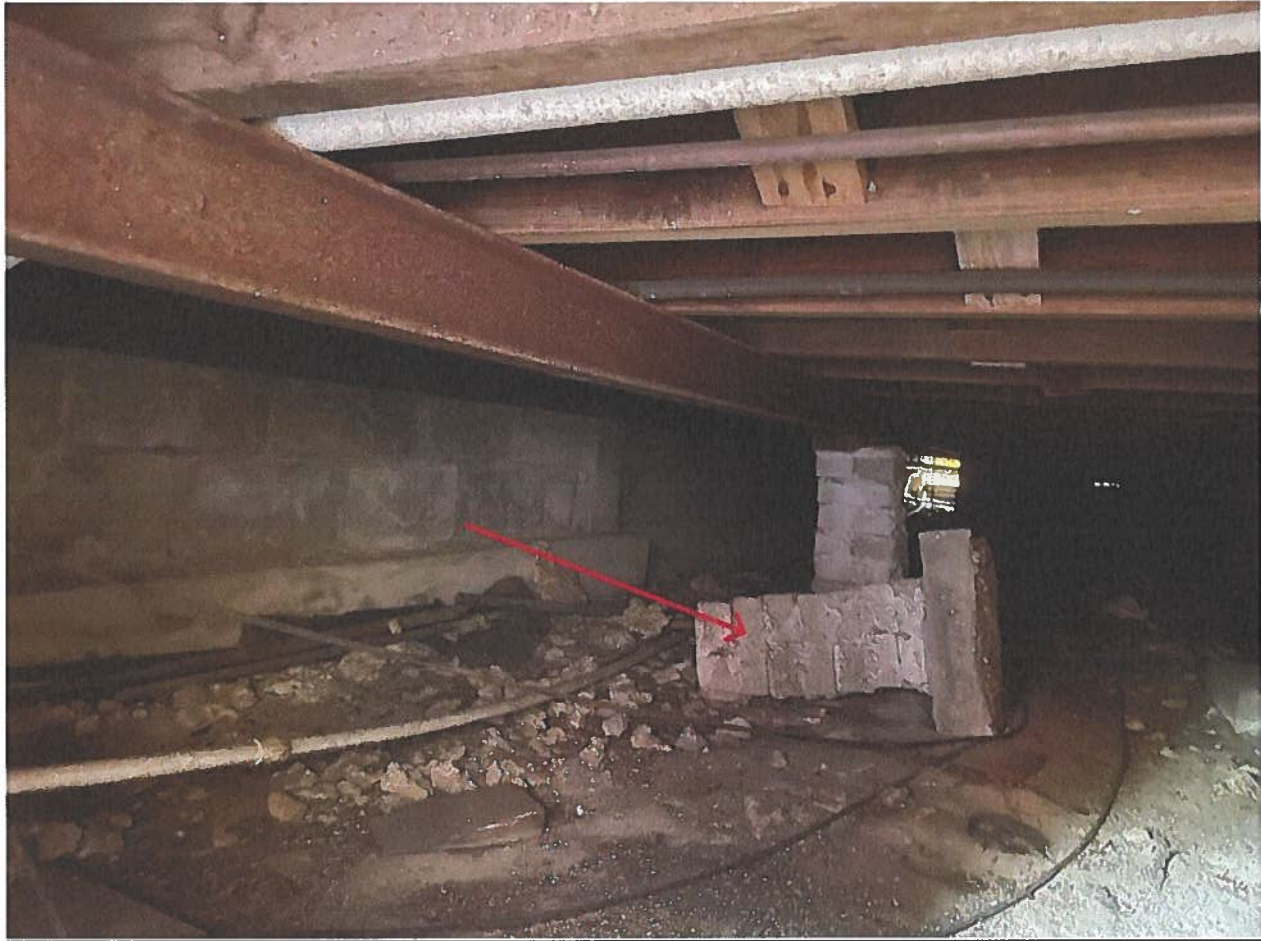
Image A

The existing Floor joists in certain areas of the house were noted to be disrepair, and presumably succumbing to enough deflection where someone decided to support the joists from below with a steel I-beam under the floor joists (See images A & B). The steel beams were positioned under the existing floor joists without the use of metal wood connectors. The steel beam was placed on 8"x8" concrete blocks with no steel reinforcement. The concrete blocks appear to be bearing over a 4" thick concrete footing over compacted gravel. This method of repair is not appropriate and, as seen in the image "A" preceding this report, has already begun to fail. The floor joists repairs will need to be re-constructed if the house undergoes renovation.

This image show the CMU supports toppled-over due to improper design, means, and methods for the supports.

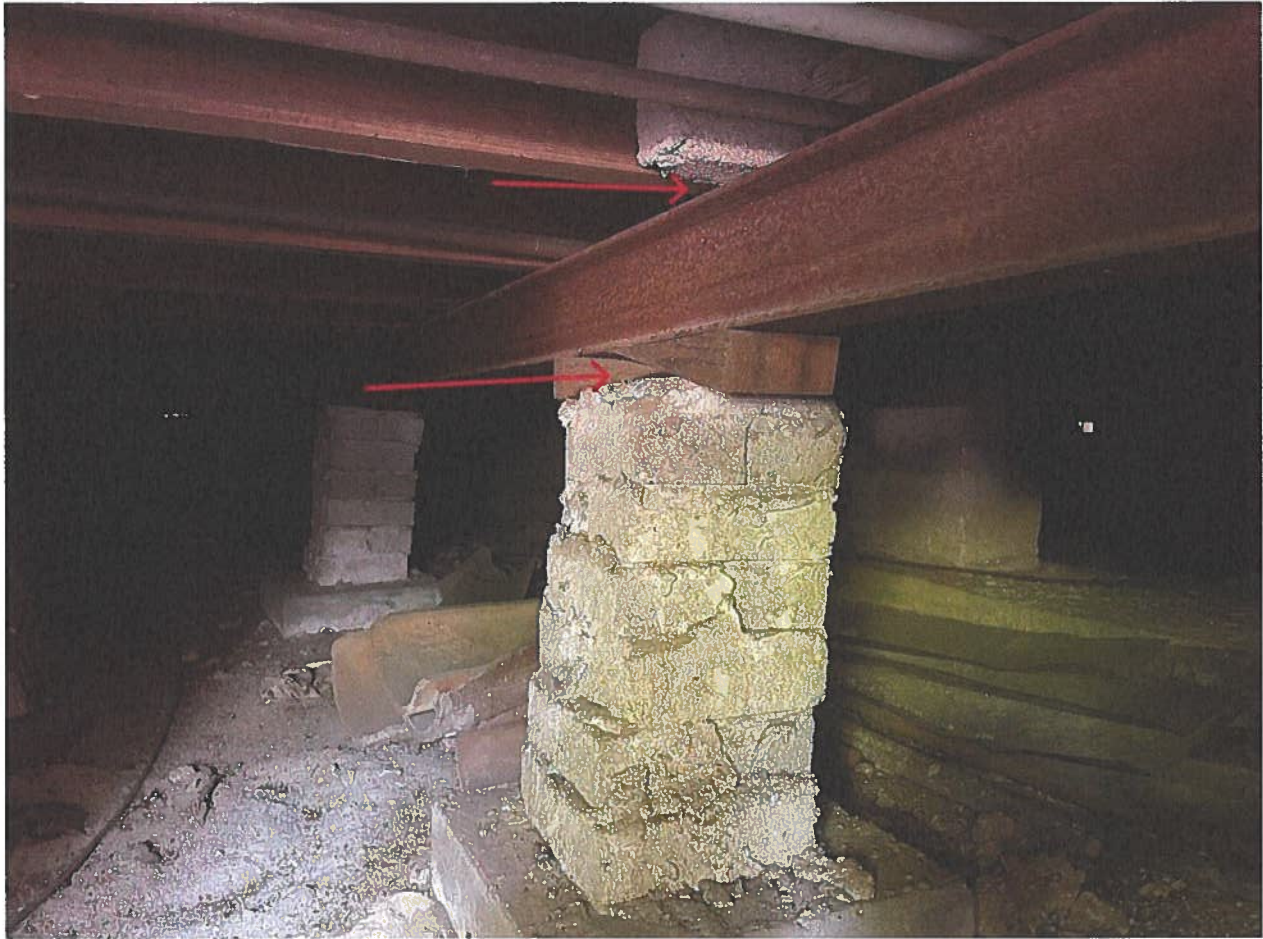
Image B

This image shows the CMU supports lacking connections to the steel beam. Further, the steel beam lacks proper connections and fasteners to the wood joists it is supporting.

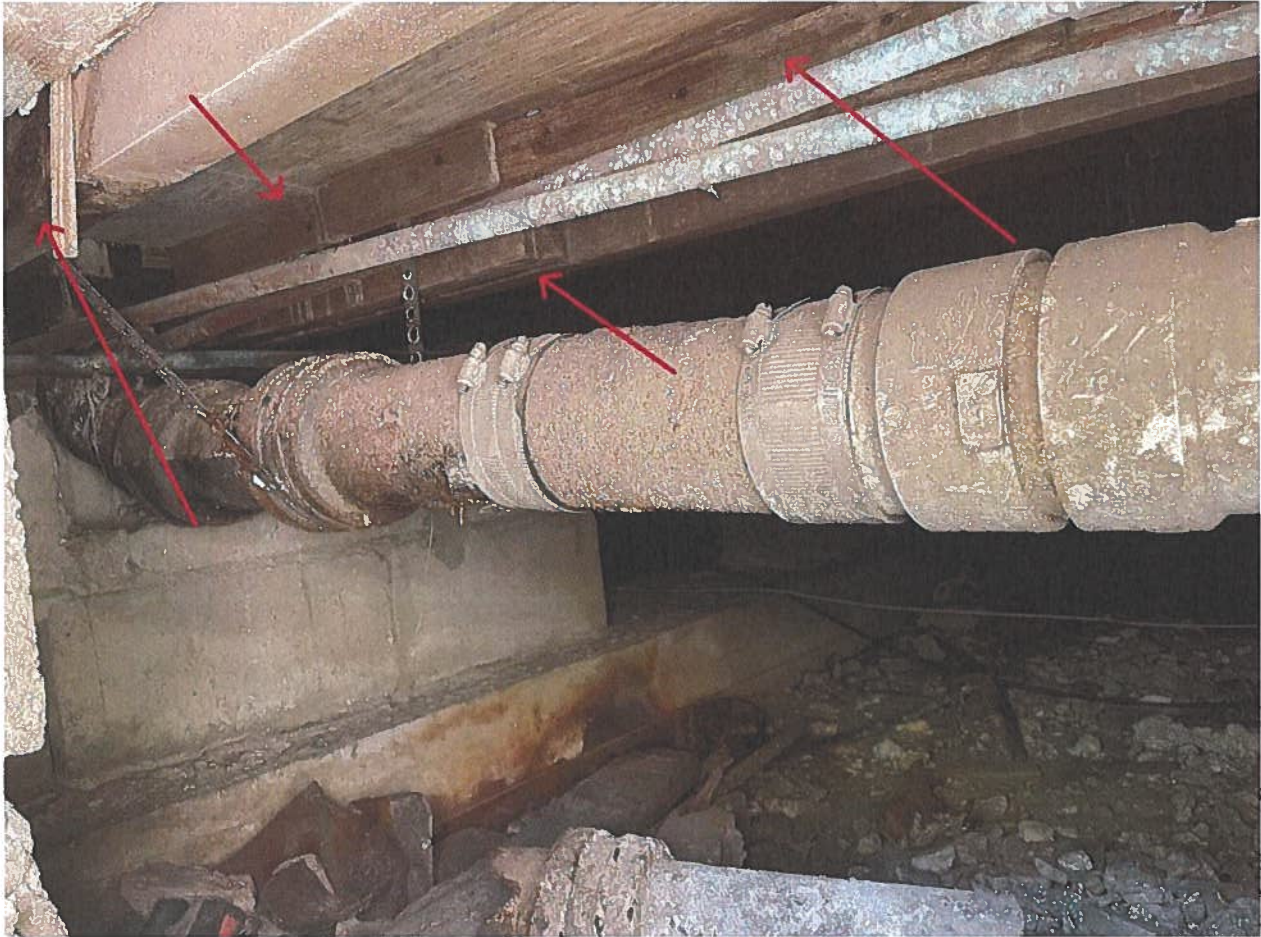
Image C

A small number of existing floor joists were identified to be experiencing degradation and slight deflection (See images C & D). While the joists are not yet in complete disrepair, the same proposed method of reinforcement used to reconstruct the existing floor joists repairs should be used for the areas where the floor joists are damaged.

This image shows the wood floor joists with degradation as well as various attempts to “scab” the joists, presumably due to excessive deflection.

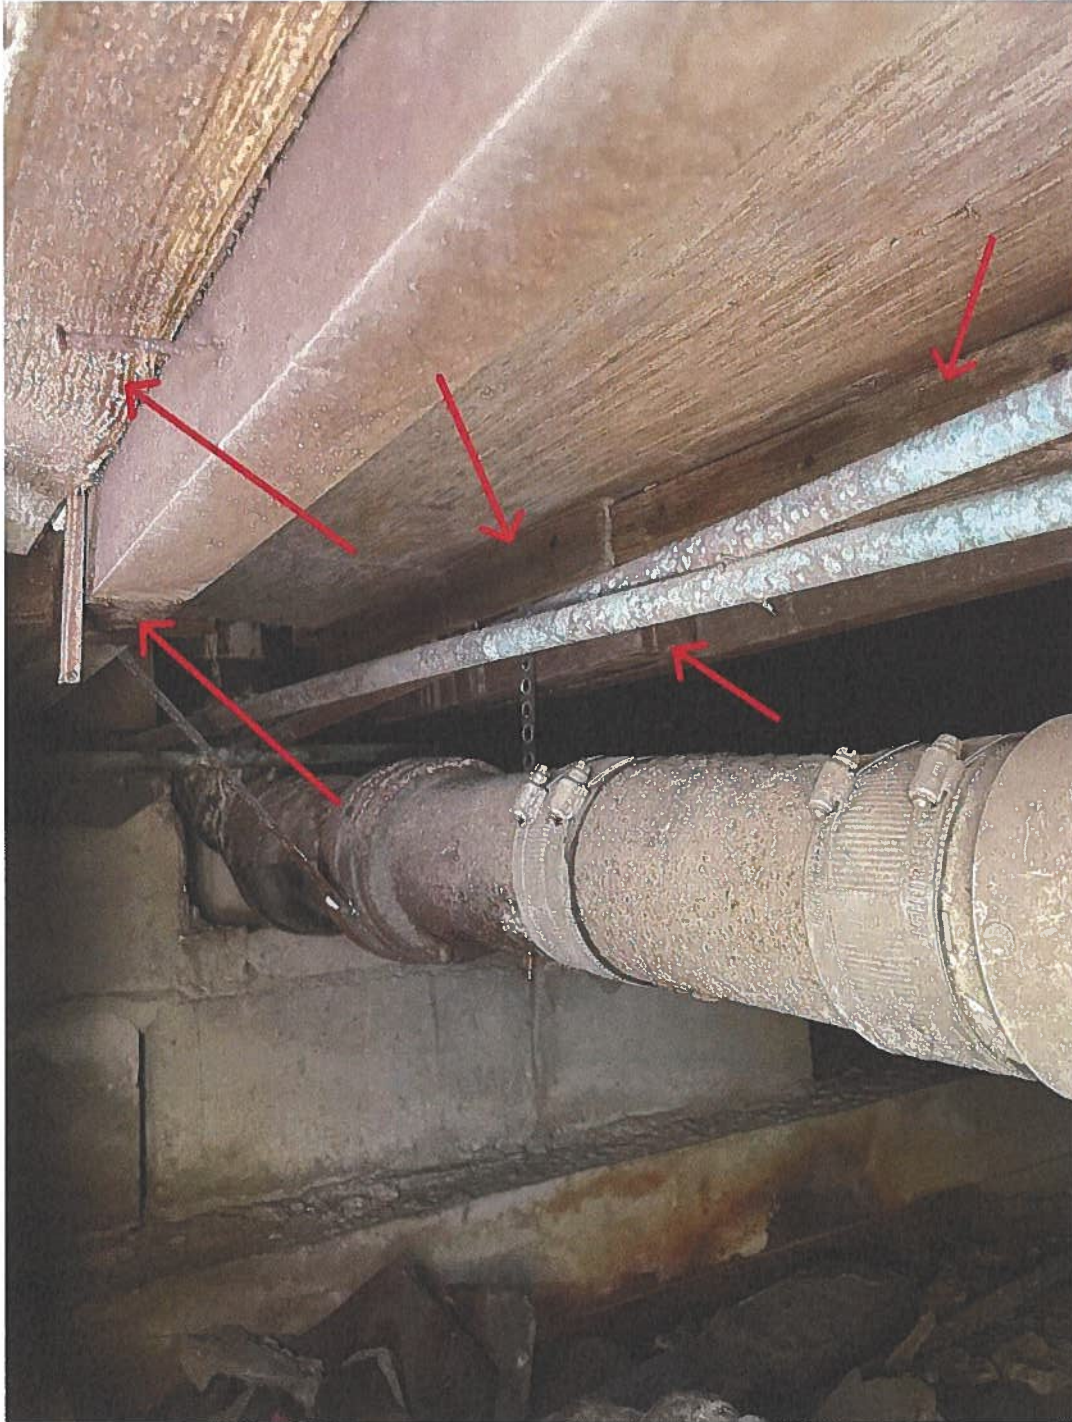
Image D

This image shows the wood floor joists with degradation as well as various attempts to "scab" the joists, presumably due to excessive deflection.

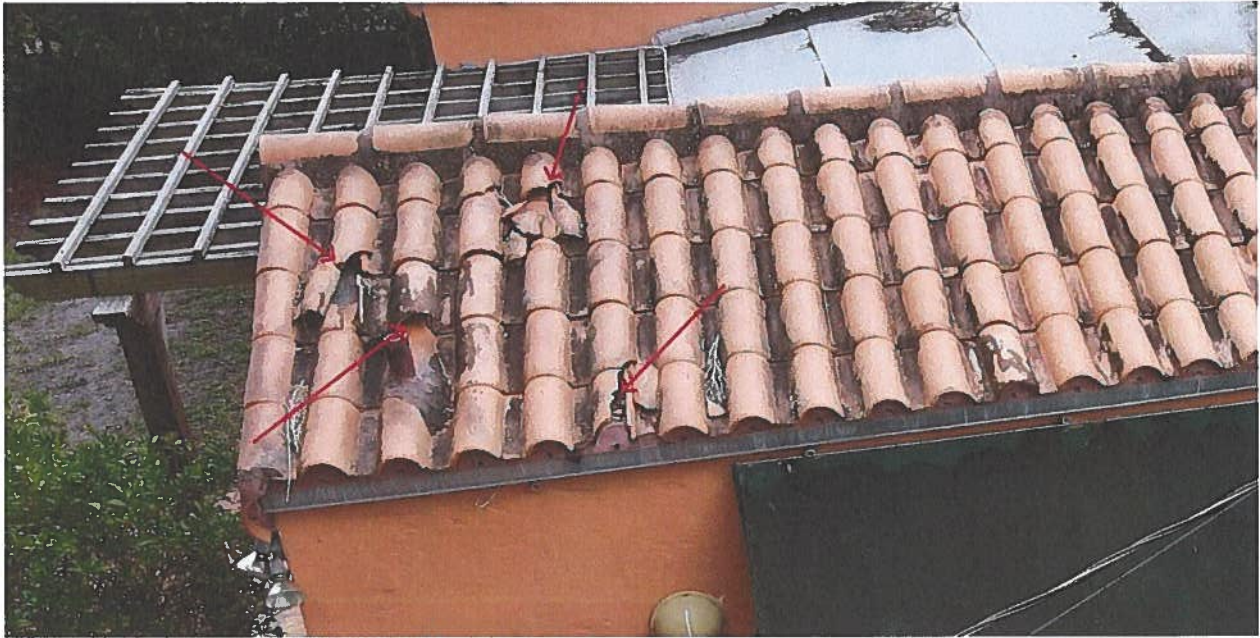
Image E

The roof was inspected through high-definition imagery provided by ana aerial drone camera. The observations resulted in the discovery of a large number of "S Tiles" being completely broken or damaged. While evidence of leakage was not found, the roof will likely need to be replaced in the very near future.

This image shows several "S Tile" roofing tiles either broken or damaged.

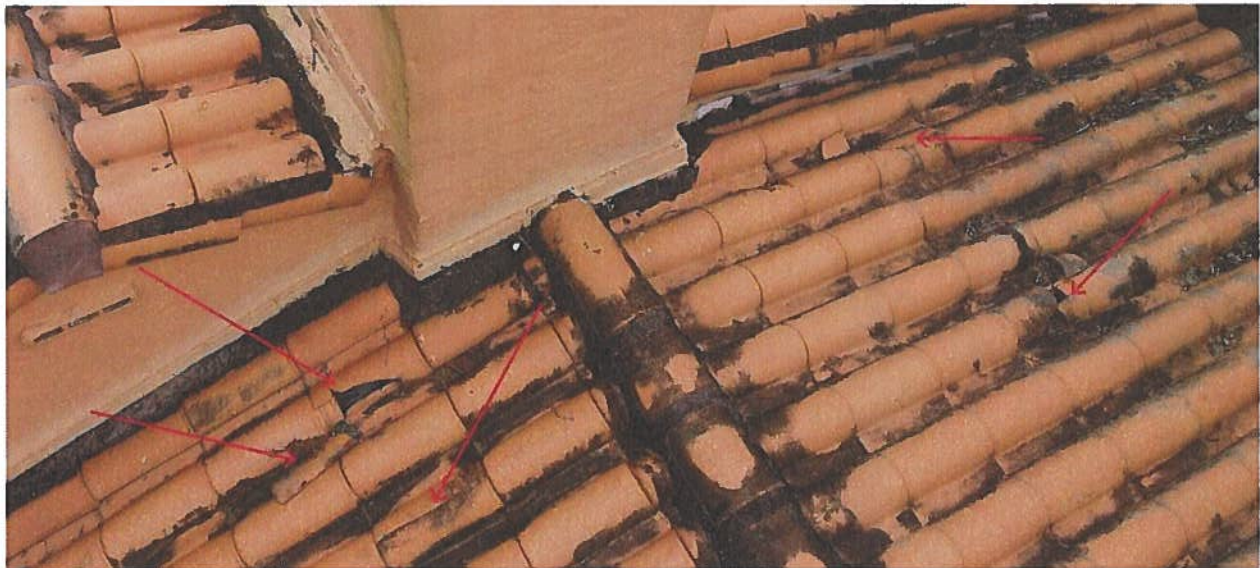
Image F

This image shows several "S Tile" roofing tiles either broken or damaged.

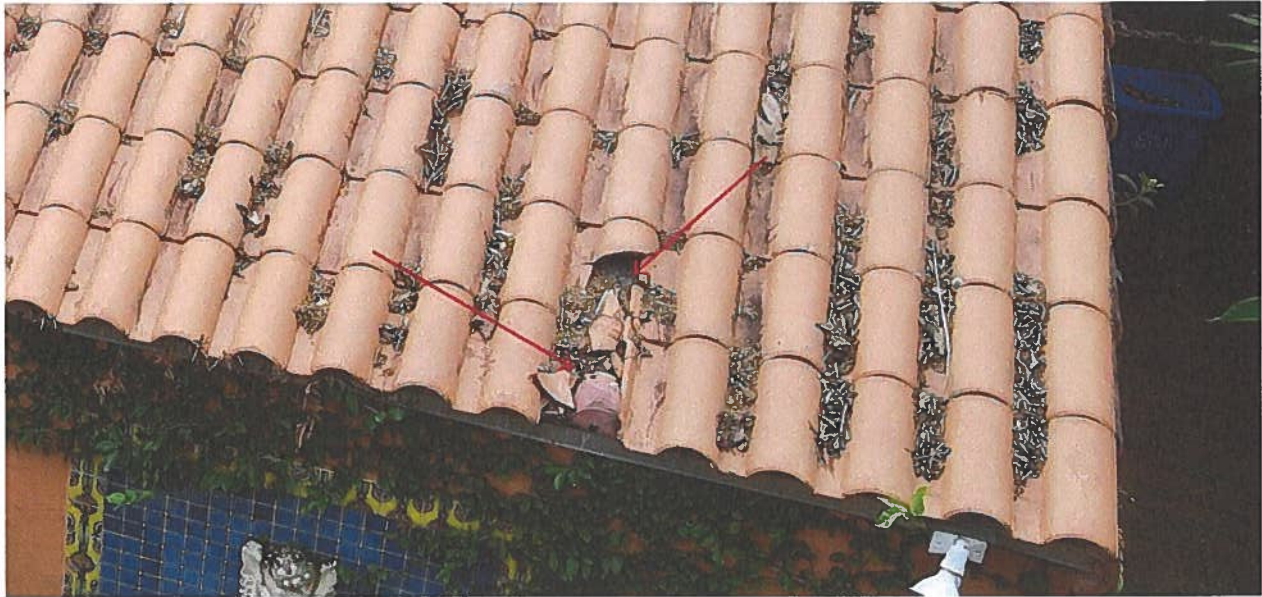
Image G

This image shows several "S Tile" roofing tiles either broken or damaged.

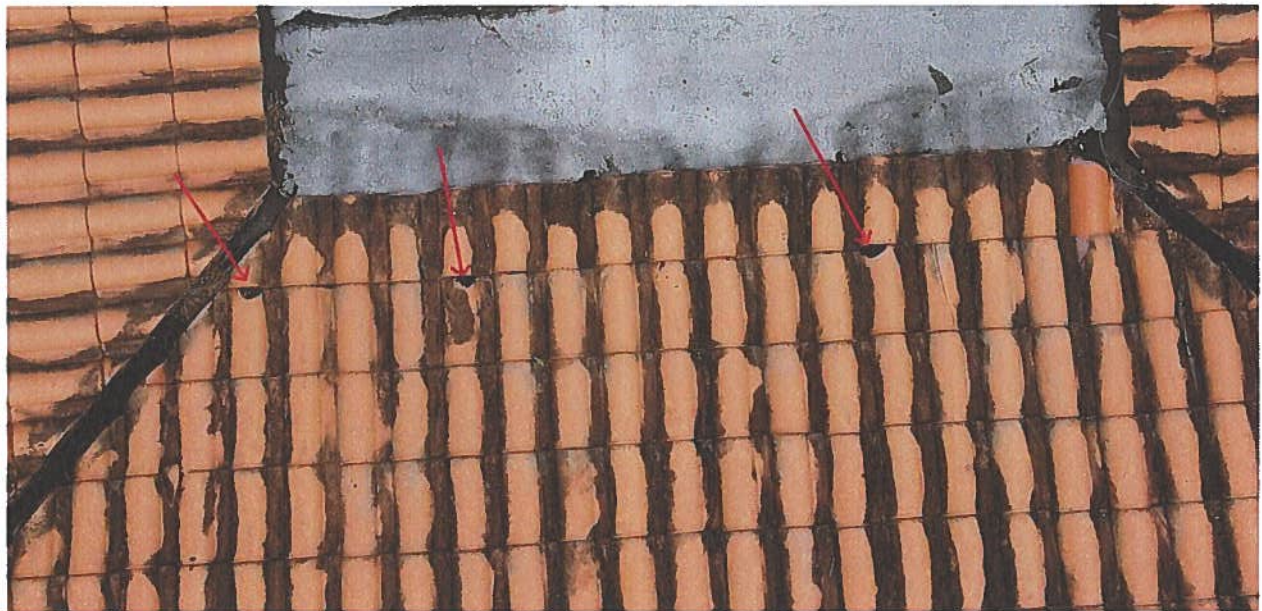
Image H

This image shows several "S Tile" roofing tiles either broken or damaged.

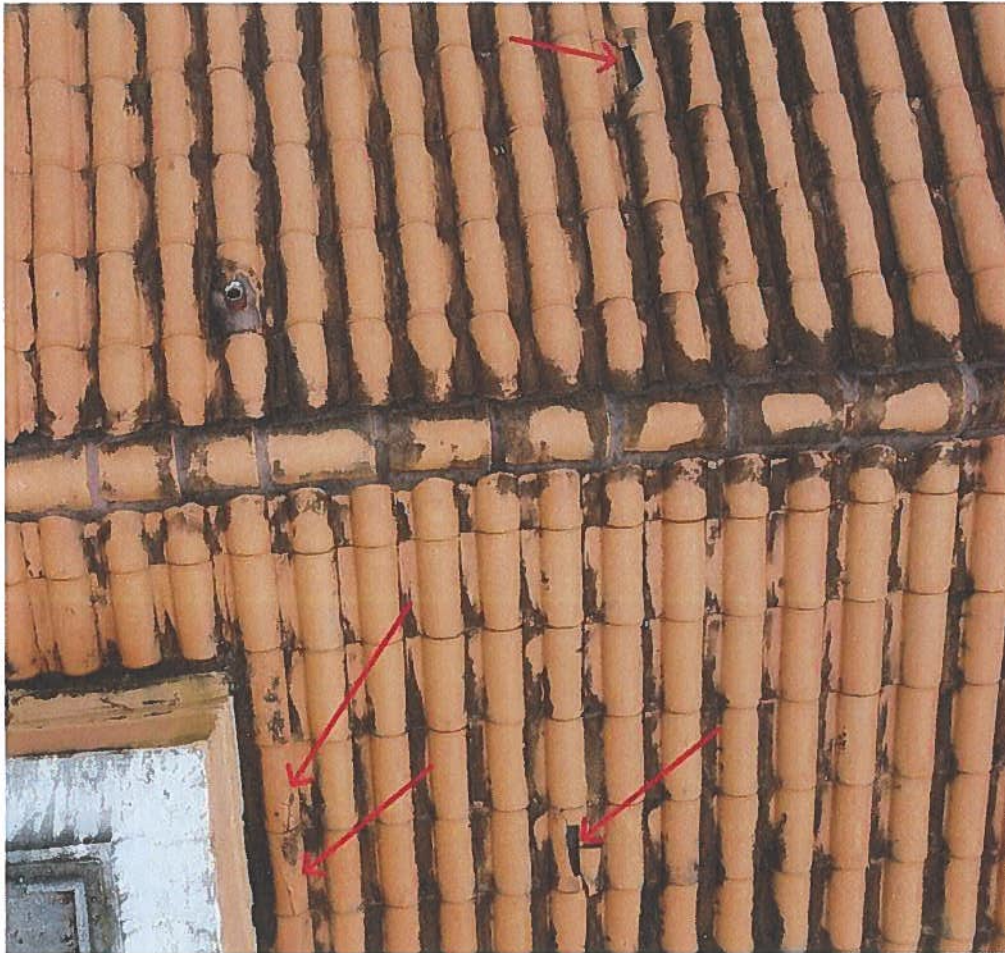
Image 1

This image shows several "S Tile" roofing tiles either broken or damaged.

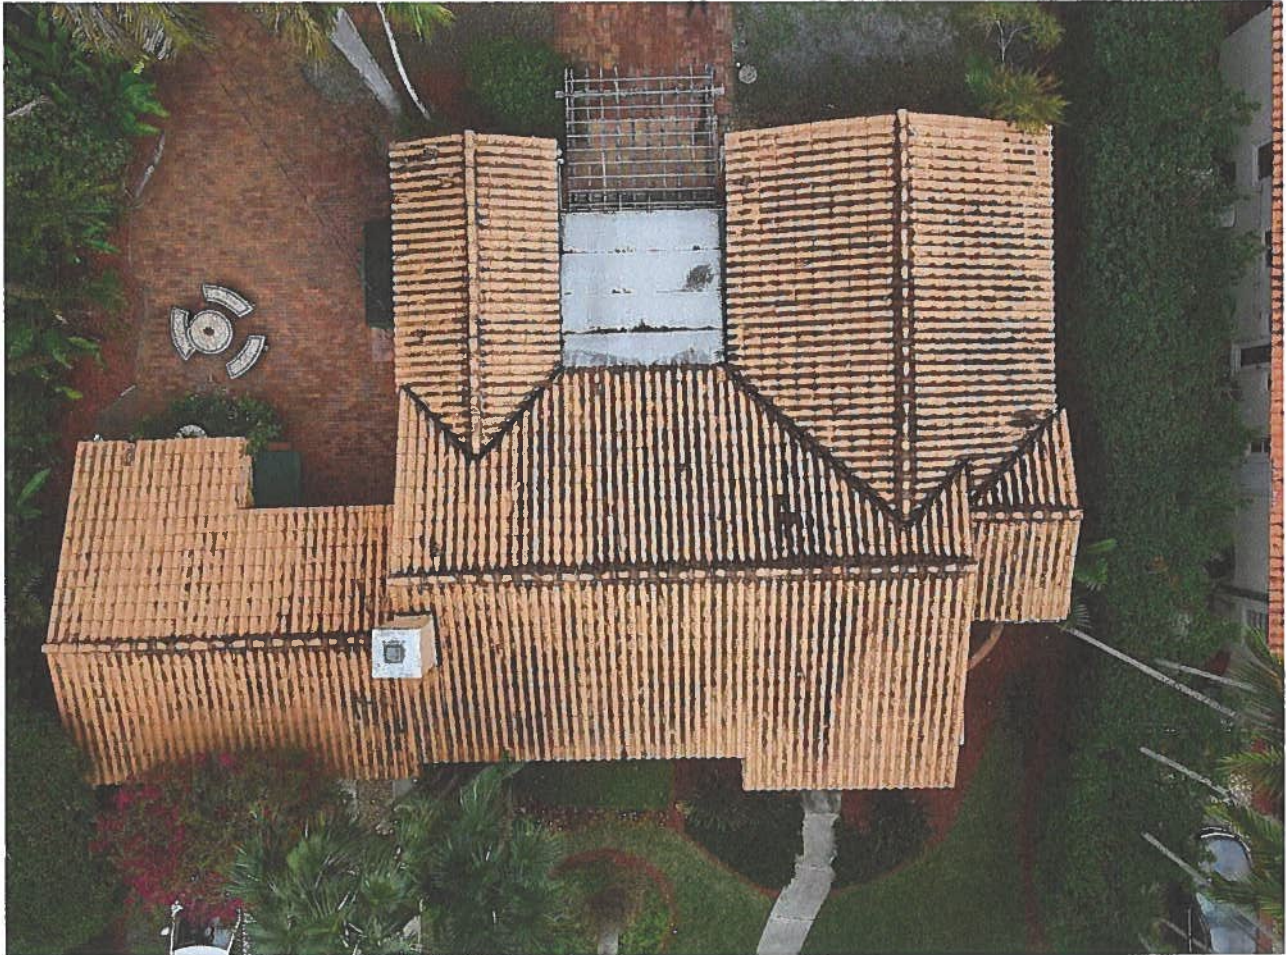
Image J

This image shows the overall roof shot of the existing roof in need of replacement.
