Introduction: I was notified of an issue at this residence on 10.29.2025 in afternoon via email from Officer Pedro Gonzalez from Code Enforcement. He asked me to inspect site for tree damages. It was verified by Code Enforcement that no Permit for tree work or ROW improvements were applied for or approved at this site.

City of Coral Gables

Urban Forester / Greenspace Management Division

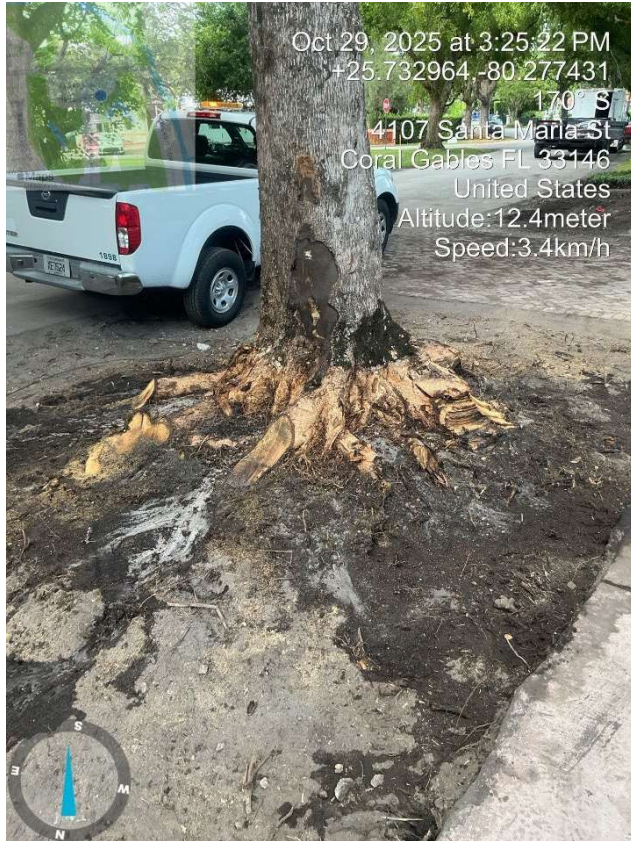
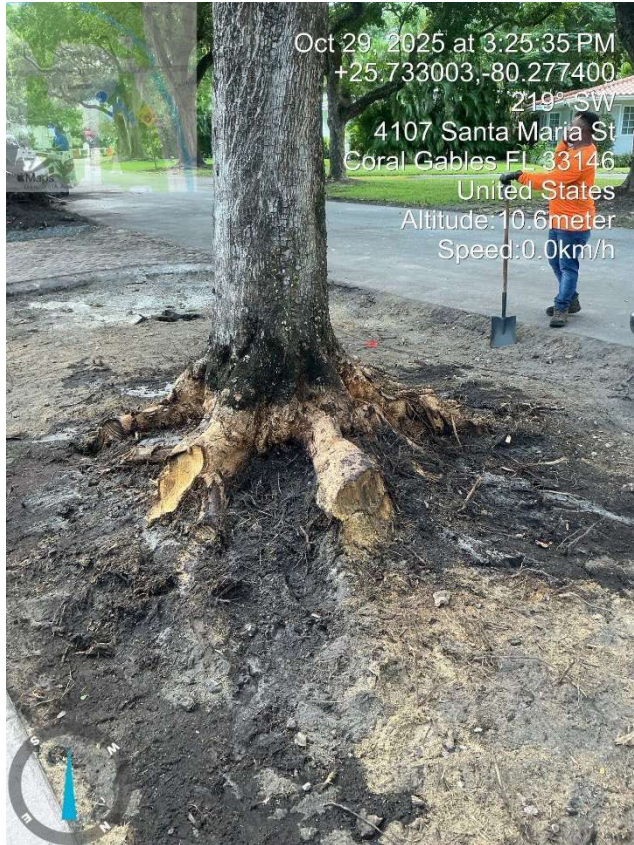
Trees have had MAJOR structural roots ground or broken from basal areas and the critical root zone destroyed, as this is what is integral to structurally supporting/balancing the crown. Making trees a major risk to retain. All or most absorption roots were removed and trees already showing wilting of leaves. Severed roots in this close of proximity to trunk and the methods to “cut” roots make trees more susceptible to fungal pathogens and death or decline in coming 3-5 years, even if trees theoretically could be retained without risk of whole tree failure from lack of roots. Tree # 3 had soil rubbed into large area where bark was damaged in attempt to conceal wound.

*Tree 3 Ground away CRZ Roots*

- We/I recommend removal of trees 1, 2, 3 with crown reduction (safe up) immediately. (Any cost incurred by city to be reimbursed).
- Tree #4 to have independent ISA certified arborist's inspection report and plan created thereafter in coordination with the City urban forester.
- Any fines for tree damage and or working in ROW without permits as per.
- Cost of economic loss TBD and mitigation resolved thereafter.
- Public Works should inspect roadbed.

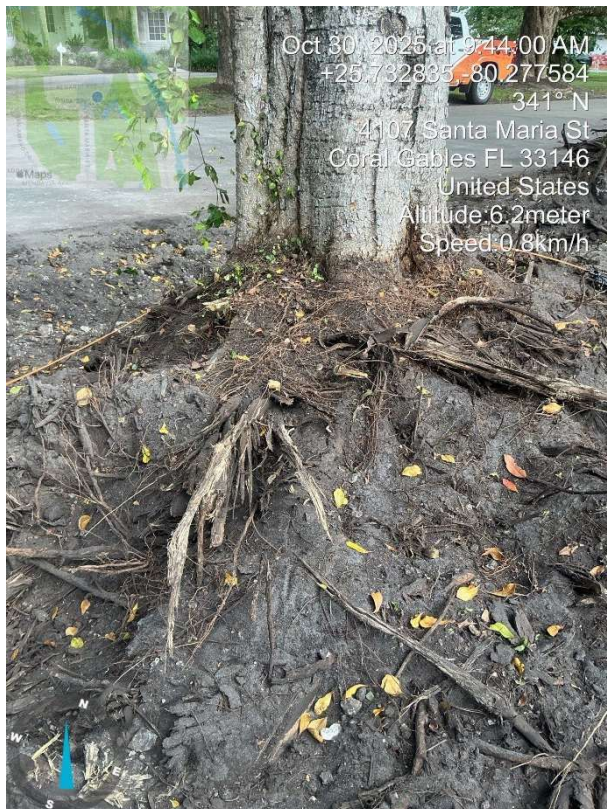
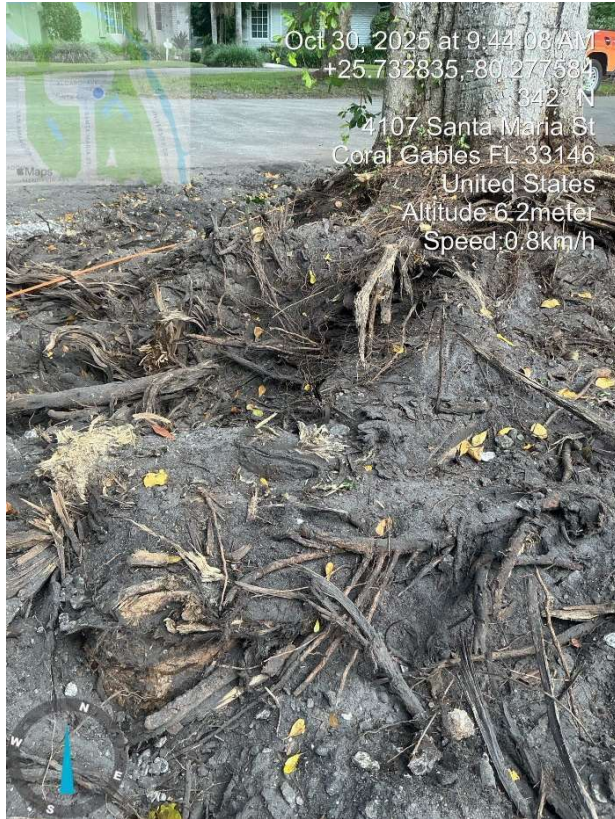
*Tree 1 Broken CRZ roots*

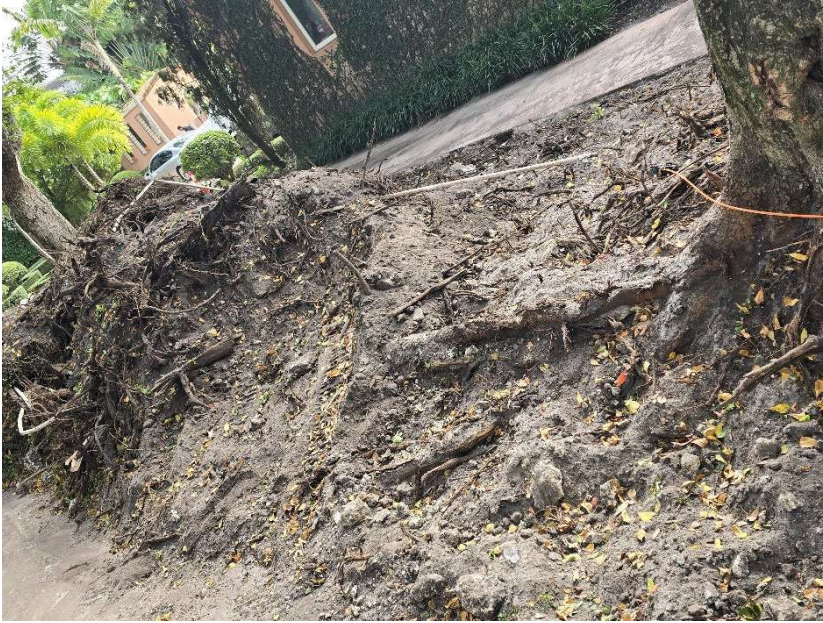
*Trees 1 &2 with fill*

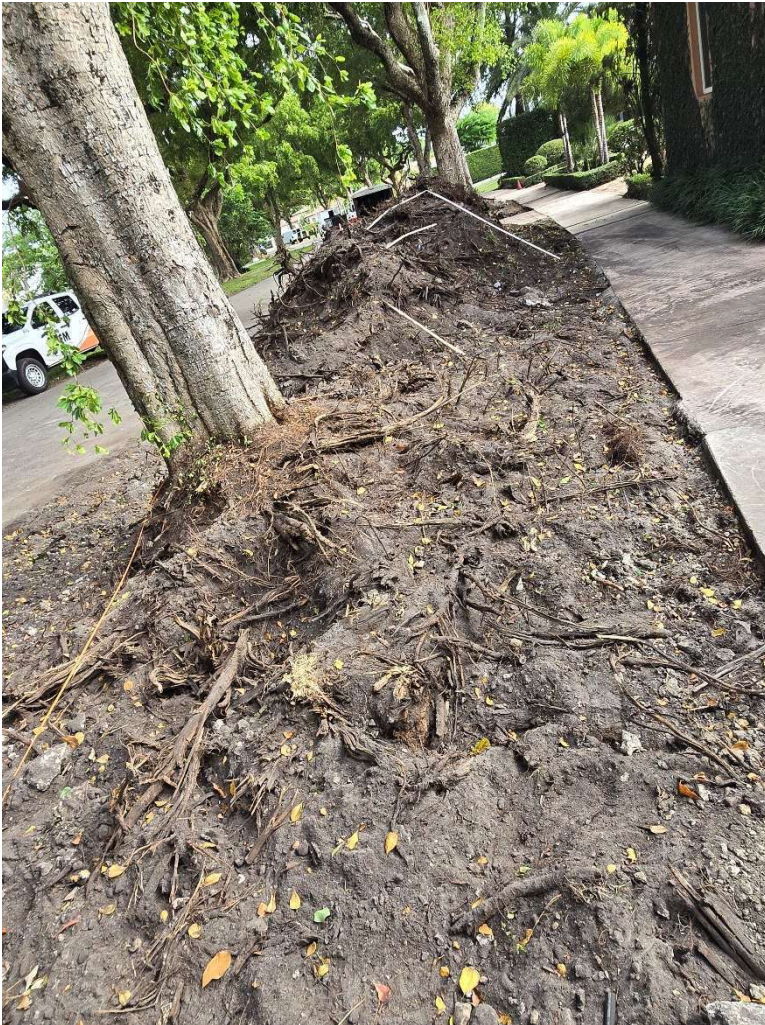
*Trees 1 &2 with fill and damaged*

*roots*

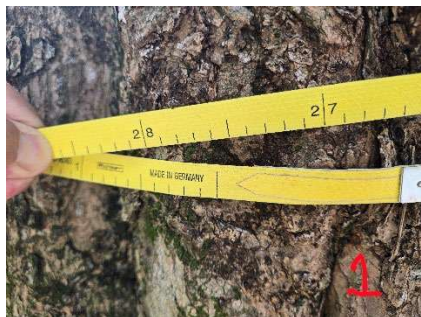
**Trees # 1,2,3 :** (Southern most 3 trees) “Effectively Destroyed” and should be removed and mitigated in full as per Chapter 82 of City Code : 1 new tree, 16’ minimum overall planted height, or \$ 2,500 for each 500 square feet of tree canopy lost. The resident must submit an ISA certified arborist’s report that calculates the square footage of canopy loss to be confirmed by City arborists.

Tree #1 **27.5" DBH** Black Olive (*Terminalia buceras*)

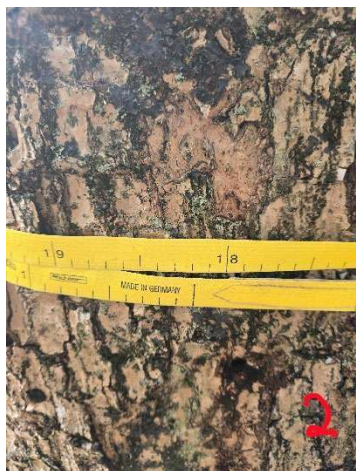
Tree #2 **18.25" DBH** Black olive (*Terminalia buceras*)

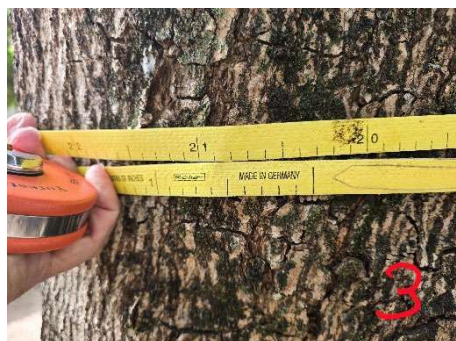
Tree #3 **20.25" DBH** Black olive (*Terminalia buceras*)

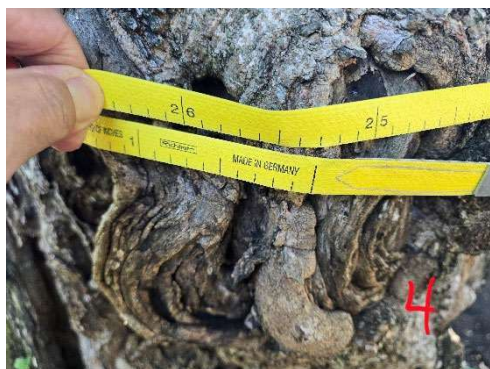
**Tree listed as # 4** (Tree resides on neighboring property to north) could POSSIBLY be retained but should have an independent arborist inspect and render assessment on retention and stability via air spade root inspection in quadrant affected by ROW. It is apparent that some structural roots were ground away, but not on same scope as the other 3 trees. Tree has poor trunk beyond current issue created.

Tree #4 **25.25" DBH** Black olive (*Terminalia buceras*)
