CORAL GABLES WHITE WAY HISTORIC LAMPPOST ASSESSMENT

City of Coral Gables, Florida

Date: February 17, 2020

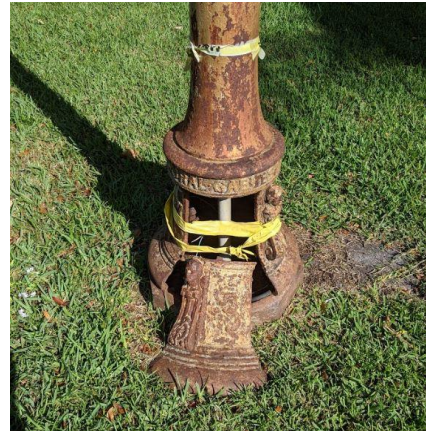
It was noted that a number of access panels of lampposts on the street were completely detached and no longer held in place with caution tape (figure 6). It is recommended that these panels be removed and put into storage or re-attached to the post as soon as possible so as to avoid them going missing. These posts are noted in Table 1 below.

Figure 6. Example of access panel at risk of going missing (No. H28) (photo by EverGreene, 2020).

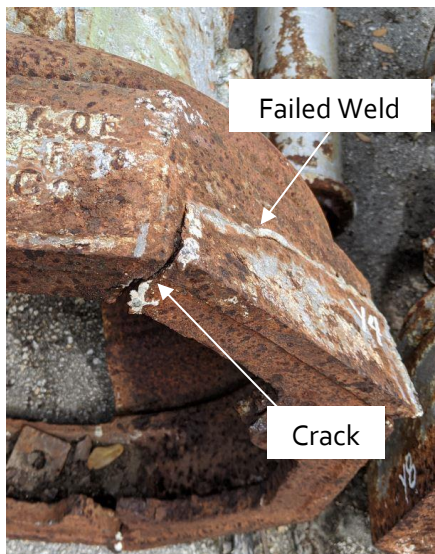
Welds used to fix cracks or pieces that had previously broken off were found on lampposts Y4 and H16. These welds have mostly already failed and are visually incompatible.

Figure 7. Improper weld around piece broken off from base plate (Y4), since failed. (photo by EverGreene, January 2020)

The current failed welds should be repaired and reattached with an appropriate repair method for historic cast iron. Re-attachment of broken pieces can be performed with mechanical attachments or stitch welding. As welding is notoriously difficult with cast iron, welds should only be used when necessary. Mechanical repairs would allow for a long-term solution that would minimize risk of damage to the historic cast iron. Stitch welding the pieces is not recommended due to the curved and decorative nature of the pieces.

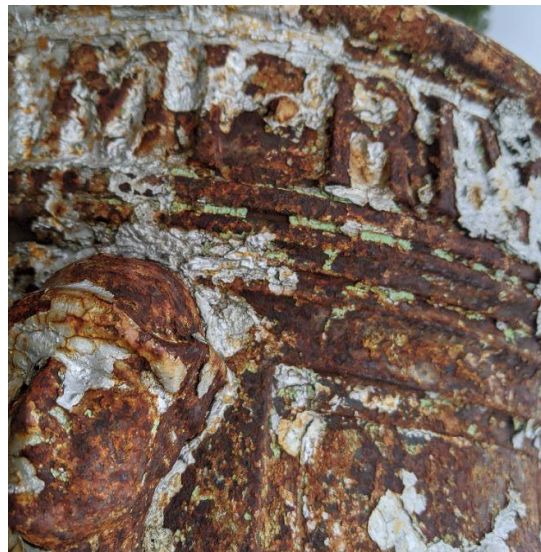
Corrosion is concentrated at the post base, where the ornament tends to catch and hold moisture. As a result, some of the definition of the ornament has been lost. Conditions are categorized as follows:

Figure 8. Close-up of lamppost base showing corrosion where paint has worn off. (photo by EverGreene, January 2020)

Surfaces should be cleaned to a SSPC-SP 10 (Near White Metal). Cleaned surfaces should be primed within eight hours of blasting and removal of residue. The presence of lead or other metals in the coatings should be tested prior to cleaning and, if found, appropriate containment and disposal measures should be taken. Coating recommendations are discussed below.

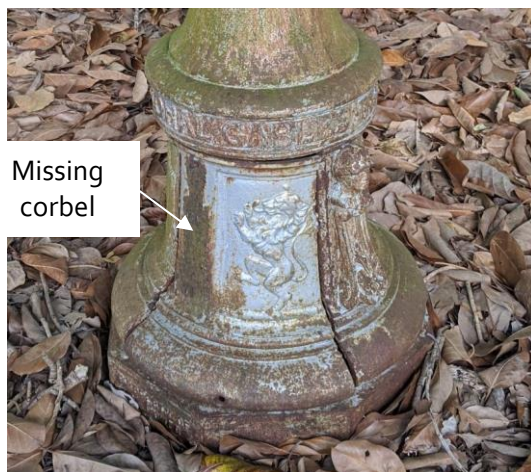
Figure 9. Missing figurative corbel (photo by EverGreene, January 2020).

Missing pieces should be recreated. Replacement for missing cast iron elements should be based on scans or molds of cleaned existing matching elements re-sized to accommodate shrinkage during casting. They should be attached using a similar method as to the historic assembly methods (bolted). Recast materials can be fiberglass, iron, or aluminum. If re-casting with iron, special attention should be made to compensate for the shrinkage of the iron. Prior to choosing the replacement material, care should be taken to ensure that the replacement material meets needs for strength and function.

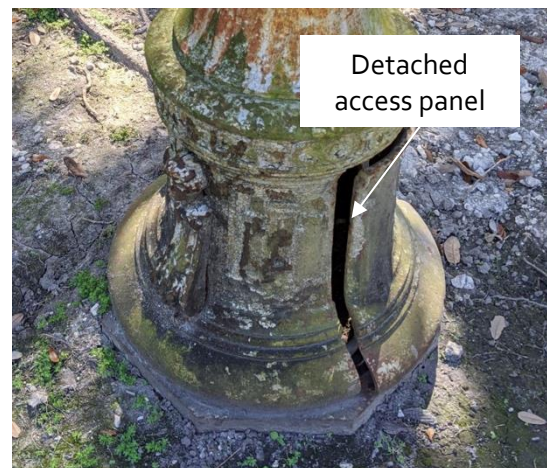
Wherever accessible, each corbel and access plate on the base of the lampposts were tested to determine if any pieces were loose. Other than loose access panels, of which there were many, only a few post bases had loose decorative pieces. Detachment was generally exclusive to the access panels which are only held in place with one screw at the bottom.

Figure 10. Detached access panel (photo by EverGreene, January 2020).
