**BILTMORE II CONDOMINIUM BUILDING**

**FORTY-YEAR INSPECTION**

**Biltmore II Condominium Building  
600 Biltmore Way  
Coral Gables, FL 33134**

**Project No. 06-269-L**

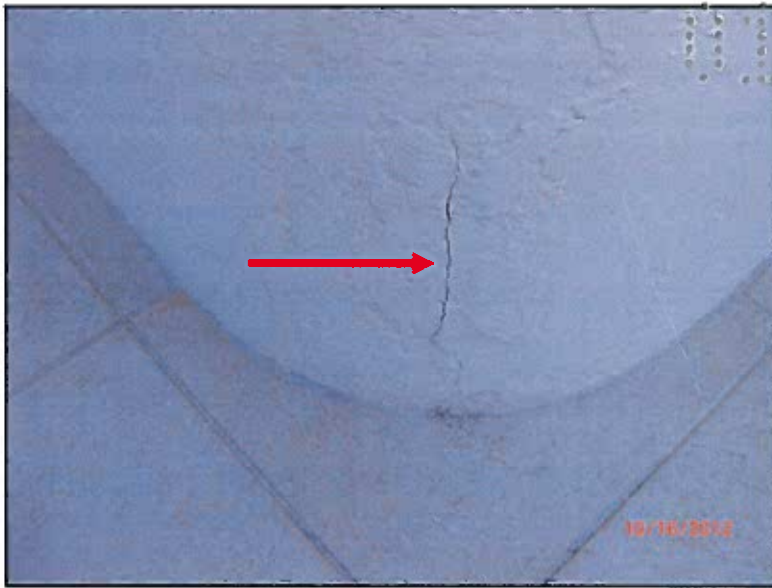
1. The building structure is generally in good condition.
2. The interior walls of balconies are in good condition overall. Minor cracking was observed on interior balcony wall and building wall (photo #1, photo #2 and photo #3) location.

PHOTO # 1: Vertical cracking on building wall located at balcony Unit #219

The walls of the balcony slabs are typically in good condition, the inspected residential units' exhibit cracking at balconies. This is an indication of moisture intrusion into the block wall, with subsequent delamination of stucco. If left unabated, the stucco at the balcony block wall will eventually spall off, creating a falling debris and life safety hazard for residents and pedestrians below. We recommend the balcony walls be repaired where there are sign of cracking and

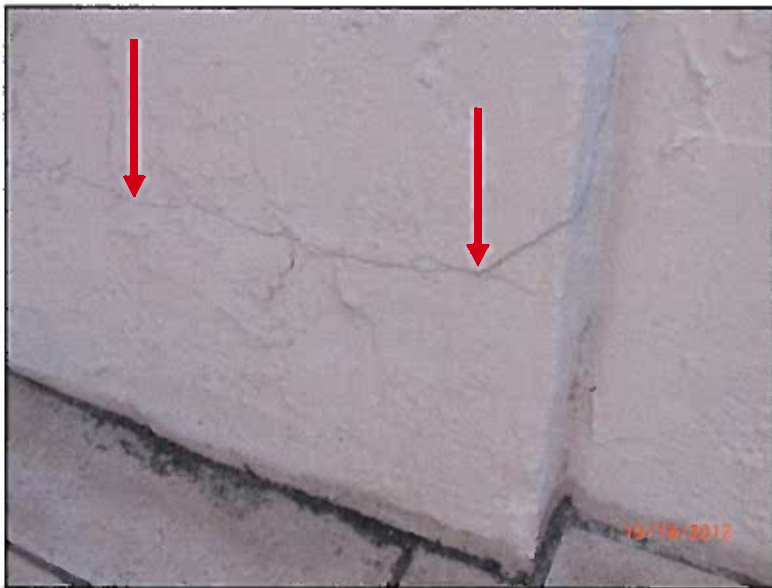
PHOTO # 2: Horizontal cracking/delaminated stucco at balcony wall Unit #219

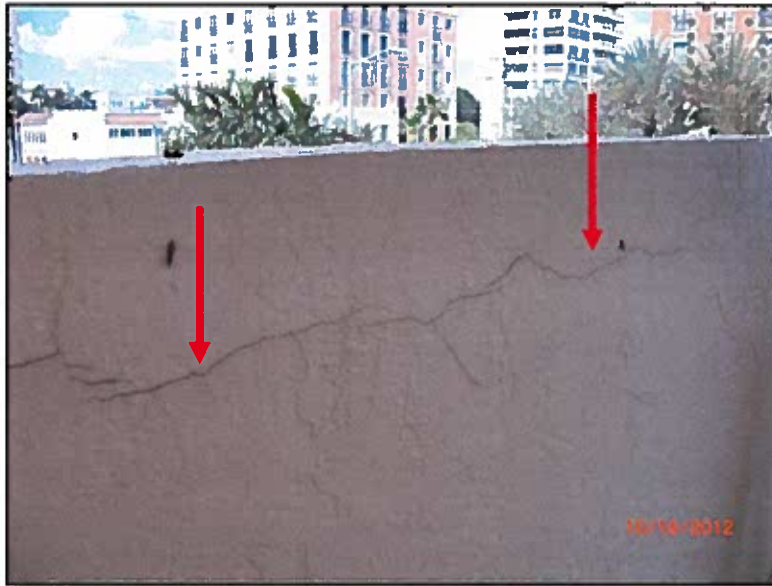
**PHOTO # 3: Horizontal cracking on balcony block wall concrete cap at Unit #219**

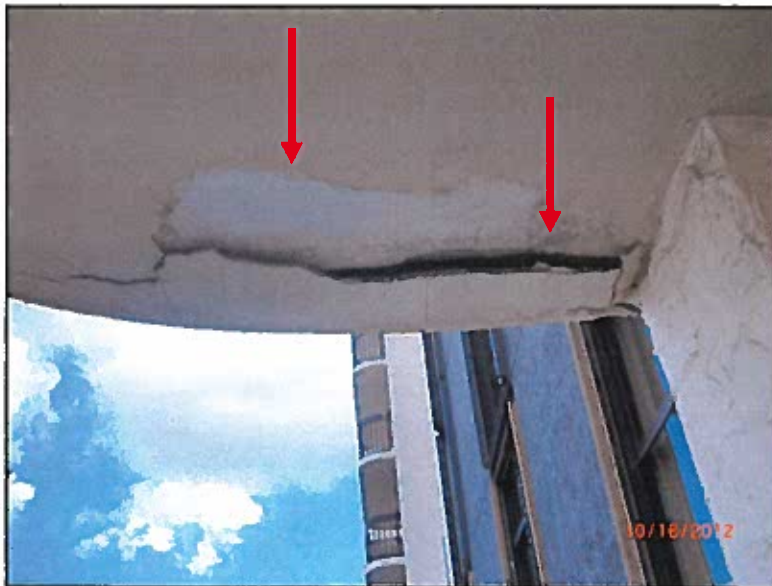
3. The balcony slabs are in fair condition. Spalled concrete with corroded reinforcing steel was noted on the balcony ceilings of Units 219 and 416 (photo #4 and photo #5).

**PHOTO # 4: Concrete spalling/exposed steel rebar at balcony ceiling at Unit #219**

Although the edges of the balcony slabs are typically in fair condition, some units exhibit cracking and concrete spalling at the slab edge and at the underside of slab above. This is an indication of moisture intrusion into the concrete, with subsequent corrosion of the reinforcing steel. If left unabated, the concrete at the edges of balconies will eventually spall off, creating a falling debris and life safety hazard for residents and pedestrians below. It's recommended that balcony edges be repaired where there are signs of cracking and concrete spalling. In addition, we also recommend that all balconies be surveyed to document similar conditions.

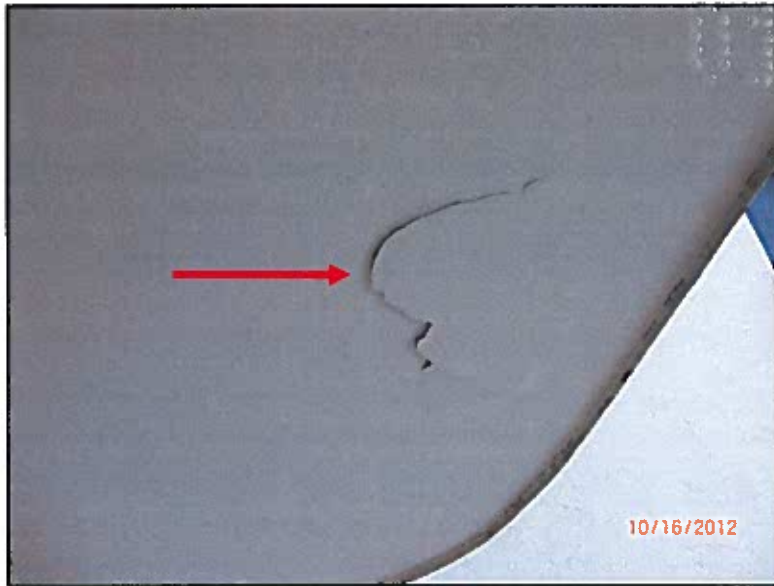
**PHOTO # 5: Concrete spalling at balcony ceiling at Unit #416**

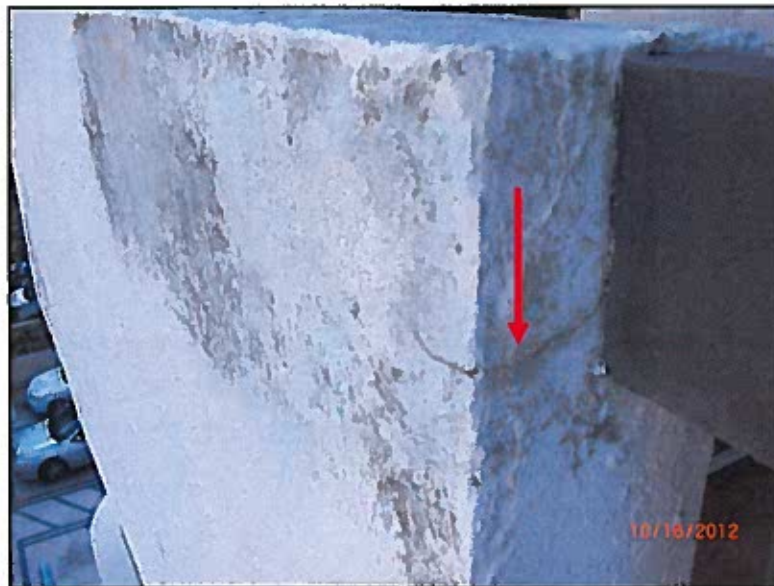
4. Minor stucco cracking at balcony railing connection to block wall of Unit 407 (photo #6).
5. We observed stucco cracking along balcony's edge of Unit 407 (photo #7) and connection between block wall and building column of Unit 219 (photo #8).

**PHOTO # 6: Cracking stucco at balcony railing connection at Unit #407**

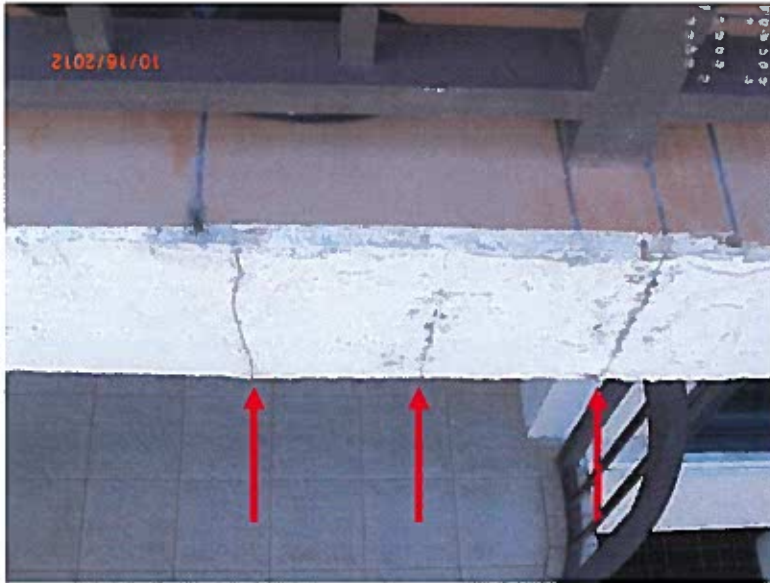
**PHOTO # 7: Cracking/delaminated stucco on balcony slab edge at Unit #407**

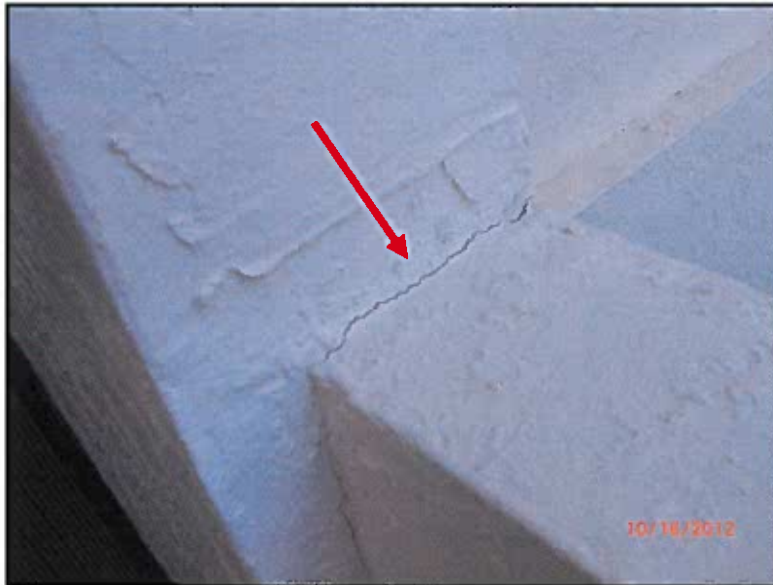
**PHOTO # 8: Cracking at connection between balcony wall and bldg. column at Unit #219**

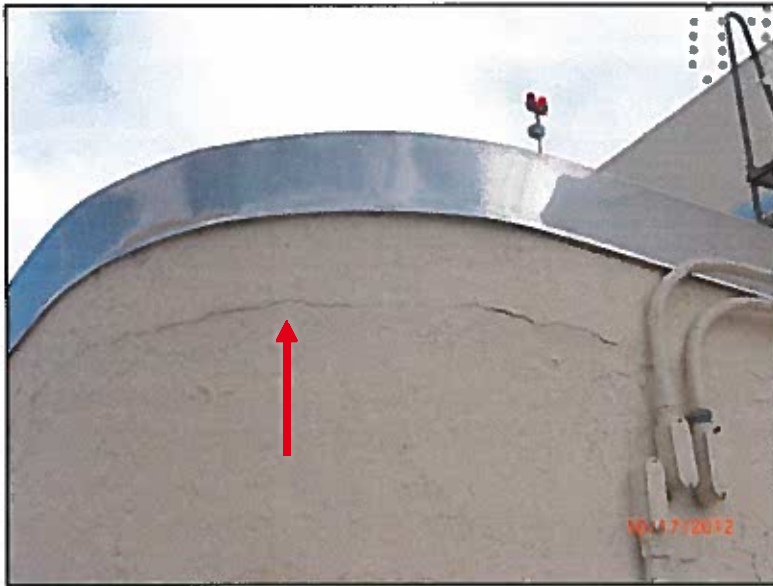
6. The roof edges of the Generator Room (photo #9) and East Elevator Machine Room (photo #10) at Roof Area have fine horizontal cracks which exhibit signs of water infiltration.

**PHOTO # 9: Delaminated/cracking stucco at exterior of Generator Room at roof area**

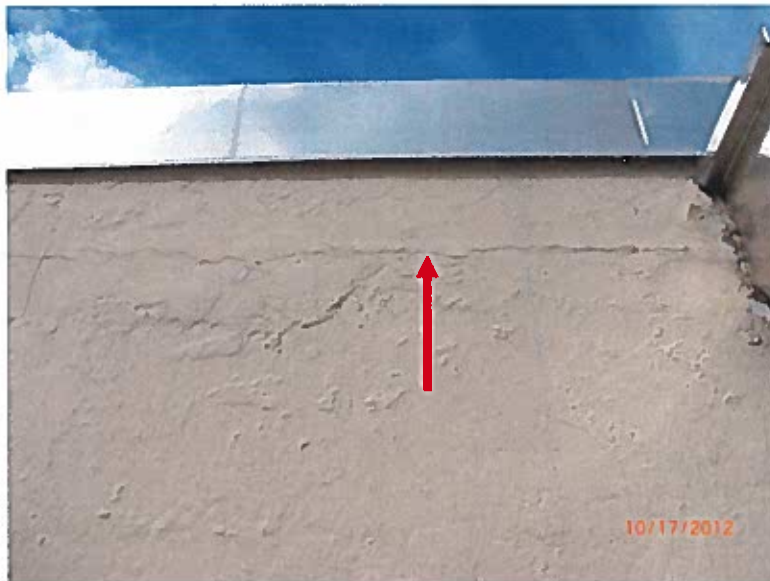
**PHOTO # 10: Delaminated/cracking stucco at exterior of east Elevator Machine Room at Roof Area**

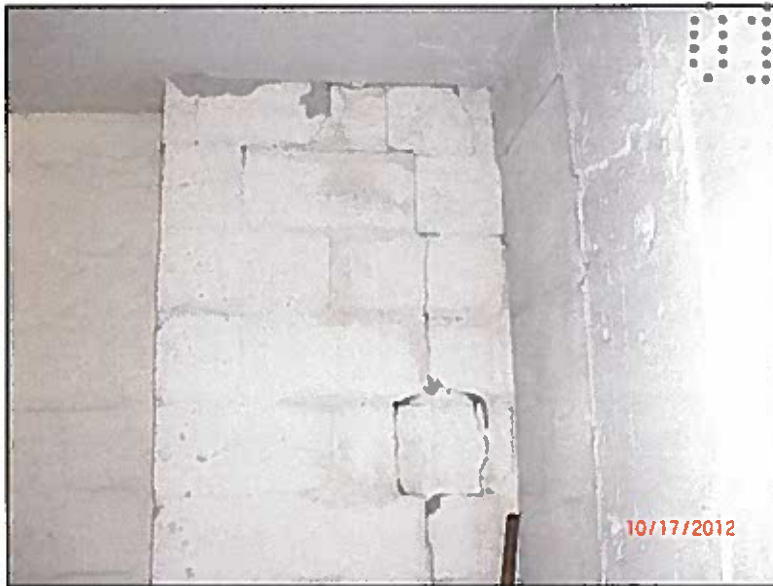
7. The interior block wall at the east side of the Elevator Machine Room at the Roof Area was observed with step cracking (photo #11).
8. The roof edge of the Penthouse exterior wall (photo #12) was noted with fine horizontal cracks which exhibit signs of water infiltration.

**PHOTO # 11: Step cracking at corners of east side Elevator Machine Room**

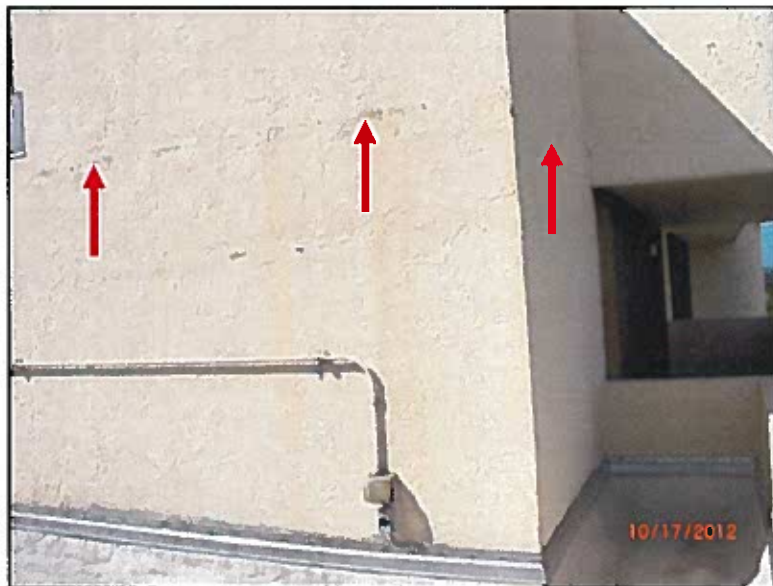
**PHOTO # 12: Horizontal cracking at PH exterior wall**

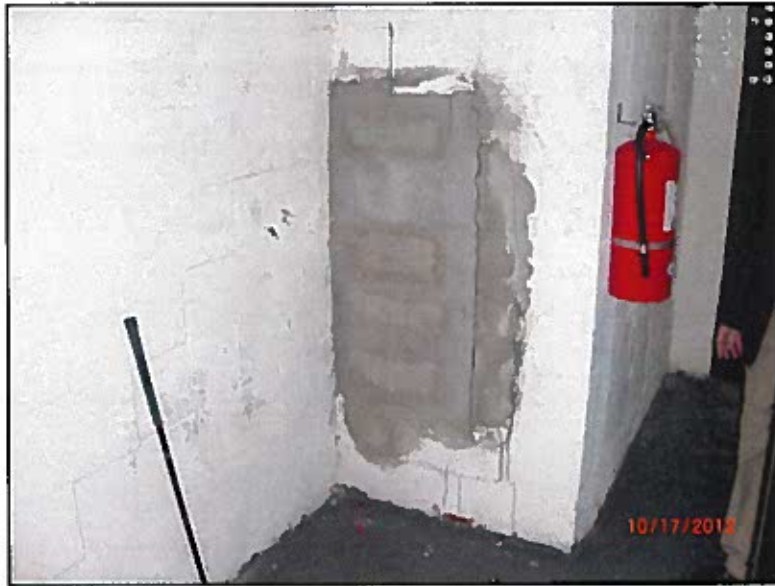
9. The interior block wall at the West Elevator Machine Room is not mortared properly at patched area (photo #13).
10. Hair Line cracking across column drop panel next to Parking Space No. 267 (photo #14 and photo #15).

**PHOTO # 13: Cracks on block wall at inside of West Elevator Machine Room**

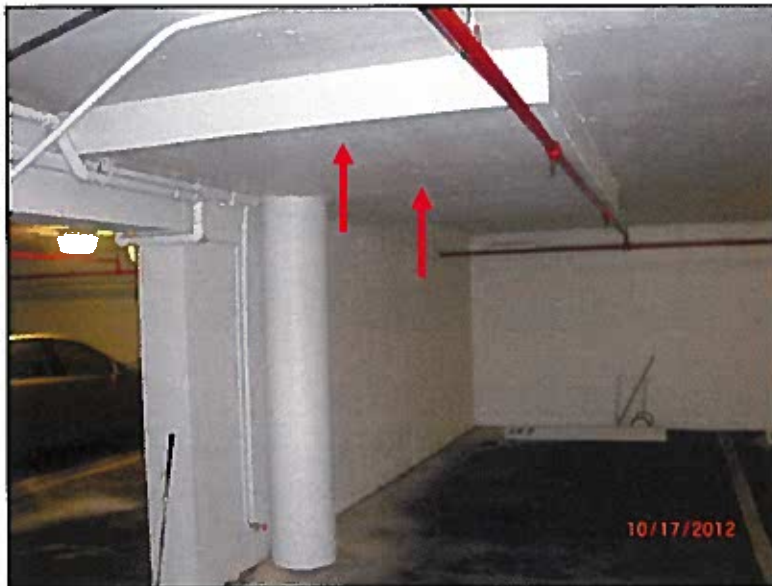
**PHOTO # 14: slab cracking at column drop panel next to Parking Space No. 267**

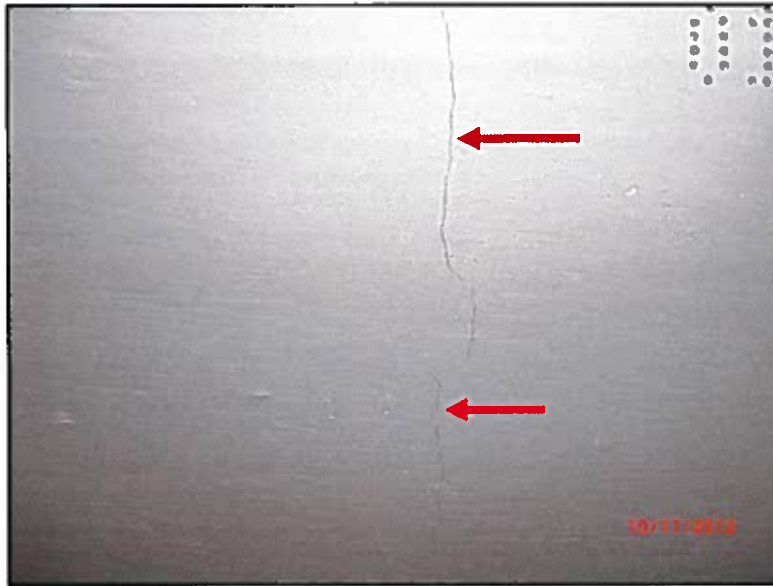
**PHOTO # 15: slab cracking at column drop panel next to Parking Space No. 267**

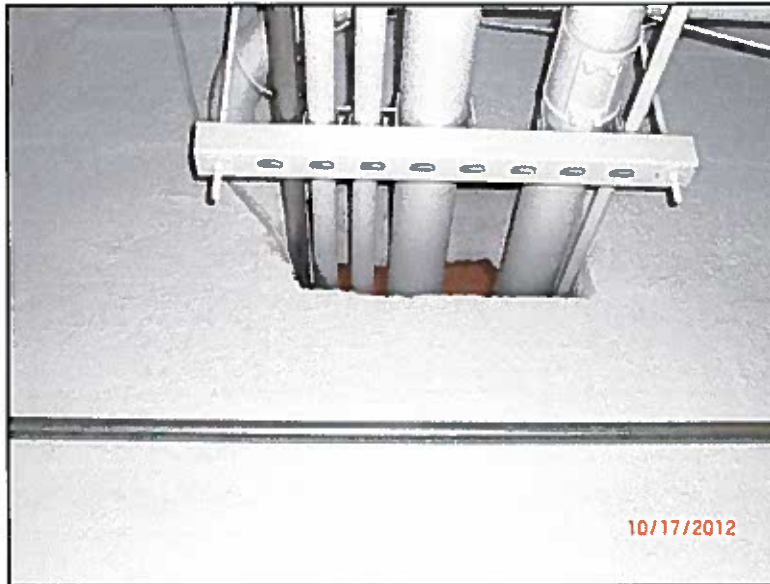
11. Unscaled wall pipe penetration at fire rated separation (2hr Fire rate assembly) (photo #16).
12. Hair line cracking on slab and beam was noted next to Parking Space No. 210 (photo #17 and photo #18).

**PHOTO # 16: Unsealed wall, pipe penetration at Fire rated assembly (2hr fire rated assembly)  
Paint Storage Room**

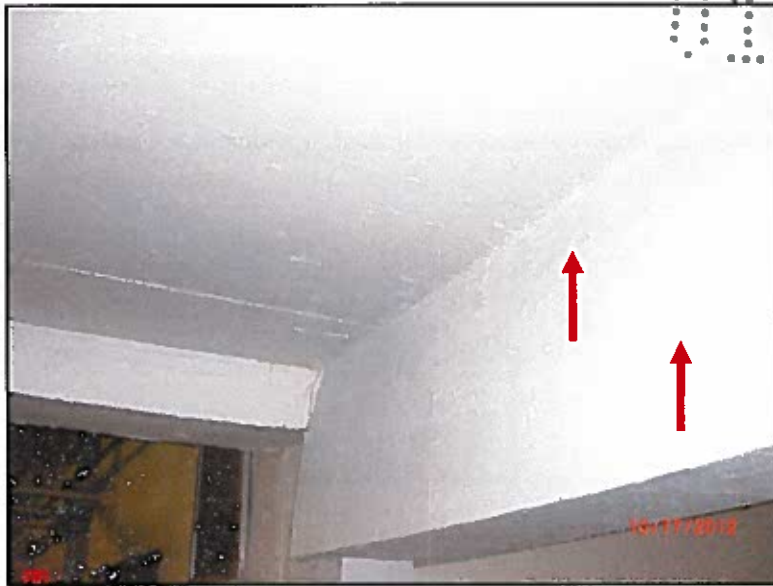
**PHOTO # 17: slab cracking and beam cracks next to Parking Space 210**

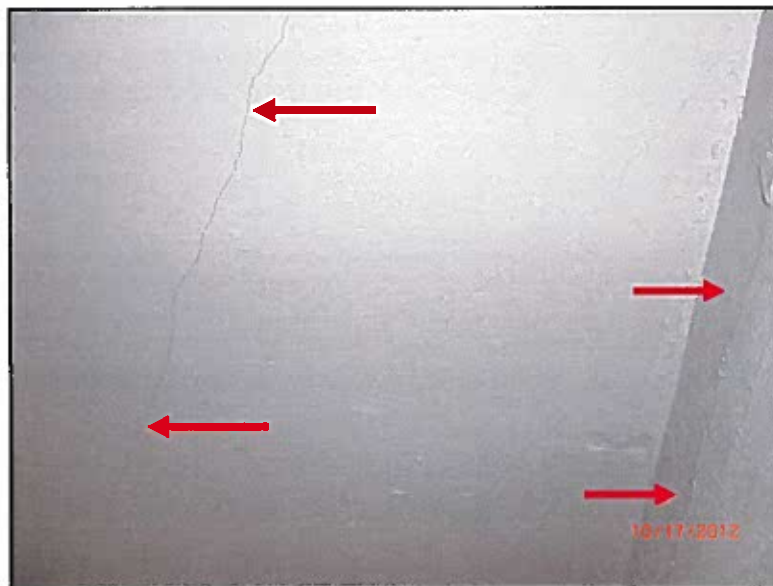
**PHOTO # 18: slab cracking at column drop panel next to Parking Space 210**

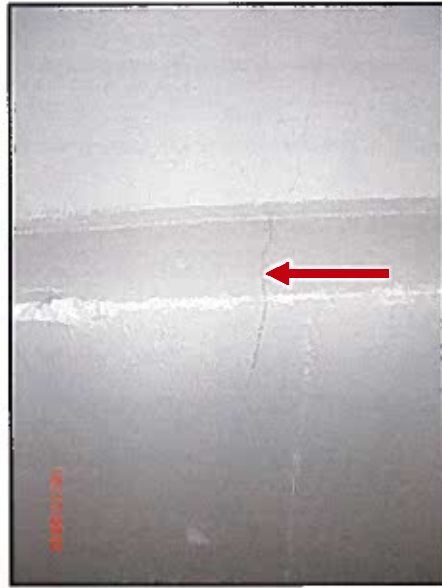
13. Hair line cracking across column drop panel between Parking Space No. 248 & 249 (photo #19).
14. Hair Line cracking at column drop panel corner between Parking Space No. 245 & 246 (photo #20).

**PHOTO # 19: slab cracking at column drop panel between Parking Spaces 248 & 249**

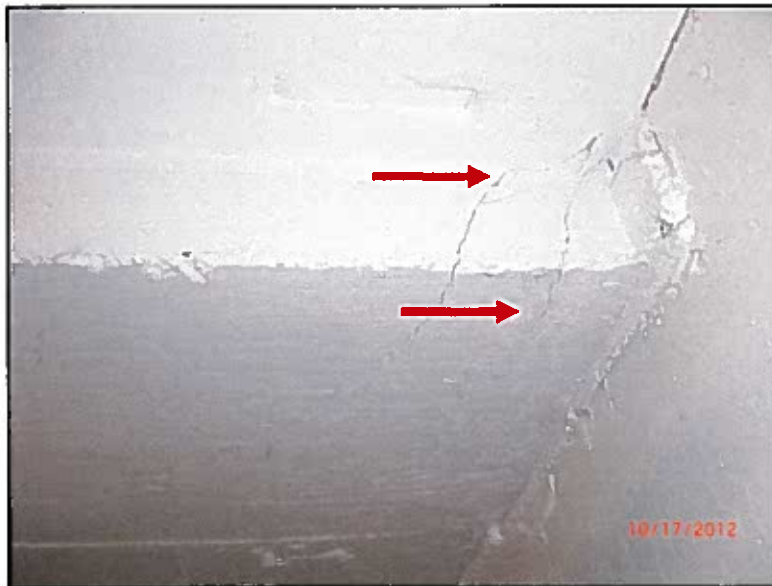
**PHOTO # 20: slab cracking at column drop panel between Parking Spaces 245 & 246**

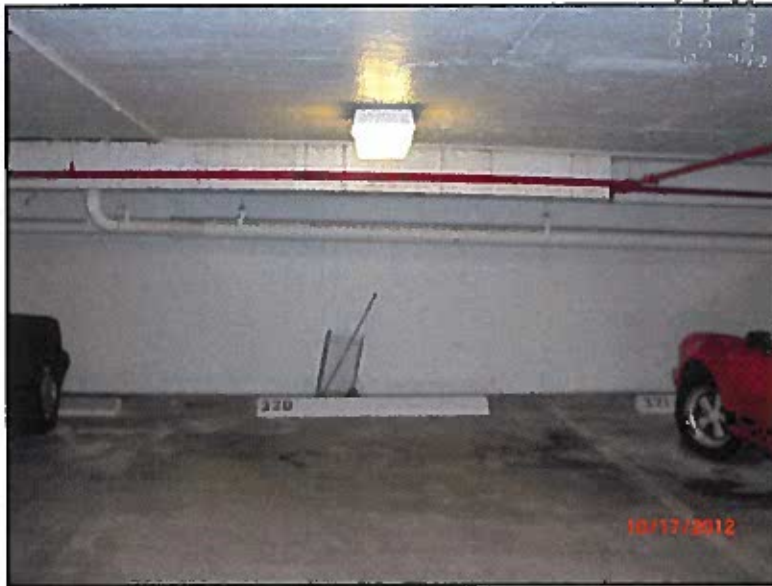
15. Trench drain drop ceiling opening over flows at opening between Parking Spaces No. 314 & 327 (photo #21 and photo #22).
16. Surface cracking and water intrusion was noted at underside of ramp on front of Parking Space No. 61 (photo #23).

**PHOTO # 21: trench drain drop ceiling between Parking Spaces 314 & 327**

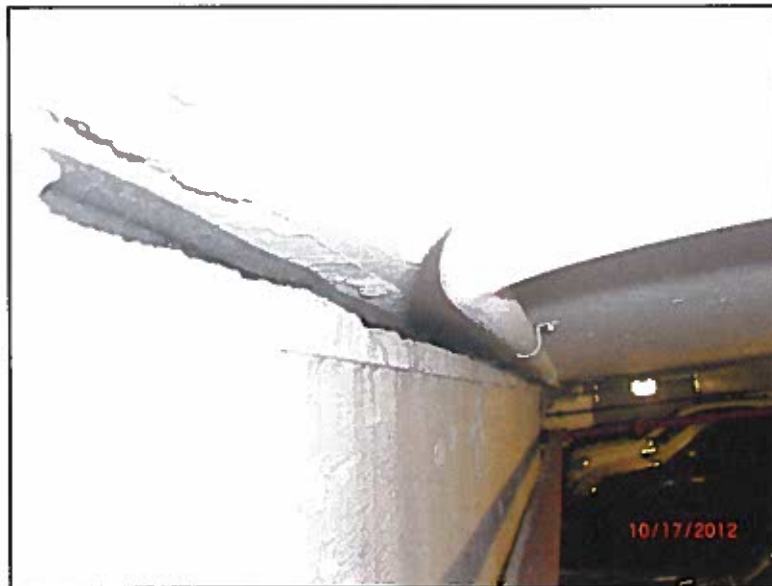
**PHOTO # 22: trench drain drop ceiling opening between Parking Spaces 314 & 327**

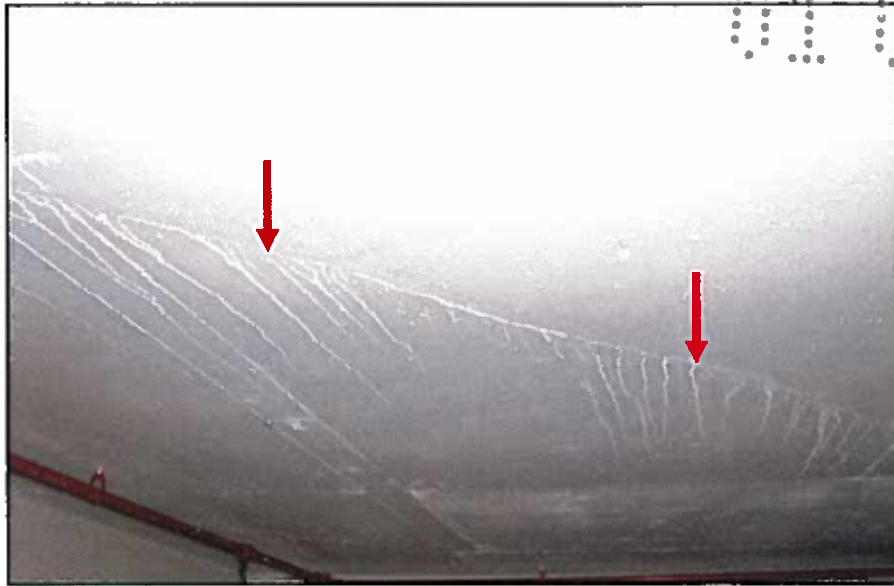
**PHOTO # 23: cracking and water intrusion at underside of ramp in front of Parking Space 61**

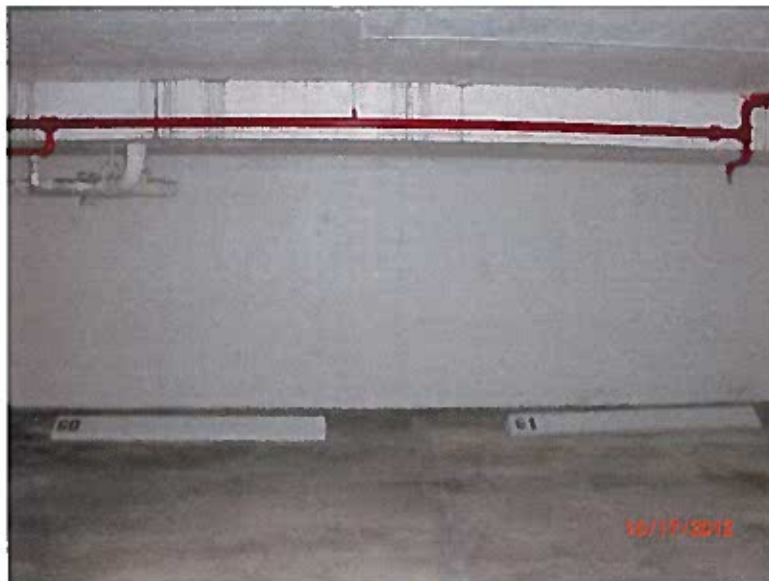
17. Trench drain drop ceiling opening over flows at opening between Parking Space No. 52 & 61 (photo #24 and photo #25).
18. The East end of the Parking Garage wall exhibits hair line cracking next to Parking Space No. 51 (photo #26).

**PHOTO # 24: trench drain drop ceiling between Parking Spaces 52 & 61**

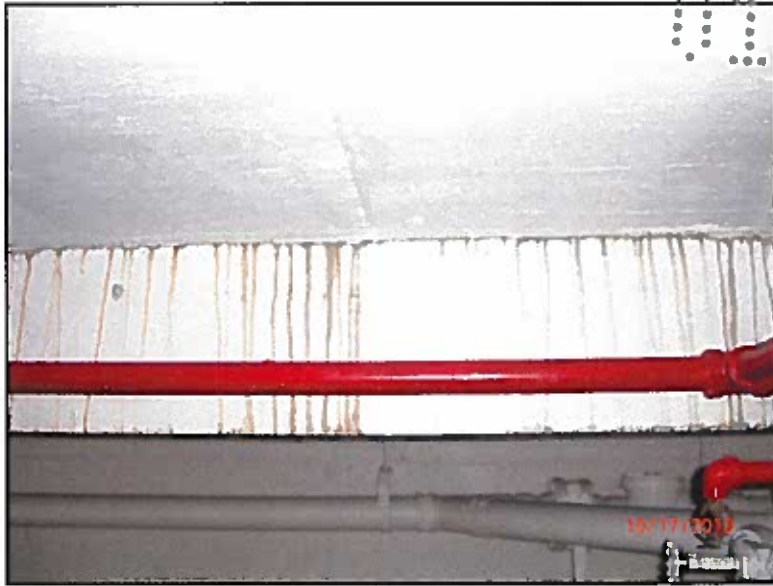
**PHOTO # 25: trench drain drop ceiling between Parking Spaces 52 & 61**

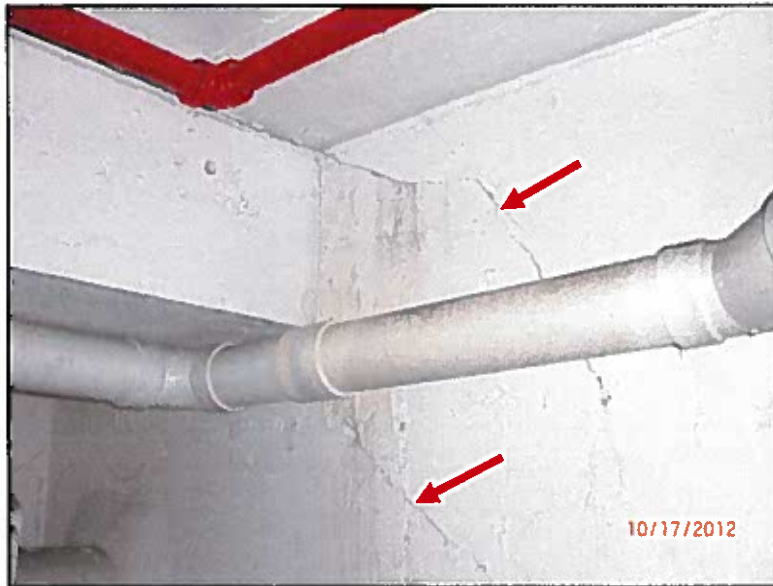
**PHOTO # 26: cracking on wall next to Parking Space 51**

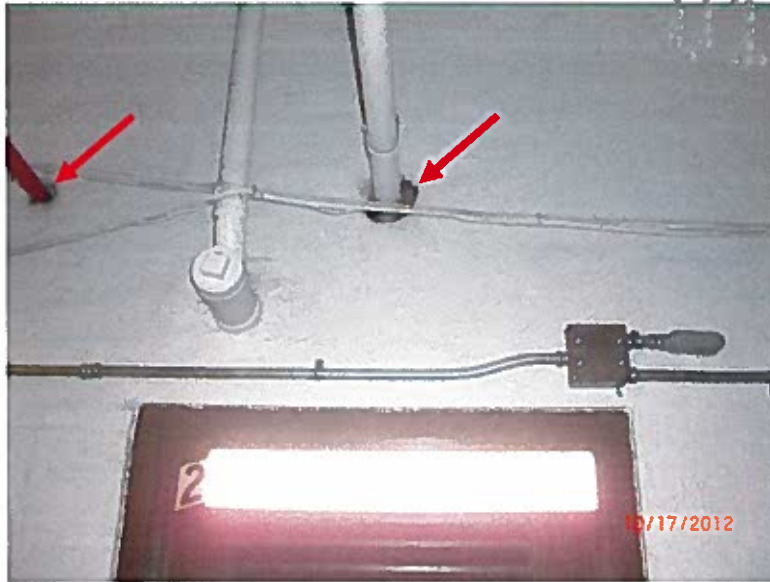
19. Unsealed wall pipe penetration at fire rated separation (2hr Fire rate assembly) above Fire Pump Room door (photo #27).
20. Hair Line Cracking on Overhang at West side (photo #28).

**PHOTO # 27: Unsealed wall, pipe penetration at Fire rated assembly (2hr fire rated assembly)  
Paint Storage Room**

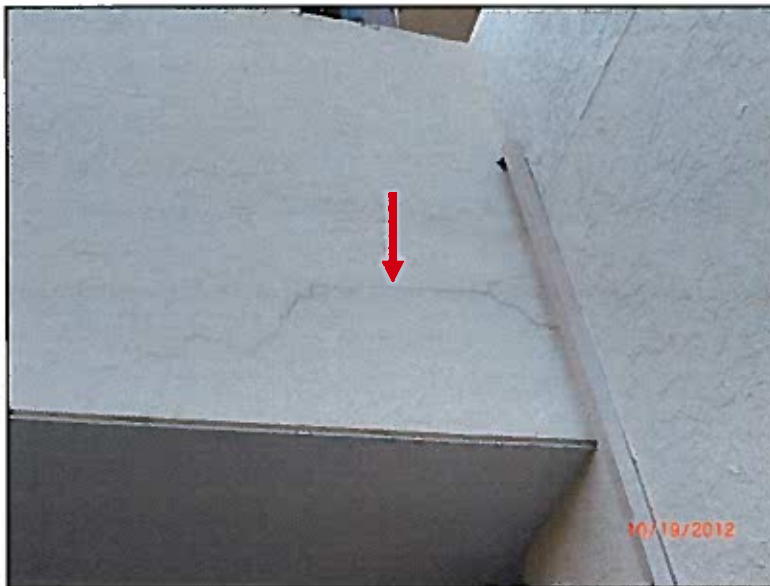
**PHOTO # 28: cracking on overhang at West side**

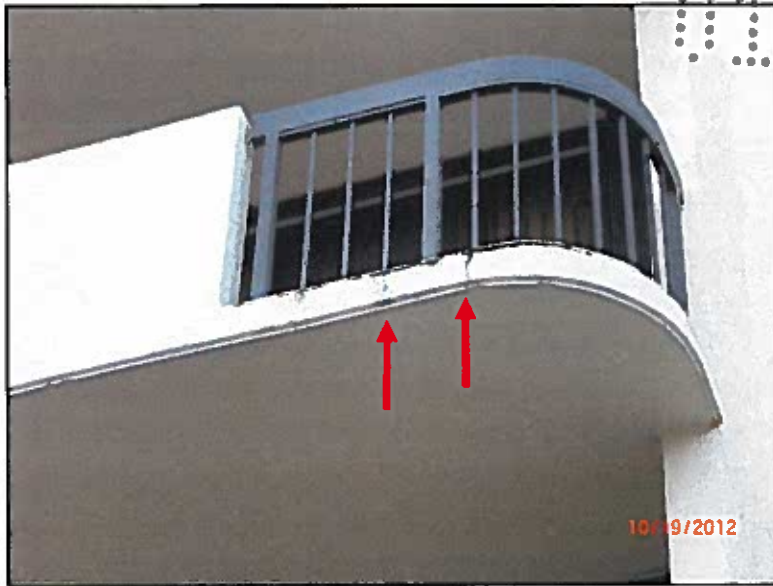
21. Hair Line Cracking and staining on balcony edge at Third level on north side (photo #29).
22. Blistering and underside cracking was observed at Overhang (photo #30).

**PHOTO # 29: cracking and staining on balcony edge**

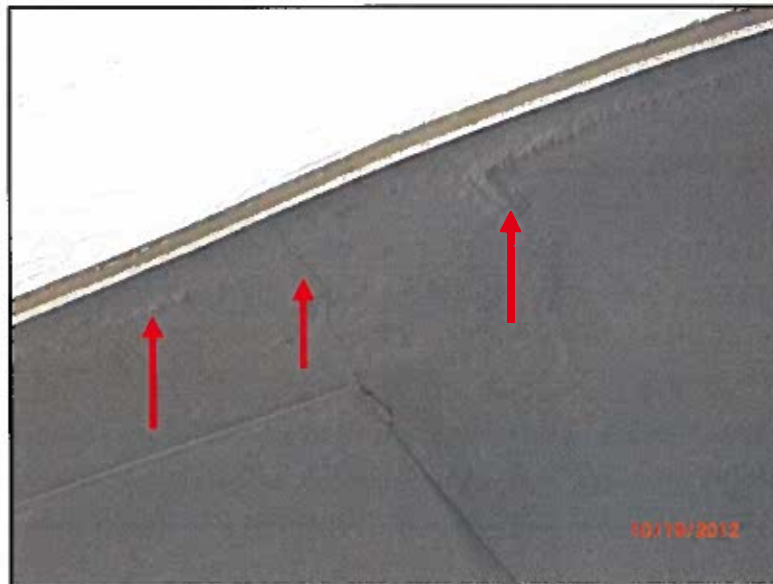
**PHOTO # 30: cracking & blistering at underside of overhang edge**

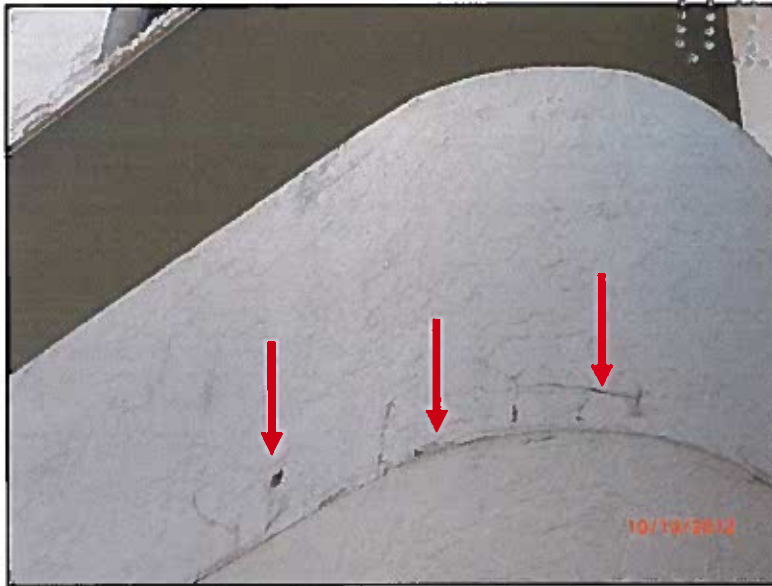
23. Cracking at bottom of balcony wall was noted (photo #31).
24. Crack along tiled pedestrian ramp east of main entrance was observed (photo #32).
25. Delaminated stucco and cracking at bottom of fourth floor balcony wall on east (photo #33).

**PHOTO # 31: stucco cracking at bottom of third floor balcony wall on East side**

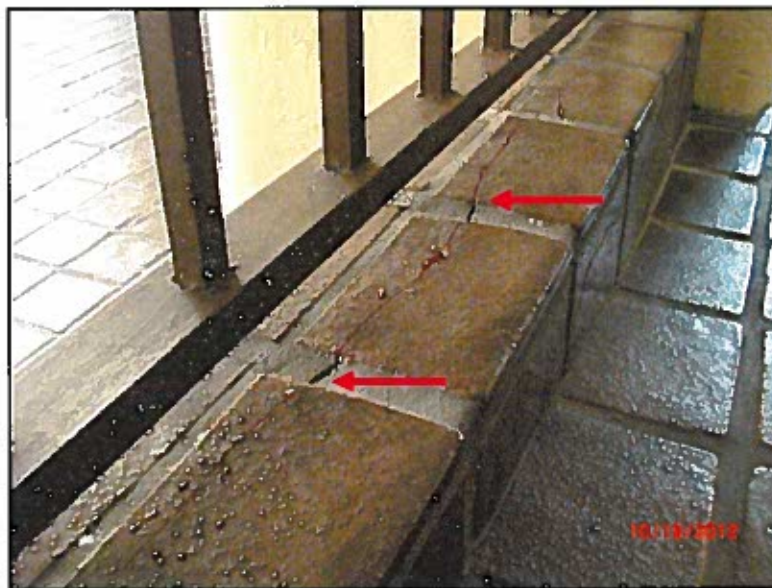
**PHOTO # 32: crack along tiled ramp east of main entrance**

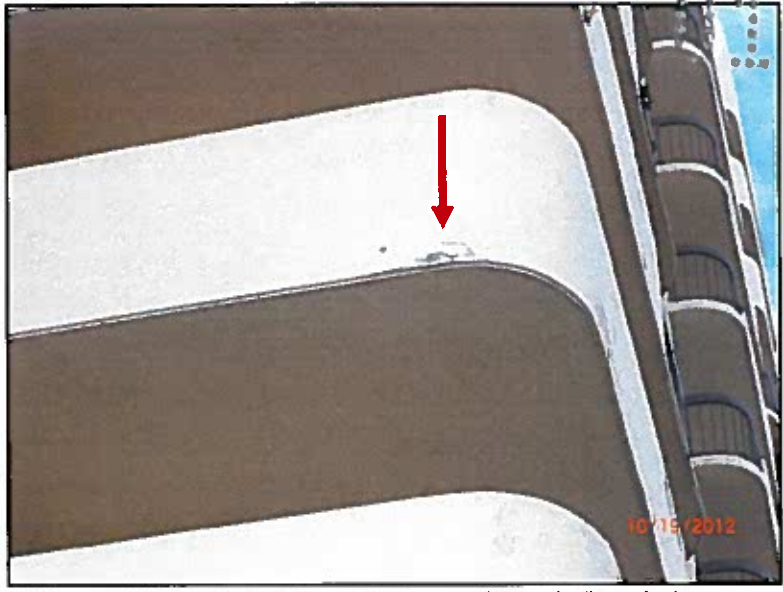
**PHOTO # 33: cracking and staining at bottom of fourth floor balcony wall on east**

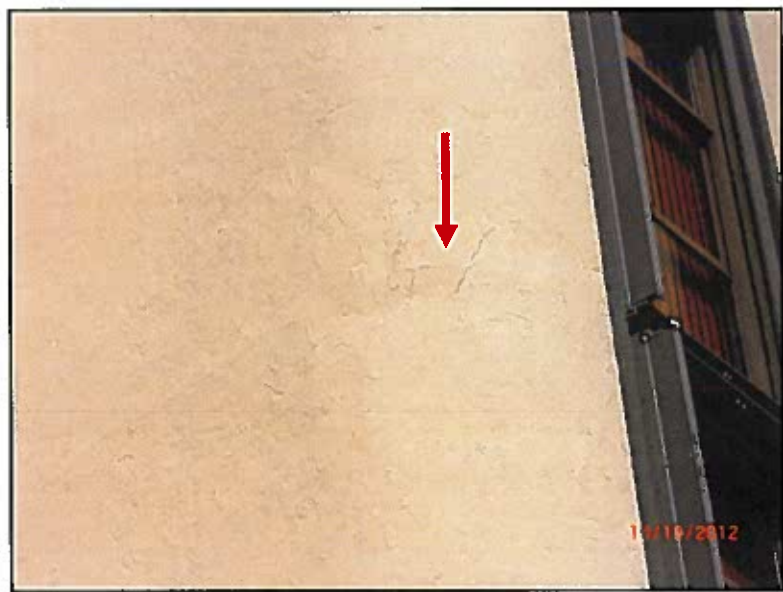
26. Surface cracks on building shear wall next to window shutter next to east stairs tower (photo #34).
27. Spider web cracking on exterior face at first balcony on East side (photo #35).

**PHOTO # 34: stucco cracking on building wall next to east stairs tower**

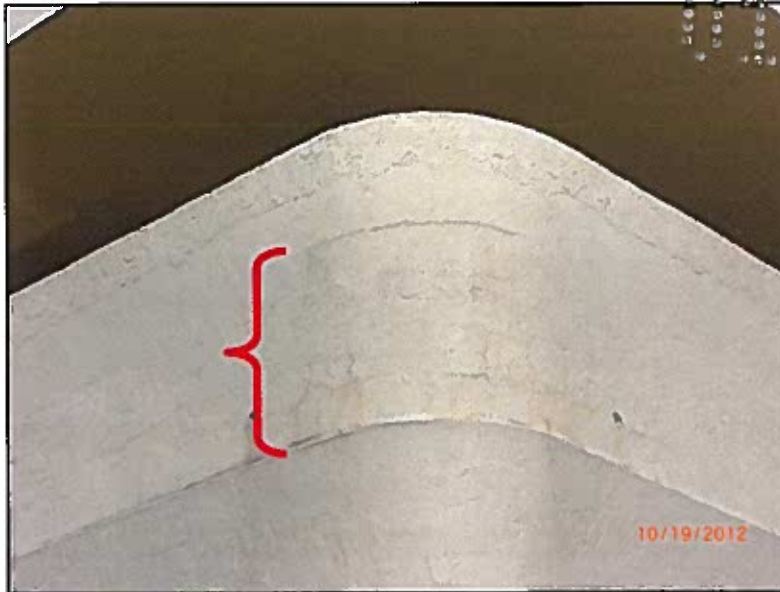
PHOTO # 35: spider web cracking on exterior face at second floor balcony on East side

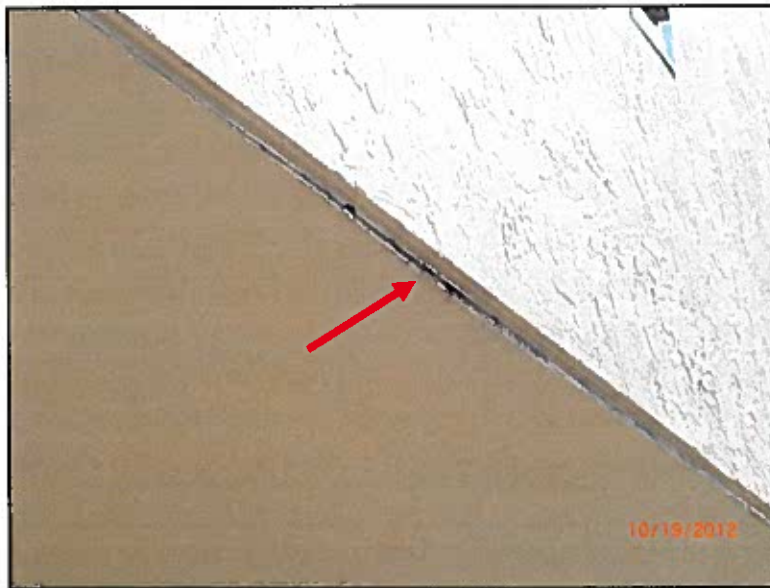
28. Ceiling panel separation at edge of South overhang (photo #36).
29. Stucco cracking on East side of building corner at Pool Deck Area (photo #37).

PHOTO # 36: ceiling separation at edge of South overhang

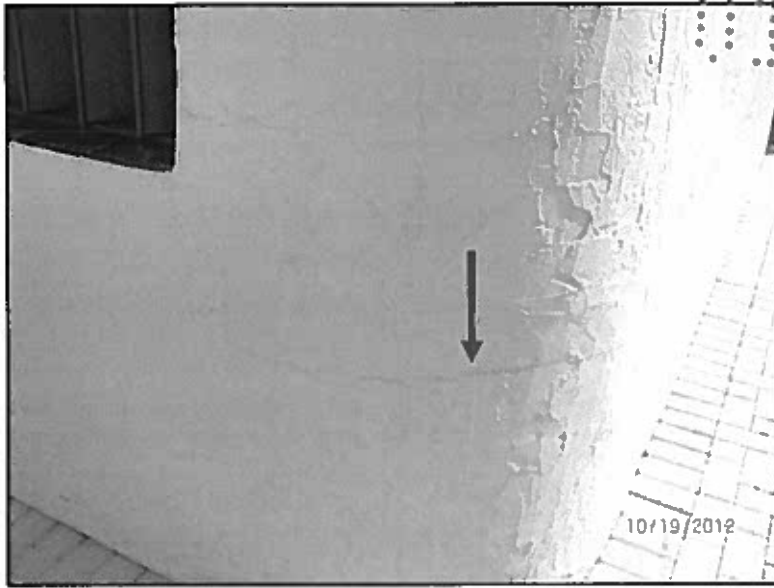
PHOTO # 37: stucco cracking on East side of building corner at pool deck area
