OFFICE OF THE PROPERTY APPRAISER

747 PONCE DE LEON BLVD - This is a 46-unit condominium, so the address for service of the initial notice of unsafe structure is the condominium association. However, if the association does not respond, the City will have to serve each individual unit owner and any related interested parties for each unit.

This Department has received the Building Recertification Report ("Report"), prepared by the Professionals listed below, that you submitted for the above property address. Please note the Report indicates <u>remedial repairs must be done to the structure</u> in order for it to meet minimum requirements stipulated for continued occupancy as prescribed in the Miami-Dade County code, Section 8-11.

I, Alexander Rochell, Professional Engineer, have been retained to perform the Structural portion of the Building Recertification for the above-mentioned property. Enclosed you will find the structural report for the required 50-Year Building Recertification by the City of Coral Gables. I hereby attest that to the best of my knowledge, belief and professional judgment, the building is structurally safe for its use and present occupancy, in compliance wit

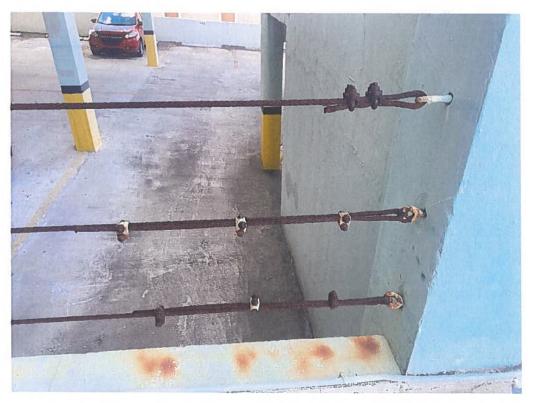
The steel barrier cables at Parking Garage needs replacement

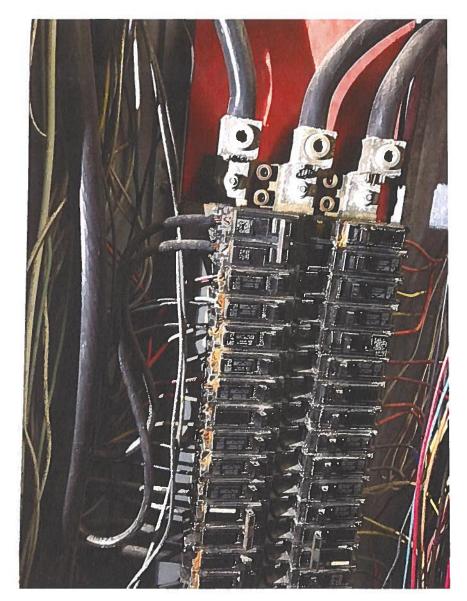
Image #2, Panel HEP

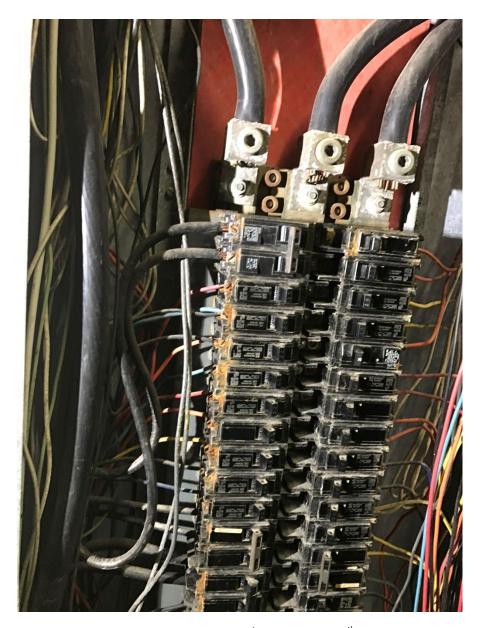
Image #3, corrosion at 120/208V panel at 5th level.

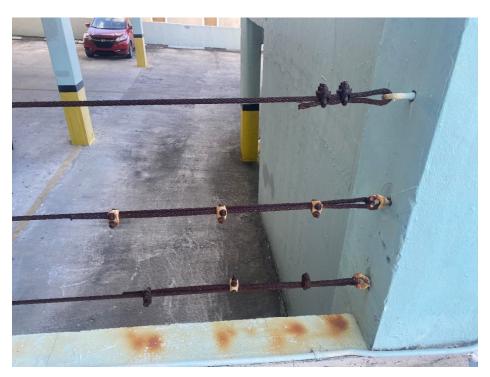
The steel barrier cables at Parking Garage needs replacement 6-7-23 UPDATE: Steel barrier cable system has been replaced

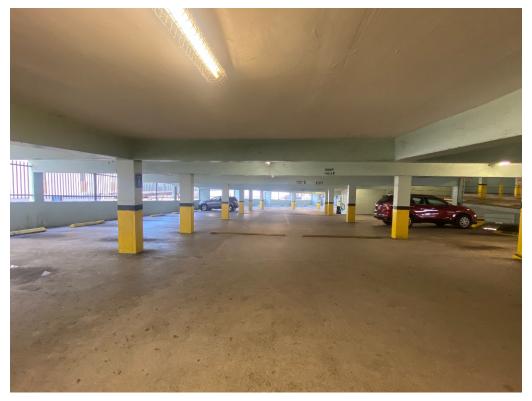
Excessive corrosion observed on barrier cables

6-7-23 UPDATE: Steel barrier cable system has been replaced

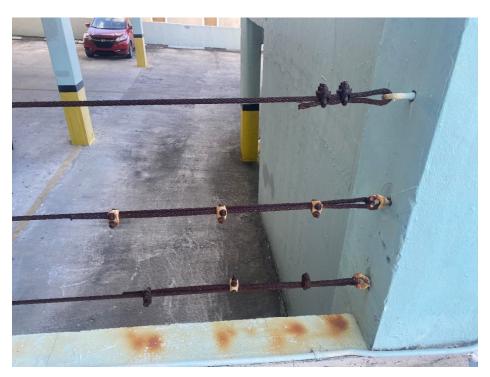
The steel barrier cables at Parking Garage needs replacement 6-7-23 UPDATE: Steel barrier cable system has been replaced

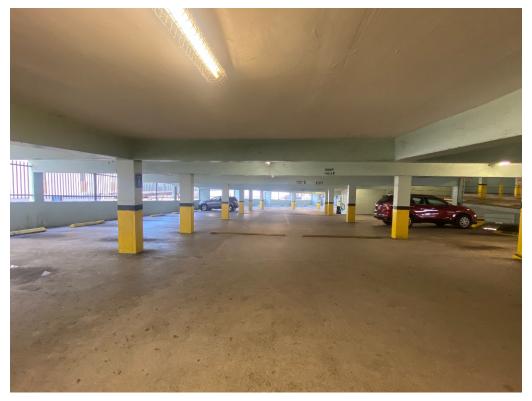
Excessive corrosion observed on barrier cables

6-7-23 UPDATE: Steel barrier cable system has been replaced

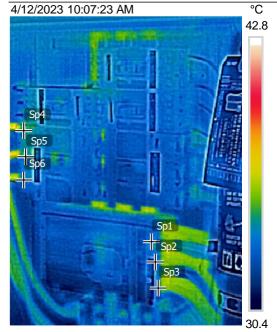
Building 747 Ponce de Leon. Lower floor. Main electrical room. Main panel 1 of 6.

Signs of corrosion in some connections were observed. Possible deficiency; warrants investigation.

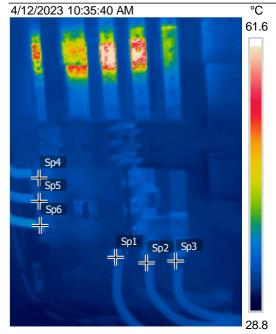
Building 747 Ponce D Leon. Lower floor. Main electrical room. Panel MDP. Main lighting panel.

Possible deficiency; warrants investigation.

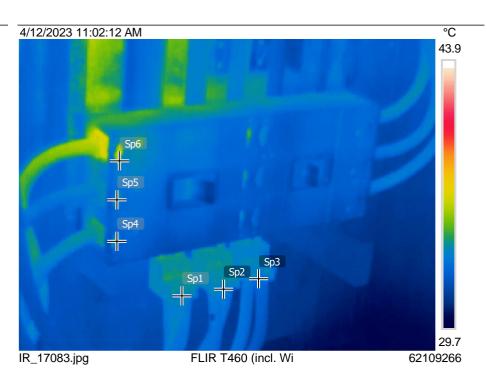
Building 747 Ponce de Leon. Lower floor. Main electrical room. Panel B. Wires are not color coded. Possible deficiency; warrants investigation.

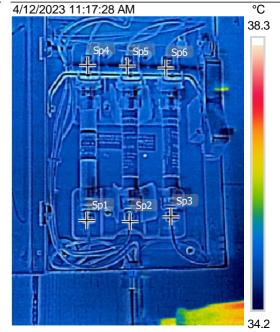
Building 747 Ponce de Leon. Lower floor. Main electrical room. Disconnect emergency switch. Possible deficiency; warrants investigation.

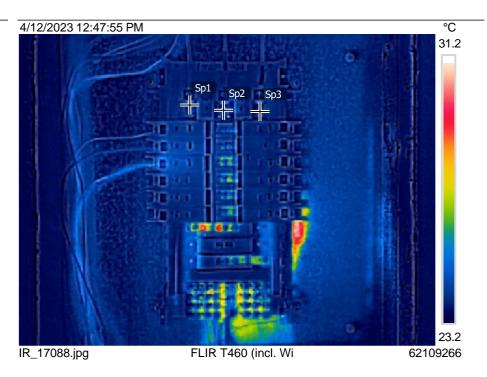
There is a single polo breaker used as a three-pole breaker.
Possible deficiency; warrants

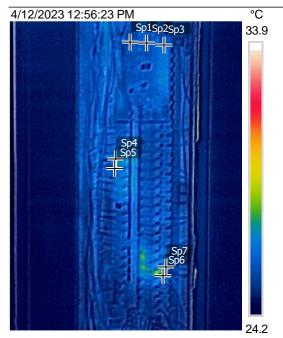
Building 747 Ponce de Leon. 1st floor. Radiation offices. Panel A1. Double tapping. Spliced cables were observed. Possible deficiency; warrants investigation.

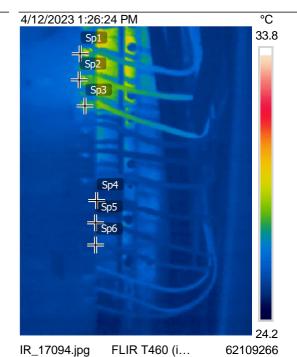
Building 747 Ponce de Leon. 1st floor. Radiation offices. Panel D bottom right. The panel is in a confined space. Working distance violation as per the NEC.

Possible deficiency; warrants investigation.

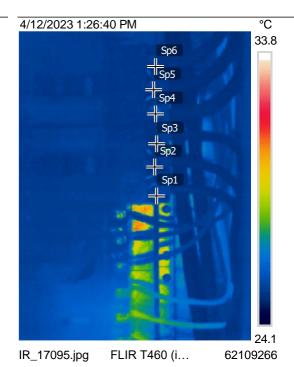
Building 747 Ponce de Leon. 1st floor. Radiation offices. Panel D top right. The panel is in a confined space. Working distance violation as per the NEC.

Possible deficiency; warrants investigation.

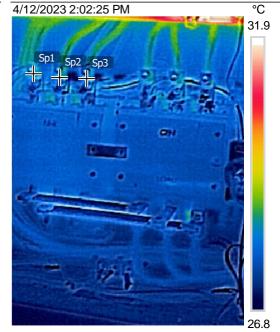
Building 747 Ponce de Leon. 2nd floor. Generator room. ATS. Signs of corrosion and spliced cables were observed.

Possible deficiency; warrants investigation.

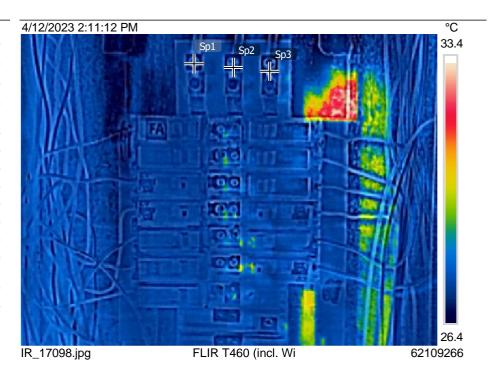
Building 747 Ponce de Leon. 2nd floor. Generator room. Emergency panel. Signs of severe corrosion, wires with no color codes, and spliced cables were observed.

Possible deficiency; warrants investigation.

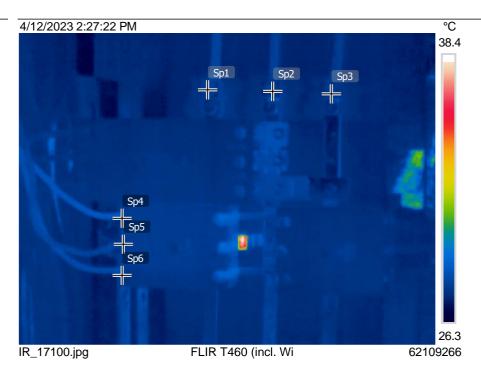
Building 747 Ponce de Leon. 2nd floor. Generator room. Main emergency panel.

Wires are not color coded. Signs of some corrosion were observed. Possible deficiency; warrants

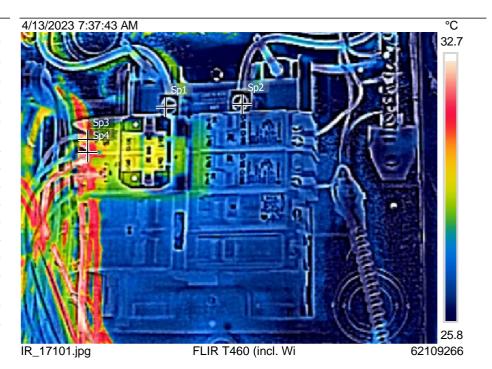
Building 747 Ponce de Leon. 2nd floor. Mechanical room. Receptables panel

Possible deficiency; warrants investigation.

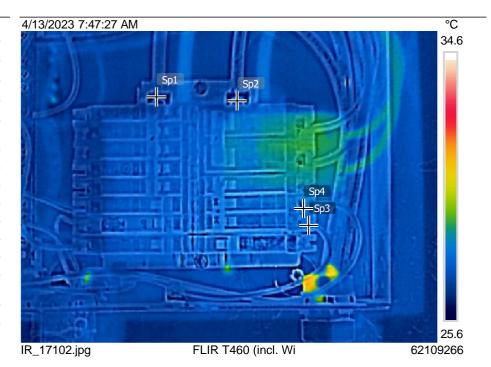
Wires are not color coded.
Spliced cables were observed.
Visible short circuit on the box.
Some components on the panel look burned.

Possible deficiency; warrants investigation.

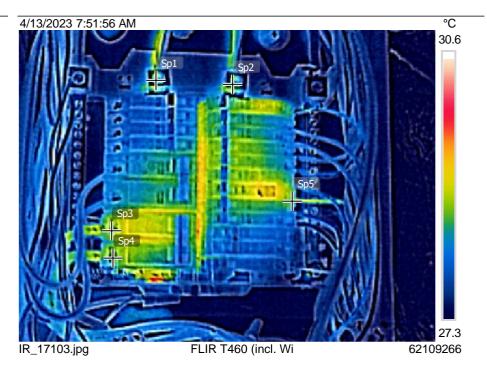
Loose screws were found. Breaker 6B is visibly damaged.

Possible deficiency; warrants investigation.

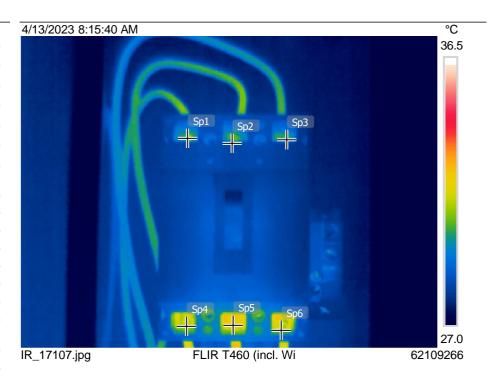
Building 747 Ponce de Leon. 2nd floor. Mechanical room. AC mechanical room breaker

Wires are not color coded. Possible deficiency; warrants investigation.

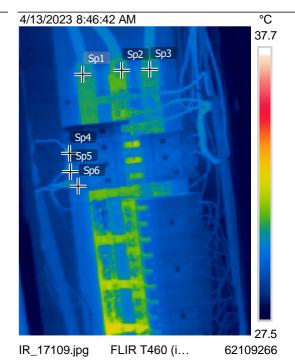
Building 747 Ponce de Leon. 2nd floor.
Mechanical room. Lighting AC panel
277/480. Top.
The electrical panel
shows signs of water
damage.
Wires are not color
coded.
Spliced cables
and signs of
severe
corrosion were
observed.
The electrical panel is in critical condition.
Possible deficiency; warrants

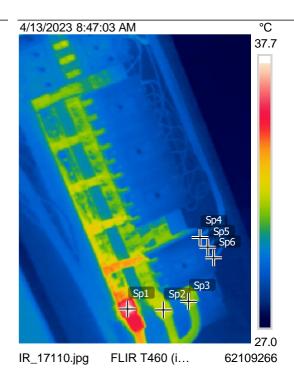
The electrical panel is in critical condition. Indicates probable deficiency; repair as time permits.

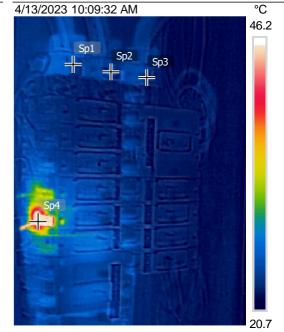
Signs of corrosion were observed. Wires are not color coded.

The panel is in a critical condition. Major discrepancy; repair immediately.

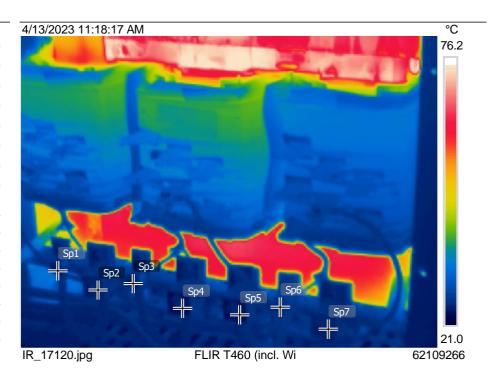
Building 747 Ponce de Leon. 4th floor. A/C equipment room. Transformer 480 to 120/208.

Possible deficiency; warrants investigation.

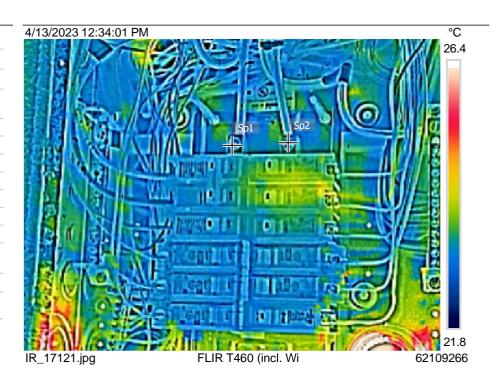
Building 747 Ponce de Leon. 4th floor. Dental clinic office. Distribution panel. Possible deficiency; warrants investigation.

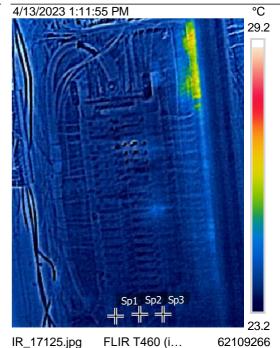
Building 747 Ponce de Leon. 7th floor. Electrical room. Panel B. Spliced cables were observed. Possible deficiency; warrants investigation.

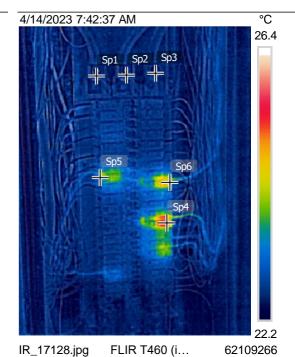
The breaker 20 reads 17 A and the size is 20 A.

Possible deficiency; warrants investigation.

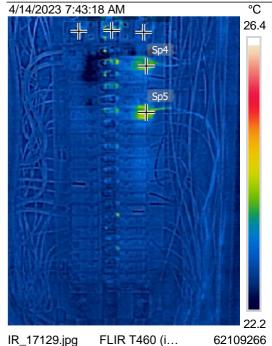
Building 747 Ponce de Leon. 5th floor. Electrical room. Panel A. Spliced cables and signs of corrosion were observed. Incorrect wire color codes were found. Wire on the breaker is exposed. Possible deficiency; warrants investigation.

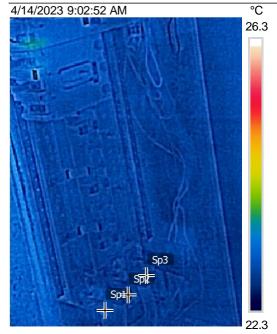
Mold and signs of corrosion inside the panel were found.

Possible deficiency; warrants investigation.

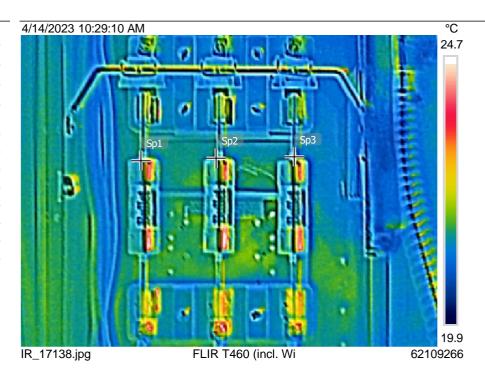
Building 747 Ponce de Leon. 8th floor. Disconnect left switchin elevator room. Possible deficiency; warrants investigation.

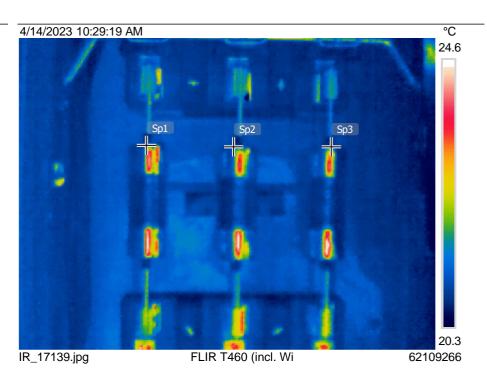
Building 747 Ponce de Leon. 8th floor. Disconnect right switch in elevator room. Possible deficiency; warrants investigation.

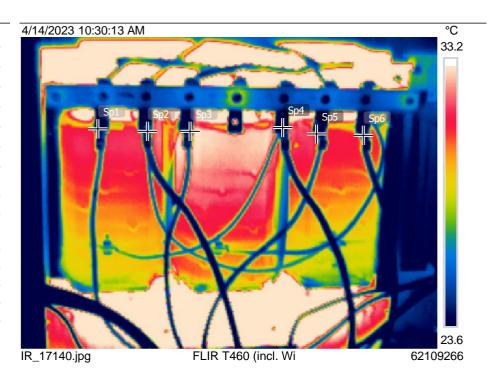
Building 747 Ponce de Leon. 8th floor. Transformer 1 elevator room. Possible deficiency; warrants investigation.

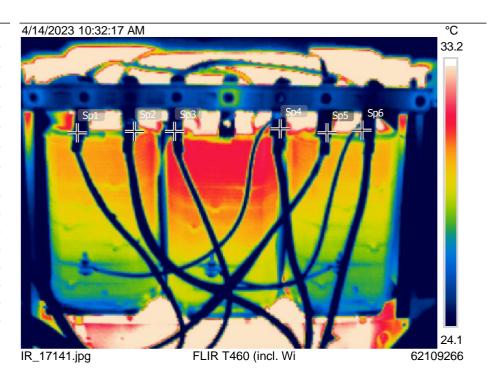
Building 747 Ponce de Leon. 8th floor. Transformer 2 elevator room. Possible deficiency; warrants investigation.

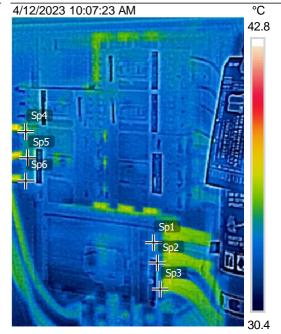
Building 747 Ponce de Leon. Lower floor. Main electrical room. Main panel 1 of 6.

Signs of corrosion in some connections were observed. Possible deficiency; warrants investigation.

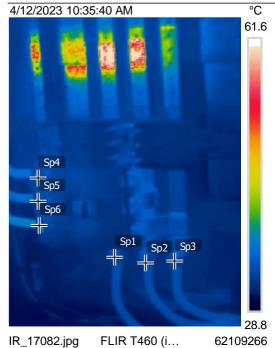
Building 747 Ponce D Leon. Lower floor. Main electrical room. Panel MDP. Main lighting panel.

Possible deficiency; warrants investigation.

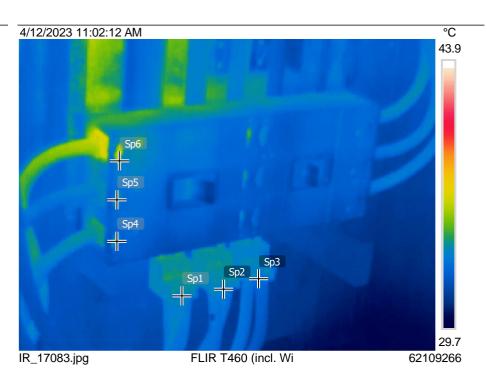
Building 747 Ponce de Leon. Lower floor. Main electrical room. Panel B. Wires are not color coded. Possible deficiency; warrants investigation.

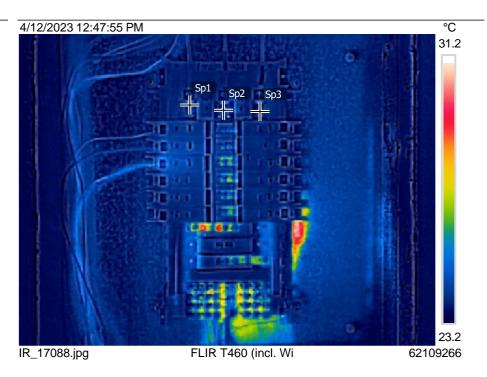
There is a single polo breaker used as a three-pole breaker.
Possible deficiency; warrants

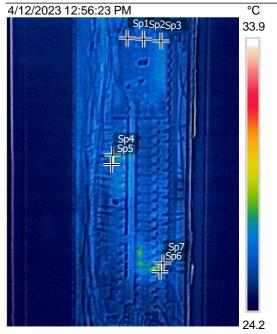
Building 747 Ponce de Leon. 1st floor. Radiation offices. Panel A1. Double tapping. Spliced cables were observed. Possible deficiency; warrants investigation.

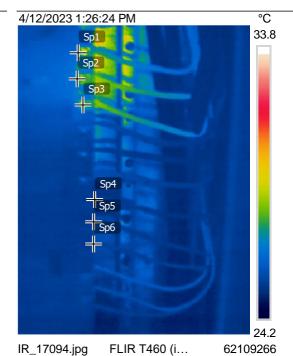
Possible deficiency; warrants investigation.

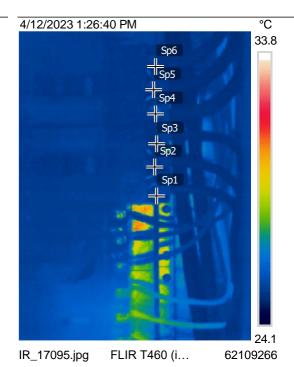
Possible deficiency; warrants investigation.

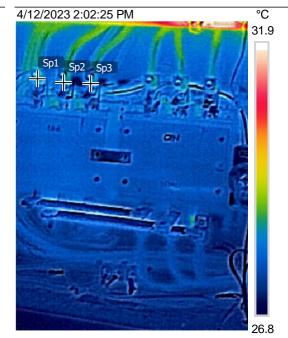
Building 747 Ponce de Leon. 2nd floor. Generator room. ATS. Signs of corrosion and spliced cables were observed.

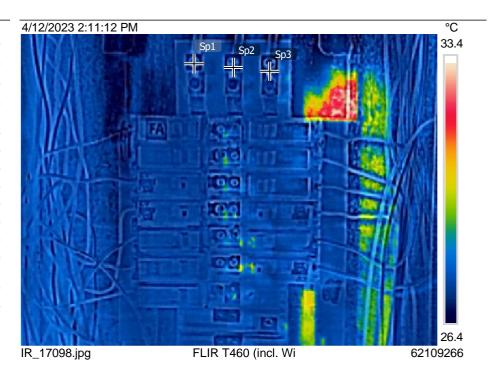
Possible deficiency; warrants investigation.

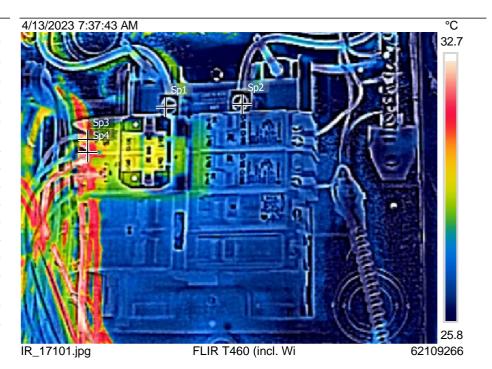
Possible deficiency; warrants investigation.

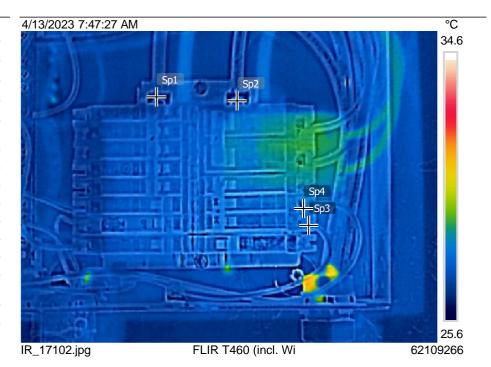
Possible deficiency; warrants investigation.

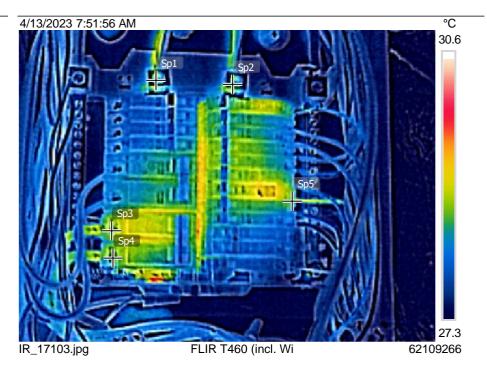
Possible deficiency; warrants investigation.

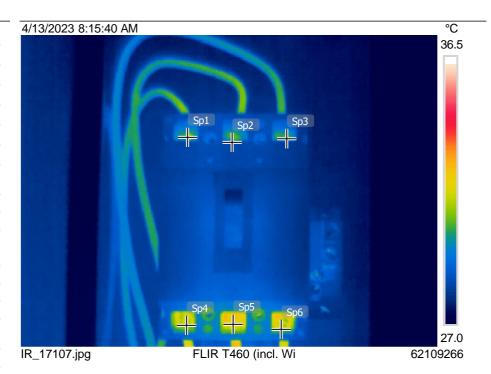
Wires are not color coded. Possible deficiency; warrants investigation.

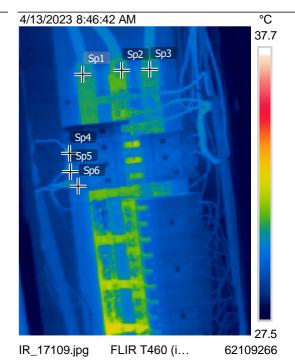
Building 747 Ponce de Leon. 2nd floor.
Mechanical room. Lighting AC panel
277/480. Top.
The electrical panel
shows signs of water
damage.
Wires are not color
coded.
Spliced cables
and signs of
severe
corrosion were
observed.
The electrical panel is in critical condition.
Possible deficiency; warrants

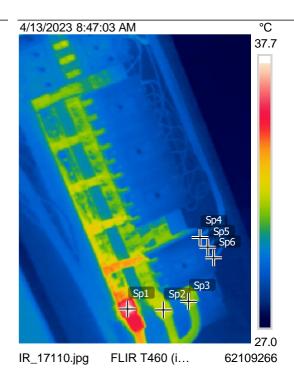
The electrical panel is in critical condition. Indicates probable deficiency; repair as time permits.

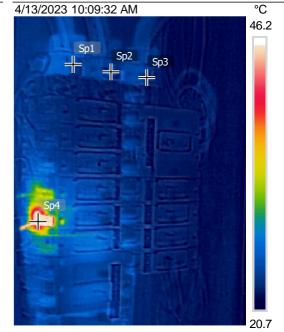
The panel is in a critical condition. Major discrepancy; repair immediately.

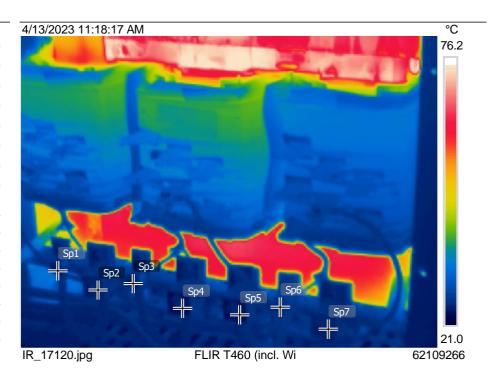
Possible deficiency; warrants investigation.

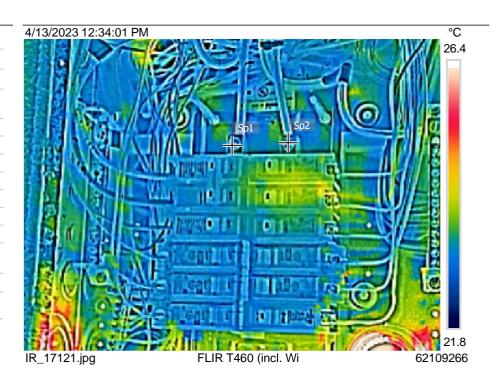
Building 747 Ponce de Leon. 4th floor. Dental clinic office. Distribution panel. Possible deficiency; warrants investigation.

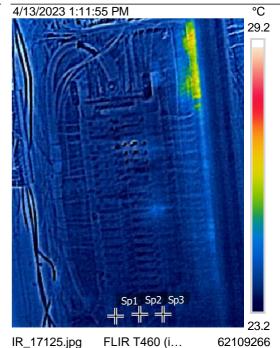
Building 747 Ponce de Leon. 7th floor. Electrical room. Panel B. Spliced cables were observed. Possible deficiency; warrants investigation.

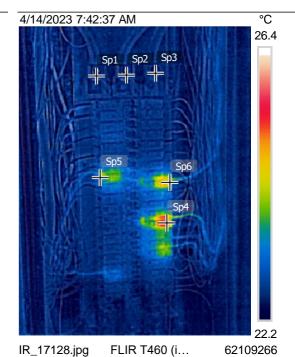
Possible deficiency; warrants investigation.

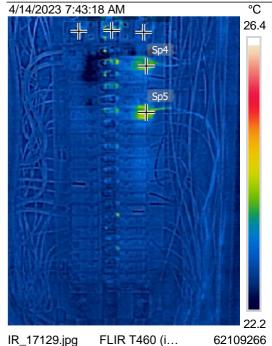
Building 747 Ponce de Leon. 5th floor. Electrical room. Panel A. Spliced cables and signs of corrosion were observed. Incorrect wire color codes were found. Wire on the breaker is exposed. Possible deficiency; warrants investigation.

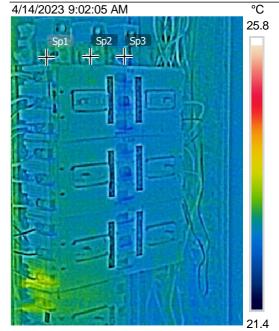
Mold and signs of corrosion inside the panel were found. Possible deficiency; warrants investigation.

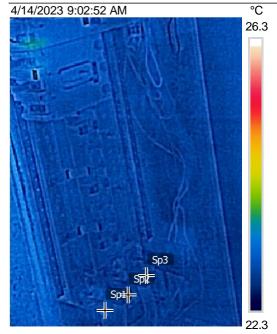
Possible deficiency; warrants investigation.

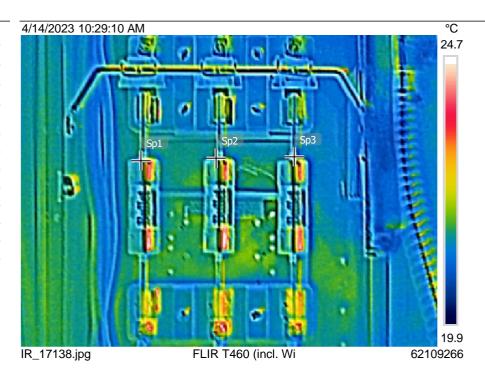
Building 747 Ponce de Leon. 8th floor. Disconnect left switchin elevator room. Possible deficiency; warrants investigation.

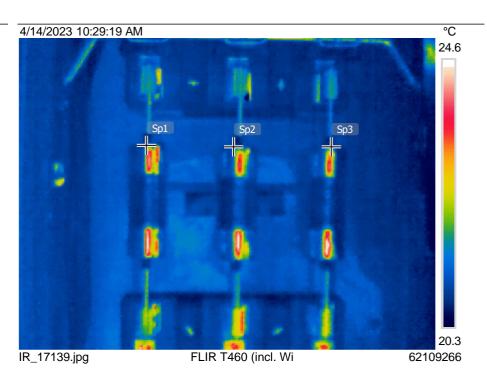
Building 747 Ponce de Leon. 8th floor. Disconnect right switch in elevator room. Possible deficiency; warrants investigation.

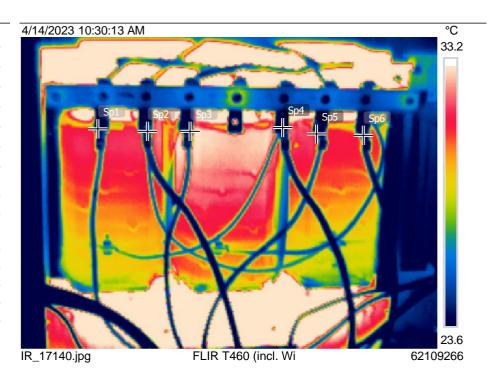
Building 747 Ponce de Leon. 8th floor. Transformer 1 elevator room. Possible deficiency; warrants investigation.

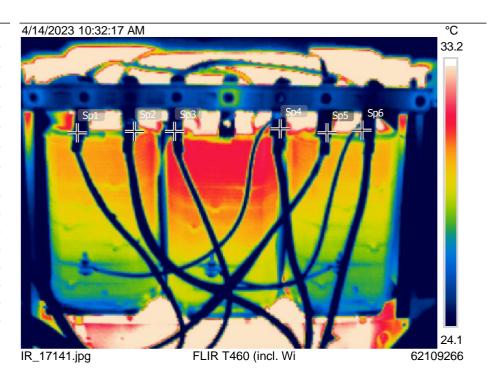
Building 747 Ponce de Leon. 8th floor. Transformer 2 elevator room. Possible deficiency; warrants investigation.
