Arboriculture Tree Report 1125 Hardee Rd, Coral Gables

To: FXD Construction
Attn: Danny Sanchez

Date: January 30th, 2026
Phone: (786)973-0590
Email: Danny@fxdconstruction.com

Prepared by: Trea Jones
International Society of Arboriculture Certified Arborist

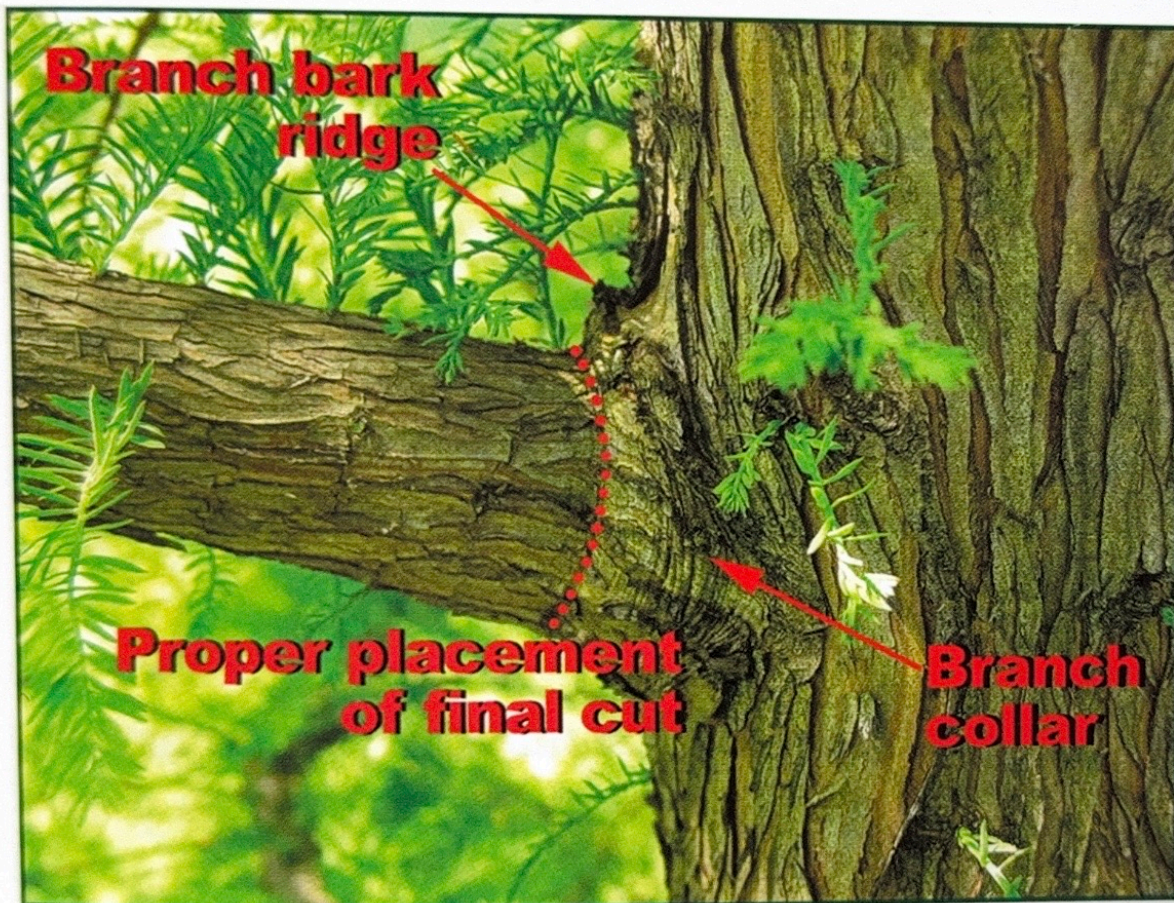
FIGURE 8.6 Cutting outside the branch collar does not damage trunk tissue.

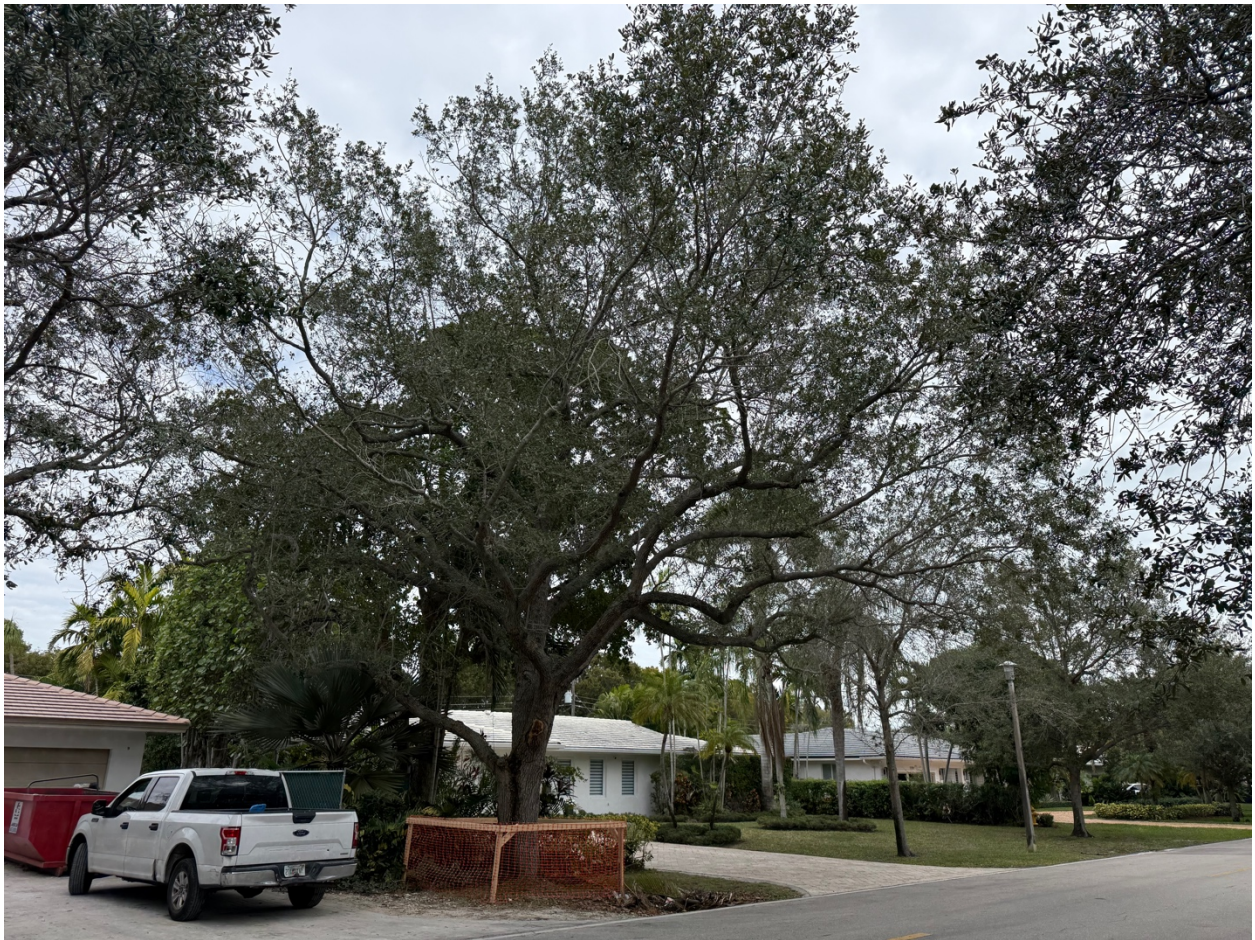
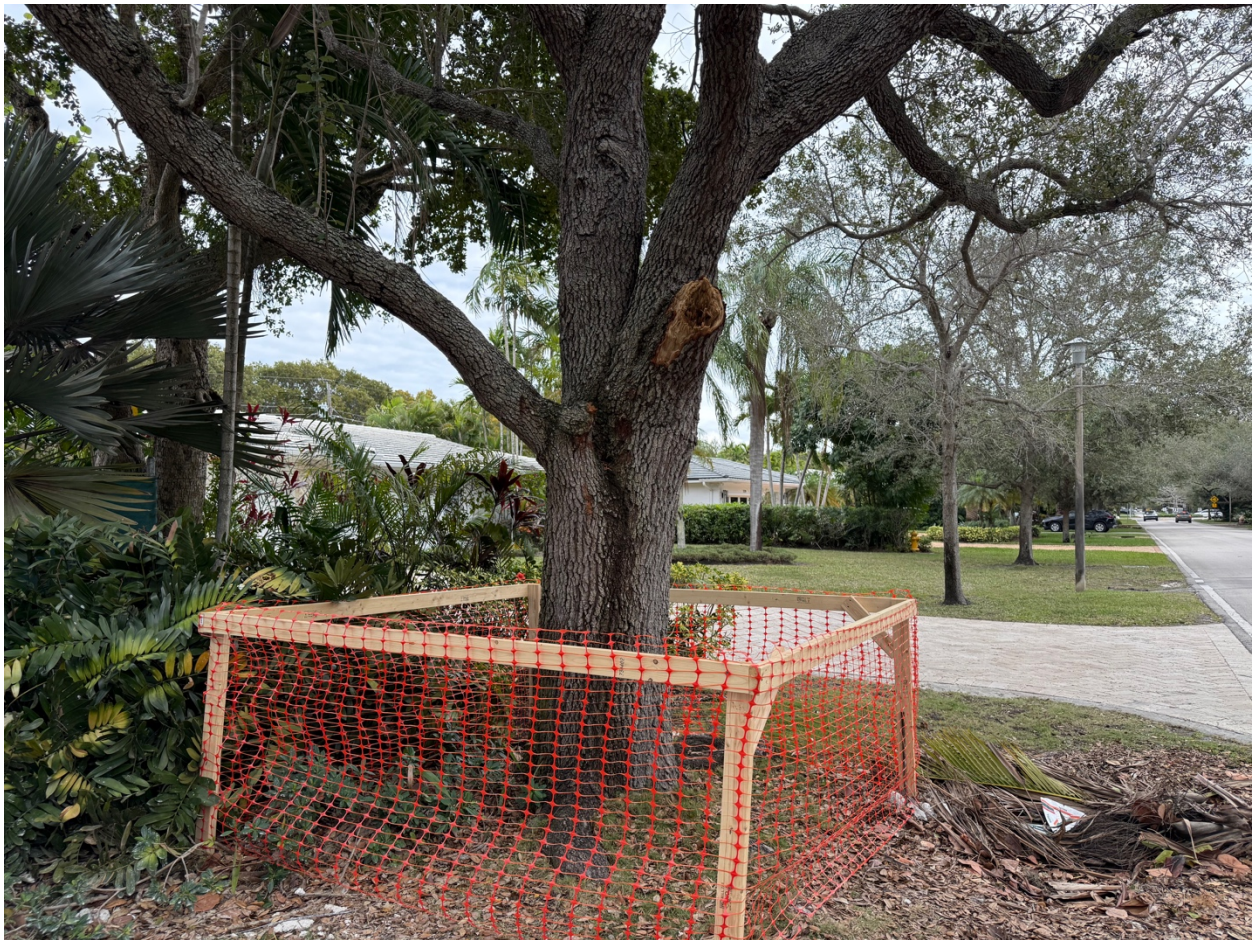
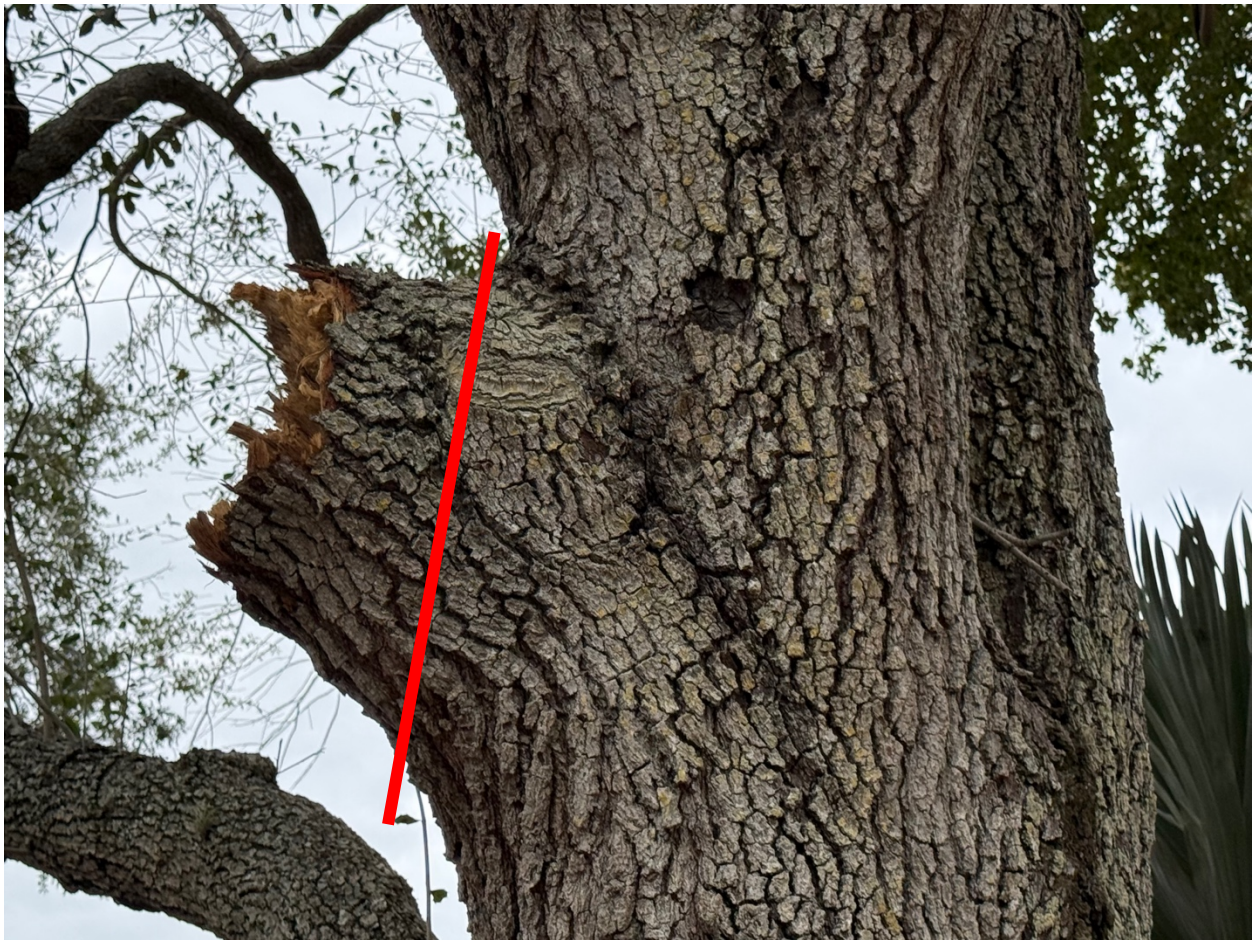
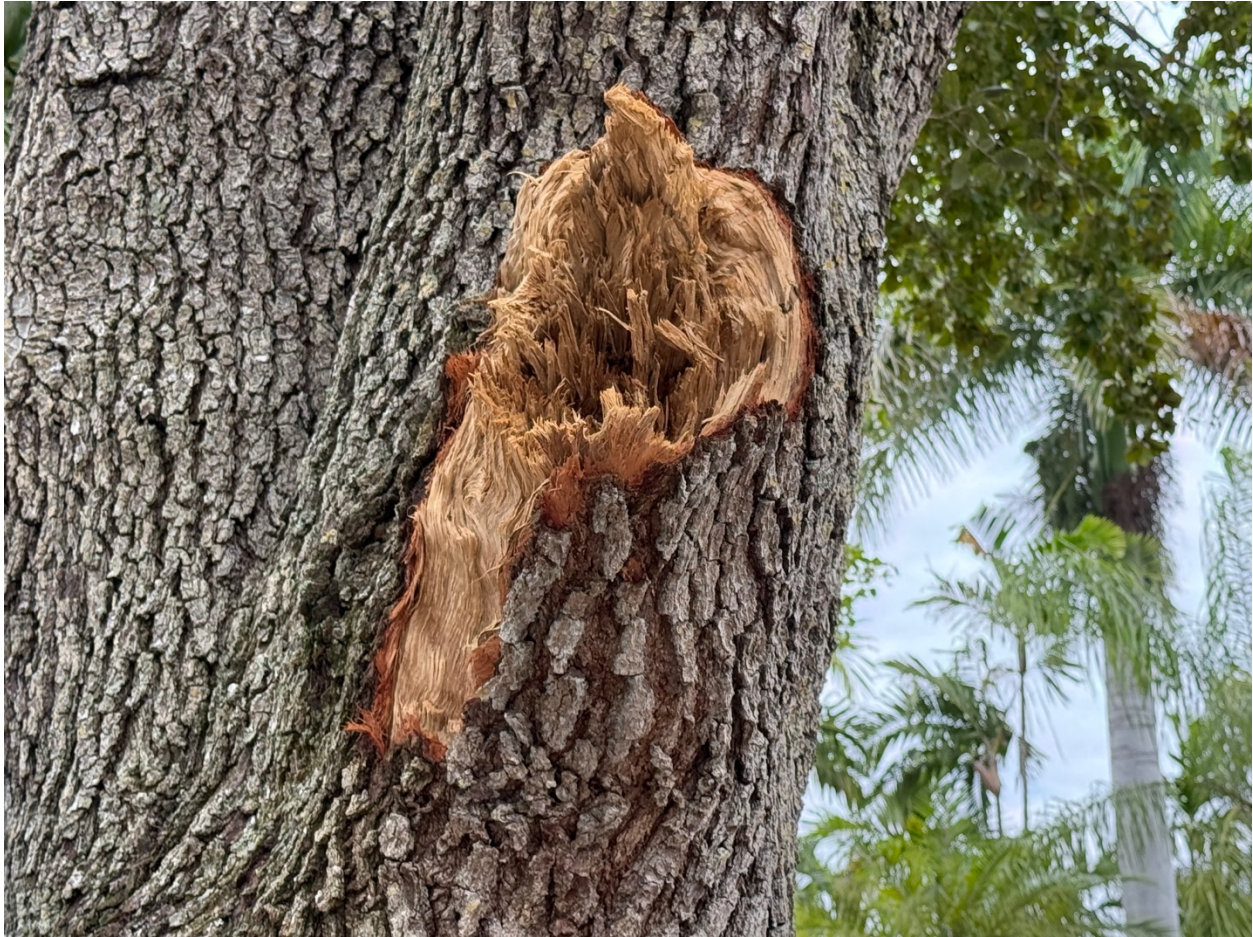
The tree evaluated is a Live Oak (*Quercus virginiana*) with a measured trunk diameter of approximately 26 inches DBH. The failed limb was a lower first-order branch, reported and measured at approximately 11 inches in diameter near the remaining stub, in the vicinity of the branch bark collar. Photographs provided show a mature Live Oak with an established canopy and a large, fresh mechanical wound where the branch tore out, leaving a jagged stub and exposed wood fibers.

During one phase of construction, a truck reportedly contacted the lower first-order limb with sufficient force to cause failure at the limb's attachment. The failure presents as a "rip-out" type break with torn wood fibers at the separation point. Importantly, based on your notes and the images, the fracture did not tear down the trunk in a long vertical strip, and the remaining stub appears to be outside the branch bark collar rather than ripped deeply into the trunk tissue. This distinction matters because when trunk tissue is not extensively peeled or stripped, the tree's ability to form defensive boundaries and initiate wound closure is typically far better than when trunk fibers are catastrophically torn down the main stem.

If the torn stub is left as-is, the remaining wood will be nonfunctional and will begin to desiccate. The jagged tear surface dramatically increases exposed area, traps moisture and debris, and creates irregular pockets that are highly favorable for decay fungi to colonize. A retained stub also tends to die back beyond the intended boundary, which often results in a longer period of exposed, non-compartmentalized tissue before the tree can effectively wall it off. Over time, this scenario commonly produces an expanding column of internal discoloration and decay that progresses from the dead stub inward toward the union, because the tree is forced to defend a poorly defined, irregular wound with compromised edges rather than a cleanly positioned pruning cut. In a mature tree, that can translate into avoidable internal defect development at a major union point.

The appropriate mitigation at this stage is a single restorative pruning cut to remove the remaining torn stub just outside the branch bark collar, leaving the branch collar intact. This cut is not cosmetic, it is a functional, biologically-driven correction intended to (1) remove fractured wood that will not recover, (2) eliminate a jagged, high-surface-area entry point for decay

The corrective pruning should consist of a single final cut to remove the remaining stub at the proper location just outside the branch bark collar, maintaining the collar intact and avoiding any cut that planes into the trunk. The objective is to create a clean wound margin that the tree can compartmentalize efficiently while preserving the biological “defense zone” that exists at the collar. No wound paint or dressing is recommended; the tree’s defense response is internal and at the wound margin, and wound dressings do not improve compartmentalization and can sometimes create an environment that retains moisture against the wound surface.

Following the corrective cut, the wound should be monitored over time for appropriate woundwood development (even rolling closure from the wound edge), and for any signs of progressive decay or abnormal response such as excessive cracking, persistent wetwood/oozing, or fungal fruiting bodies at or below the wound. With proper cut placement and given the tree’s reported strong vigor and generally good architecture, the prognosis for successful compartmentalization and functional recovery is favorable.
