GENERAL FEASIBILITY ASSESSMENT

RELOCATION OF THE EXISTING RESIDENTIAL STRUCTURE

**603 MINORCA AVENUE
CORAL GABLES, FLORIDA**

PREPARED BY:
DOUGLAS WOOD ASSOCIATES, INC.

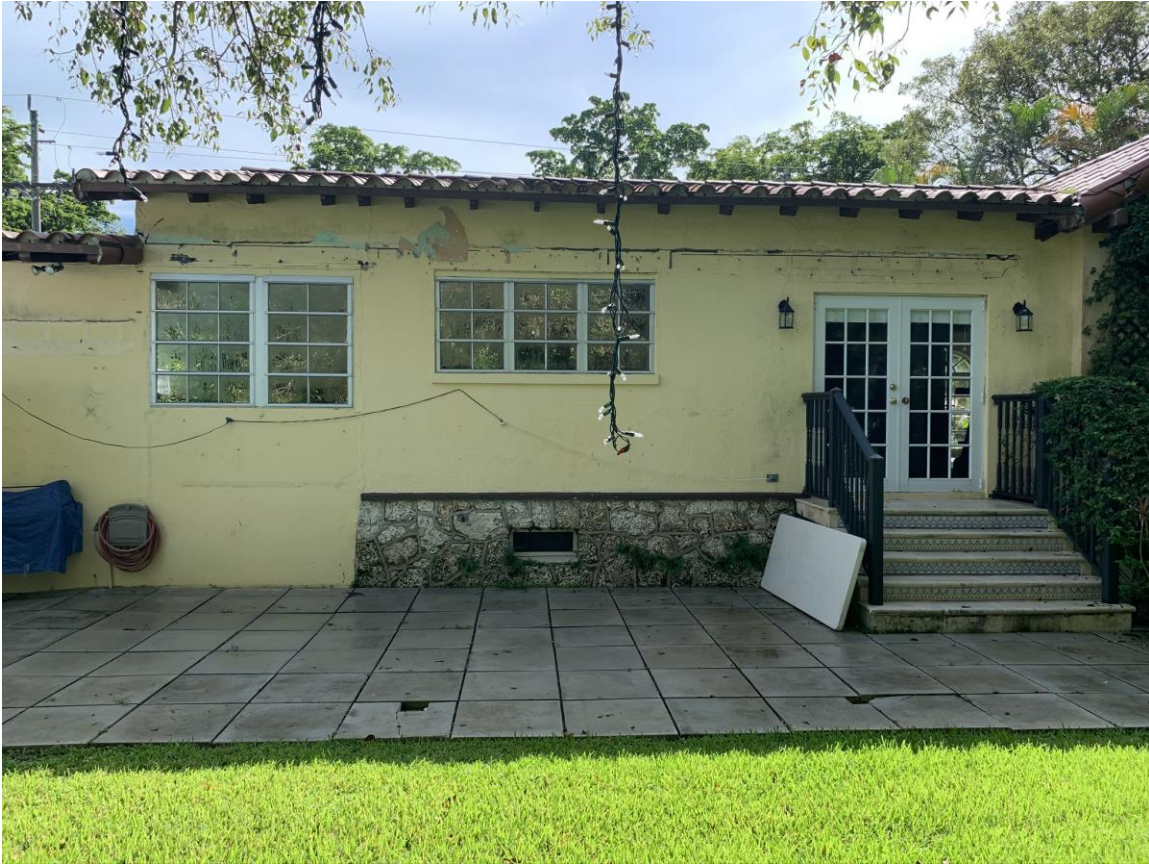
PHOTOGRAPH NO. 11

1. There are some previously sealed stucco cracks. These appear to be normal for this type of construction.
2. There is some damage to the exterior stucco, and there are numerous abandoned anchors in the exterior wall where a previous trellis/canopy was removed from the west side of the residence. Refer to Photographs Nos. 11 and 15. Repairs should be made to prevent water infiltration.

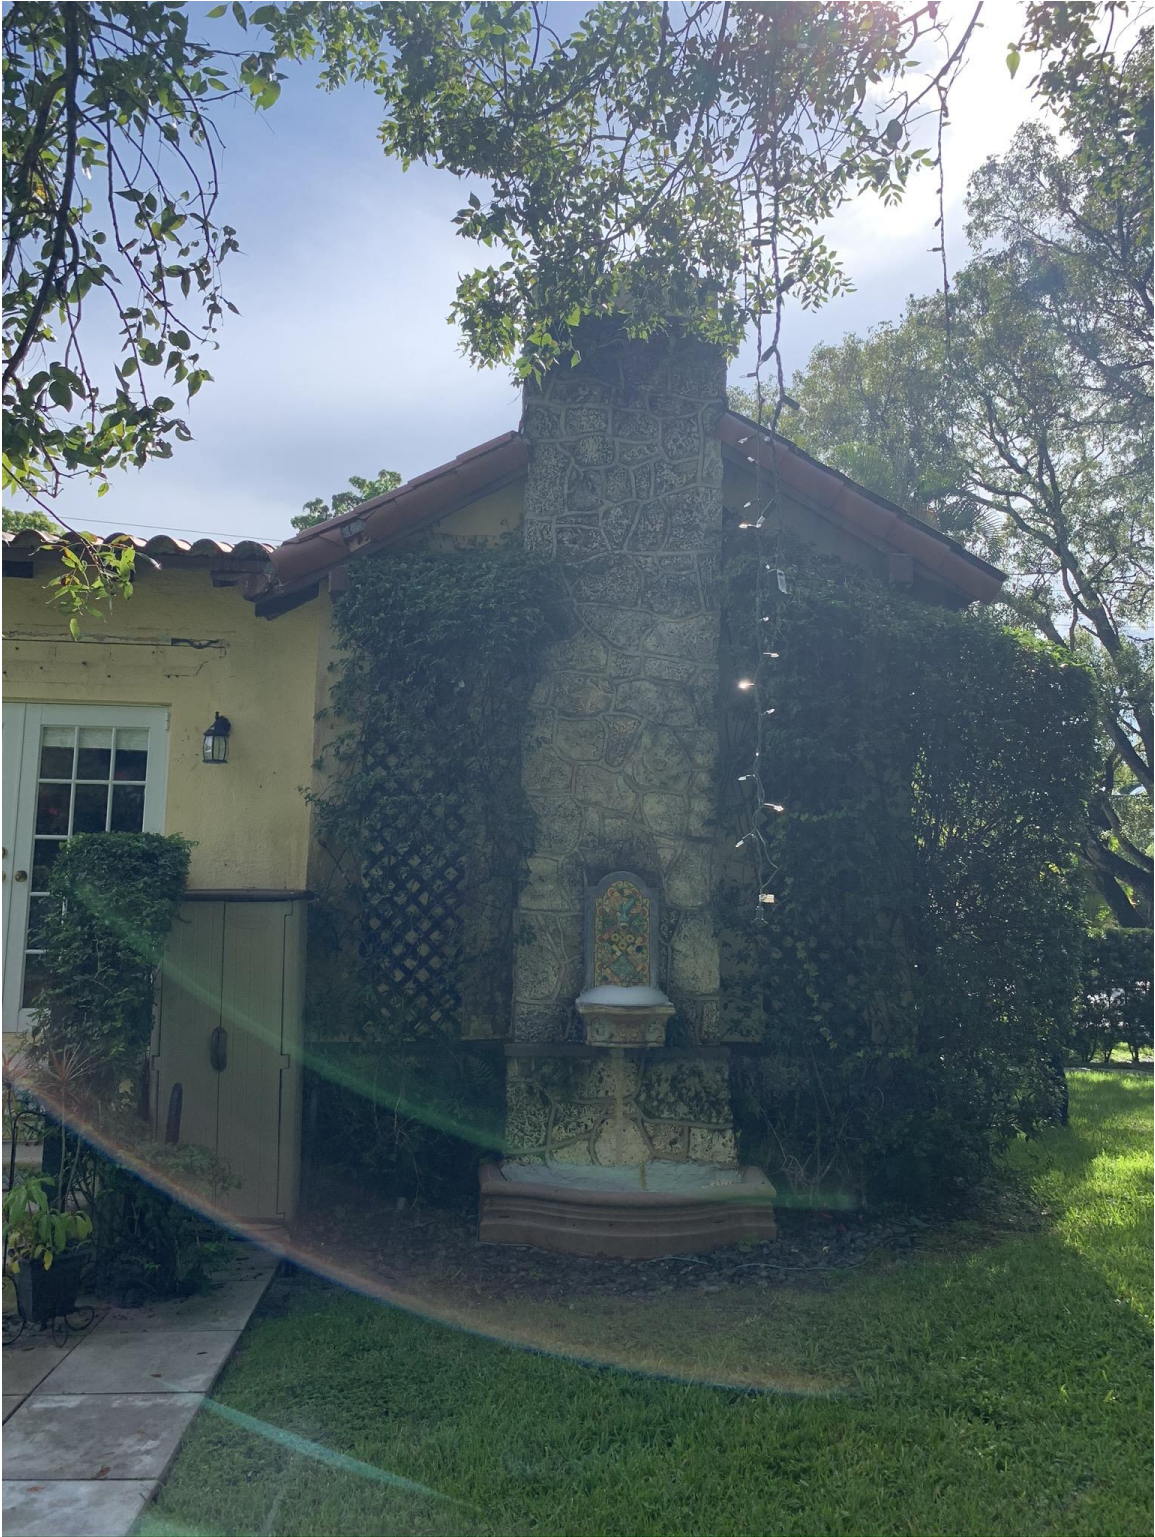
PHOTOGRAPH NO. 12

Near the south end of the west exterior wall, there is a fireplace chimney constructed of oolitic limestone rubble with mortar joints (refer to Photographs Nos. 12 and 13).

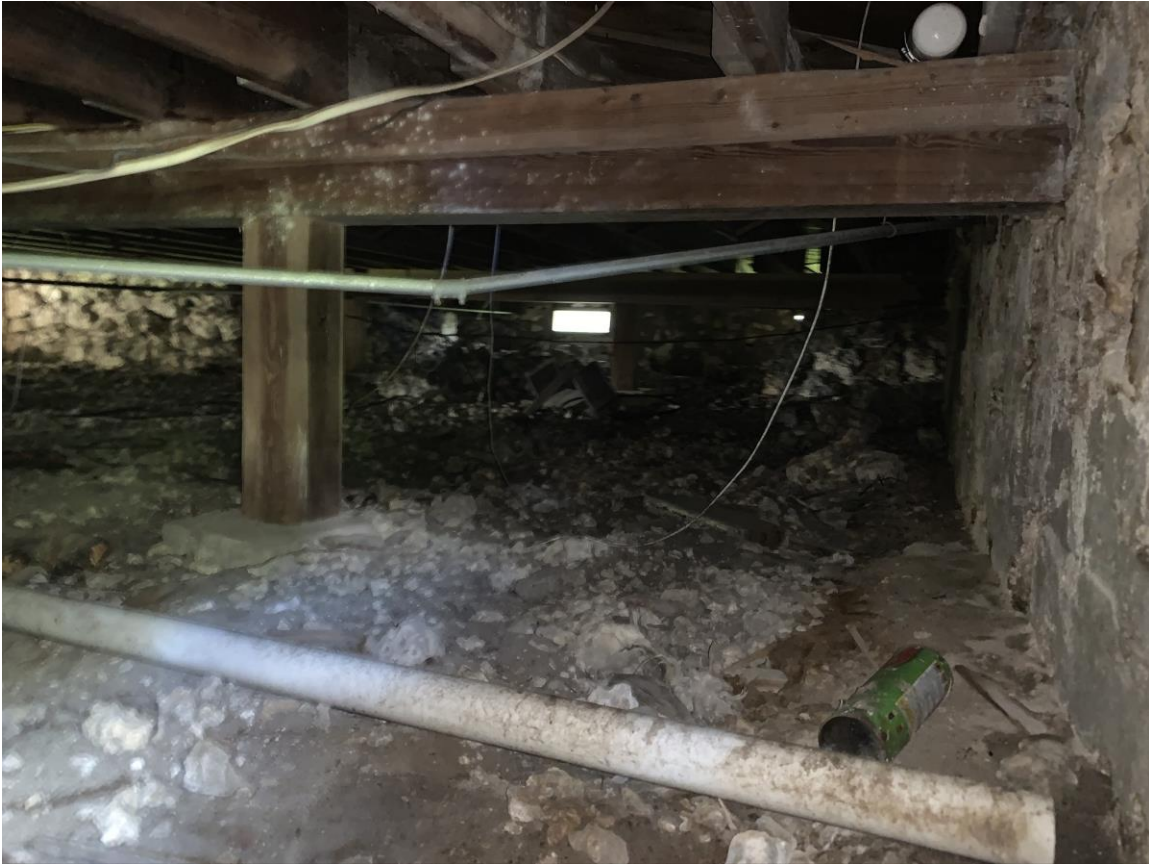
PHOTOGRAPH NO. 16

1. There are some areas of a white color on areas of the underside of the wood floor sheathing and floor joists. These areas may be mortar splatterings or other substances, but some might also be fungus. Refer to Photographs Nos. 16, 17, 19, 20 and 21. Testing by an appropriate laboratory could be accomplished. Areas of fungus (if extent) should be cleaned. Over-cooling of the living space above should be avoided so as not to encourage condensation and the consequent moisture.
2. At the end of at least one floor joist, where it bears in the stone stem-wall, there appears to be some rot. Refer to Photograph No. 22 (third joist from left). It should be assumed that this condition exists in other locations, and that repairs will be appropriate.

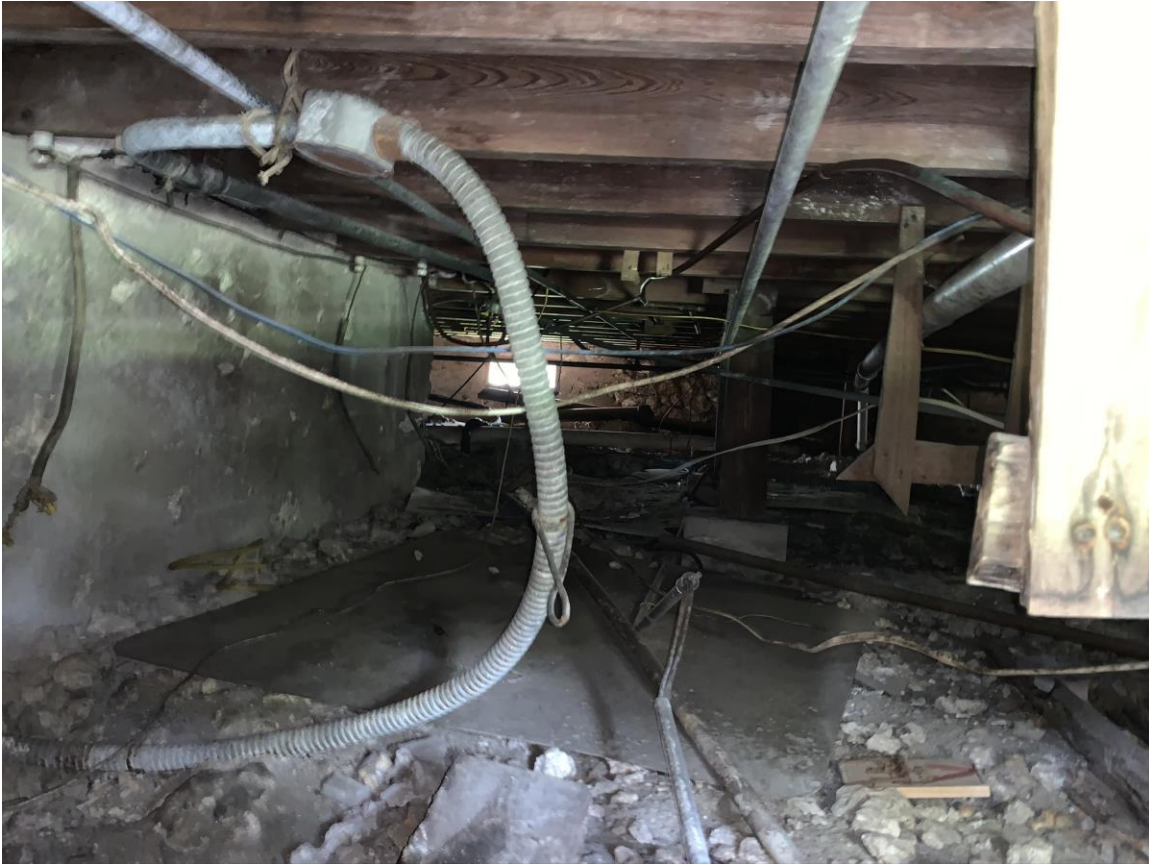
PHOTOGRAPH NO. 18

Refer to Photographs Nos. 16 through 23. The floor and walls appear to have been "platform" framed. As such, it appears that the stone stem-walls were erected, the joists were placed (bearing on the stem-walls), a wood plate was set on the stem-walls where the joists are parallel to the exterior wall, and the wood sheathing placed. At this time, nothing is visible above the bottom of the floor sheathing. It is assumed that there is likely a single or double wood plate on top of the sheathing, on to which the studs bear.

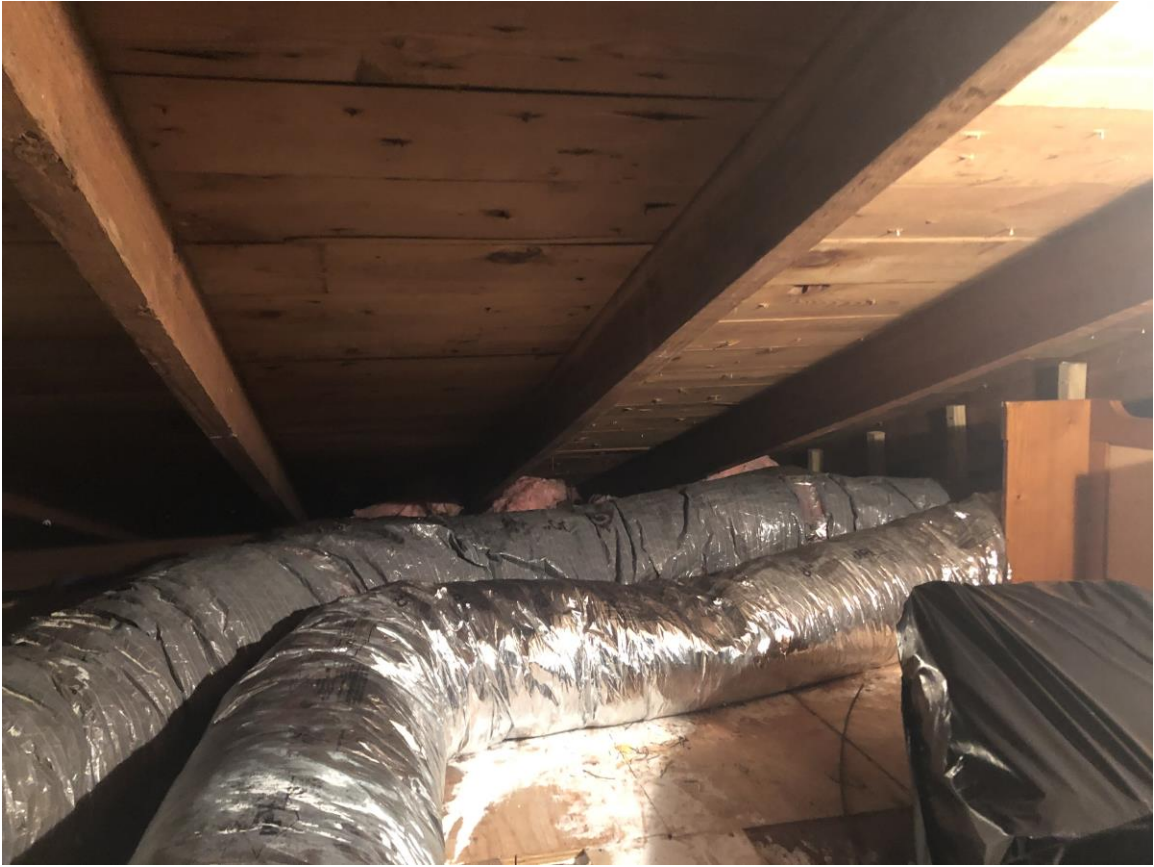
PHOTOGRAPH NO. 24

1. In general, the existing roof sheathing boards appear to be in serviceable condition. Refer to Photographs Nos. 24, 26, 29, 30, and 31.
2. In general, the existing roof rafters appear to be in serviceable condition. Refer to Photographs Nos. 24 through 31.
