**CORAL GABLES PUBLIC ART
CONDITION ASSESSMENT
MIAMI, FLORIDA**

Prepared for:
Catherine Cathers
Arts & Culture Specialist

Prepared by:
Kelly Caldwell
Senior Conservator & Director of Conservation
kcaldwell@evergreene.com

Submission Date: March 19, 2021

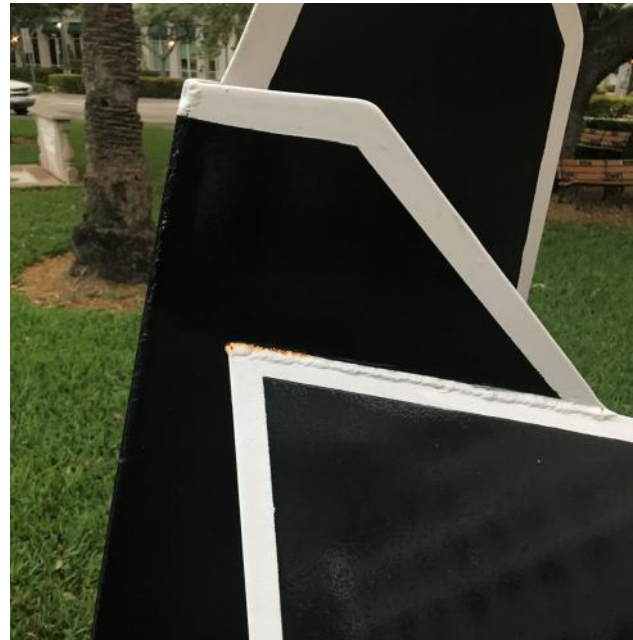
Figure 2. Corrosion on weld (photo by EverGreene, February 2021).

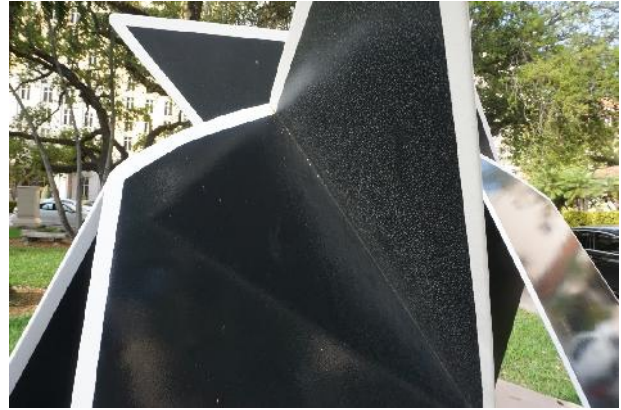
Figure 4. Soiling on surface that does not get washed with rain (photo by EverGreene, February 2021).

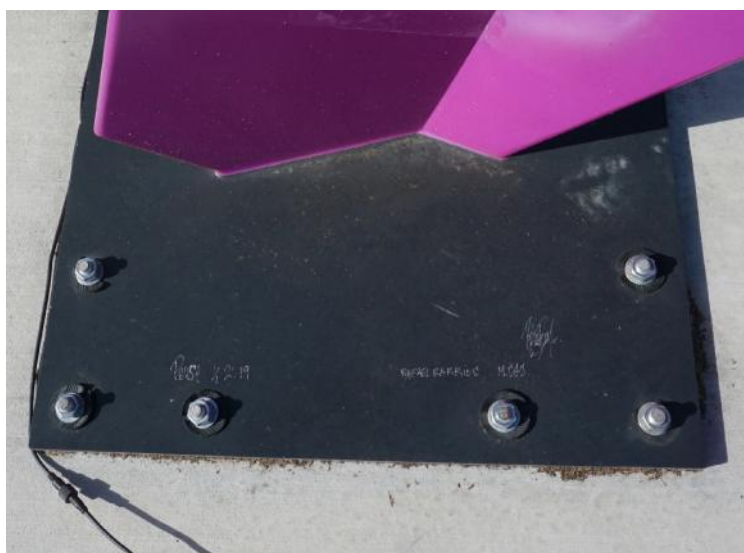
Figure 2. Stainless-steel plate with artist's signature and date bolted to concrete pad, soiling the base of the sculpture (photo by EverGreene, February 2021).

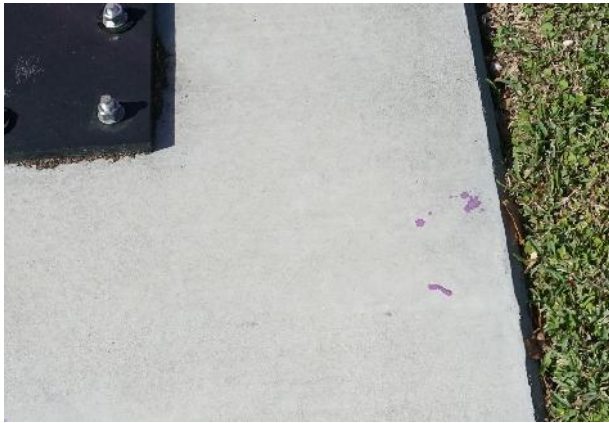
Figure 3. Magenta/purple coating drips on concrete pad (photo by EverGreene, February 2021).

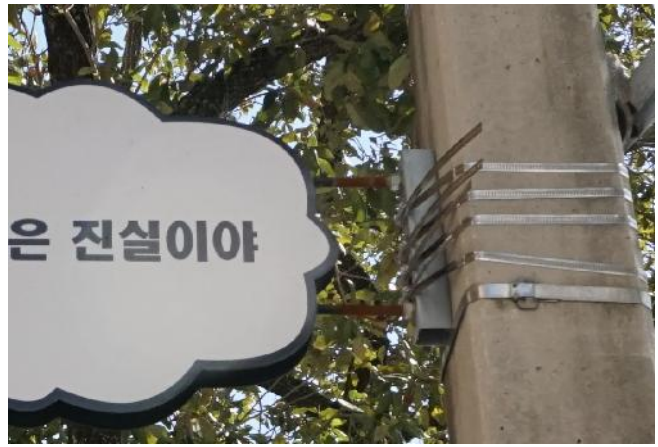
Figure 3. T: The Truth is I Remember You, two corroded threaded rods (photo by EverGreene, February 2021).

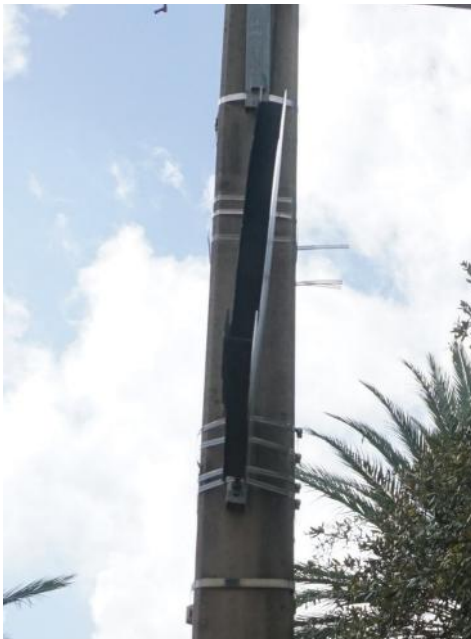
Figure 4. N: The Truth is I See You, displaced (photo by EverGreene, February 2021).

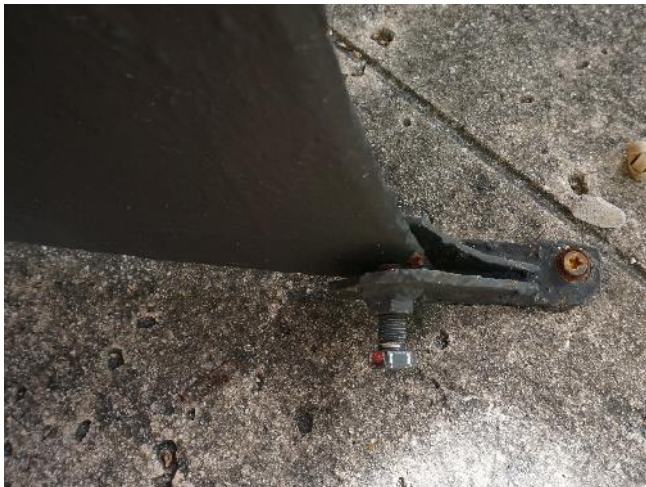
Figure 3. Deteriorated black clamp and Tapcon screw (photo by EverGreene, February 2021).

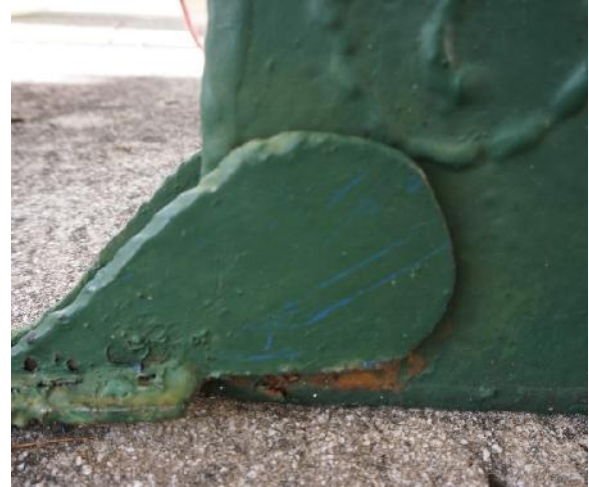
Figure 4. Deterioration on and around the green clamp, blue paint on the surface of the green clamp (photo by EverGreene, February 2021).

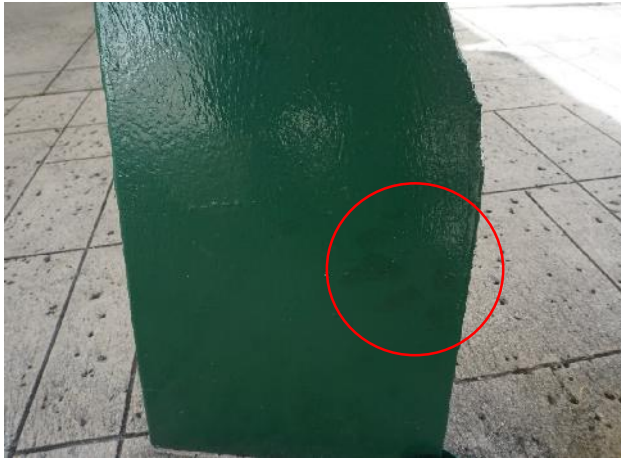
Figure 5. Previous touch up on green piece (photo by EverGreene, February 2021).

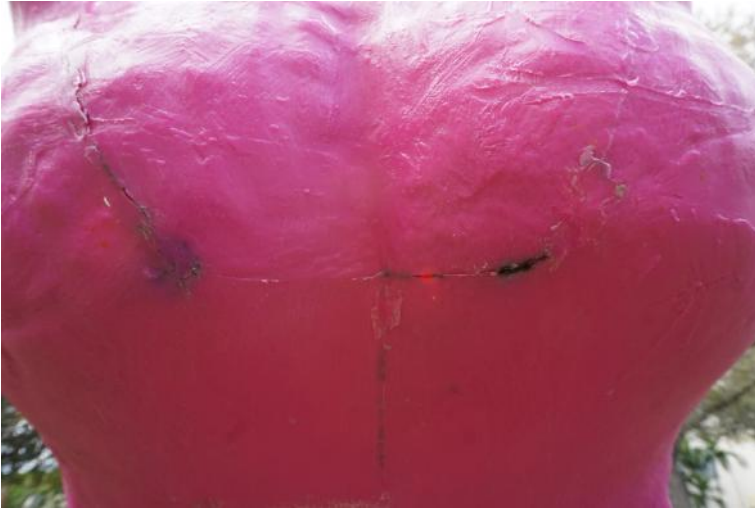
Figure 3. Deterioration at the seams (photo by EverGreene, February 2021).

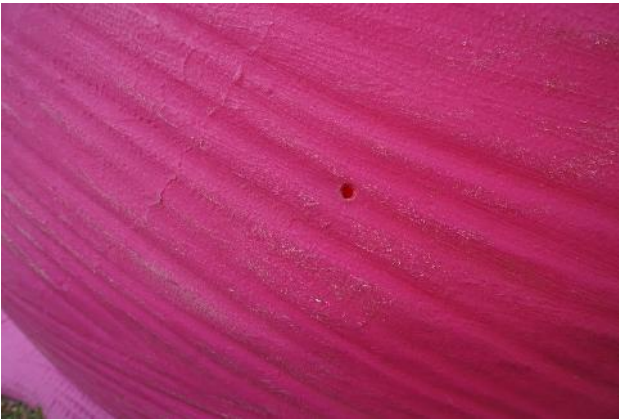
Figure 5. Entry hole in shell on proper left (photo by EverGreene, February 2021).

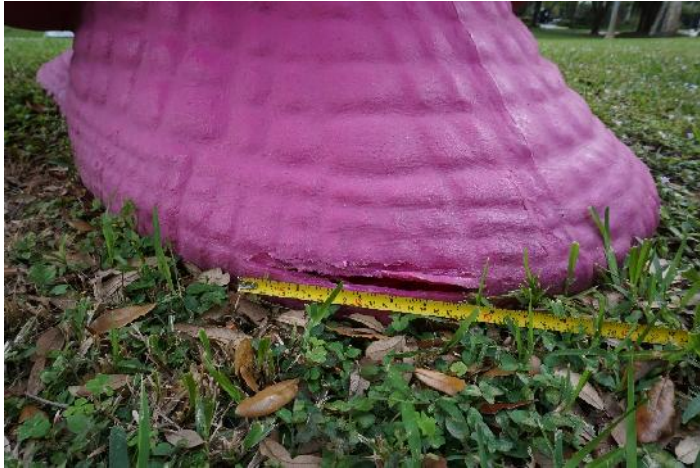
Figure 7. Large hole in base of tail, likely caused by landscaping equipment (photo by EverGreene, February 2021).

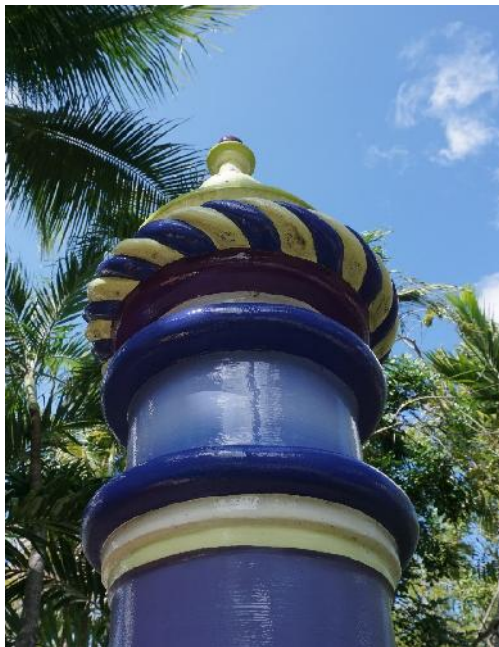
Figure 1. Capital of *Passionflower* showing soiling on underside of details (photo by EverGreene, February 2021).

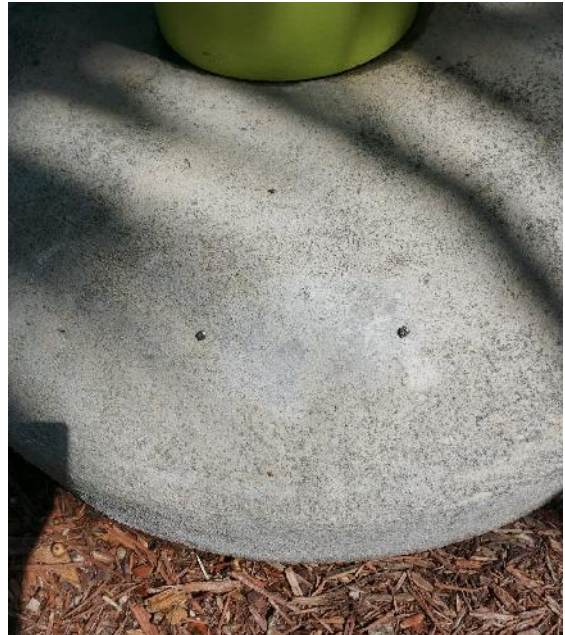
Figure 4. Missing plaque on base on *Passionflower*; remnant crews and small plaque fragment (photo by EverGreene, February 2021).

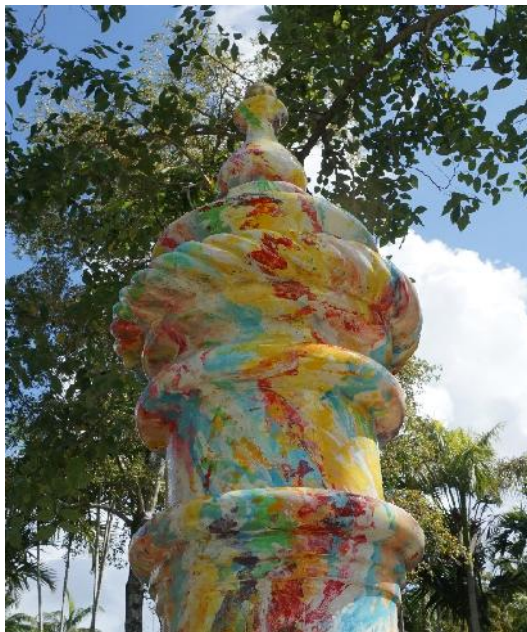
Figure 1. Capital of *Decomposition*; soiling is present on undersides of details, hidden due to the paint scheme (photo by EverGreene, February 2021).

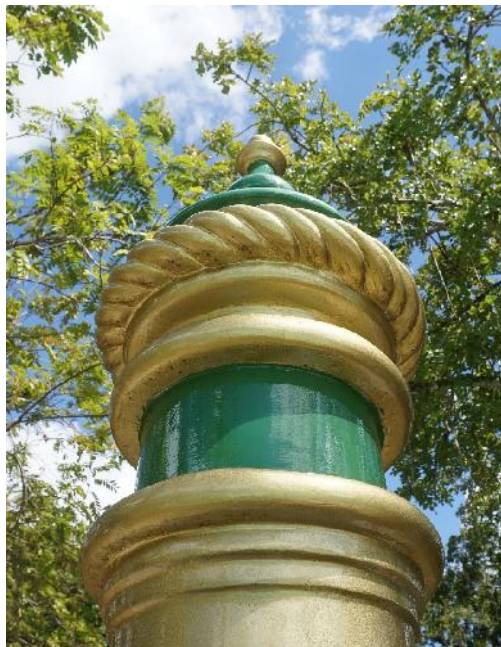
Figure 1. Capital of *Triad of Venice* with soiling on underside surfaces (photo by EverGreene, February 2021).

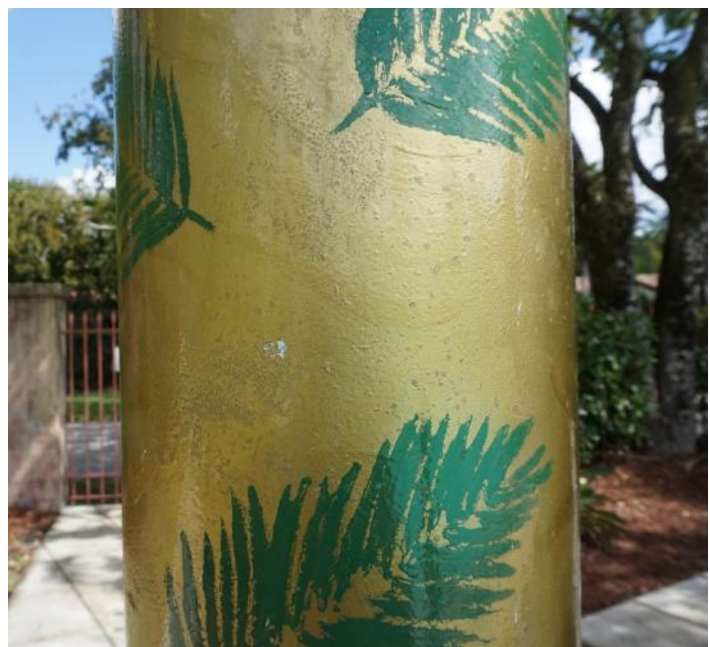
Figure 2. Paint failure/bubbling on shaft (photo by EverGreene, February 2021).

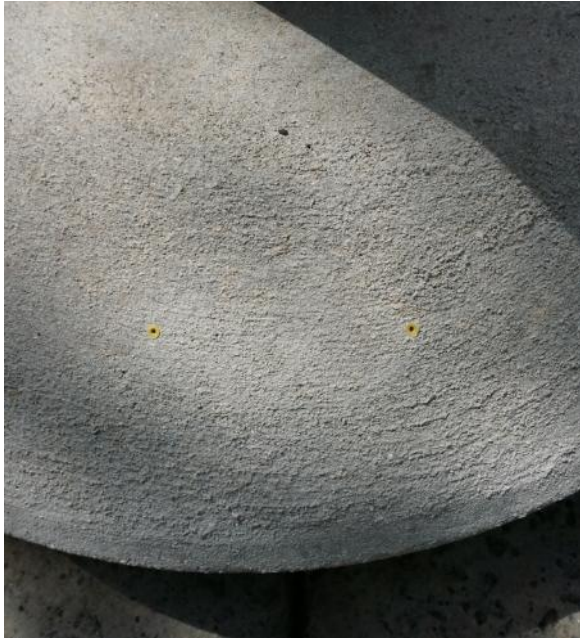
Figure 3. Missing plaque and screws (photo by EverGreene, February 2021).

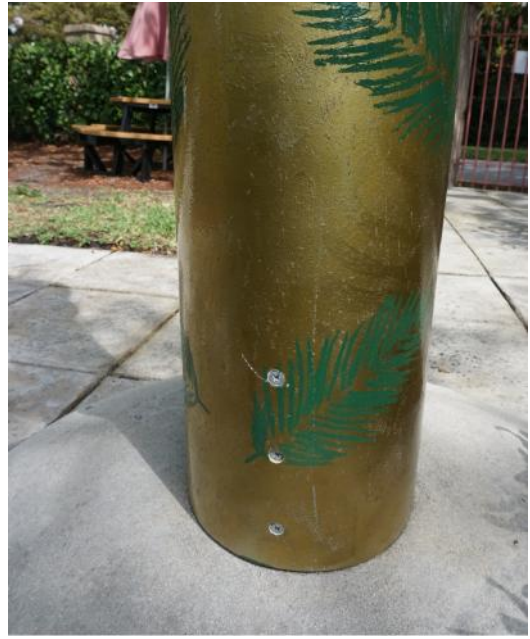
Figure 4. Vertical abrasion on shaft (photo by EverGreene, February 2021).

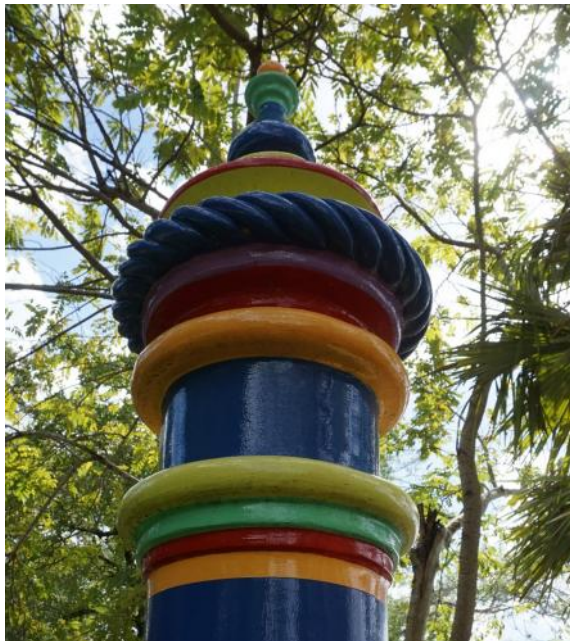
Figure 1. Soiling on underside of capital (photo by EverGreene, February 2021).

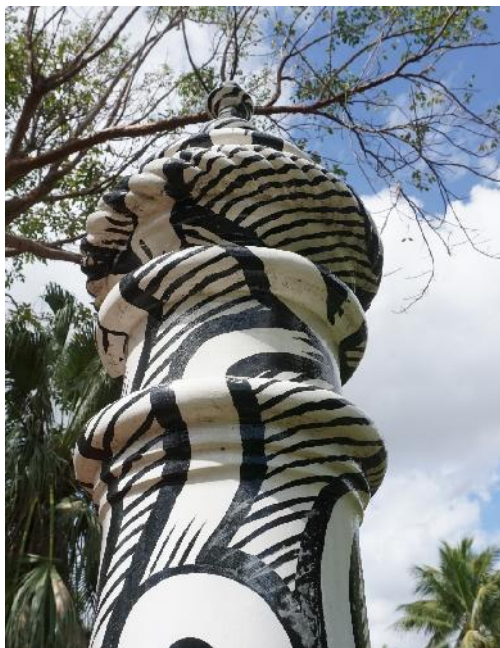
Figure 1. Soiling on undersides of the capital
(photo by EverGreene, February 2021).

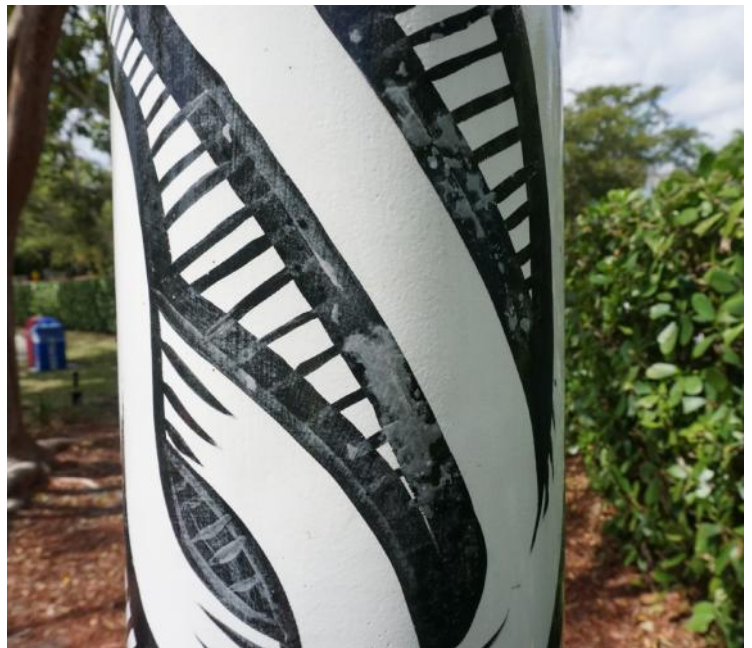
Figure 2. Coating failure (photo by EverGreene, February 2021).

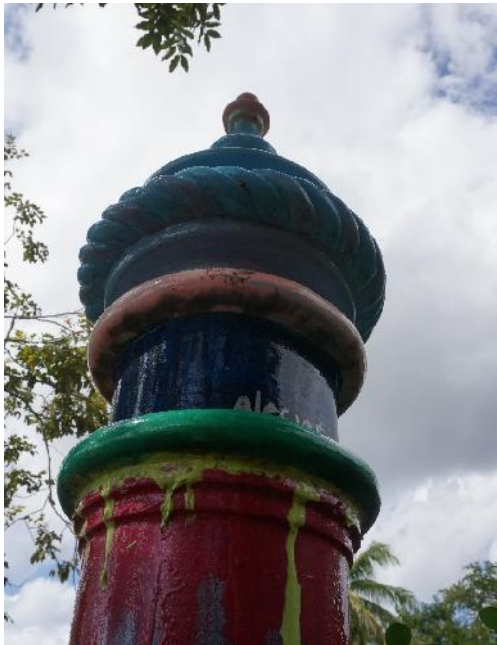
Figure 1. Soiling on underside of capital; artist's signature (photo by EverGreene, February 2021).

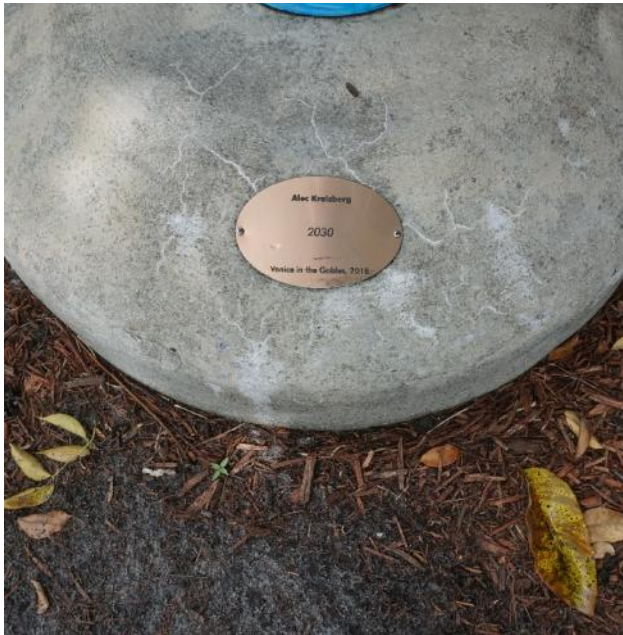
Figure 3. Plaque; network cracking of concrete base (photo by EverGreene, February 2021).

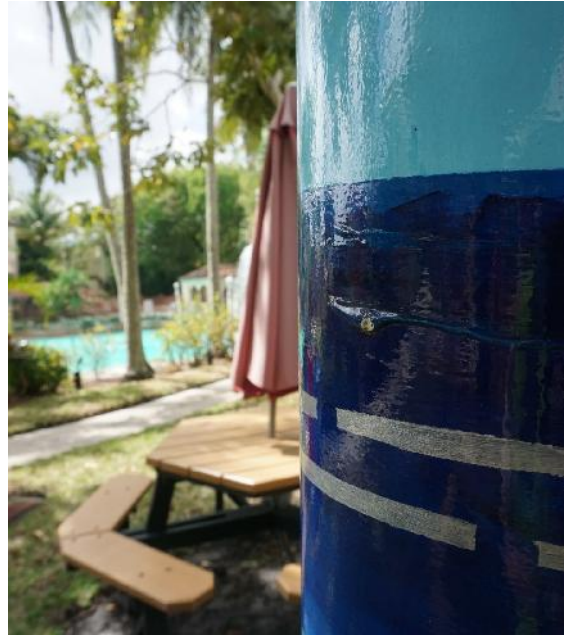
Figure 4. Abrasion (photo by EverGreene, February 2021).

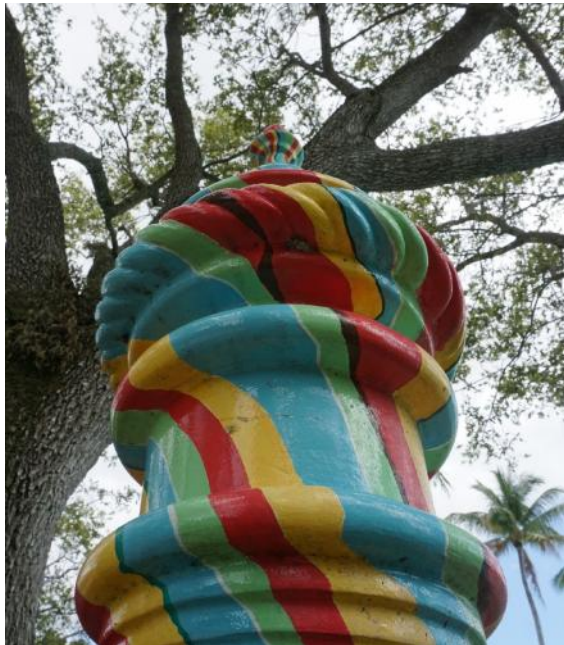
Figure 1. Soiling on underside of capital details (photo by EverGreene, February 2021).

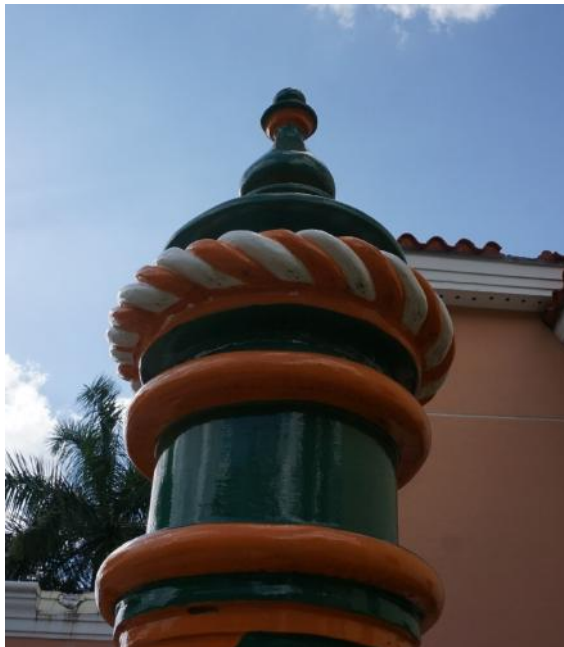
Figure 1. Soiling on underside of capital details (photo by EverGreene, February 2021).

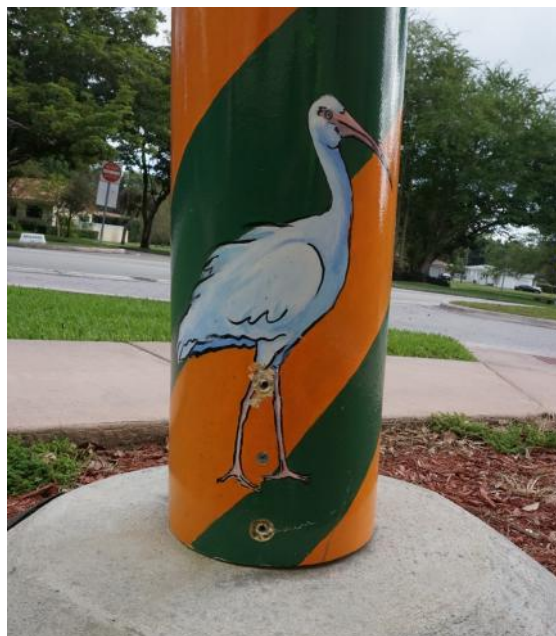
Figure 4. Missing fasteners and damage (photo by EverGreene, February 2021).

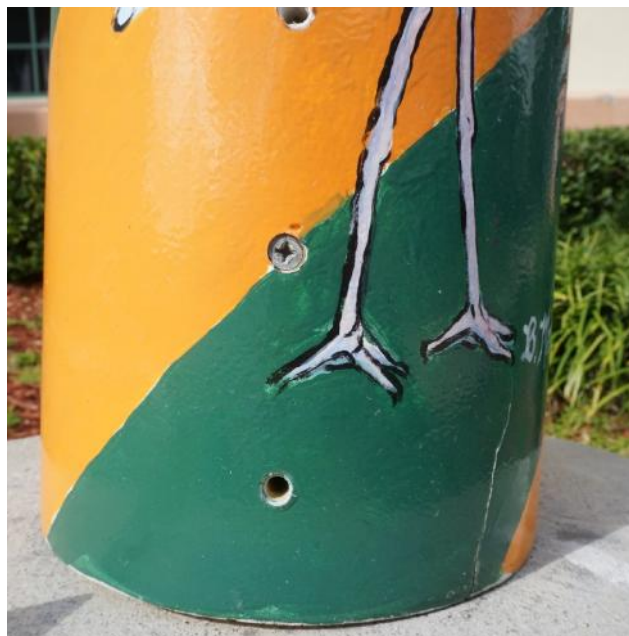
Figure 5. Missing fasteners (photo by EverGreene, February 2021).

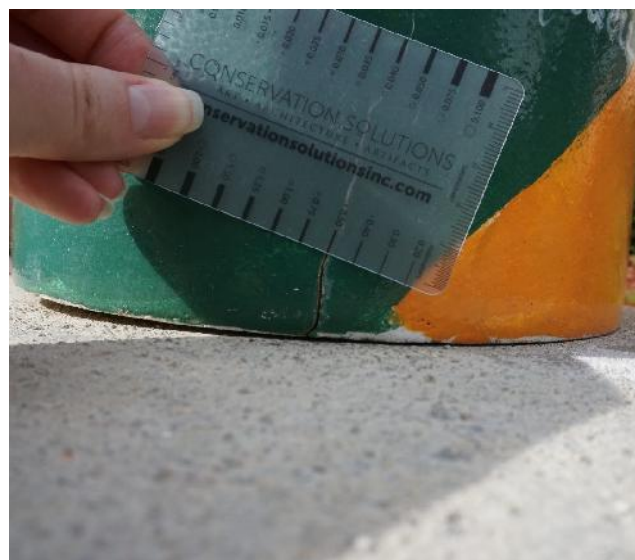
Figure 6. Crack (photo by EverGreene, February 2021).

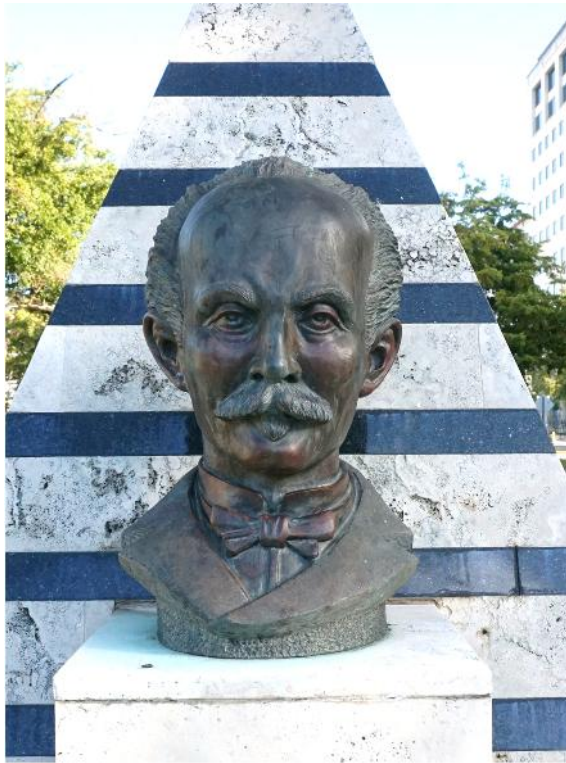
Figure 1. Bust of Jose Marti; copper staining on pedestal (photo by EverGreene, February 2021).

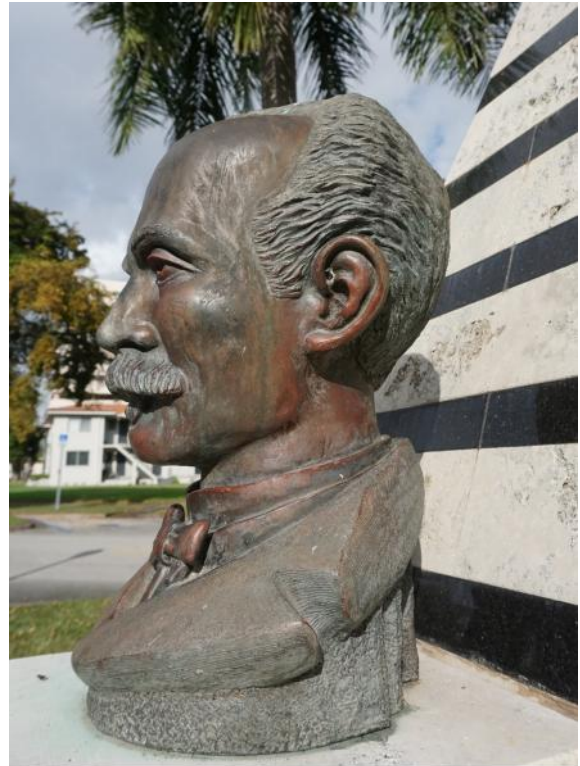
Figure 2. East side of Jose Marti bust, copper corrosion and discoloration of bust; wax coating failure (photo by EverGreene, February 2021).

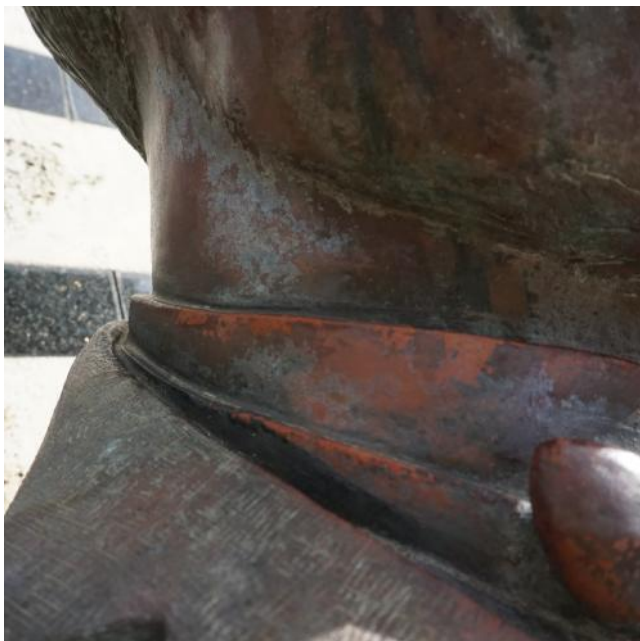
Figure 3. Coating failure and loss of patina, proper right side bust (photo by EverGreene, February 2021).

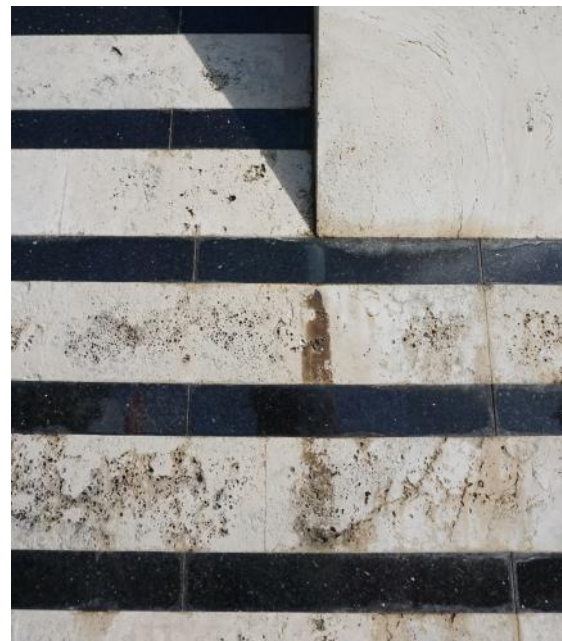
Figure 4. Soiling on pyramid (photo by EverGreene, February 2021).

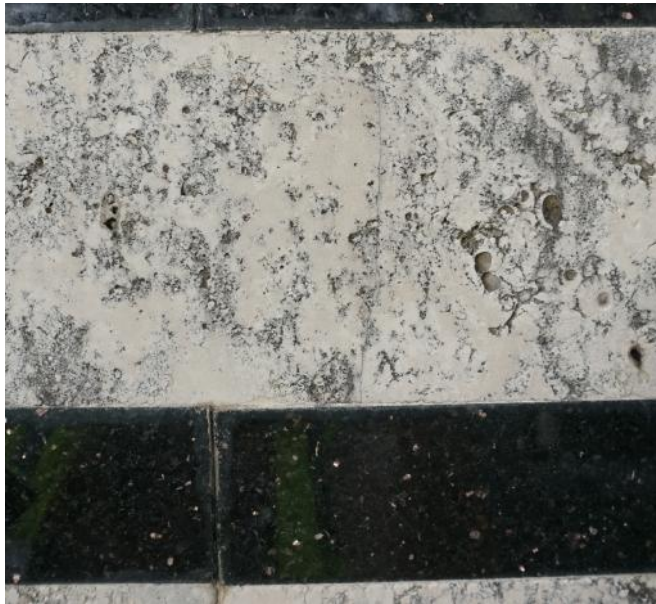
Figure 5. Mortar loss in granite joint, crack in marble (photo by EverGreene, February 2021).

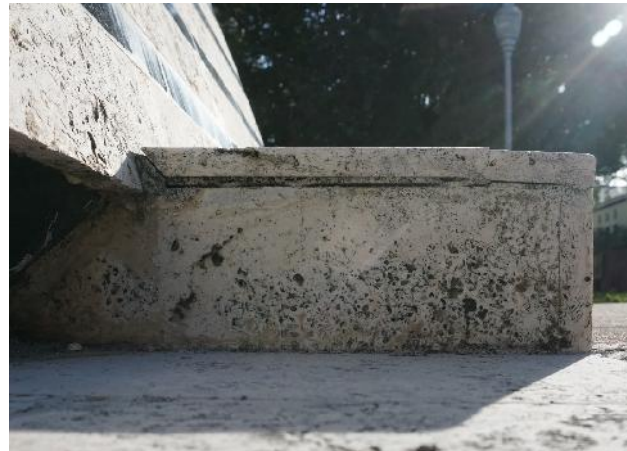
Figure 8. Cracked and displaced marble on step on south side (photo by EverGreene, February 2021).

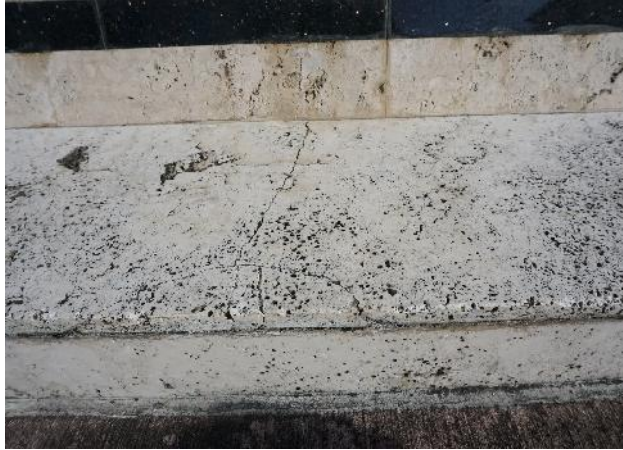
Figure 9. Large fracture in marble step (photo by EverGreene, February 2021).

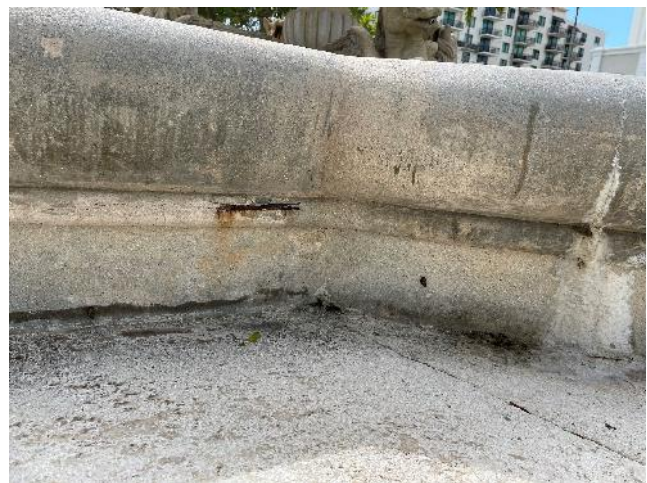
Figure 7. Corroded ferrous metal resulted in damage and loss in concrete (photo by EverGreene, February 2021).

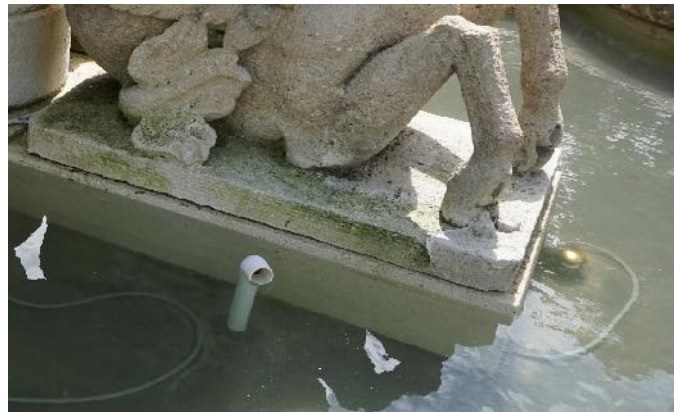
Figure 11. Previously repaired spall on west Pegasus; biological growth (photo by EverGreene, February 2021).

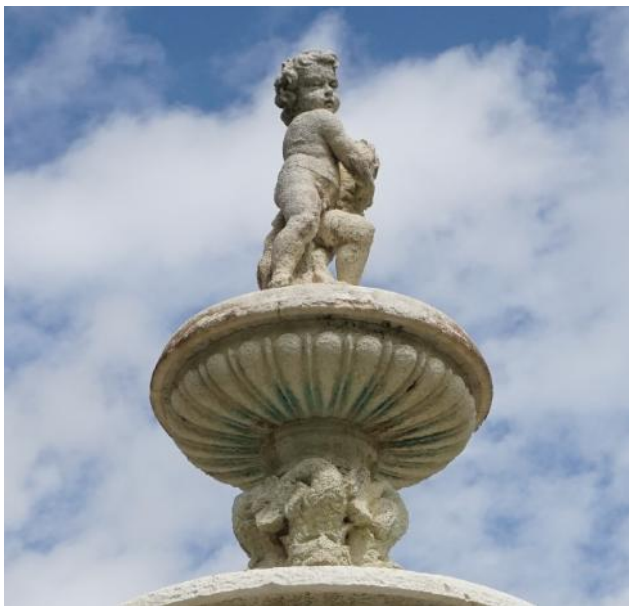
Figure 14. Copper staining on underside of top basin; cracks along entire edge of top basin; soiling and biological growth (photo by EverGreene, February 2021).

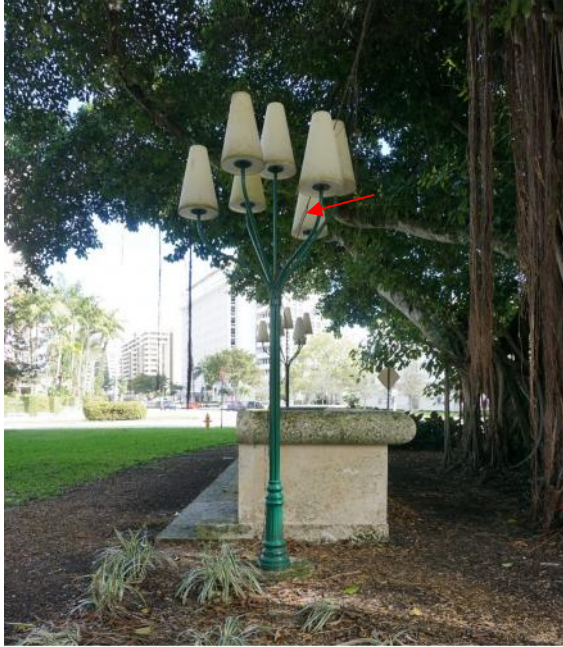
Figure 1. Northwest lamp and northwest side of bench; red arrow points to the vine that has entered the lamp structure (photo by EverGreene, February 2021).

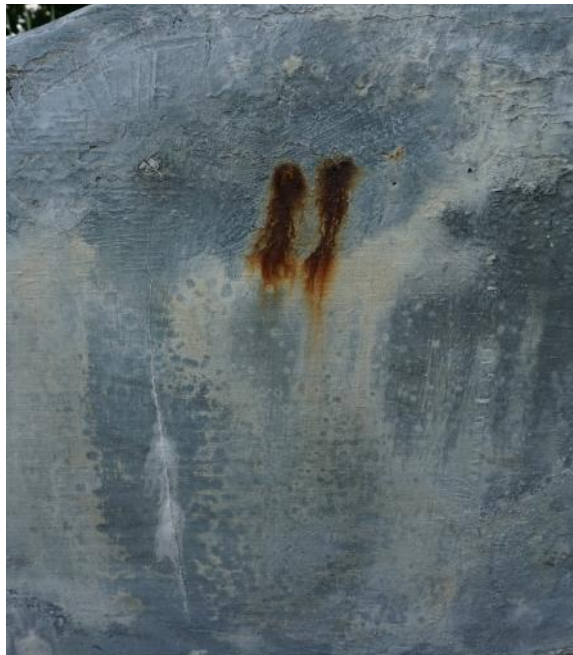
Figure 2. Ferrous corrosion deposits and staining on the bottom of the north shoe (photo by EverGreene,

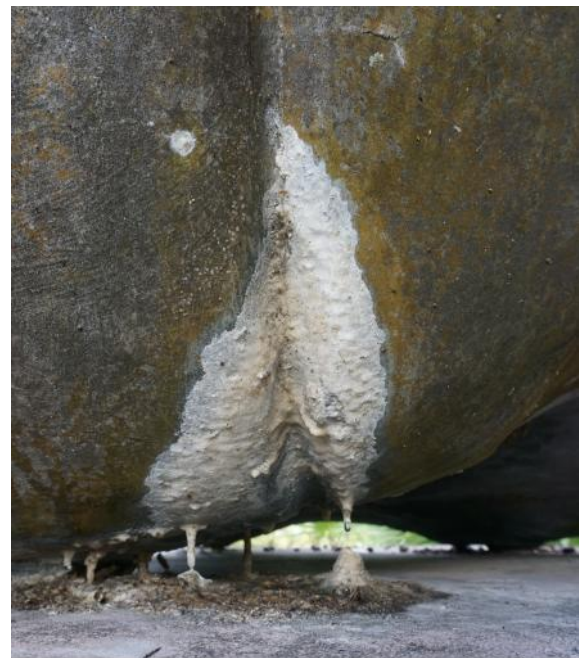
Figure 3. Extensive mineral accretions, typical stalactites and stalagmites forming on bottom of sculpture (photo by EverGreene, February 2020).

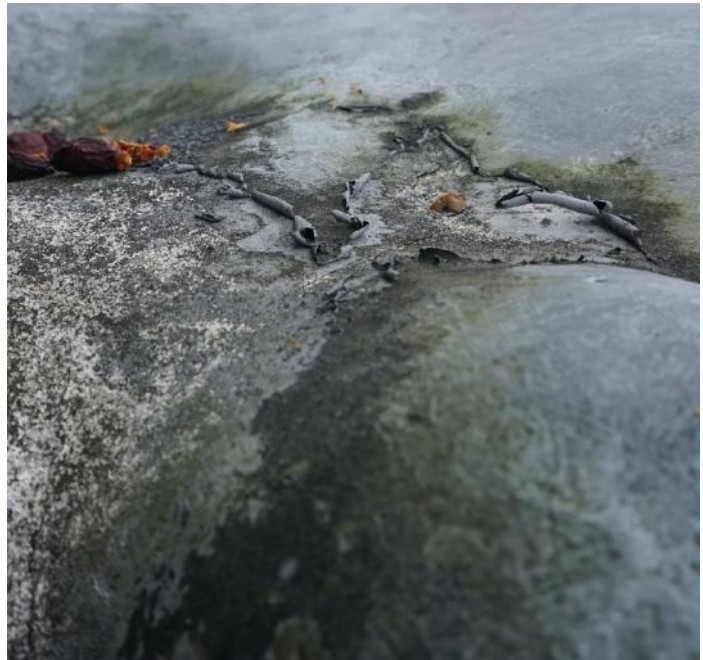
Figure 9. Coating failure and loss (photo by EverGreene, February 2021).

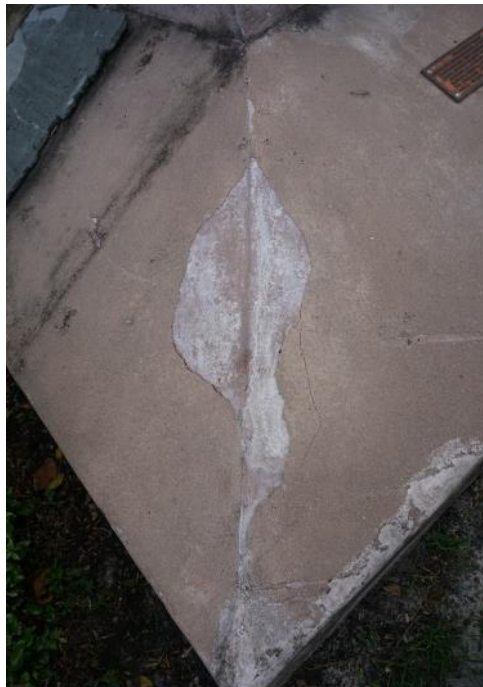
Figure 10. Typical loss of surface of platform (photo by EverGreene, February 2021).

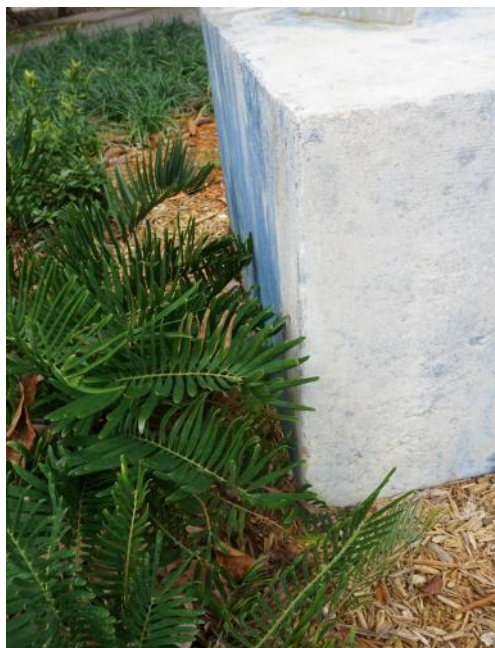
Figure 1. Landscaping generally well-maintained, foliage encroaching on artwork and mulch surrounding base of artwork. (photo by EverGreene, February 2021).

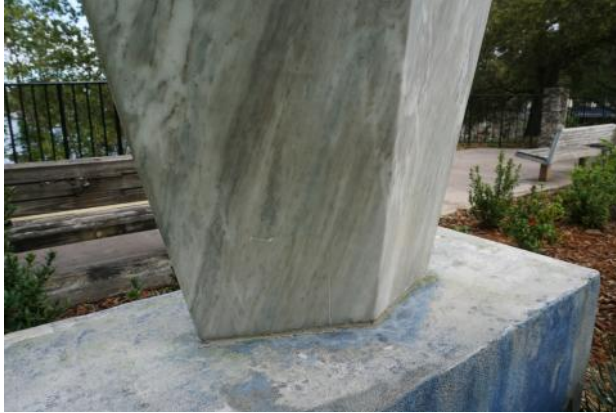
Figure 3. Joint is in good condition, concrete staining has deteriorated (photo by EverGreene, February 2021).

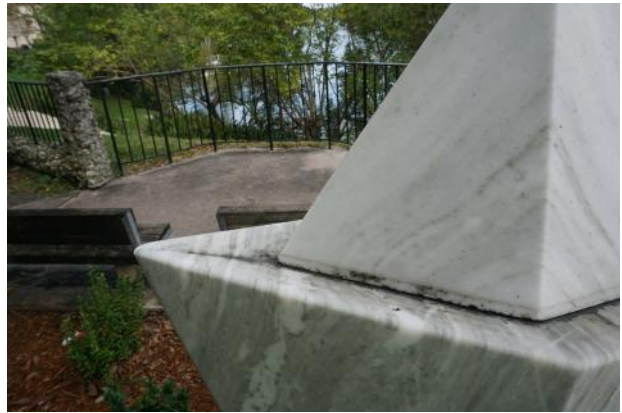
Figure 4. Detail of soiling accumulation on top of marble sculpture where rainwater pools (photo by EverGreene, February 2021).

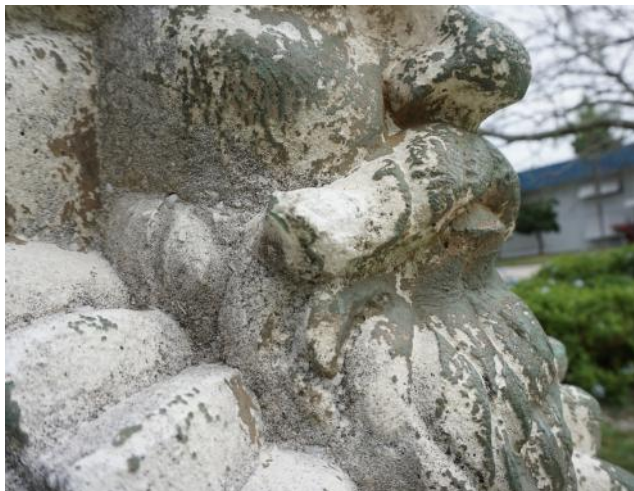
Figure 3. Previous repair on mustache (photo by EverGreene, February 2021).

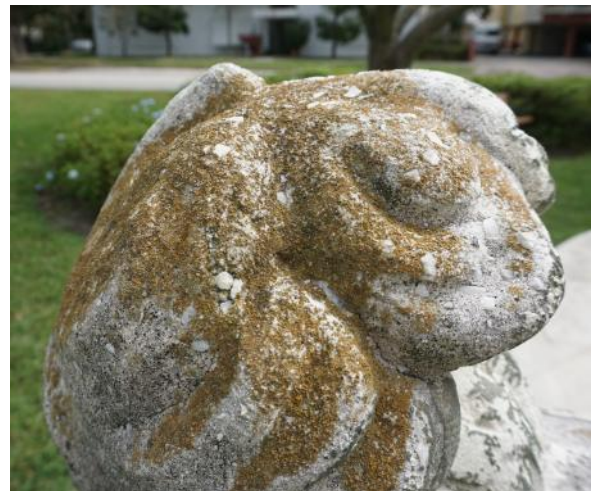
Figure 4. Biological growth on the top of the bust (photo by EverGreene, February 2021).

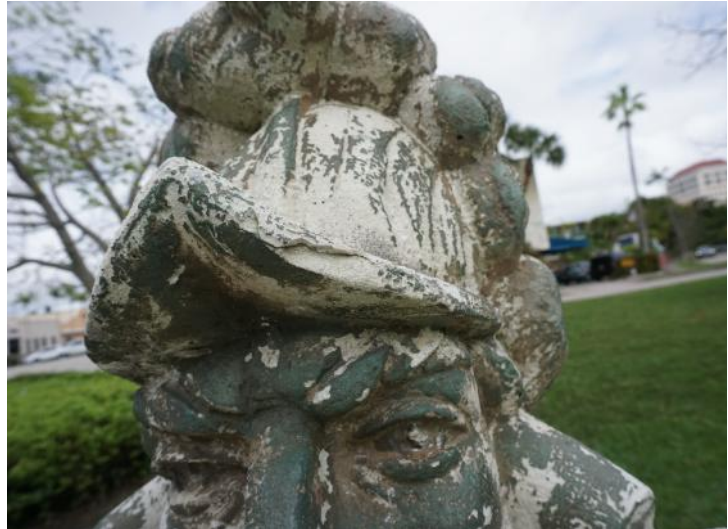
Figure 6. Loss and corroded paint coating (photo by EverGreene, February 2021).
