#### HISTORIC PRESERVATION AD-VALOREM TAX EXEMPTION

#### PART 2 - REQUEST FOR REVIEW OF COMPLETED WORK

## Nason Residence Photographs 1021 Alhambra Circle, Coral Gables

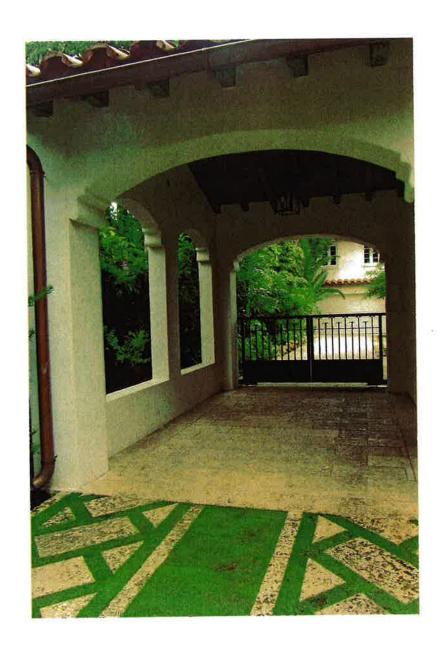
#### Photo #1

Port Cochere was preserved; original ceiling and walls were painted.

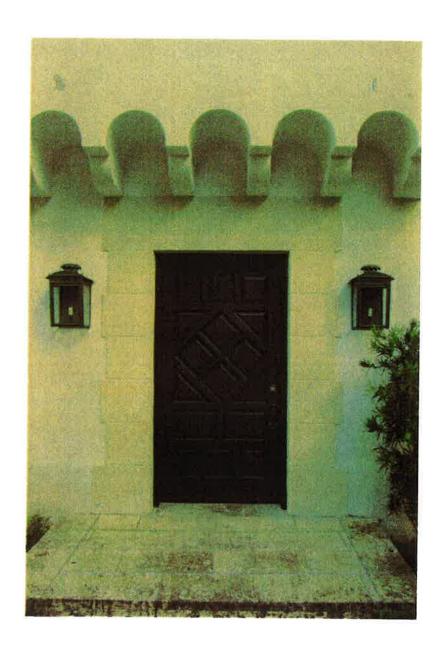
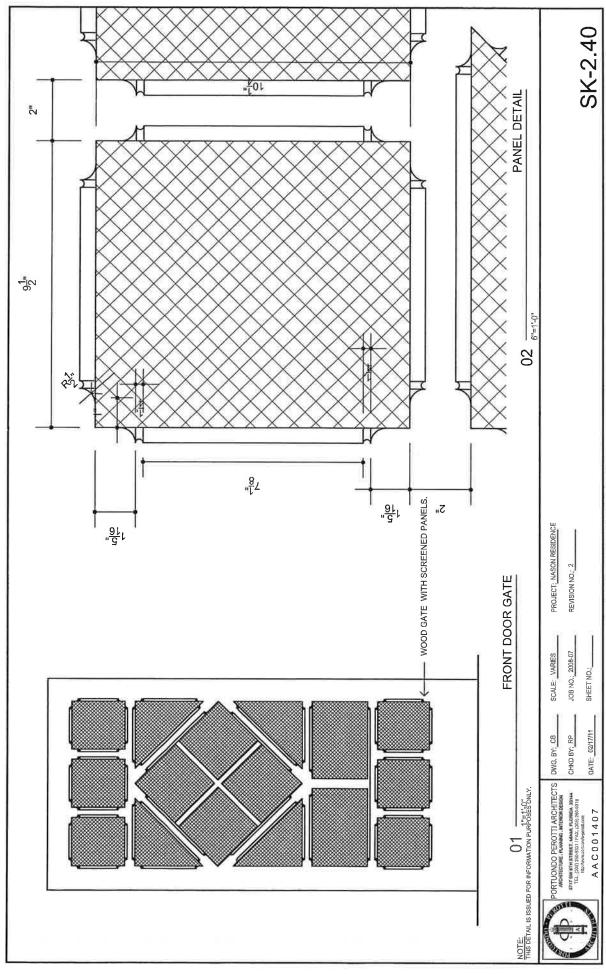
#### Photo #2

Wood door was preserved and a decorative metal screen was designed to match original wood door existing shape.

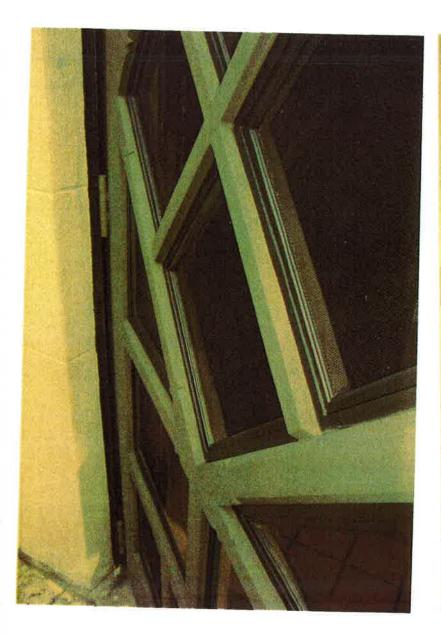
#### Photo #2

Wood door was preserved and a decorative metal screen was designed to match original wood door existing shape.

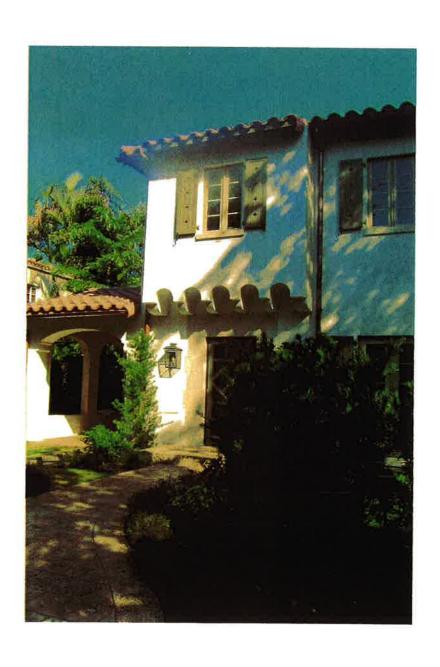
# 1021 Alhambra Circle, Coral Gables Photo #3 Bay Window at Front elevation –South Concrete detail was preserved.

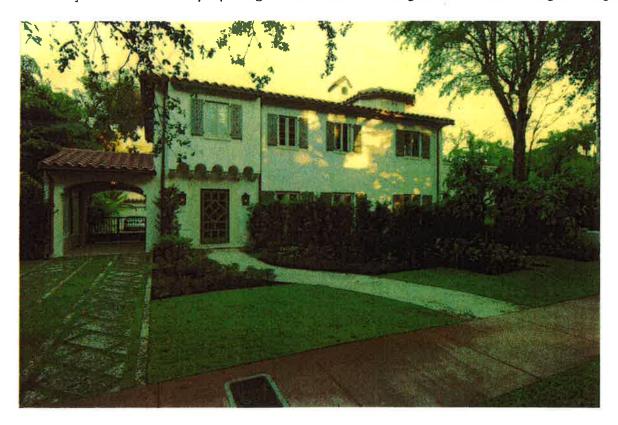
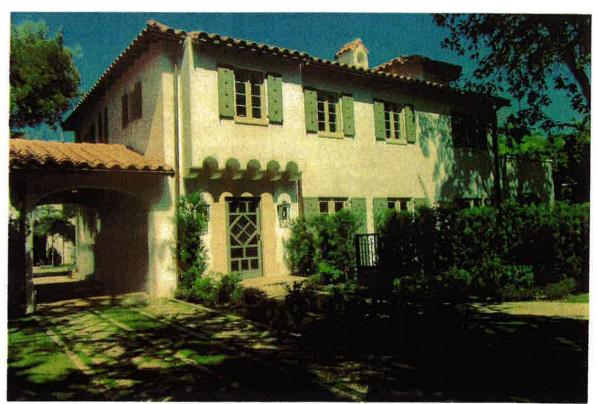
#### Photo #4

Main façade was restored by replacing the windows and adding shutters to reflect original design.

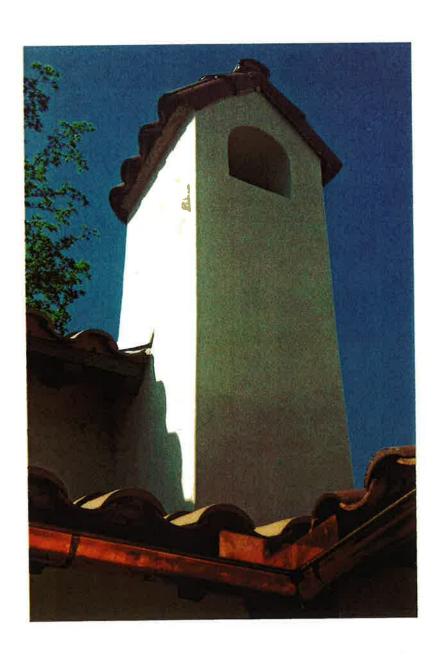
Photo #5

Original chimney designed was preserved.

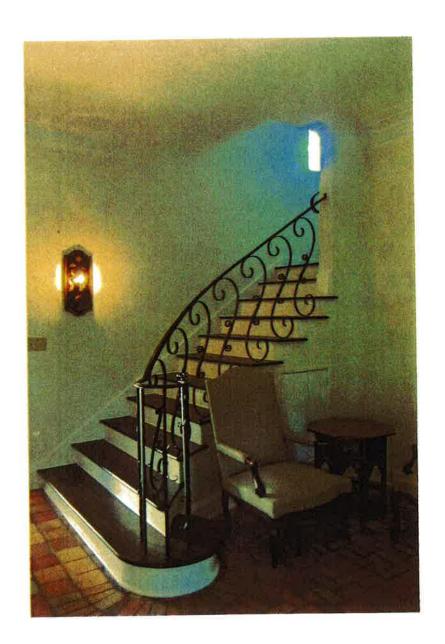
Photo #6

Main stair –treads, moldings and railing were completely restored.

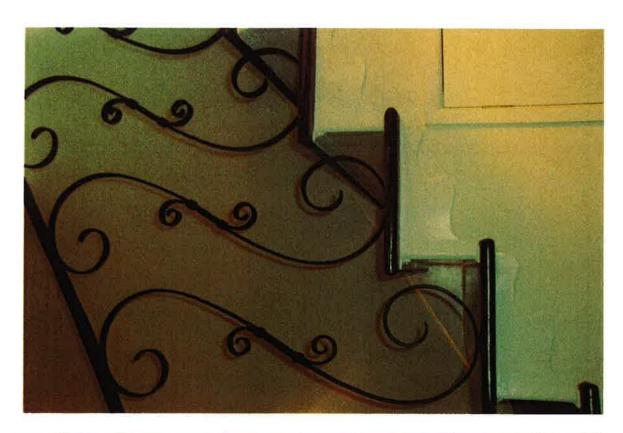
Photo #6

Main stair –treads, moldings and railing were completely restored.

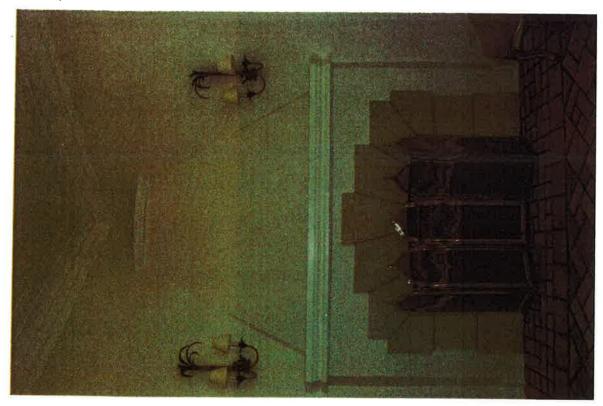
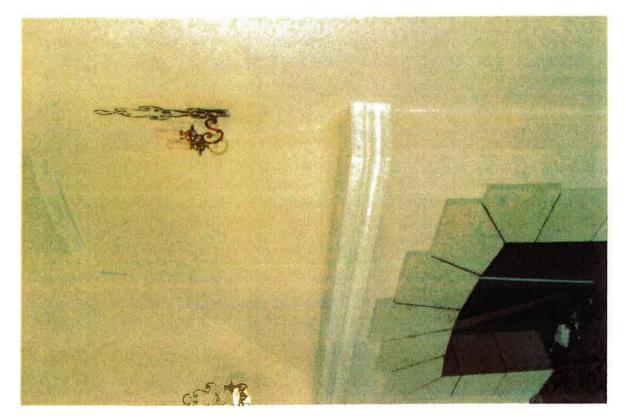
Photo #7

Fireplace at main level was restored by adding a decorative stone surround as per original plans.

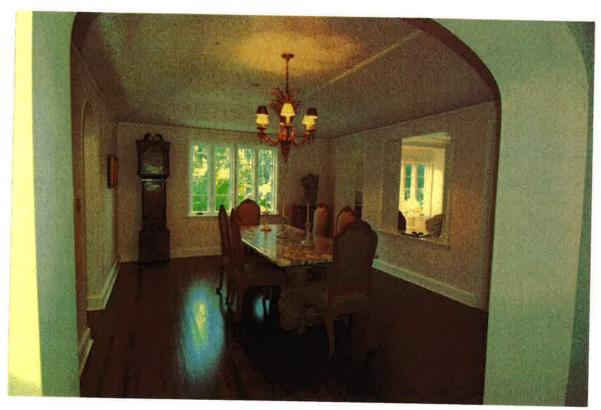
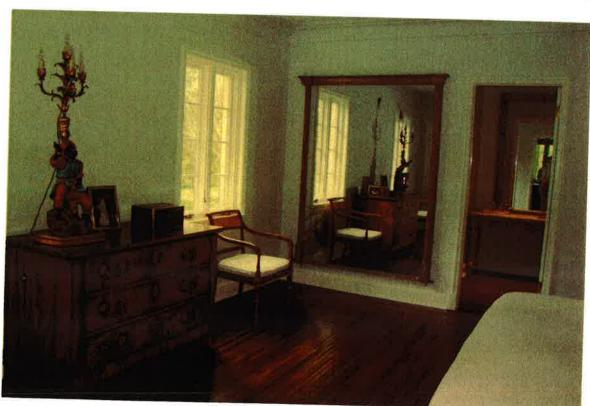
Photo #9

Wood floors at dining room and at master bedroom were restored.

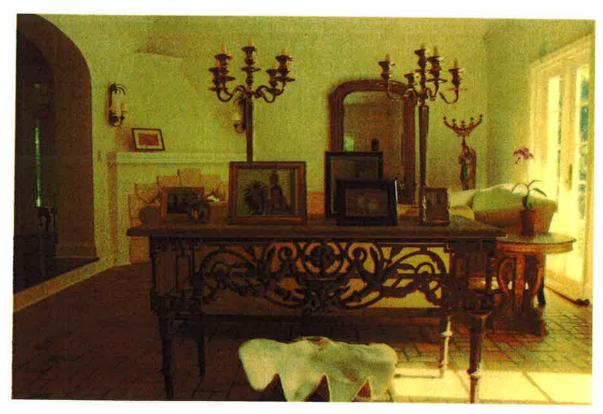
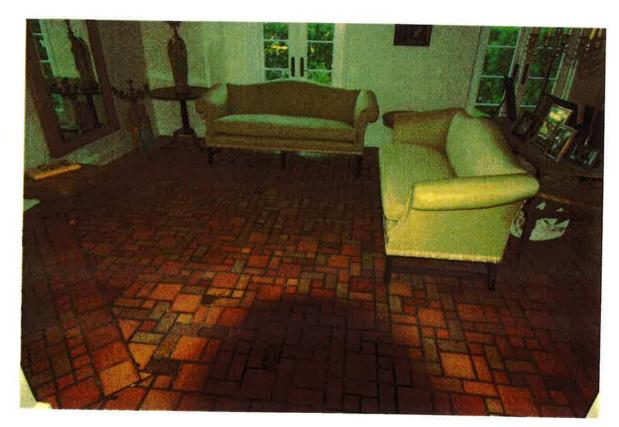
#### Photo #10

Original tile floor was preserved at living room .

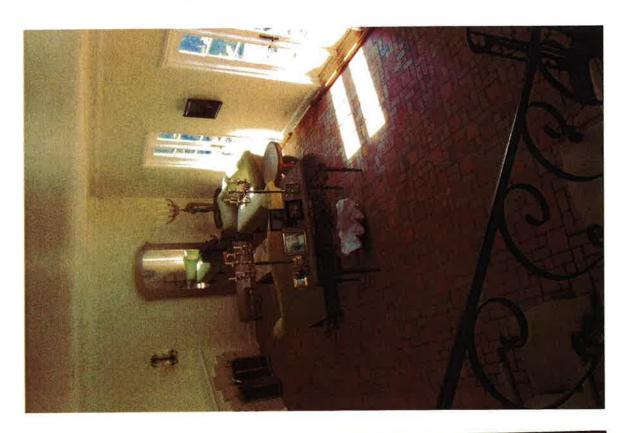
#### Photo #10

Original tile floor was preserved at living room .

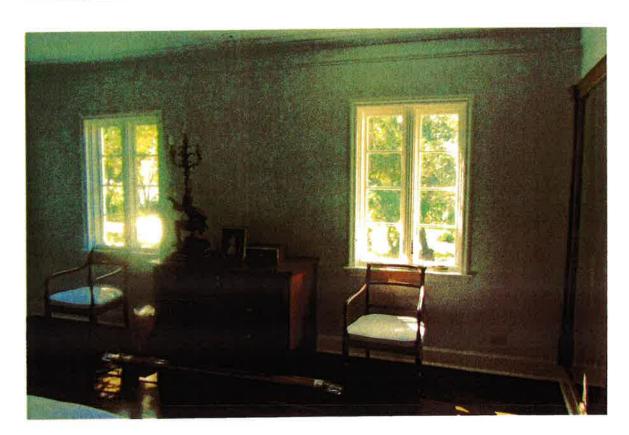
Photo #11

Ceiling plaster molding at living room and at master bedroom was preserved.

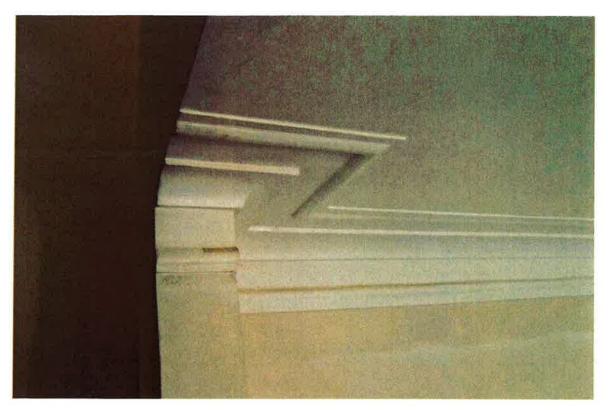
Photo #11
Ceiling plaster molding at living room and at master bedroom was preserved.

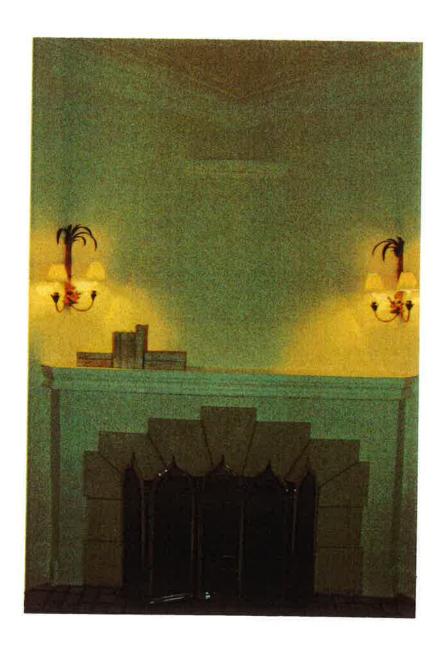
Photo #11

Ceiling plaster molding at living room and at master bedroom was preserved.

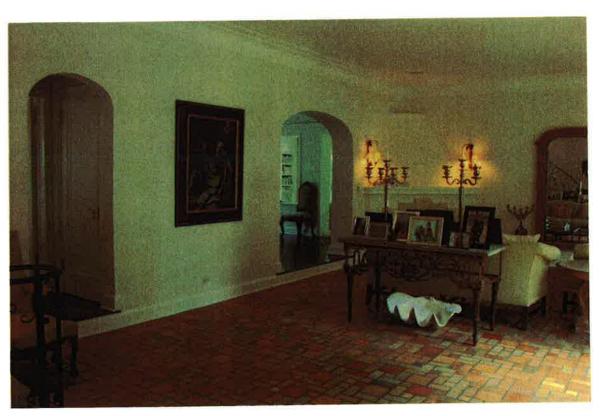
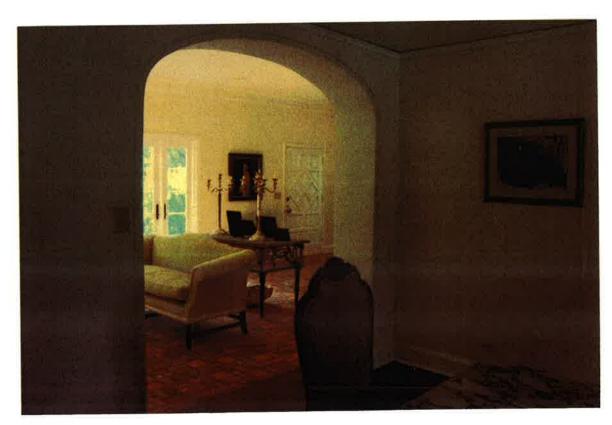
Photo #12

Arches at living room and dining room were preserved.

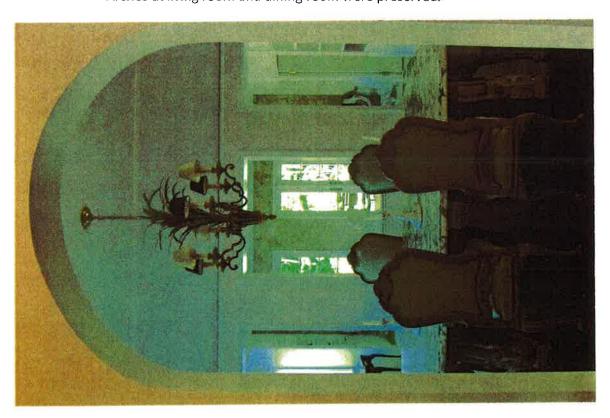
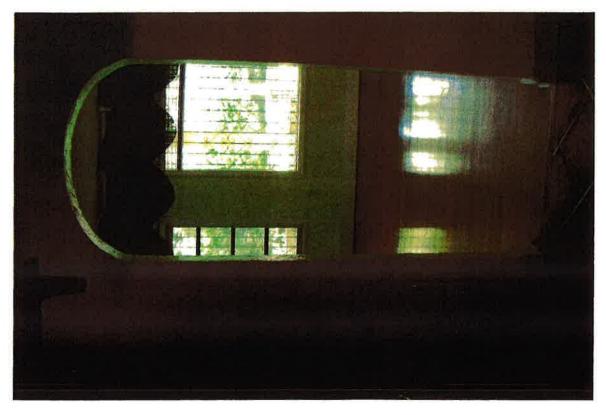
Photo #12

Arches at living room and dining room were preserved.

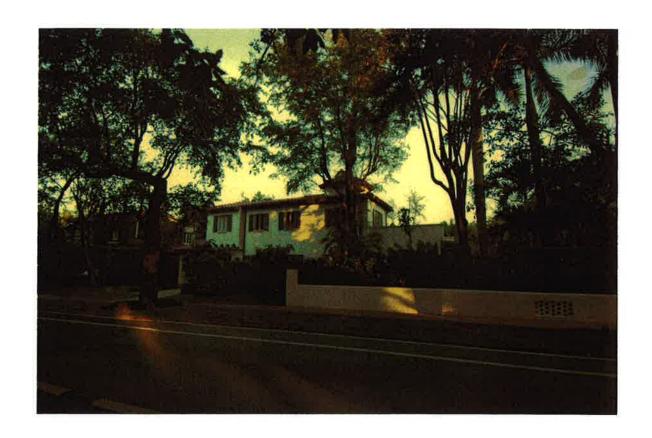
Photo #14

Front low wall original brick feature was preserved.

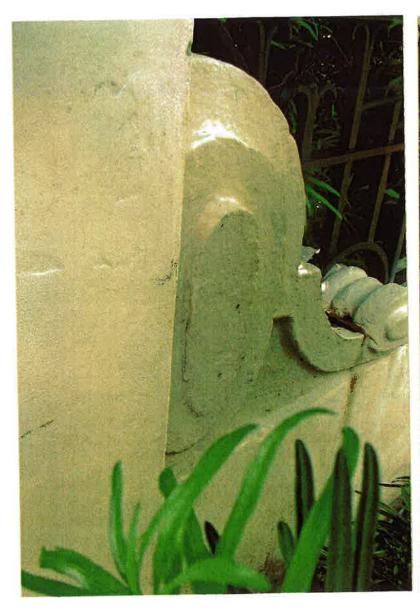
#### Photo #15

Wing wall located at the front of the house was preserved.

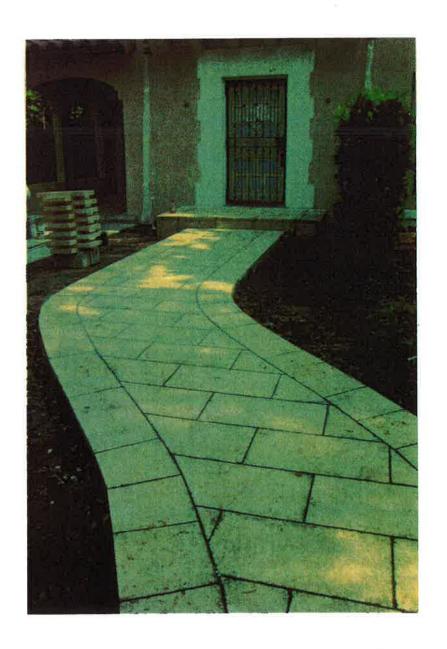
Photo #16

Entry walkway located at the front of the house was restored by keeping the same path.

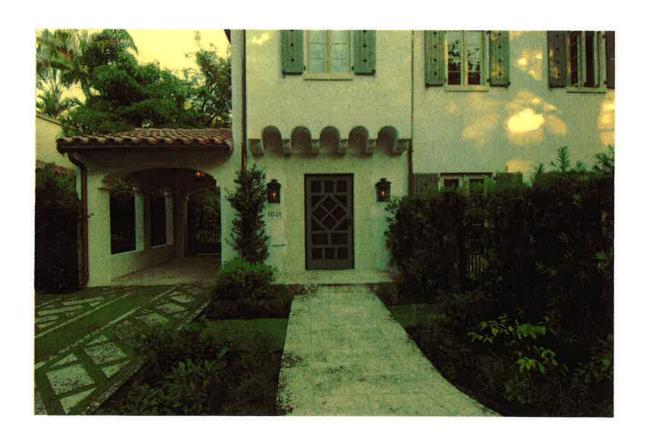
#### Photo #16

Entry walkway located at the front of the house was restored by keeping the same path.

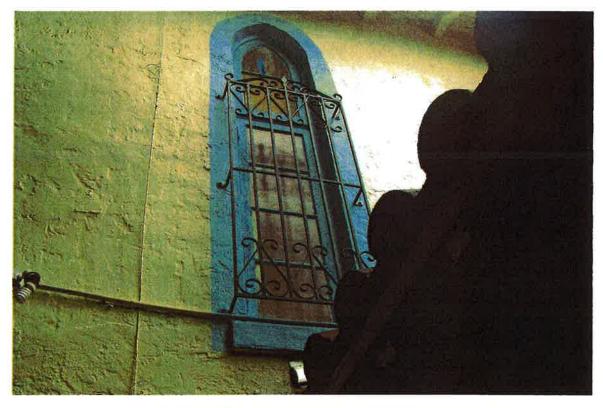
Photo #17
Window at main stair was restored to keep original size and shape.

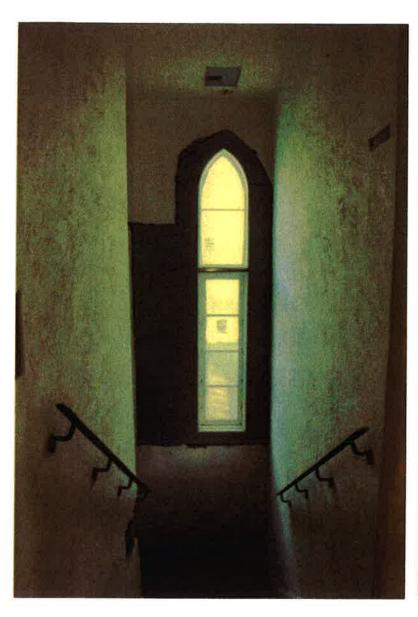
#### Photo #17

Window at main stair was restored to keep original size and shape.

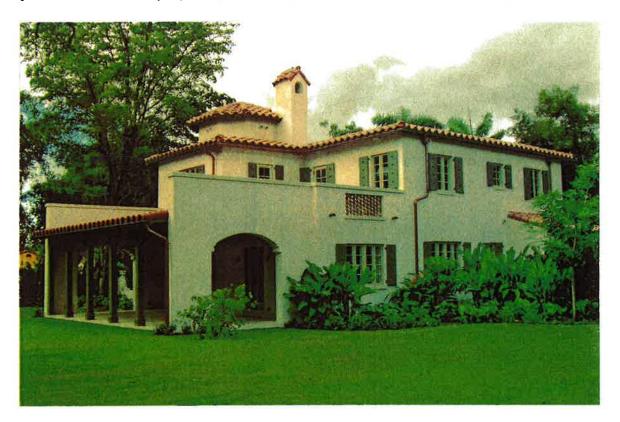
Photo #18

All façades were restored by replacing the windows and adding shutters to reflect original design.

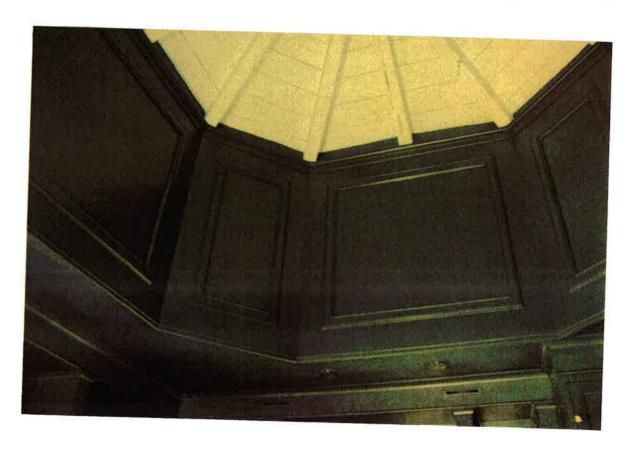
Photo #19

Original ceiling at upper level tower was restored.

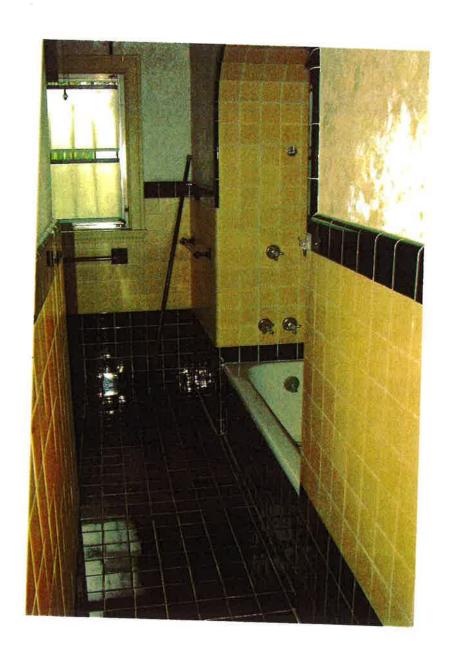
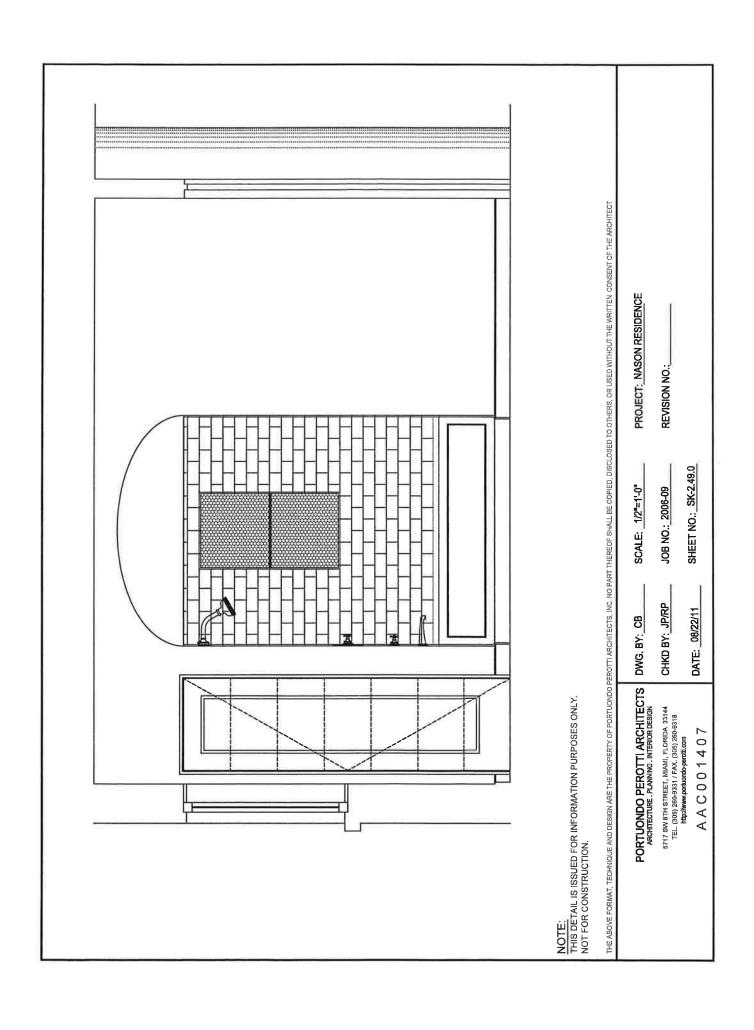
#### Photo #20

Upper level bathroom was completely restored by keeping the same arch original design and re-enameling original bath tub.

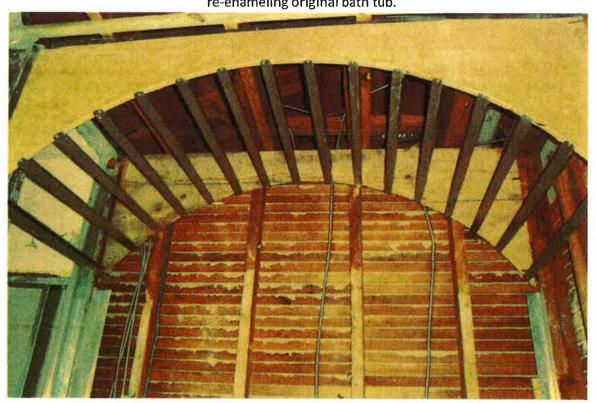
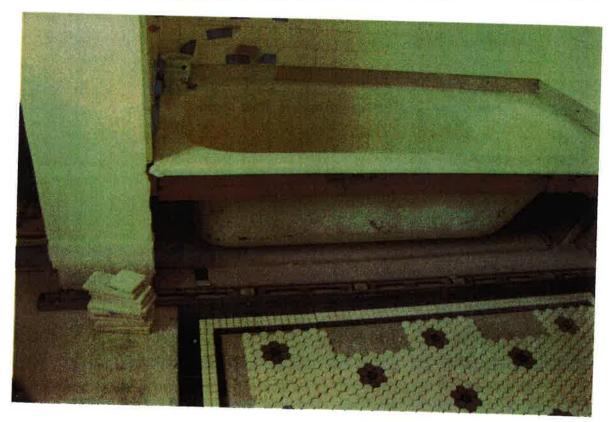
#### Photo #20

Upper level bathroom was completely restored by keeping the same arch original design and

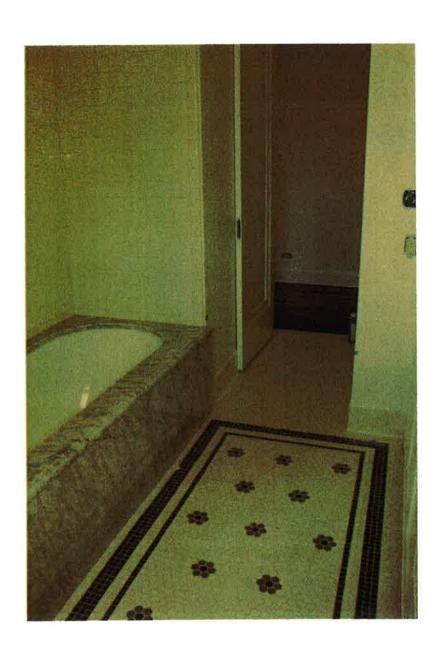
Photo #20

Upper level bathroom was completely restored by keeping the same arch original design and re-enameling original bath tub.

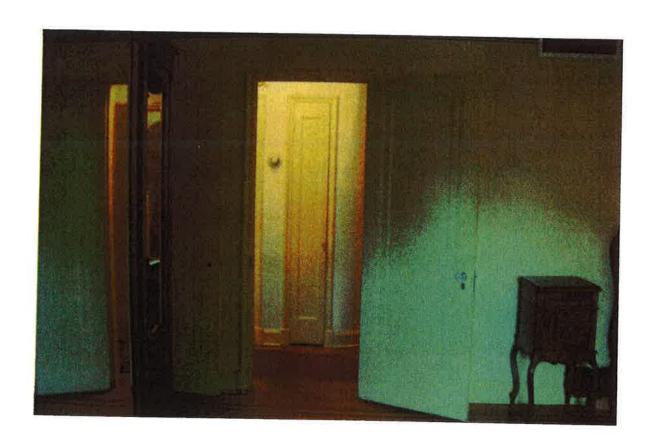
Original upper level hall linen closet handles mechanisms were restored.

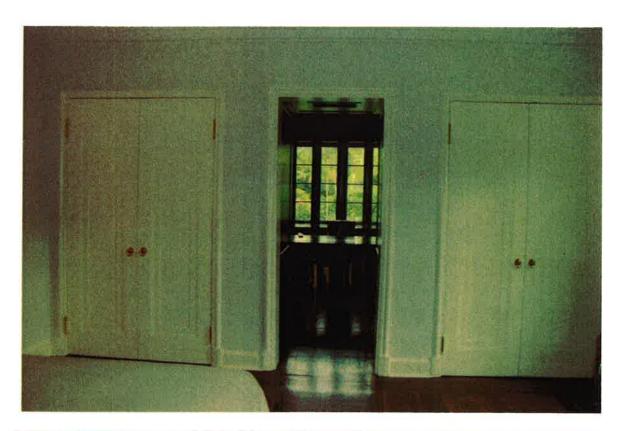
Photo #22

All interior doors and wood baseboards through the house were restored.

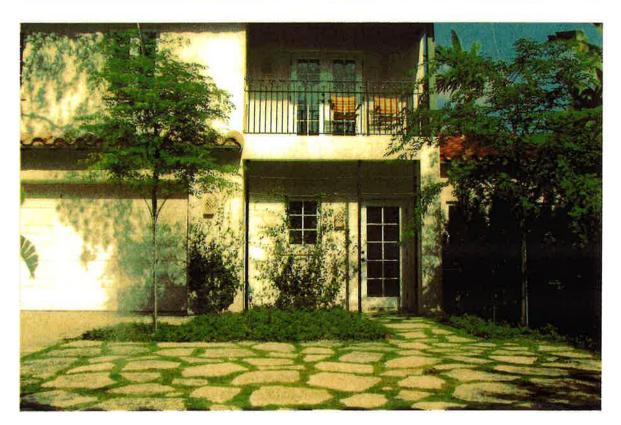
### Photo #23

All openings along the facades were restored by replacing the existing windows and doors by impact

resistant products.

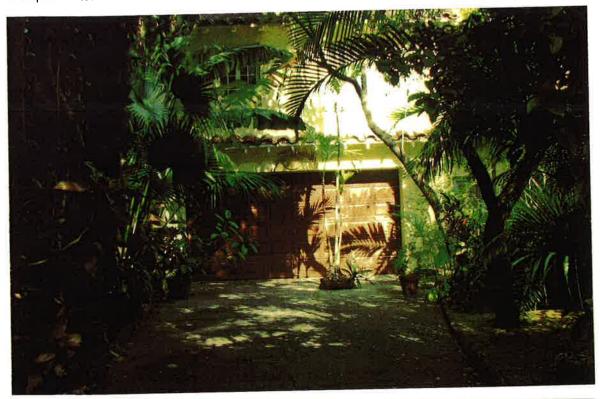
### Photo #23

All openings along the facades were restored by replacing the existing windows and doors by impact resistant products.

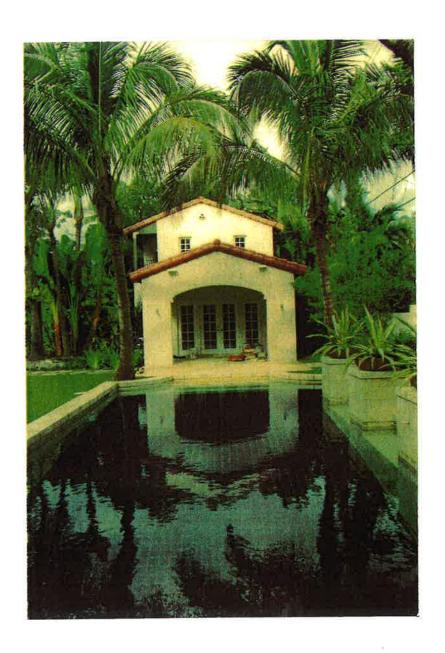
#### Photo #24

Staying true to the original design, the den was restored; a covered loggia was added to help engage the new pool and landscape design.

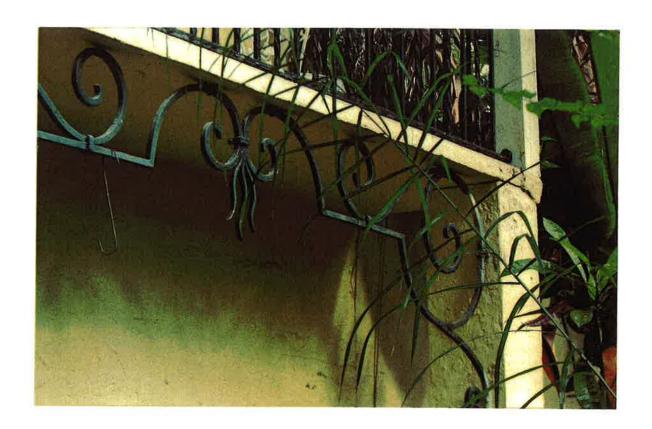
### Photo #25

The balcony was completely restored and was reinforced structurally.

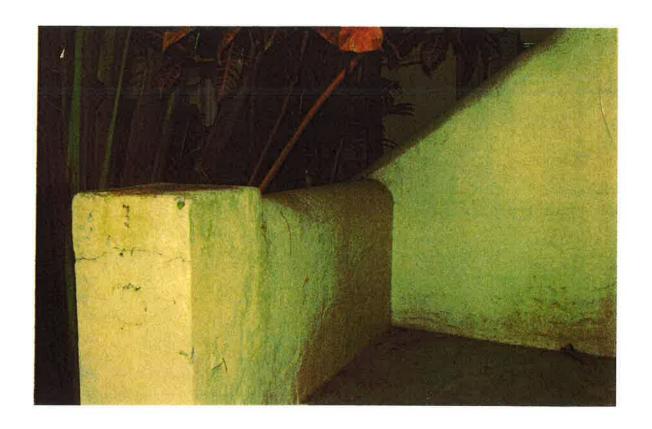
Photo #26

Exterior stair at Auxiliary building refinished with decorative terracotta tile.

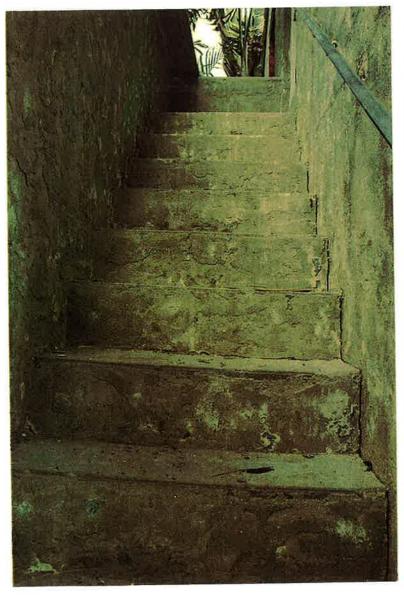
### Photo #26

Exterior stair at Auxiliary building refinished with decorative terracotta tile.
