# The Cla-Reina Hotel (La Palma Hotel)

City of Coral Gables Ad Valorem Tax Exemption Application

**MIAMI-DADE COUNTY  
HISTORIC PRESERVATION AD-VALOREM TAX EXEMPTION**

**PART 1 – PRECONSTRUCTION APPLICATION**

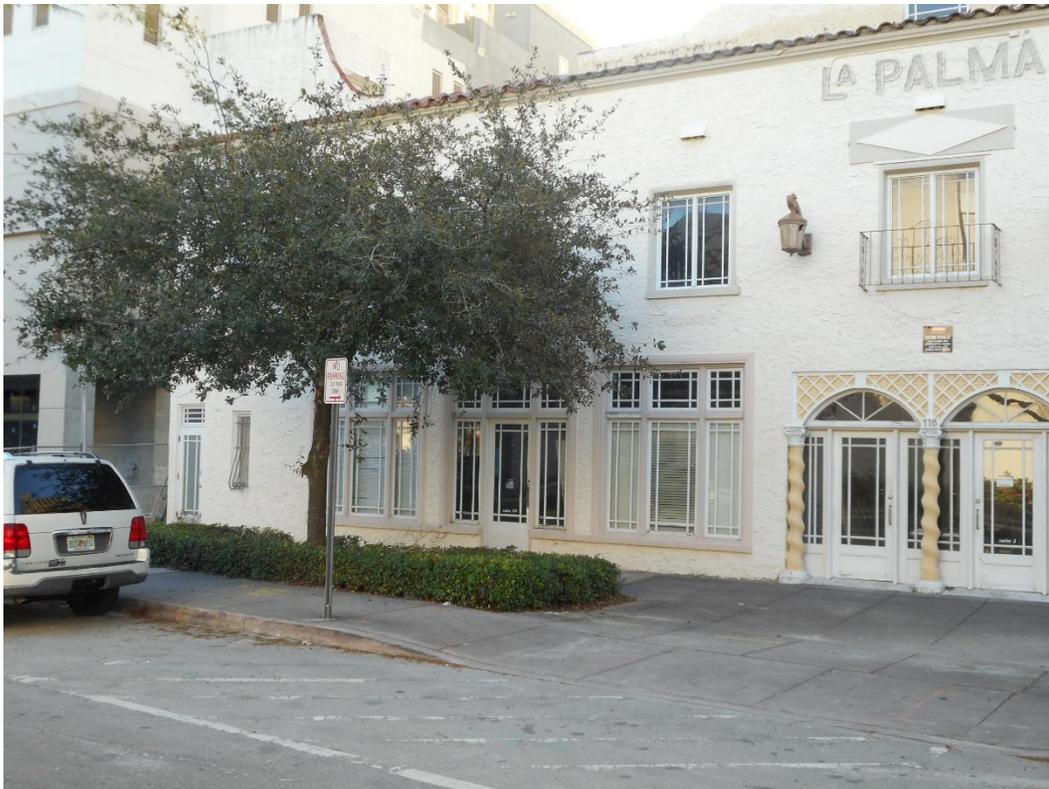
PHOTO 2.

The north façade of "La Palma" building. The suspended canopy over the central entrance long since removed, probably during the 1960s renovation.

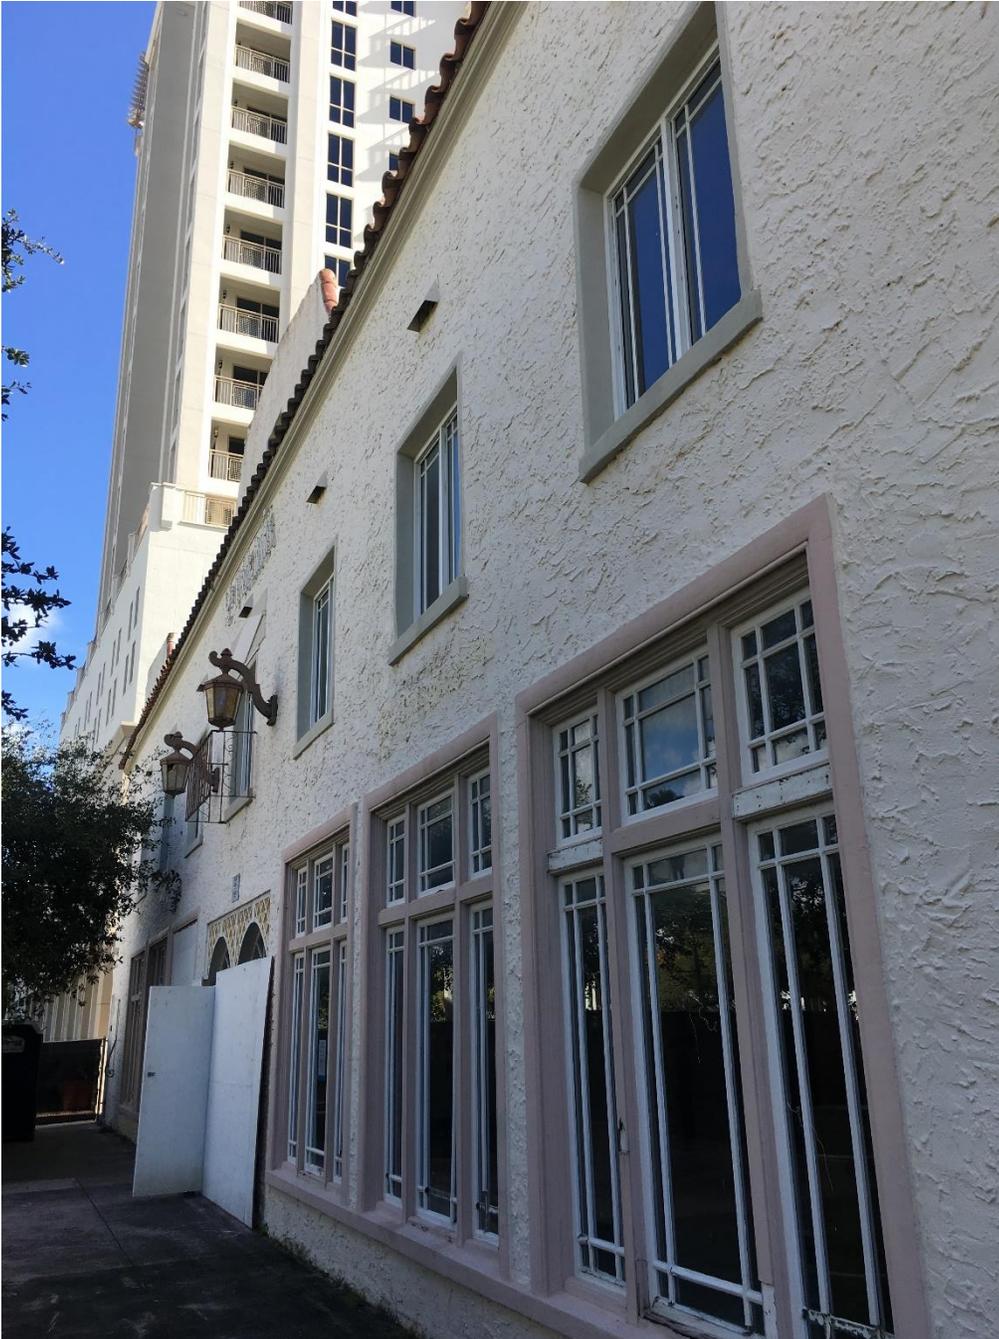
**PHOTO 5.**

According to City of Coral Gables permit records, the windows were replaced in 1969 with aluminum awning windows.

Another renovation in the 1980s reintroduced wood windows on the first floor and aluminum impact on the second.

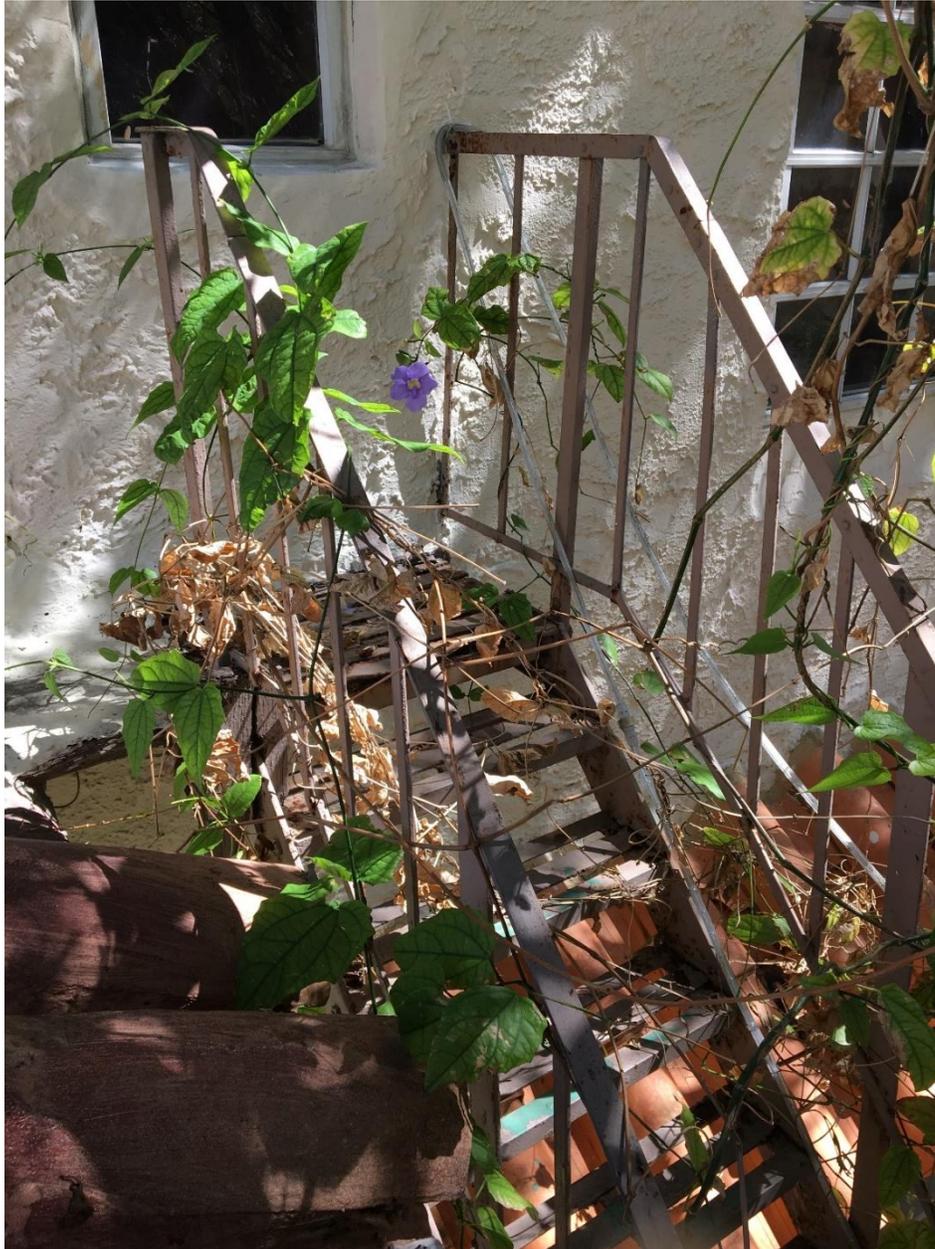
PHOTO 25.

A second exterior metal staircase that runs from the roof to the ground along the courtyard's north façade. The landing at the top was enclosed at some point, rendering this feature useless as an actual means of egress, but the staircase will be retained and partially restored (though will remain inoperable) since it is an original feature.

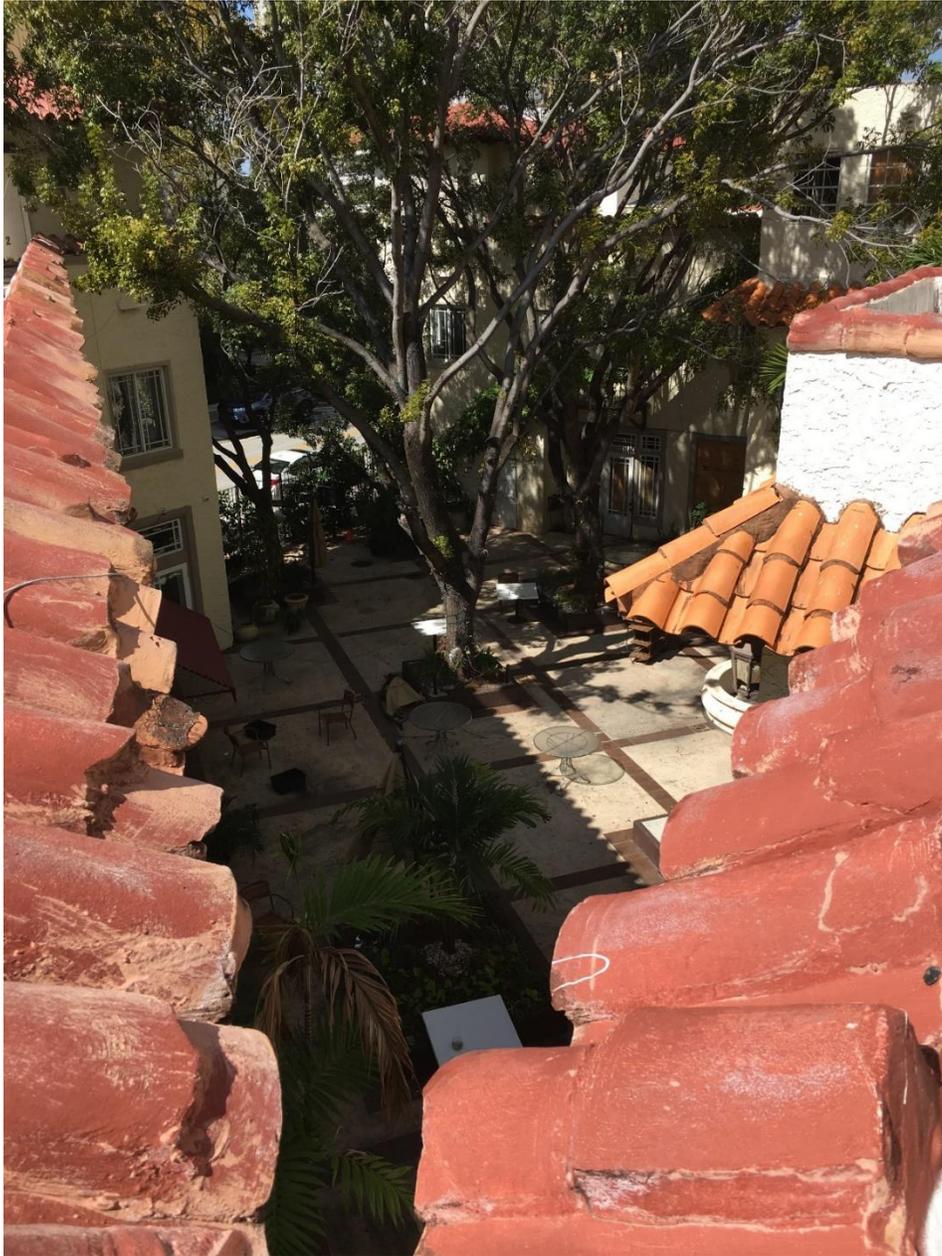
PHOTO 26.

Note the condition of barrel tiles, which will be retained when possible.

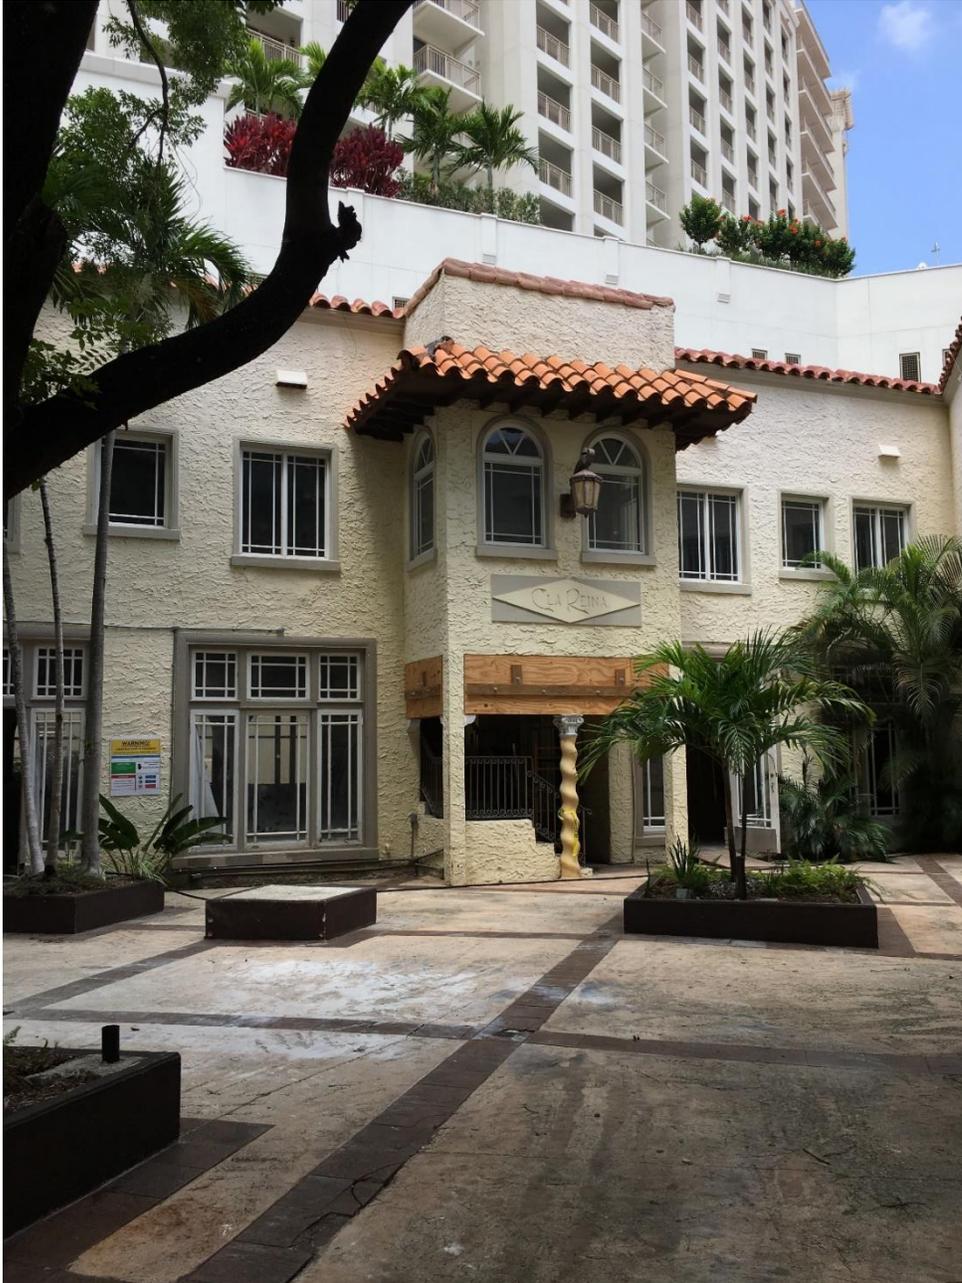
PHOTO 28.

The courtyard's east elevation, looking east.  
Note the original "Cla Reina" stucco-relief panel on the projecting bay.  
Plywood was used to cover original diamond-pattern reliefs surrounding the  
entrance arches to protect them from damage.

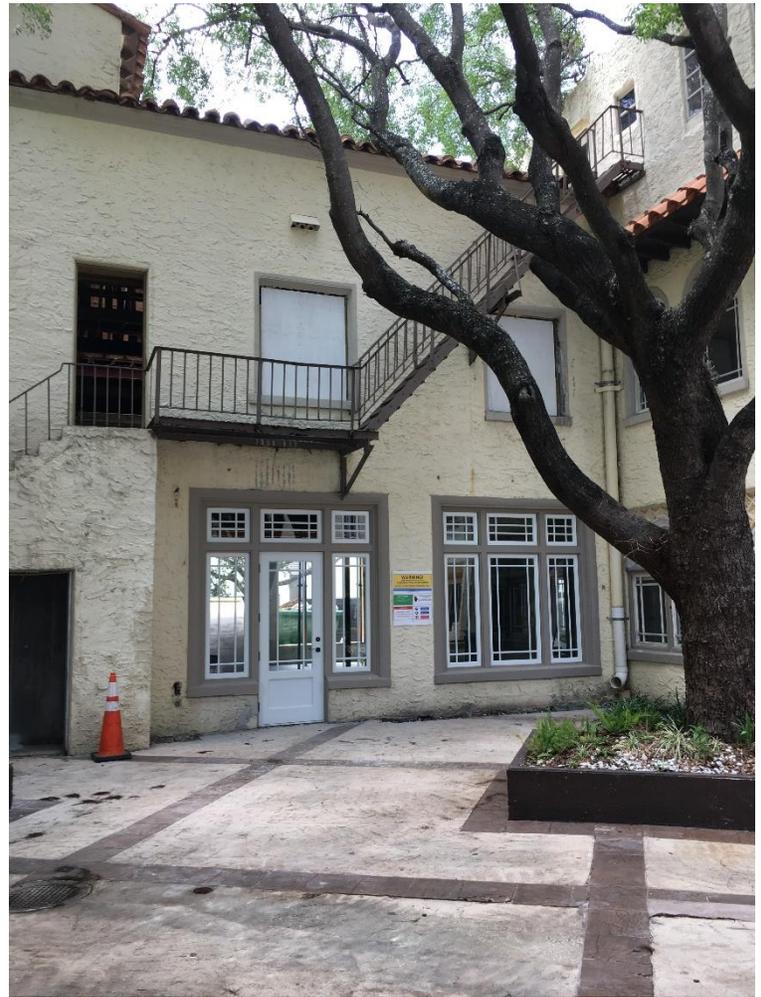
PHOTO 36.

Note the exterior metal staircase, which will be retained as an original feature but will remain inoperable.

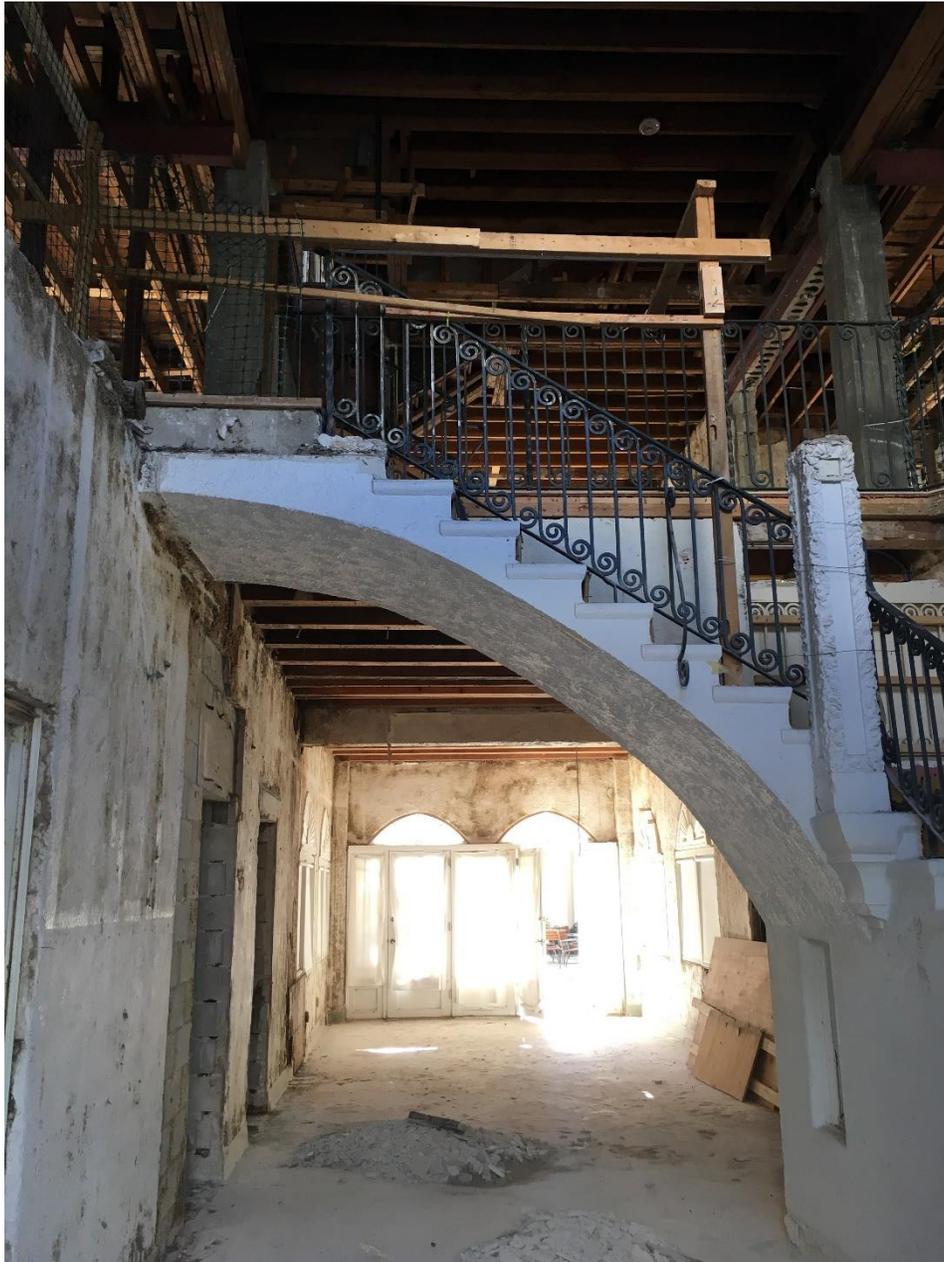
PHOTO 39.

The curved staircase is being retained. The code-compliant wrought iron railing was installed during the 1980s renovation.

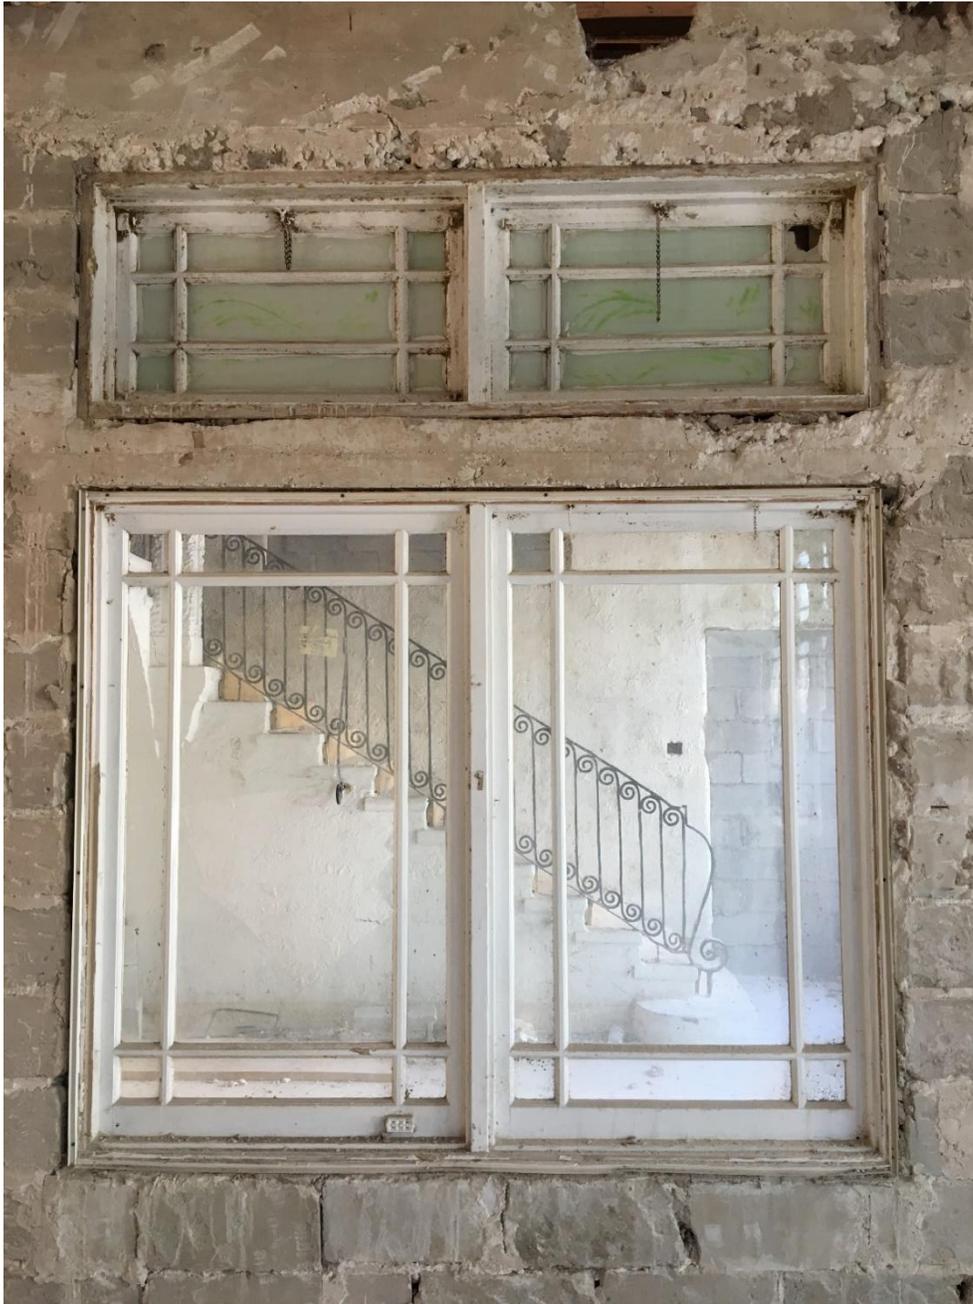
PHOTO 44.

The single pair of original windows with transom that remains in the building, that had been covered up with plywood. Taken from the northeast side of the building looking west into the original lobby space. These will be restored and retained in place.

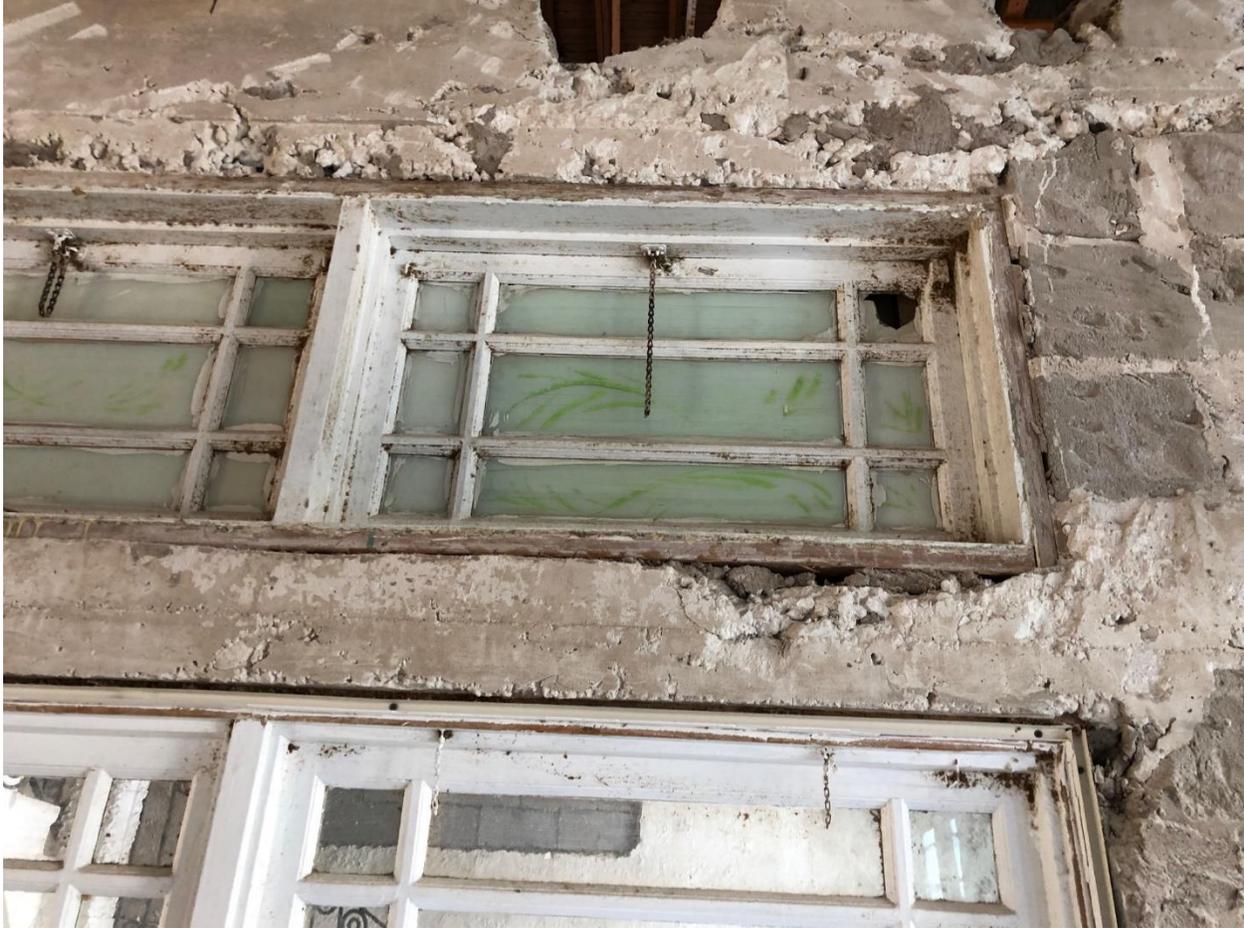
PHOTO 45.

Detail of the single pair of original windows (with transom) that remains in building, that had been covered up with plywood. Photo taken from the northeast side of the building looking west into the original lobby space. These will be restored and retained in place.

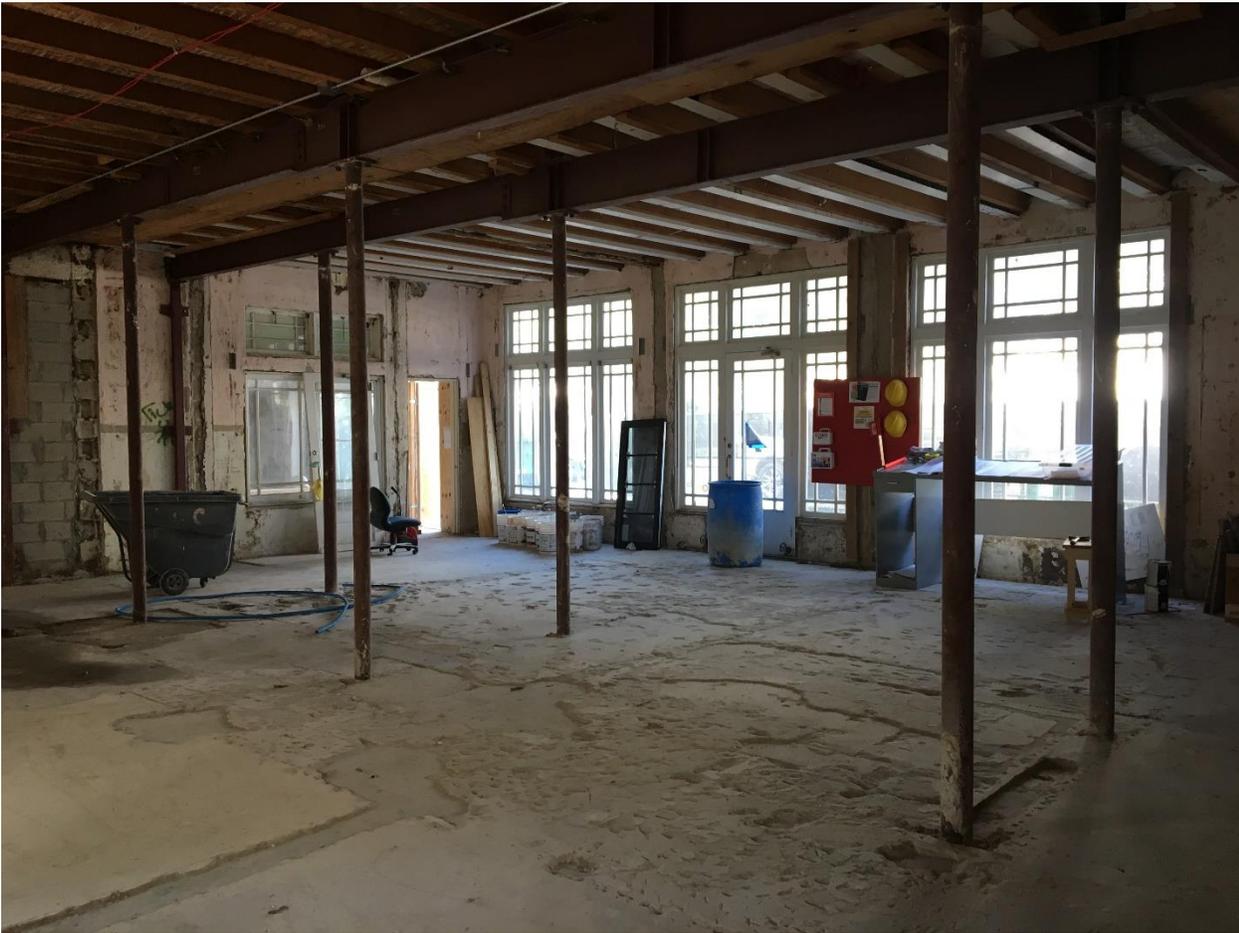
PHOTO 46.

The majority of the 1<sup>st</sup> and 2<sup>nd</sup> floor, with the exception of the restaurant in the south wing, was completely gutted before 2017, during previous renovation attempts.

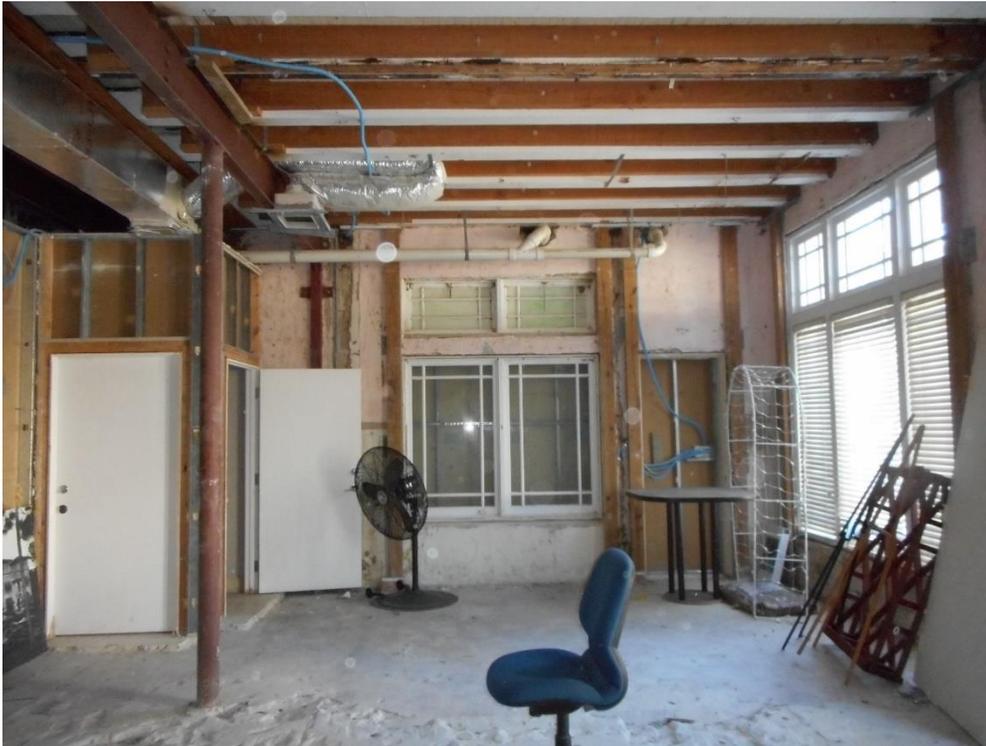
PHOTO 55.

DATE: December 2017.  
Most all of the interior of the structure on the first and second floor had been gutted in a previous renovation attempt.

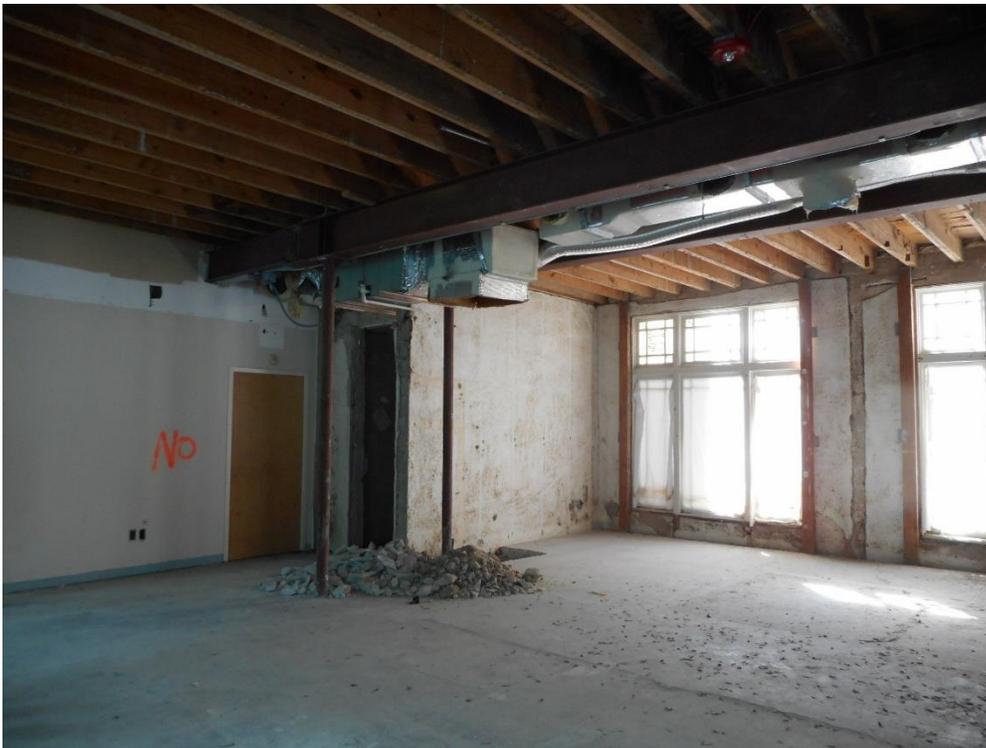
PHOTO 56.

DATE: December 2017.  
Most all of the interior of the structure on the first and second floor had been gutted in a previous renovation attempt.

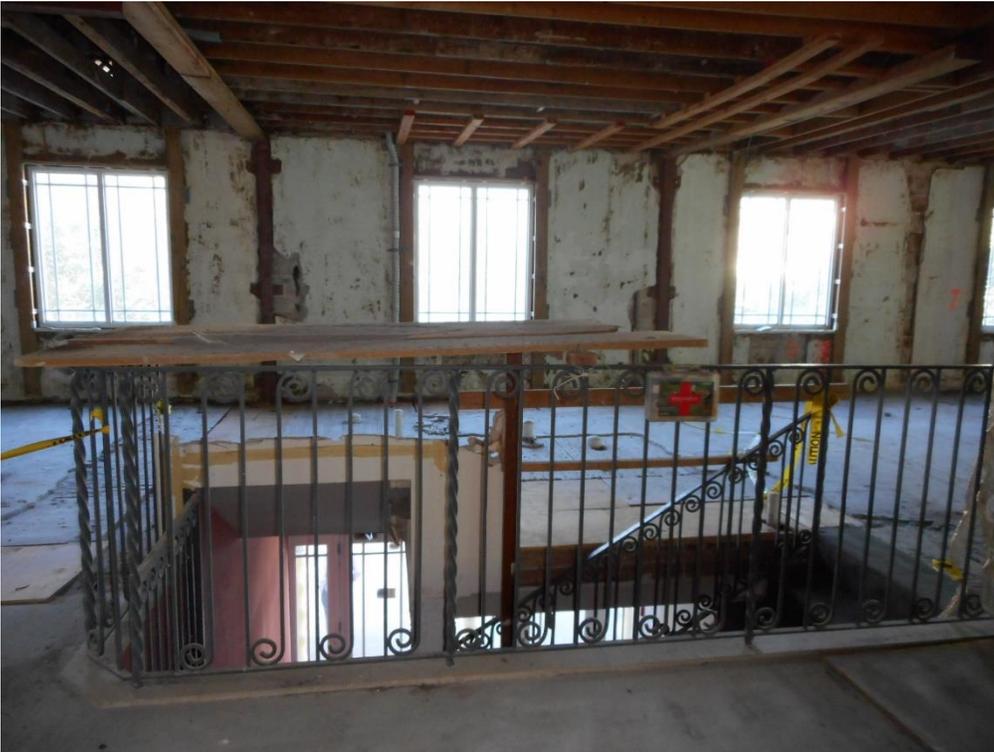
PHOTO 57.

Most of the interior of the structure on the first and second floor had been gutted in a previous renovation attempt.
