# STAFF REPORT SPECIAL CERTIFICATE OF APPROPRIATENESS FOR THE PROPERTY AT 415 ARAGON AVENUE A LOCAL HISTORIC LANDMARK

The application requests design approval to correct work

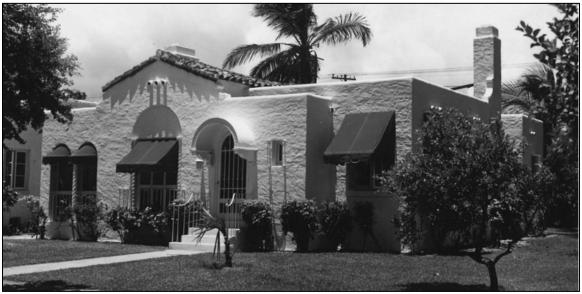
Figure 1: ca. 1940s photo

The application proposes replication of the hood feature seen in the 1940s photo and in the original drawings (see Figure 1 and original drawings attached to the Local Historic Designation Report). No construction details/sections were provided for this element. Note that the original drawings call the element out as a "wood hood" with "copper roof," although in the 1940s photo it appears to be stucco or plaster.

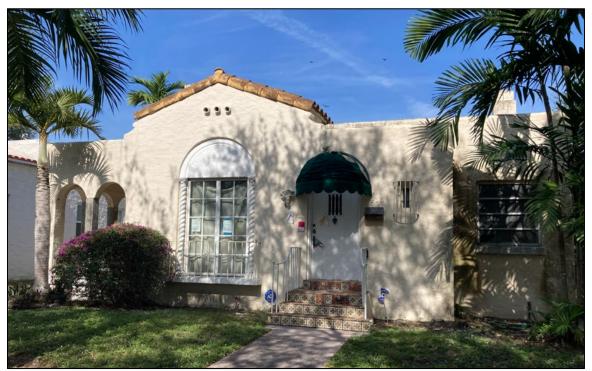
Figure 3: Current Photo, December 2023

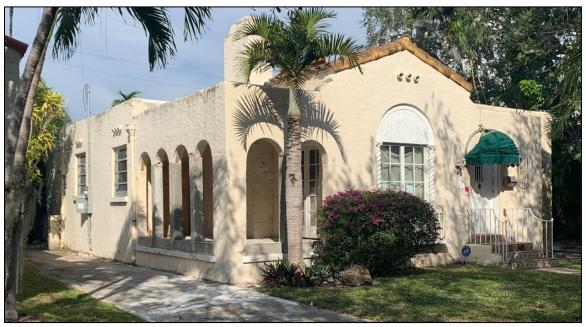
Figure 4: Current Photo, December 2023

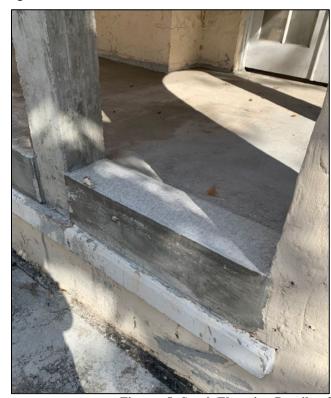
The other original ironwork on this façade is called out to be repaired. New impact-resistant windows and doors are proposed with a pair of fixed French doors at the balconette and a pair of casements to the east. The muntin patterns match those found on the original permit drawings. No notation was made for the low relief arched panel atop the French doors. It is to remain and not be disturbed during the installation of the French doors (see Figures 5).

Figures 5: South Elevation Details - Current Photos, December 2023

- 6. French doors to have higher bottom rails/kickplates.
- 7. Roof tile is to be true, two-piece barrel tile.
- 8. The low relief arched panel atop the French doors at the south façade is to remain and not be disturbed during the installation of new doors. The columns flanking the opening are to remain as well.

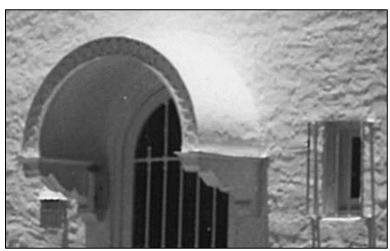
At the south end of the existing residence, the proposed copper-clad door hood is visible at the front door. It is noted to project 3'-0" from the south façade. Note that, as drawn, it does not match the original design intent (see Figures 6). The carport with two arched openings obscures a portion of the existing residence. To the north is the flat-roofed master bedroom addition. The addition façade is largely blank except for a pair of casement windows (no protruding sill, typical on the additions). Beyond, the detached garage is visible with the roofed connection to the back terrace of the residence. At the garage – to be converted to living space – a window is proposed to be relocated and a door opening removed.

Figures 6: Hood Detail – 1940s photo [left] and Permit #286 [right]

- 13. Provide construction details and sections of the front door hood. Work with Staff to ensure it is a replication. If this cannot be achieved, the element should be eliminated rather than adding a conjectural feature.
- 14. Reduce the parapet height of the master bedroom addition to be lowered to be more in keeping with the parapet height on the north façade of the home and eliminate the corner pieces at the south façade.
- 15. Stucco texture of the new addition should be differentiated from the existing residence. A score line is to be added to demarcate the location of new construction.
- 16. Recess of original garage door opening to remain.
- 17. If the floor elevation of the detached garage is too low for living space, staff does not support the raising of the roof/parapet to achieve a raised floor.

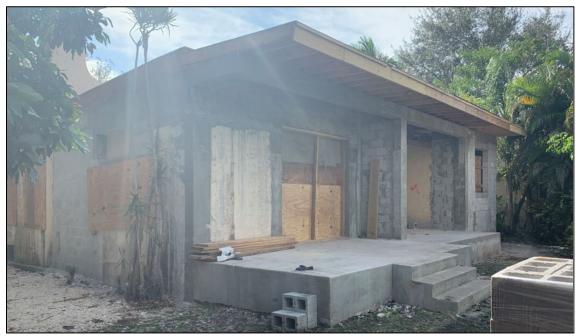
The rear elevation has been completely demolished by the unpermitted work except for a sliver of the south wall of the small bumpout added to the northeast corner of the home in the 1940s (see Figure 7). For all intents and purposes, this elevation is entirely new. The master bedroom features a small bathroom bumpout under a tiled gable roof at the easternmost end of this façade. An arch-topped window is centered under the gable. This window type is repeated again on this elevation. Two large pairs of casement windows provide light into the master bedroom. To the west a shed-roofed covered terrace spans almost the entire length of the remainder of the façade. A series of wood wrapped steel columns support the shed roof. Single and double French doors with sidelites provide access to the terrace.

Figure 7: North (Rear) Elevation - Current Photo, December 2023

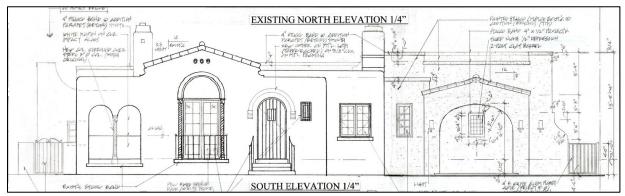
Figure 9: BOA approved proposal with gable roofed carport

The additions are limited to one-story, but should be better incorporated into the residence. The applicant may consider recessing the connector piece beyond the corner condition (Figure 8) or lowering the height. The carport details can be simplified so they do not compete or replicate the details of the original home. Staff suggests that the carport be open on three sides and not engaged with the master bedroom suite.
