COA (SP) 2017-006
June 15, 2017

✉ hist@coralgables.com

**STAFF REPORT
SPECIAL CERTIFICATE OF APPROPRIATENESS
FOR THE PROPERTY AT
711 UNIVERSITY DRIVE
A LOCAL HISTORIC LANDMARK**

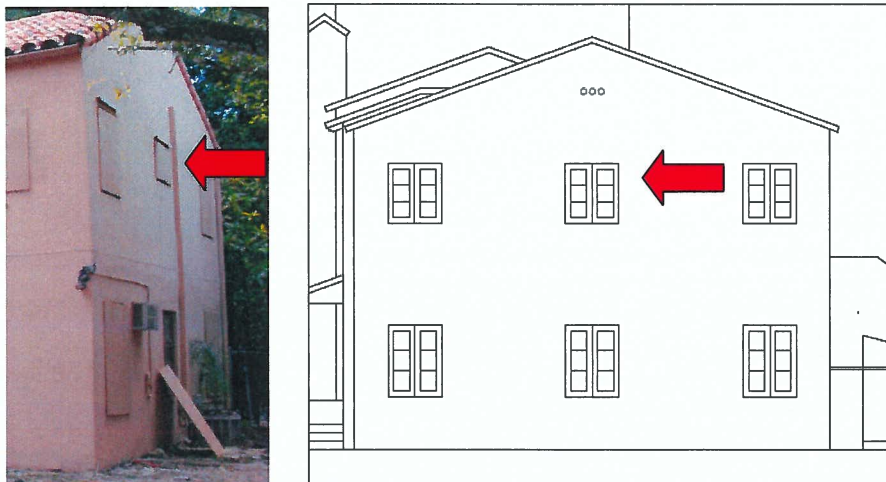
Figures 4: North elevation windows – 2016 photograph [left]; existing elevation [right]

Sheet A3.2 On the north elevation, the windows are to be replaced with the exception of the middle first floor window which will be enlarged and converted into a pair of French doors. Note that the middle second floor window is not depicted correctly on the existing elevation drawings and is smaller than the two flanking windows (see Figures 4). The proposed trellis spans two-thirds of this elevation over three round concrete columns. The one-story addition on the west elevation is visible behind a new 5'-0" wall with an iron picket gate. On the east side of this elevation, the new gate (similar the west side, but smaller) proposed for the perimeter wall is visible beyond.

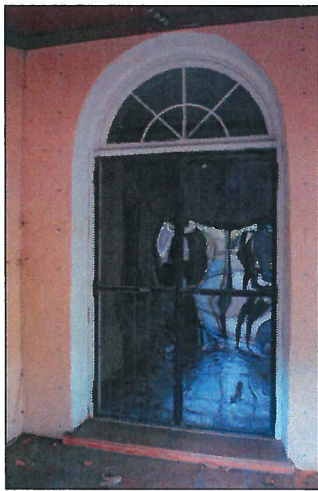
Figures 5: Southwest elevation – existing condition (leading into living room) [left]; Original drawings showing elongated windows [right]

Sheet A3.6 The media room addition is visible at the south end of the southwest façade. A pair of French doors with an arched transom above lines up with the same door configuration that exists on the current southwest façade now within the addition (see Figure 5). To the north, the existing windows will be replaced and the two northernmost windows will be elongated to match the other longer windows on this façade. It appears from the existing sills that these windows were shortened from the original size at some point. The proposed alteration returns the windows to their correct size.

- The muntins of the new arched transom on the southwest elevation of the media room addition should match the original configuration found within (see Figures 5).
