COA (SP) 2017-006  
June 15, 2017

Historical Resources &  
Cultural Arts

**STAFF REPORT  
SPECIAL CERTIFICATE OF APPROPRIATENESS  
FOR THE PROPERTY AT  
711 UNIVERSITY DRIVE  
A LOCAL HISTORIC LANDMARK**

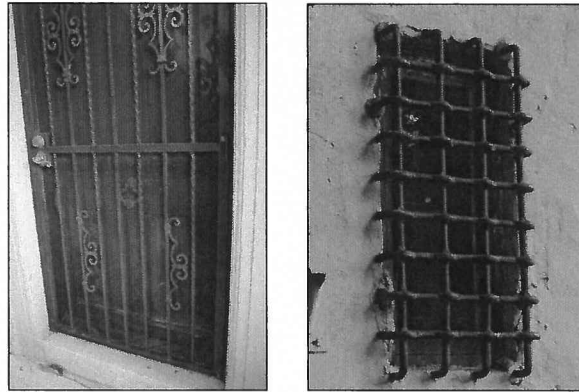
**Figures 1: Main Entry, 2017 - Original door behind security door [left]  
Existing casement window behind iron grille [right]**

The existing screen door is a non-original iron and screen security door, not hurricane protection (see Figures 1 left). The two original wrought iron picket railings for the balconettes are proposed to be removed. The existing iron grilles found on this façade are to remain. Two windows – one on the second floor window within the tower and one behind the iron grille on the first floor will be replaced with fixed windows. The existing tower window is believed to be a stained glass window although it is drawn without muntins. The first floor window is not depicted, but should have a single horizontal muntin to match what the existing window (see Figures 1 right).

- The two iron railings at the balconettes on the south elevation (facing University Drive) should remain and be restored.
- The stained glass window in the tower is to remain and can be mounted behind a fixed impact-resistant unit.

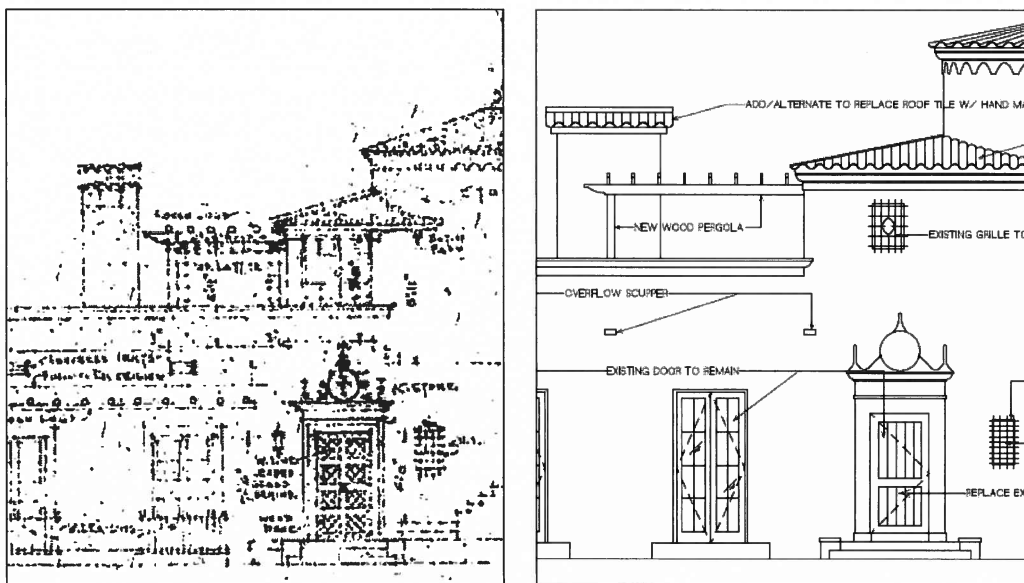
**Figures 2: South Elevation - Original drawing showing pergola [left]  
Proposed pergola [right]**

At the second floor roof terrace, a new wooden pergola is proposed to evoke the pergola shown in the original permit drawings (see Figures 2). The pergola is not visible in the earliest photograph located for the property (1940s), and it is not known if it was constructed and removed or eliminated during construction. Additional overflow scuppers are also proposed for the existing roof terrace.

- The new wood pergola at the second floor terrace should be shortened in length to achieve a proportion more consistent with the original permit drawings (see Figures 2).

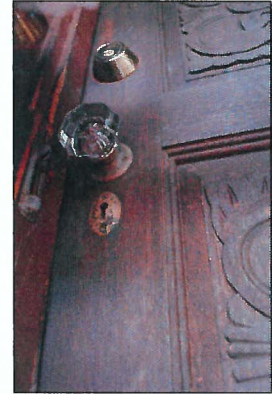
**Sheet A3.1** At the east façade facing Palmarito Street, the existing doors and windows will be replaced with impact-resistant units that match the existing original windows. The existing side door is proposed to be removed. Note that the side door in the existing elevation does not depict what is actually on site. The existing door is obscured behind steel and screen security door and Staff is not able to verify if it is original to the residence at this time. The existing awnings is to be removed and a new wood canopy clad with two-piece barrel tile is proposed to provide protection for the door. Details were not provided for the canopy. The existing steps are to be replaced, but the material for the new steps was not provided. To the north, the existing garage doors (not original) will be replaced with new roll-up garage doors that are intended to give the appearance of carriage doors.

**Figure 3: Existing Side Door**

- All overflow scuppers are to be copper per the BOA recommendation.
- If Staff determines that the side door facing Palmarito Street is original, it is to remain.

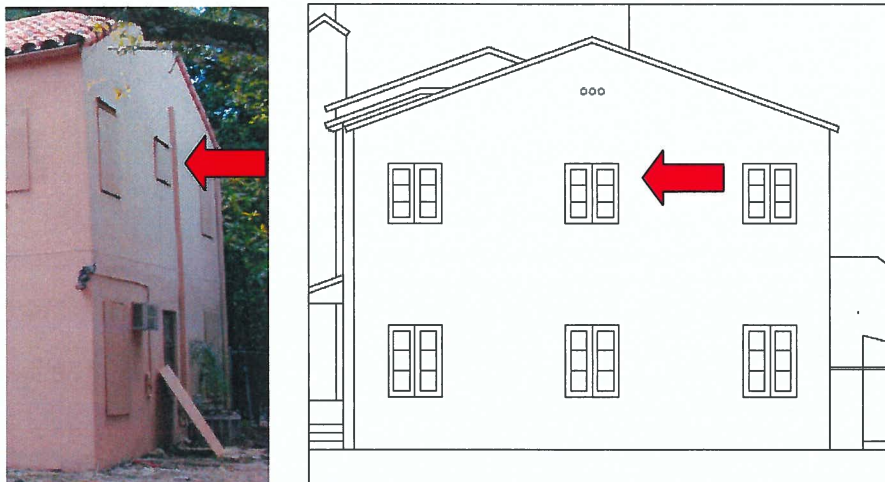
**Figures 4: North elevation windows – 2016 photograph [left]; existing elevation [right]**

**Sheet A3.2** On the north elevation, the windows are to be replaced with the exception of the middle first floor window which will be enlarged and converted into a pair of French doors. Note that the middle second floor window is not depicted correctly on the existing elevation drawings and is smaller than the two flanking windows (see Figures 4). The proposed trellis spans two-thirds of this elevation over three round concrete columns. The one-story addition on the west elevation is visible behind a new 5'-0" wall with an iron picket gate. On the east side of this elevation, the new gate (similar the west side, but smaller) proposed for the perimeter wall is visible beyond.

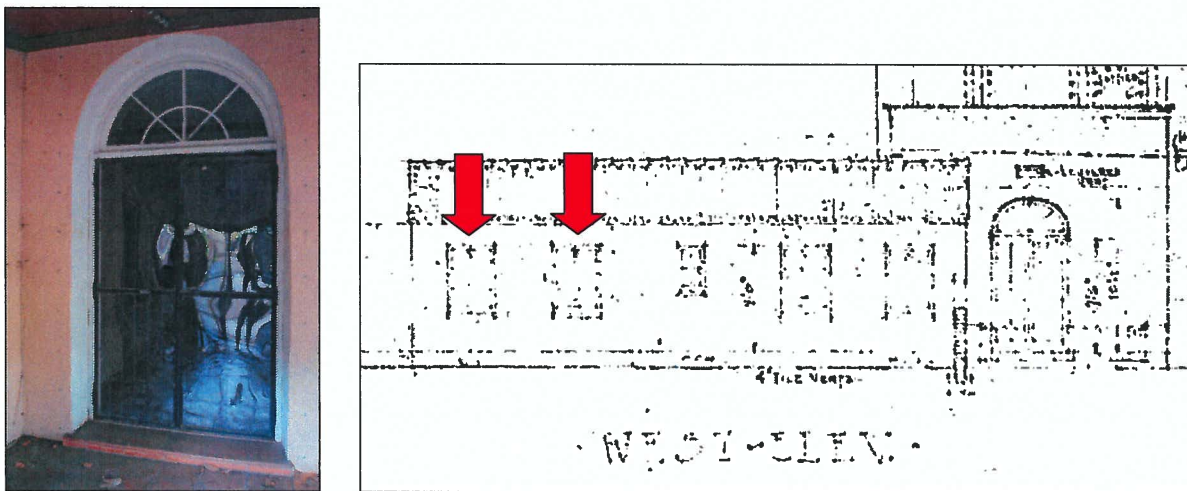
**Figures 5: Southwest elevation – existing condition (leading into living room) [left]; Original drawings showing elongated windows [right]**

**Sheet A3.6** The media room addition is visible at the south end of the southwest façade. A pair of French doors with an arched transom above lines up with the same door configuration that exists on the current southwest façade now within the addition (see Figure 5). To the north, the existing windows will be replaced and the two northernmost windows will be elongated to match the other longer windows on this façade. It appears from the existing sills that these windows were shortened from the original size at some point. The proposed alteration returns the windows to their correct size.

- The muntins of the new arched transom on the southwest elevation of the media room addition should match the original configuration found within (see Figures 5).

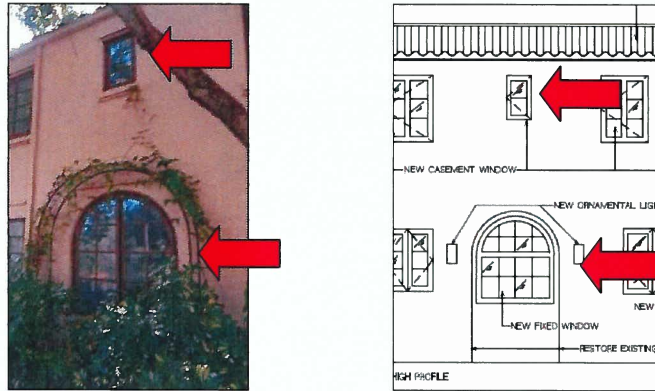
- Because the existing window openings of the residence are boarded up, Staff cannot verify that each of the windows shown on the existing and proposed elevations is correct. Discrepancies were noted between the listing photographs and the drawings (see Figure 6 for example). The existing window openings are to remain unchanged throughout (unless noted) and Staff wants the opportunity to verify that the existing windows are being matched.

**Figure 6: East elevation windows – listing photograph [left]; proposed elevation [right]**

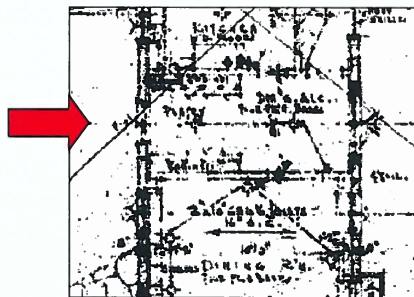
**Figure 7: Location of existing door to remain in place;  
note the horizontal line indicating alignment of door and window**

- On Sheet A3.3, the existing casement windows into the kitchen are to remain in the current location and not shifted to align with a window on the second floor and the

existing door location into the proposed kitchen is to remain as it is intended to align with the arched window on the east façade.
