**STAFF REPORT
SPECIAL CERTIFICATE OF APPROPRIATENESS
FOR THE PROPERTY AT
415 ARAGON AVENUE
A LOCAL HISTORIC LANDMARK**

*Historical Resources &
Cultural Arts*

Proposal: The application requests design approval to correct work without a permit with additions and alterations to the residence and detached garage, and sitework.

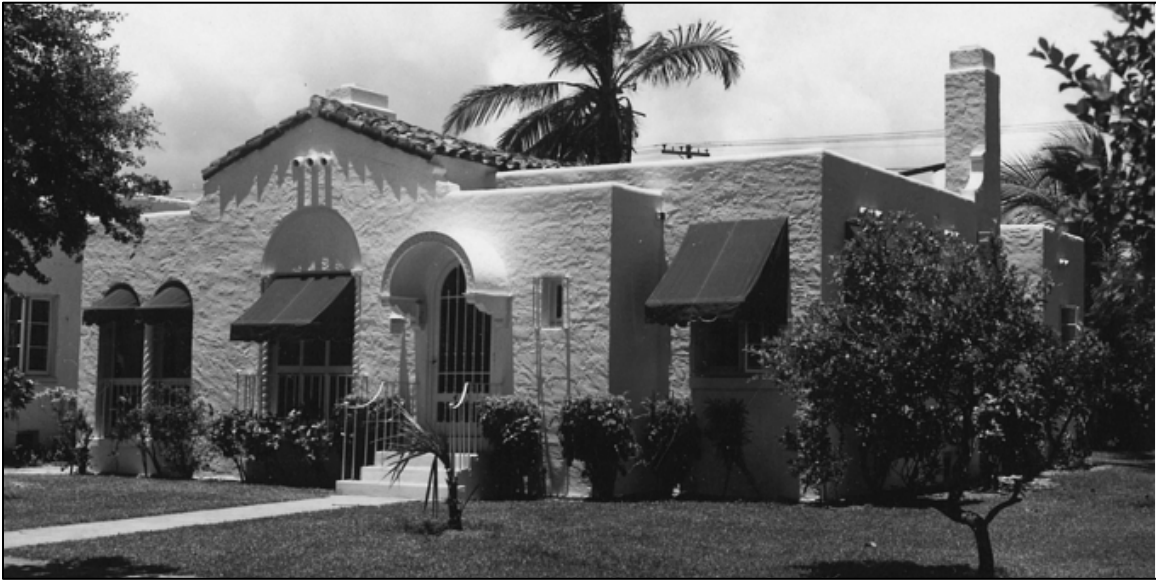
Figure 1: ca. 1940s photo

The application proposes replication of the hood feature seen in the 1940s photo and in the original drawings (see Figure 1 and original drawings attached to the Local Historic Designation Report). No construction details/sections were provided for this element. Note that the original drawings call the element out as a “wood hood” with “copper roof,” although in the 1940s photo it appears to be stucco or plaster.

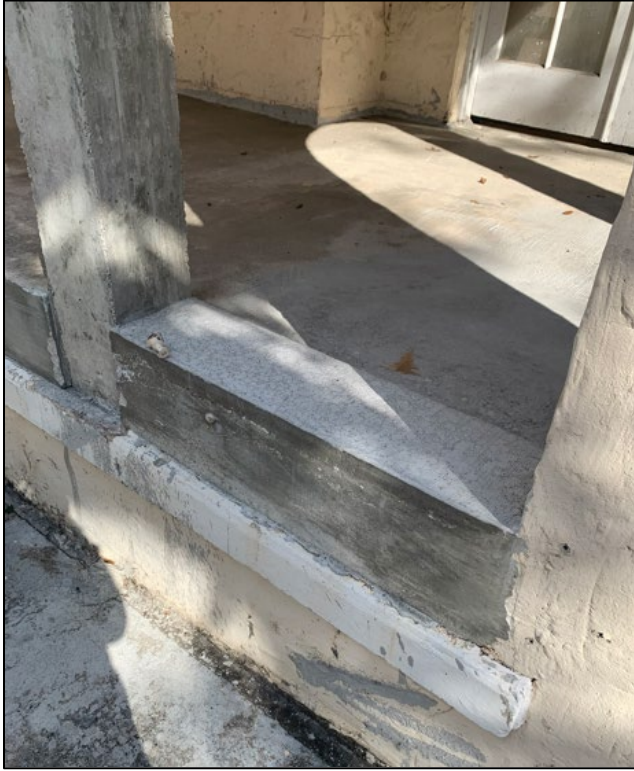
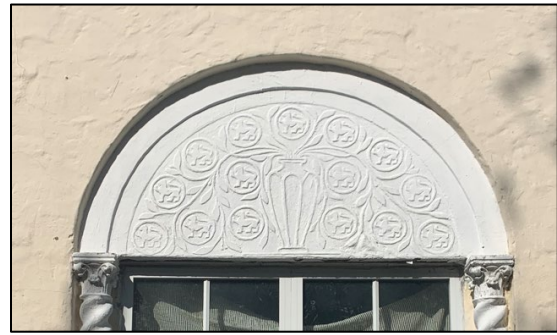
Figures 5: South Elevation Details - Current Photos, December 2023

The other original ironwork on this façade is called out to be repaired. New impact-resistant windows and doors are proposed with a pair of fixed French doors at the balconette and a pair of casements to the east. The muntin patterns match those found on the original permit drawings. No notation was made for the low relief arched panel atop the French doors. It is to remain and not be disturbed during the installation of the French doors (see Figures 5).

6. French doors to have higher bottom rails/kickplates.
7. Roof tile is to be true, two-piece barrel tile.
8. The low relief arched panel atop the French doors at the south façade is to remain and not be disturbed during the installation of new doors. The columns flanking the opening are to remain as well.

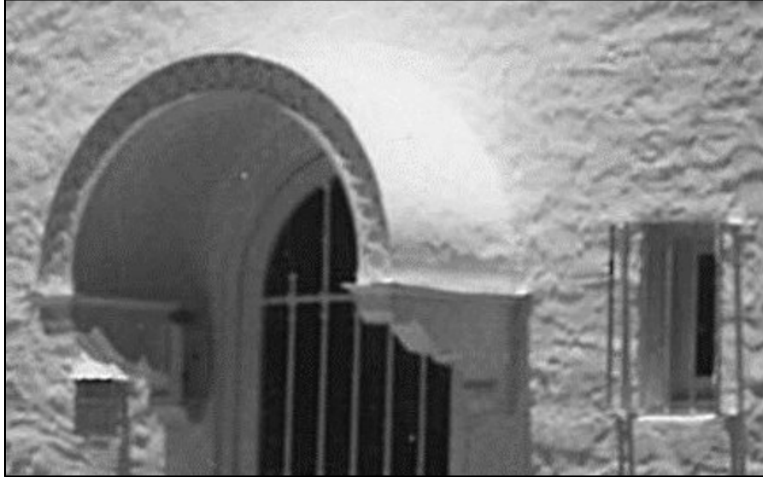
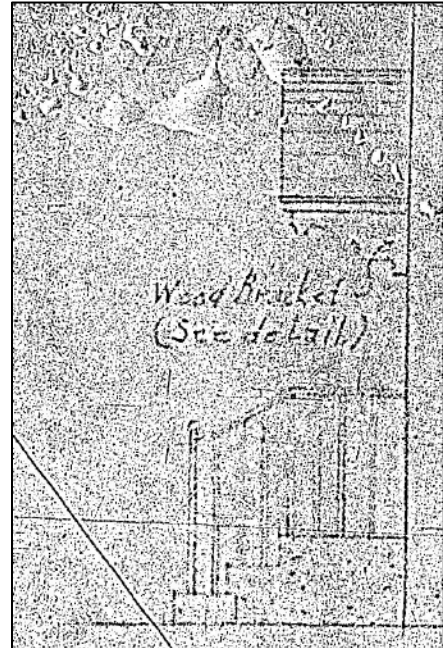
Figures 6: Hood Detail – 1940s photo [left] and Permit #286 [right]

At the south end of the existing residence, the proposed copper-clad door hood is visible at the front door. It is noted to project 3’-0” from the south façade. Note that, as drawn, it does not match the original design intent (see Figures 6). The carport with two arched openings obscures a portion of the existing residence. To the north is the flat-roofed master bedroom addition. The addition façade is largely blank except for a pair of casement windows (no protruding sill, typical on the additions). Beyond, the detached garage is visible with the roofed connection to the back terrace of the residence. At the garage – to be converted to living space – a window is proposed to be relocated and a door opening removed.

12. Provide details of all repair/restoration work to be done on the original features of the residence.
13. Provide construction details and sections of the front door hood. Work with Staff to ensure it is a replication. If this cannot be achieved, the element should be eliminated rather than adding a conjectural feature.

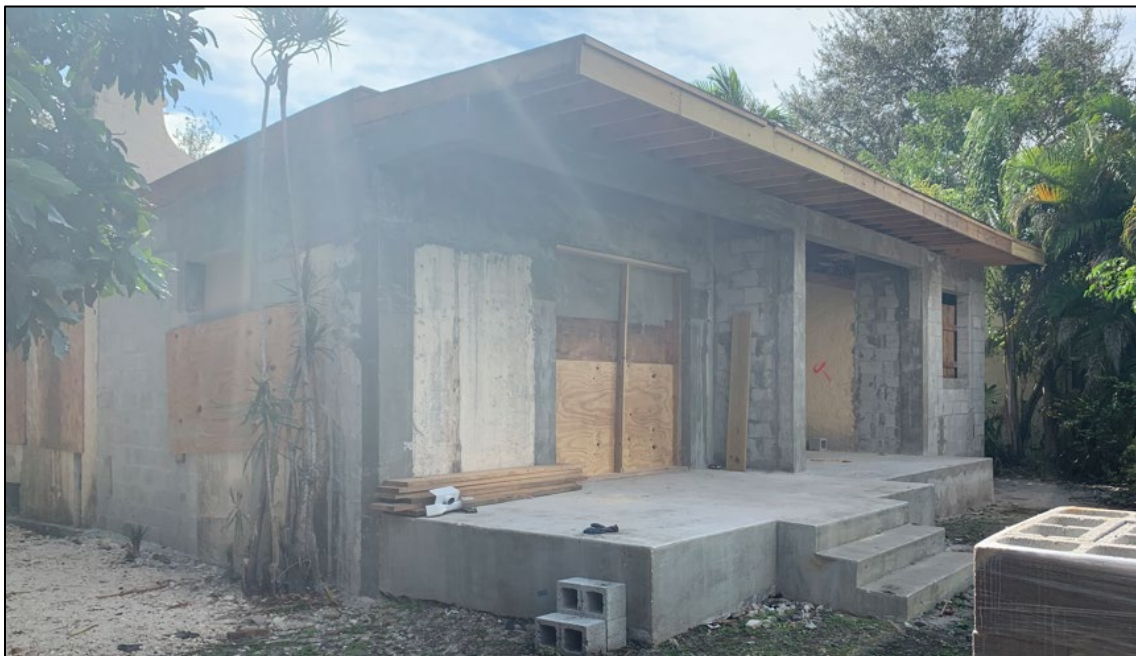
Figure 7: North (Rear) Elevation - Current Photo, December 2023

The rear elevation has been completely demolished by the unpermitted work save for a sliver of the south wall of the small bumpout added to the northeast corner of the home in the 1940s (see Figure 7). For all intents and purposes, this elevation is entirely new. The master bedroom features a small bathroom bumpout under a tiled gable roof at the easternmost end of this façade. An arch-topped window is centered under the gable. This window type is repeated again on this elevation. Two large pairs of casement windows provide light into the master bedroom. To the west a shed-roofed covered terrace spans almost the entire length of the remainder of the façade. A series of wood wrapped steel columns support the shed roof. Single and double French doors with sidelites provide access to the terrace.

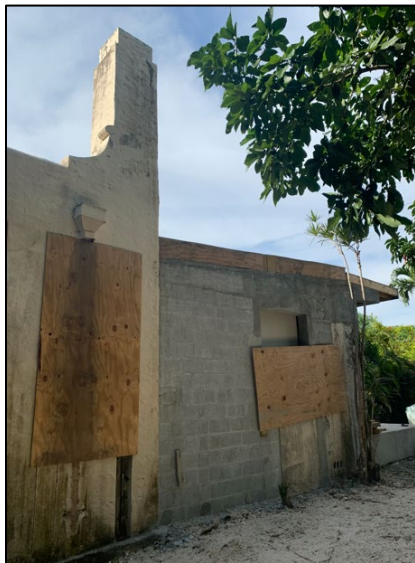
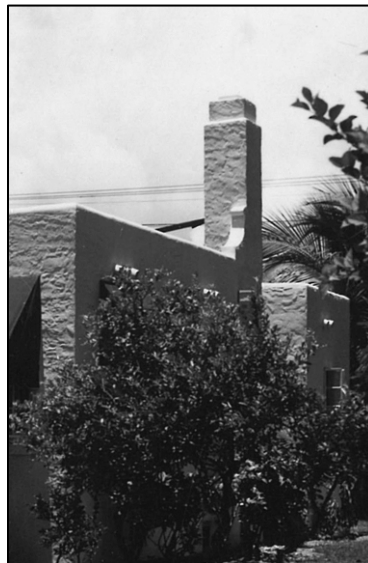
Figures 8: Corner Detail – Current Photo, December 2023 [left] and 1940s photo [right]

The additions are limited to one-story, but should be better incorporated into the residence. Staff recommends that the connector to the carport be pushed back beyond the original northeast corner of the residence in order to respect the highly decorative original corner detail that exists (see Figures 8). There appears to be plenty of room to shift the entire carport/master bedroom addition to the rear to accommodate this request. Some floor plan changes may be required, but this is an important and unique feature of this home.

1. Work with Staff on the relocation of the carport connector and the restudy of the carport details.
2. The front porch is to remain open/unenclosed. The concrete added atop the porch floor is to be removed (original sills to remain) and an iron railing to replicate the original is to be returned to the openings.

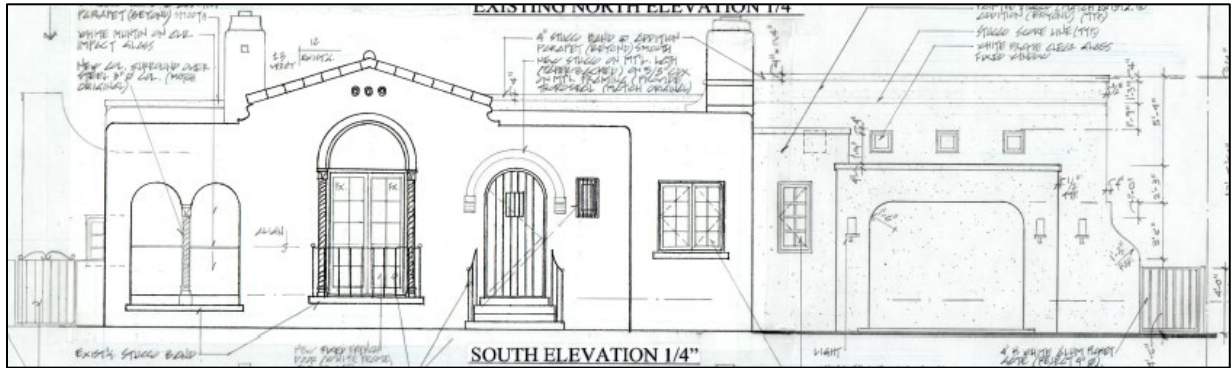
Figure 9: First BOA submittal with flat roofed carport

Similarly, the carport seems repetitive of the gable roof portion on the existing home. The arched opening competes with distinctive series of arches on the original home arches and perhaps should not be replicated at the carport. However, the original proposal included a flat roofed carport but was not accepted by the BOA (see Figure 9). Staff suggests that the carport be open on three sides and not engaged with the master bedroom suite.
