**Pre-Construction
Ad-Valorem Application Package for:
Historical Restoration, Addition, and Alteration to:**

Olivera Residence

641 San Lorenzo Avenue

Pre-Construction Ad-Valorem Application Package: Olivera Residence

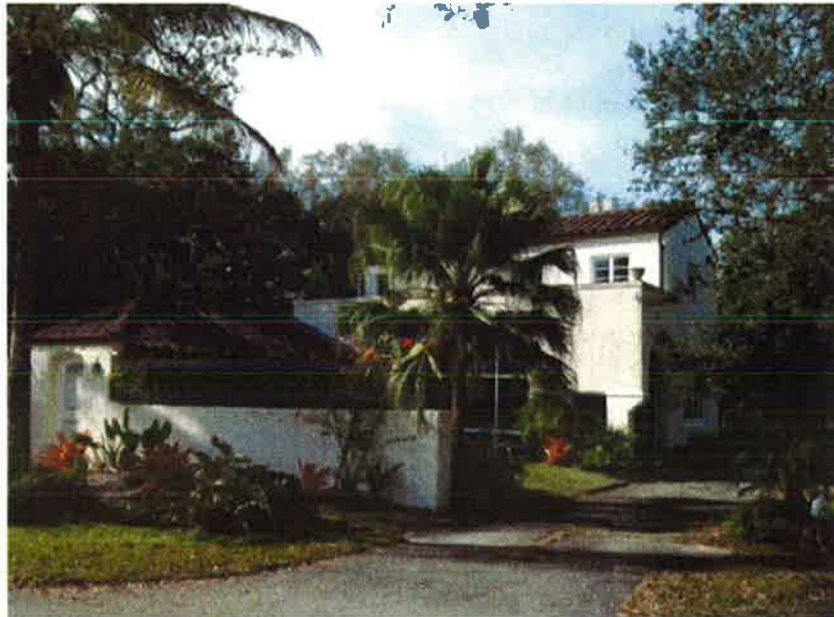
Photo Number: Image 2

Front Elevation

Describe Work and Impact on Existing Feature: New paint, new Landscape

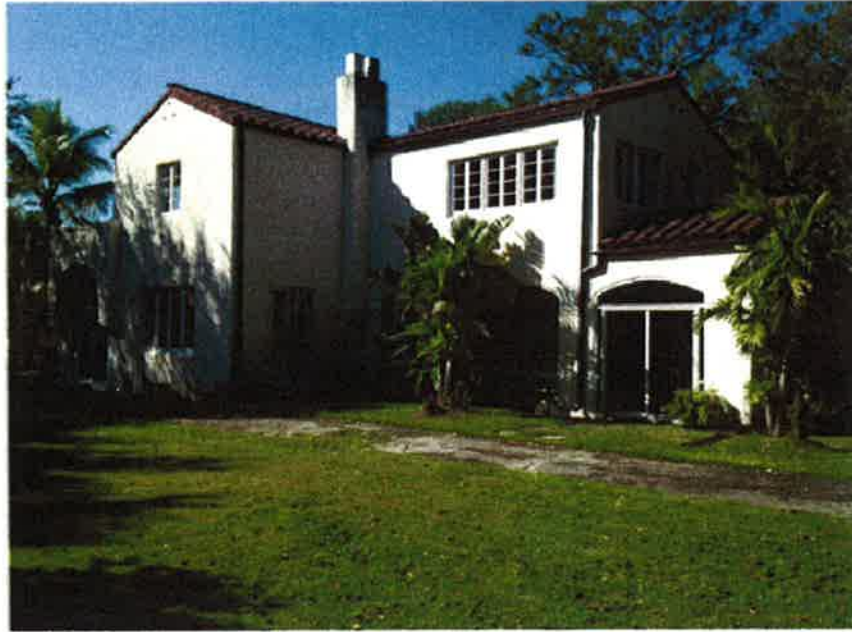
Overall East Side Elevation

Describe Work and Impact on Existing Feature: New paint, new impact windows, new roof, remove windows at terrace and restore as open-air, and additional landscaping (Existing Structure to Remain)

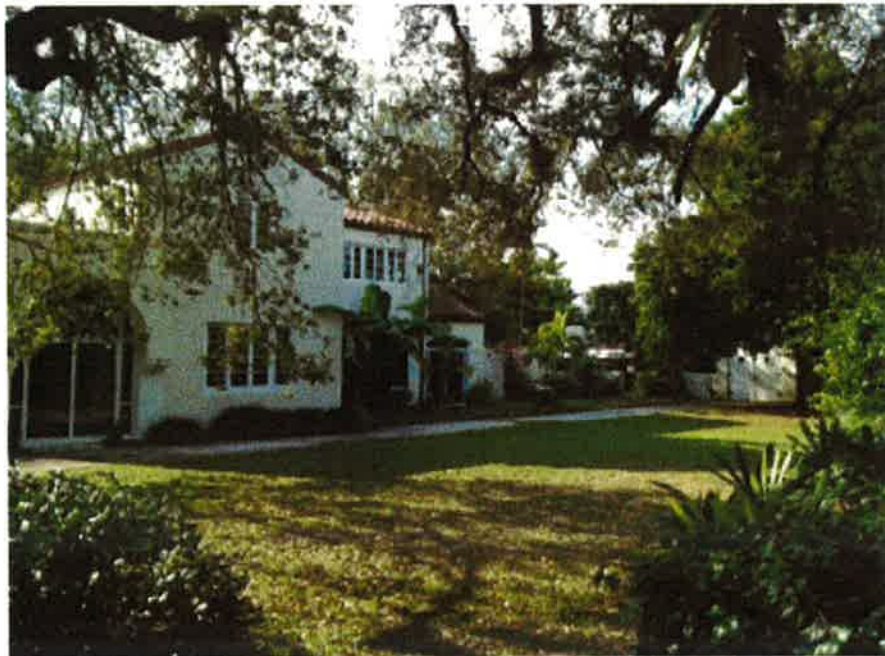
Photo Number: Image 4

Overall East Side Elevation

Describe Work and Impact on Existing Feature: New paint, new impact windows, new roof, and additional landscaping (Existing Structure to Remain)

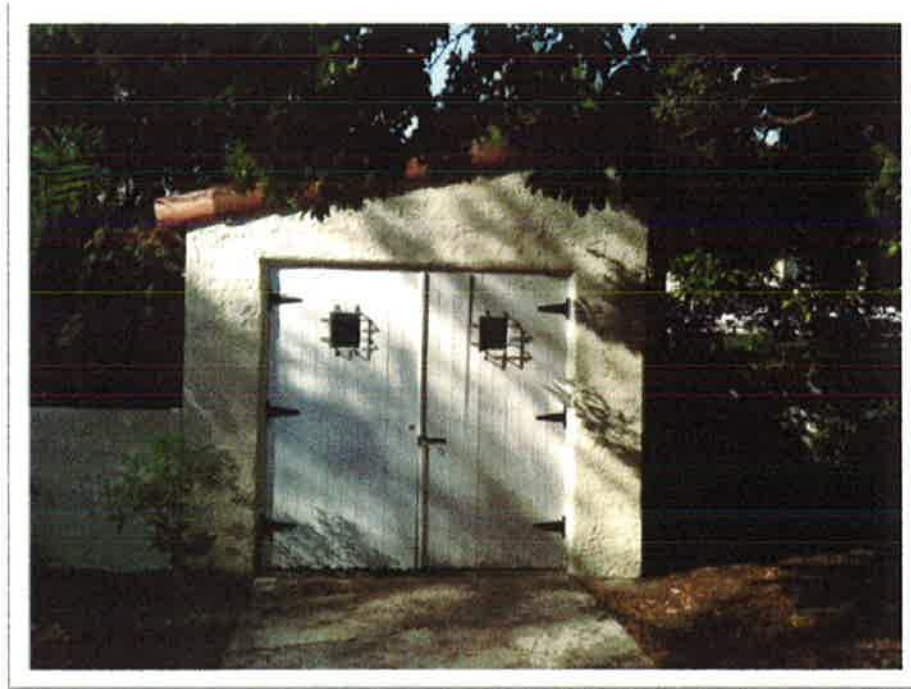
Garage

Describe Work and Impact on Existing Feature: Existing Garage to Remain, New Paint, New Roof, New Impact Windows, Existing Door & Hardware to Remain

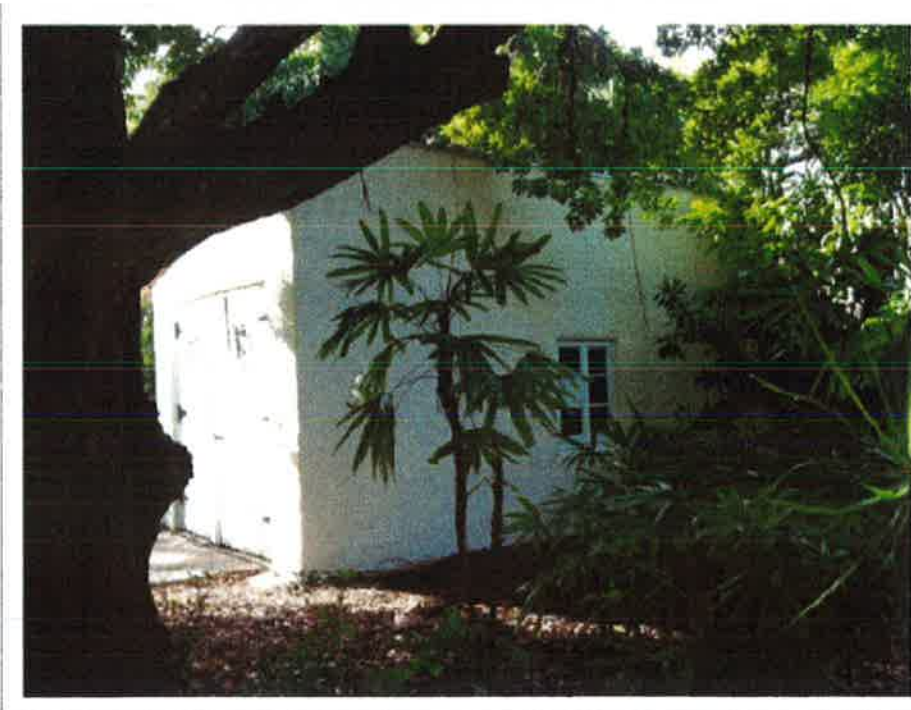
Photo Number: Image 6

Garage from East Side

Describe Work and Impact on Existing Feature: Existing Garage to Remain, New Paint, New Roof, New Impact Windows, Existing Door & Hardware to Remain

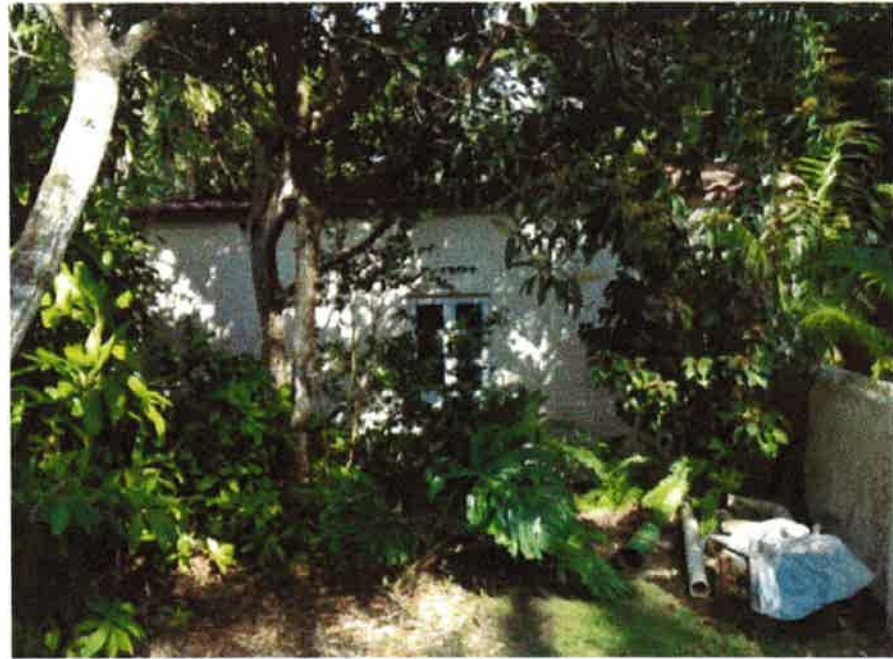
Garage View from Palmarito

Describe Work and Impact on Existing Feature: Existing Garage to Remain, New Paint, New Roof, New Impact Windows, Existing Door & Hardware to Remain

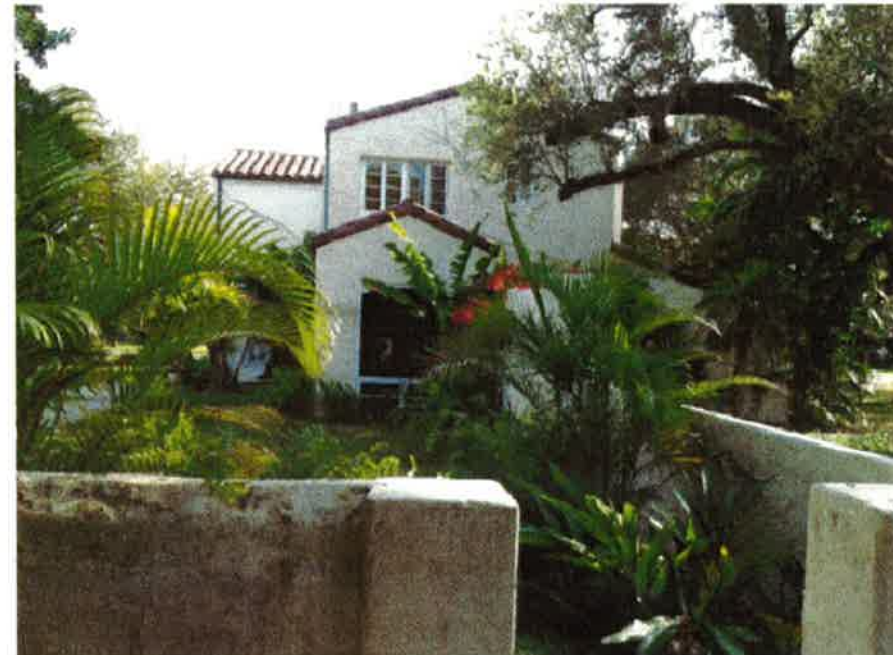
Photo Number: Image 8

View from Garage of Rear Elevation

Describe Work and Impact on Existing Feature: Garden low wall to be removed, New paint, new impact windows, new roof, remove windows at terrace and restore as open-air and additional landscaping (Existing Structure to Remain)

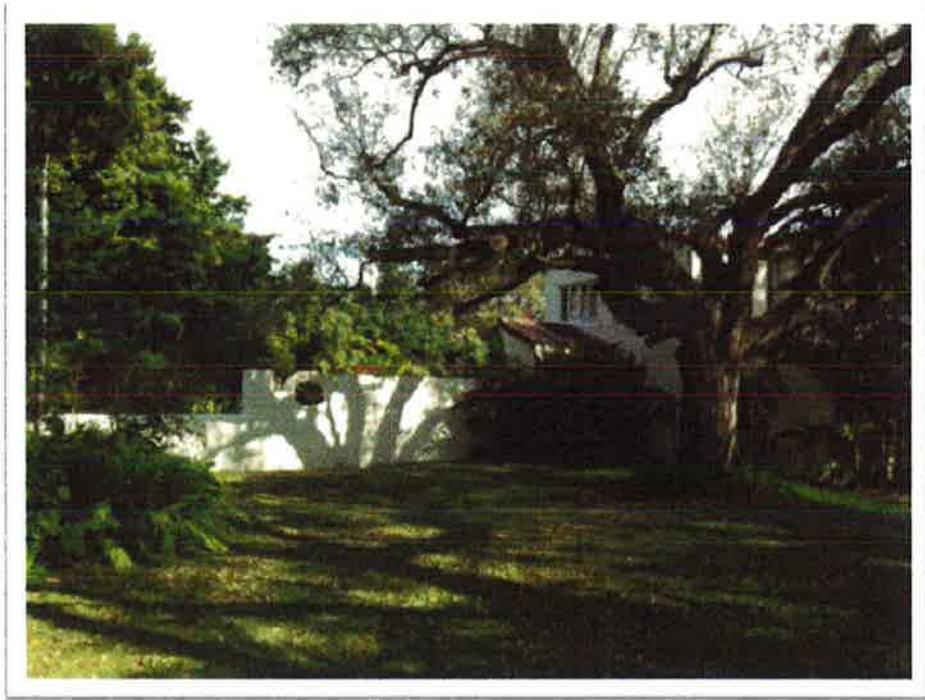
Rear Elevation View from Palmarito

Describe Work and Impact on Existing Feature: Garden low wall to be removed, New paint, new impact windows, new roof, and additional landscaping (Existing Structure to Remain)

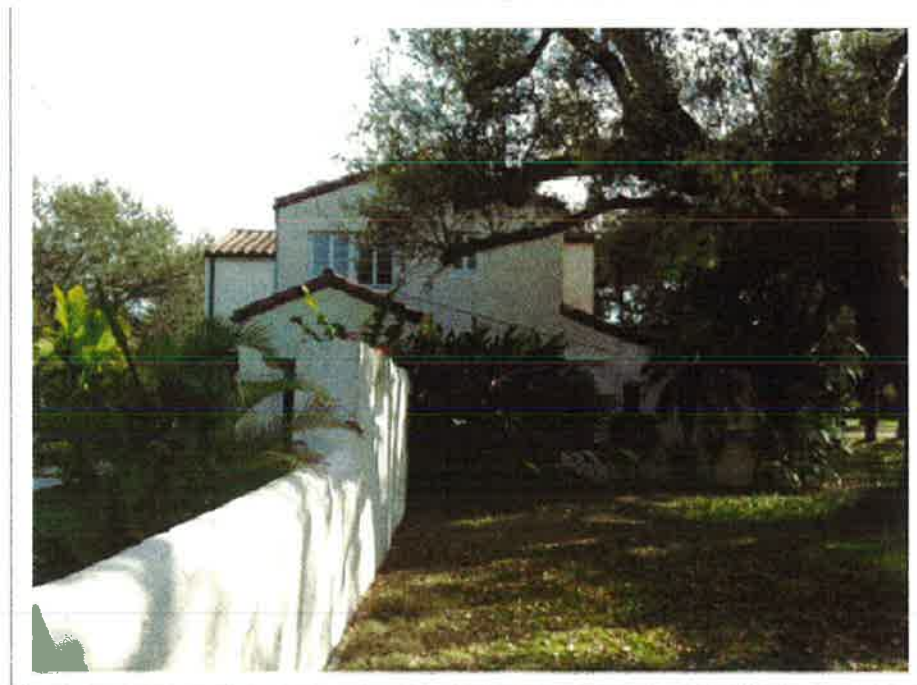
Photo Number: Image 10

Rear Elevation

Describe Work and Impact on Existing Feature: Garden low wall to be removed, New paint, new impact windows, new roof, and additional landscaping (Existing Structure to Remain)

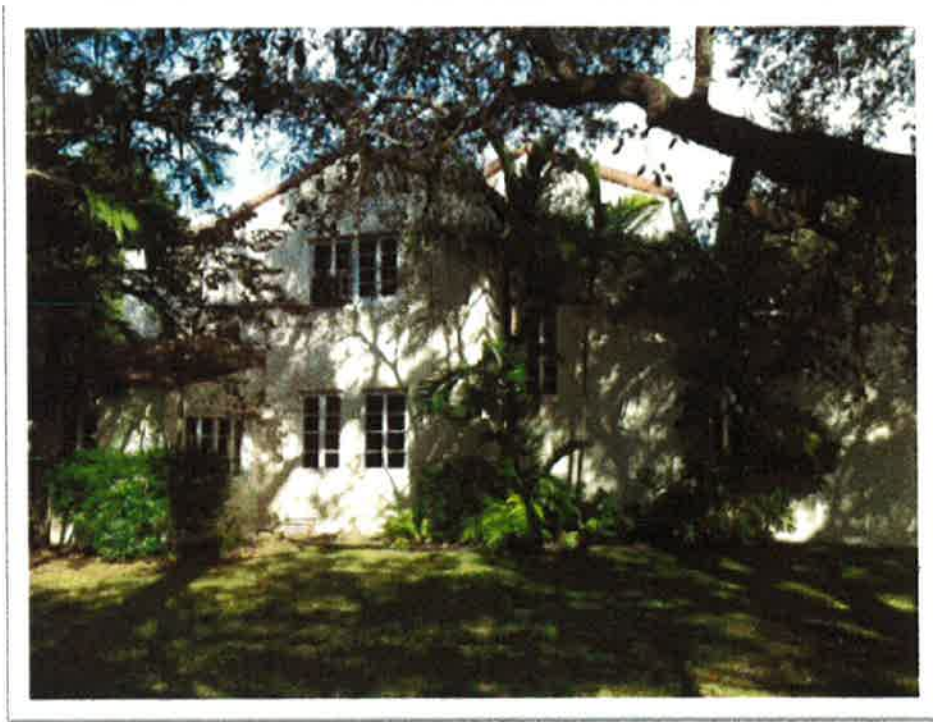
A SIDE LAUNDRY ROOM (WEST SIDE) WAS ADDED IN THE LATE 1920'S OR EARLY 1930'S ... NO PERMIT INFORMATION EXIST.

Side View from Palmarito

- REMOVE AND REPLACE WINDOW SYSTEM WITH IMPACT (TYPICAL).
- REPLACE CONC. BARREL TILE WITH CLAY BARREL TILE ROOF SYSTEM (TYPICAL).
- DEMO 1-STORY LAUNDRY ROOM (ADDED WITHOUT PERMIT) AND REBUILD.

Describe Work and Impact on Existing Feature: One-Story structure to be removed, New paint, new impact windows, new roof, and additional landscaping (Existing Structure to Remain)

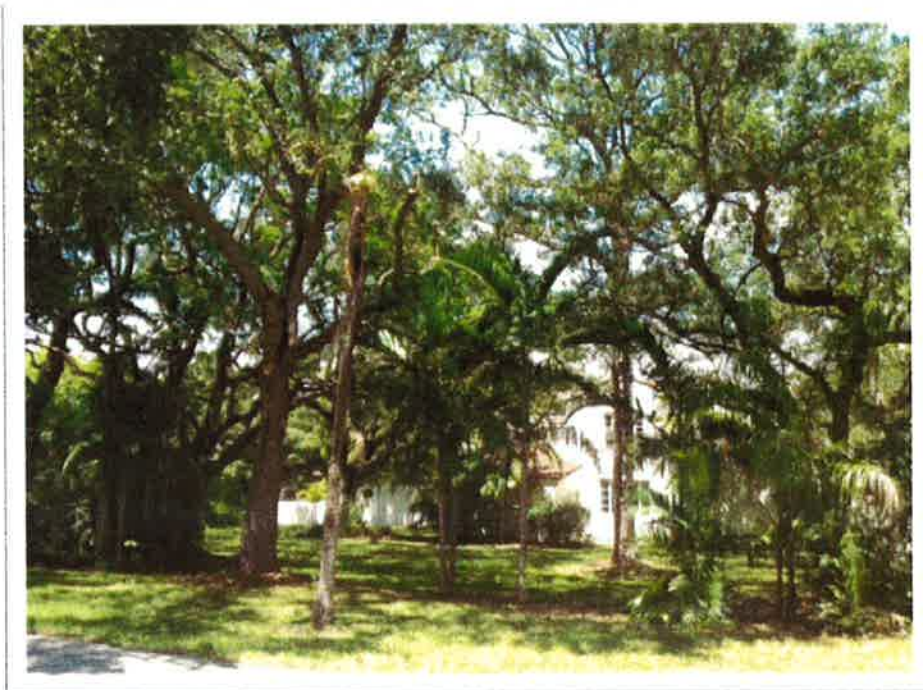
Photo Number: Image 12

Side View from Palmarito

Describe Work and Impact on Existing Feature: One-Story structure to be removed, New paint, new impact windows, new roof, and additional landscaping (Existing Structure to Remain)

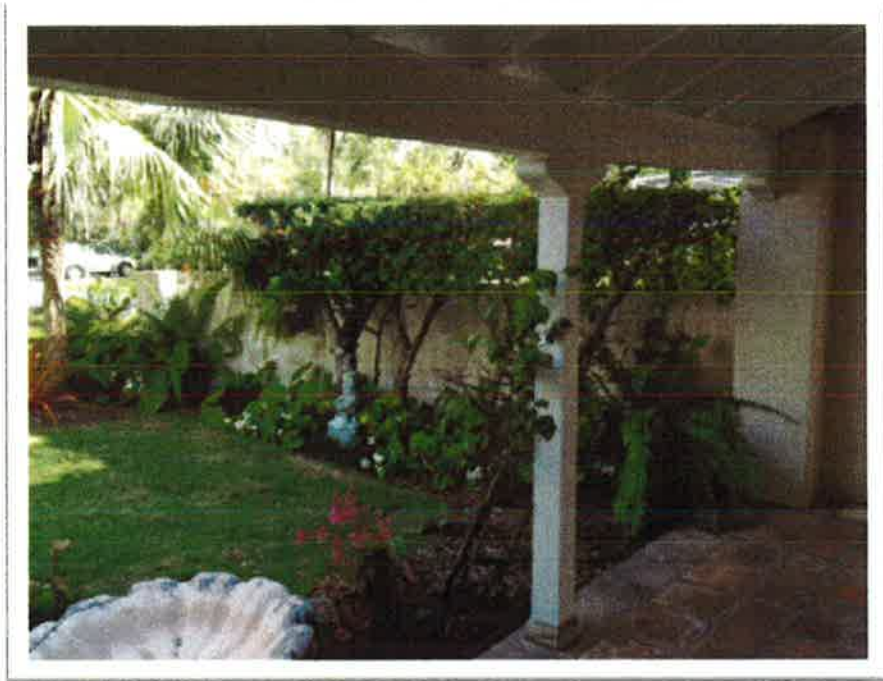
Courtyard View

Describe Work and Impact on Existing Feature: New Paint, Repair Cracks in Existing Beam/Column as needed, Clean & Seal Existing Floor Tiles, and new Landscape

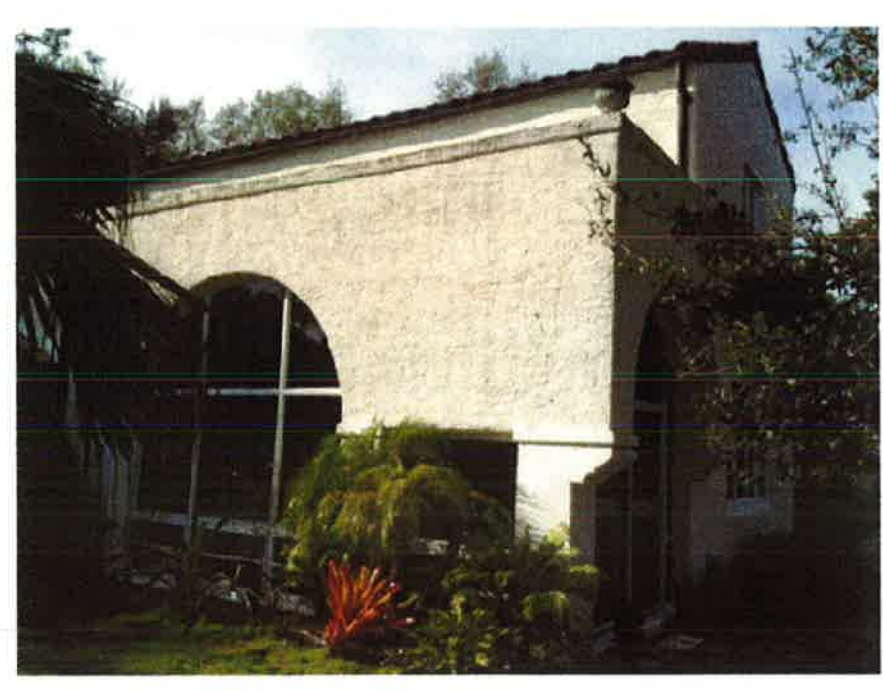
Photo Number: Image 14

Courtyard View

Describe Work and Impact on Existing Feature: New Paint, New Impact Windows, Repair cracks in decorative stucco trim, New Roof to match existing

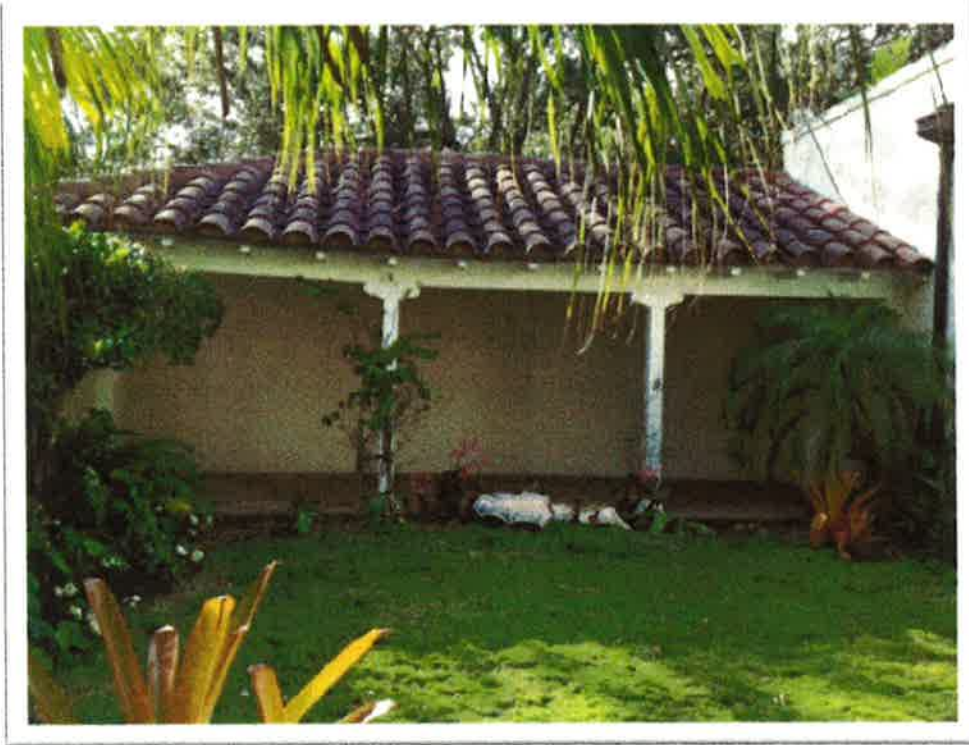
Courtyard View

Describe Work and Impact on Existing Feature: New Paint, Repair Cracks in Existing Beam/Column as needed, Clean & Seal Existing Floor Tiles, New Landscape, New Barrel Roof Tile

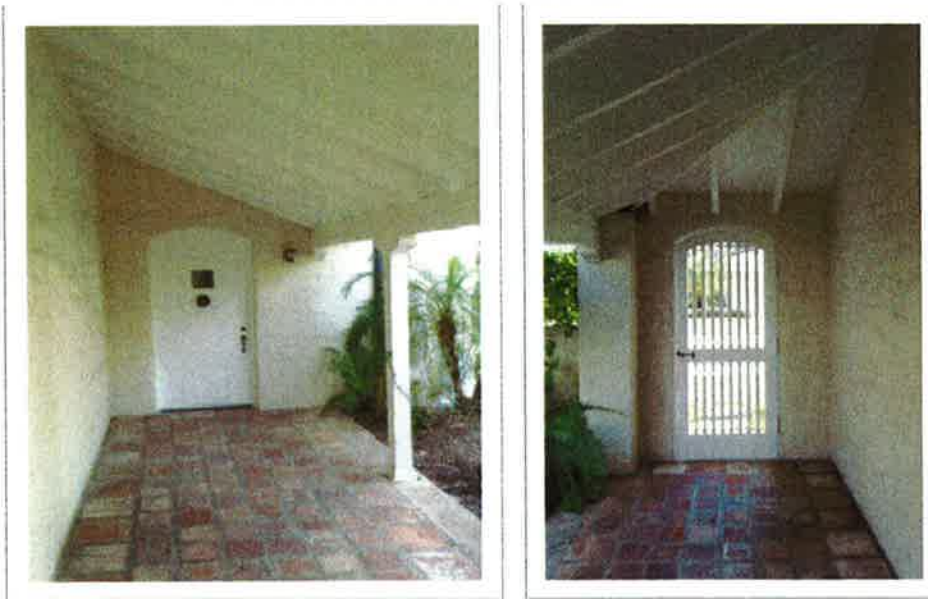
Photo Number: Image 16 & 17

Courtyard View to Front Door & Entry Gate

Describe Work and Impact on Existing Feature: New Paint, Clean & Seal Existing Floor Tiles, Repair any stucco cracks as needed, Restore Existing Wood Doors

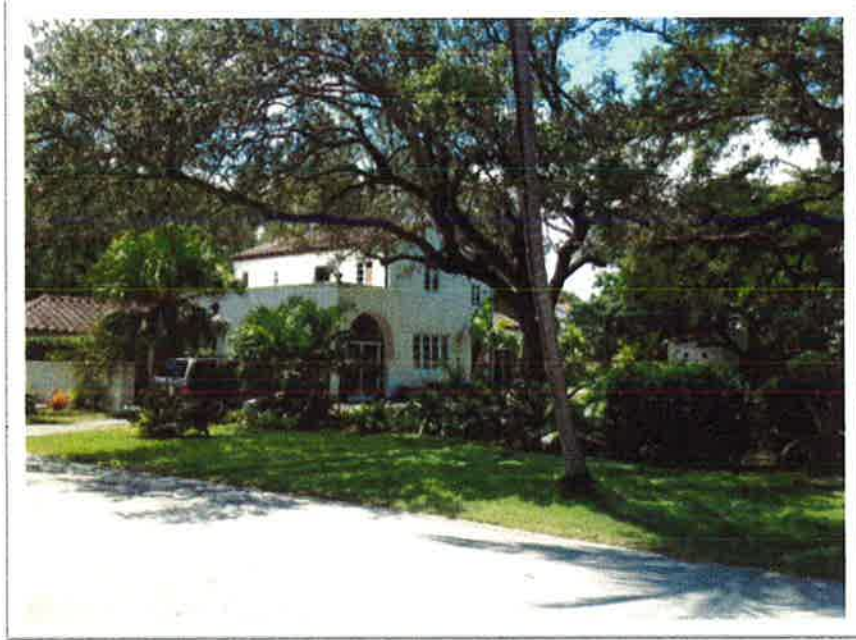
View of SE Corner

Describe Work and Impact on Existing Feature: New paint, new impact windows, new roof, and additional landscaping (Existing Structure to Remain)

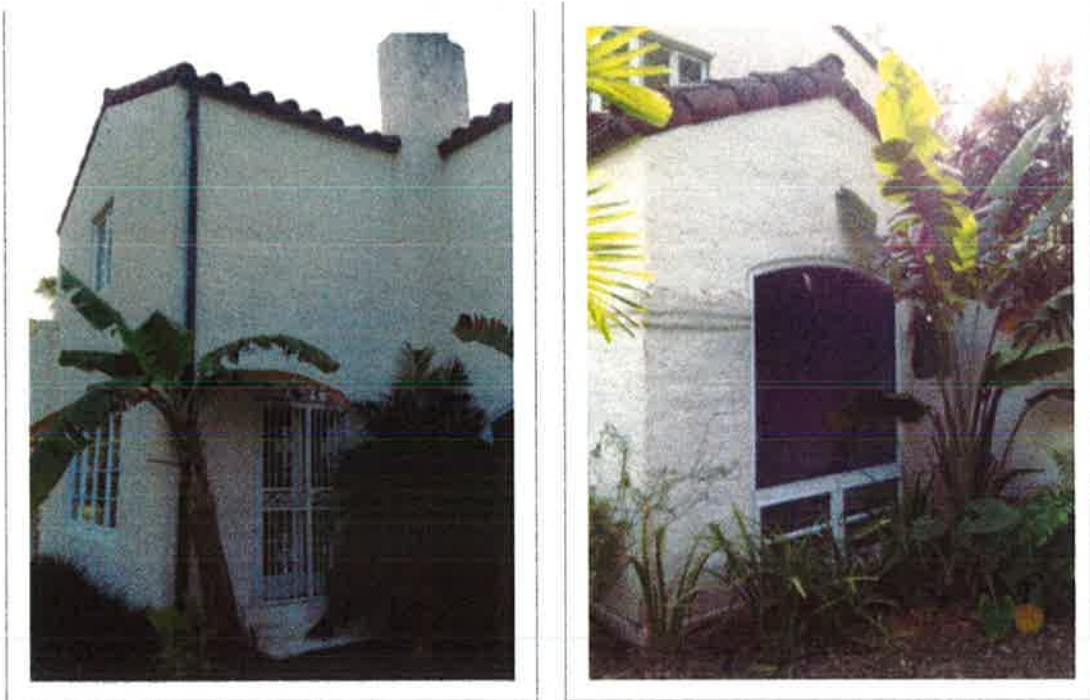
Photo Number: Image 19 & 20

View of Living Room from Rear & Porch from Rear

Describe Work and Impact on Existing Feature: New paint, new impact windows, new roof, (Existing Structure to Remain)

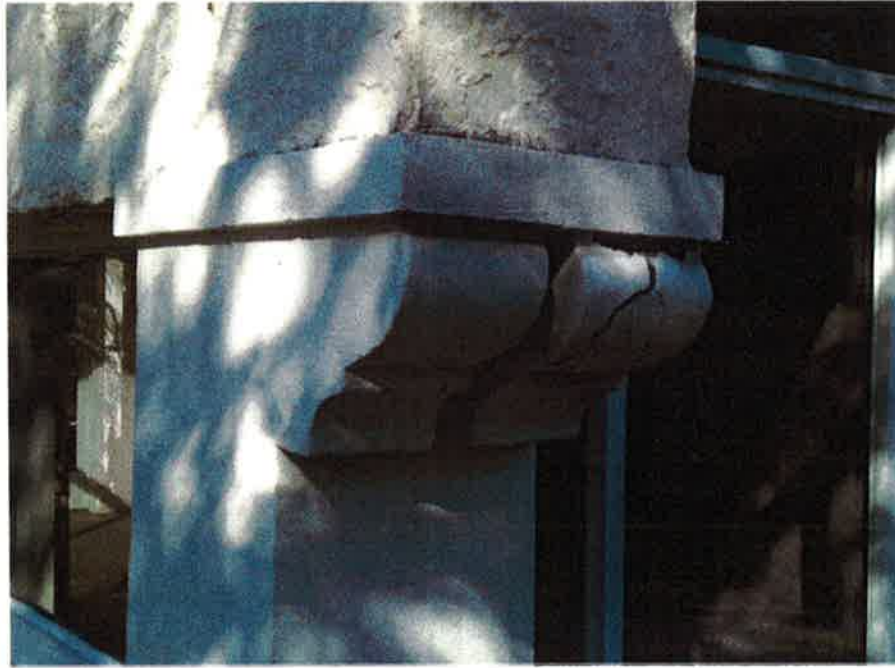
Photo Number: Image 21

Plan Number: **Stucco Detail View of Porch Column Capitals**

Describe Work and Impact on Existing Feature: Repair stucco cracks at Column Capital, New Paint

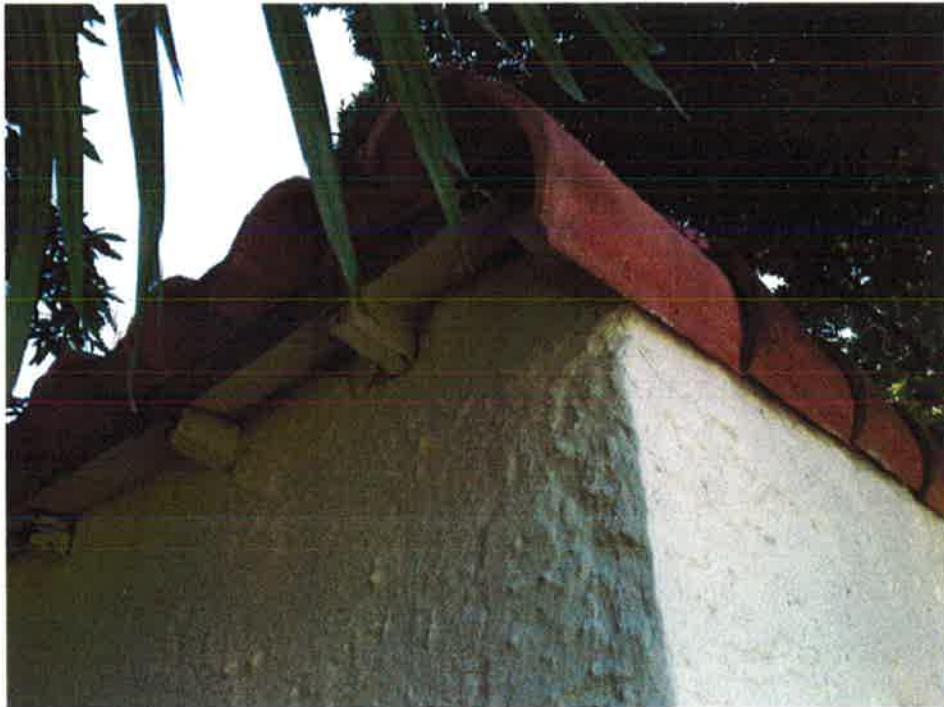
Detail View of Typical Roof Overhang

Describe Work and Impact on Existing Feature: New Barrel Roof Tile, Repair Wood Overhang, New Paint

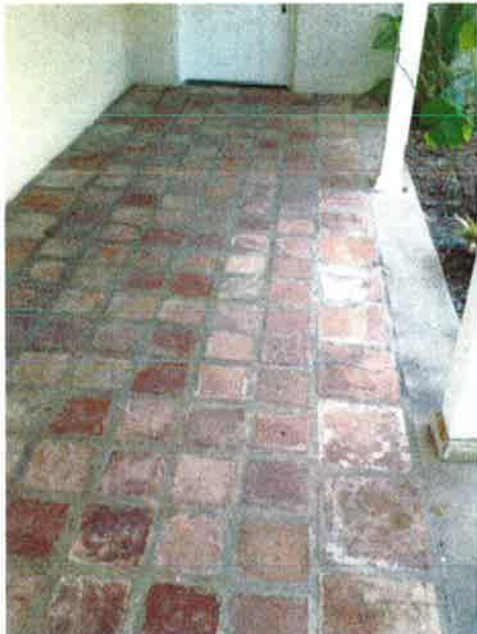
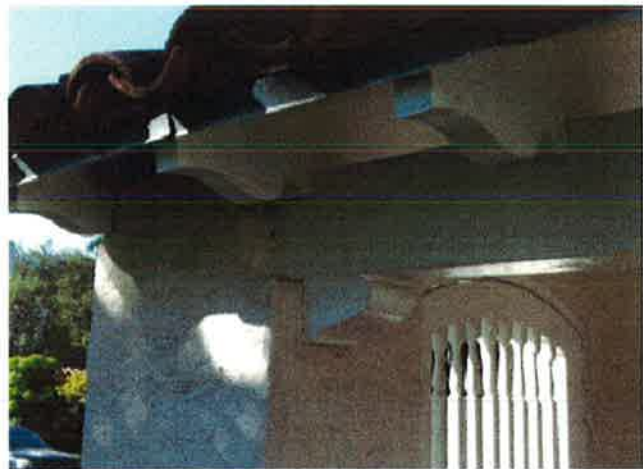
Photo Number: Image 24 & 25

Detail View of Floor Tile at Courtyard, View of Beam & Outriggers at Courtyard

Describe Work and Impact on Existing Feature: Clean and Repair visible cracks in wood beam, New Paint

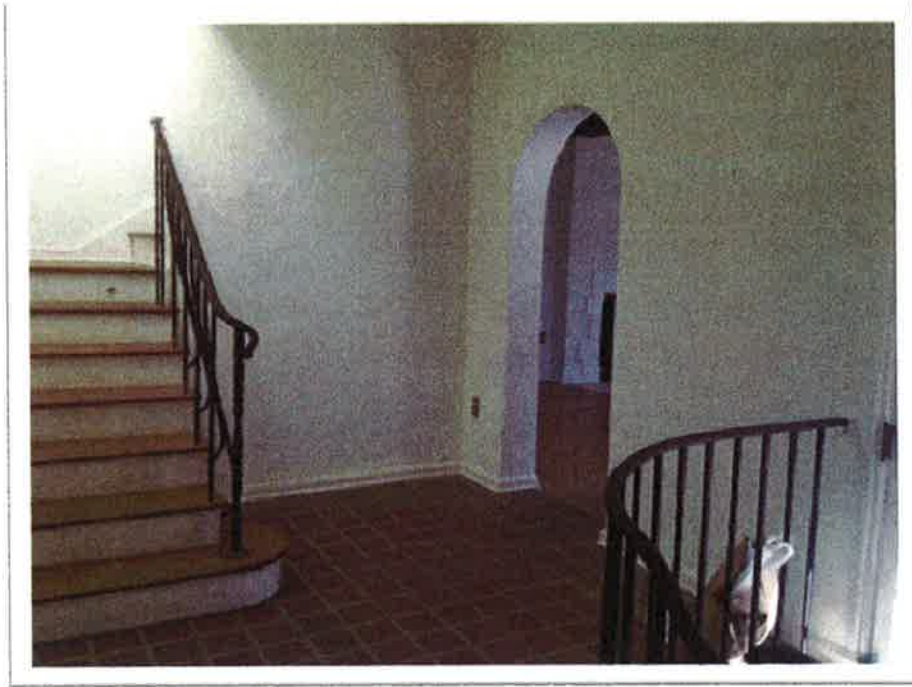
Entry Foyer

Describe Work and Impact on Existing Feature: New Paint, Existing Flooring and Rail to be restored

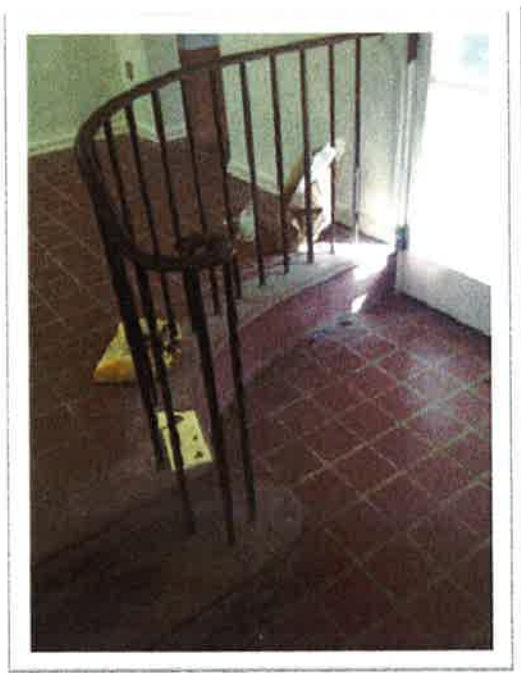
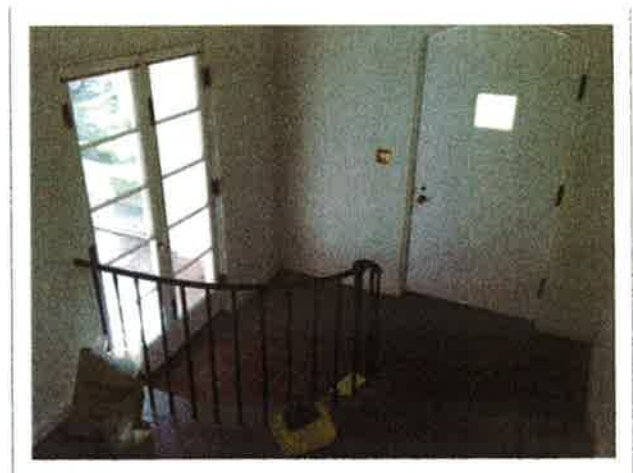
Photo Number: Image 27 & 28

Entry Foyer

Describe Work and Impact on Existing Feature: New Paint, Existing Flooring and Rail to be restored

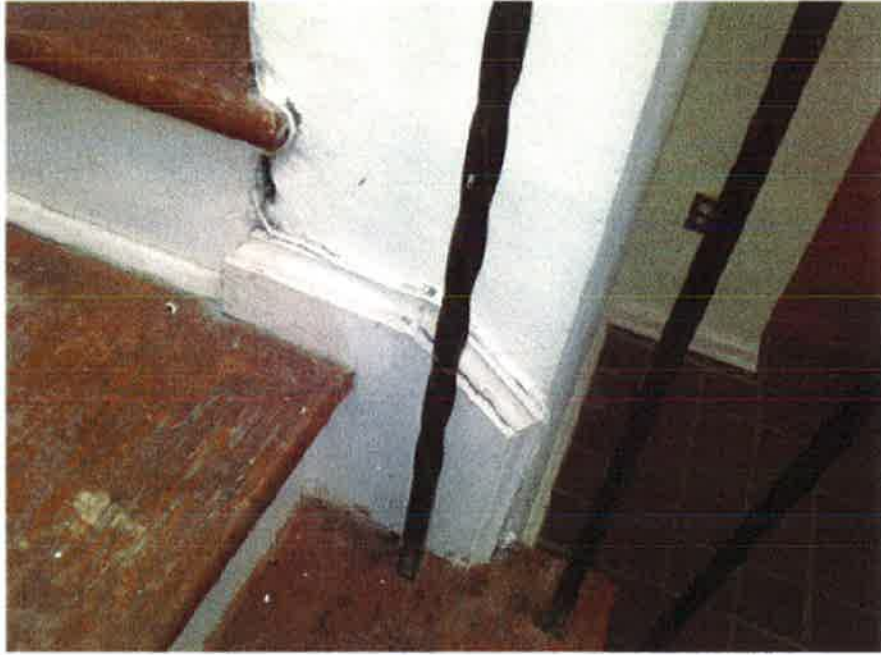
Existing Wood Treads & Iron Rails

Describe Work and Impact on Existing Feature: Refinish Existing Wood Treads, Railings

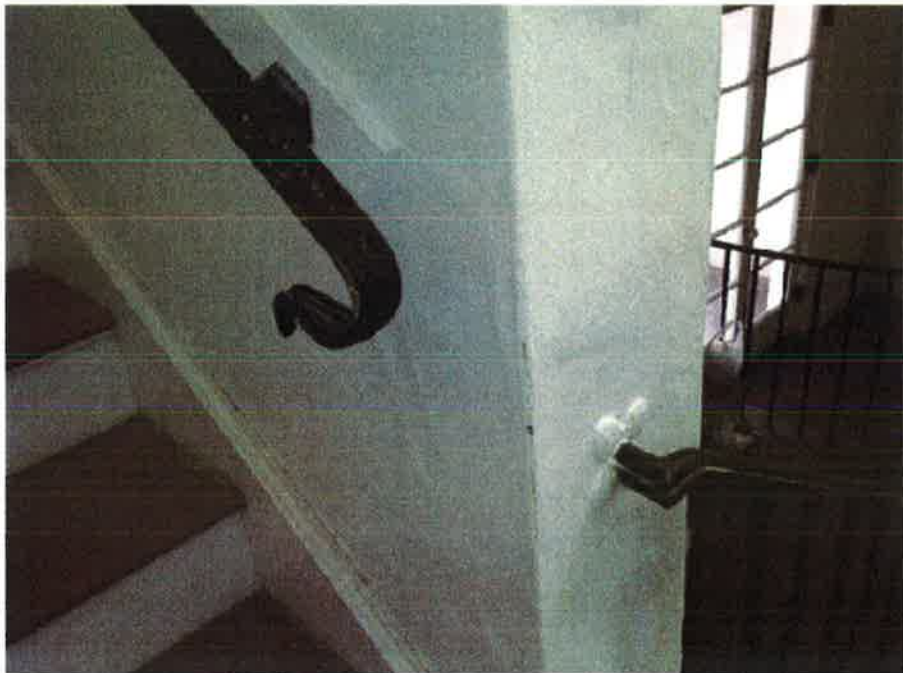
Existing Handrail

Describe Work and Impact on Existing Feature: Re-finish Existing Handrail and Details

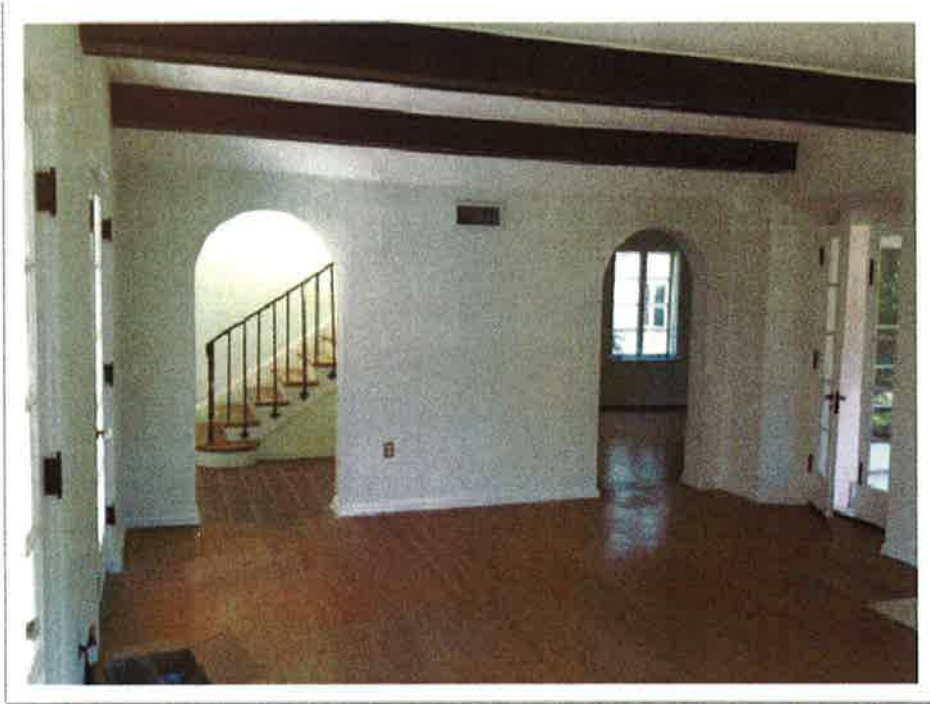
Existing Living Room

Describe Work and Impact on Existing Feature: Refinish Existing Wood Floors, New Paint

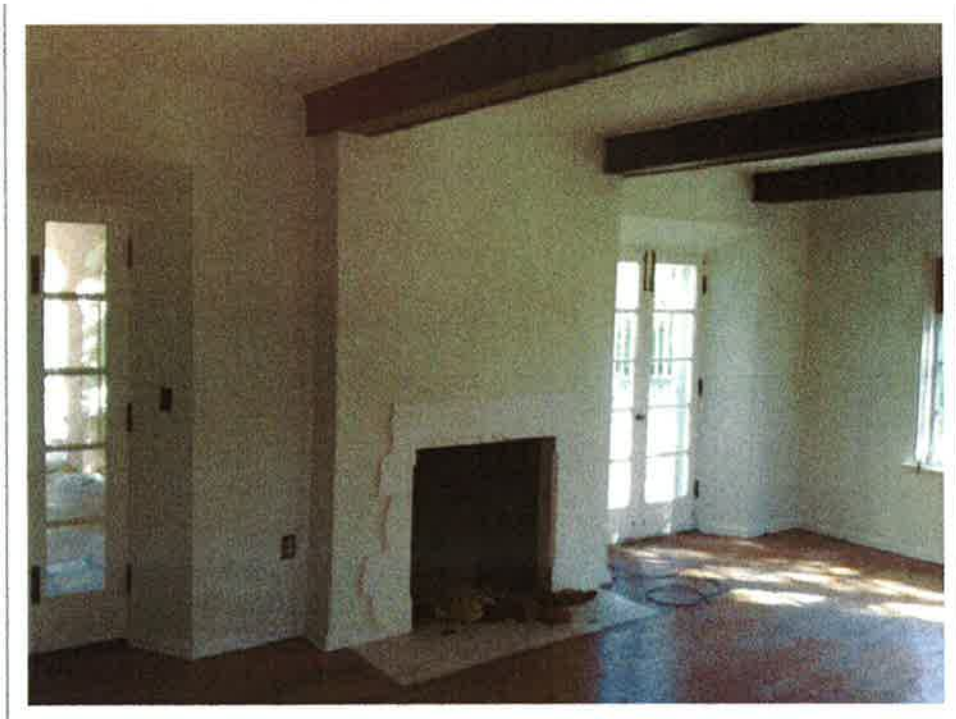
Photo Number: Image 32

Existing Living Room & Fireplace

Describe Work and Impact on Existing Feature: Restore Fireplace to working order, Refinish existing wood floor, new paint, new Impact-Rated Doors

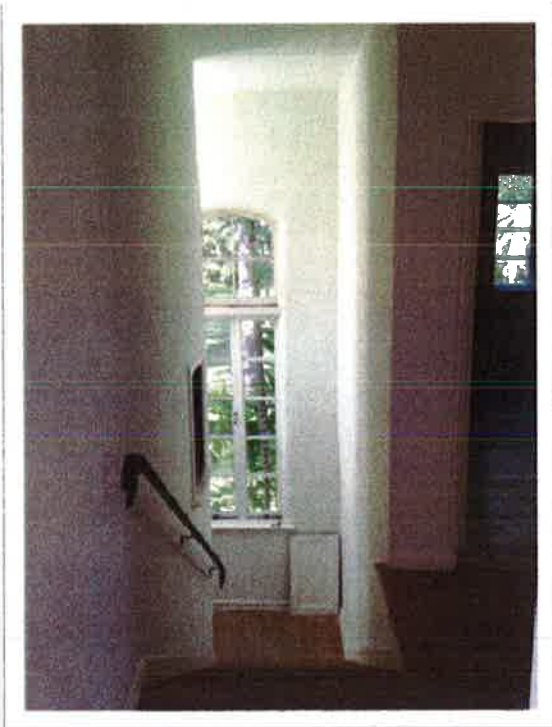
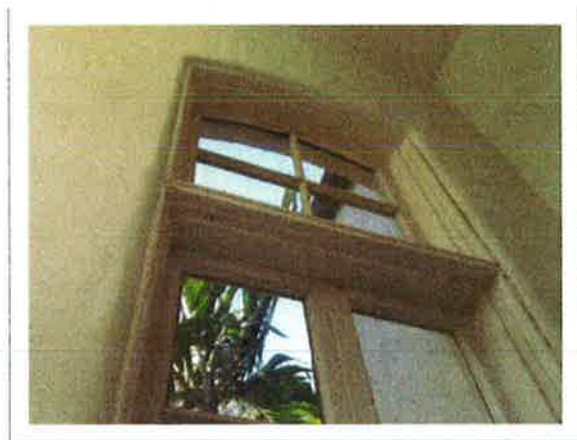
Photo Number: Image 34 & 35

Existing Staircase

Describe Work and Impact on Existing Feature: Refinish Wood Floors, Paint Handrails, New Paint, Replace window with impact rated window

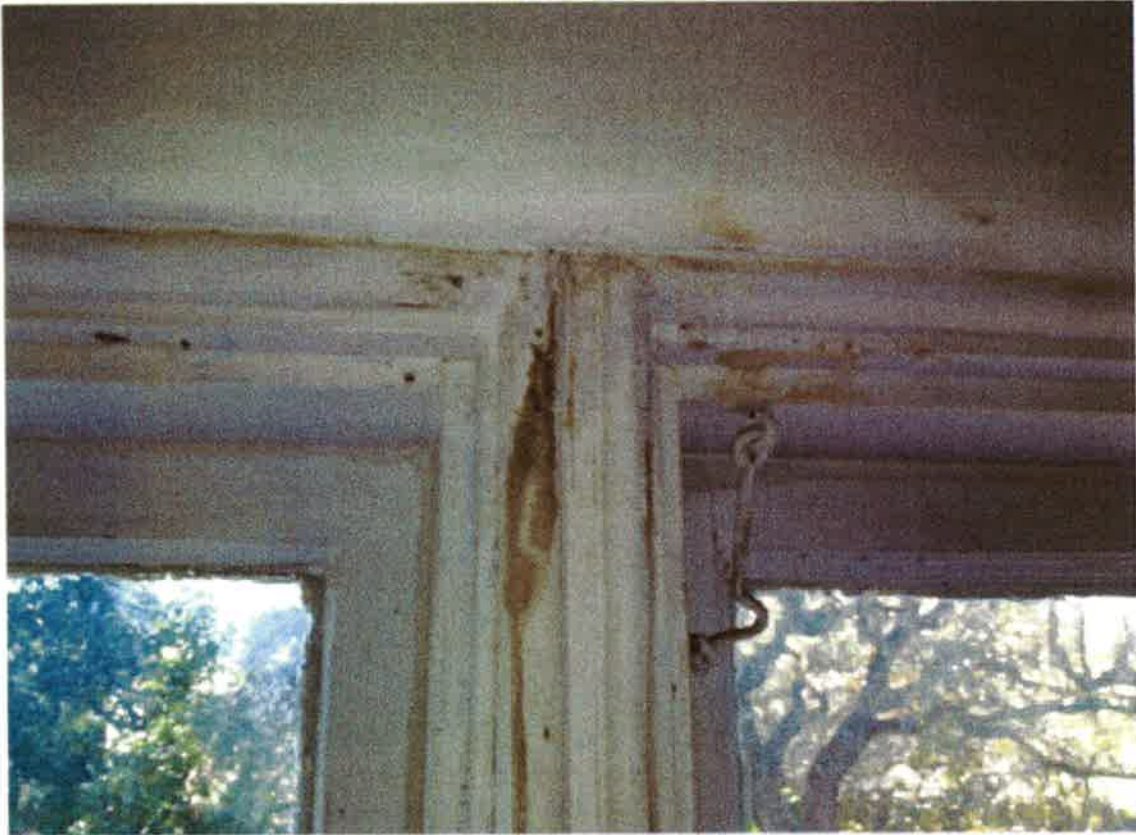
Existing Window Frame at Header

Describe Work and Impact on Existing Feature: Replace with New Impact-Rated Window

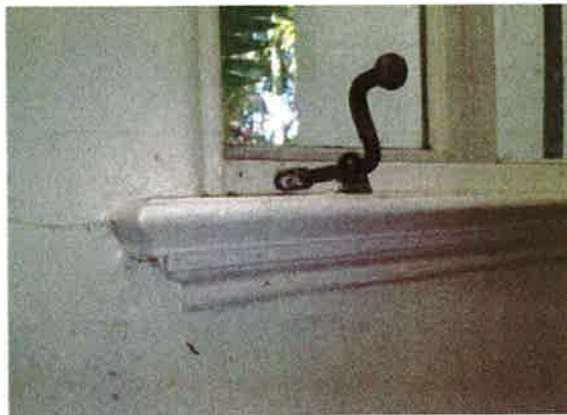
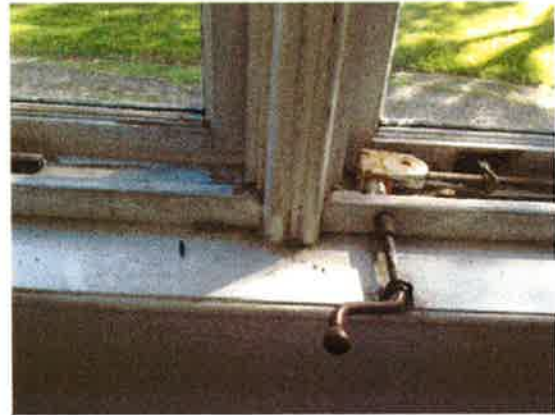
Photo Number: Image 37 & 38

Existing Window Sill

Describe Work and Impact on Existing Feature: Replace with New Impact-Rated Window, Decorative Wood Sill to Remain

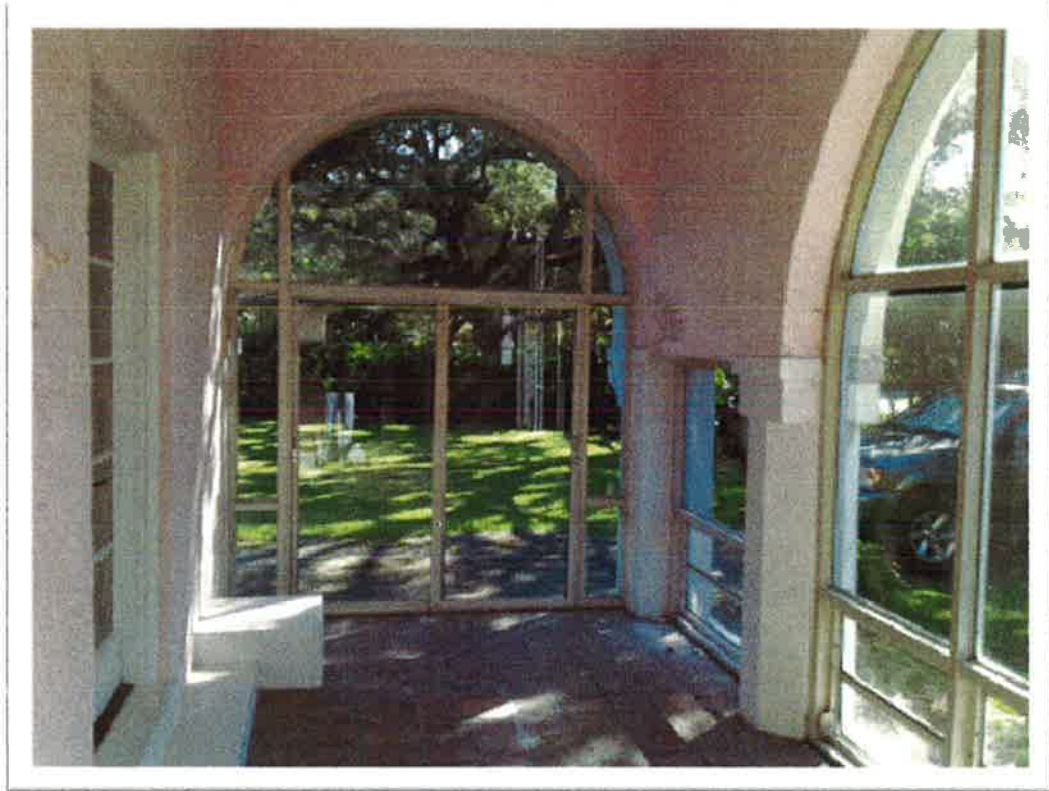
Sunroom

Describe Work and Impact on Existing Feature: New Impact Doors and Windows, new paint

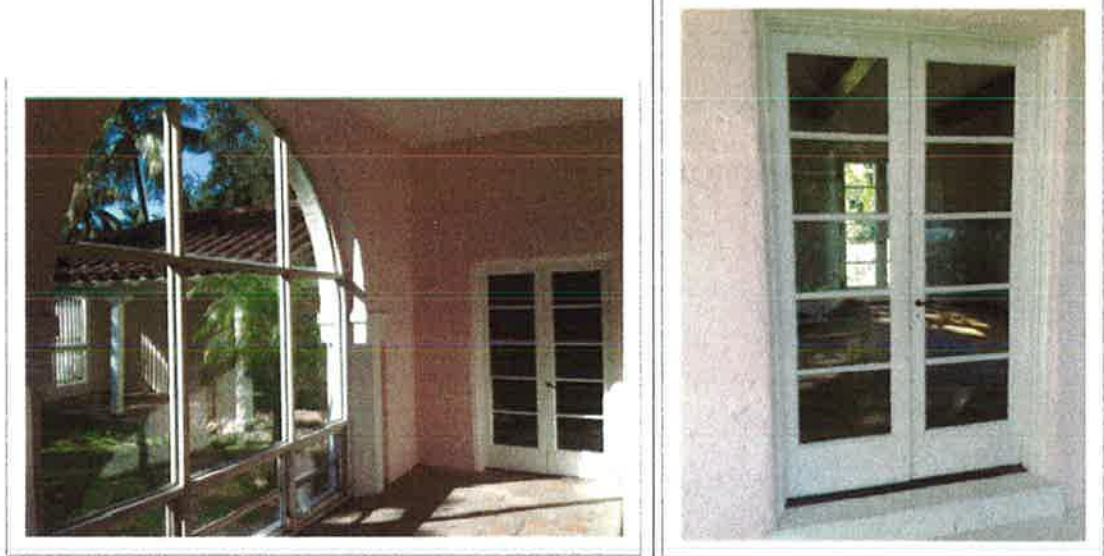
Photo Number: Image 40 & 41

Sunroom

Describe Work and Impact on Existing Feature: New Impact-Rated window, new paint, Interior doors to remain

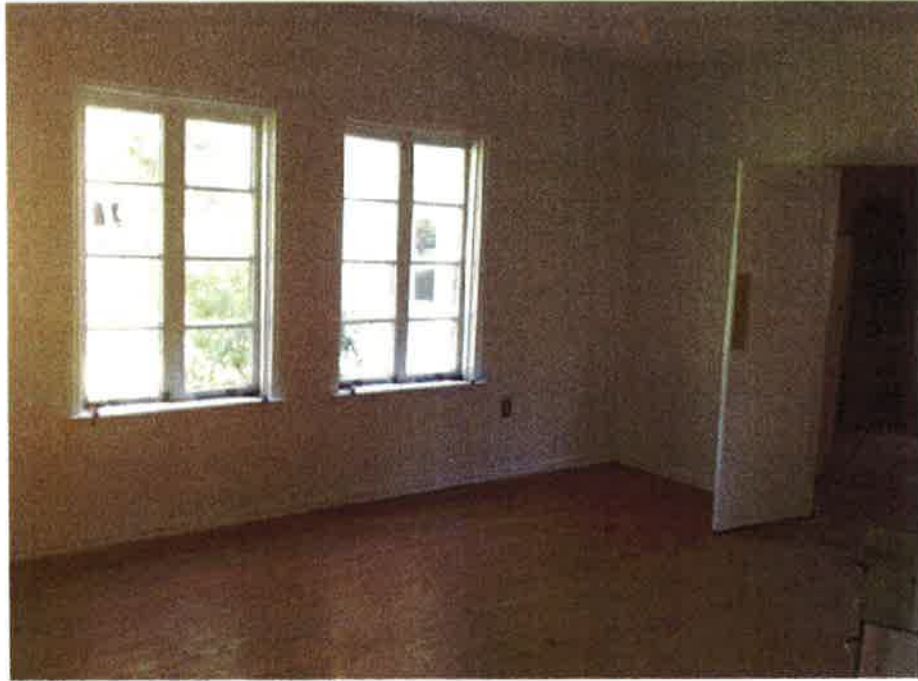
Existing Dining Room

Describe Work and Impact on Existing Feature: Refinish existing wood floor, new paint, new impact windows

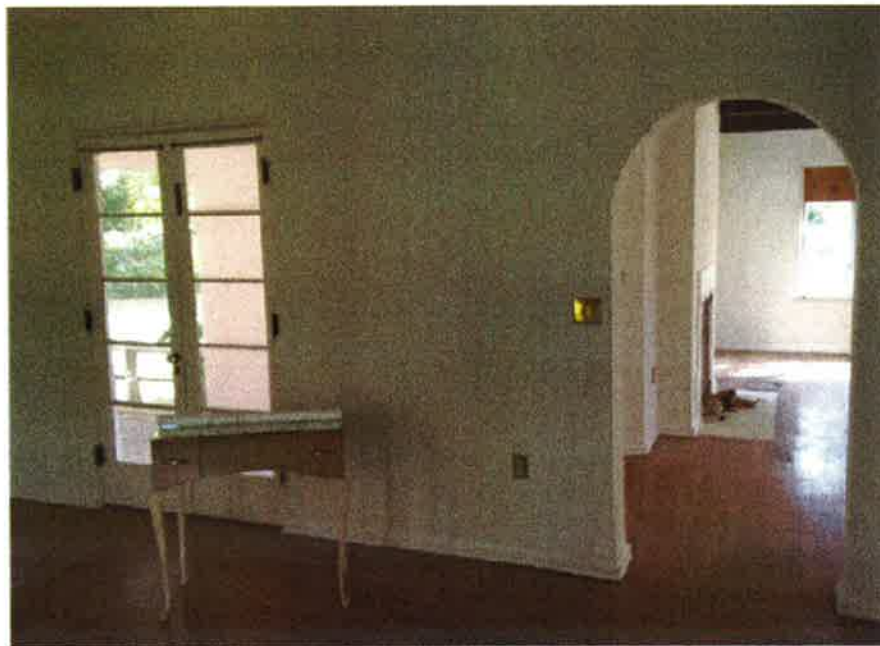
Photo Number: Image 43

Existing Dining Room

Describe Work and Impact on Existing Feature: Refinish existing wood floor, new paint, new impact windows

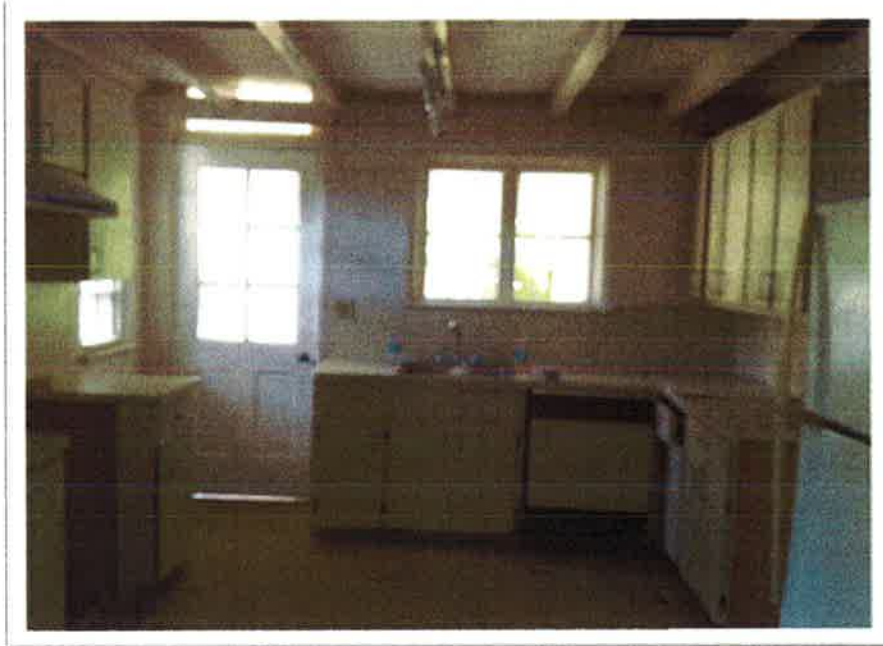
Existing Kitchen

Describe Work and Impact on Existing Feature: Remove Existing Cabinets, Flooring, area to be converted to new Butler's Pantry
