**Pre-Construction
Ad-Valorem Application Package for:
Historical Restoration, Addition, and Alteration to:**

Olivera Residence

641 San Lorenzo Avenue

Pre-Construction Ad-Valorem Application Package: Olivera Residence

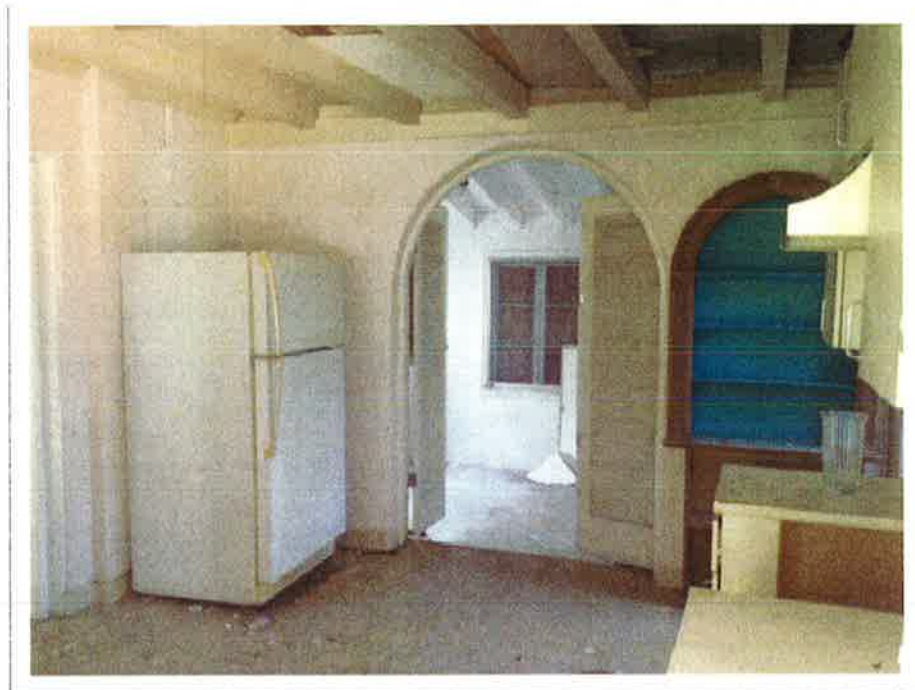
Photo Number: Image 45

Existing Kitchen

Describe Work and Impact on Existing Feature: Remove Existing Cabinets, Flooring, area to be converted to new Butler's Pantry

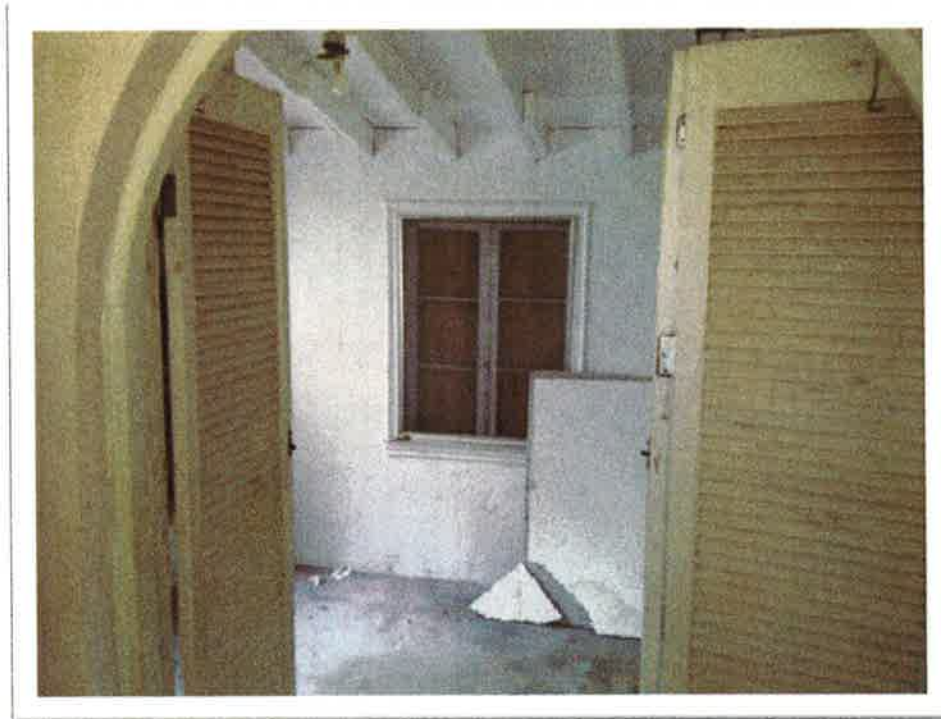
Existing Laundry

Describe Work and Impact on Existing Feature: Complete Demo of Existing Structure

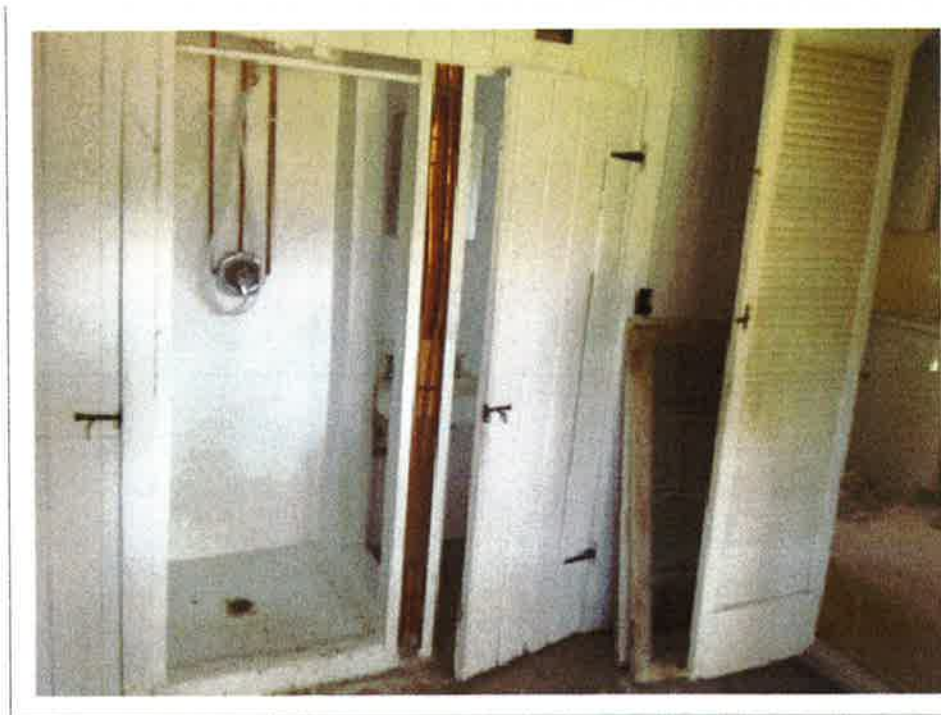
Photo Number: Image 47

Existing Laundry

Describe Work and Impact on Existing Feature: Complete Demo of Existing Structure

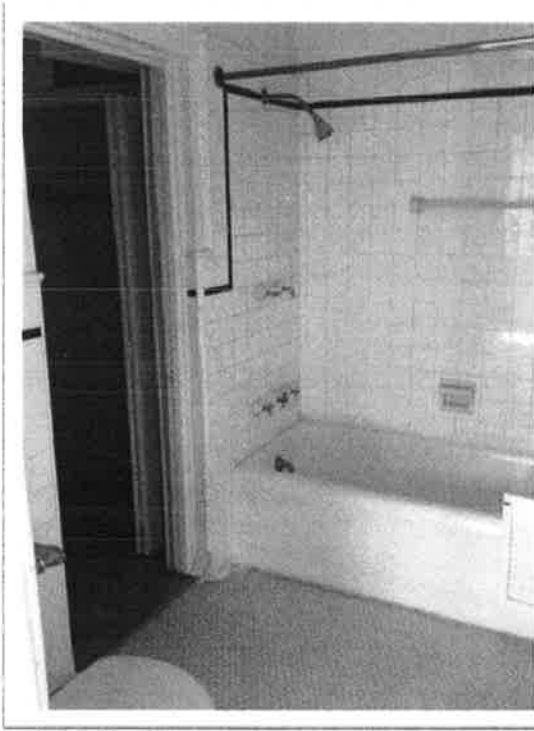
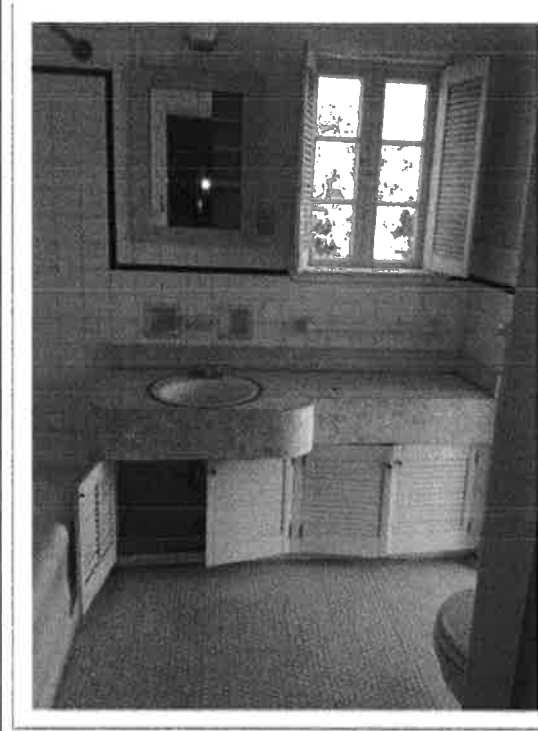
Existing Bathroom#1

Describe Work and Impact on Existing Feature: New Plumbing Fixtures, New Tile, New Lighting and New impact rated window

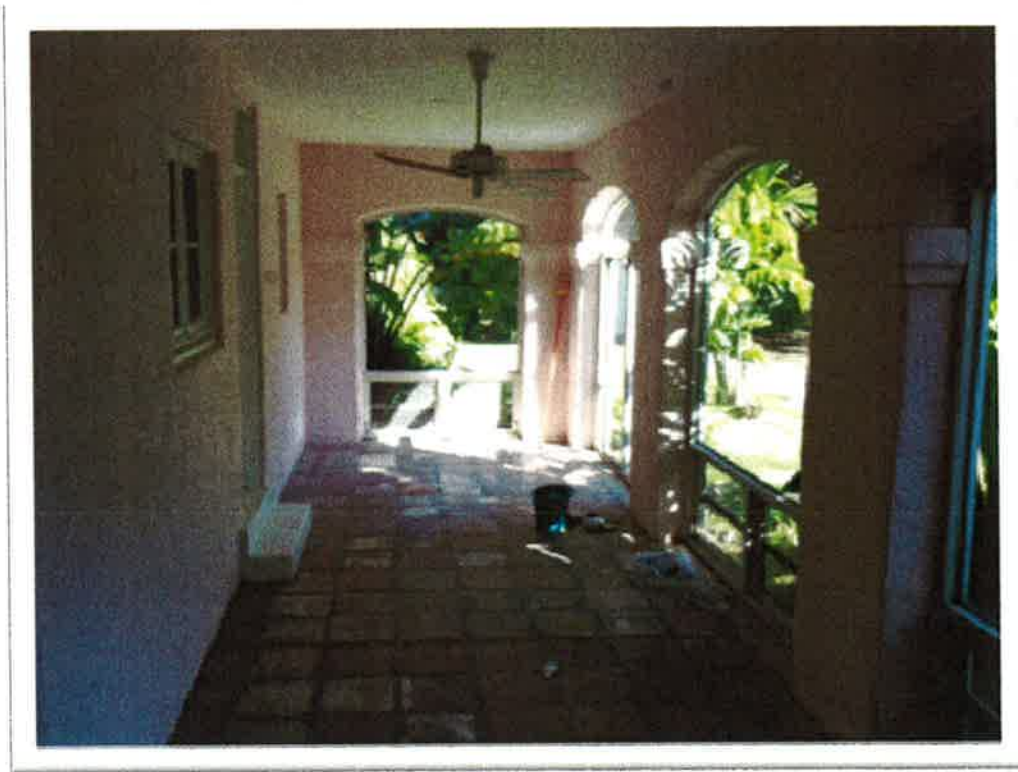
Existing Enclosed Side Terrace

Describe Work and Impact on Existing Feature: Windows to be removed and terrace to be open (non a/c), new paint finish, new fans, floors to be cleaned and resealed

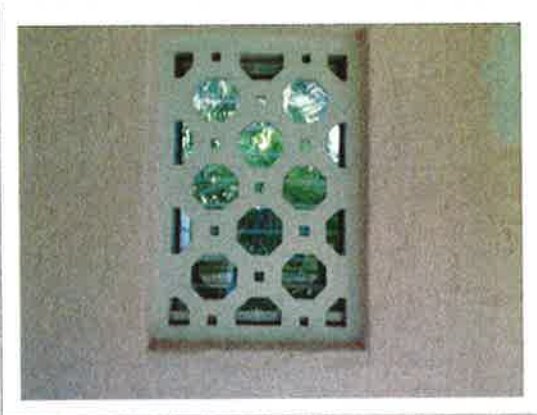
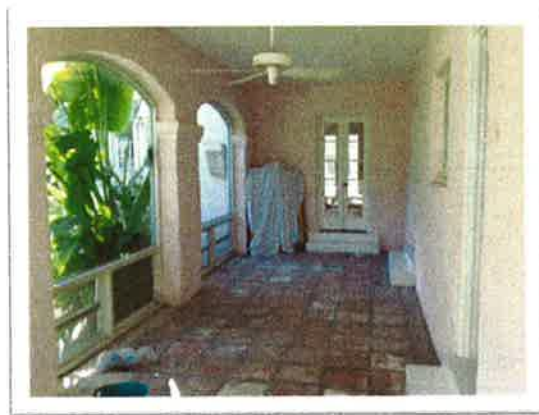
Photo Number: Image 51 & 52

Existing Enclosed Side Terrace

Describe Work and Impact on Existing Feature: Windows to be removed and terrace to be open (non a/c), new paint finish, new fans, floors to be cleaned and resealed, existing stucco vent to be removed and resued

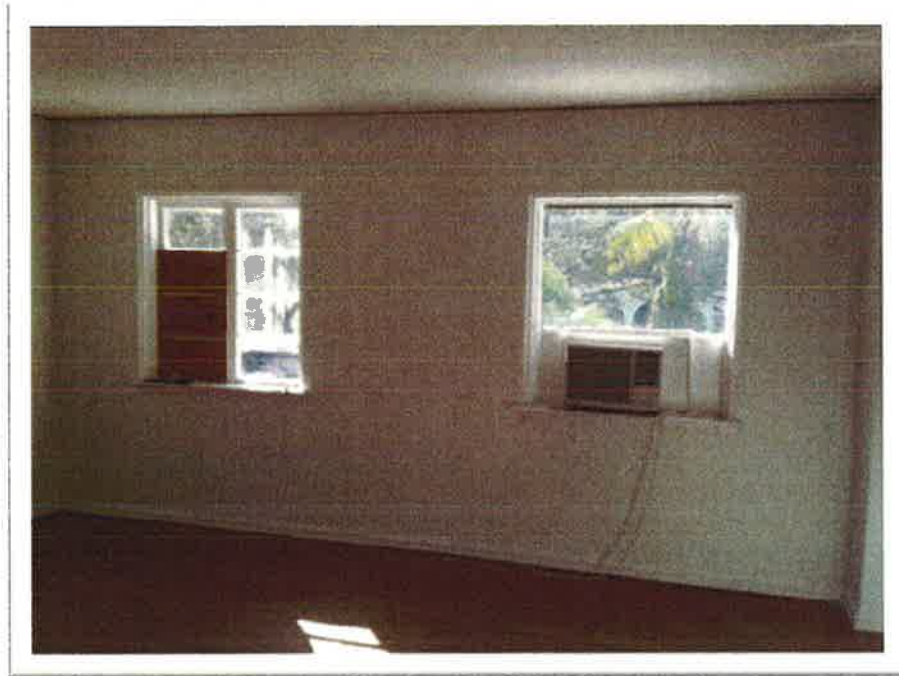
Existing Bedroom #2

Describe Work and Impact on Existing Feature: Remove wall A/C, New paint finish, floors to be refinished, new impact windows

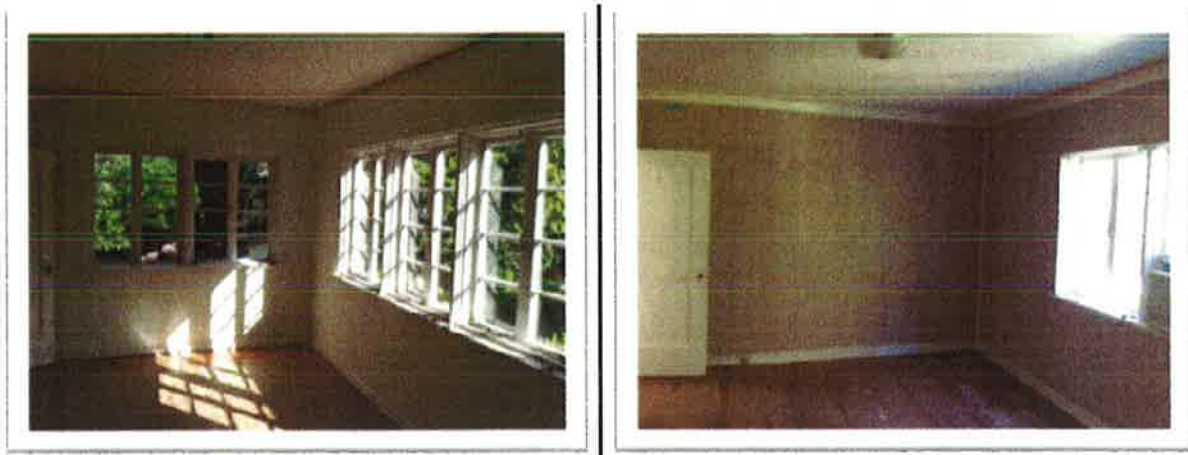
Photo Number: Image 54

Existing Bedroom #3

Describe Work and Impact on Existing Feature: Remove wall A/C, New paint finish, floors to be refinished, new impact windows

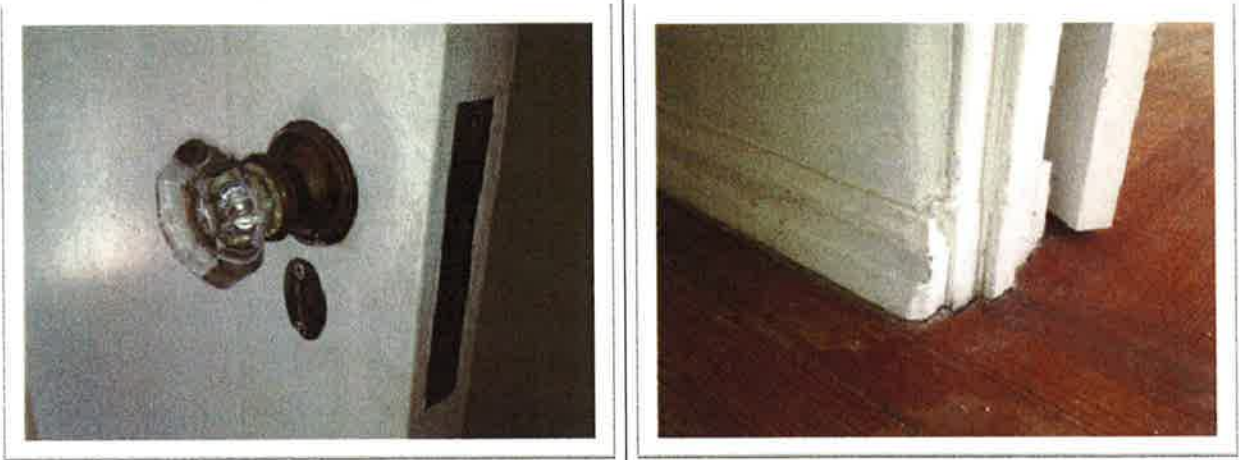
Door Hardware, Baseboards

Describe Work and Impact on Existing Feature: Existing hardware and baseboards to remain, repair as needed

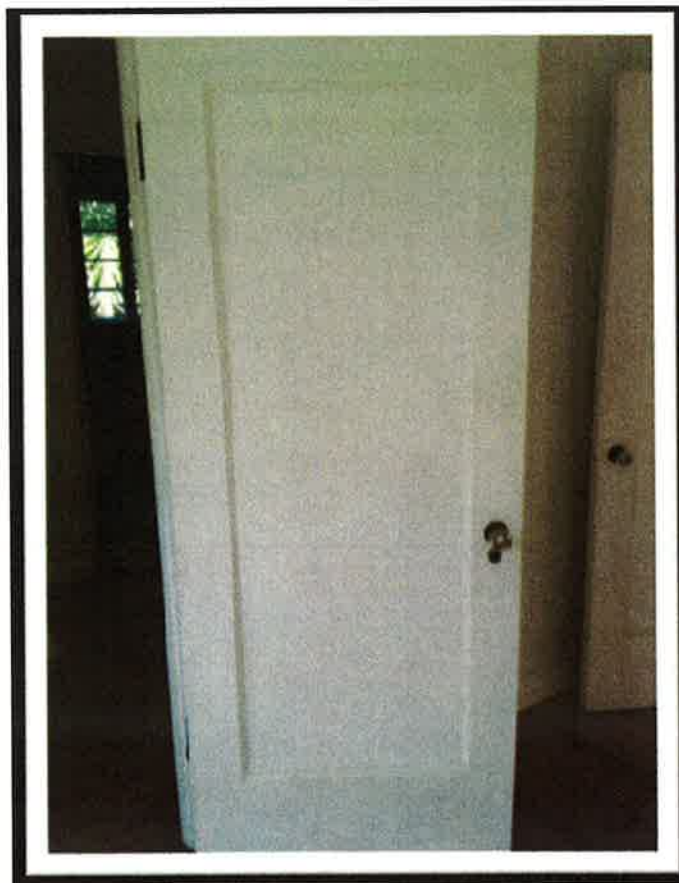
Photo Number: Image 57

Existing Door

Describe Work and Impact on Existing Feature: Existing hardware and interior door to remain, repair as needed

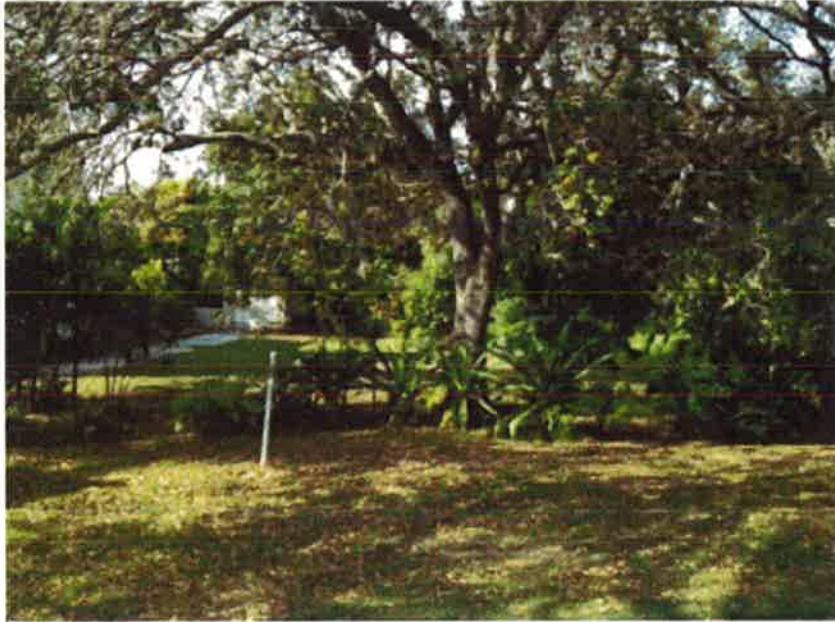
East Side Yard

Describe Work and Impact on Existing Feature: New Low wall at perimeter, new landscaping

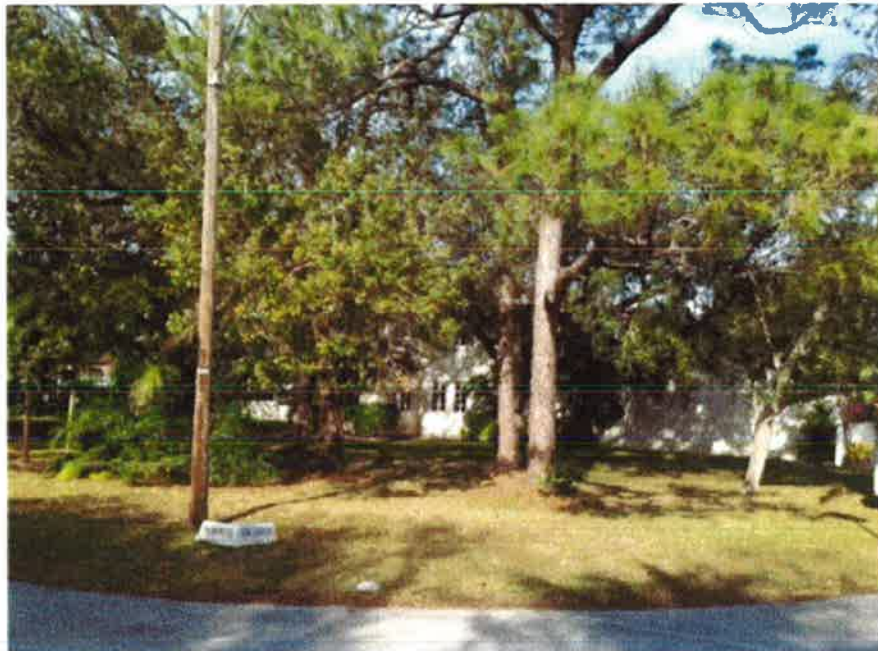
Photo Number: Image 59

View of Yard from Intersection

Describe Work and Impact on Existing Feature: New Low wall at perimeter, new landscaping

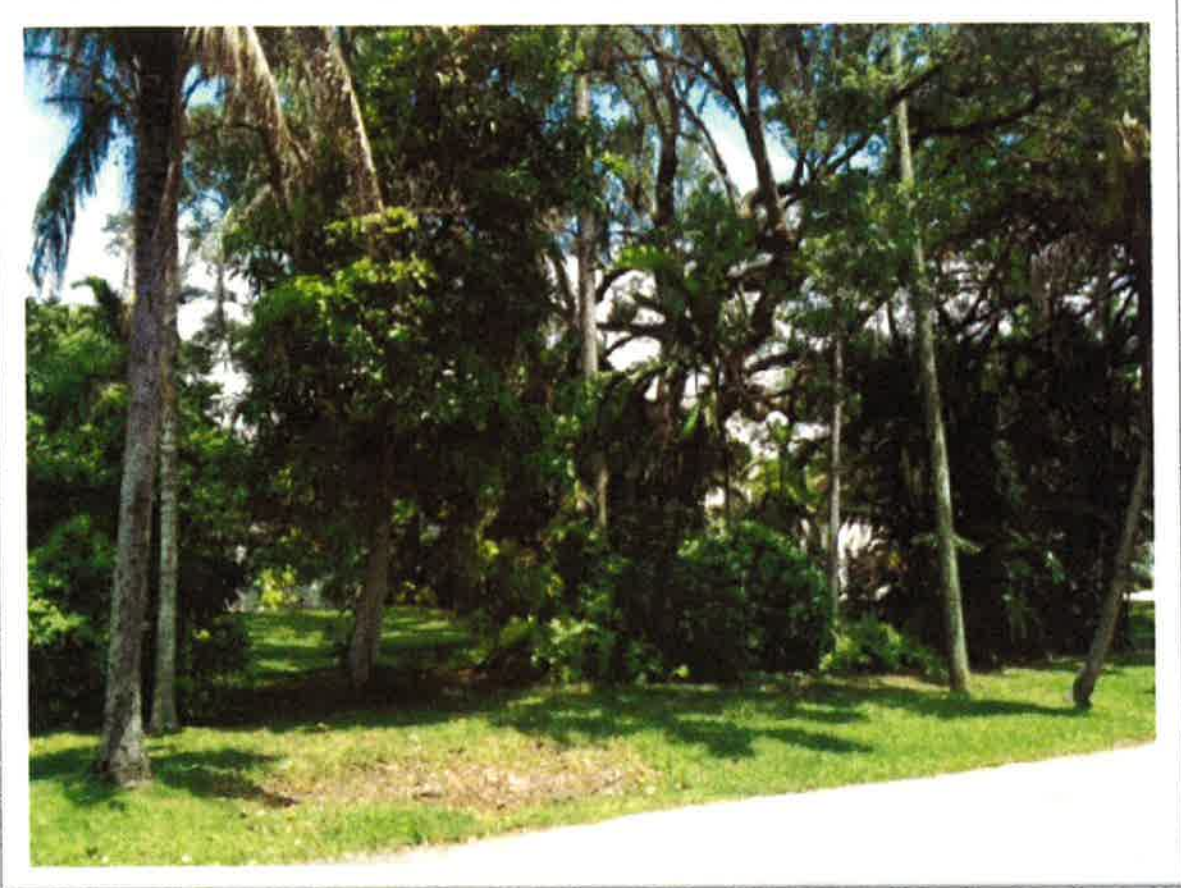
Northwest Corner View

Describe Work and Impact on Existing Feature: New Low wall at perimeters, new driveway, new landscaping
