MIAMI-DADE COUNTY
HISTORIC PRESERVATION AD-VALOREM TAX EXEMPTION

PART 1 – PRECONSTRUCTION APPLICATION

Historic/Site Name: 1203 Asturia Ave
Property Address: 1203 Asturia Ave., Coral Gables, FL
Folio Number: 03-4107-016-0720
Legal Description: Coral Gables Sec E PB 8-13
Lots 17 & 18 BLK 5

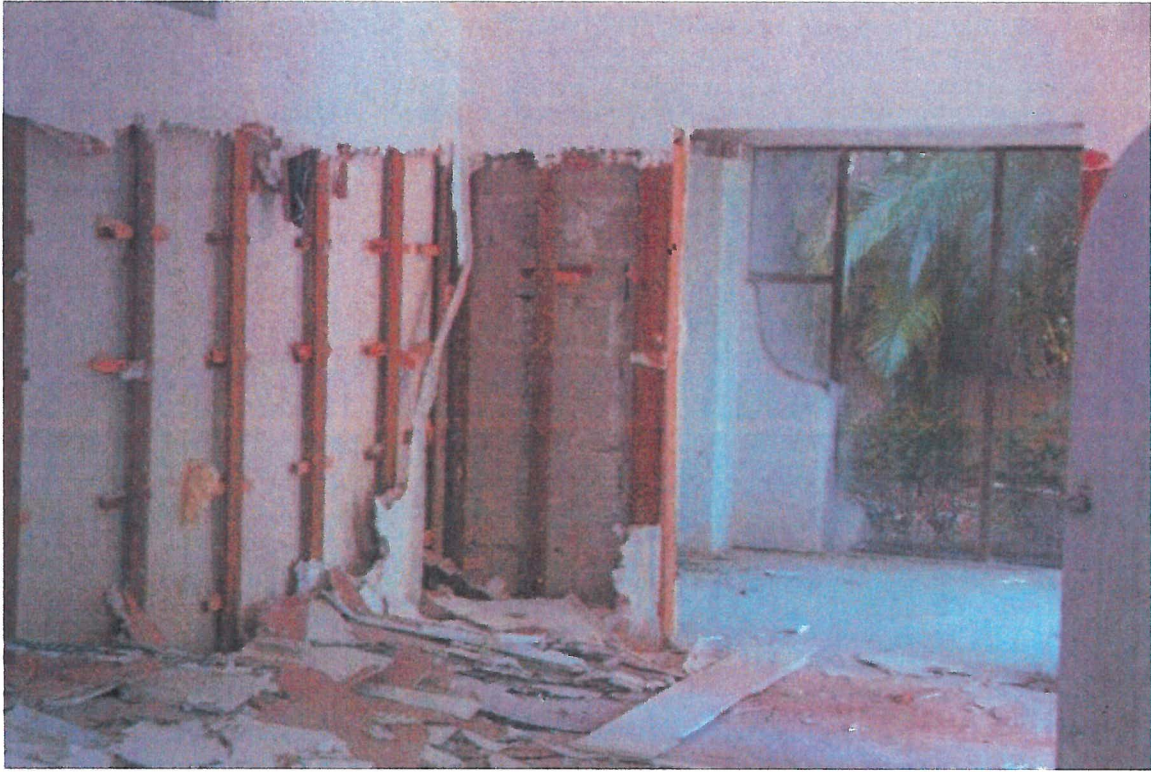
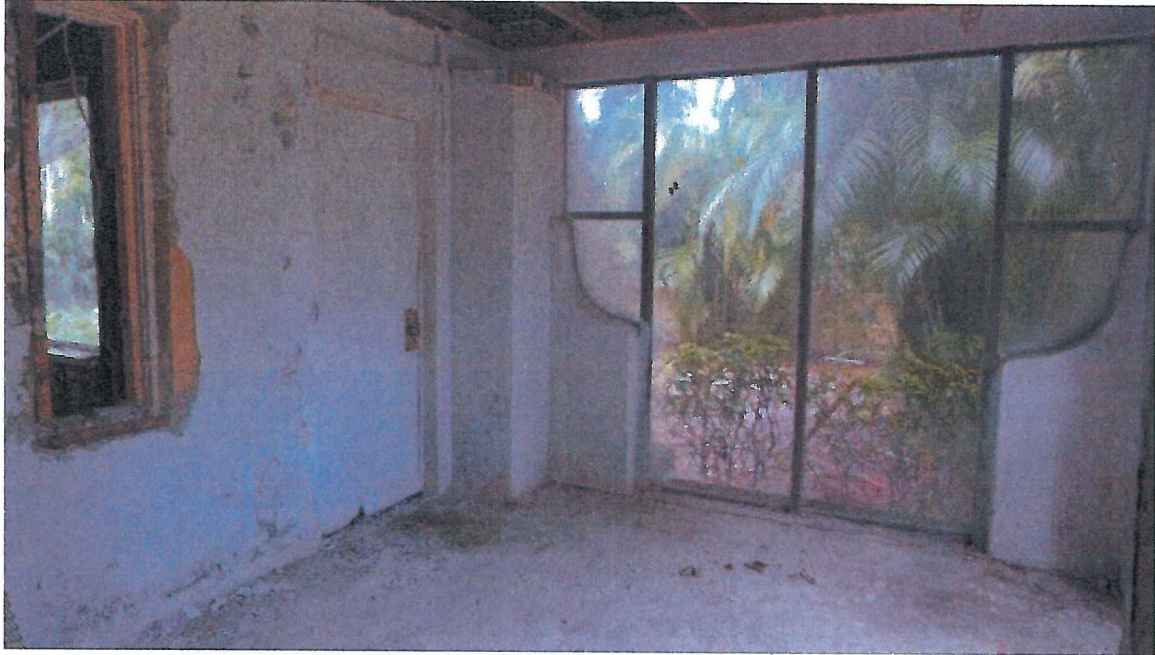
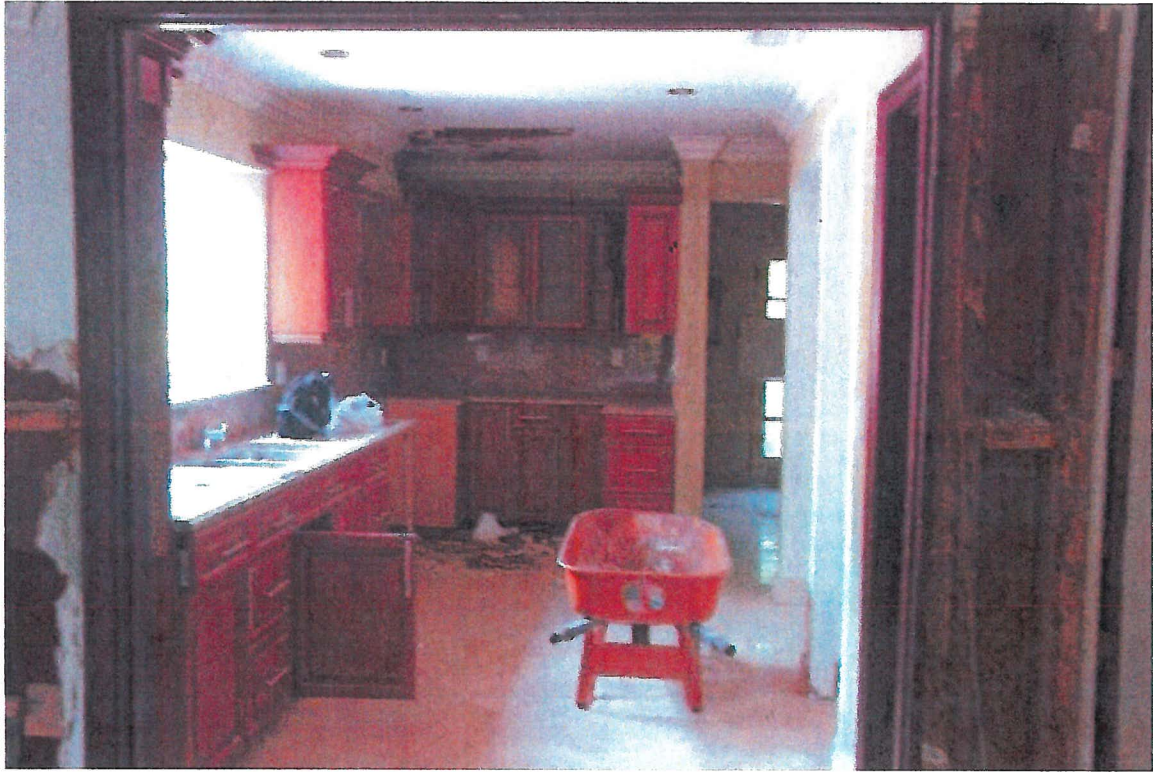
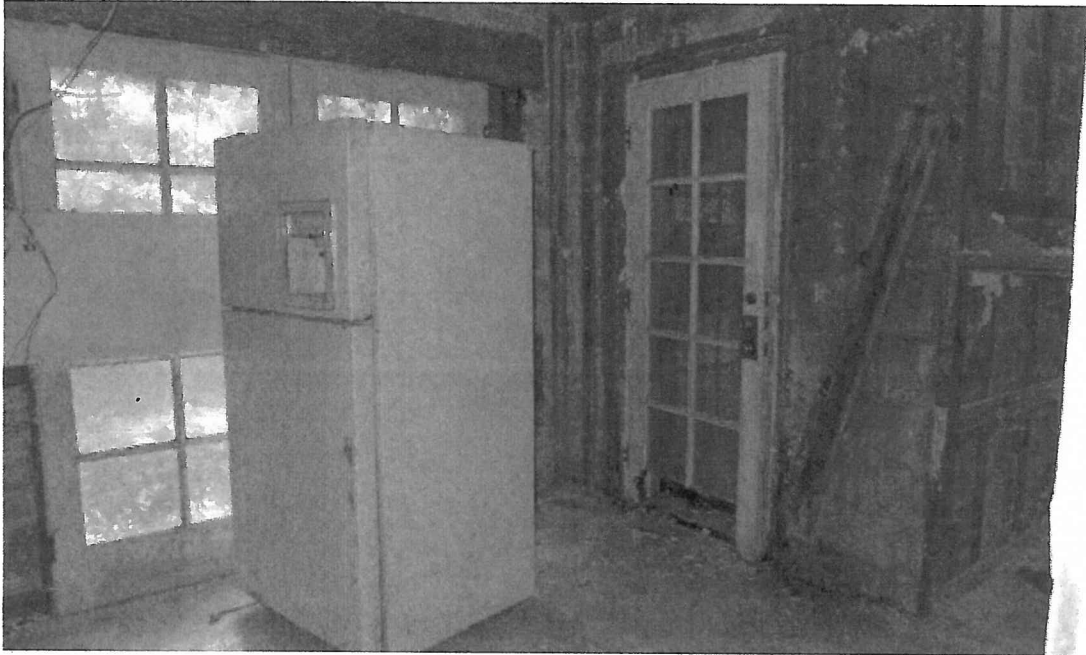
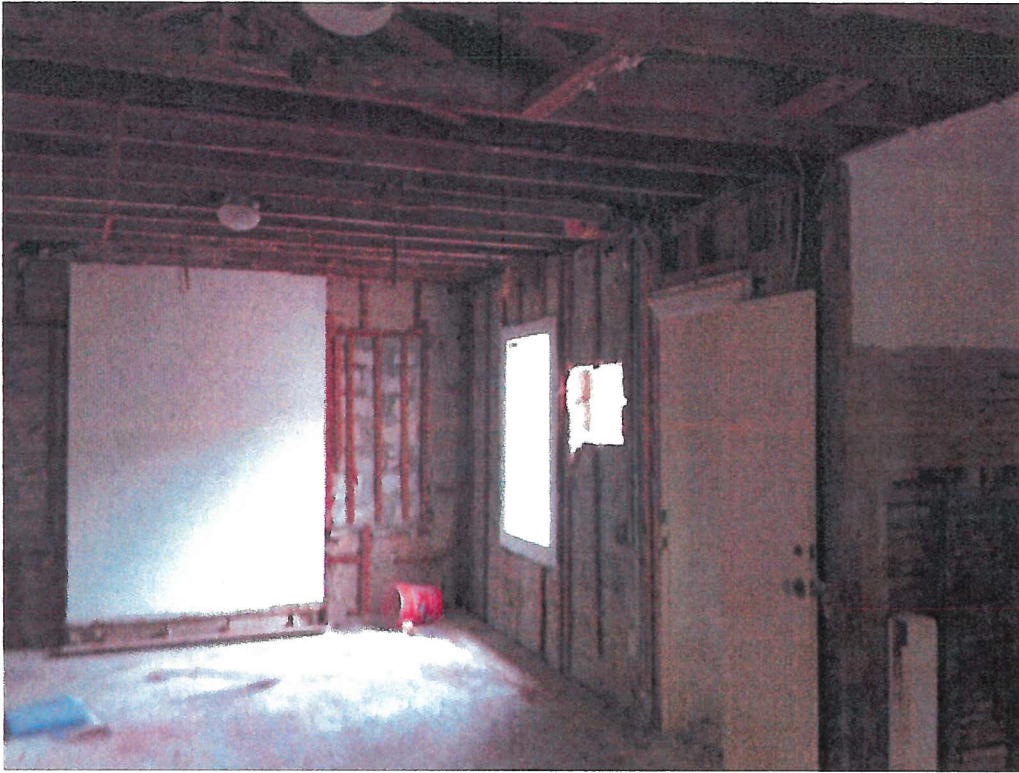
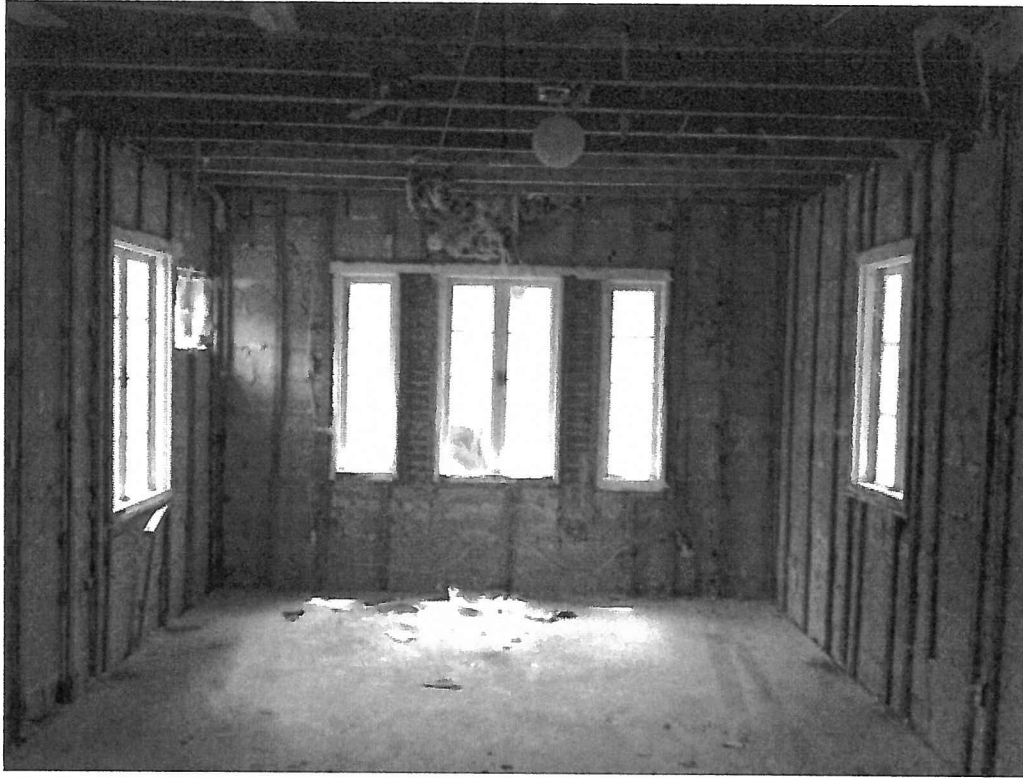
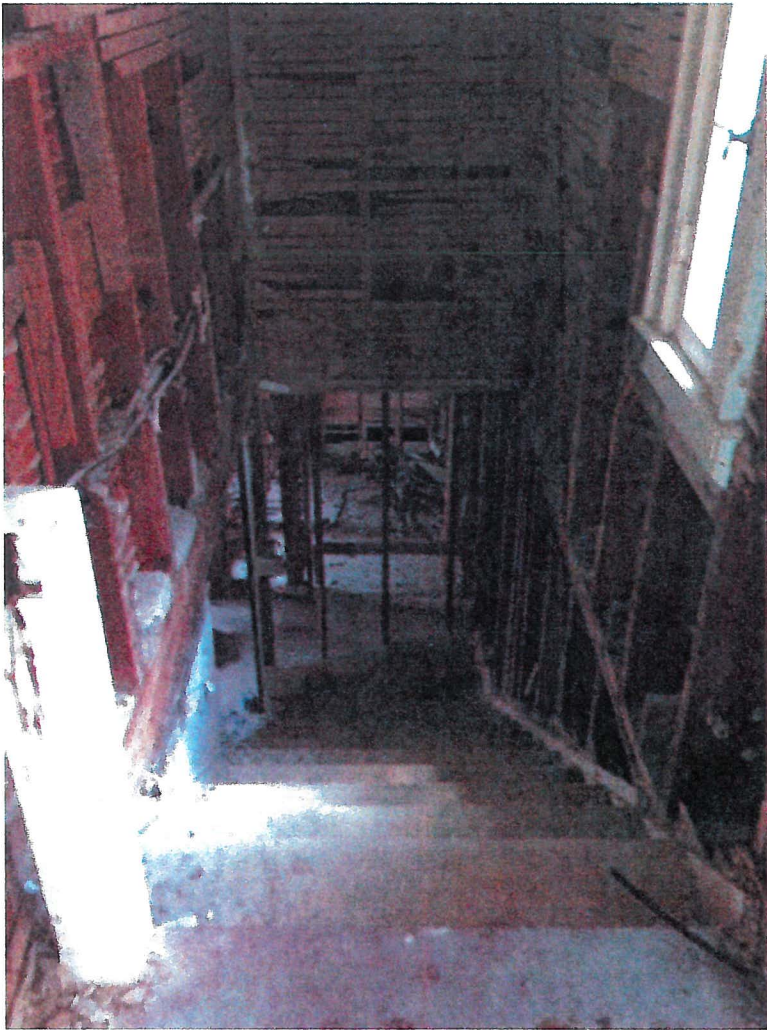
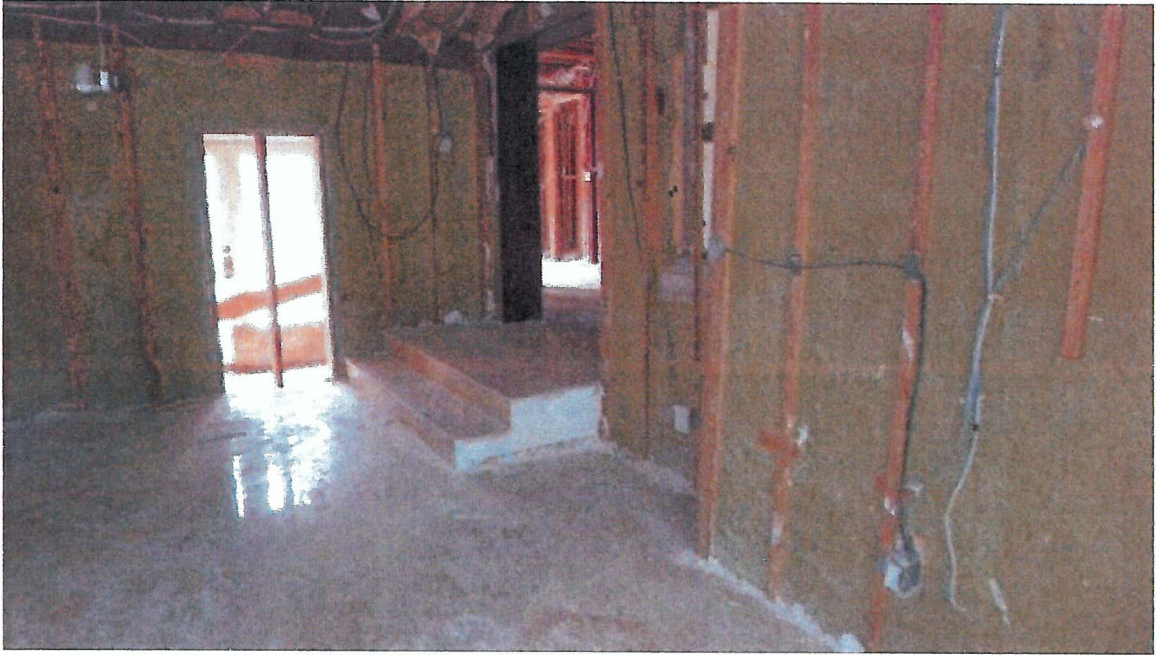
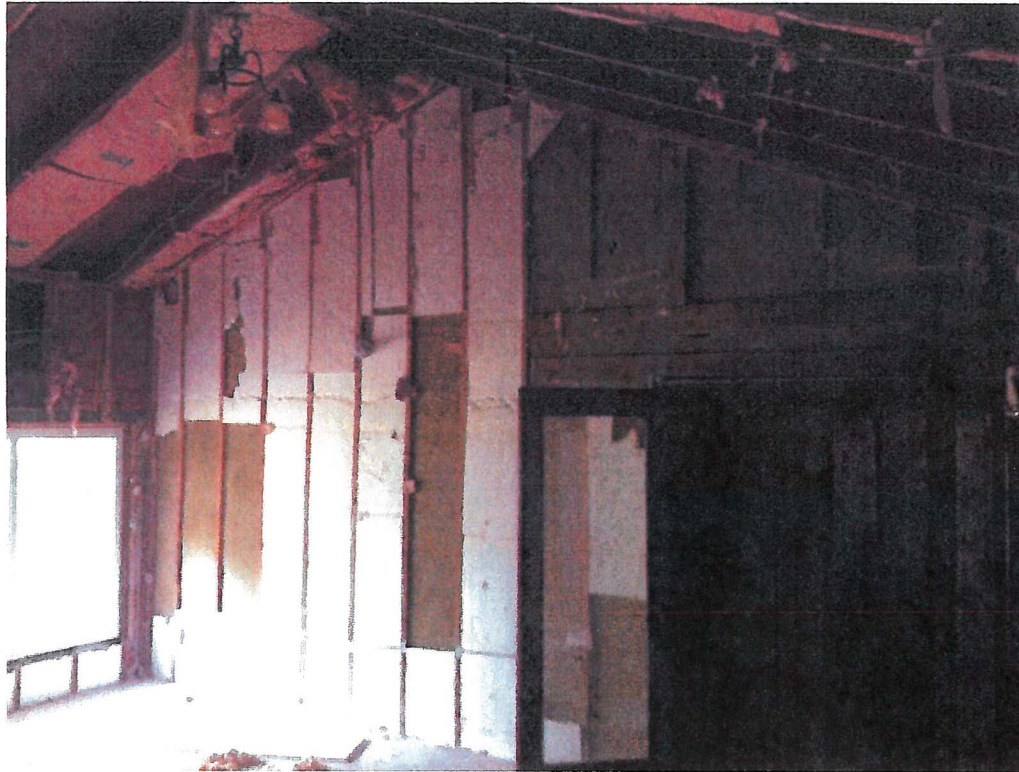
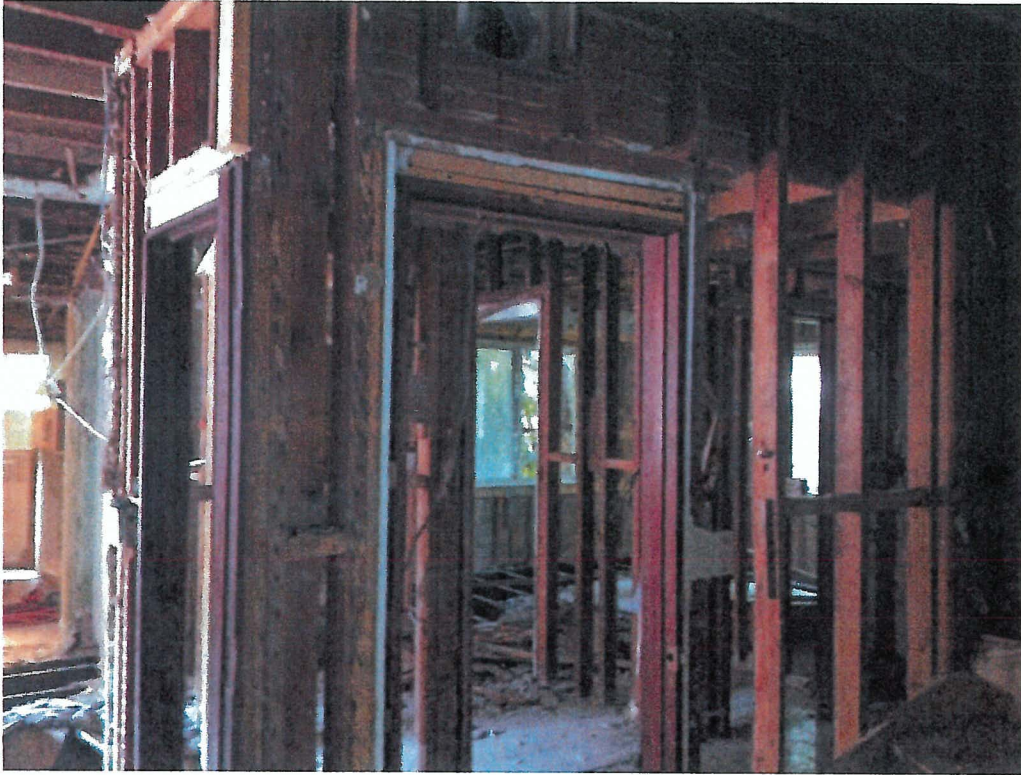
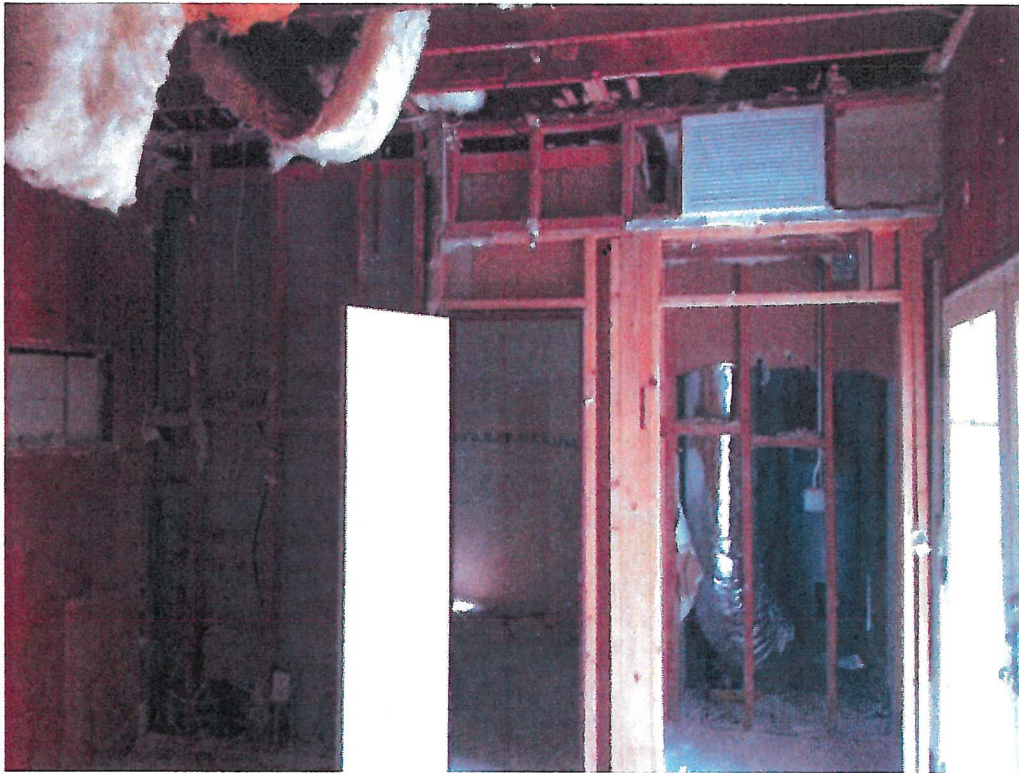
The property was totally gutted by a previous owner. "Before" photos show this work

The entire interior of the property will be renovated and upgraded. New mechanical, electrical and plumbing systems will be installed throughout the home. All leaks will be resolved, and the roof will be rebuilt with barrel tile. The property will receive all new impact casement windows, impact exterior doors, and a new garage door. The interior work will also include new framing, drywall, interior doors, moldings, flooring, kitchen and bathrooms.
