MIAMI-DADE COUNTY
HISTORIC PRESERVATION AD-VALOREM TAX EXEMPTION

PART 1 – PRECONSTRUCTION APPLICATION

Historic/Site Name: Byam Residence

Property Address: 711 University Drive, Coral Gables, FL

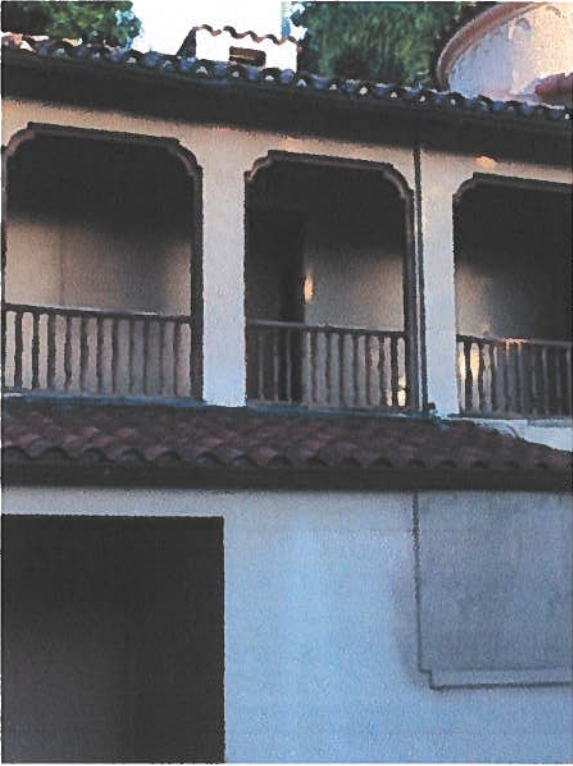
Room: 2nd Floor Corridor #2
Existing Photo Number: 13

FEATURE 3: Exposed Rafters

13a – Restore exposed rafters as required to match original.
