MIAMI-DADE COUNTY
HISTORIC PRESERVATION AD-VALOREM TAX EXEMPTION

PART 1 – PRECONSTRUCTION APPLICATION

Historic/Site Name: Byam Residence

Property Address: 711 University Drive, Coral Gables, FL

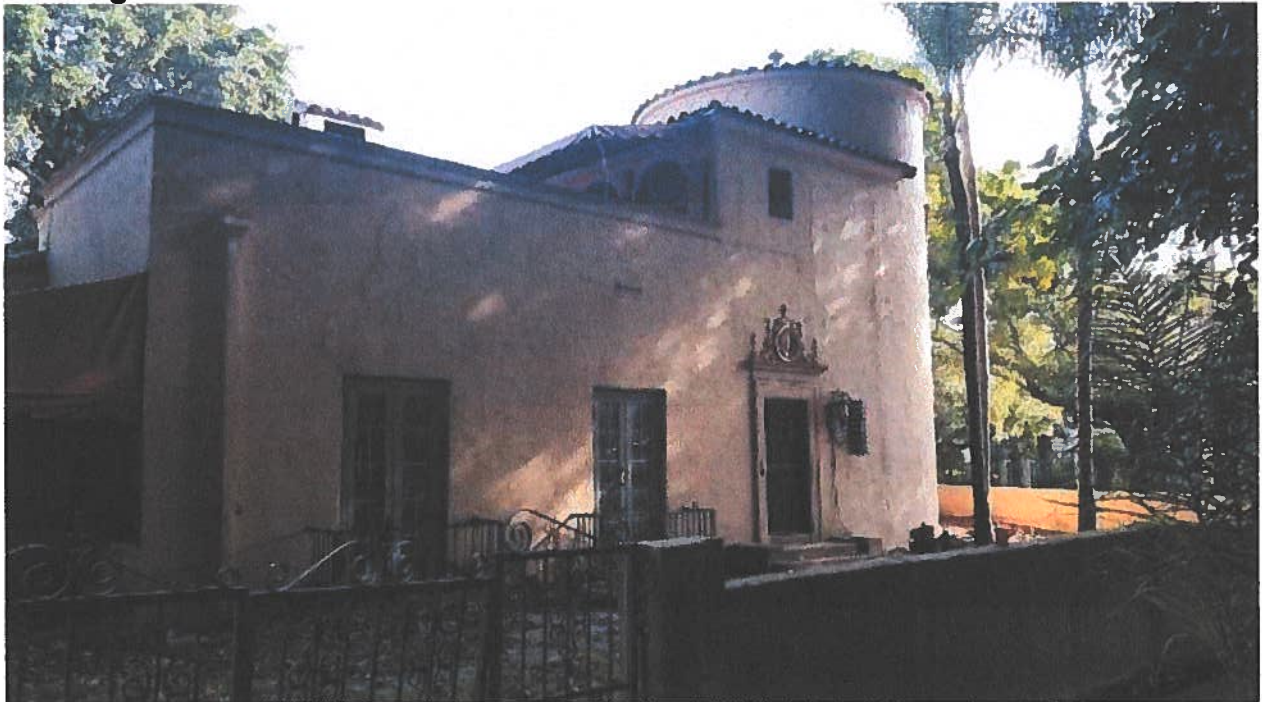
Existing Photo Number: 1

FEATURE 1: Solid Wood Front Door and French Doors

- 1a - Existing wood front door to have security screen removed, and existing door to be repaired and restored.
- 1b- Two French doors to be repaired and restored.

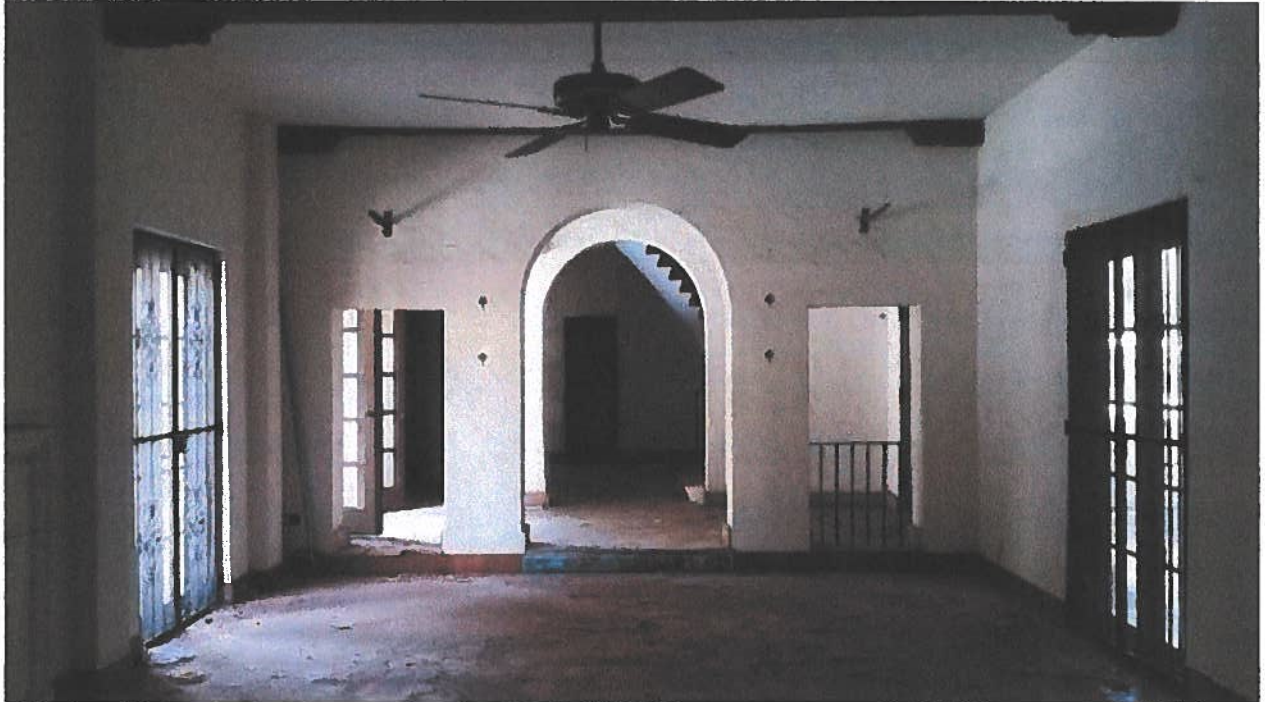
Existing Photo Number: 11

FEATURE 1: Terra Cotta Floor Tiles

11a – Replace existing original damaged Terra Cotta floor tiles with new floor tiles to match existing.

11b – Replace existing original decorative iron railing in living room to match existing on other side of opening.

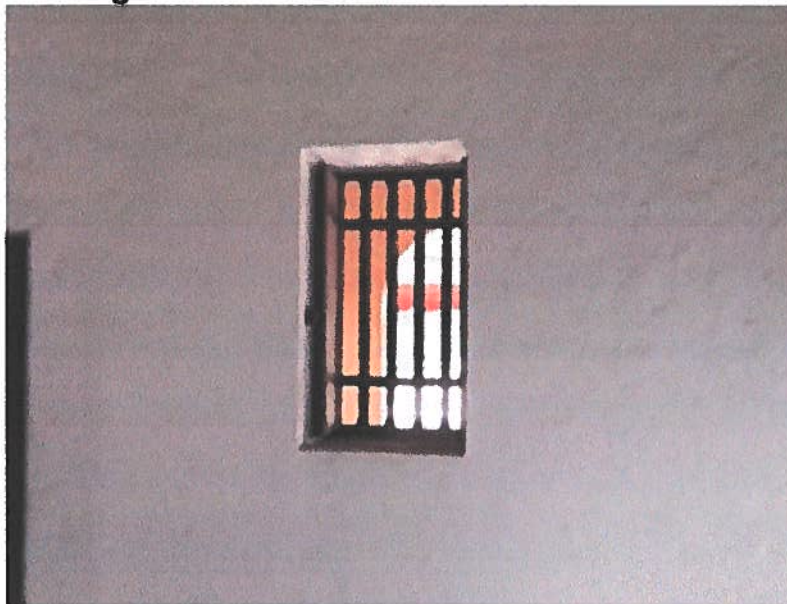
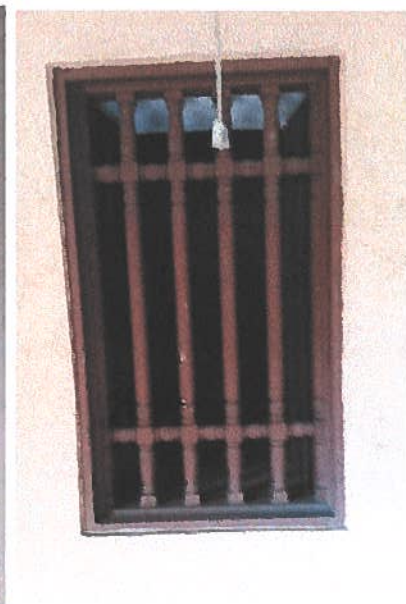
Existing Photo Number: 12

FEATURE 2: Decorative Window Screen

12a – Replace existing original damaged wood spindle window screen with to match existing.

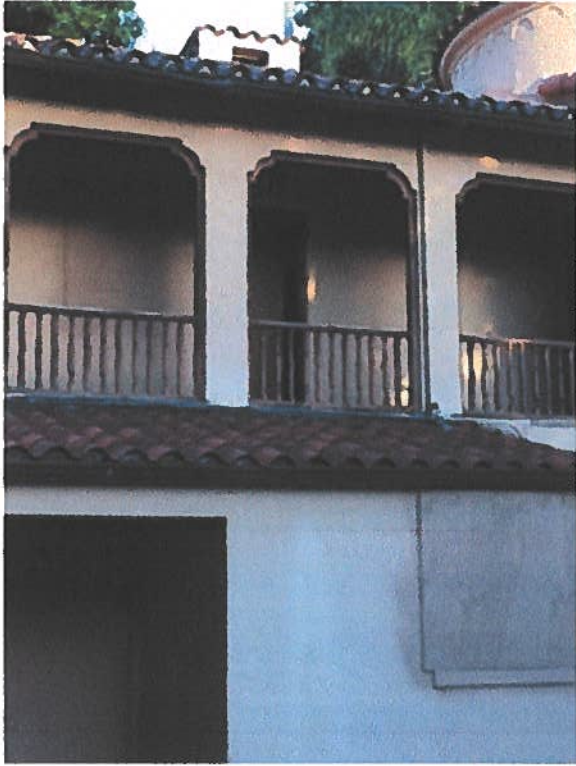
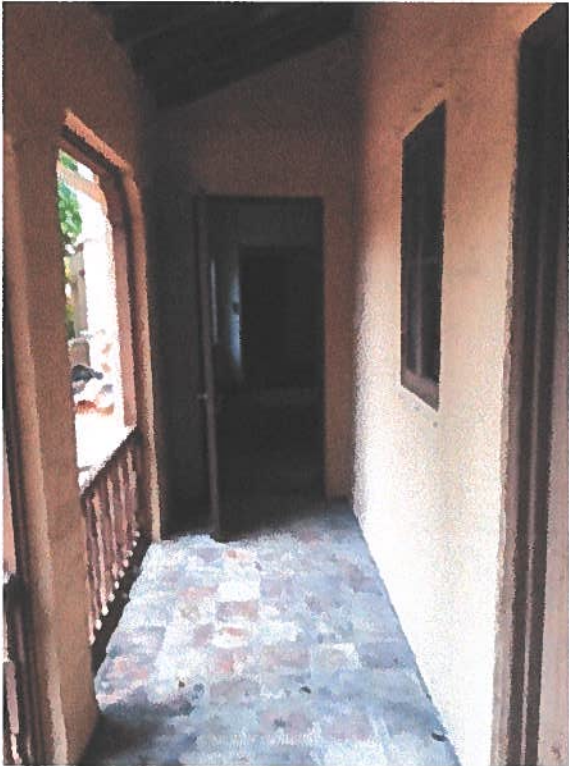
Room: 2nd Floor Corridor #2
Existing Photo Number: 13

FEATURE 3: Exposed Rafters

13a – Restore exposed rafters as required to match original.

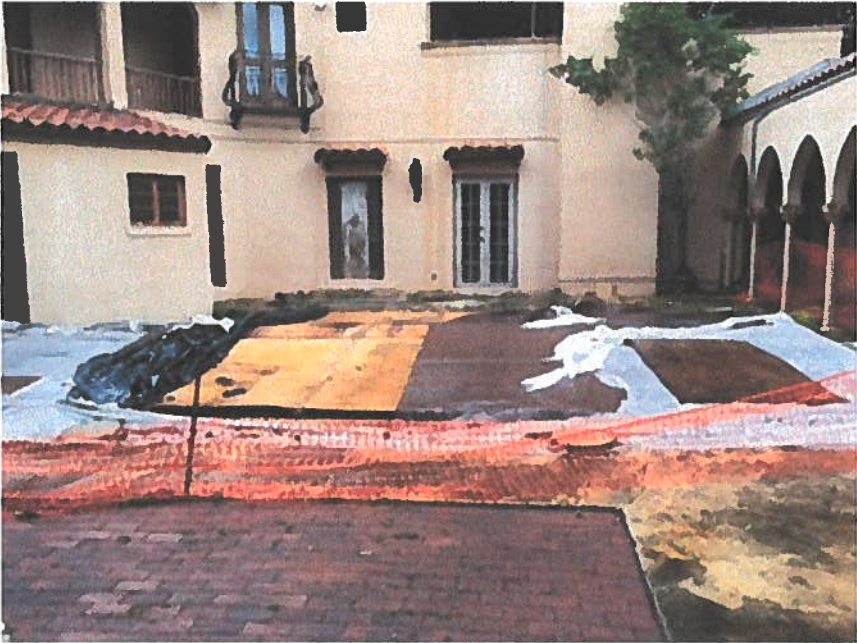
FEATURE 1: Pool
Photo Number: 15

1. *Masonry site walls – Existing masonry site wall in the front and back yards require partial replacement of sections, and repair of other sections. Stucco patching and painting is required.*
2. *The existing pool is in a state of disrepair and needs to be removed.*
3. *The existing driveway and side entry on the East elevation need to be replaced.*

14 - Demolish pool and replace with new pool.
