# CONSERVATION CONSULTATION REPORT AGUSTÍN CÁRDENAS / LE COUPLE

**Date of Report:** October, 17, 2025

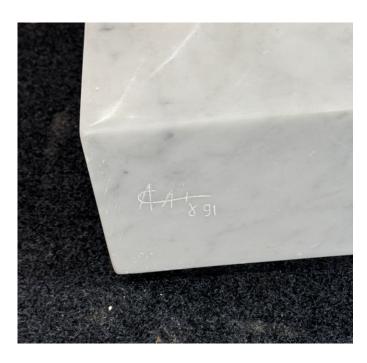
Detail of artist's signature at the base of the sculpture. Possible minor scratches are visible on the corner of the sculpture.
