## CONSERVATION CONSULTATION REPORT

### AGUSTÍN CÁRDENAS / *LE COUPLE*

**Date of Assessment:** N/A  
**Date of Report:** October, 17, 2025

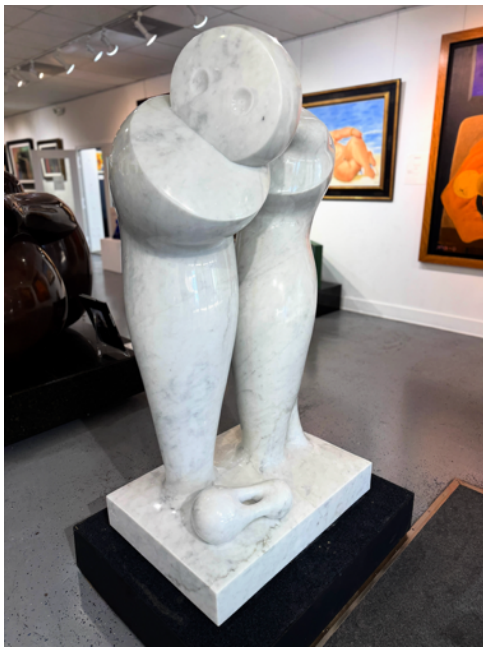
*Overall image of sculpture.  
Image from appraiser's report.*

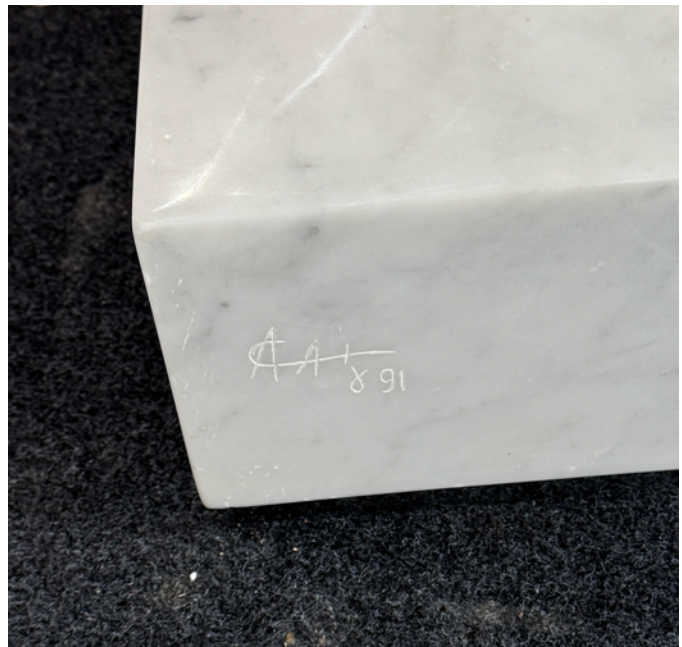
*Detail of artist's signature at the base of the sculpture. Possible  
minor scratches are visible on the corner of the sculpture.  
Image from appraiser's report.*
