# APPRAISAL OF REAL PROPERTY

1258 Obispo Ave  
Coral Gables, FL 33134  
Lots 1 and 2 , Block 3, Coral Gables, Section E, PB 8-13

LAND APPRAISAL REPORT

STRUCTURAL INSPECTION IN A SINGLE FAMILY RESIDENCE.

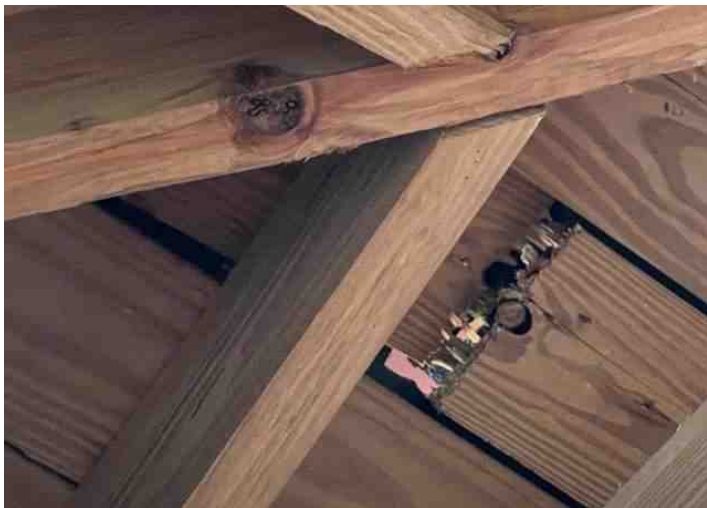
- As results of the termites infection, the water intrusion and the house aging, the stability and carrying capacity of some structural wood elements were affected and the deterioration can continue increasing.

Wood Rot in Trusses

- 1-The roofing system and tiles, the roof plywood sheathing, and a big portion of the roof wood joists, the ceiling wood joists, must be removed and replaced. Also, we strongly recommend to cover the whole house with a tent and fumigate in order to eliminate any possibility of alive termites and avoid any future deterioration of the wood elements.
- 2-The wood floor and subfloor and maybe a significant portion of the wood joists at ground floor need to be replaced, also we recommend to brace the exterior CMU walls to the ground floor wood joists (above the crawl space) w/ some connectors, in order to reduce the wall slenderness for lateral wind suction.
- 3-All the exterior windows and doors must be replaced.

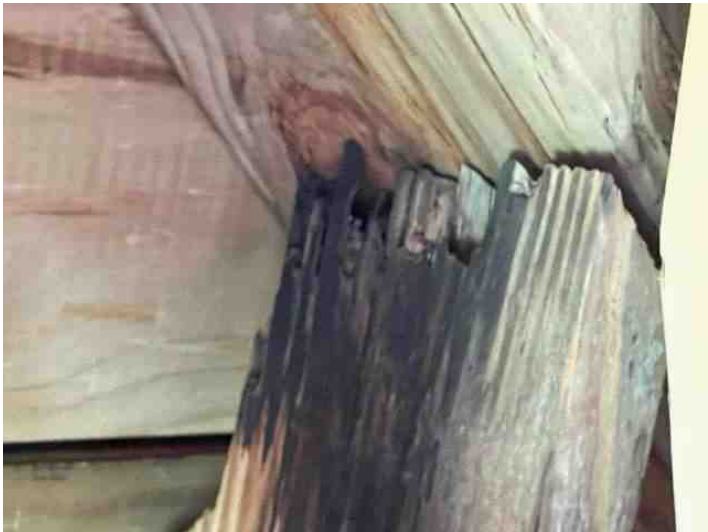
Wood Rot in Trusses

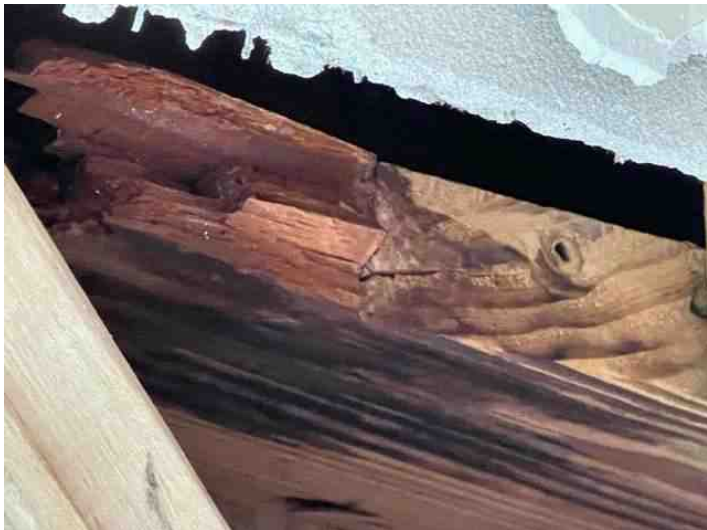
Wood Rot in Trusses

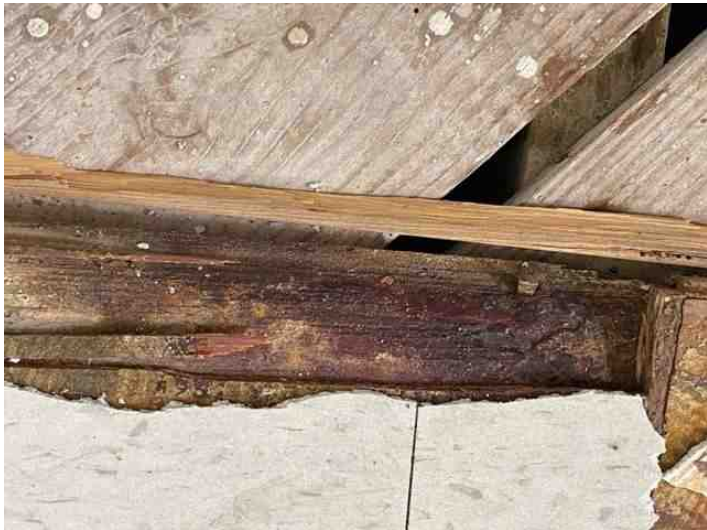
- The house was infested by termites. It was observed in many places traces of termites. For example wood ceiling joists, wood joist or rafters, wood floors planks, wood floor joists, and windows and doors wood framings.

Termite Damage
