## PART TWO

### 2907 Columbus Boulevard ARCHITECTURAL FEATURES

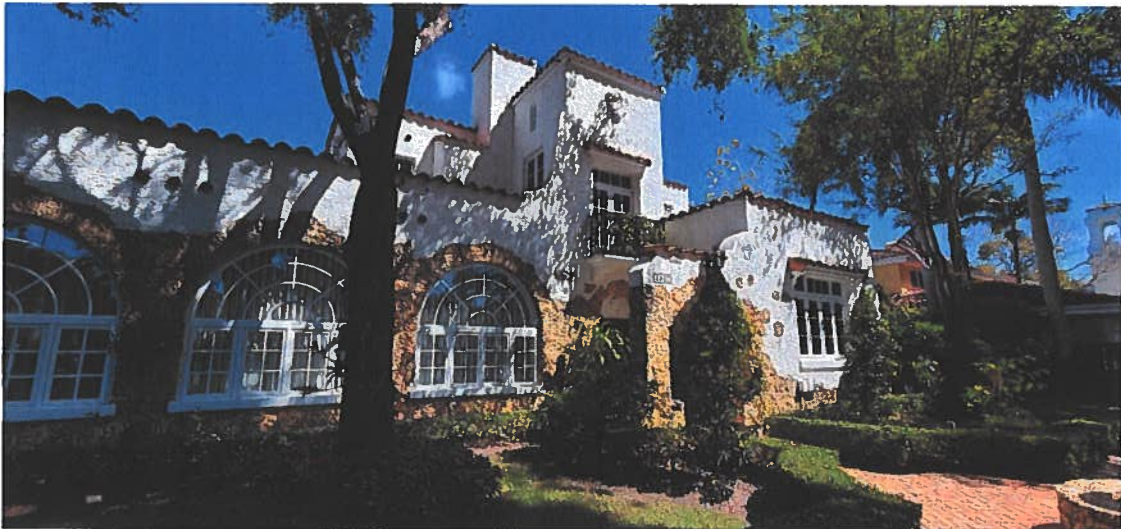
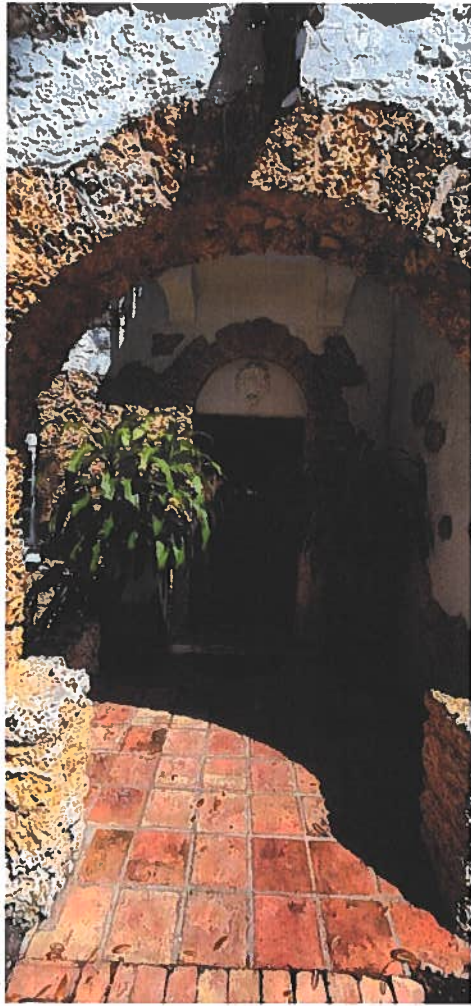
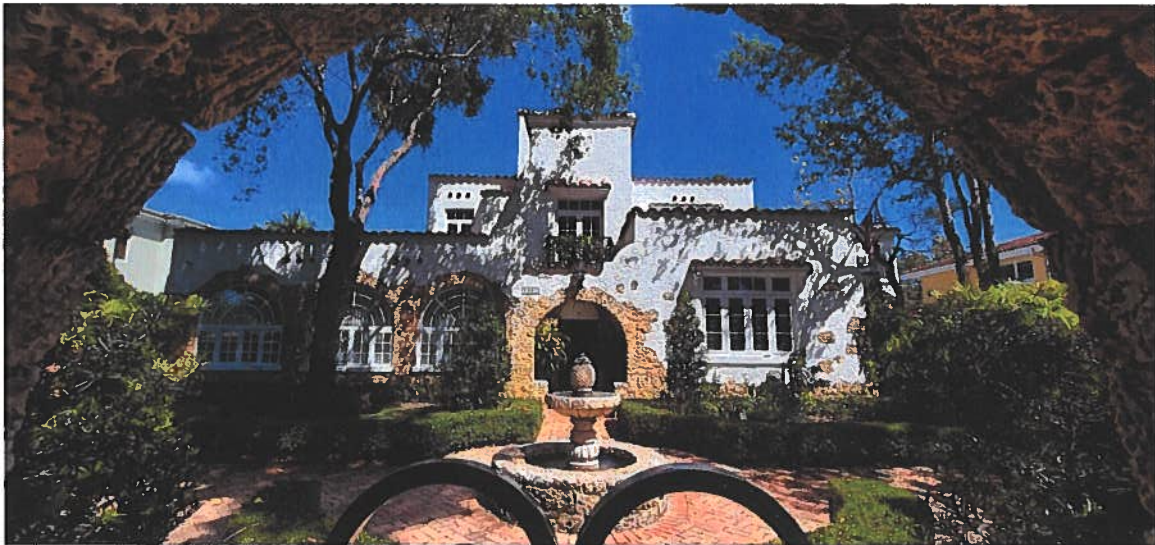
**Photo Number: 1, 2, 3, 4**

**Elevation: Front (west)**

**Description:** As described, the existing massing remained, all of the existing windows and doors were replaced in the original configuration (including transoms) and color as originally built (white). The tiled window awnings were removed only to leave the original ones. All decorative tiled window sills were removed.

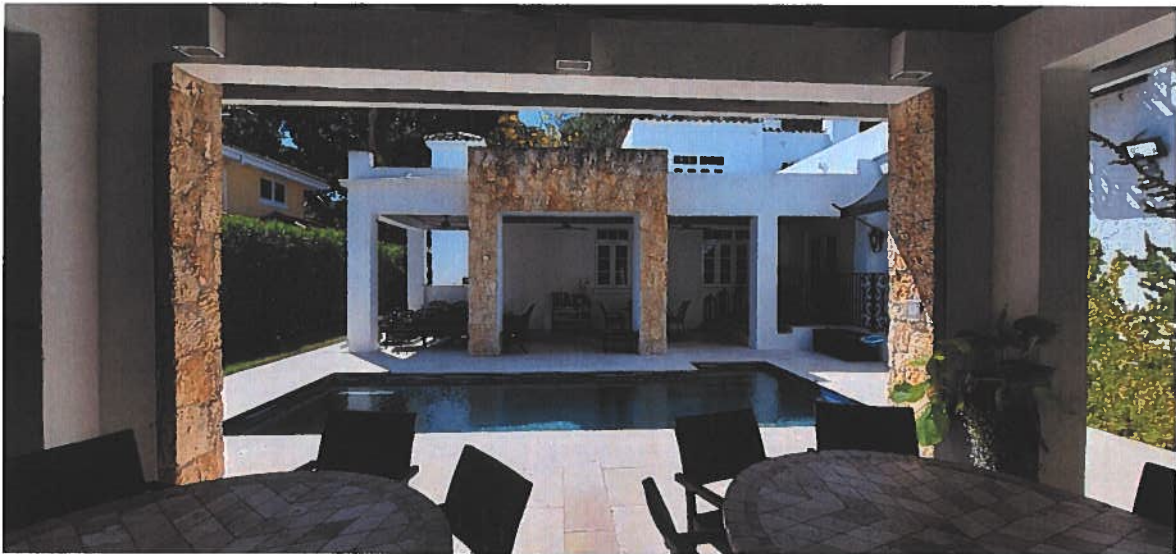
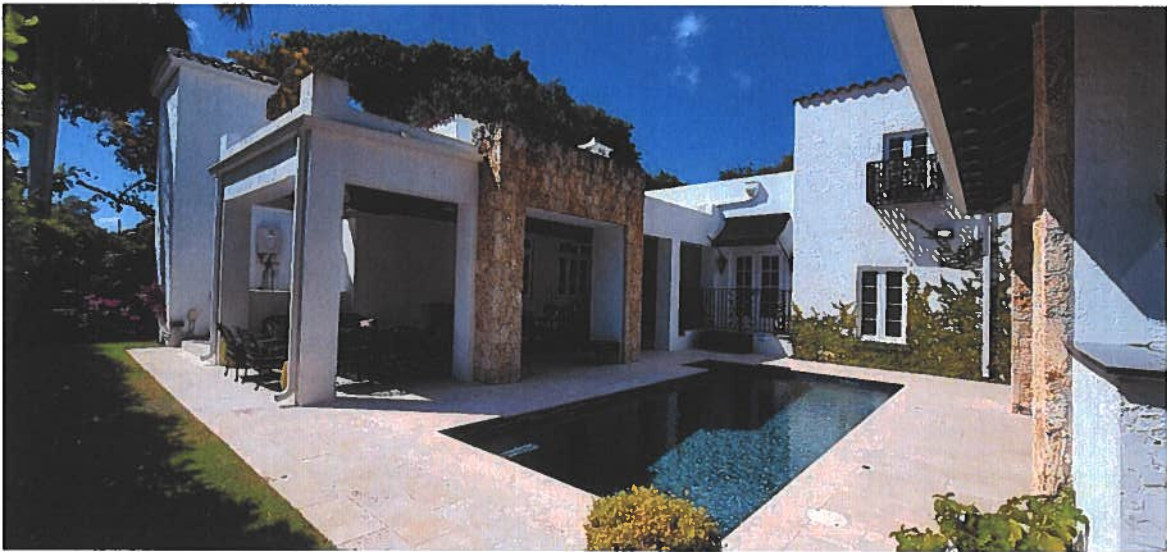
**Photo Number: 6,7**

**Elevation: Rear (east)**

**Description: A covered terrace was added however all of the existing windows and doors were replaced in the original configuration (including transoms) and color as originally built (white). All decorative tiled window sills were removed.**

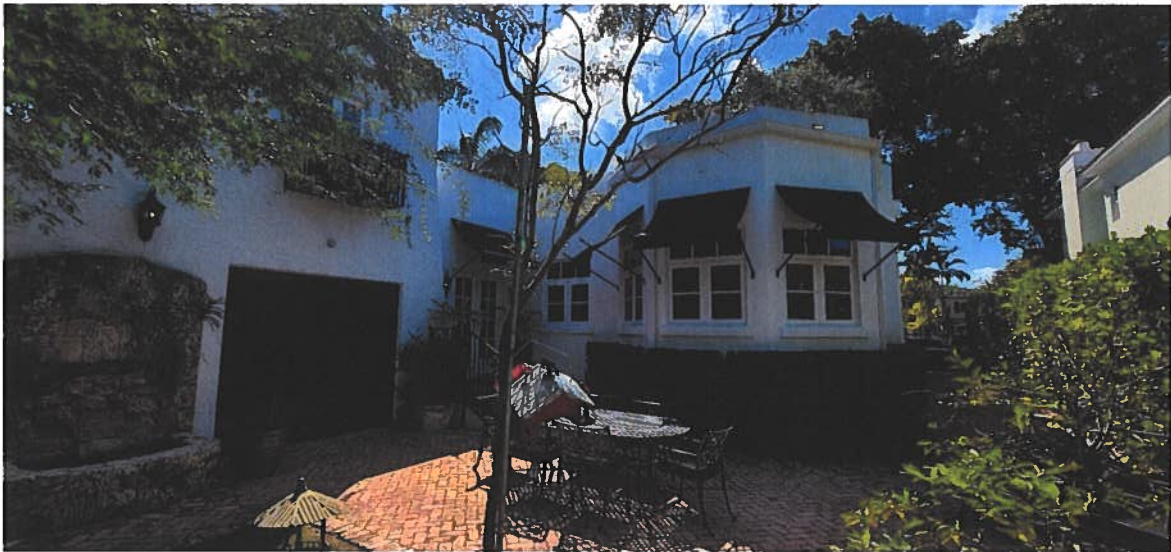
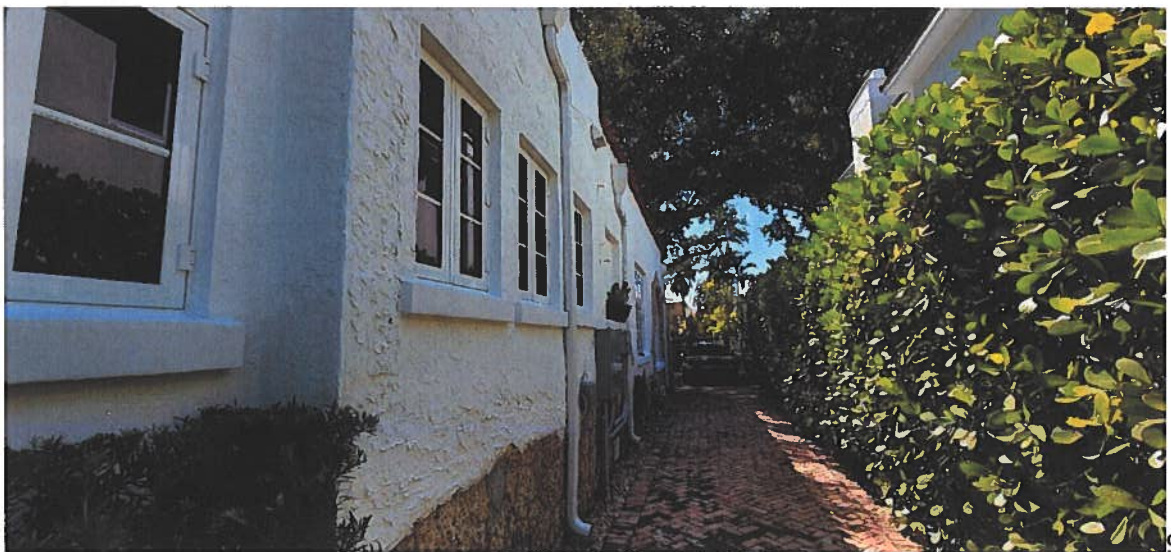
Photo Number: 8,9

Elevation: Side (north)

Description: Proposed windows in kitchen expansion followed similar configuration to existing windows. All of the existing windows and doors were replaced in the original configuration (including transoms) and color as originally built (white). The tiled window awnings were removed . All decorative tiled window sills were also removed.

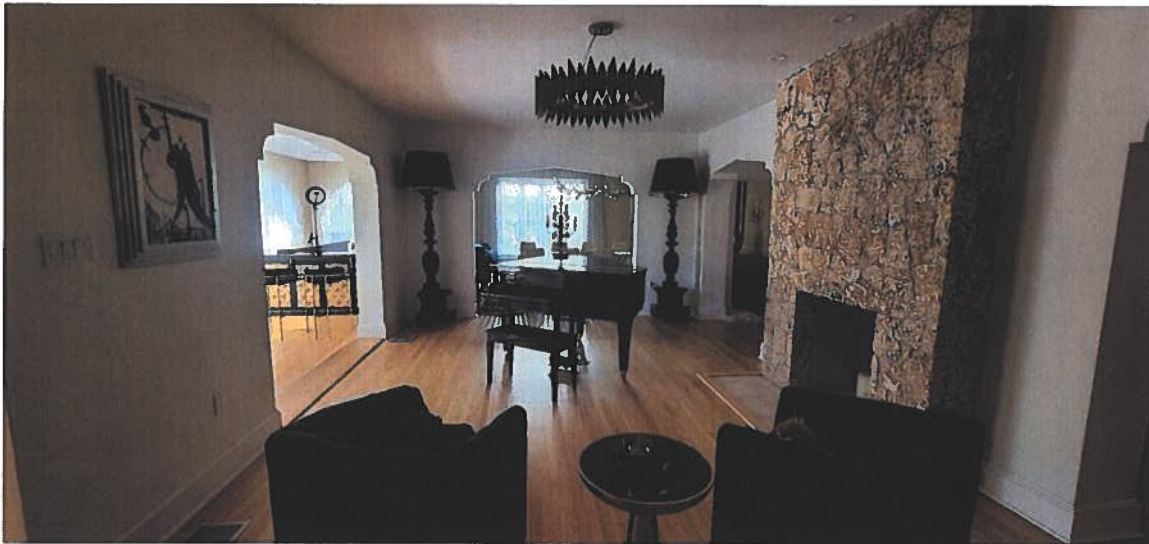
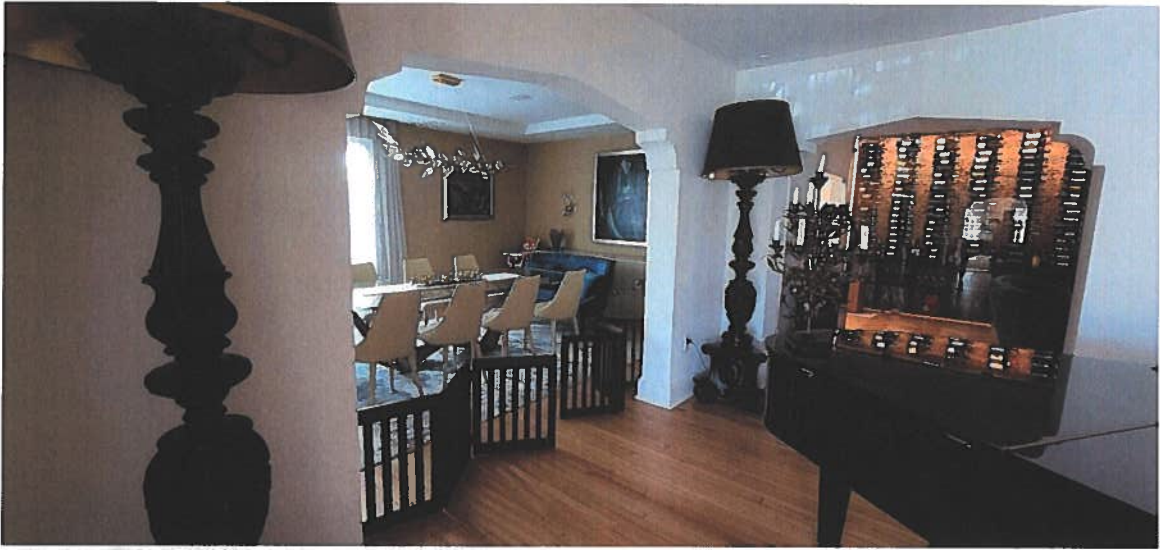
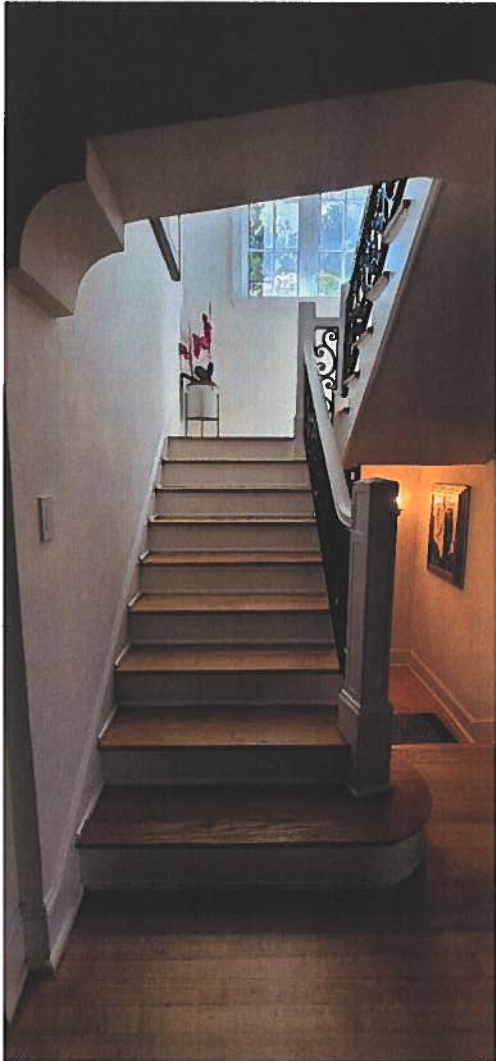
**Photo Number: 10, 11, 12, 13**

**Room: Living / Dining**

**Description: Decorative arches, wood floor, baseboards and crown moldings were preserved**
