# PROPERTY APPRAISER OF MIAMI-DADE COUNTY

| PROPERTY INFORMATION | | | | |
|---|---|---|---|---|
| Property Address | 4800 LE JEUNE RD<br>CORAL GABLES, FL 33146-0000 | | | |

## Thermography Report

4800 Lejuene Road Coral Gables, FL 33146, is a Three-Story Commercial Building. Main is located in Meter Room. This Building has 6 Main Disconnects in Meter Room. The majority of this buildings mains and panels are currently inactive because this building has no current occupants. Infrared was done on only active Electrical Equipment that is connected. Pictures will be provided with Electrical Report on inactive units. (Active Units) Main (1 of 6) 800 Amp Three-Phase 120/208v; Main (5 of 6) (House) 100 Amp Three-Phase 120/208v and Main (6 of 6) (Elevator) 100 Amp Three-Phase 120/208v. (Inactive Mains) Main (2 of 6) 225 Three-Phase 120/208; Main (3 of 6) 225 Three-Phase 120/208 and Main (4 of 6) 225 Three-Phase 120/208. Further detail information provided with each Thermographic picture taken. Upon completion of inspection on April 16, 2024 no major anomalies were found through Infrared Thermographic Inspection. Visual Inspection of Mains and Panels was also conducted and did not identi

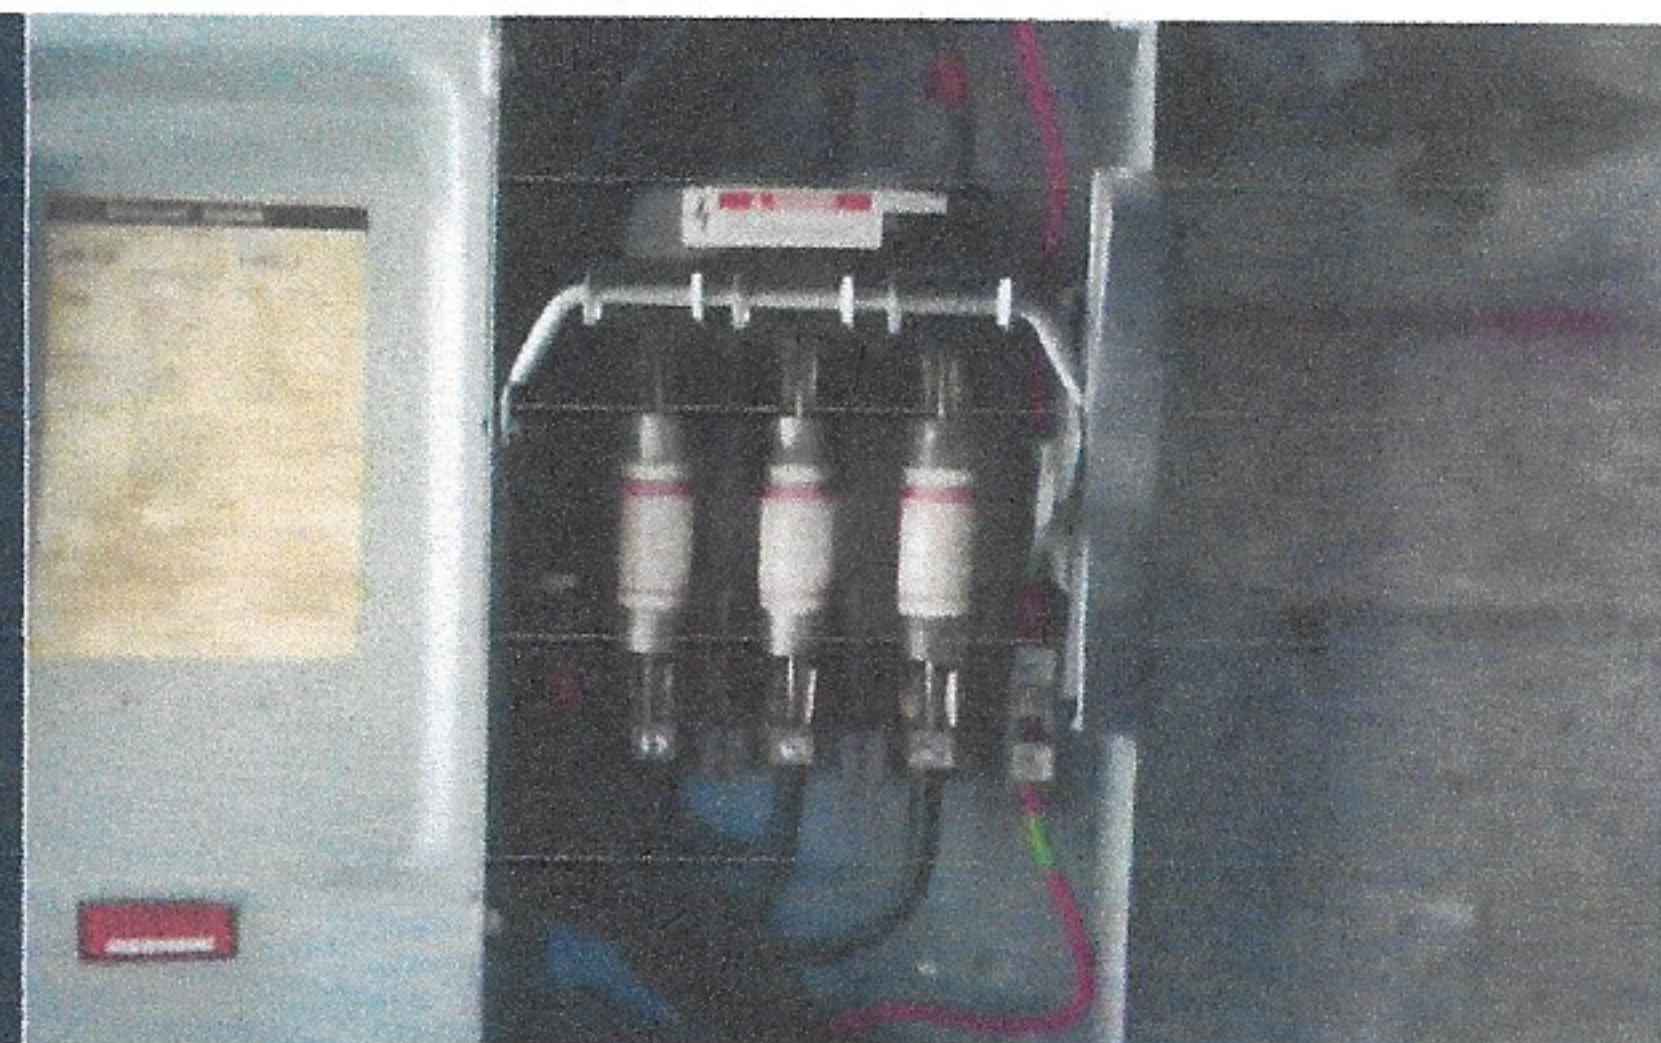
4800 Elevator Sub.jpeg

| Measurements | |
|---|---|
| R1:Max. Temp. | 85.3°F |
| R1:Min. Temp. | 74.7°F |

| Remarks | |
|---|---|
| <u>Anomaly:</u> | None Detected |

| Remarks | |
|---|---|
| <u>Recommendation:</u> | None at this time. |

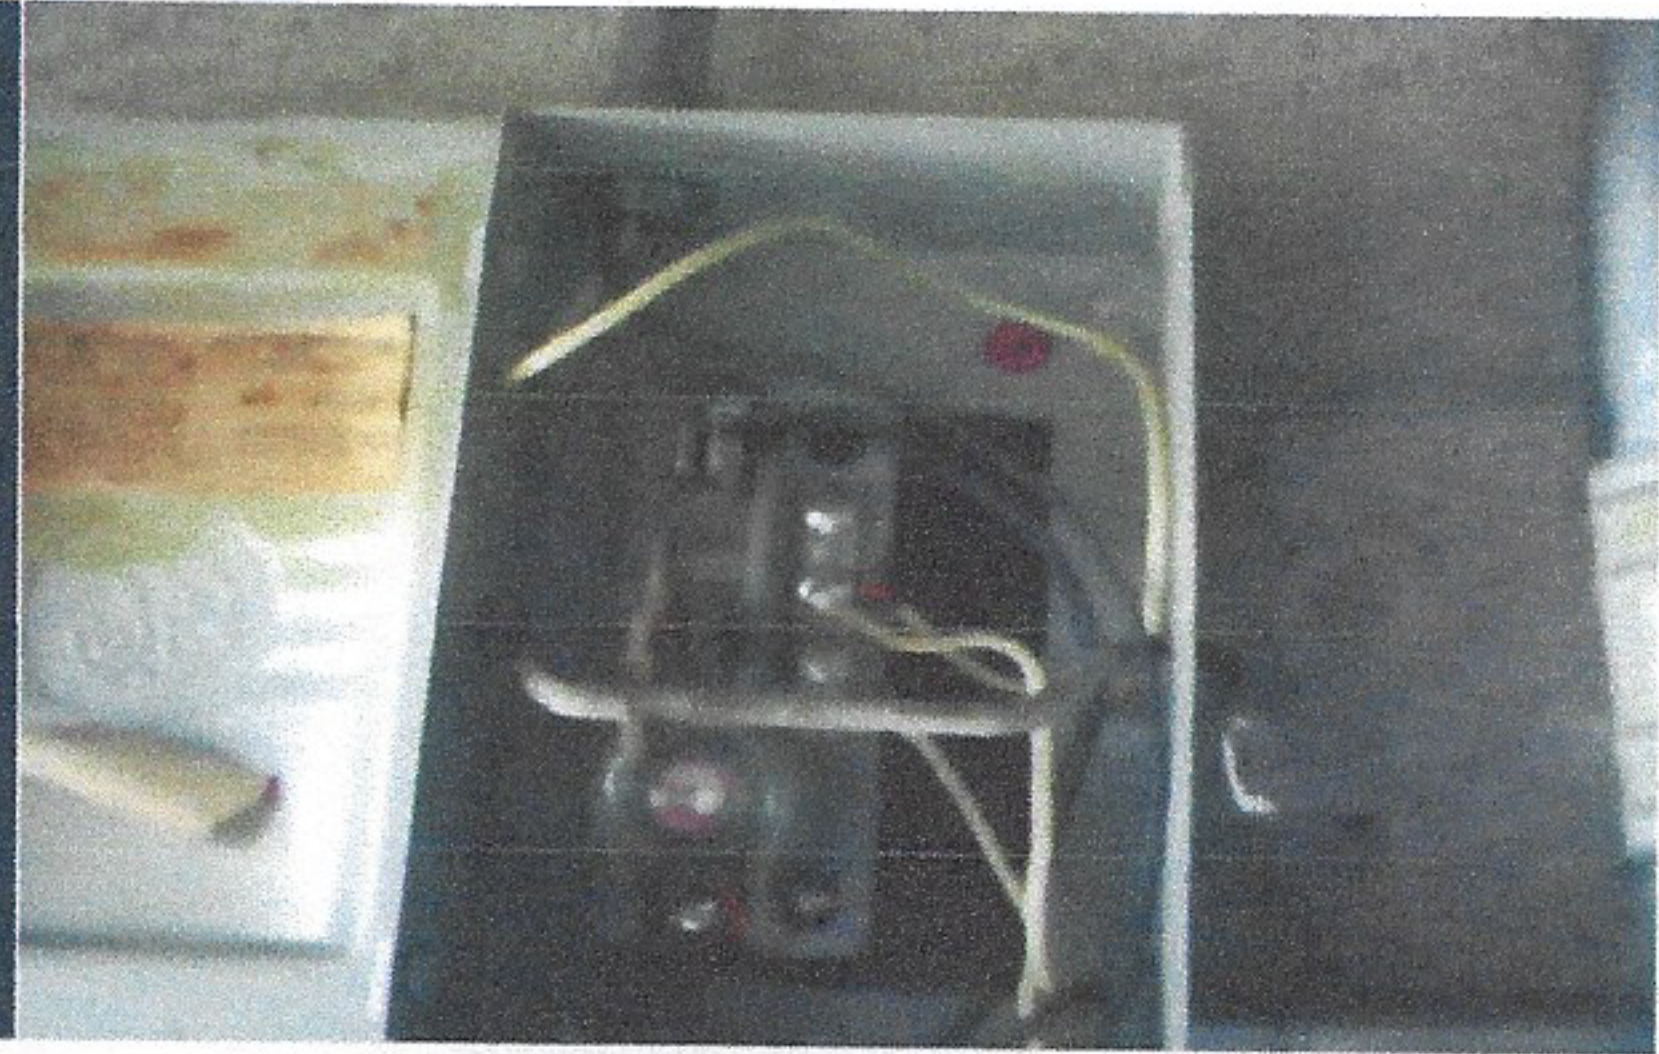
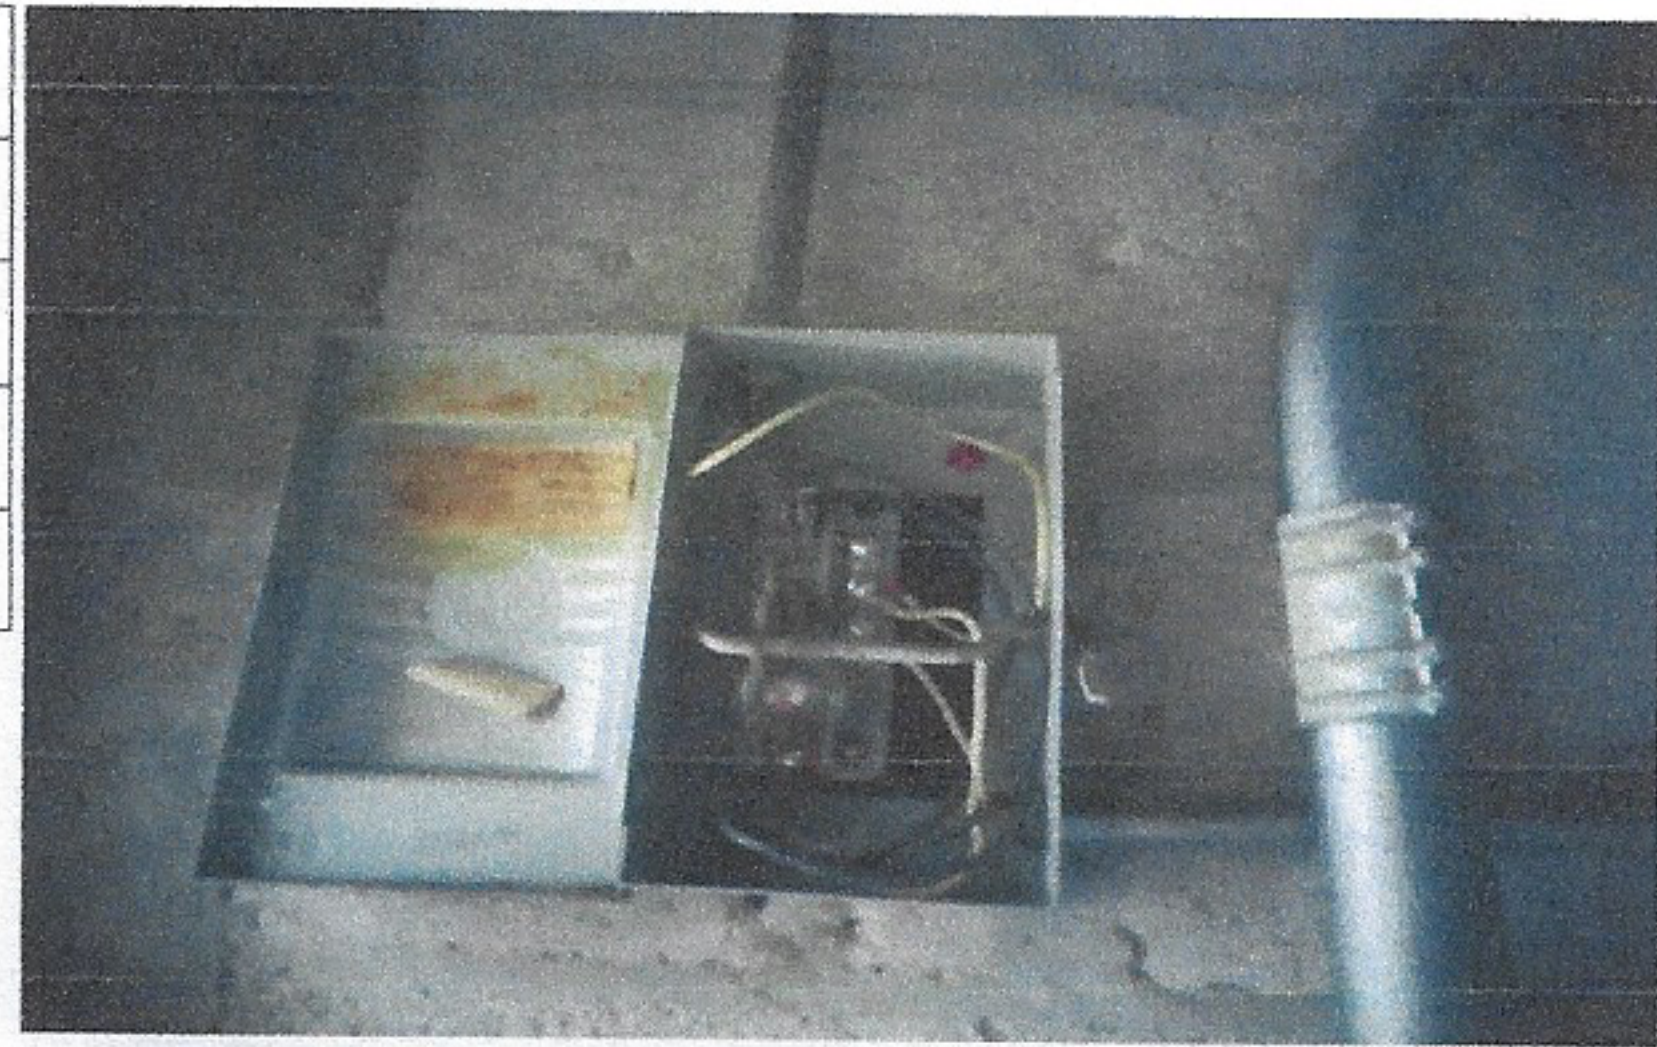
4800 Cab Light Sub.jpeg

| Measurements | |
|---|---|
| R1:Max. Temp. | 84.6°F |
| R1:Min. Temp. | 74.5°F |

| Remarks | |
|---|---|
| <u>Anomaly:</u> | None Detected |

| Remarks | |
|---|---|
| <u>Recommendation:</u> | None at this time. |

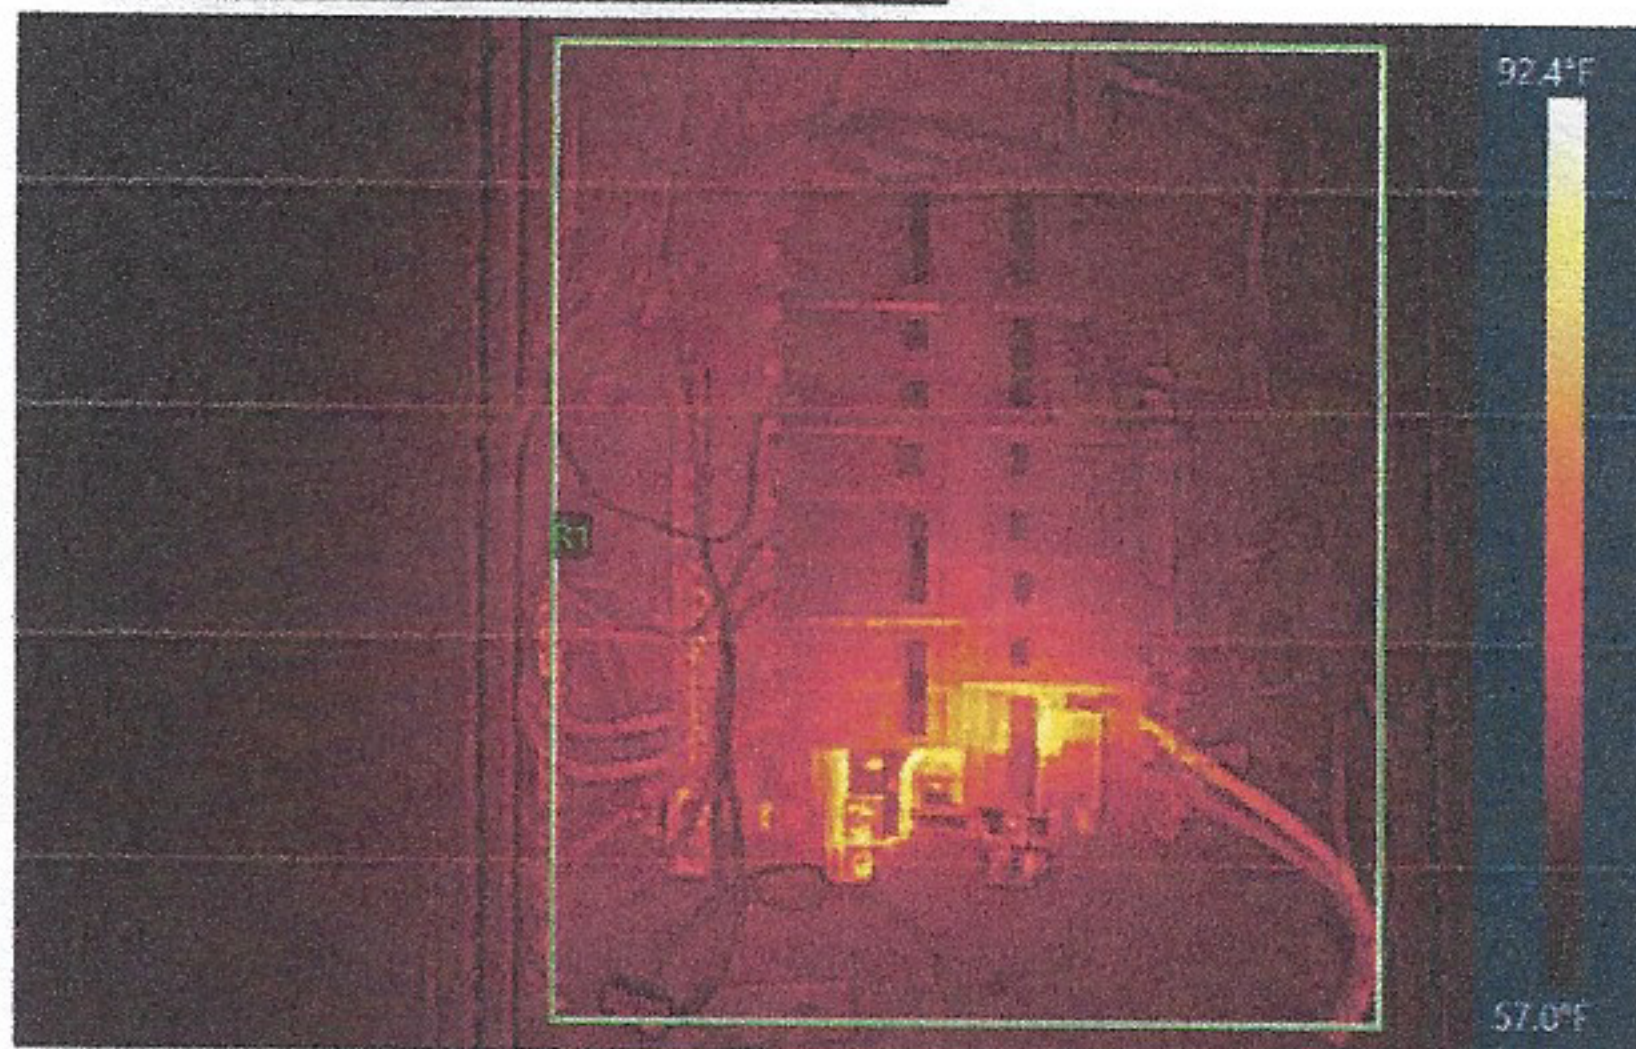
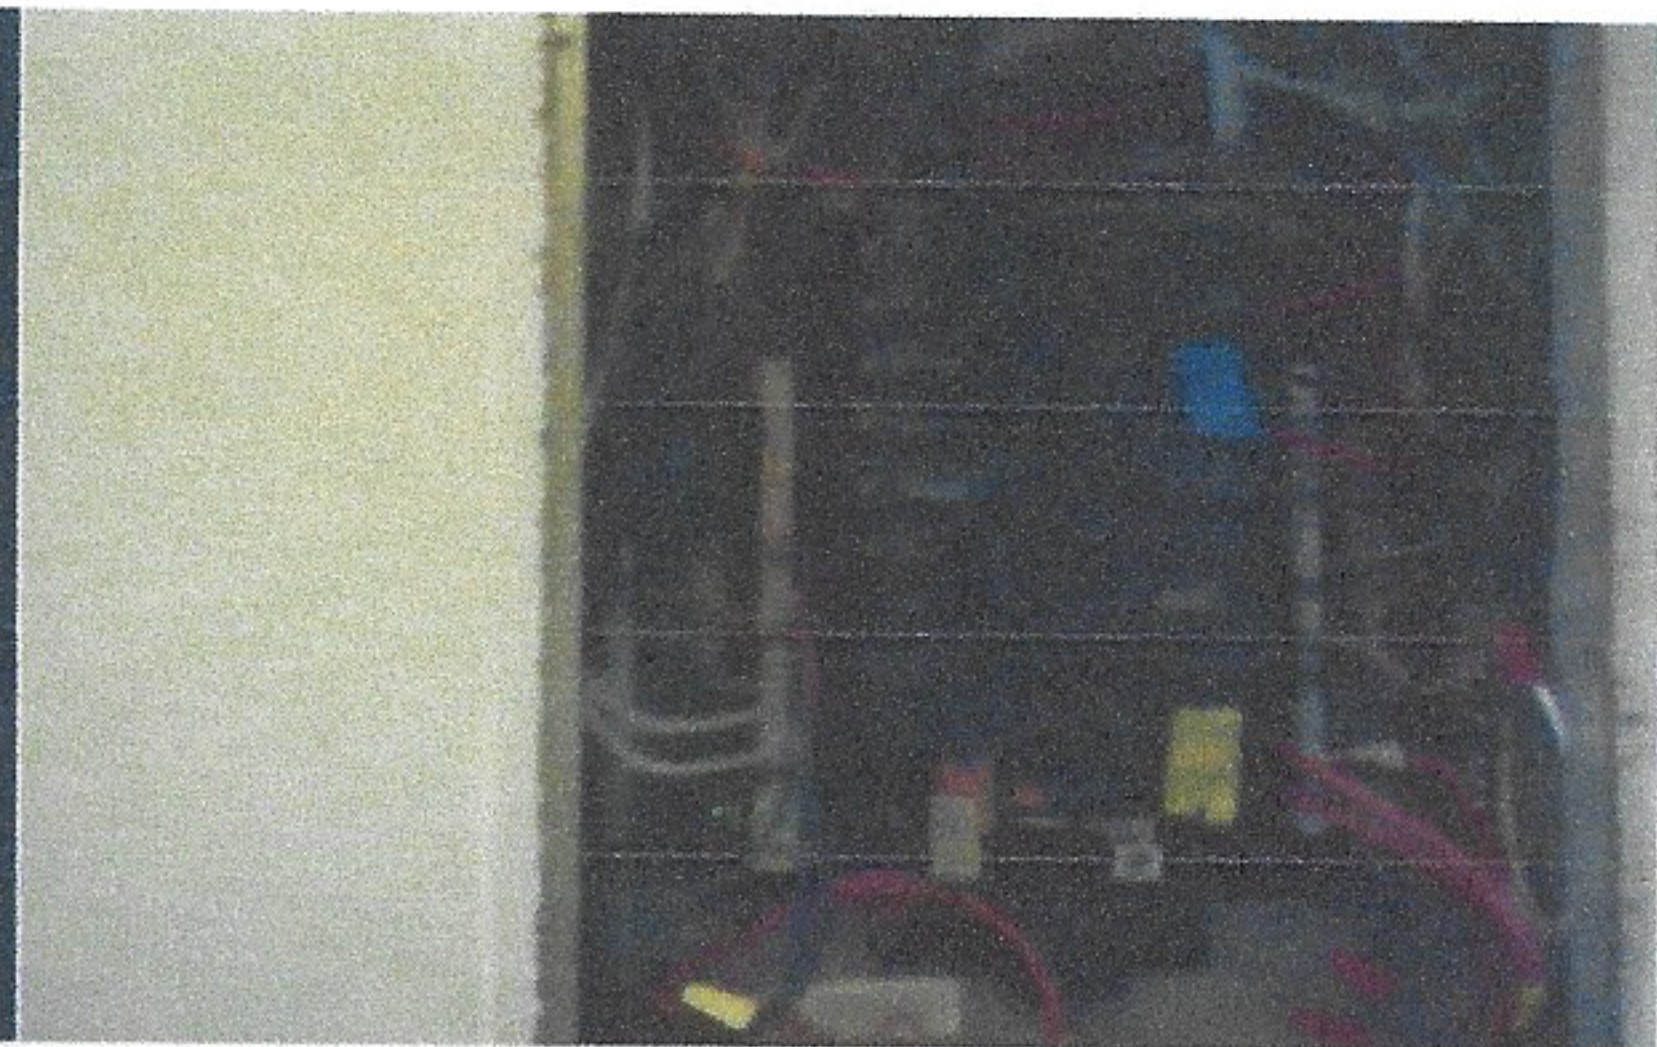
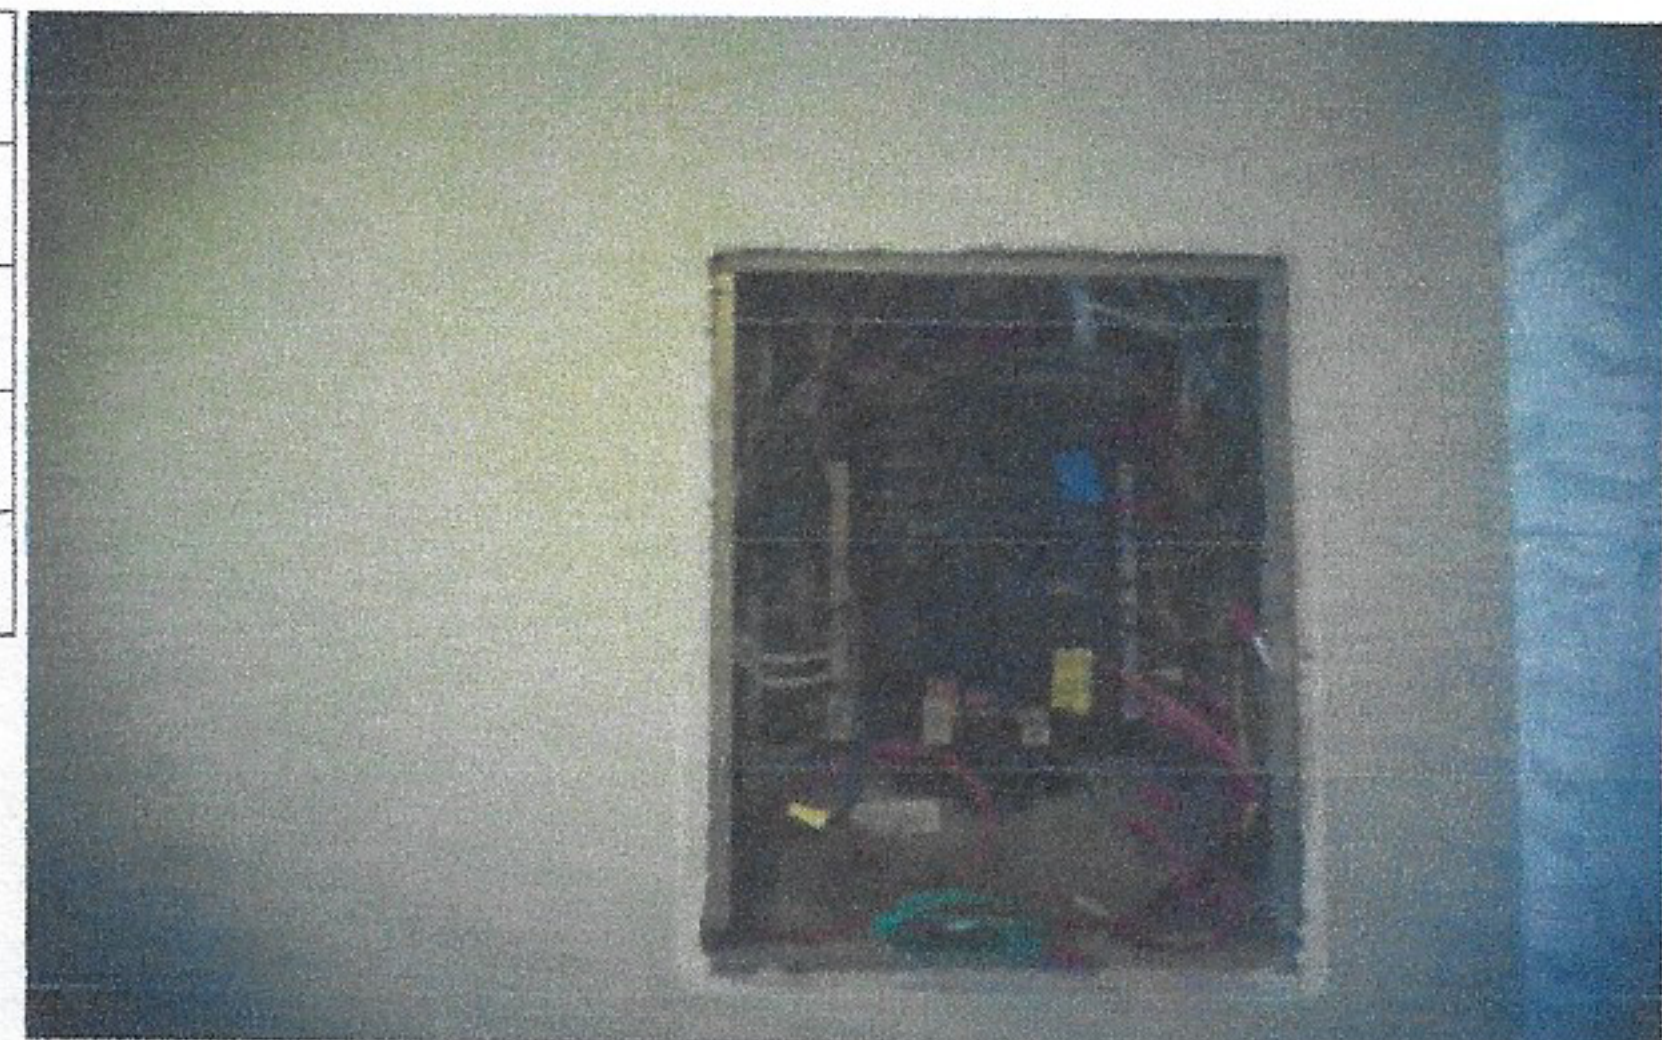
4800 Lejuene Road Panel D.jpeg

| Measurements | |
|---|---|
| R1:Max. Temp. | 89.4°F |
| R1:Min. Temp. | 58.1°F |

| Remarks | |
|---|---|
| <u>Anomaly:</u> | None Detected |

| Remarks | |
|---|---|
| <u>Recommendation:</u> | None at this time. |

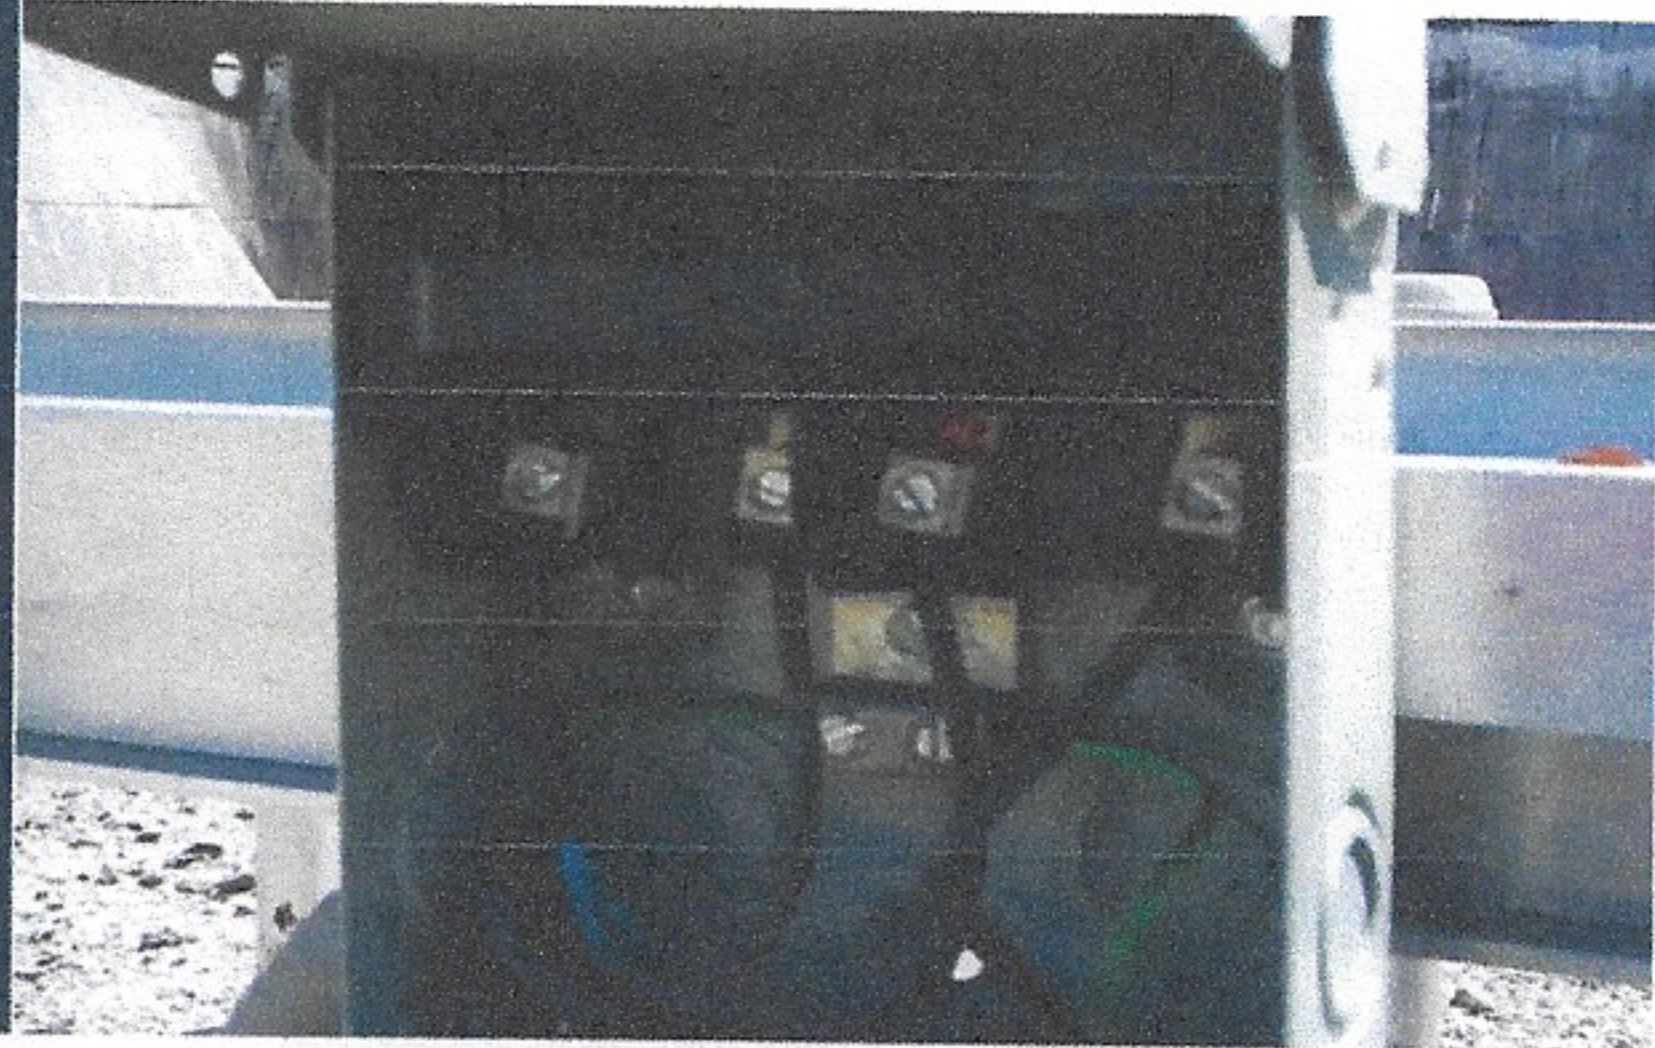
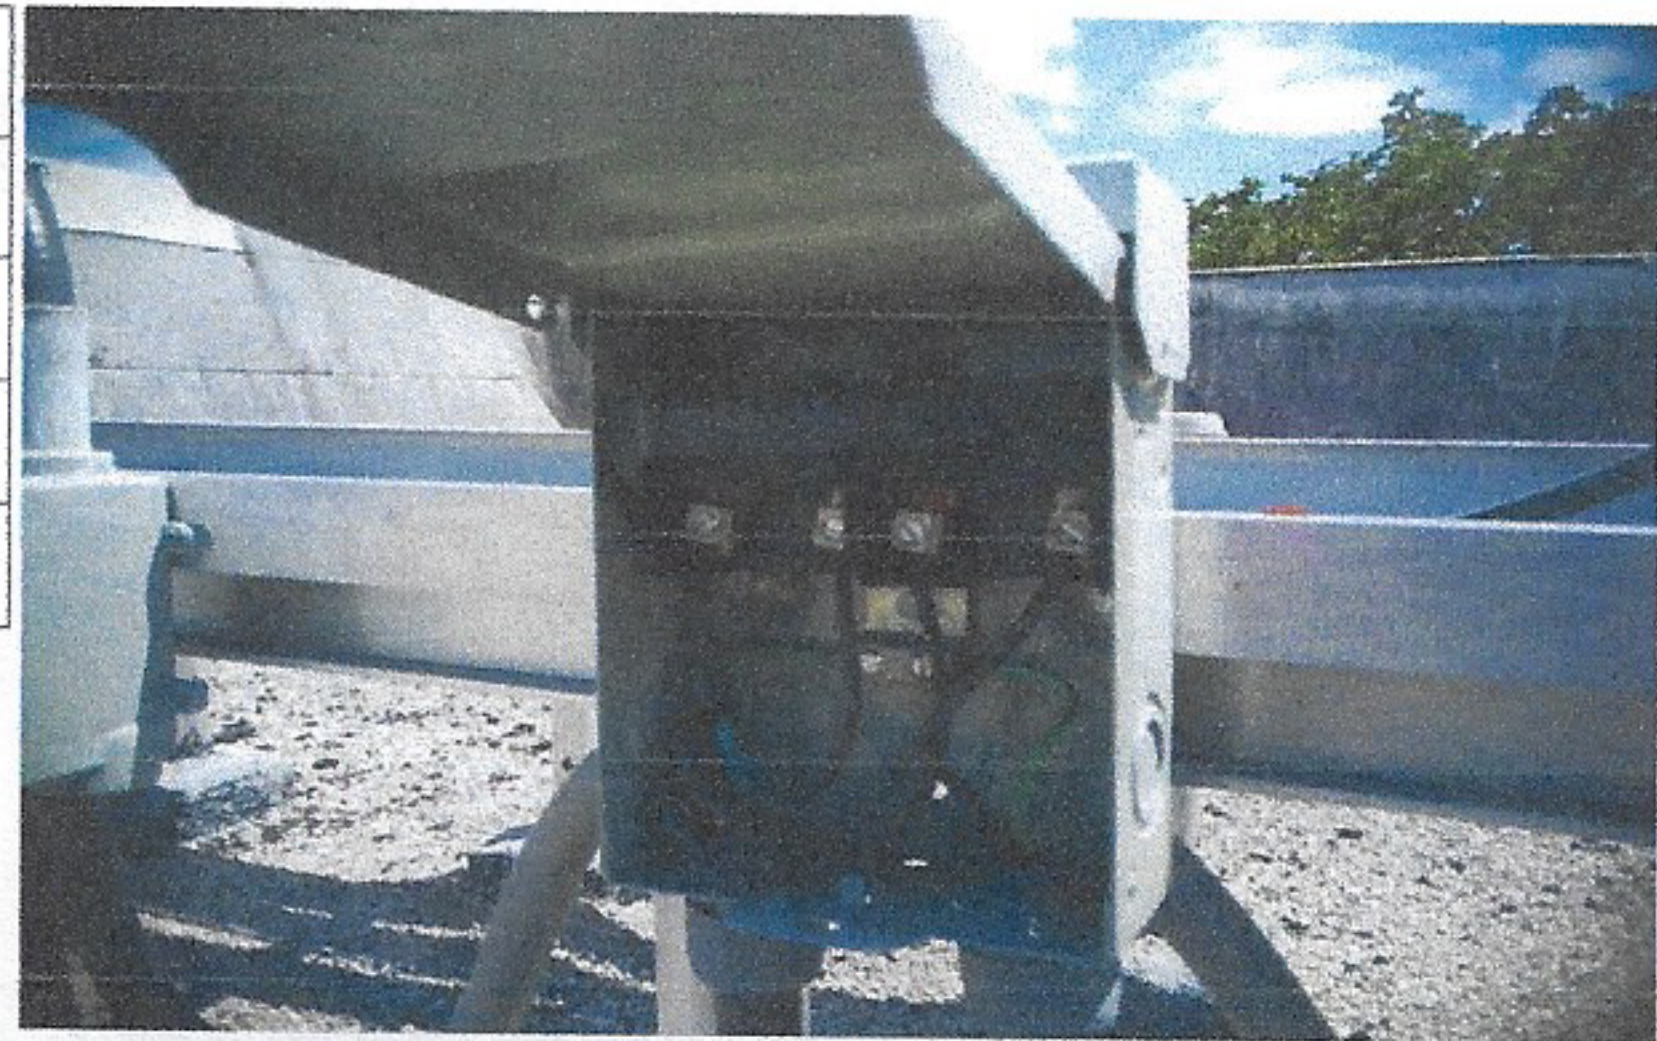
4800 AC DC 1.jpeg

| R1:Max. Temp. | 114.4°F |
| R1:Min. Temp. | 69.1°F |

Location: Roof  
Unit/Equipment: AC Disconnect #1/ 30 Amp/ Single-Phase/ 120/208v  
Anomaly: None Detected  
Recommendation: None at this time.

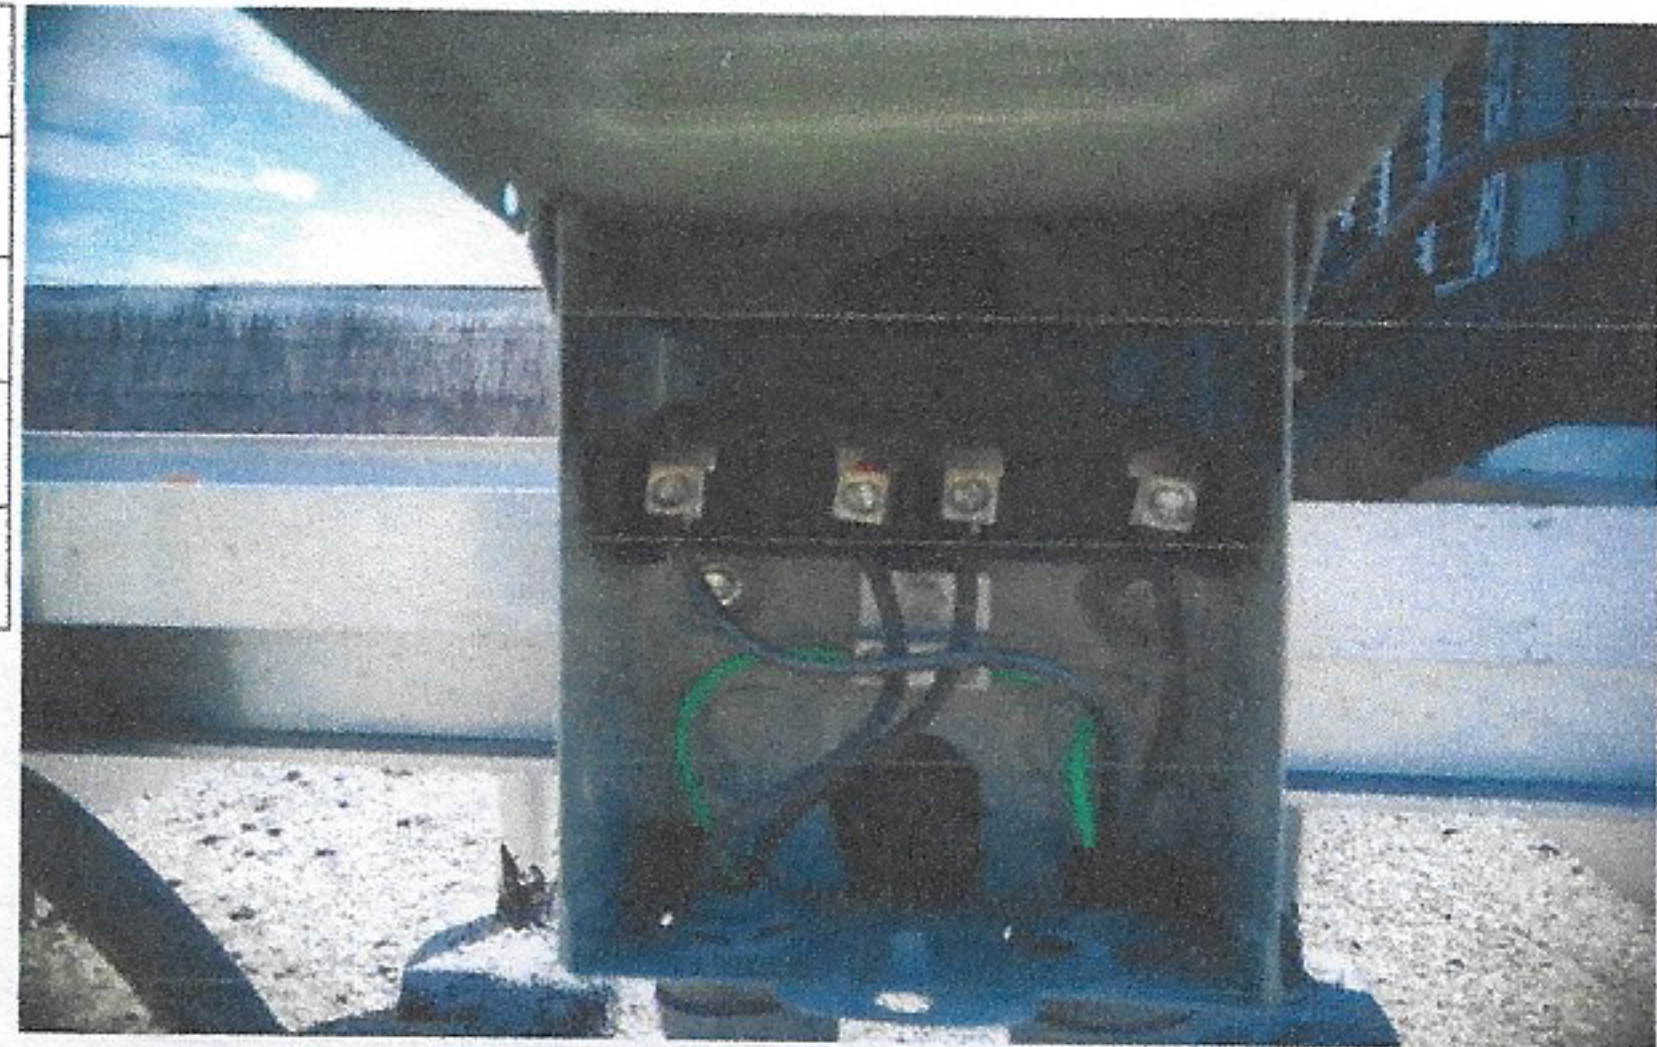
4800 AC DC 2.jpeg

| R1:Max. Temp. | 107.2°F |
| R1:Min. Temp. | 84.9°F |

| <u>Recommendation:</u> | None at this time. |
