# PROPERTY APPRAISER OF MIAMI-DADE COUNTY

List of service addresses for 19 Sidonia Ave

**NOTICE OF UNSAFE STRUCTURE VIOLATION FOR FAILURE TO RECERTIFY  
AND NOTICE OF HEARING**

# Electrical Thermography Report

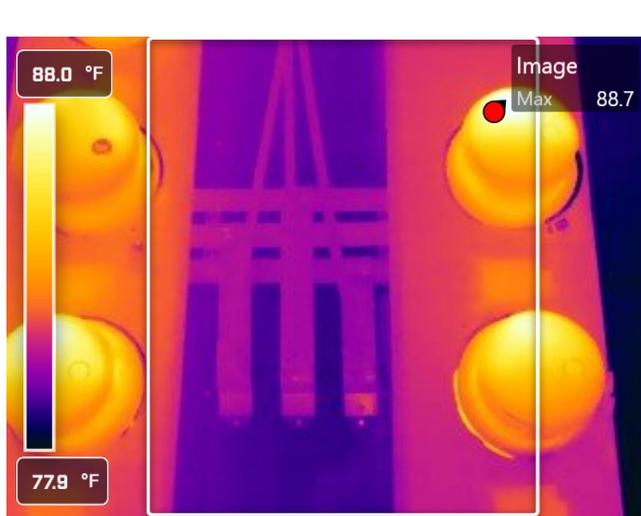
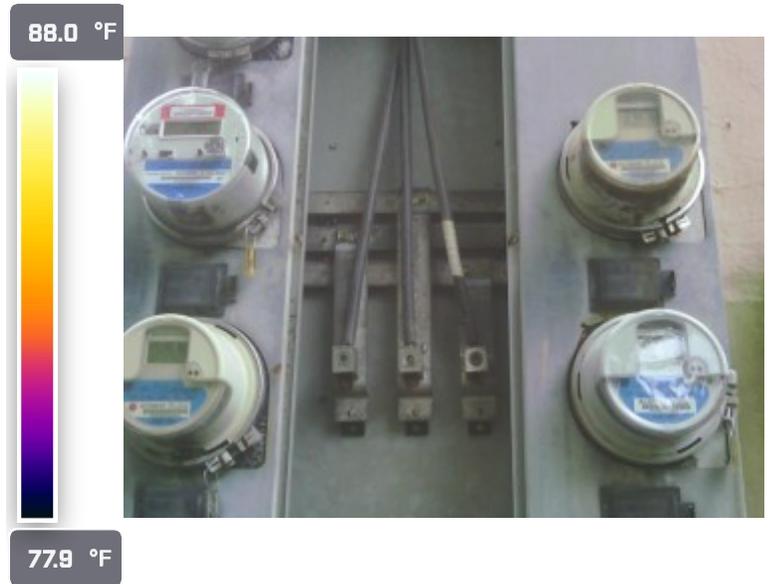
Site	19 Sidonia Ave
Address	19 Sidonia Ave. Coral Gables, FL 33134
Location	Outside
Equipment	Main Incoming
Rated Amps.	400
Measured load	9/15/na/5

NO THERMAL PROBLEMS FOUND

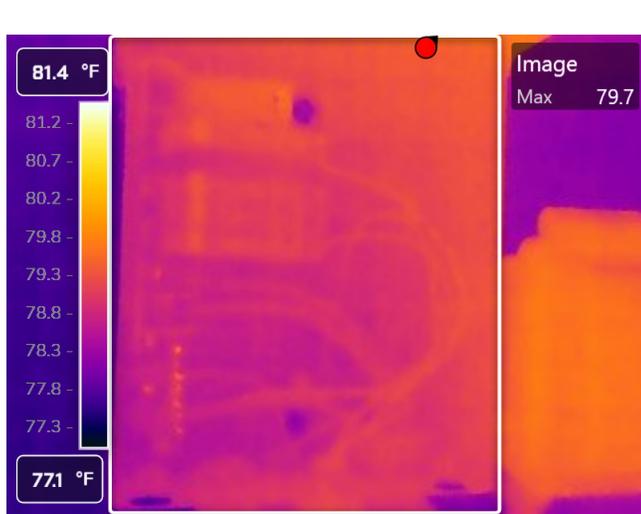
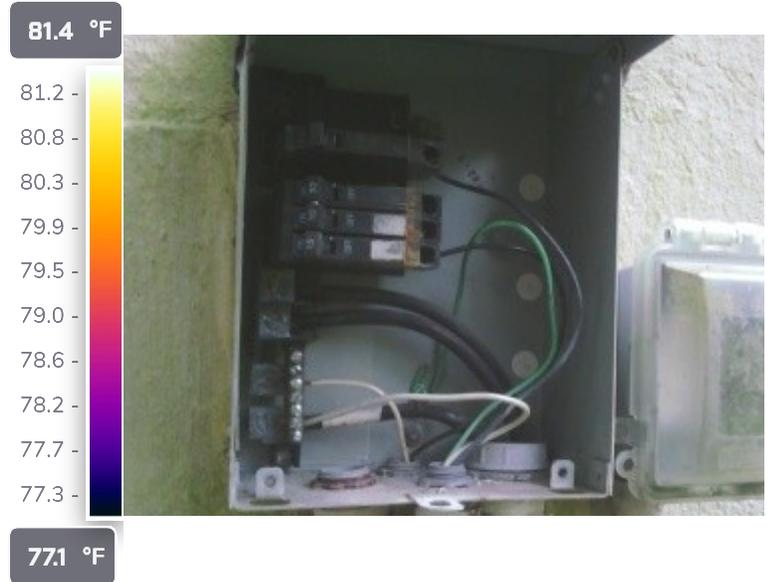
Site	19 Sidonia Ave
Address	19 Sidonia Ave. Coral Gables, FL 33134
Location	Outside
Equipment	House Panel
Rated Amps.	125
Measured load	0/1/na/1

NO THERMAL PROBLEMS FOUND

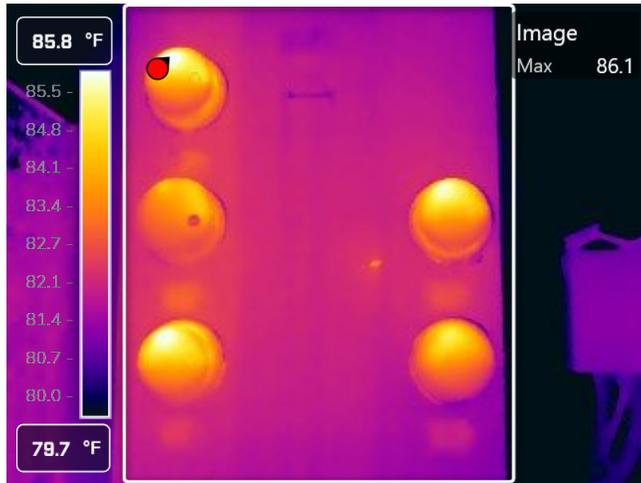
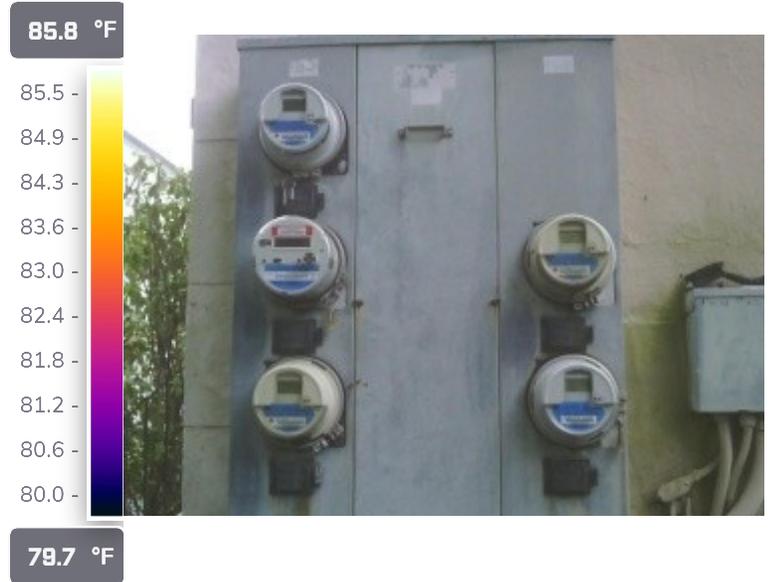
Site	19 Sidonia Ave
Address	19 Sidonia Ave. Coral Gables, FL 33134
Location	Outside
Equipment	Meters Racks
Rated Amps.	100
Measured load	N/A

NO THERMAL PROBLEMS FOUND
