# APPRAISAL OF REAL PROPERTY

1258 Obispo Ave  
Coral Gables, FL 33134  
Lots 1 and 2 , Block 3, Coral Gables, Section E, PB 8-13

LAND APPRAISAL REPORT

Structural Inspection Report

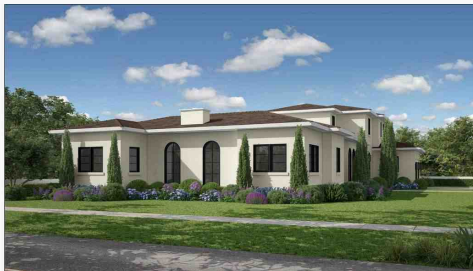
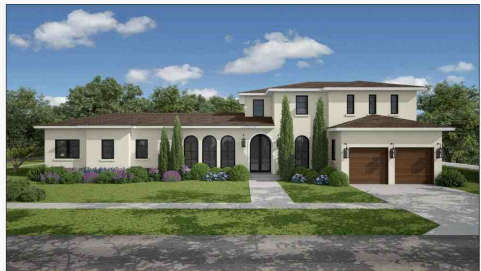
## CONCEPTUAL RENDERINGS

THE SCOPE OF WORK UNDER THIS APPLICATION ENCOMPASSES THE DESIGN OF 2 STORY RESIDENCE IN A LOT WHEREA THERE IS AN EXISTING ONE STORY HOME. THE CONCEPT IS TO DEMOLISH THE EXISTING STRUCTURE DUE TO ITS STRUCTURALLY UNSAFE CONDITION; AND TO BUILD A HOME THAT FOLLOWS THE OUTLINE AND ROOF LINE OF THE EXISTING ONE ON THE FIRST FLOOR. THE DESIGN THEN EXPANDS TO A LARGER FOOTPRINT THAT TAKES ADVANTAGE OF THE LARGE LOT AND ALSO INCLUDE A SECOND STORY OVER A PORTION OF THE LOWER FOOTPRINT.
