# APPRAISAL OF REAL PROPERTY

1258 Obispo Ave  
Coral Gables, FL 33134  
Lots 1 and 2 , Block 3, Coral Gables, Section E, PB 8-13

LAND APPRAISAL REPORT

Structural Inspection Report

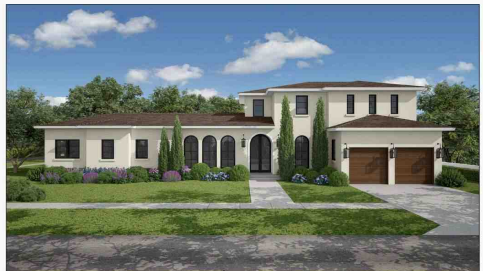
## CONCEPTUAL RENDERINGS

THE SCOPE OF WORK UNDER THIS APPLICATION ENCOMPASSES THE DESIGN OF 2 STORY RESIDENCE IN A LOT WHEREA THERE IS AN EXISTING ONE STORY HOME. THE CONCEPT IS TO DEMOLISH THE EXISTING STRUCTURE DUE TO ITS STRUCTURALLY UNSAFE CONDITION; AND TO BUILD A HOME THAT FOLLOWS THE OUTLINE AND ROOF LINE OF THE EXISTING ONE ON THE FIRST FLOOR. THE DESIGN THEN EXPANDS TO A LARGER FOOTPRINT THAT TAKES ADVANTAGE OF THE LARGE LOT AND ALSO INCLUDE A SECOND STORY OVER A PORTION OF THE LOWER FOOTPRINT.
