Thermography Report

Project Address:	4800 Lejuene Road Coral Gables, FL 33146
Electrical Contractor and Contact information:	Alfredo Blaya, Assurance Services Inc. (305) 479-0810
Electrical Contractor License:	EC-13006637
Thermographer:	Omar Martinez
Thermographer Certification #:	140924162
Thermographer Contact #:	(954) 594-5953
Inspection Date:	April 16, 2024

4800 Lejuene Road Coral Gables, FL 33146, is a Three-Story Commercial Building. Main is located in Meter Room. This Building has 6 Main Disconnects in Meter Room. The majority of this buildings mains and panels are currently inactive because this building has no current occupants. Infrared was done on only active Electrical Equipment that is connected. Pictures will be provided with Electrical Report on inactive units. (Active Units) Main (1 of 6) 800 Amp Three-Phase 120/208v; Main (5 of 6) (House) 100 Amp Three-Phase 120/208v and Main (6 of 6) (Elevator) 100 Amp Three-Phase 120/208v. (Inactive Mains) Main (2 of 6) 225 Three-Phase 120/208; Main (3 of 6) 225 Three-Phase 120/208 and Main (4 of 6) 225 Three-Phase 120/208. Further detail information provided with each Thermographic picture taken. Upon completion of inspection

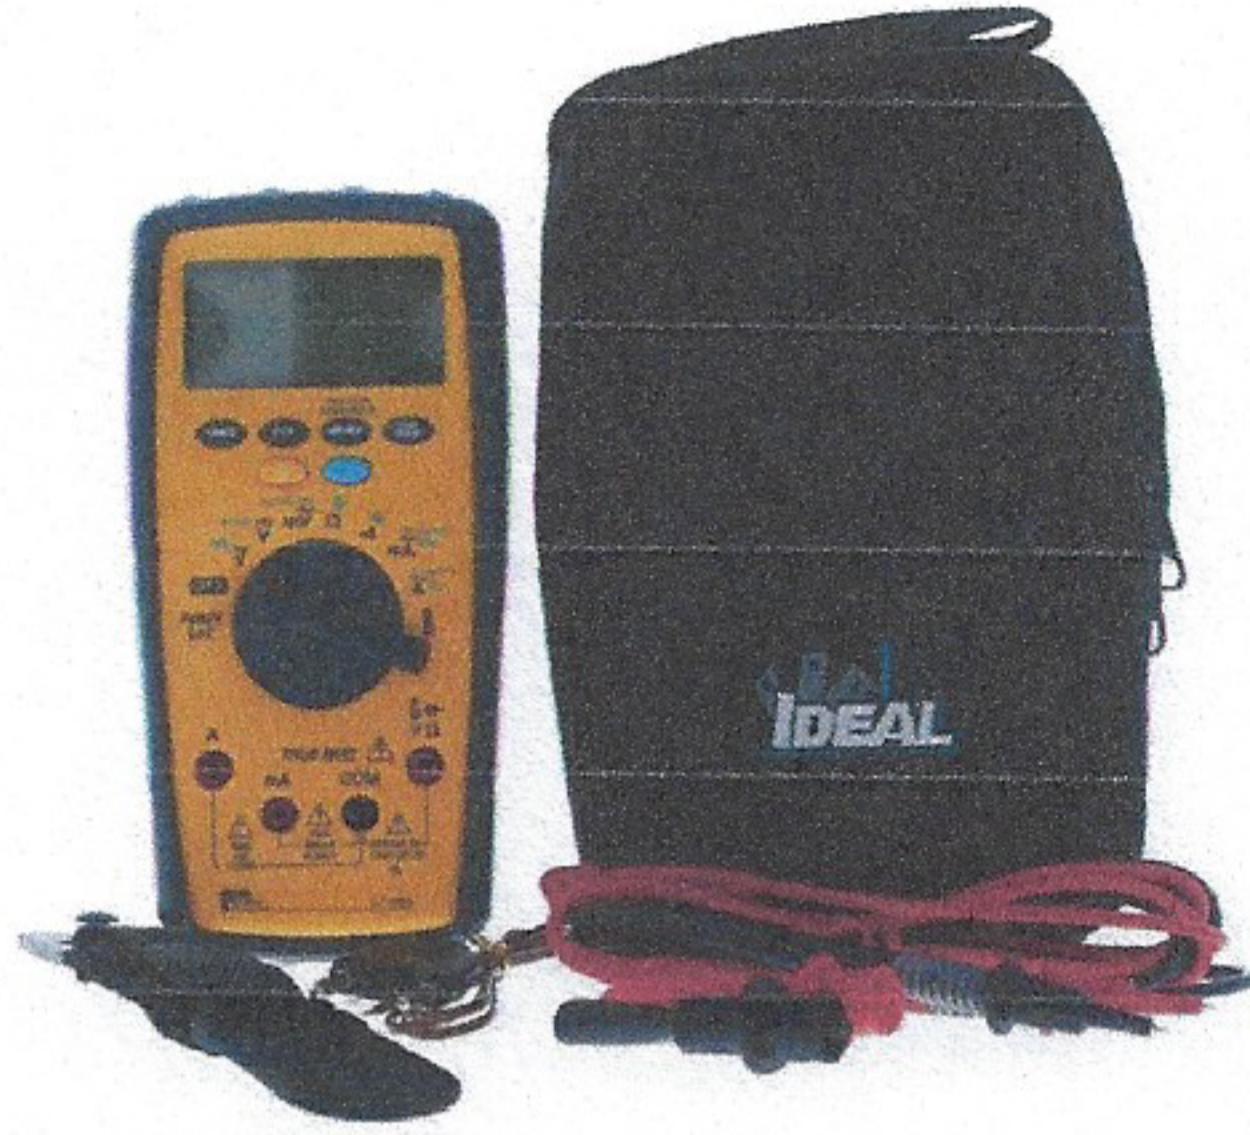
IDEAL INDUSTRIES INC. 61-486 Commercial Grade Multimeter with Low Impedance, TRMS, Cap, Freq, NCV, Temp, AC/DC Voltage Detection, CATIII for 1000v, CATIV for 600v

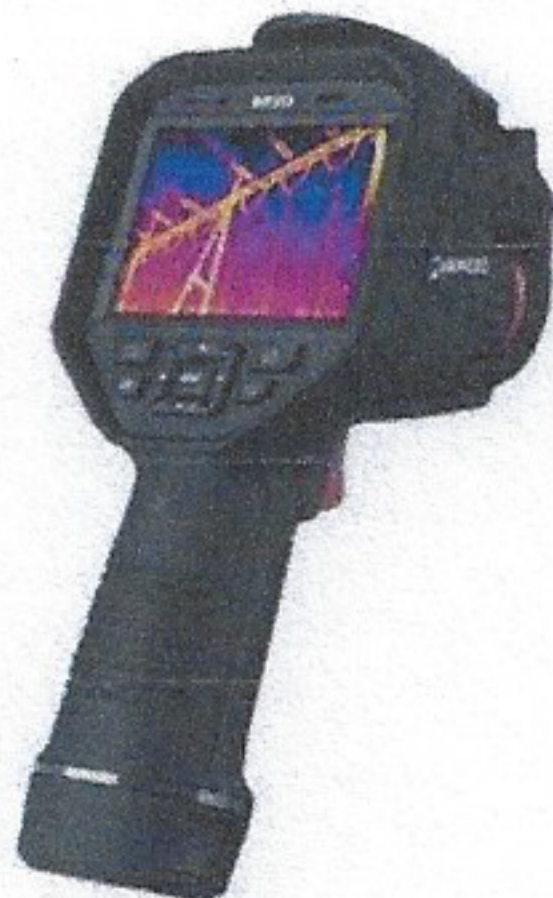
HIKMICRO M30 Professional Thermal Imaging Camera with 384x288 Resolution and Full Analysis Functions

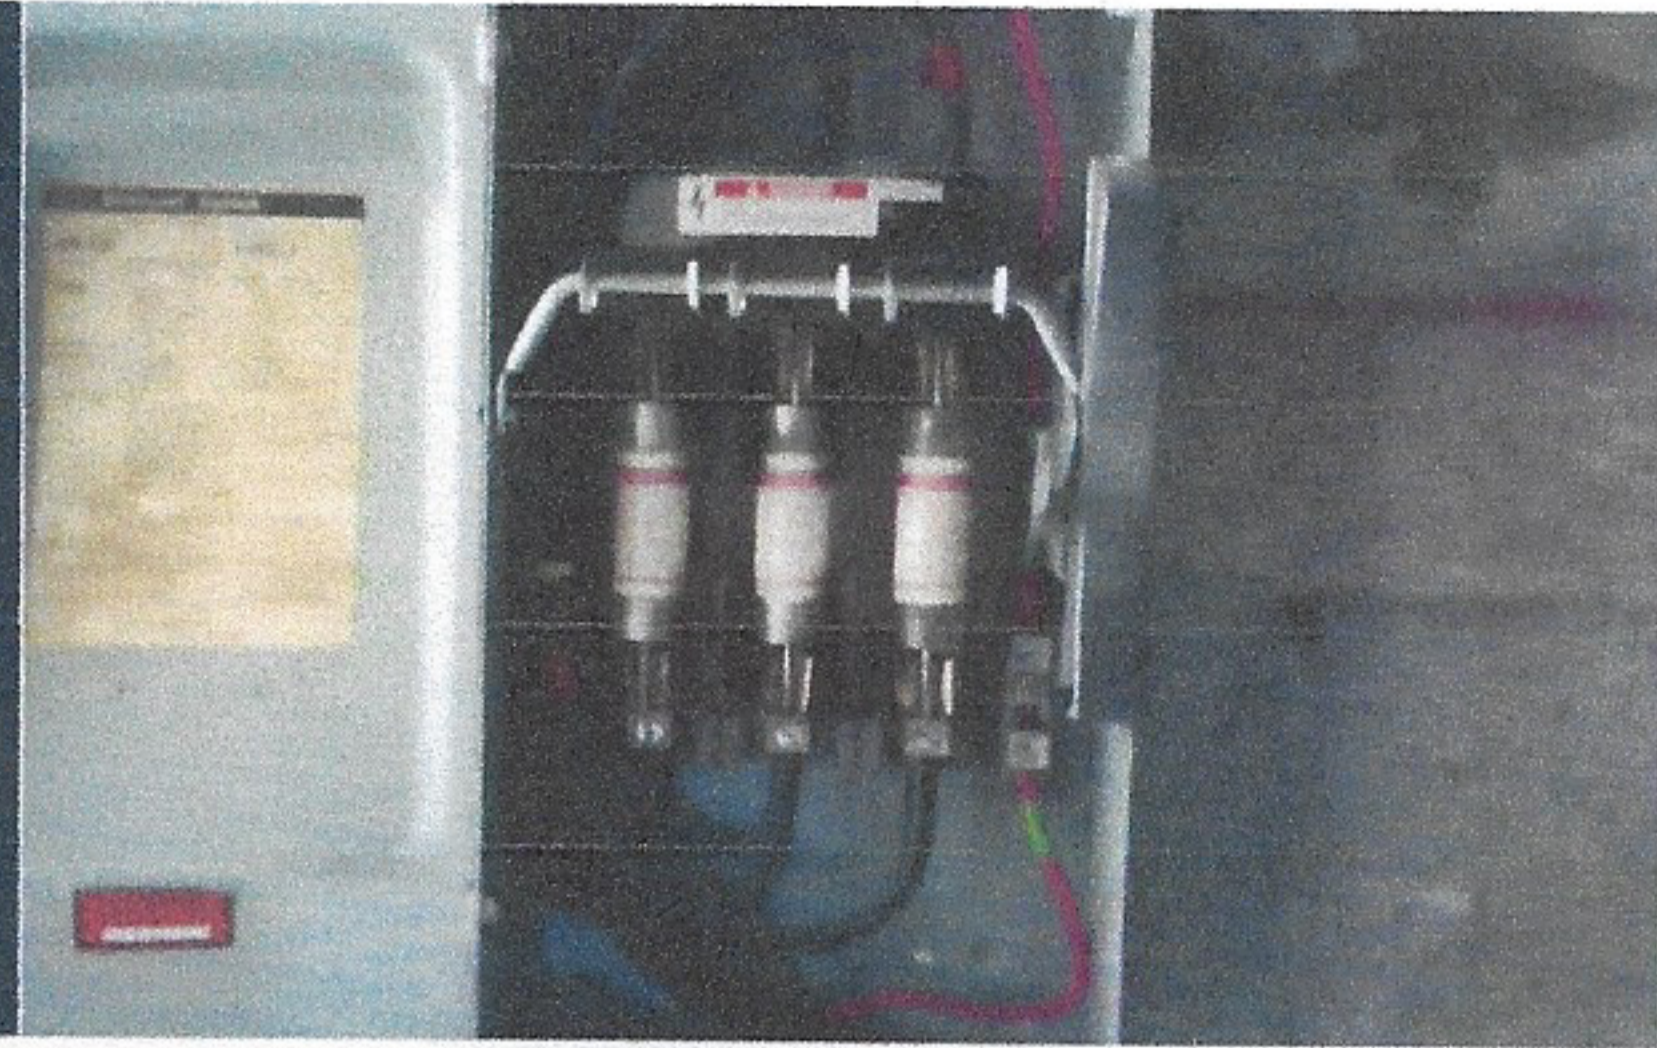
4800 Elevator Sub.jpeg

Measurements	
Image:Max. Temp.	85.3°F
Image:Min. Temp.	72.7°F
R1:Max. Temp.	85.3°F
R1:Min. Temp.	74.7°F

Remarks	
<u>Location:</u>	Elevator Room
<u>Unit/Equipment:</u>	Elevator Sub-Disconnect/ 100 Amp/ Three-Phase/ 120/208v
<u>Anomaly:</u>	None Detected
<u>Recommendation:</u>	None at this time.

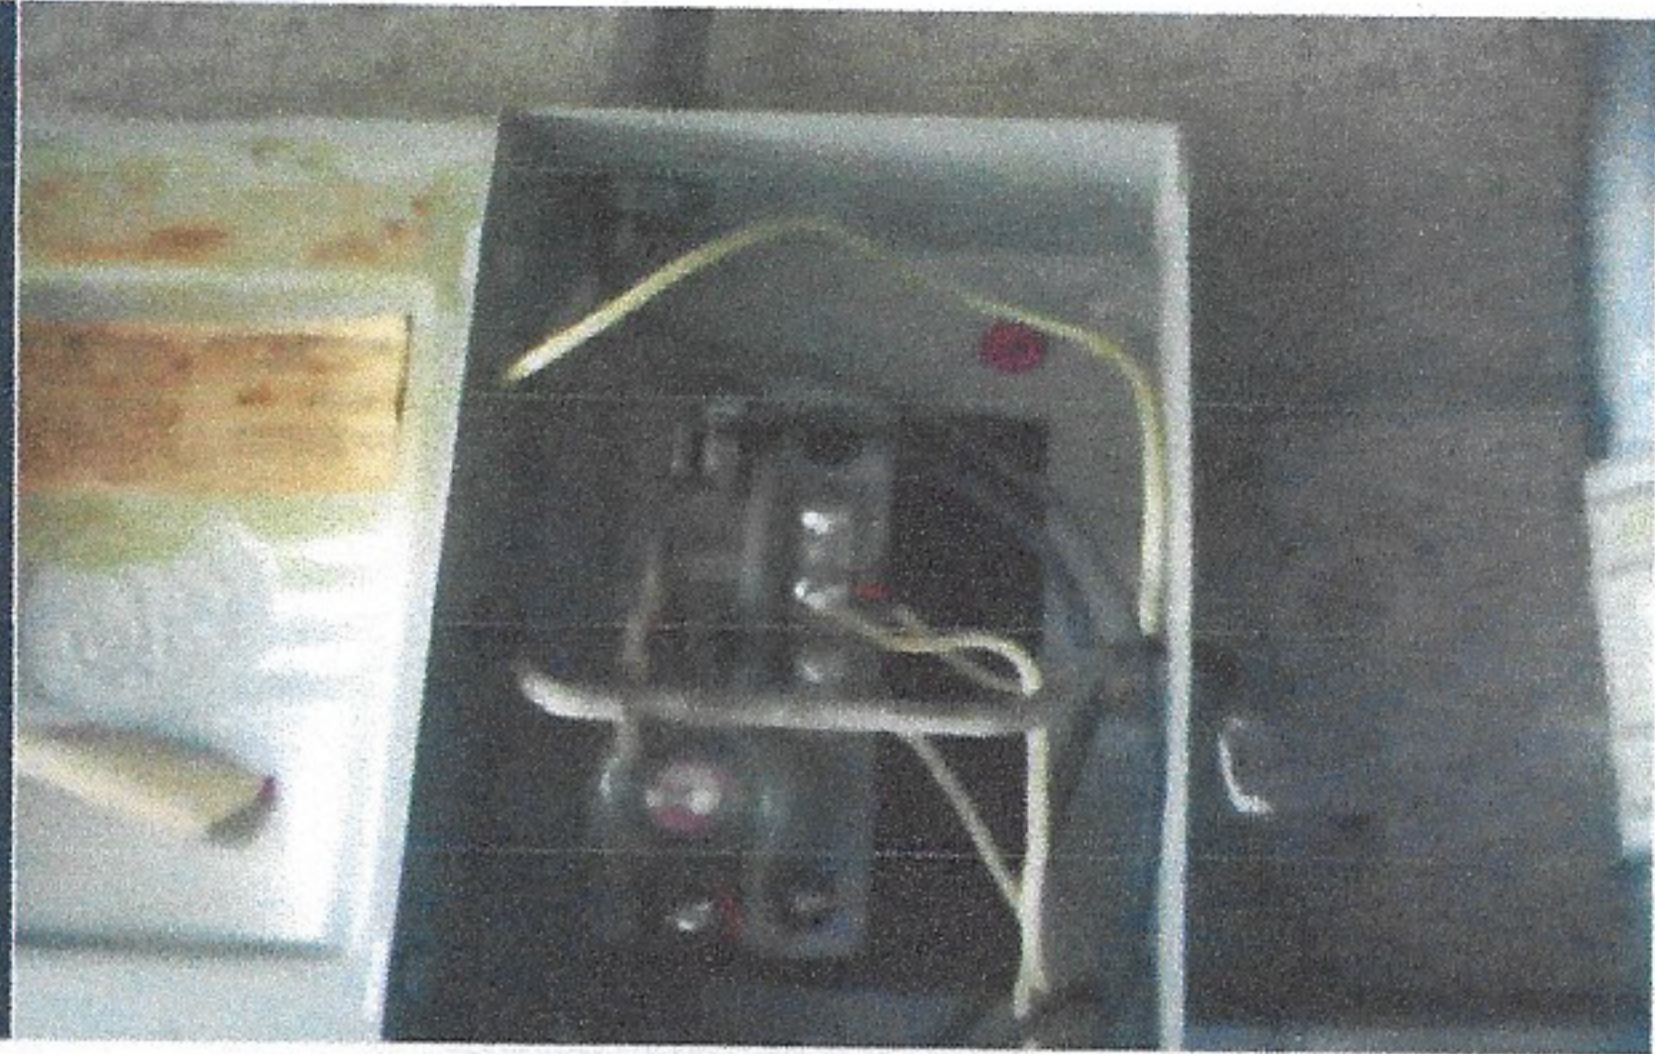
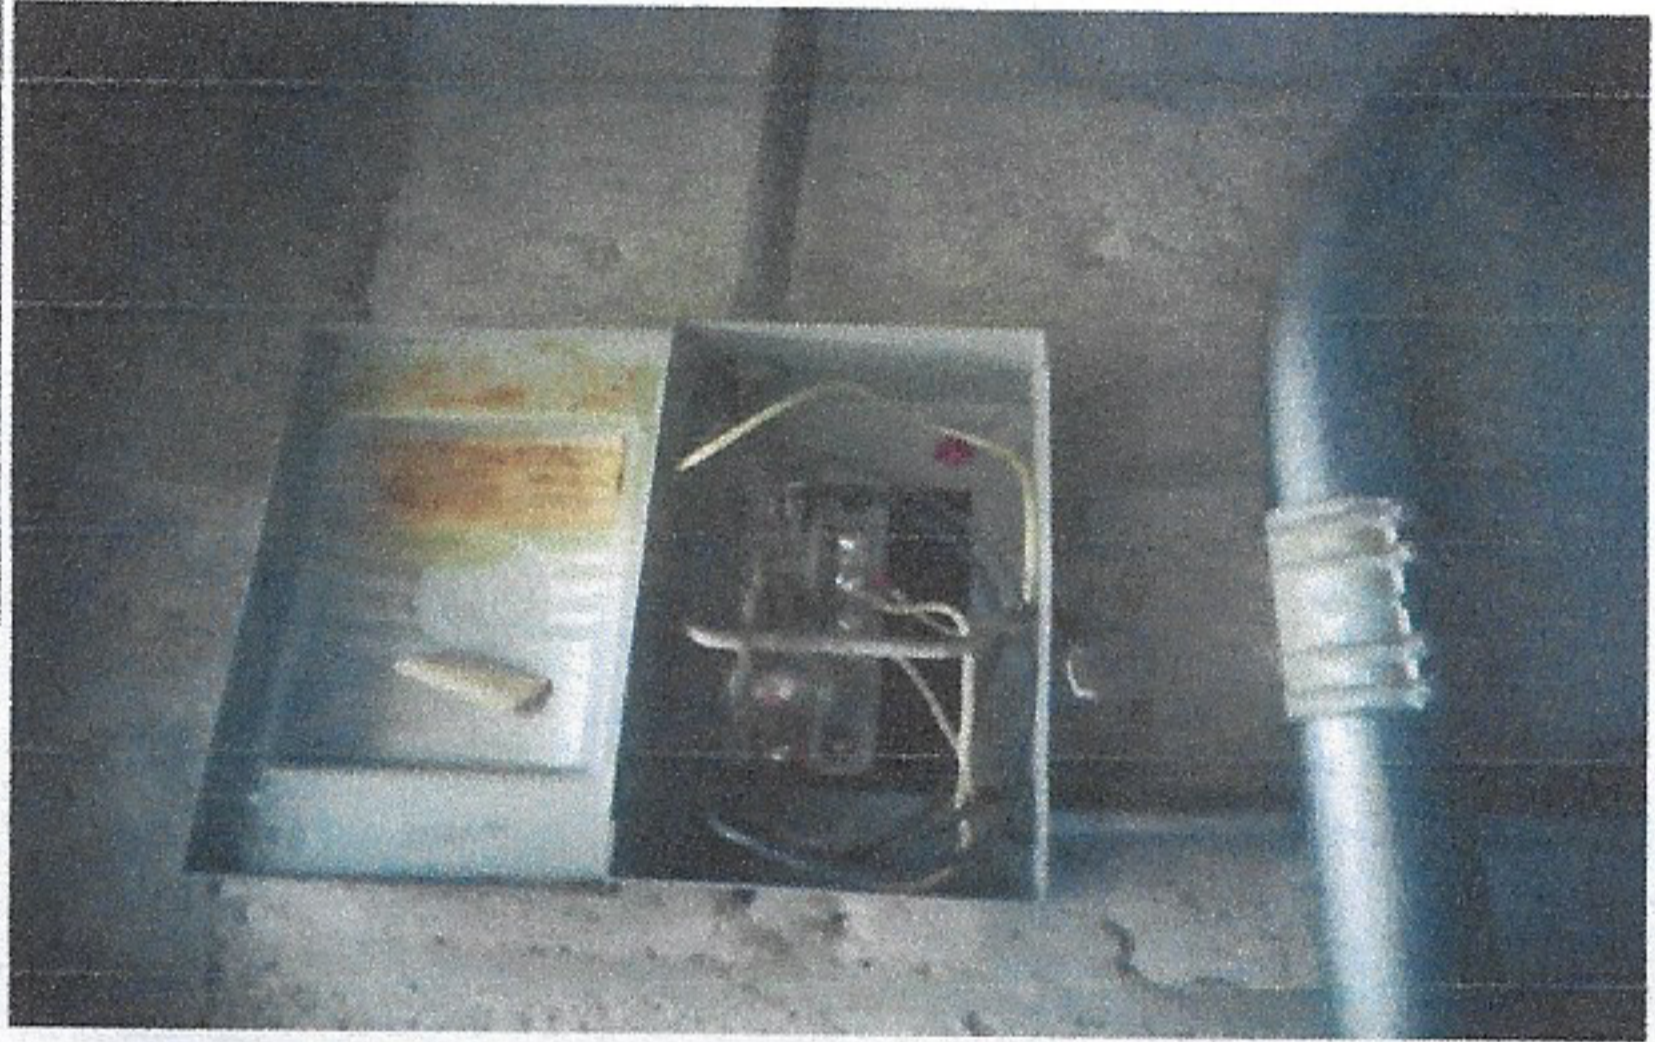
4800 Cab Light Sub.jpeg

Measurements	
Image:Max. Temp.	84.6°F
Image:Min. Temp.	72.7°F
R1:Max. Temp.	84.6°F
R1:Min. Temp.	74.5°F

Remarks	
<u>Location:</u>	Elevator Room
<u>Unit/Equipment:</u>	Cab Light Sub-Disconnect/ 30 Amp/ Single-Phase/ 120/208v
<u>Anomaly:</u>	None Detected
<u>Recommendation:</u>	None at this time.

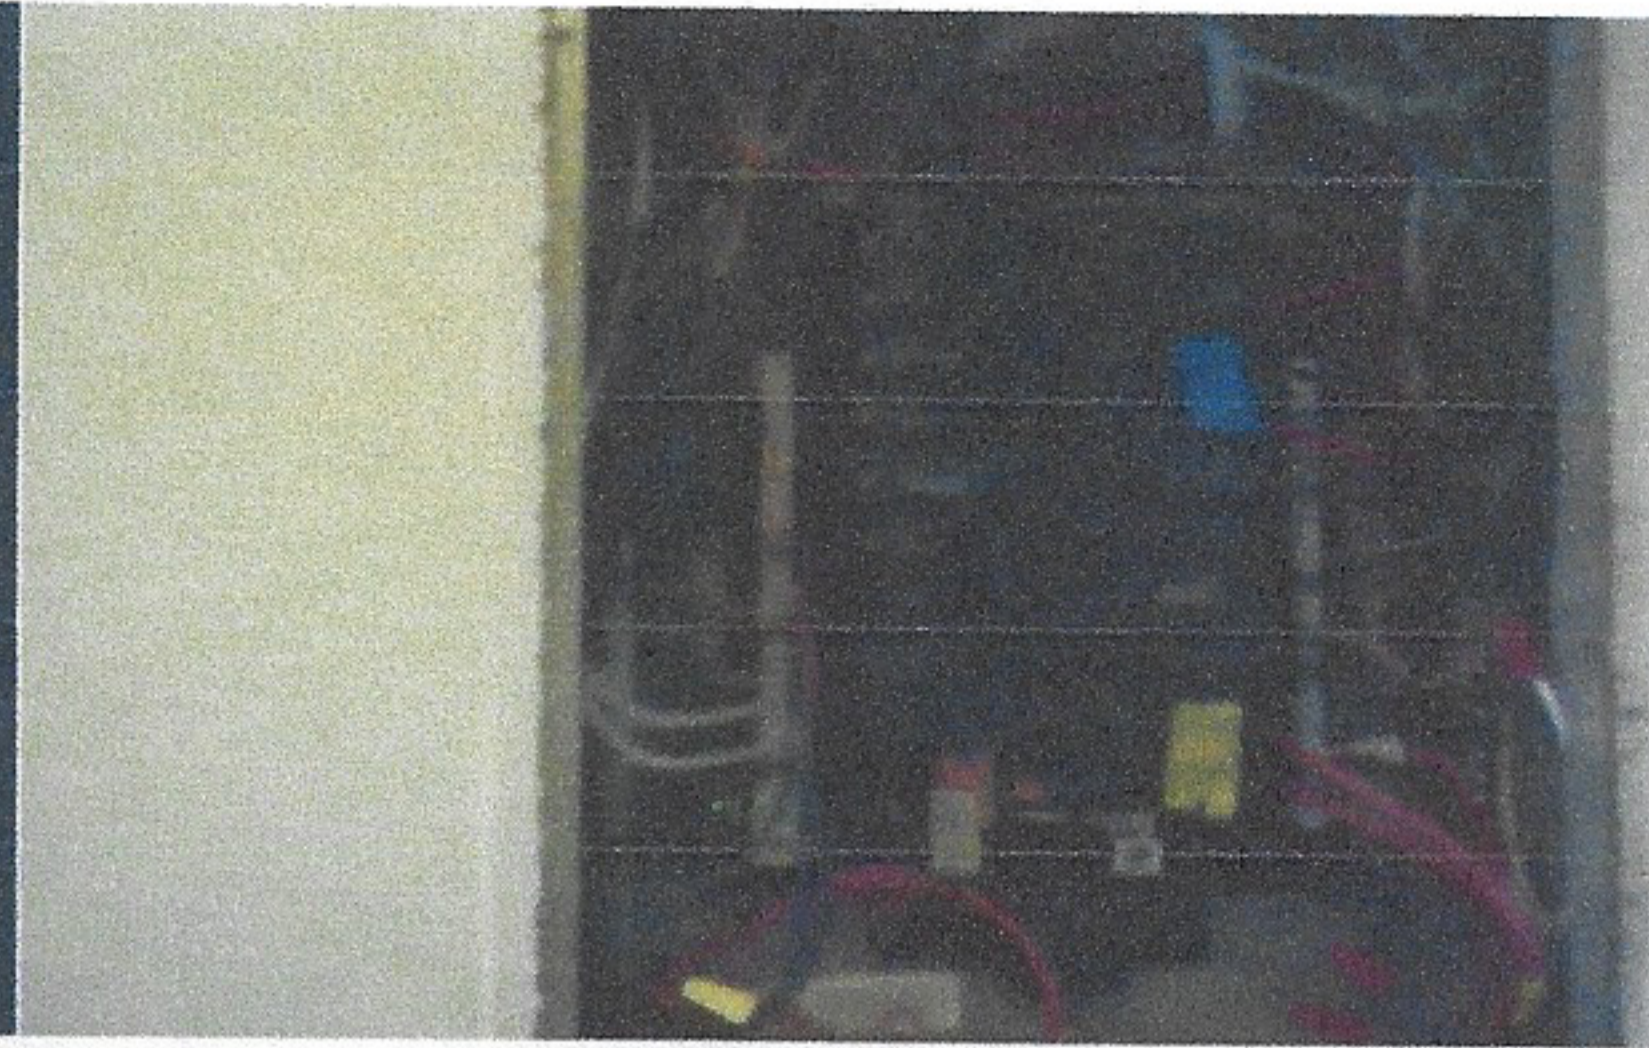
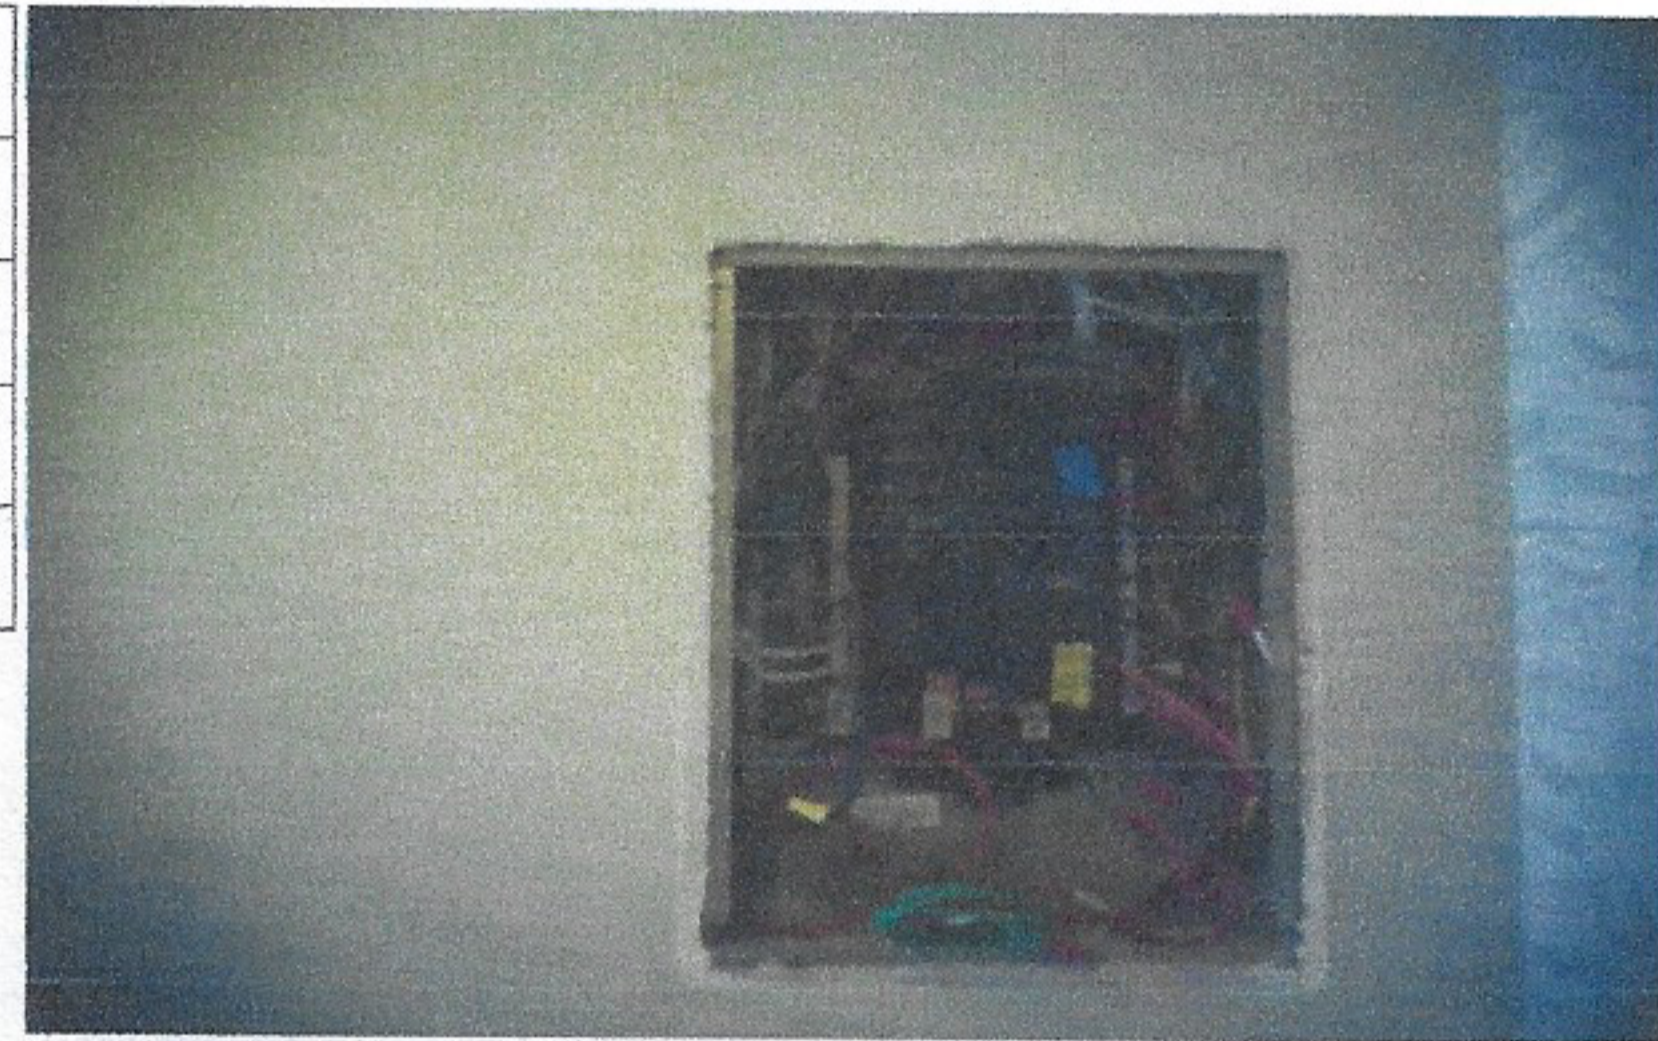
4800 Lejuene Road Panel D.jpeg

Measurements	
Image:Max. Temp.	89.4°F
Image:Min. Temp.	56.1°F
R1:Max. Temp.	89.4°F
R1:Min. Temp.	58.1°F

Remarks	
<u>Location:</u>	2nd Floor
<u>Unit/Equipment:</u>	Panel D/ 100 Amp/ Three-Phase/ 120/208v
<u>Anomaly:</u>	None Detected
<u>Recommendation:</u>	None at this time.

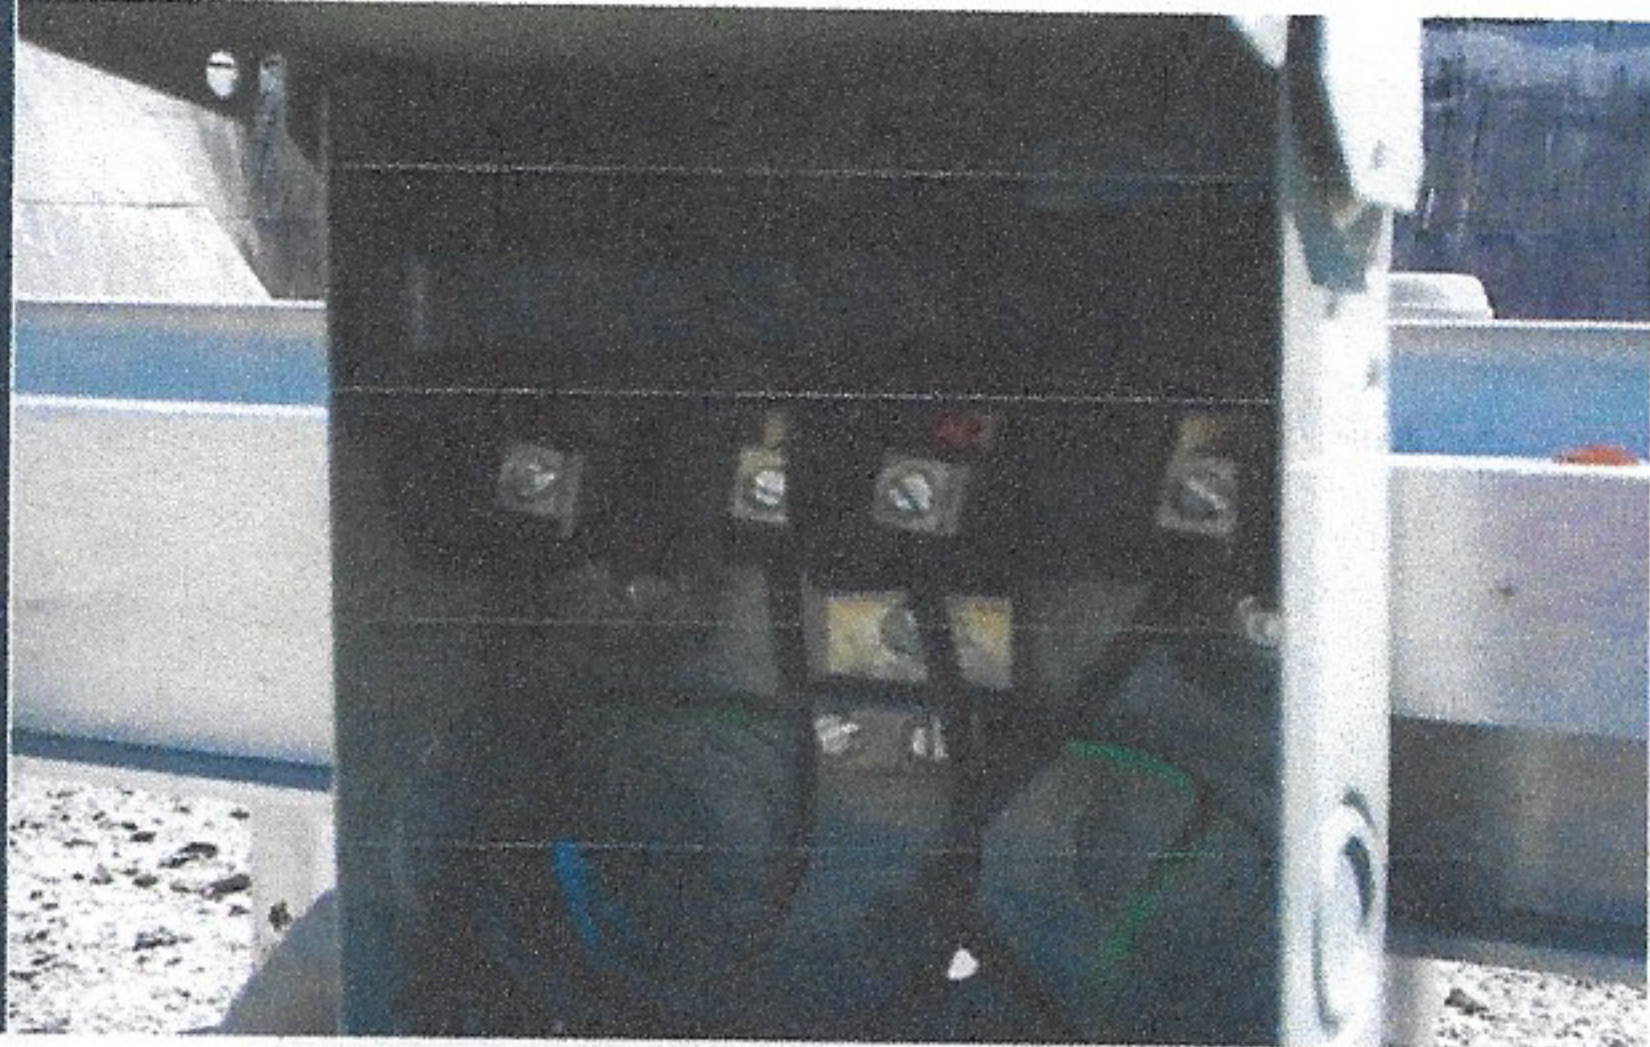
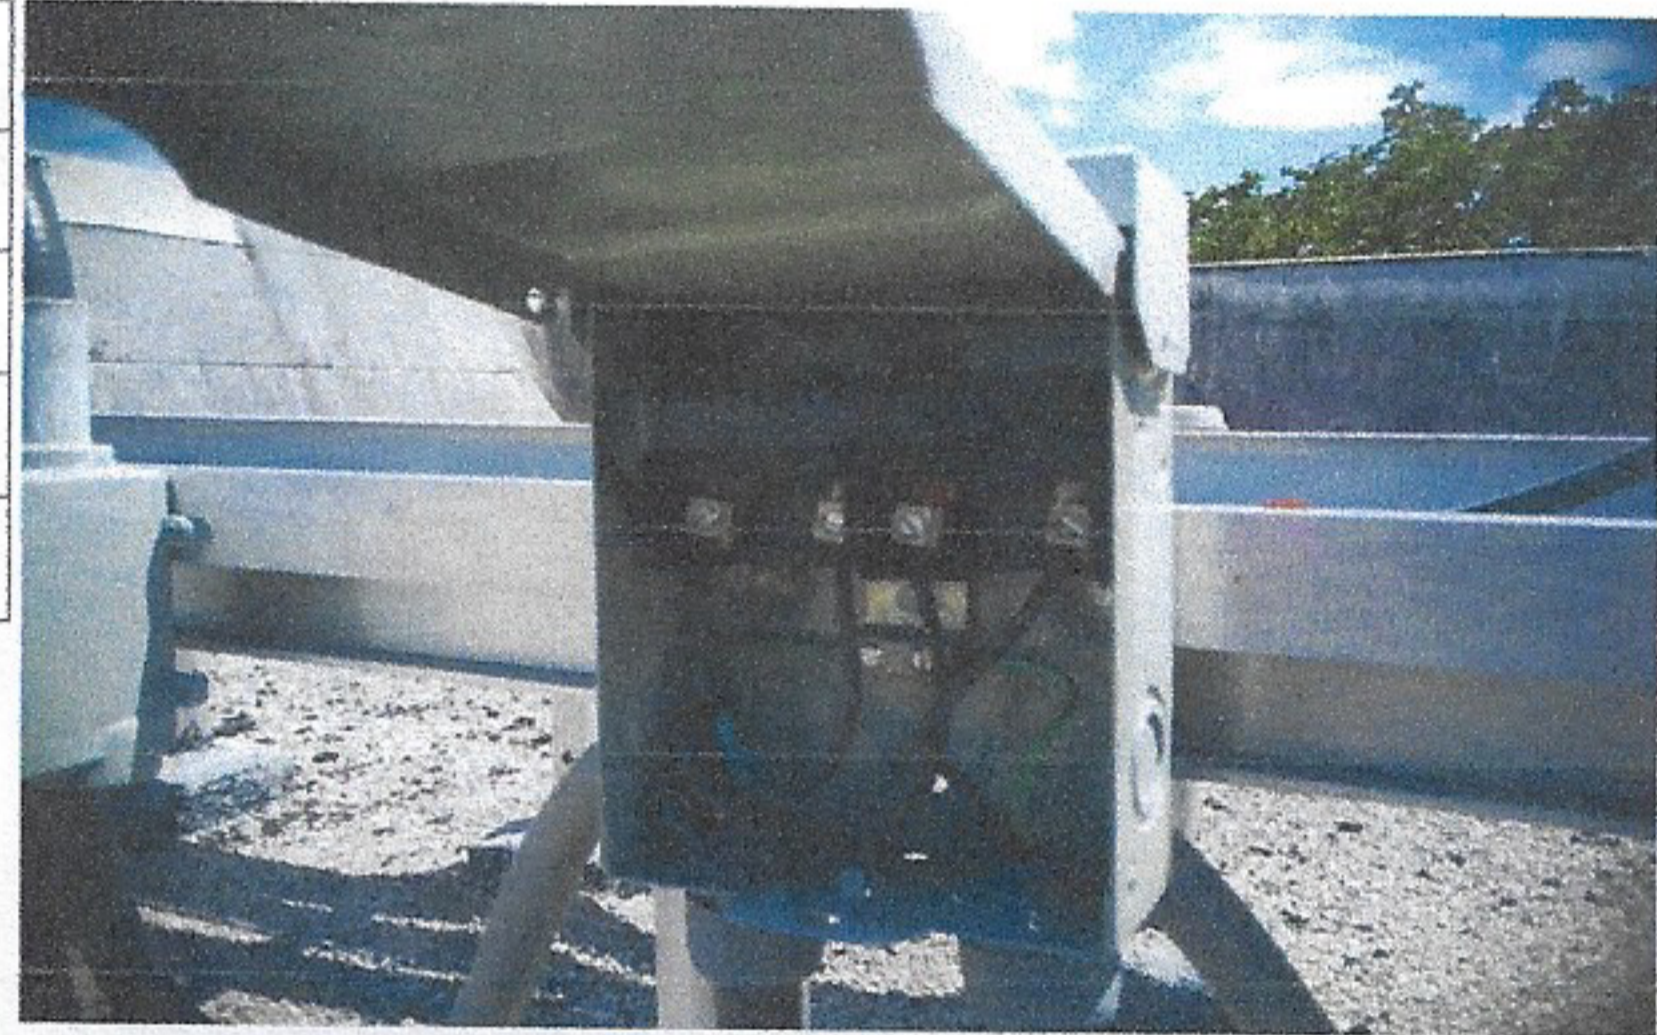
4800 AC DC 1.jpeg

Measurements	
Image:Max. Temp.	137.8°F
Image:Min. Temp.	61.2°F
R1:Max. Temp.	114.4°F
R1:Min. Temp.	69.1°F

Remarks	
<u>Location:</u>	Roof
<u>Unit/Equipment:</u>	AC Disconnect #1/ 30 Amp/ Single-Phase/ 120/208v
<u>Anomaly:</u>	None Detected
<u>Recommendation:</u>	None at this time.

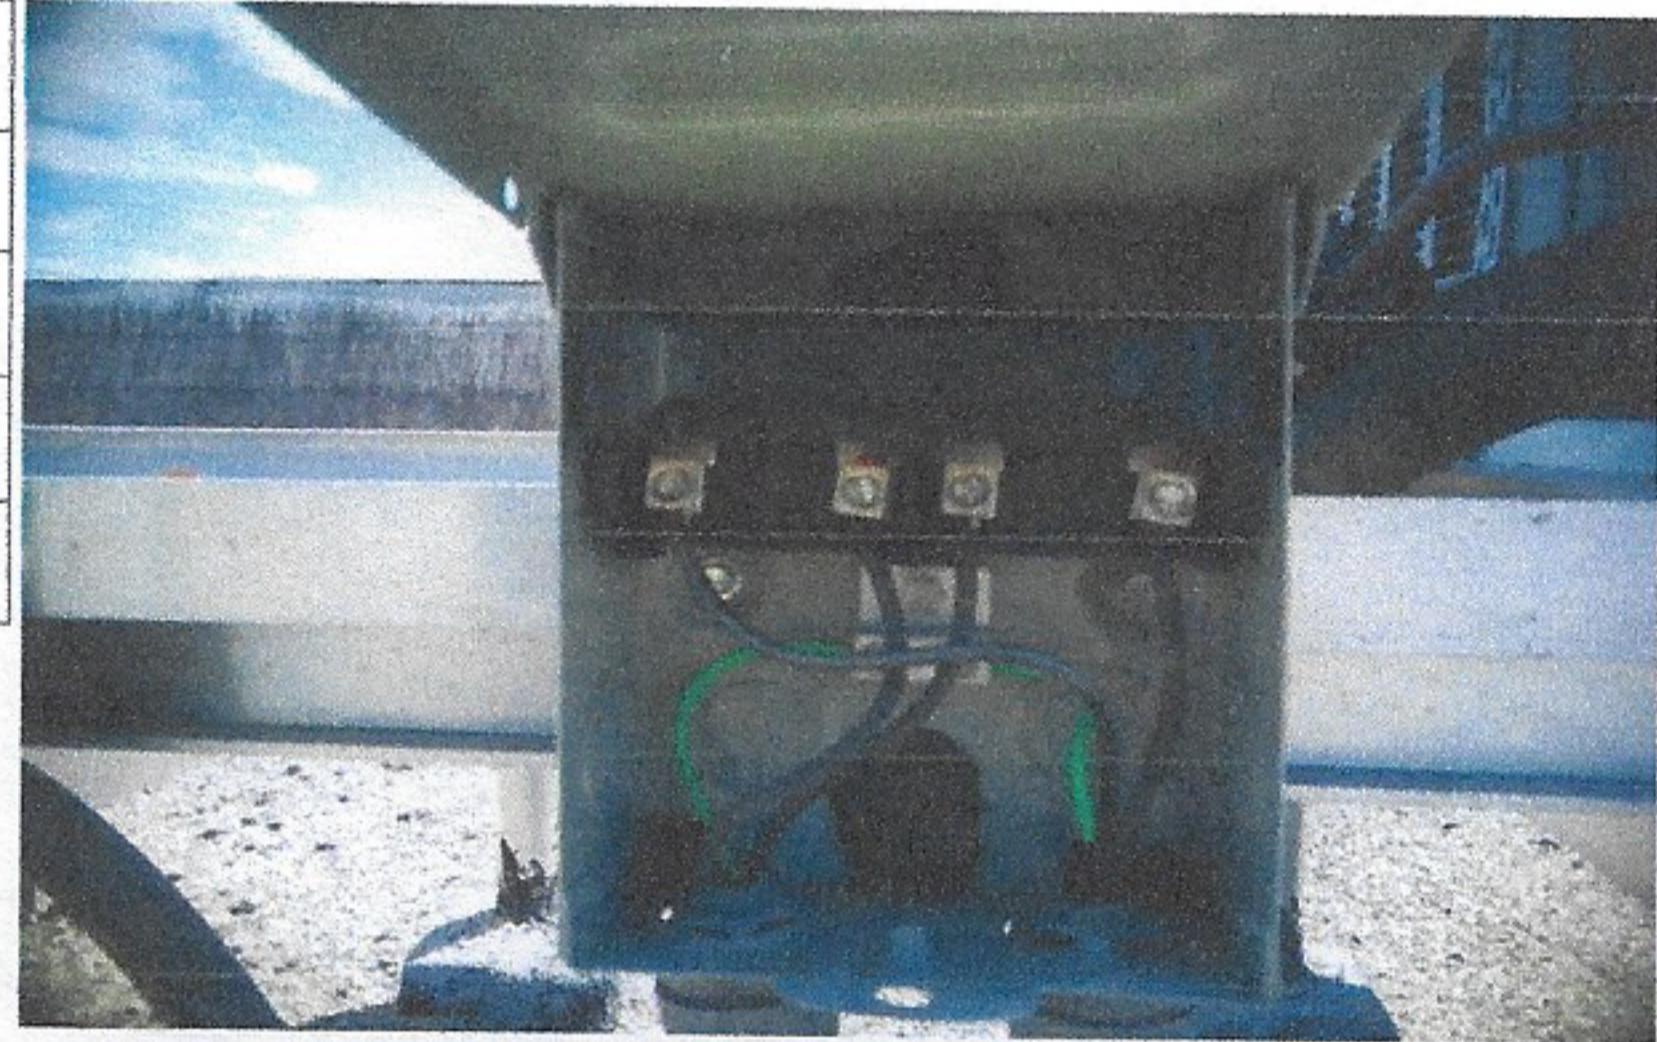
4800 AC DC 2.jpeg

Measurements	
Image:Max. Temp.	136.6°F
Image:Min. Temp.	57.4°F
R1:Max. Temp.	107.2°F
R1:Min. Temp.	84.9°F
