PROPERTY INFORMATION	
Folio	03-4120-023-2360
Property Address	4944 LE JEUNE RD CORAL GABLES, FL 33146-0000
Owner	4944 LE JEUNE RD LLC
Mailing Address	150 SE 2 AVE 506 MIAMI, FL 33131
Primary Zone	5003 MIXED-USE
Primary Land Use	1813 OFFICE BUILDING - MULTISTORY : OFFICE BUILDING
Beds / Baths /Half	0 / 0 / 0
Floors	2
Living Units	0
Actual Area	7,500 Sq.Ft
Living Area	7,500 Sq.Ft
Adjusted Area	7,500 Sq.Ft
Lot Size	5,000 Sq.Ft
Year Built	Multiple (See Building Info.)

CITY'S EXHIBIT #1

4944 Le Jeune Rd as of 12-30-25, updated from 12-27-24

RECERTIFICATION PHOTOS

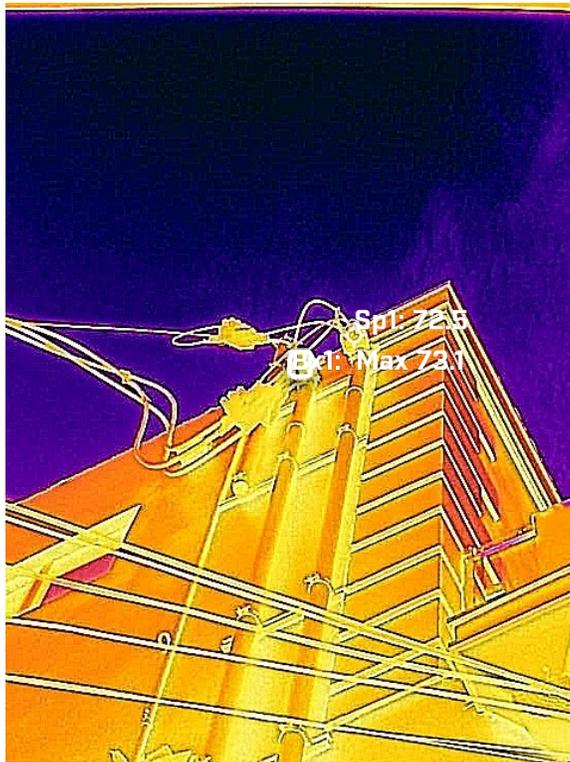
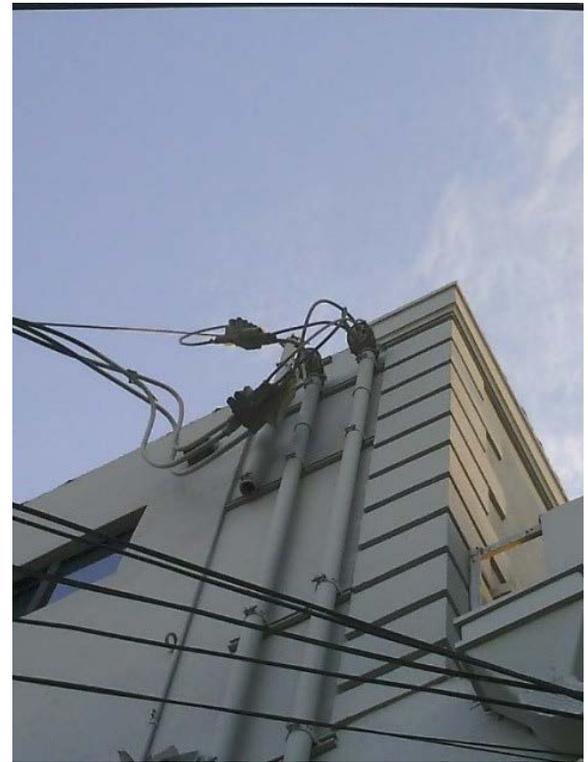
FLIR0001.jpg

Emissivity	0.95
Distance	25.02 ft
Reflected temp.	75.0 °F
Air Temperature	68.0 °F
Relative humidity	65.0%
Ext. optics temp.	68.0 °F
Ext. optics trans.	1.00

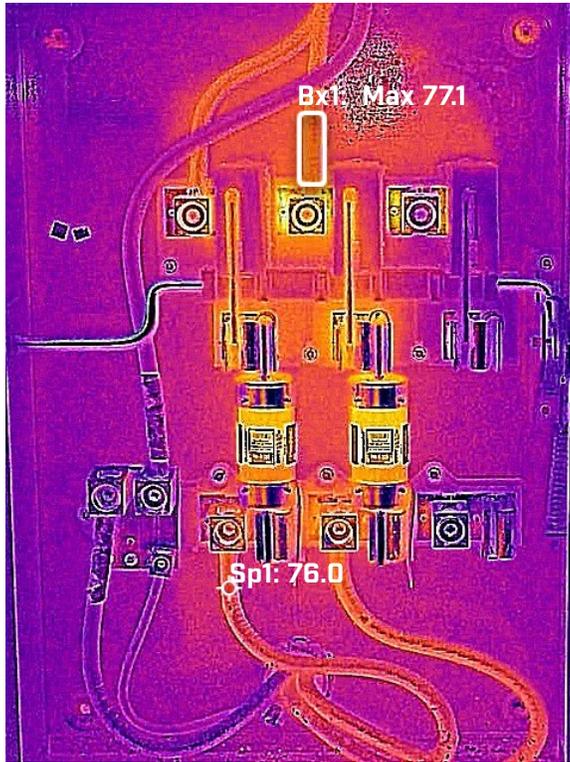
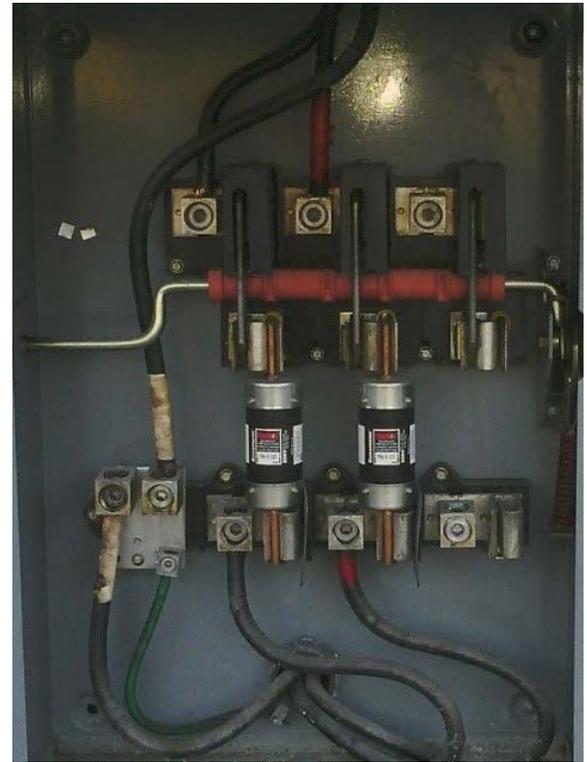
FLIR0002.jpg

Emissivity	0.95
Distance	6.00 ft
Reflected temp.	75.0 °F
Air Temperature	71.0 °F
Relative humidity	65.0%
Ext. optics temp.	68.0 °F
Ext. optics trans.	1.00

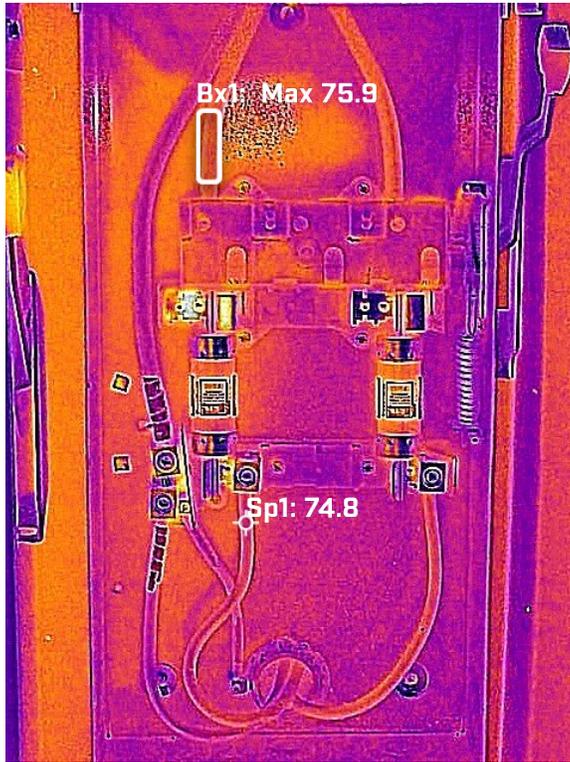
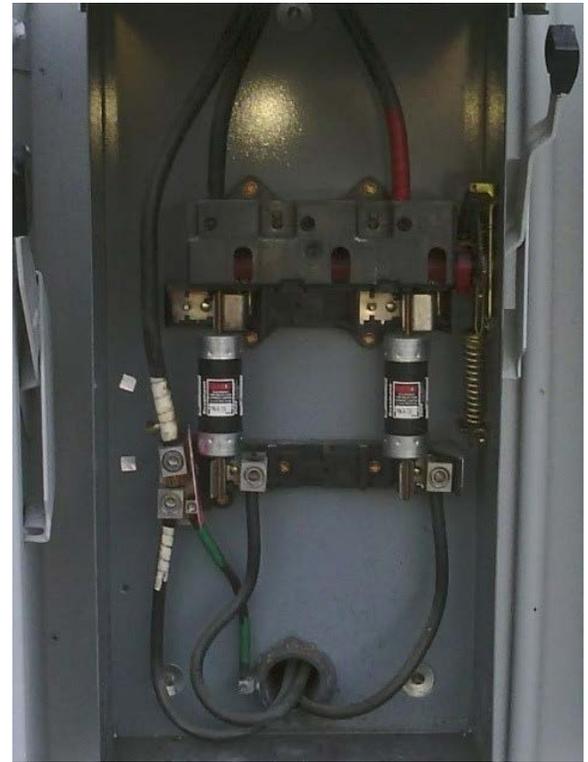
FLIR0003.jpg

Emissivity	0.95
Distance	6.00 ft
Reflected temp.	70.0 °F
Air Temperature	71.0 °F
Relative humidity	66.0%
Ext. optics temp.	68.0 °F
Ext. optics trans.	1.00

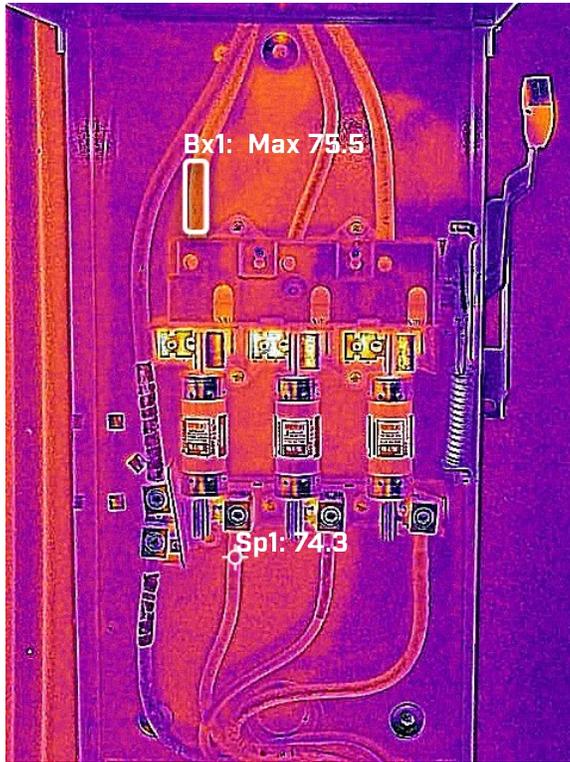
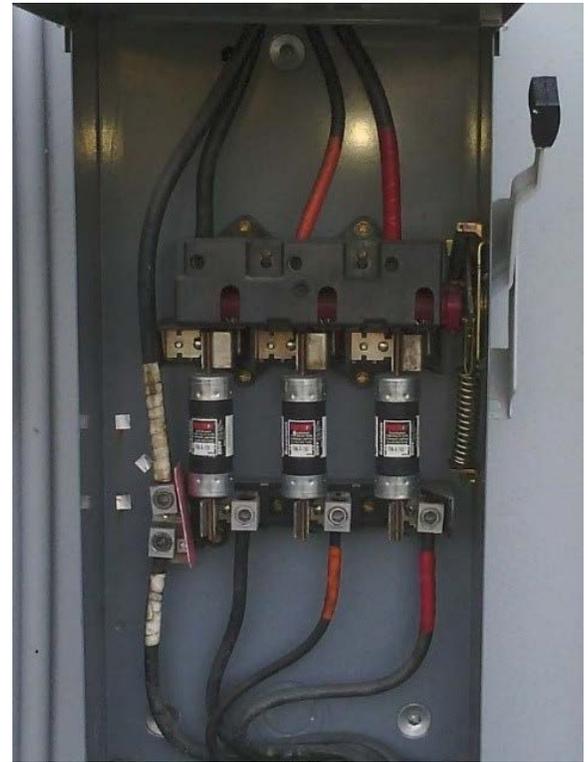
FLIR0004.jpg

Emissivity	0.95
Distance	6.00 ft
Reflected temp.	70.0 °F
Air Temperature	71.0 °F
Relative humidity	66.0%
Ext. optics temp.	68.0 °F
Ext. optics trans.	1.00

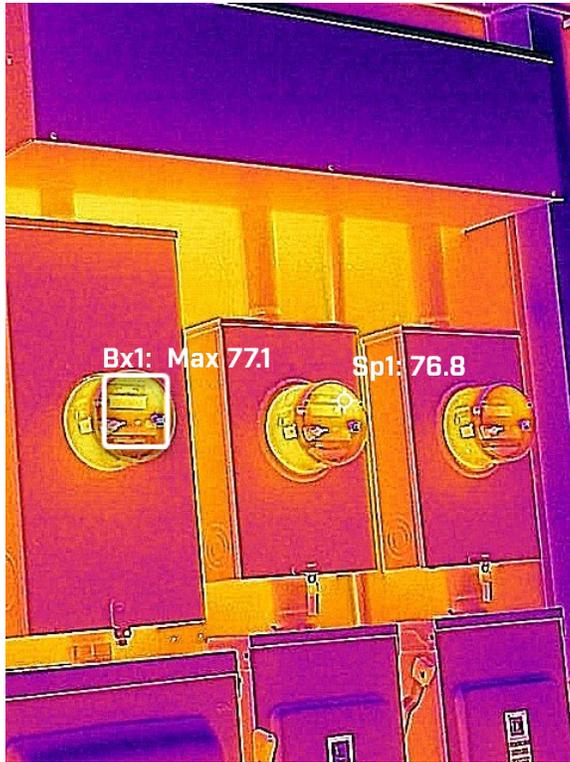
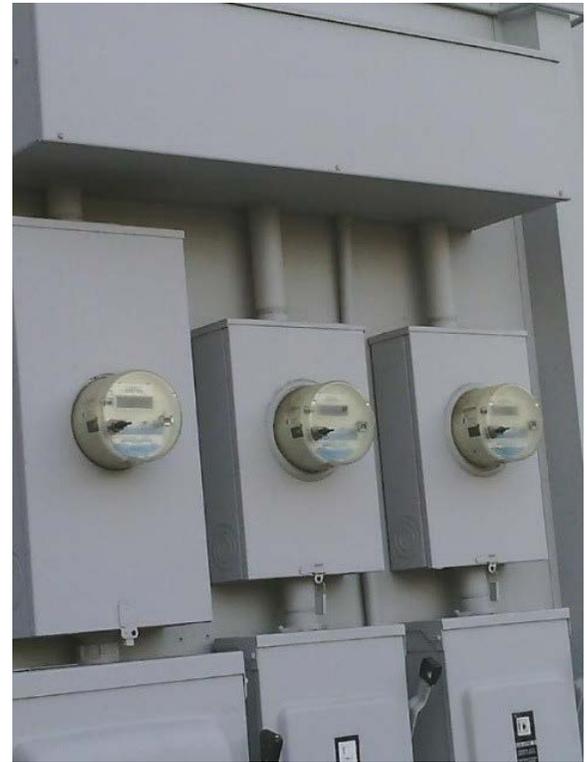
FLIR0005.jpg

Emissivity	0.95
Distance	6.00 ft
Reflected temp.	70.0 °F
Air Temperature	71.0 °F
Relative humidity	66.0%
Ext. optics temp.	68.0 °F
Ext. optics trans.	1.00

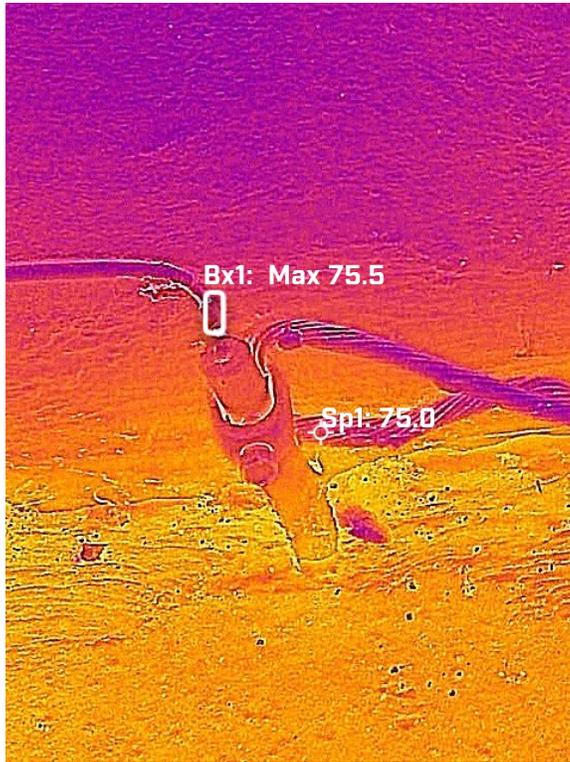
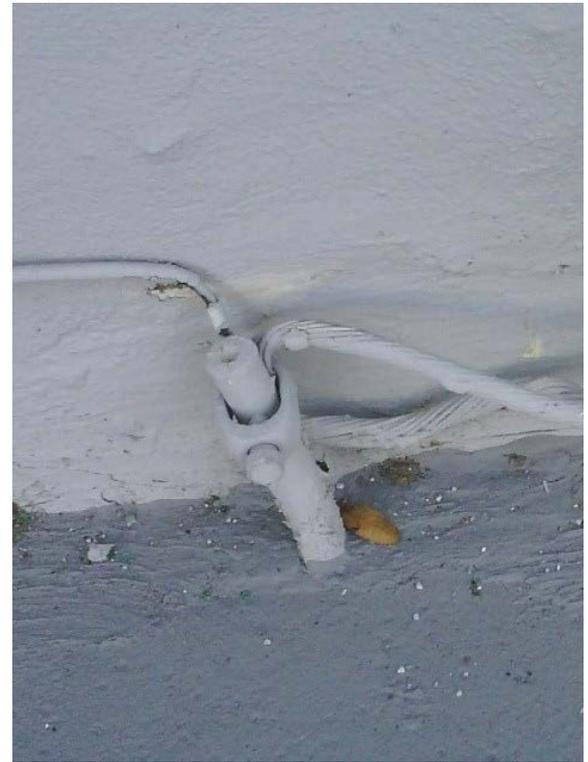
FLIR0006.jpg

Emissivity	0.95
Distance	6.00 ft
Reflected temp.	70.0 °F
Air Temperature	71.0 °F
Relative humidity	66.0%
Ext. optics temp.	68.0 °F
Ext. optics trans.	1.00

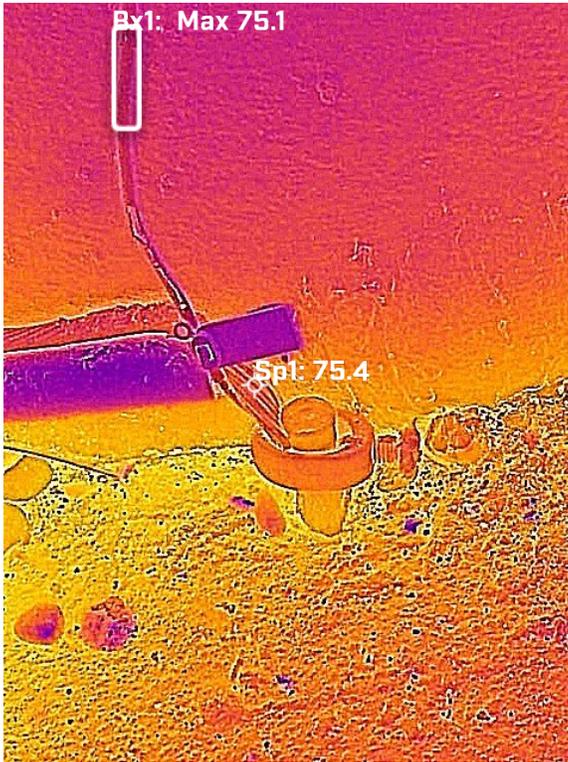
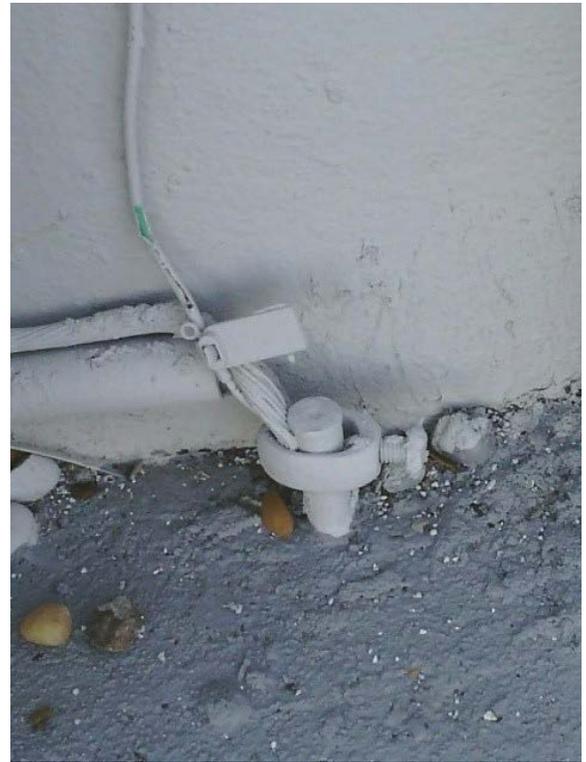
FLIR0007.jpg

Emissivity	0.95
Distance	2.27 ft
Reflected temp.	70.0 °F
Air Temperature	71.0 °F
Relative humidity	66.0%
Ext. optics temp.	68.0 °F
Ext. optics trans.	1.00

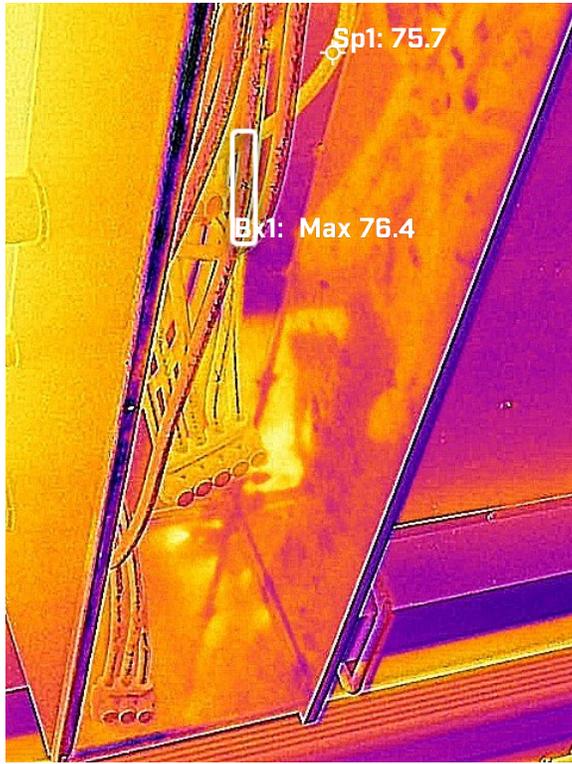
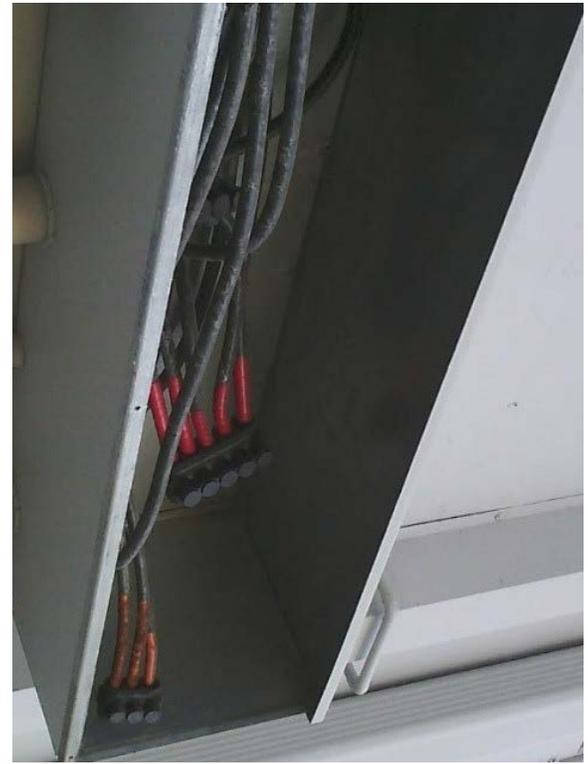
FLIR0008.jpg

Emissivity	0.95
Distance	6.00 ft
Reflected temp.	70.0 °F
Air Temperature	71.0 °F
Relative humidity	66.0%
Ext. optics temp.	68.0 °F
Ext. optics trans.	1.00

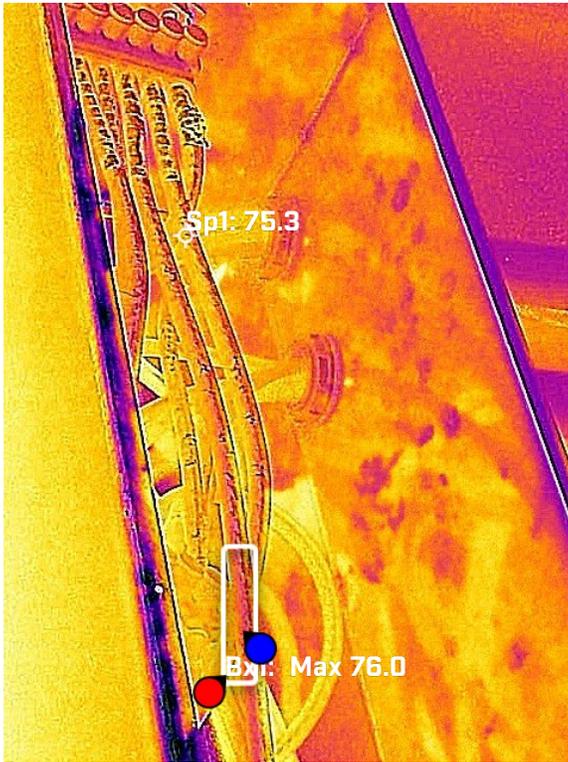
FLIR0009.jpg

Emissivity	0.95
Distance	6.00 ft
Reflected temp.	70.0 °F
Air Temperature	71.0 °F
Relative humidity	66.0%
Ext. optics temp.	68.0 °F
Ext. optics trans.	1.00

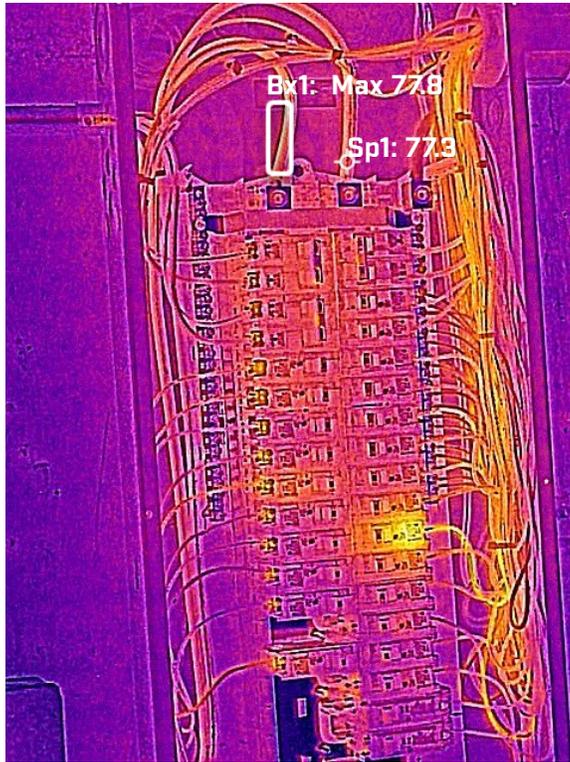
FLIR0010.jpg

Emissivity	0.95
Distance	6.00 ft
Reflected temp.	70.0 °F
Air Temperature	71.0 °F
Relative humidity	66.0%
Ext. optics temp.	68.0 °F
Ext. optics trans.	1.00

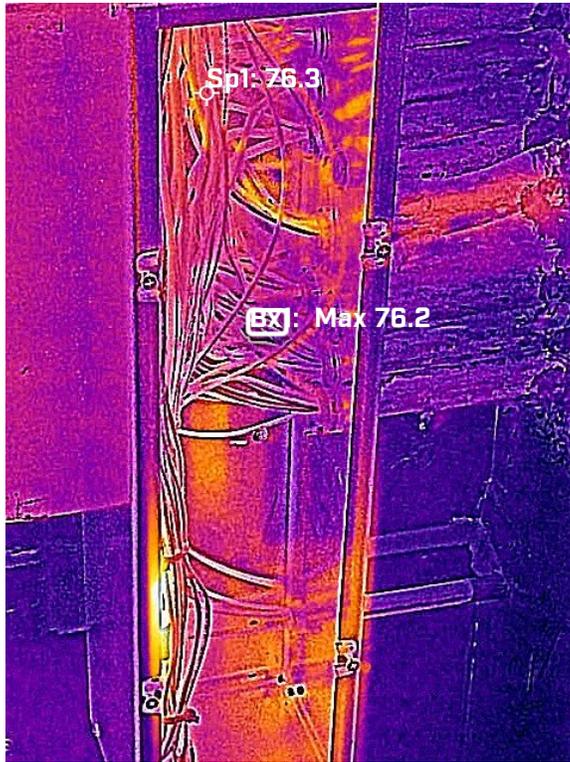
FLIR0011.jpg

Emissivity	0.95
Distance	6.00 ft
Reflected temp.	70.0 °F
Air Temperature	71.0 °F
Relative humidity	66.0%
Ext. optics temp.	68.0 °F
Ext. optics trans.	1.00

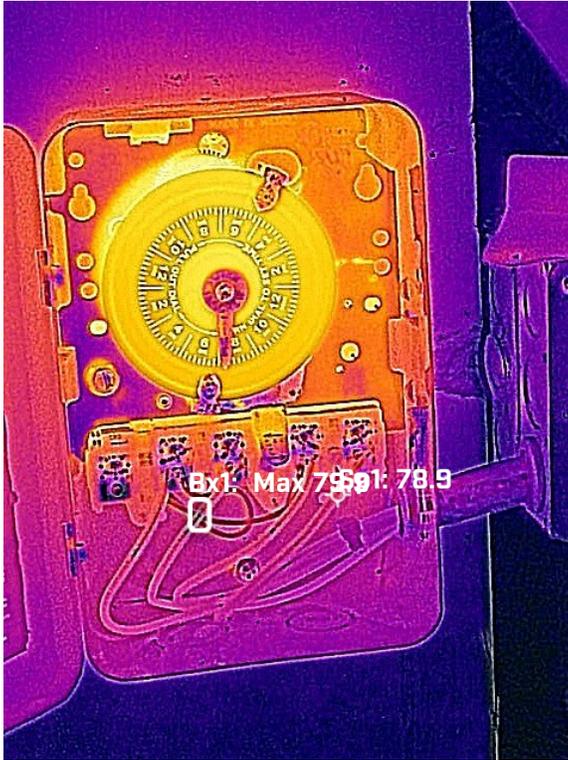
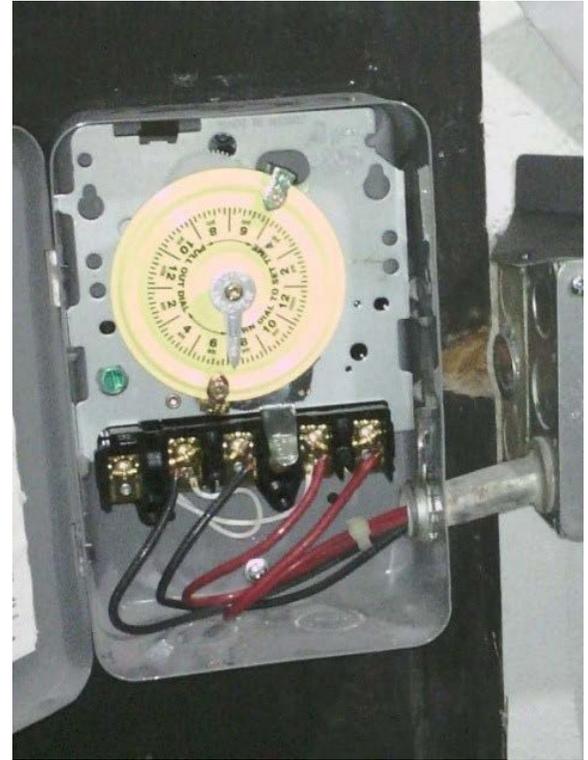
FLIR0012.jpg

Emissivity	0.95
Distance	6.00 ft
Reflected temp.	70.0 °F
Air Temperature	71.0 °F
Relative humidity	66.0%
Ext. optics temp.	68.0 °F
Ext. optics trans.	1.00

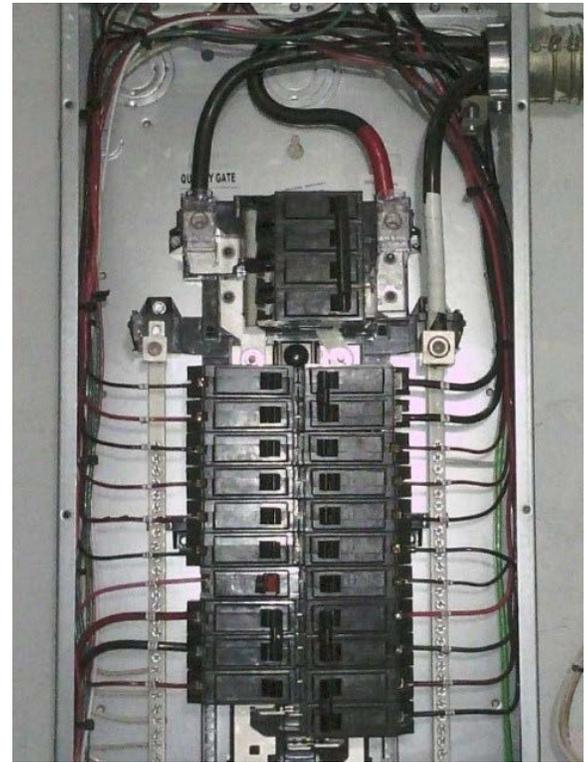
FLIR0013.jpg

Emissivity	0.95
Distance	6.00 ft
Reflected temp.	70.0 °F
Air Temperature	71.0 °F
Relative humidity	66.0%
Ext. optics temp.	68.0 °F
Ext. optics trans.	1.00

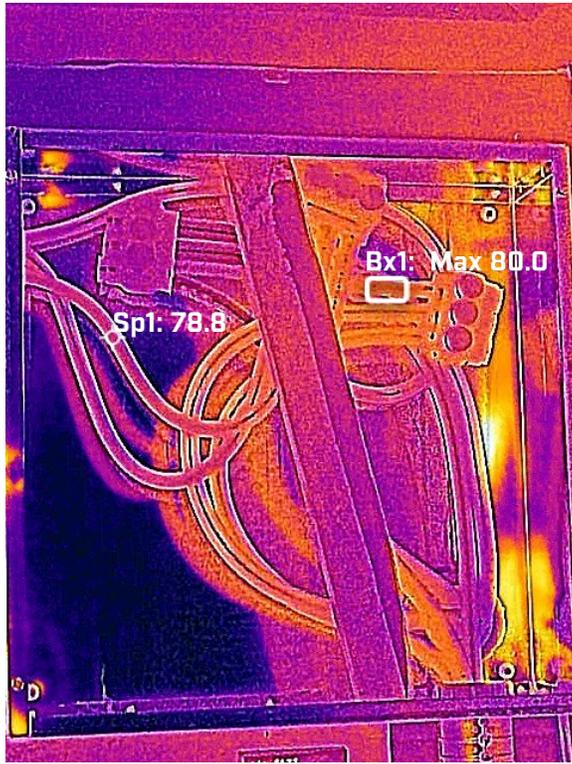
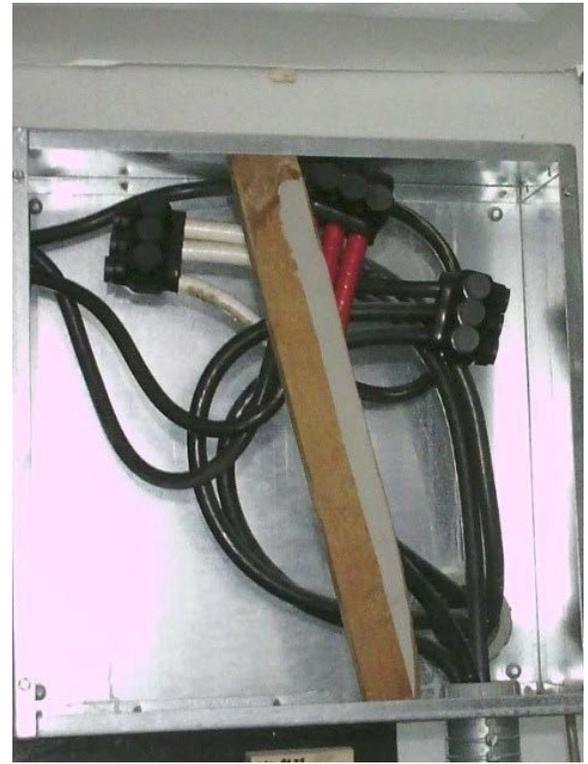
FLIR0014.jpg

Emissivity	0.95
Distance	6.00 ft
Reflected temp.	70.0 °F
Air Temperature	71.0 °F
Relative humidity	66.0%
Ext. optics temp.	68.0 °F
Ext. optics trans.	1.00

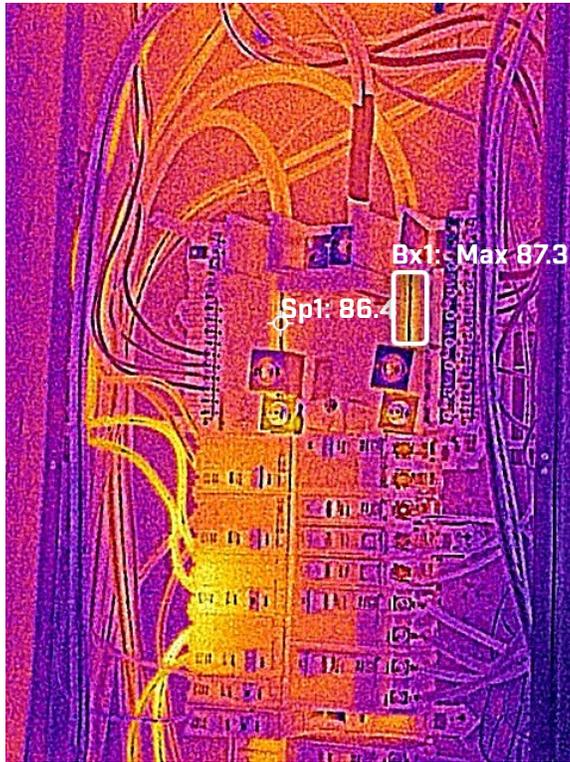
FLIR0015.jpg

Emissivity	0.95
Distance	6.00 ft
Reflected temp.	70.0 °F
Air Temperature	71.0 °F
Relative humidity	66.0%
Ext. optics temp.	68.0 °F
Ext. optics trans.	1.00

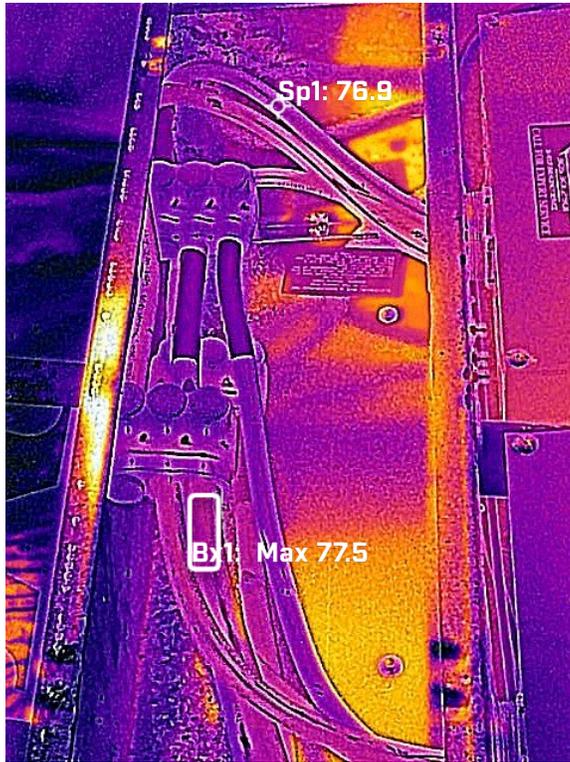
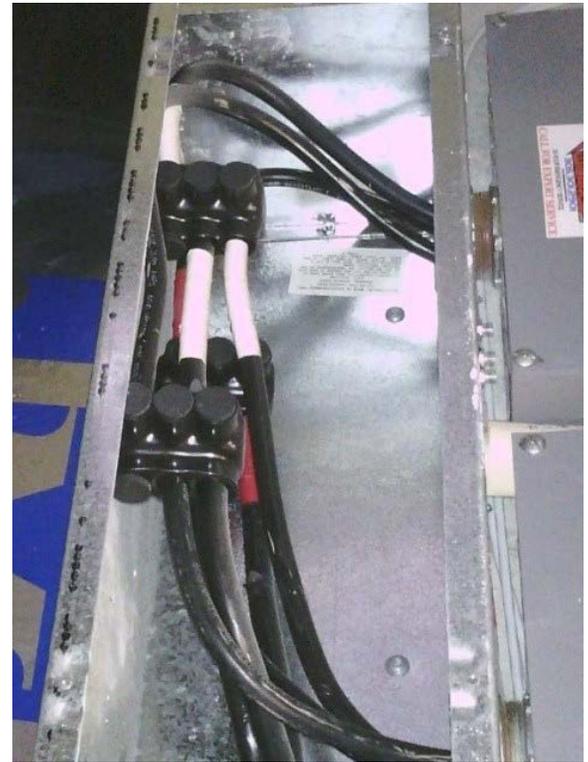
FLIRO017.jpg

Emissivity	0.95
Distance	6.00 ft
Reflected temp.	70.0 °F
Air Temperature	71.0 °F
Relative humidity	66.0%
Ext. optics temp.	68.0 °F
Ext. optics trans.	1.00

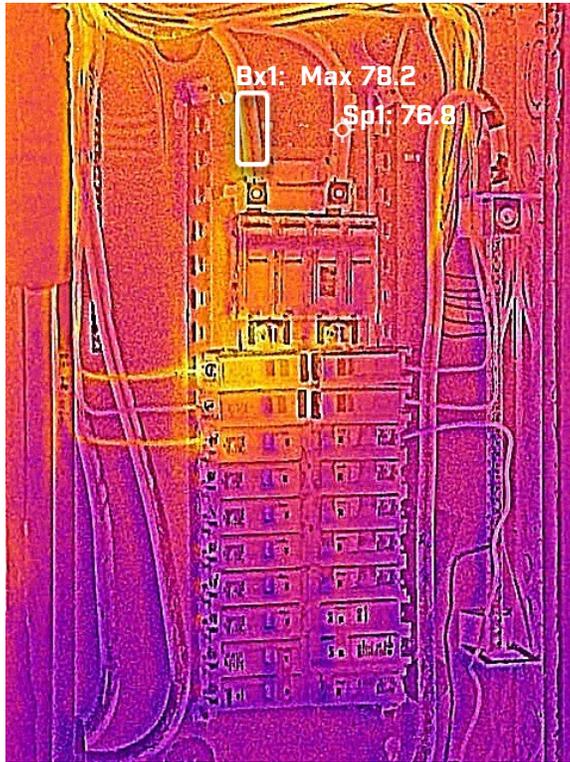
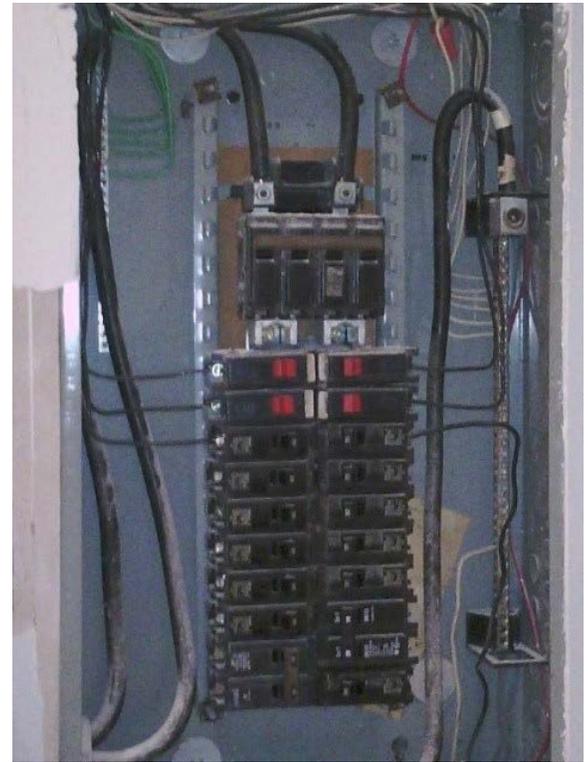
FLIR0022.jpg

Emissivity	0.95
Distance	6.00 ft
Reflected temp.	70.0 °F
Air Temperature	71.0 °F
Relative humidity	66.0%
Ext. optics temp.	68.0 °F
Ext. optics trans.	1.00

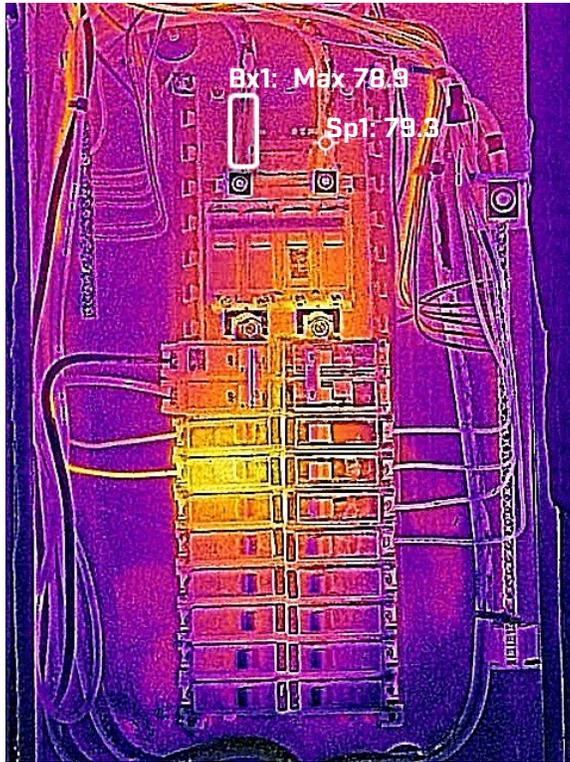
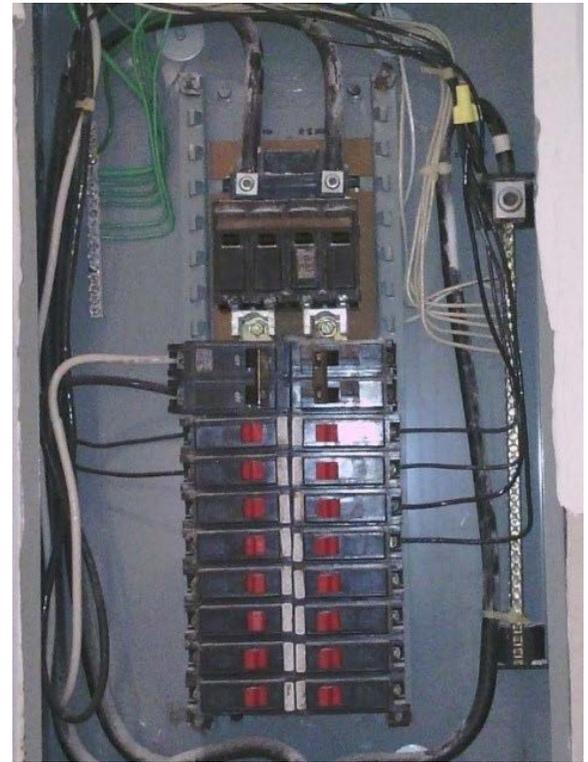
FLIR0023.jpg

Emissivity	0.95
Distance	6.00 ft
Reflected temp.	70.0 °F
Air Temperature	71.0 °F
Relative humidity	66.0%
Ext. optics temp.	68.0 °F
Ext. optics trans.	1.00

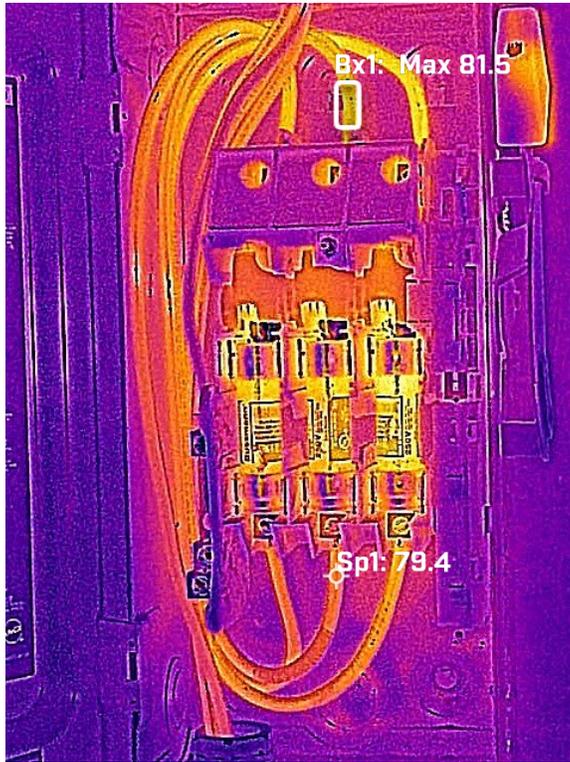
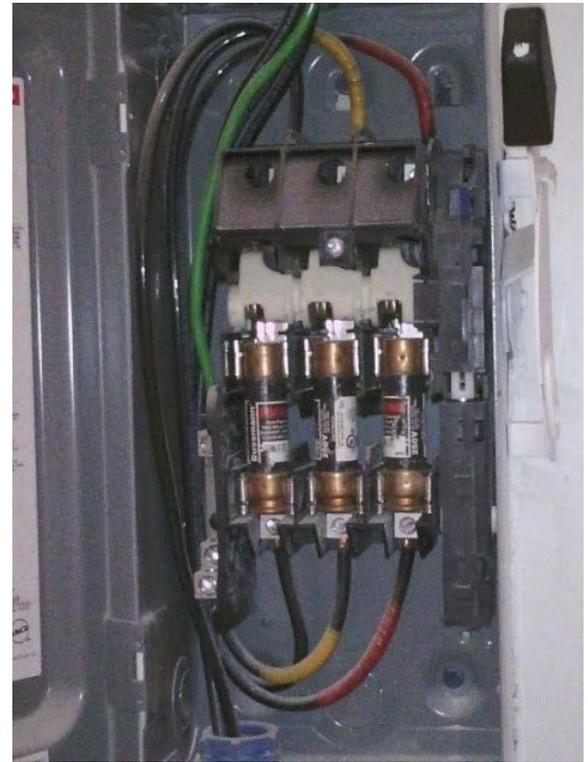
FLIR0024.jpg

Emissivity	0.95
Distance	6.00 ft
Reflected temp.	70.0 °F
Air Temperature	71.0 °F
Relative humidity	66.0%
Ext. optics temp.	68.0 °F
Ext. optics trans.	1.00

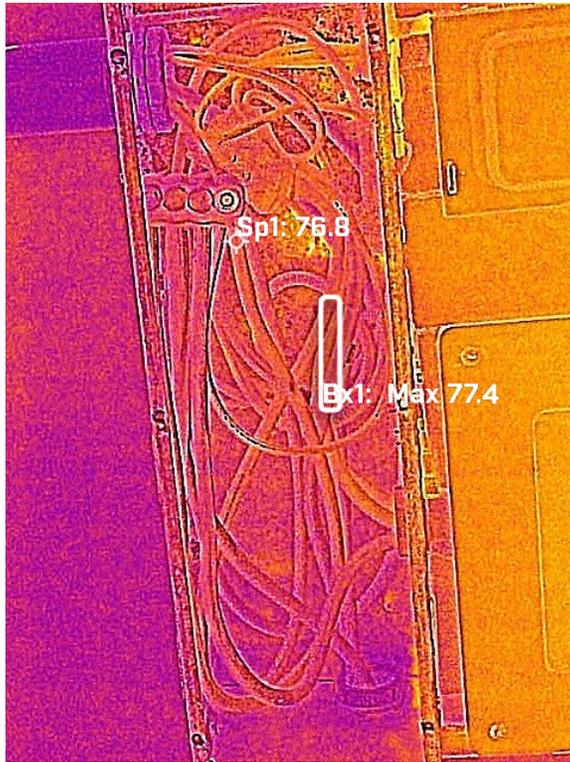
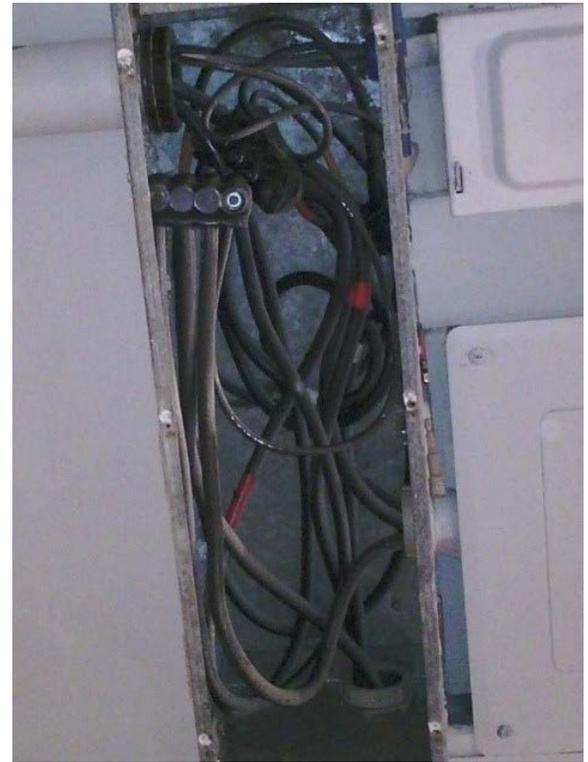
FLIR0025.jpg

Emissivity	0.95
Distance	6.00 ft
Reflected temp.	70.0 °F
Air Temperature	71.0 °F
Relative humidity	66.0%
Ext. optics temp.	68.0 °F
Ext. optics trans.	1.00
