COA (SP) 2015-015 REVISED
April 21, 2021

STAFF REPORT

SPECIAL CERTIFICATE OF APPROPRIATENESS REVISION FOR THE PROPERTY AT 6801 GRANADA BOULEVARD A LOCAL HISTORIC LANDMARK

This application requests after-the-fact design approval for a revision to the approved Certificate of Appropriateness due to deviations from the previously approved plans.

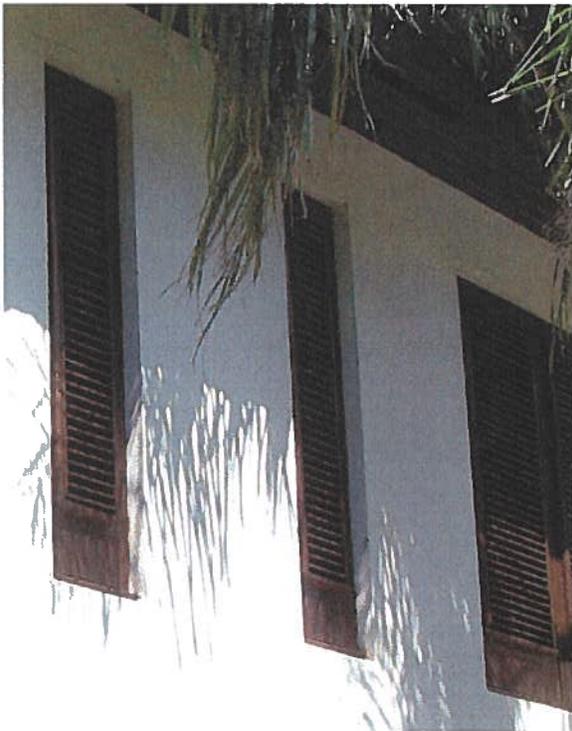
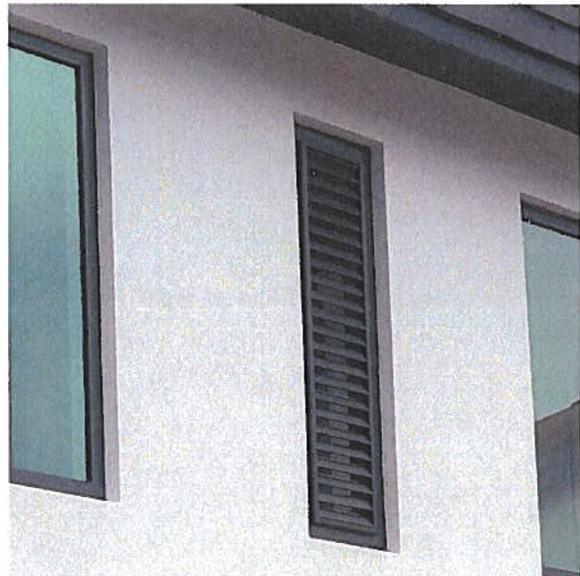
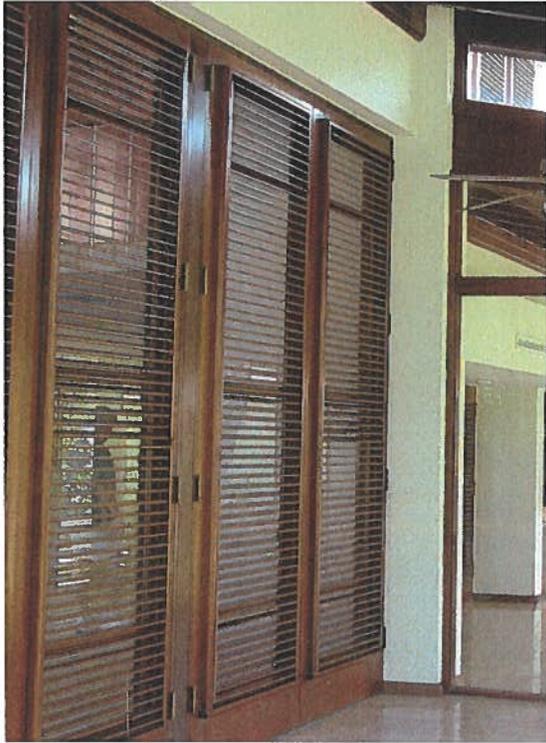
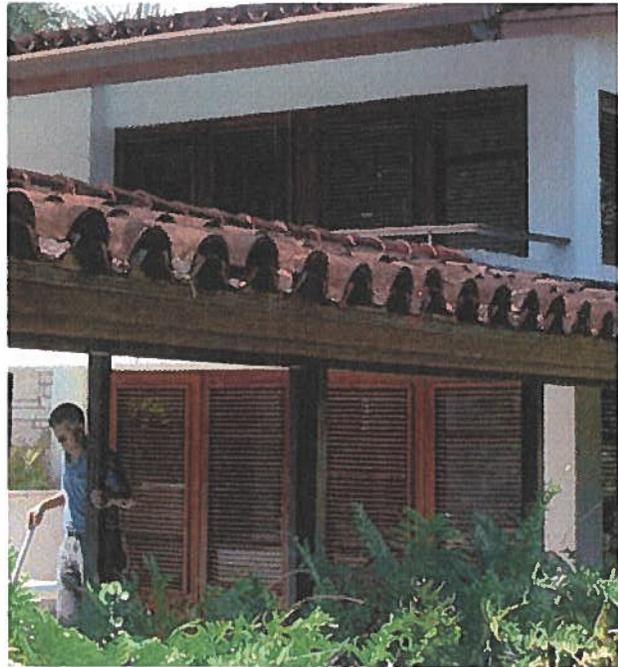
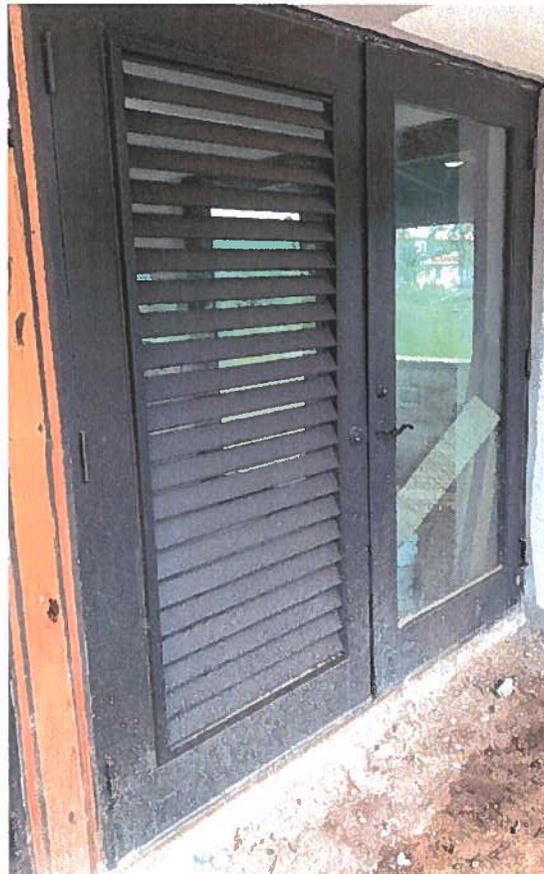
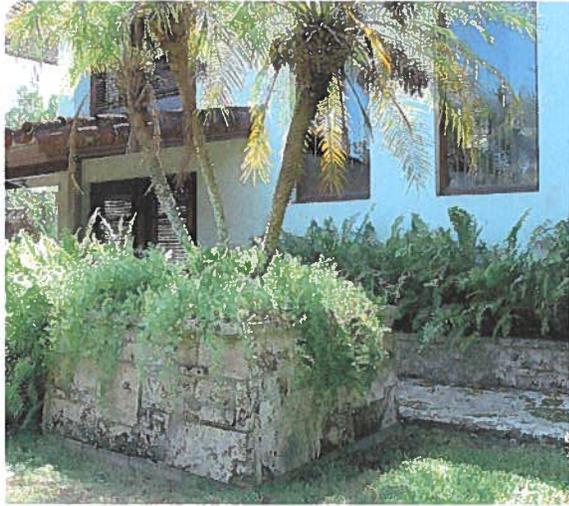
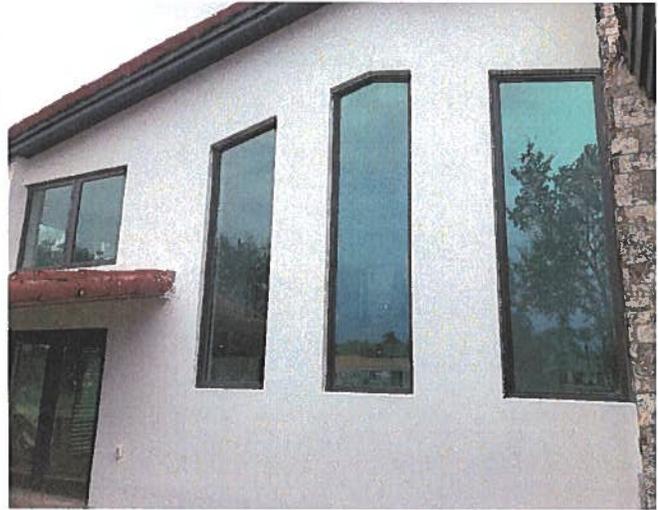
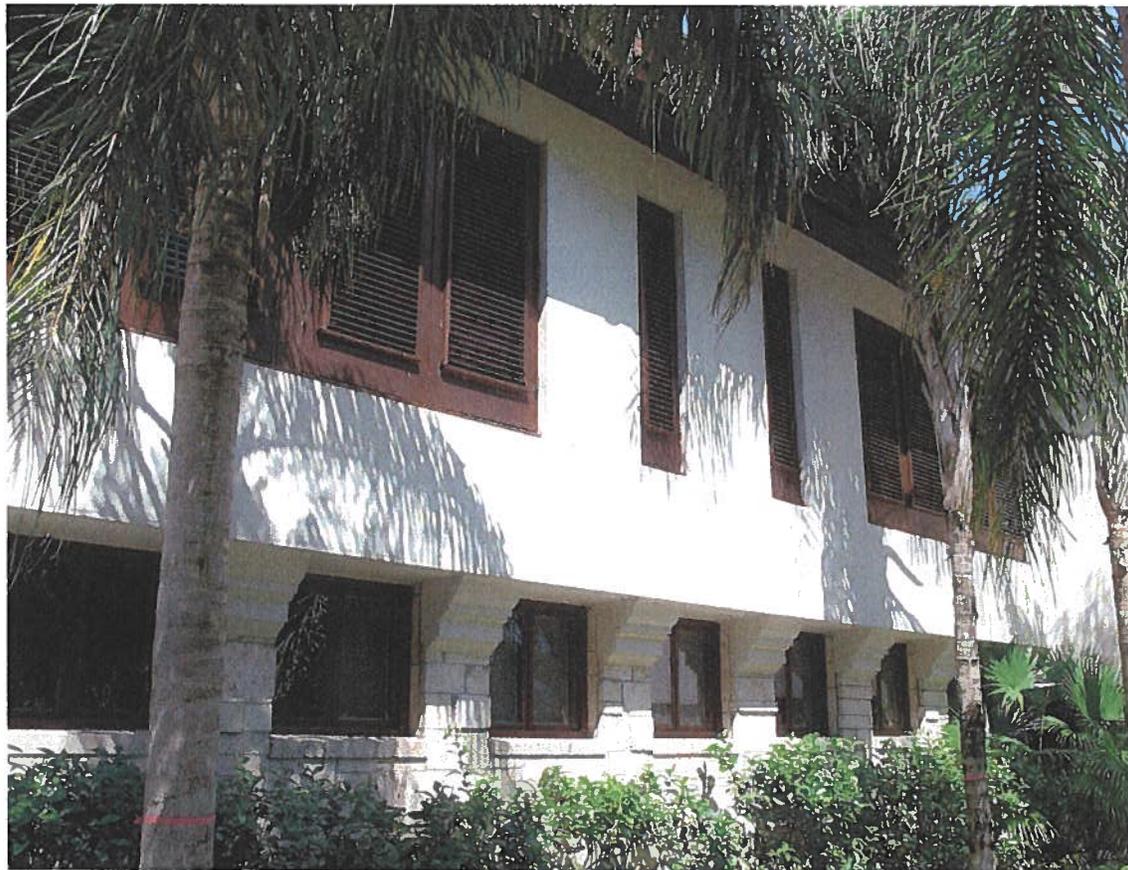
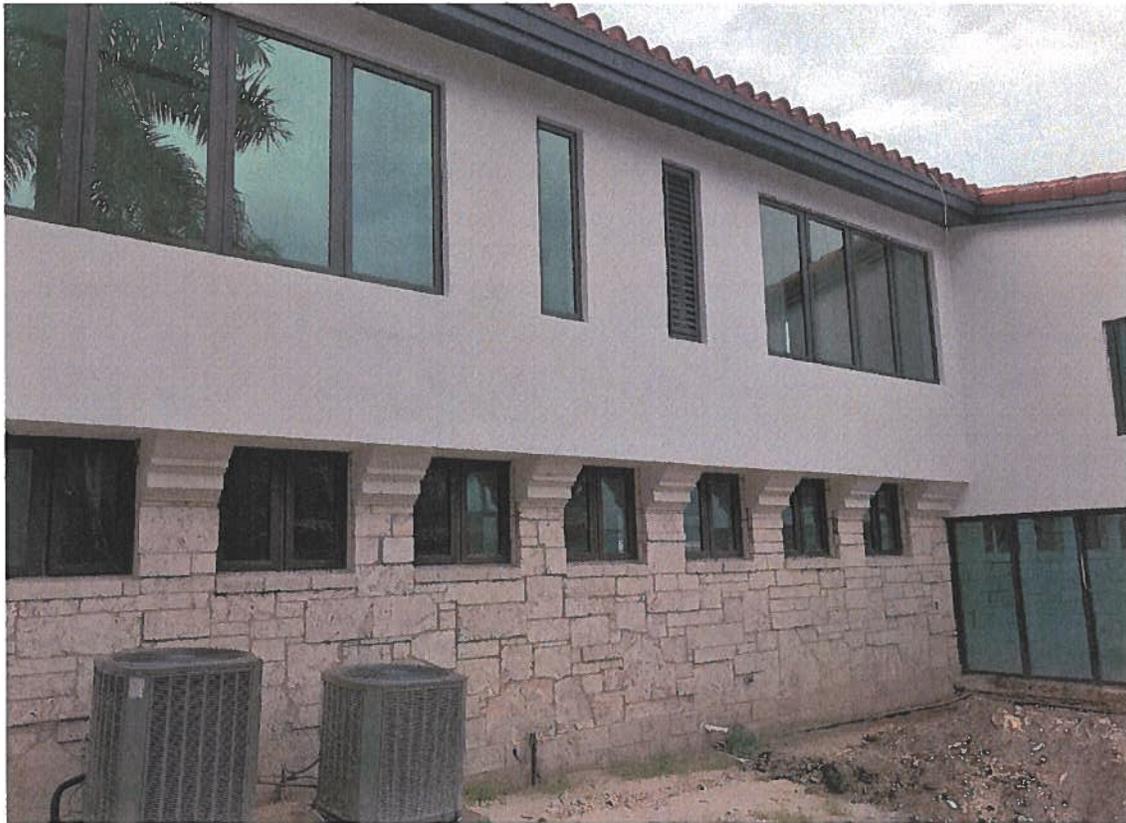
The original Persiana louver system was one of the Parker's signature features, which have now been removed. Staff commented on how the original Persians were to be reinstalled. The architect states in the letter of intent that the "original 1951 mahogany louvers could be resourced from the original material and re-purposed into the fenestrations of the new glazing...[and] utilizes the original louver material, shape, order, color, and arrangement...The design meets The Standards for Rehabilitation." Staff questions to which Standard the architect is referring.

The new windows and doors are the wrong color and have tinted/reflective glass. The louvers do not match the original in any way. They are the wrong size, color, density (number of louvers), and angle. Had the proper procedure been followed by the architect – revision followed by shop drawings – a proper solution might have been found.

(photo 2006)

(photo 09-2020)

(photo 2015)

Staff requires proof that the original Persiana louver system was retained. Are they being stored somewhere? Staff recommends denial of the window and door removal. New windows should be installed that reflect the material, clear window glass, and louver system as originally on the residence. Drawings should be prepared and permitted that detail the replacement to accurately match the original in size, color, number of louvers, and angle.

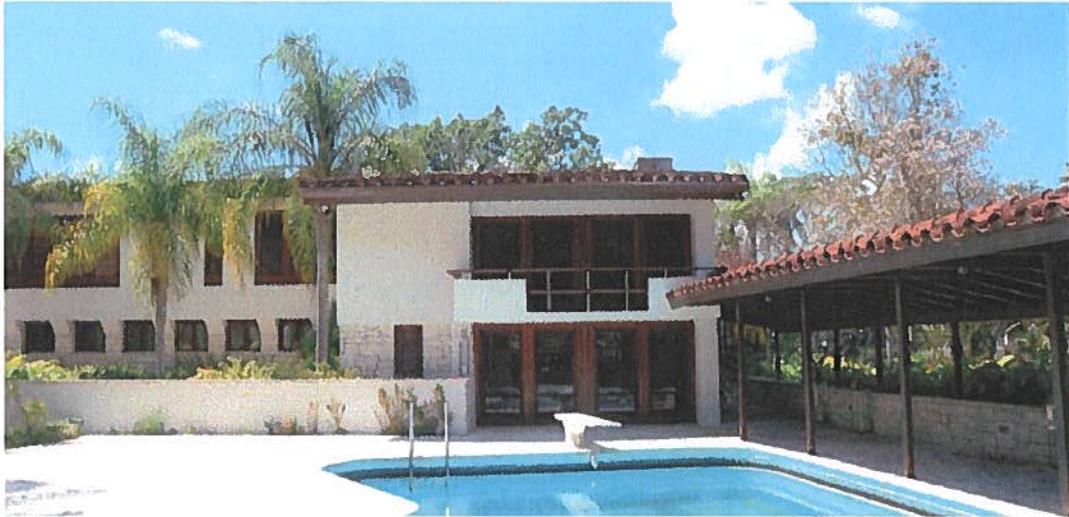
Staff’s initial note referred to the removal of an existing, to-remain wall that encircled the original pool location. While not original to the home, the stucco-clad wall was shown as to remain and was to screen the new air-conditioning units. The wall was removed. No details or elevations have been provided for its reconstruction.

(photo 2015)

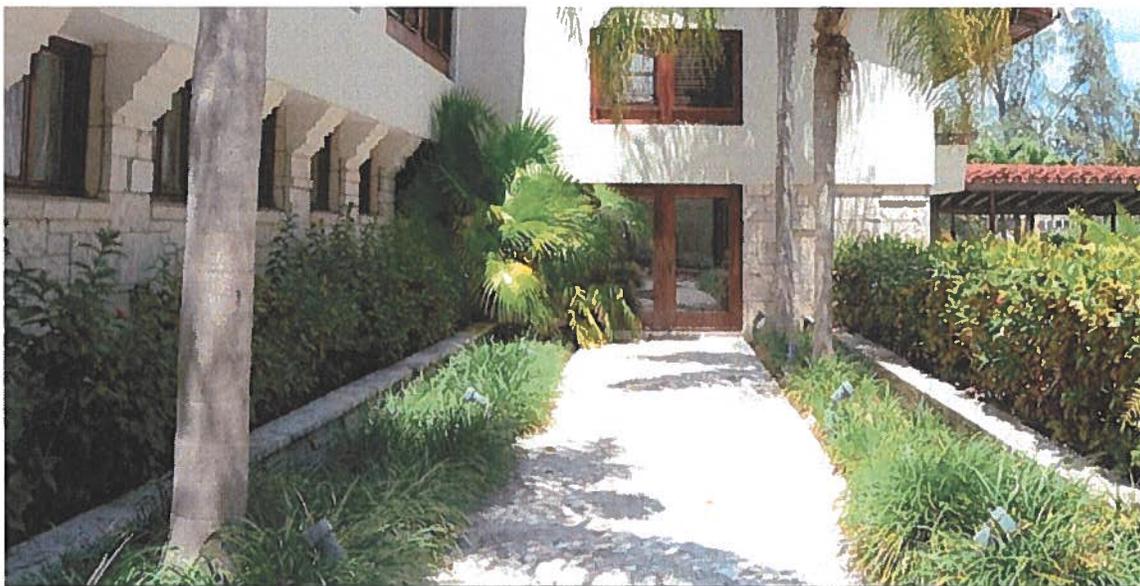
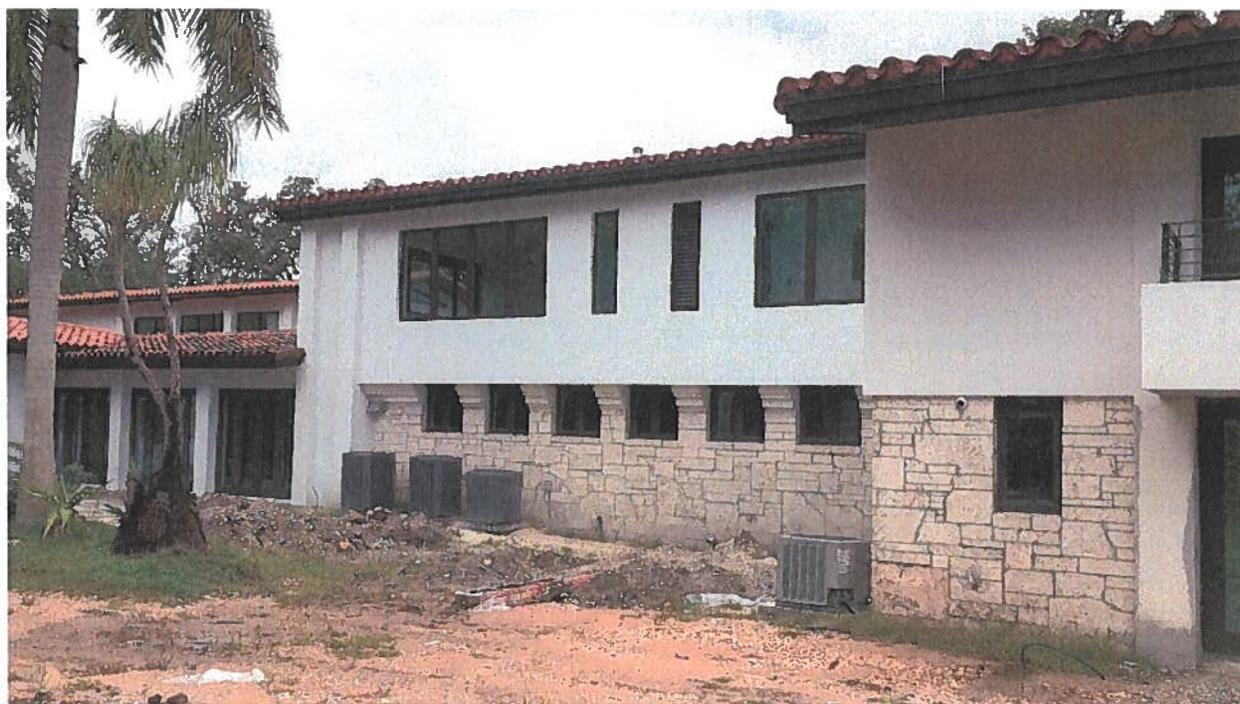
The letter also mentions a planter that was removed to accommodate an “on-site sanitary treatment plant.” The oolite-clad planter was an original Parker-designed feature of the house and was shown as existing to remain. Staff has not been given any reason for why this planter had to be removed in part or in its entirety.

(photo 2015)

(photo 09-2020)

Staff recommends that drawings be prepared and permitted that detail the replacement of the coral planter to accurately match the original in pattern and dimensions. Staff requires that the installation be done by a coral stone mason or conservator approved by the Historical Resources and Cultural Arts Department Staff.

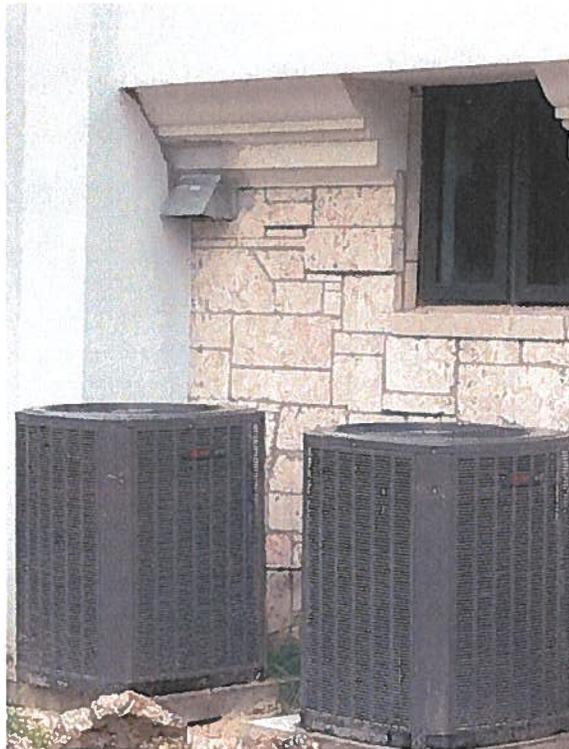
The Board packet includes a single mechanical sheet that is believed to be part of the revision but has no revision clouds or marks. Staff’s rejection comment from November 2020 states that “Mechanical exhaust front elevation not to penetrate any decorative [elements] and be low enough to screen with landscaping.” This note was in response to the condition seen in the below photo where the decorative cornice was cut for the installation. Contrary to what the architect states in his letter of intent, no photos of the installation were provided to Staff. Obviously, this location is not appropriate.

(photo 09-2020)

Staff recommends that the vent be removed, and the coral and cornice be patched by to match the adjacent surfaces. Staff requires that this work be performed by a conservator approved by the Historical Resources and Cultural Arts Department Staff.

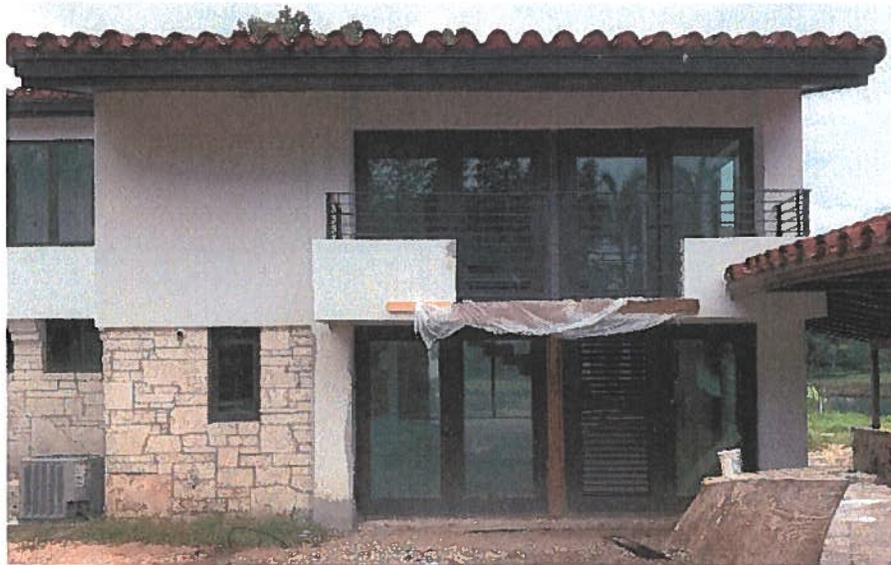
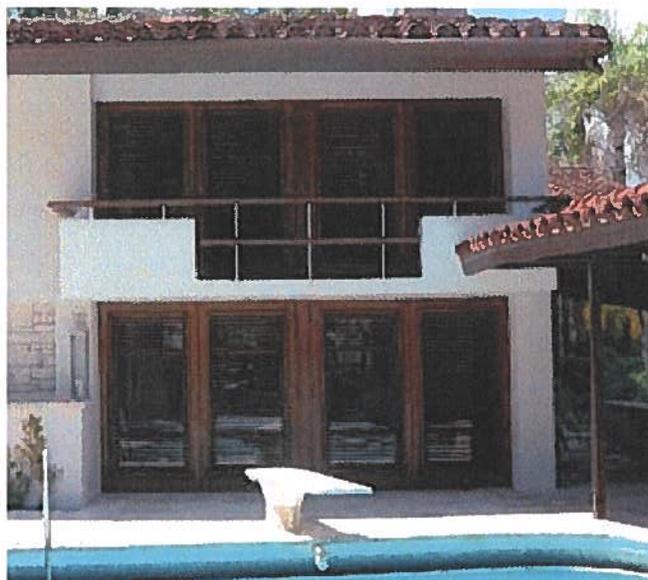
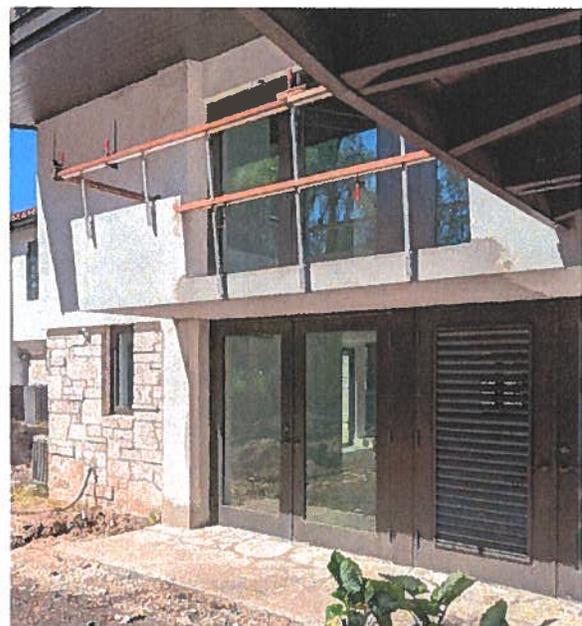
instructed by WHAA to put back to its original condition. Same for the new addition, the railing should match and the contractor has been advised not to deviate.” In 2020, an entirely new railing system had been installed. See photos below.

The railing was existing to remain. The new railing does not match the original. Details and shop drawings are to be provided.

(photo 09-25-2020)

(photo 2015)

(photo 2020, per architect)

Staff recommends that drawings be prepared and permitted that detail the replacement of the railing. Shop drawings will be required for the railing as well, once the permit is obtained.

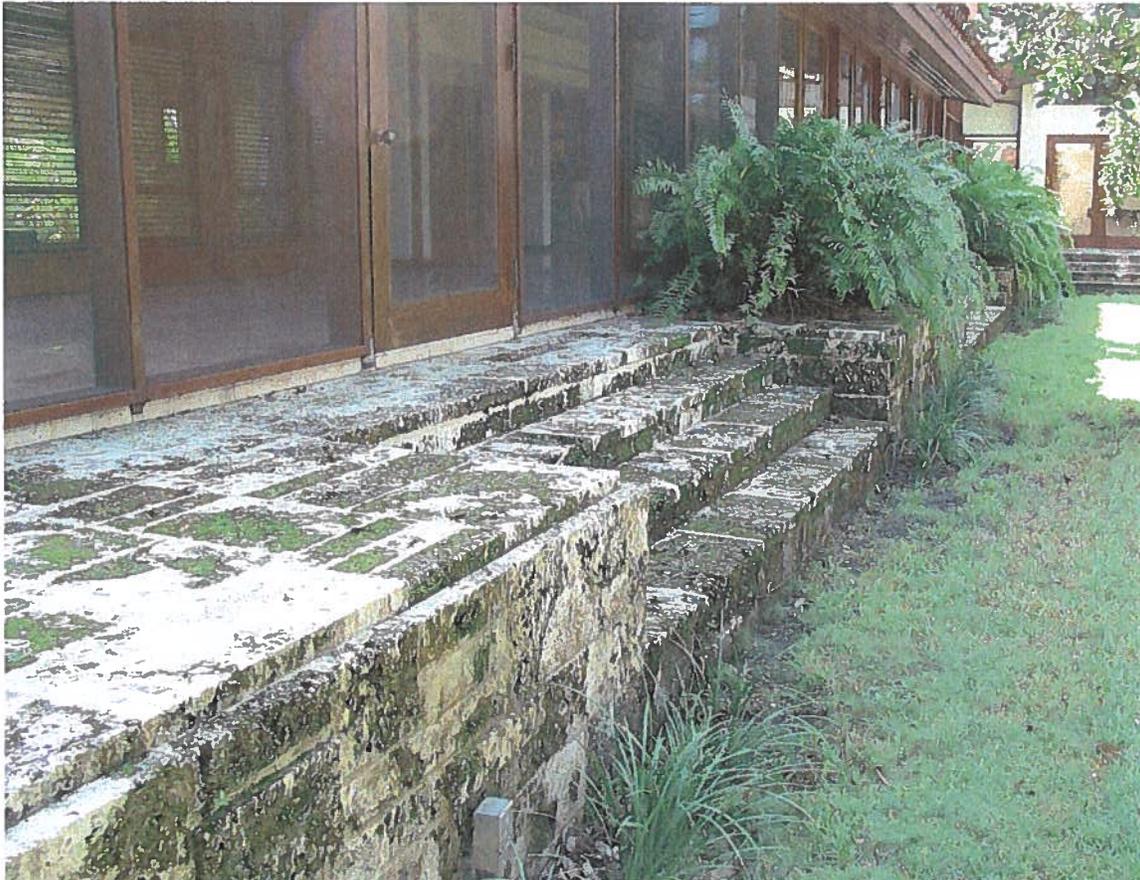
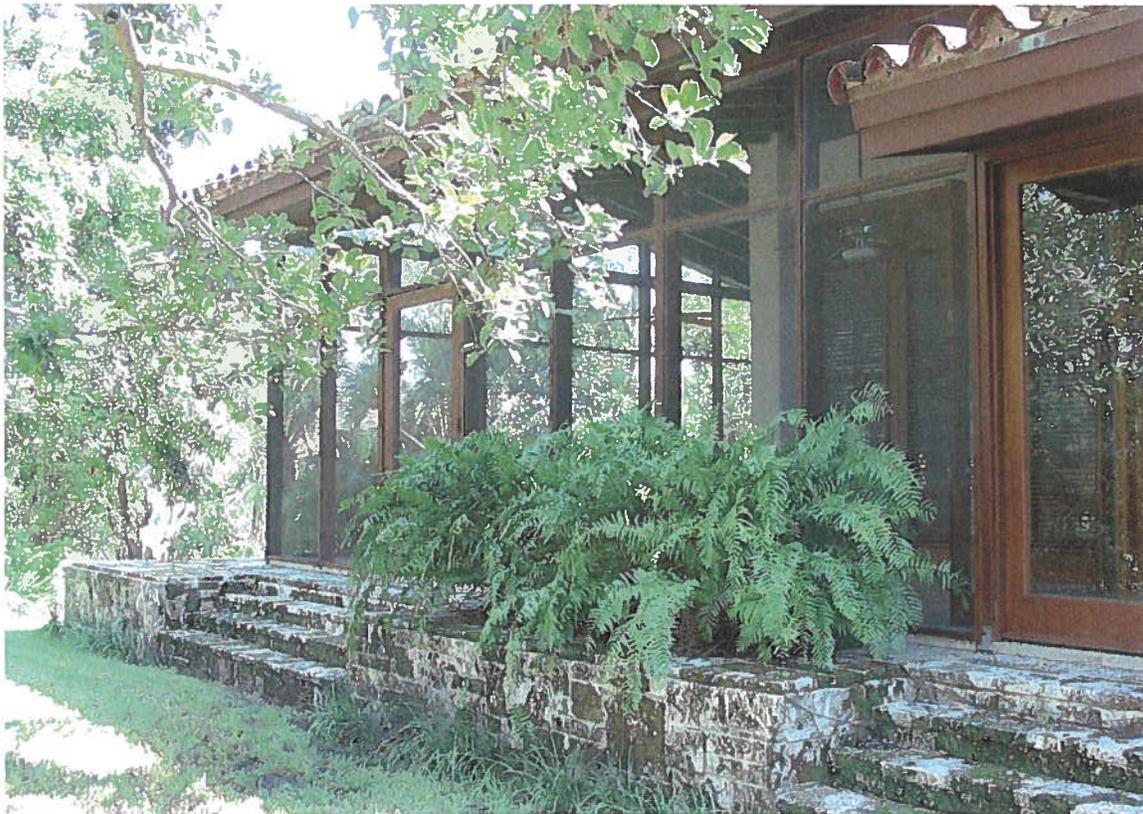
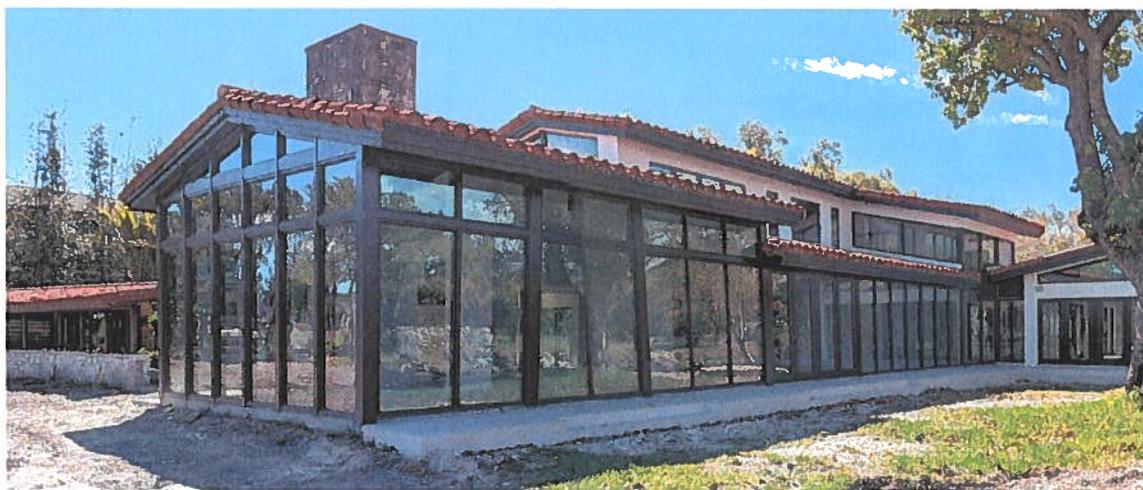
Upon review of the submittal, it was noted that the coral at the steps surrounding the residence had been removed. The coral planters that were to remain as a condition of approval for the 2015 Certificate of Appropriateness [COA (SP) 2015-015 as described previously] have also been removed. In an email to the architect, Staff requested that they provide documentation where the coral steps permitted as existing to remain were approved to be eliminated. The response from the architect stated that *“There is no documentation. Neither WHAA or the owner proposed elimination of steps or made any application to have the steps removed.”* What appears to be a new concrete slabs and steps have been installed. Please see the photos below and note the regrading of the site.

(photo 2006)

(photo 2020, per architect)

Staff recommends that drawings be prepared and permitted that detail the replacement of the coral steps and planters to accurately match the original in pattern and dimensions and with the previous grading. Staff requires that the installation be done by a coral stone mason or conservator approved by the Historical Resources and Cultural Arts Department Staff.

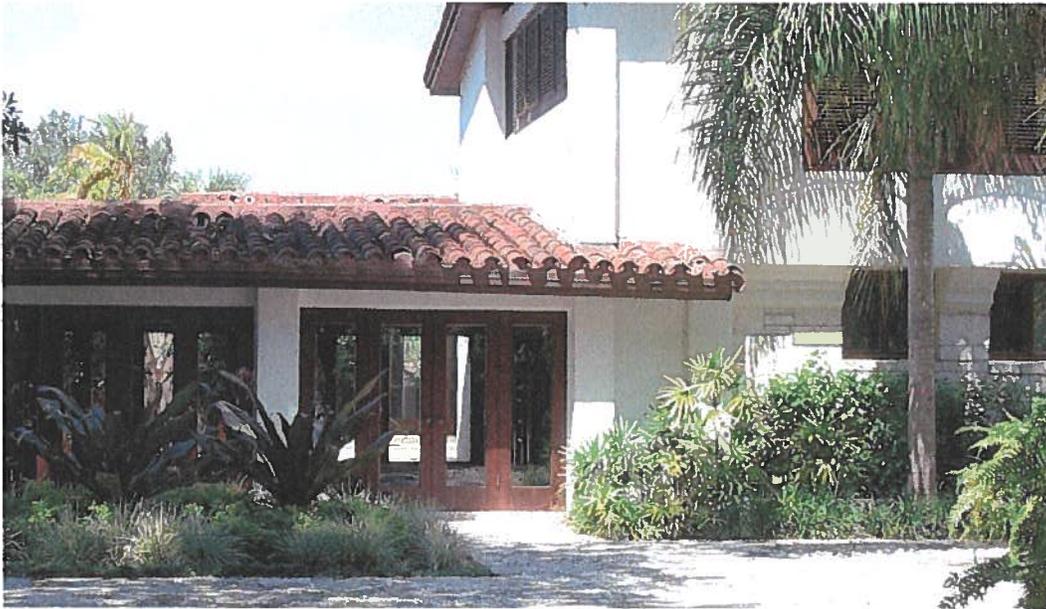
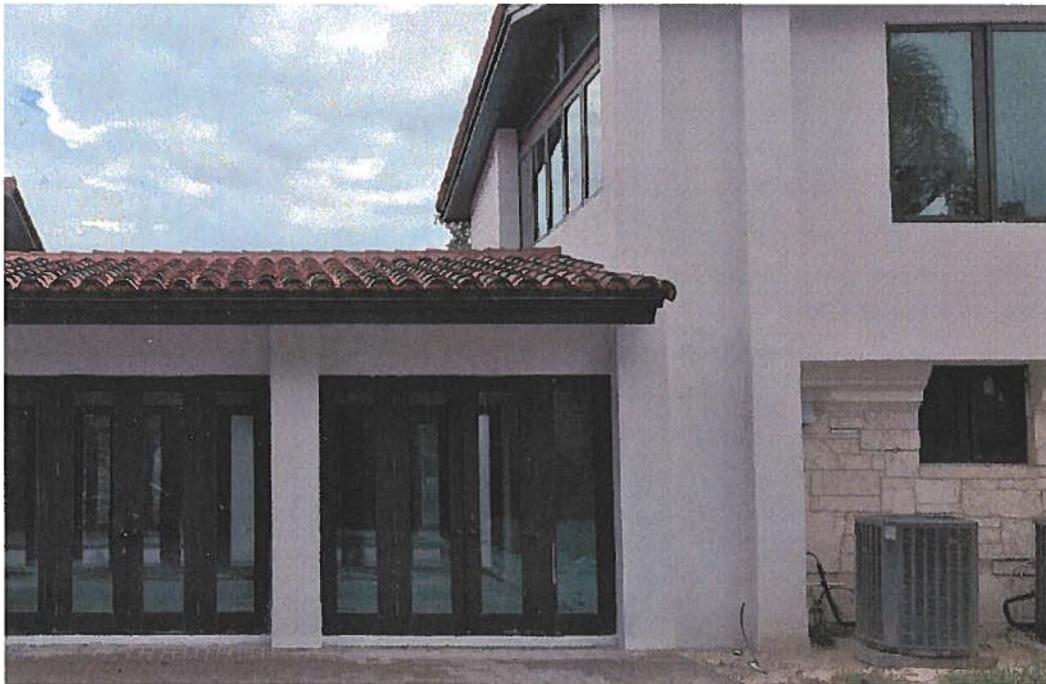
A small roof overhang original to the residence and visible in the original permit drawings (visible in the Parker’s drawing of the southeast elevation under “Removal of Existing Planter Wall” section above) has also been removed.

(photo 2006)

(photo 09-2020)

Staff recommends that drawings be prepared and permitted to have the roof overhang reinstated.
