MIAMI-DADE COUNTY
HISTORIC PRESERVATION AD-VALOREM TAX EXEMPTION

PART 1 – PRECONSTRUCTION APPLICATION

Historic/Site Name: _____
Property Address: 936 Castile Avenue, Coral Gables, FL 33134
Folio Number: 03-4107-021-0040
Legal Description: Peacock Re-Sub PB 35-60
Lot 8 Lot Size Irregular OR 29314-0878 0614 19

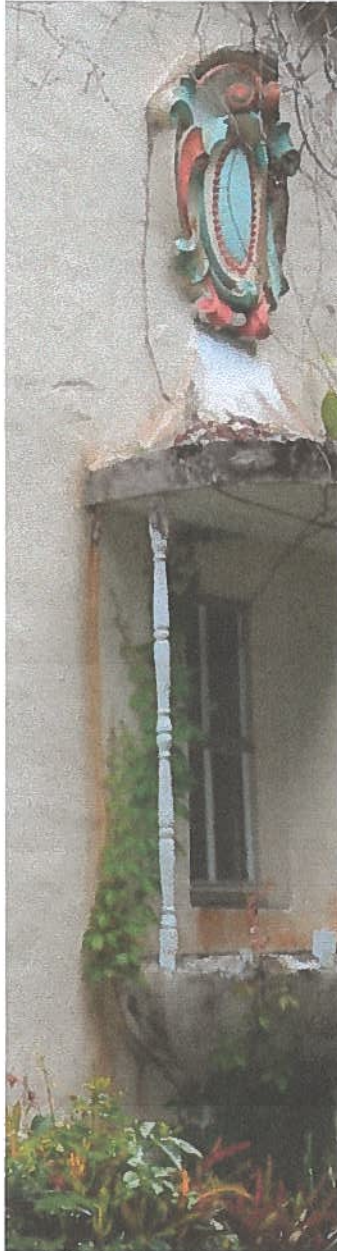
Photo 1

FEATURE 1: Existing Wood Spindle features in front window.

Elevation: North Elevation

Fortunately one of the original wood spindles was preserved. We will be able to recreate the other spindles matching the original design and restore this important architectural feature back to its original state

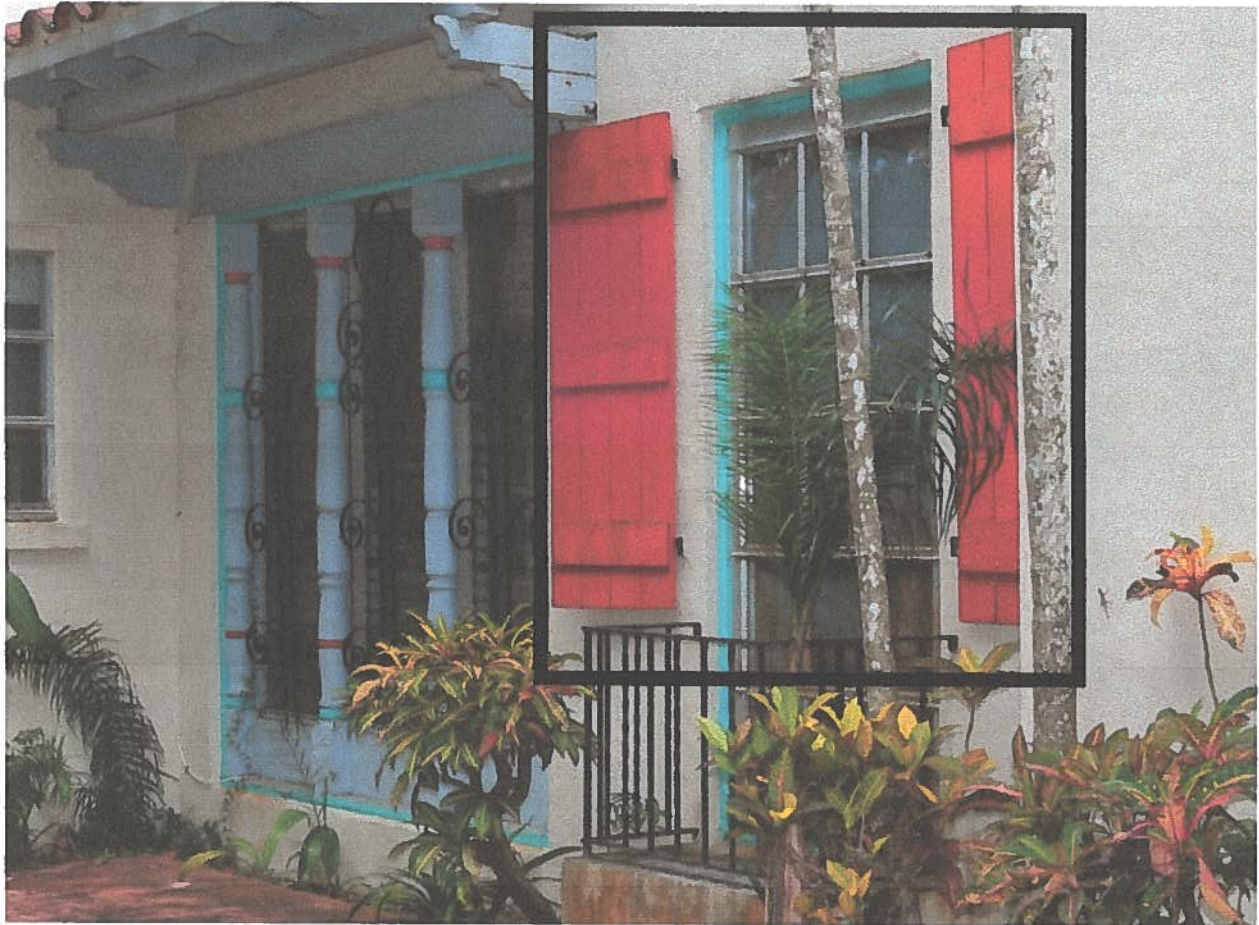
Photo 2

FEATURE 2: Barn style window Wood Shutters

Elevation: North & South Elevations

The original design by Lester Avery called for barn style wood shutters next to the windows on the front elevation of the house. We are recreating these shutters and reinstalling them as well. We are also using them as decorative elements in the rear windows facing the courtyard.

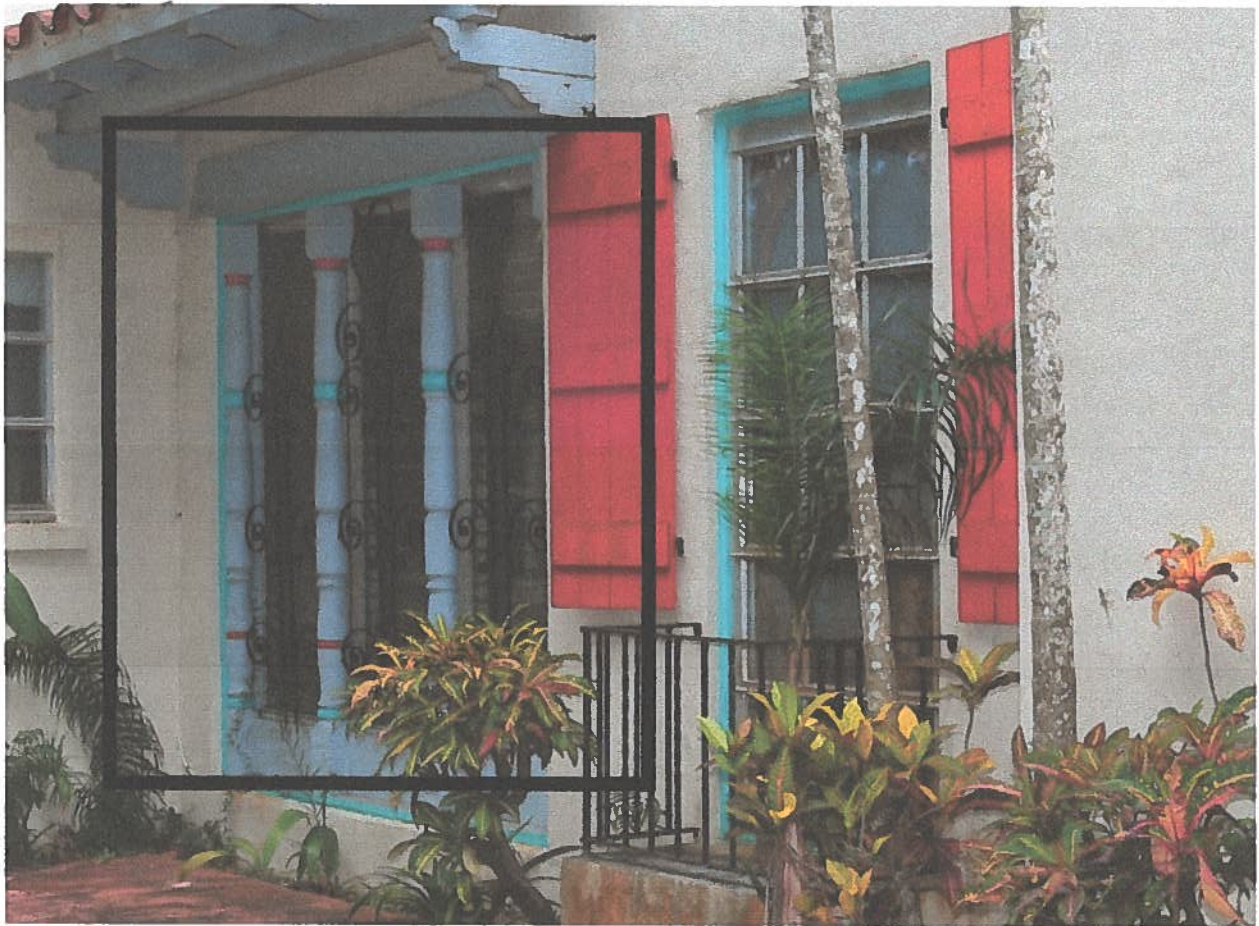
Photo 3

FEATURE 3: Large window Wood Spindles in front of original Open Porch

Elevation: North & South Elevation

The large original wood spindles in front of what used to be the original open porch will be restored. If any are found to be destroyed beyond repairs, new ones will be constructed to match the original. The new impact resistant windows have been placed behind these spindles so as not to destroy the intent and integrity of the original design.

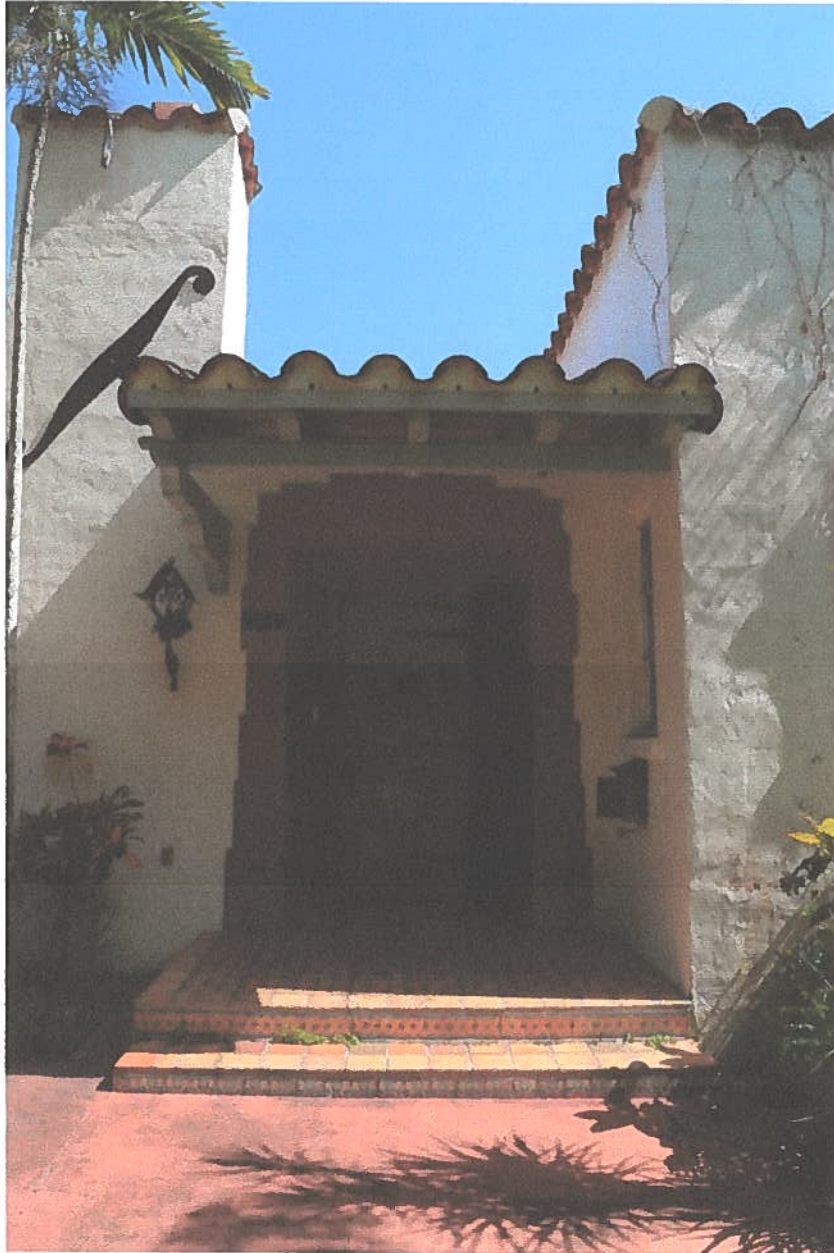
Photo 4

FEATURE 4: Front Door, Stonework, and Chimney Structure

Elevation: North Elevation

The original wood front door along with the stonework surrounding it, will be restored to original conditions. The stucco fireplace chimney and the decorative scroll element on the upper portion of the structure will also be retained.

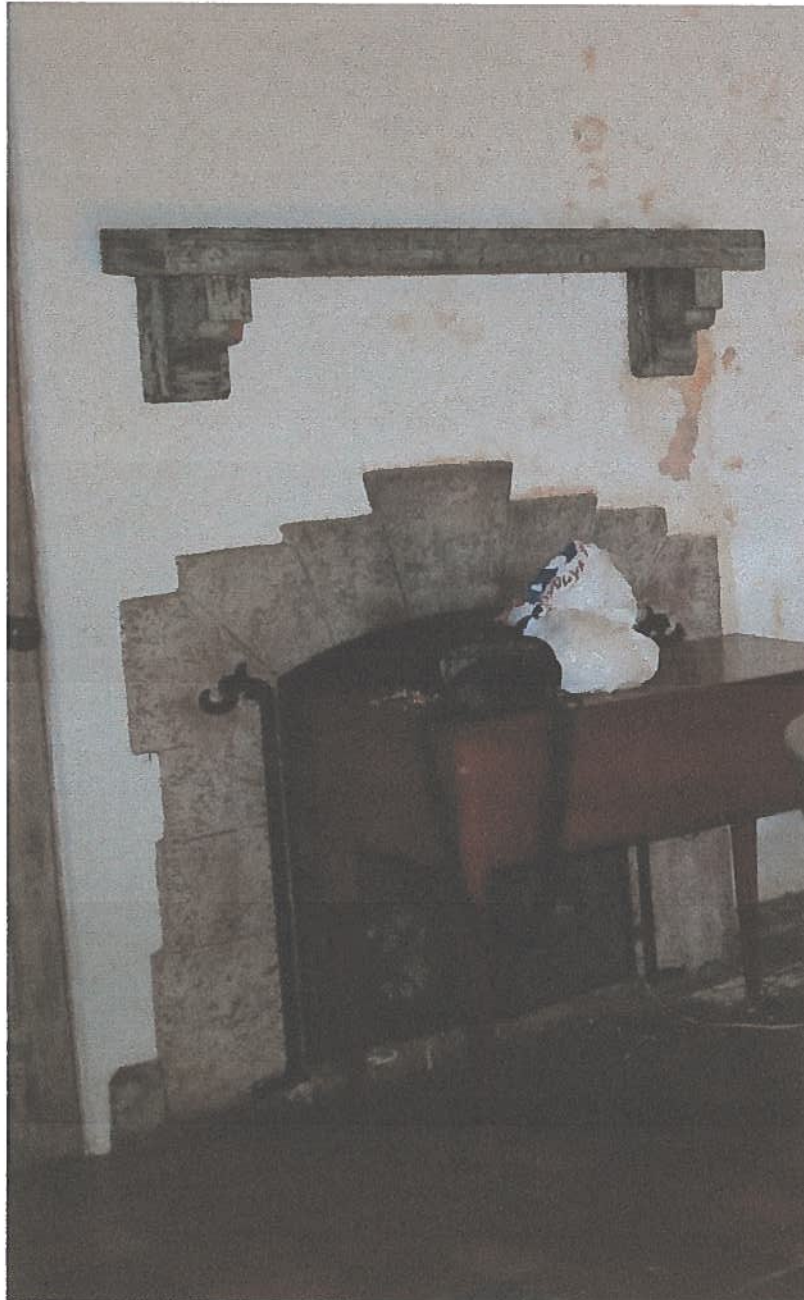
Photo 5

FEATURE 1: Existing Fireplace and Chimney @ Living Room
Room: Main Living Room
Photo Number: Photo #5
Plan Number: A-201

The existing Fireplace and Chimney will be preserved and restored to original conditions. This will no doubt become a central piece in what is the most architectural historically significant room in this residence. The importance of this room can not be overstated since it will create the first impressions and become the introducing component of the residence to visitors.

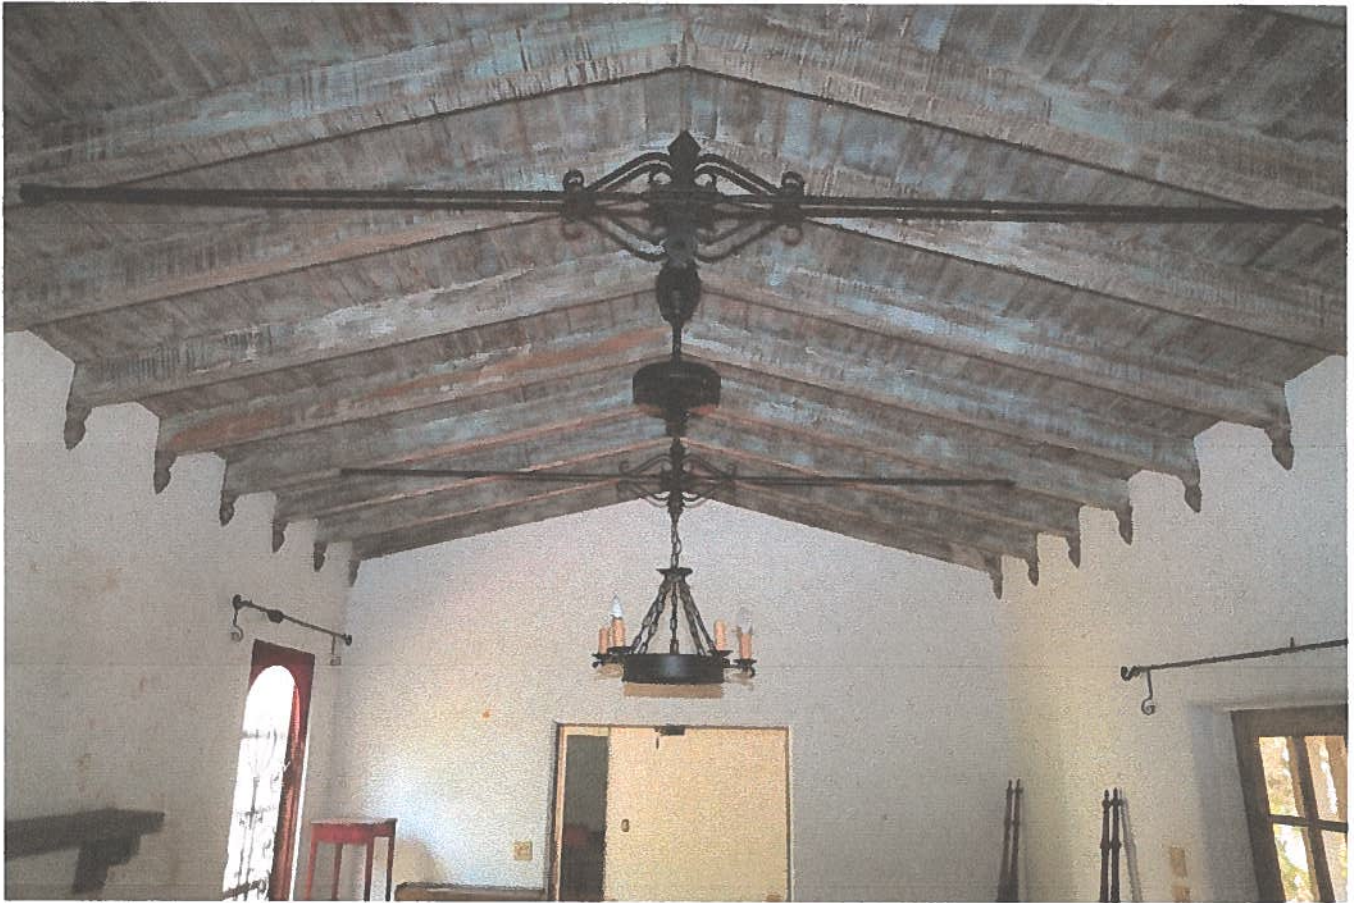
Photo 6

FEATURE 2: Existing exposed wood ceiling @ Living Room
Room: Living and Dining Room
Photo Number: Photo #6
Plan Number: A-202; A-301 & A-501

This gorgeous original wood ceiling will be preserved and restored to near original conditions. It is a very strong and important historical component in this historic home. It clearly depicts the craftsmanship and artistry of the epoch. Proper, painstaking preparation, and product application of will restore the glamour and beauty of this timeless classical piece.

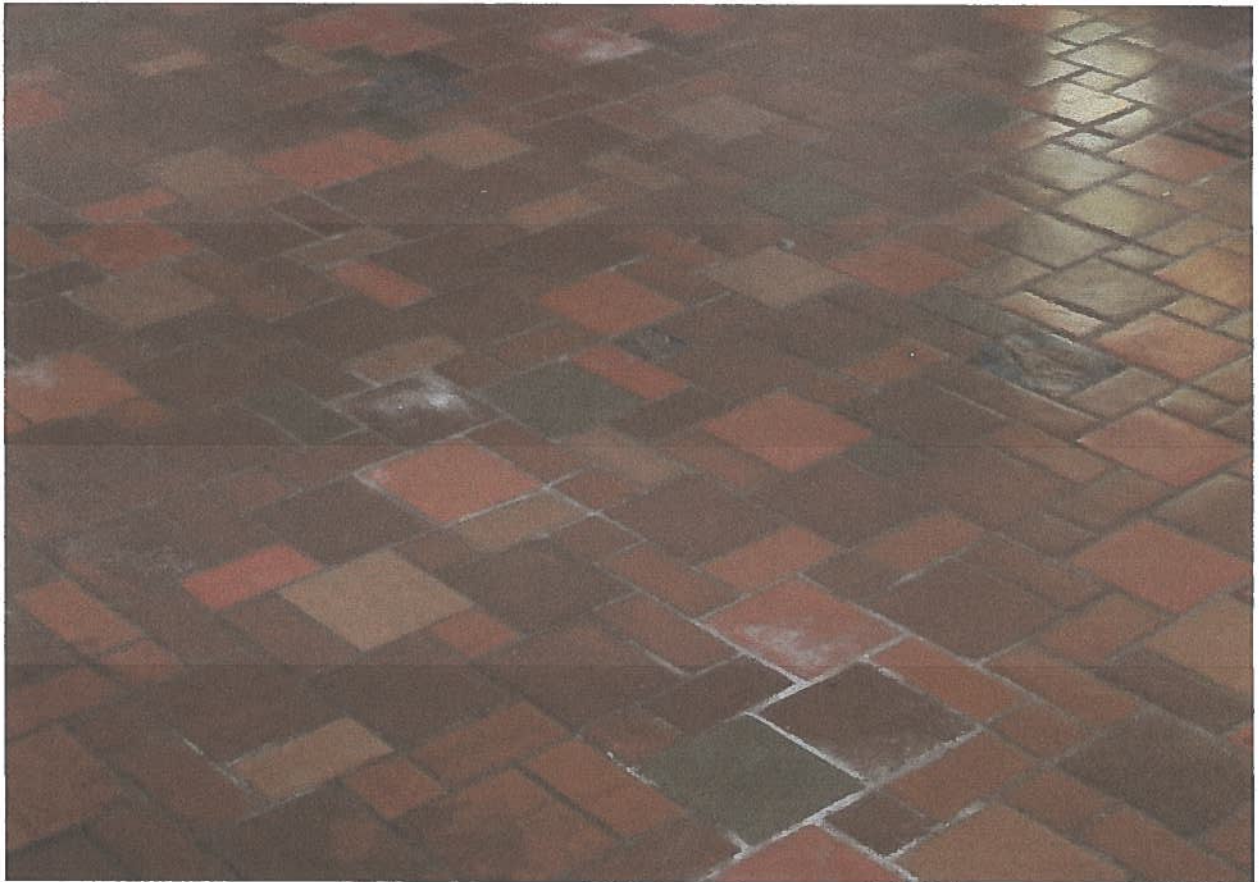
Photo 7

FEATURE 3: Existing original quarry floor tile with decorative inserts @ Living Room.
Room: Main Living Room
Photo Number: Photo #7
Plan Number: A-202 & A-501

While the intent is to preserve the existing original quarry floor tile that adorn the main living floor, and while the final objective is to preserve the original ambiance and character of this space, there is significant damage to the floor that may force replacement. We are hoping this is not the case.

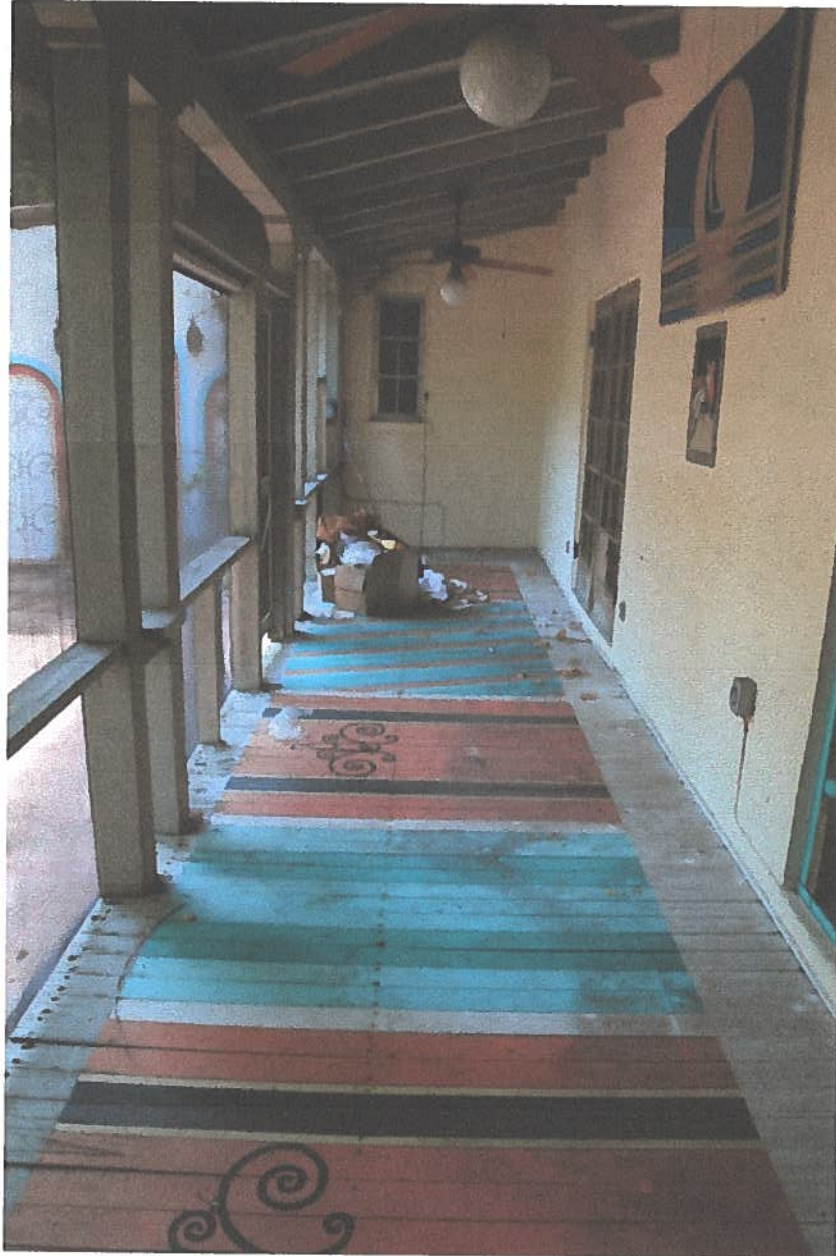
Photo 8

FEATURE 4: Retention of Rear Covered Terrace as gateway from Living Room to Courtyard.
Room: Covered Terrace behind Living and Dining Room
Photo Number: Photo #8
Plan Number: A-201 & A-402

The original covered terrace that transitions from the great living area to the exterior courtyard will be preserved. Components of this space, such as flooring, wall texture, and exposed wood ceiling will be replaced to match, to the maximum extent possible, the original character of this space.
