# APPRAISAL OF REAL PROPERTY

1258 Obispo Ave  
Coral Gables, FL 33134  
Lots 1 and 2 , Block 3, Coral Gables, Section E, PB 8-13

LAND APPRAISAL REPORT

Structural Inspection Report

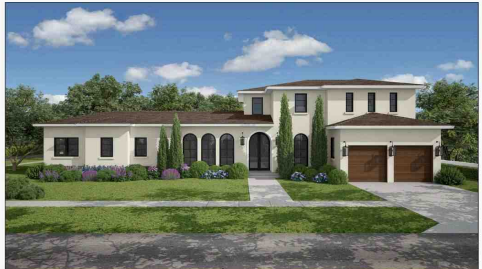
## CONCEPTUAL RENDERINGS

THE SCOPE OF WORK UNDER THIS APPLICATION ENCOMPASSES THE DESIGN OF 2 STORY RESIDENCE IN A LOT WHEREA THERE IS AN EXISTING ONE STORY HOME. THE CONCEPT IS TO DEMOLISH THE EXISTING STRUCTURE DUE TO ITS STRUCTURALLY UNSAFE CONDITION; AND TO BUILD A HOME THAT FOLLOWS THE OUTLINE AND ROOF LINE OF THE EXISTING ONE ON THE FIRST FLOOR. THE DESIGN THEN EXPANDS TO A LARGER FOOTPRINT THAT TAKES ADVANTAGE OF THE LARGE LOT AND ALSO INCLUDE A SECOND STORY OVER A PORTION OF THE LOWER FOOTPRINT.

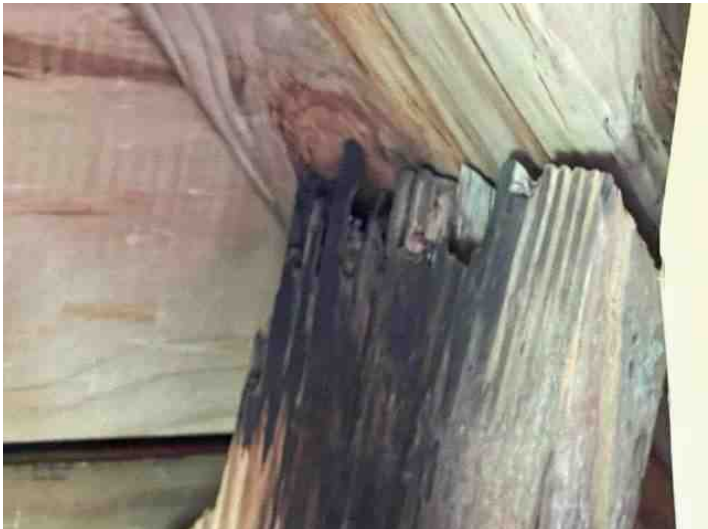
- In general the structural shell of the house is in extremely poor conditions. Can be observed water intrusion damage in the majority of the roof areas. In many places had been necessary to remove portions of the ceilings.

- As results of the termites infection, the water intrusion and the house aging, the stability and carrying capacity of some structural wood elements were affected and the deterioration can continue increasing.

Wood Rot in Trusses

- 1-The roofing system and tiles, the roof plywood sheathing, and a big portion of the roof wood joists, the ceiling wood joists, must be removed and replaced. Also, we strongly recommend to cover the whole house with a tent and fumigate in order to eliminate any possibility of alive termites and avoid any future deterioration of the wood elements.
- 2-The wood floor and subfloor and maybe a significant portion of the wood joists at ground floor need to be replaced, also we recommend to brace the exterior CMU walls to the ground floor wood joists (above the crawl space) w/ some connectors, in order to reduce the wall slenderness for lateral wind suction.
- 3-All the exterior windows and doors must be replaced.

It is our professional opinion, that this residence has significant damage and should not be inhabited. If possible that necessary repairs to restore the structural integrity of the home would over exceed the cost of a new construction.
