2701 INDIAN MOUND TRAIL

BUILDING STRUCTURE VIOLATION INVESTIGATION
FOR THE CITY OF CORAL GABLES

MINIMUM INSPECTION PROCEDURAL GUIDELINES FOR BUILDING STRUCTURAL RECERTIFICATION

- a.- Name of Title: Archbishop Edward A McCarthy
b.- Street Address: 2701 Indian Mound Trail
c.- Building No.: A - Main
d.- Legal Description: 29 53 41 7.56 AC M/L FRONTON HEIGHTS ADDN, PB 90-20,
THAT PT OF TRACT A LYING WITHIN CITY OF MIAMI LIMITS
LOT SIZE 329314 SQUARE FEET OR 10259-253 0179 5
e.- Owners Name: Archbishop Edward A McCarthy
f.- Owner's Mailing Address: 9401 Biscayne Blvd.
Miami, Florida 33138
g.- Folio Number of Building: 03-4118-002-0450
h.- Building Code Occupancy Classification : Religious
i.- Present Use: Religious/Educational
j.- General Description, Type of Construction Size, Number of Stories, and Special Features, Additions to original Structures:

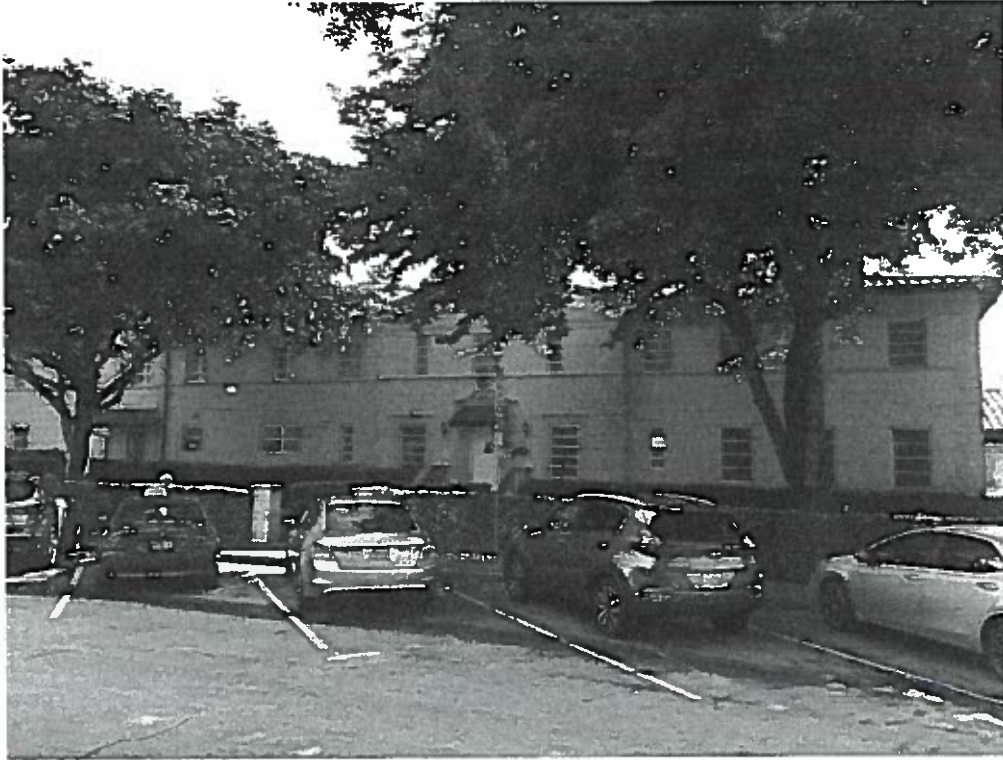
BUILDING 1 – Parrish Office

e.- General extent of deterioration – cracking or spalling of concrete or masonry; oxidation of metals; rot or borer attack in wood: None Noted

- f.- Previous patching or repairs. None Noted
- g.- Nature of present loading, indicate residential, commercial, other, estimate magnitude: Office, estimated magnitude of loading 50 PSF

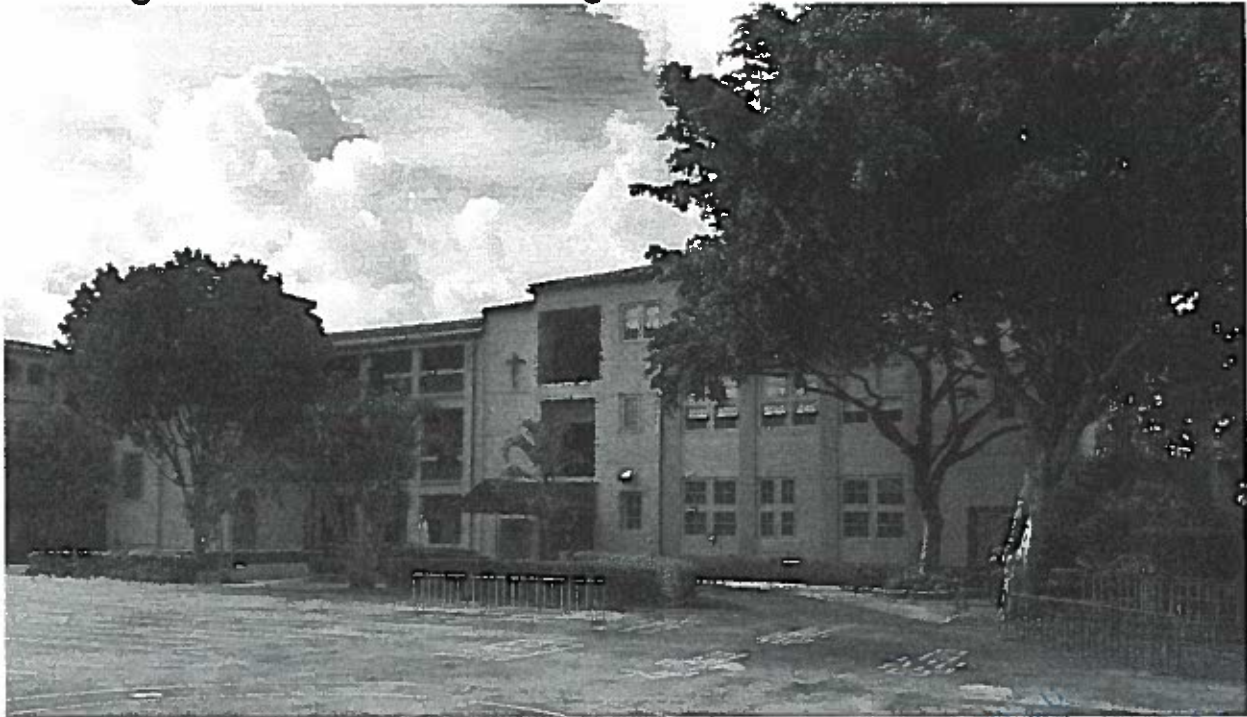
Building 2 – Main School Building

f.- Previous patching or repairs. None Noted

g.- Nature of present loading, indicate residential, commercial, other, estimate magnitude: Office and Classrooms estimated magnitude of loading 40 PSF for the classrooms, 50 PSF for the office area.

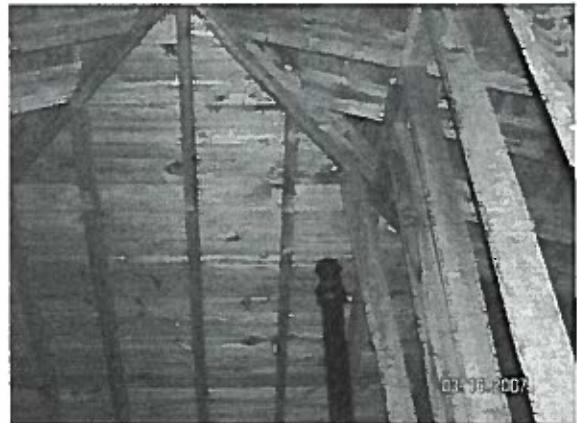
2. Note water tanks, cooling towers, air conditioning equipment, signs, other heavy equipment and condition of supports: Exhaust Fans noted, curb mounted, in good to fair condition.
3. Note types of drains and scuppers and condition: None

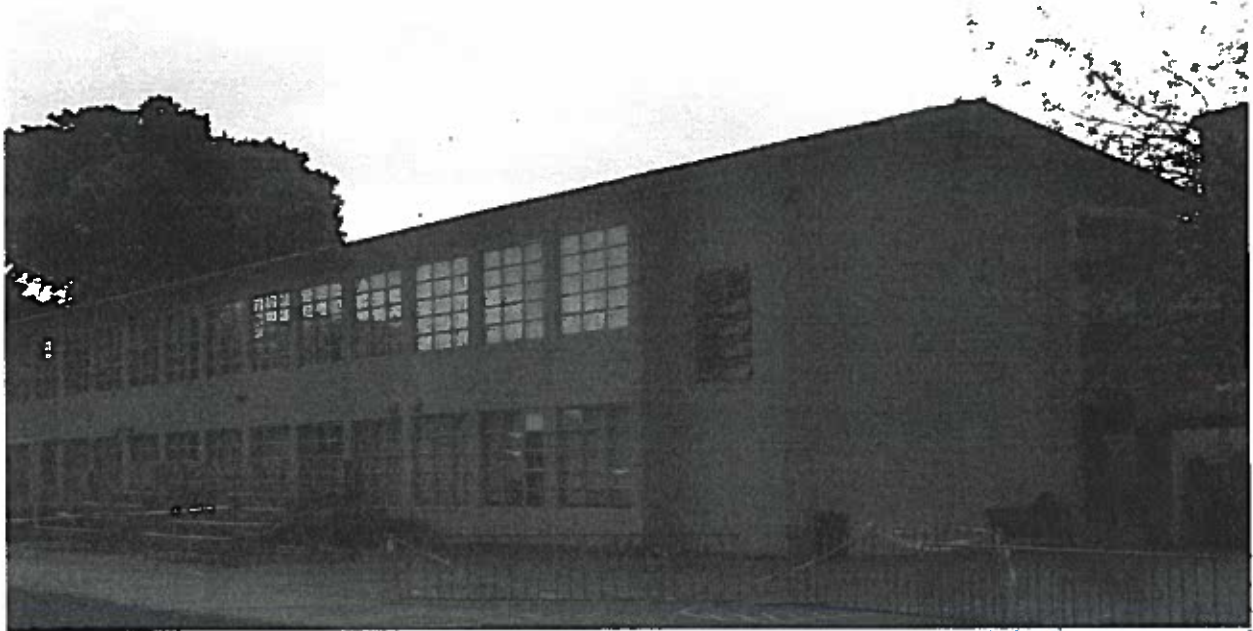
BUILDING 3 – Classroom Building

g.,- Nature of present loading, indicate residential, commercial, other, estimate magnitude: Classrooms, with a loading of 40 PSF.

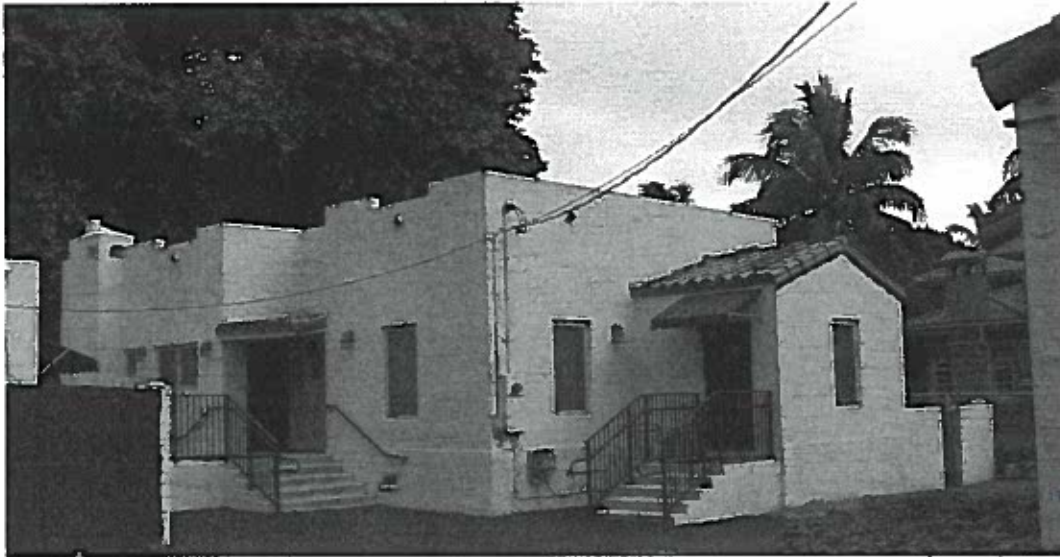
BUILDING 5 – Classroom 123 & Athletic Office

g.- Nature of present loading, indicate residential, commercial, other, estimate magnitude: Office and Classroom, with a loading of 50 and 40 PSF respectively.

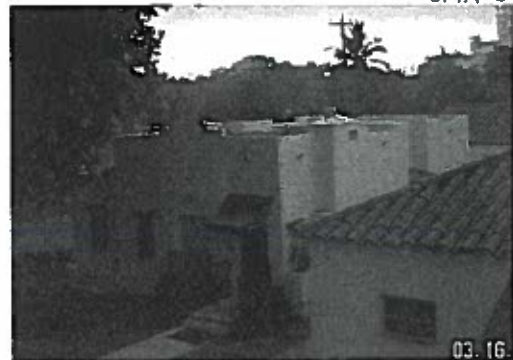
4. Describe (type of system framing, material, spans, condition): Wood framing system spanning 20 feet. Noted some sagging in the athletic office area of the building, that requires attention..
