129 Almeria Ave as of 12-29-25

<a href="#">BLDB-25-09-3660</a>	FBC Building (Commercial)	Repair Only	In Review	09/08/2025		structural and electrical repairs under engineering inspections reports	129 ALMERIA AVE
<a href="#">RECT-25-09-0580</a>	Building Recertification	Recertification	Cancelled	09/03/2025	09/04/2025	CANCELLED- SEE RECT-24-10-0408 ****40 years recertification structural and electrical repairs under engineering inspection report . Addressed by Allied Building Inspections Services INC, Robert Lara Lic: AR92824	129 ALMERIA AVE
<a href="#">RECT-24-10-0408</a>	Building Recertification	Recertification	Denied	10/21/2024		BUILDING RECERTIFICATION (YEAR BUILT 1954) CASE 24-8220	129 ALMERIA AVE

**PROPERTY ADDRESS: 129 ALMERIA AVENUE, CORAL GABLES, FL 33134**

**STRUCTURAL DEFICIENCIES:**

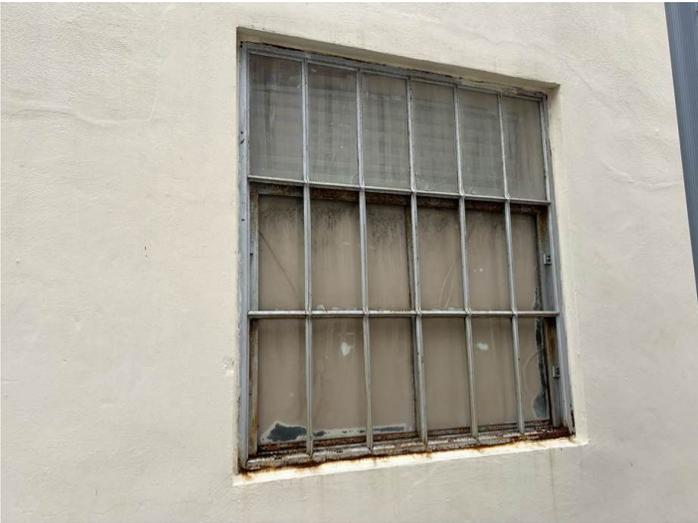
CRACKED WINDOW NOTED

5. General condition: Needs Repair
Needs repair
6. Describe any repairs needed:
Removal of iron bar windows at rear of structure; Cracked window noted at rear of structure- Repair is required.

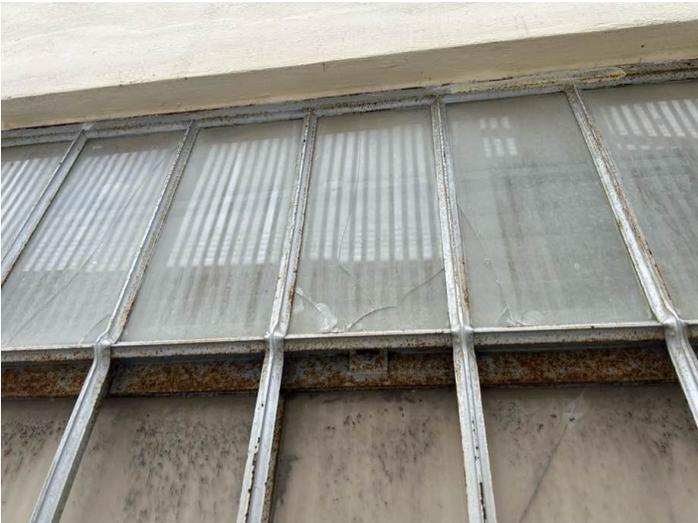
CRACKED WINDOW NOT

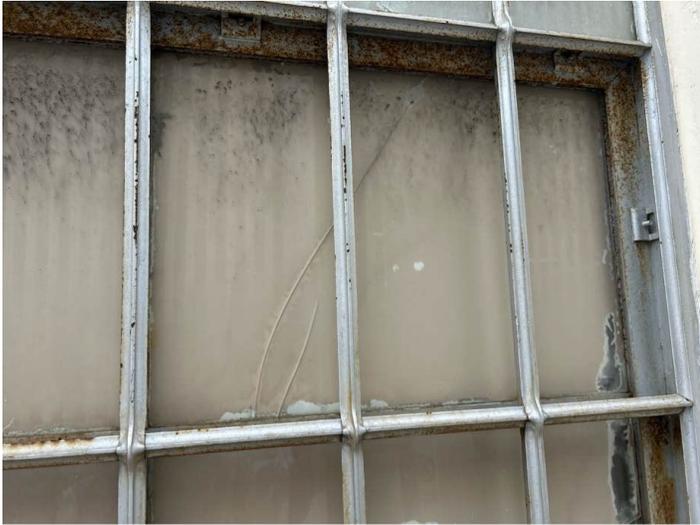
CRACKED WINDOW NOTED

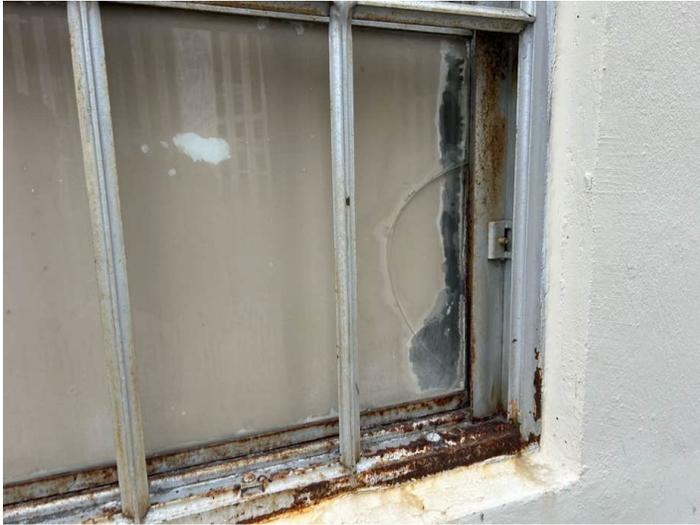
CRACKED WINDOW NOTED

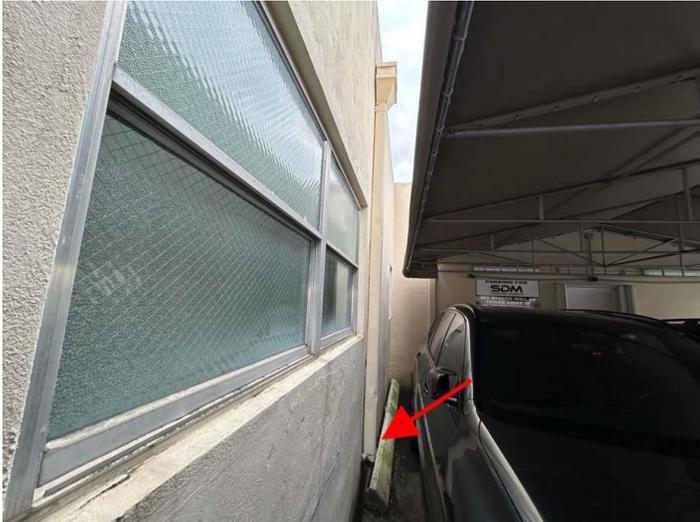
3. Describe roof drainage system, main and overflow, and indicate condition:	<b>PROVIDE PHOTO 7a3</b>
Suppers and gutter drain line downspout- Fair condition	
Missing drain line downspout located at right rear wall of structure; repair is required.

MISSING GUTTER, ELBOW DRAIN LINE

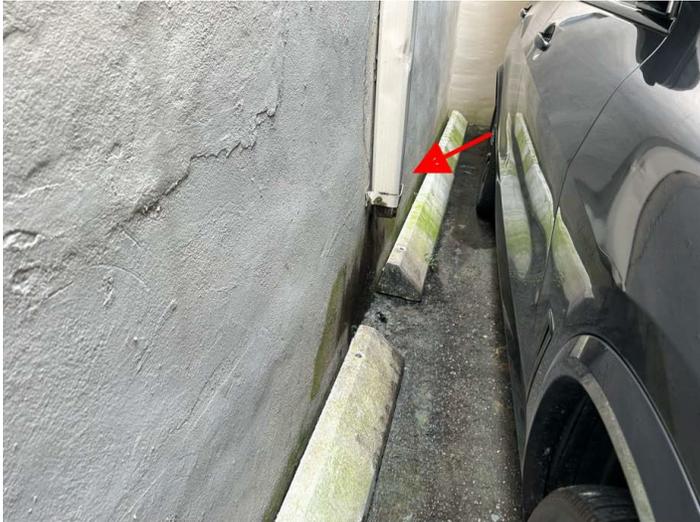
MISSING GUTTER, ELBOW DRAIN LINE

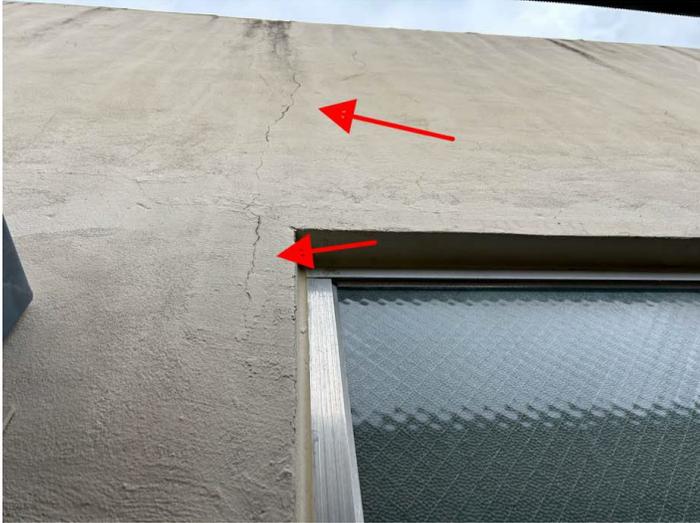
d. Cracks: Note location in significant members. Identify crack size as <b>HAIRLINE</b> if barely discernible; <b>FINE</b> if less than 1 mm in width; <b>MEDIUM</b> if between 1- and 2-mm width; <b>WIDE</b> if over 2 mm.	PROVIDE PHOTO 5d
Hairline (Barely Discer) Hairline cracks noted and barely discernible

CRACKS NOTED AT REAR RIGHT WALL OF STRUCTURE,  
REPAIRS REQUIRED

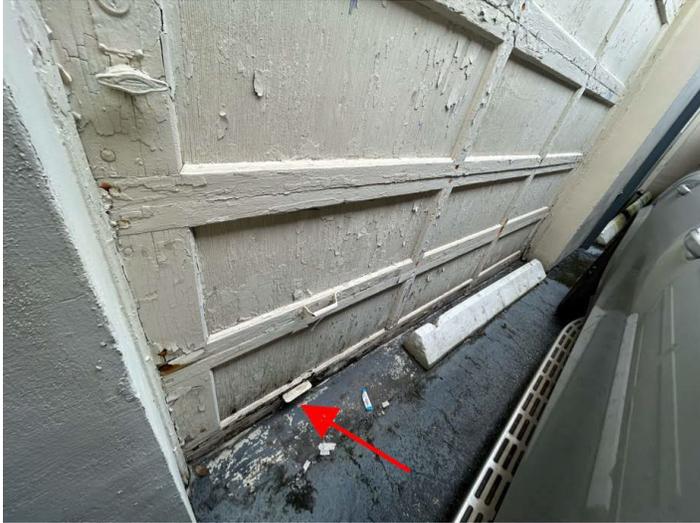
WOOD ROT NOTED AT BASE OF GARAGE DOOR

4. General condition: Needs Repair
Needs repair
5. Describe any repairs needed: Repairs Required
Removal of additional locking mechanism at rear door <del>Preventative rust treatment is required at rear doors</del>
Wood rot noted at base of wood frame garage door; repair is required.

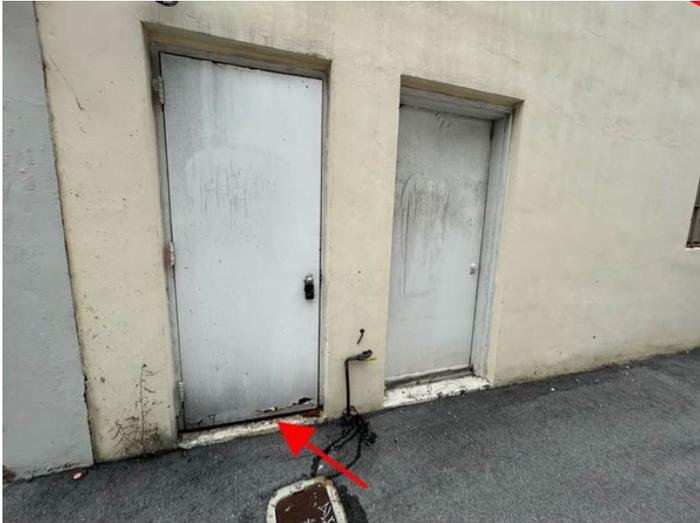
PREVENTATIVE RUST TREATMENT REQUIRED AT DOORS

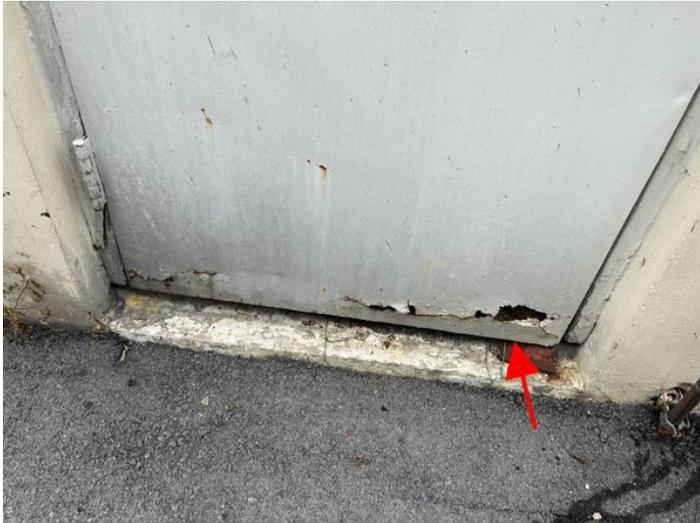
PREVENTATIVE RUST TREATMENT IS REQUIRED AT DOOR

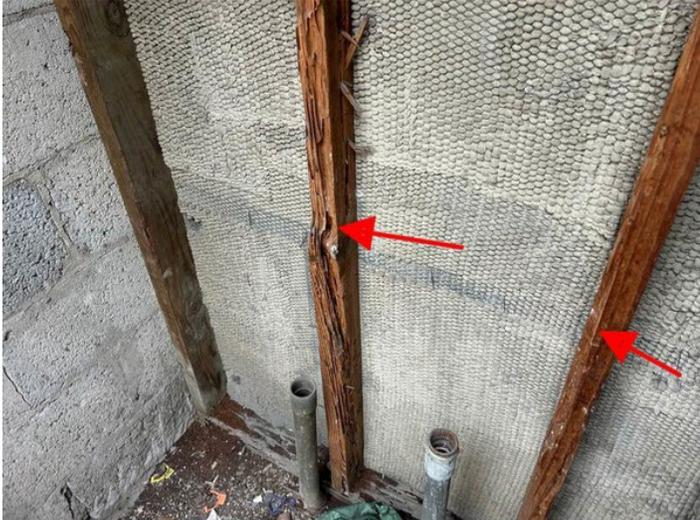
b. Portion showing distress: (Note, beams, columns, structural walls, floor, roofs, other)	PROVIDE PHOTO 5b
Crack noted at rear right wall of structure <del>Wood rot noted at garage door</del> Termite damage noted in electrical room

TERMITE DAMAGE NOTED

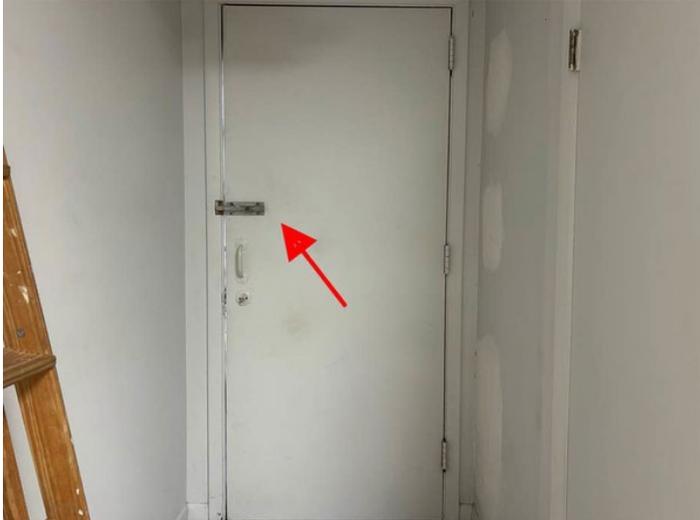
REMOVAL OF ADDITIONAL LOCKING MECHANISM

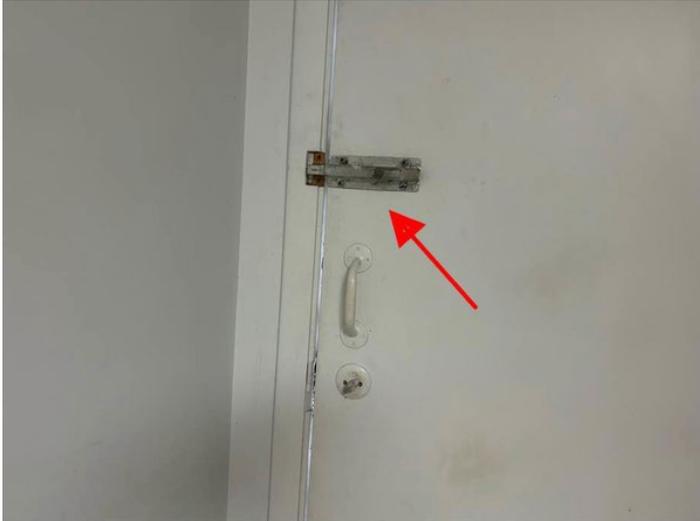
REMOVAL OF ADDITIONAL LOCKING MECHANISM TO PREVENT EMERGENCY ESCAPE

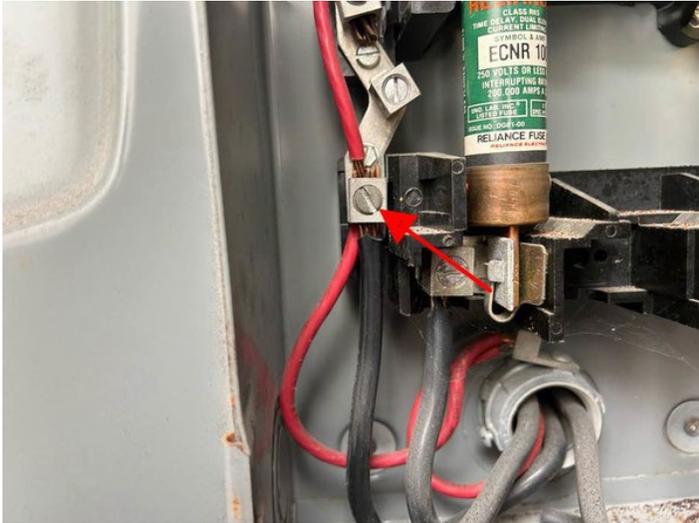
DOUBLE TAP NOTED AT GROUNDING LUGNUT

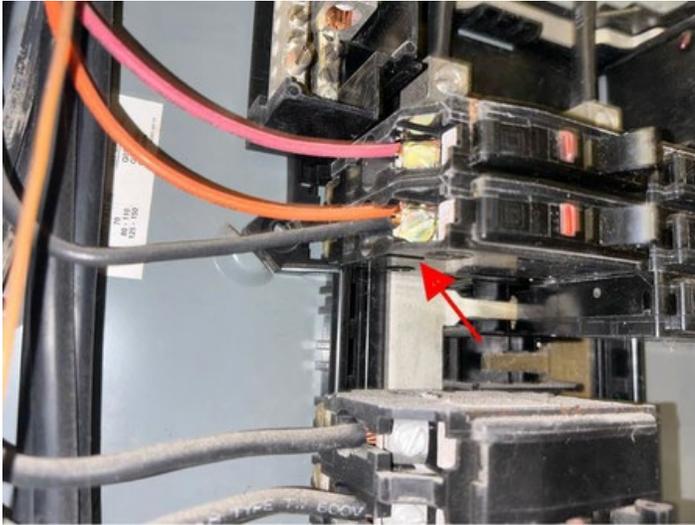
Comments:
Panel B- Double taps noted repair is required.

DOUBLE TAPS NOTED AT PANEL B

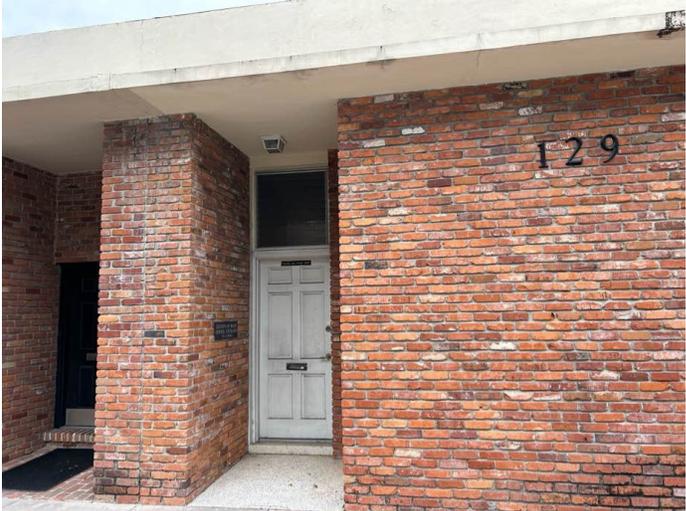
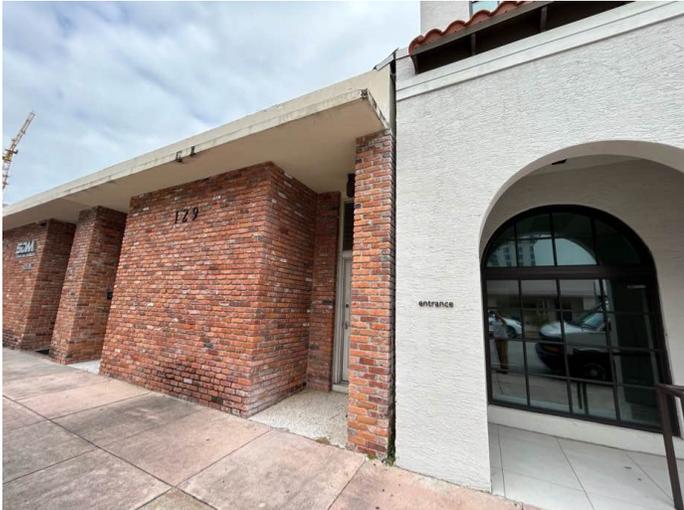
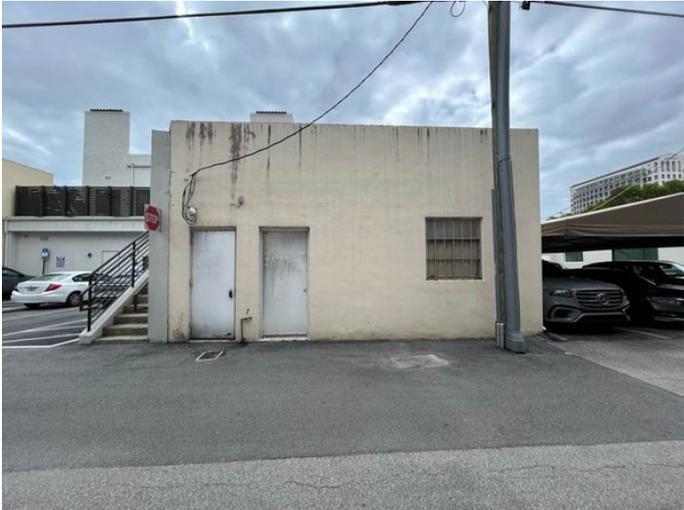
**• 5-C – SURFACE CONDITIONS:**

c. Surface conditions: Describe general conditions of finishes, cracking, spalling, peeling, signs of moisture penetration and stains.	PROVIDE PHOTO 5c
Crack noted at rear right wall of structure

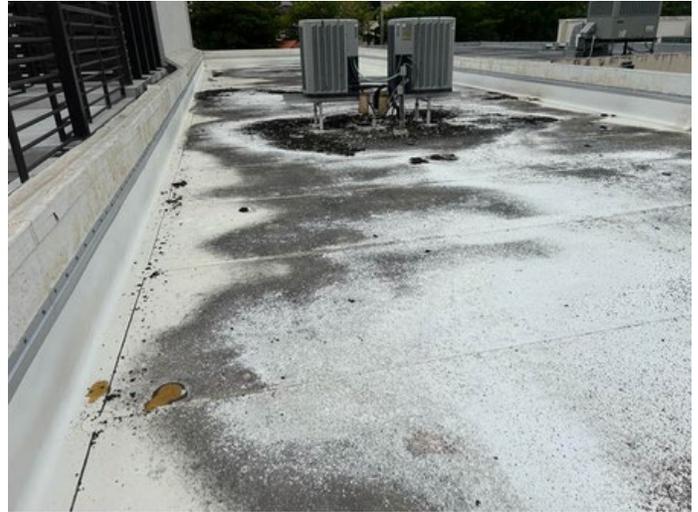
- **7-A1 – ROOF:**

<b>7. FLOOR AND ROOF SYSTEM</b>	
a. Roof (Must access and provide)	
1. Describe (roof shape, type roof covering, type roof deck, framing system, condition):	<b>PROVIDE PHOTO 7a1</b>
Flat roof Modified TPO membrane supported over tongue and groove decking & 2x10 wood trusses spaced 16"	
O.C. embedded within reinforced concrete of the structure. - Good condition

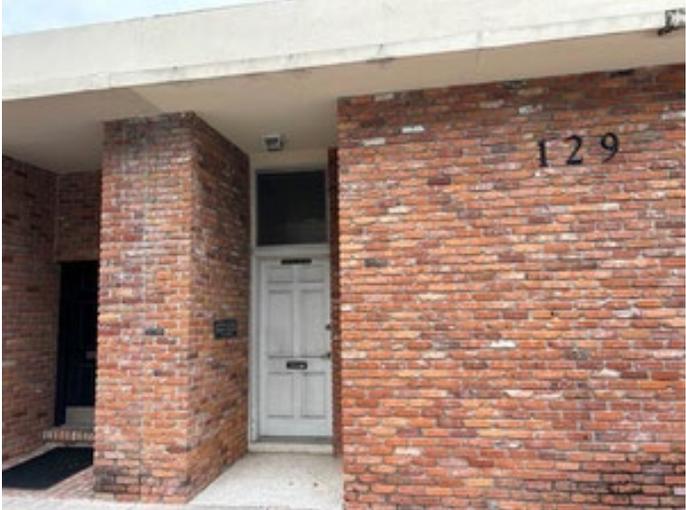
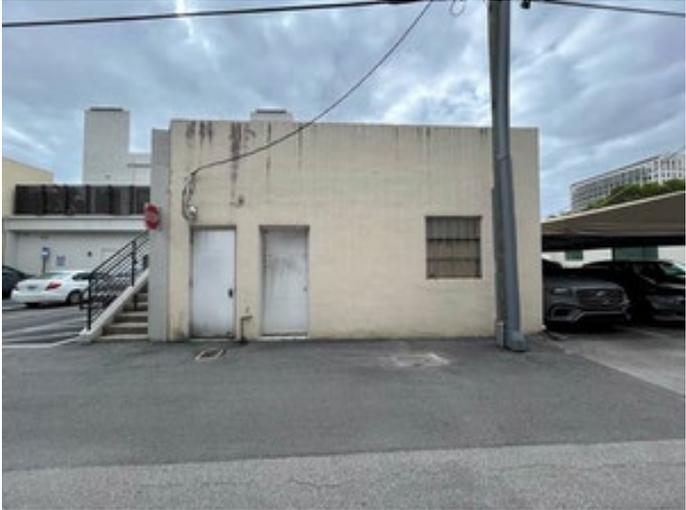
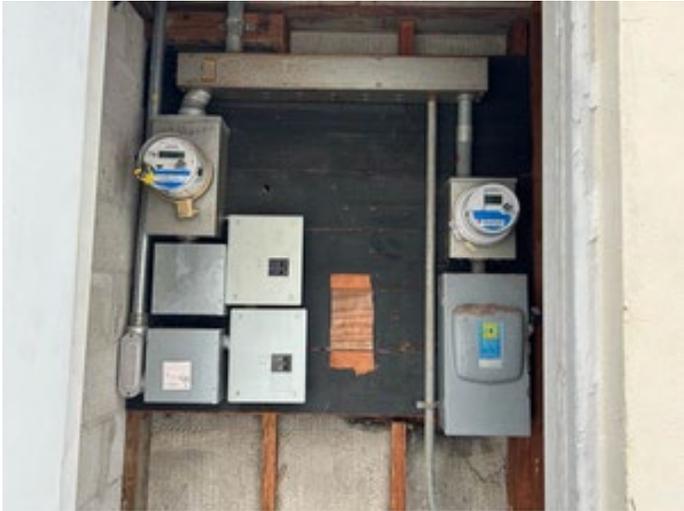
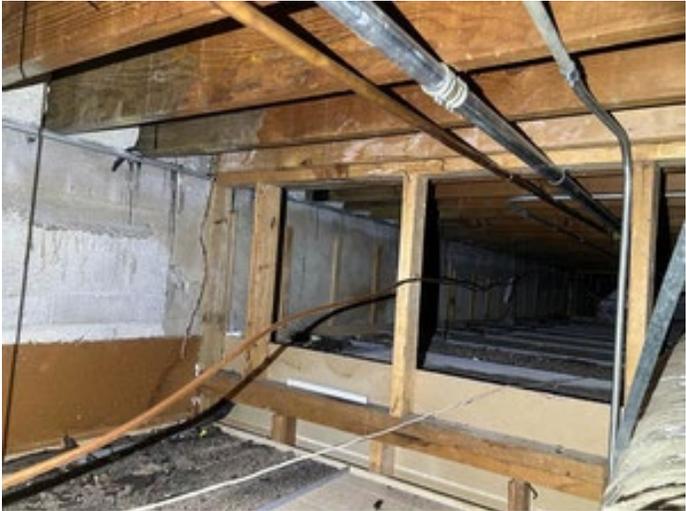
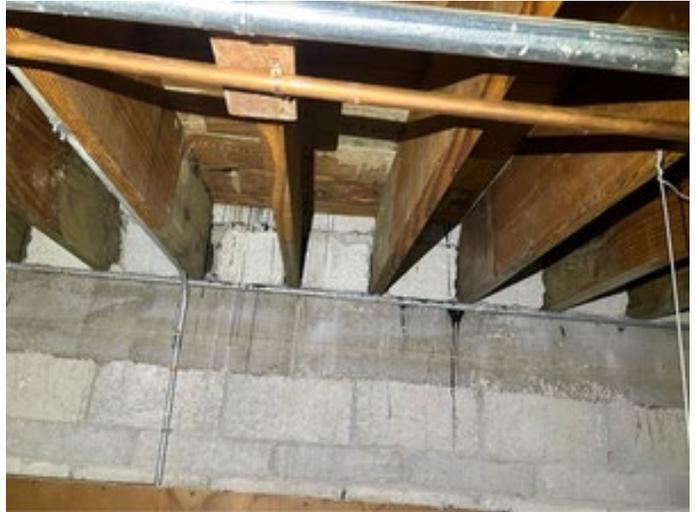
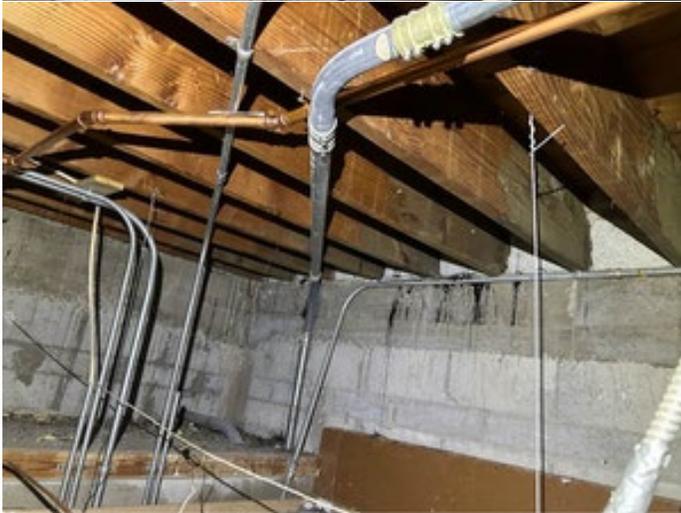
• **9-A – CONCRETE FRAMING:**

<b>9. CONCRETE FRAMING SYSTEM</b>		This Section is Not Applicable: <input type="checkbox"/>
a. Full description of concrete structural framing system:		<b>PROVIDE PHOTO 9a</b>
Cast-in-place reinforced concrete footing, floor slab and tie beams, tie columns.		
b. Cracking		<b>PROVIDE PHOTO 9b</b>
1. Significant <input type="checkbox"/> or Not significant <input checked="" type="checkbox"/> : Located at rear right wall of structure		
2. Location and description of members affected and type cracking:		
Crack noted at rear right wall of structure

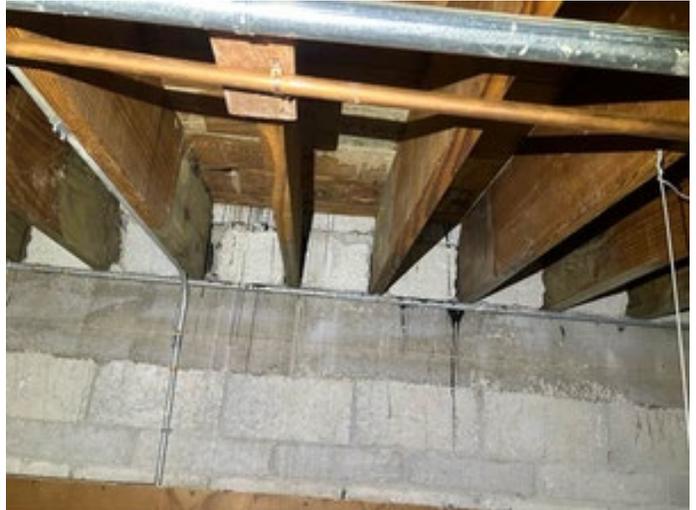
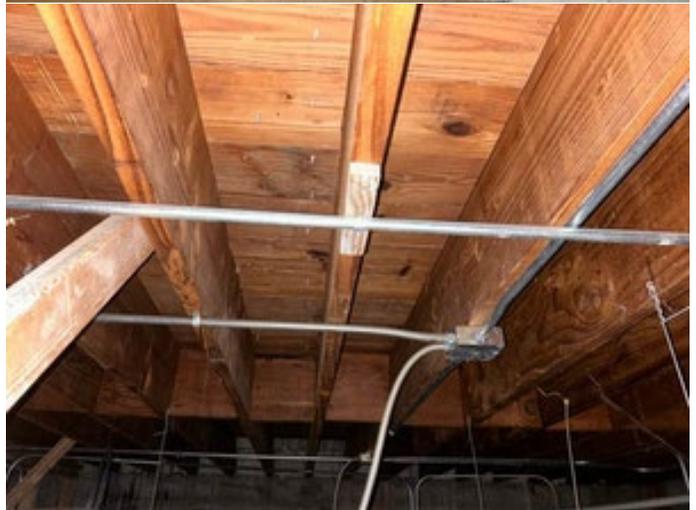
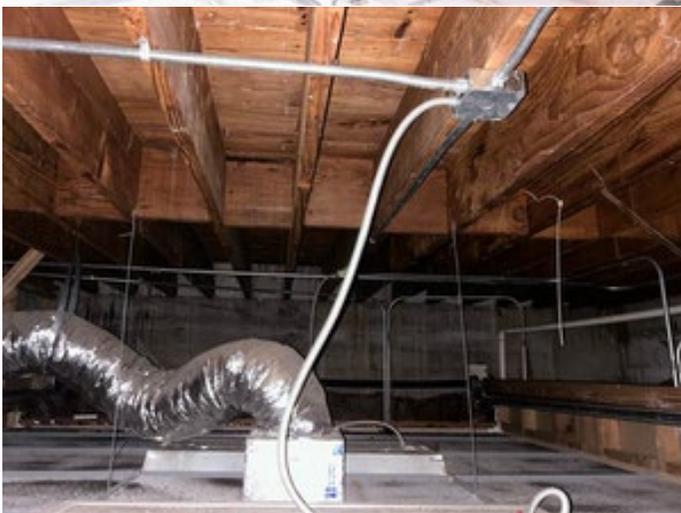
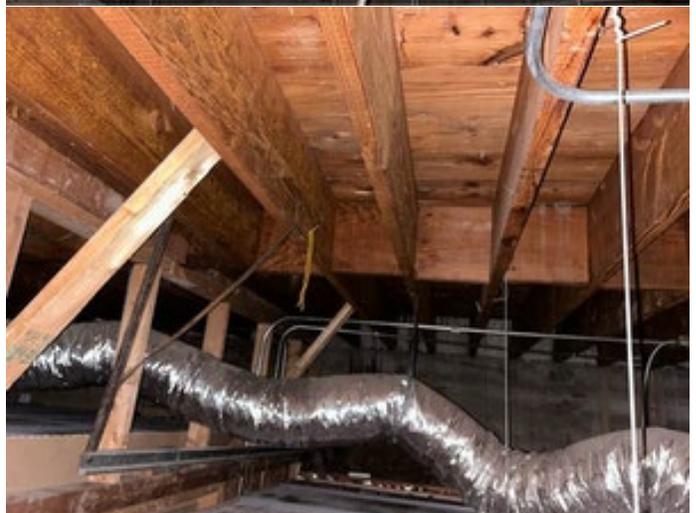
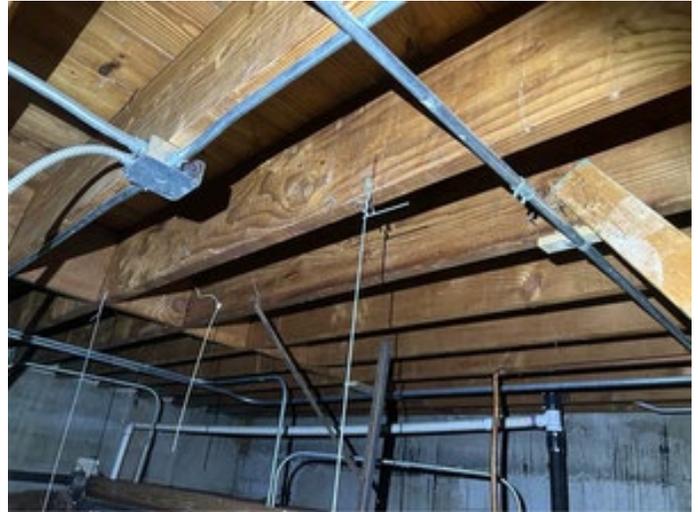
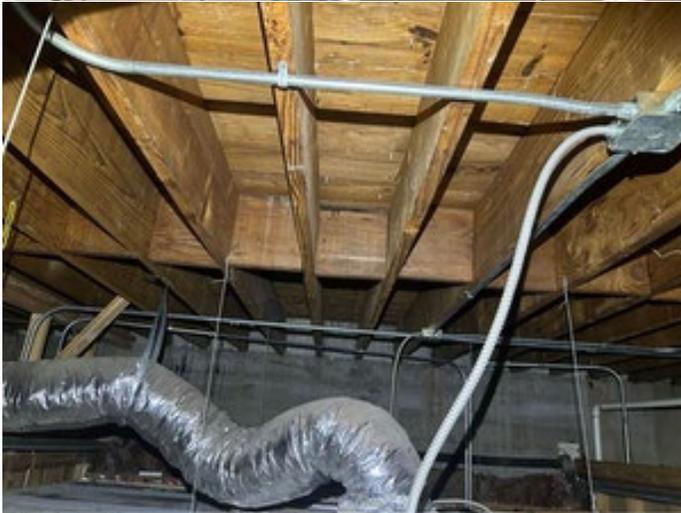
• **11A – WOOD FRAMING SYSTEM:**

<b>11. WOOD FRAMING</b>	This Section is Not Applicable: <input type="checkbox"/>
a. Fully describe wood framing system:	PROVIDE PHOTO 11a
Flat roof Modified TPO membrane supported over tongue and groove decking & 2x10 wood trusses spaced 16"	
O.C. embedded within reinforced concrete of the structure. - Good condition

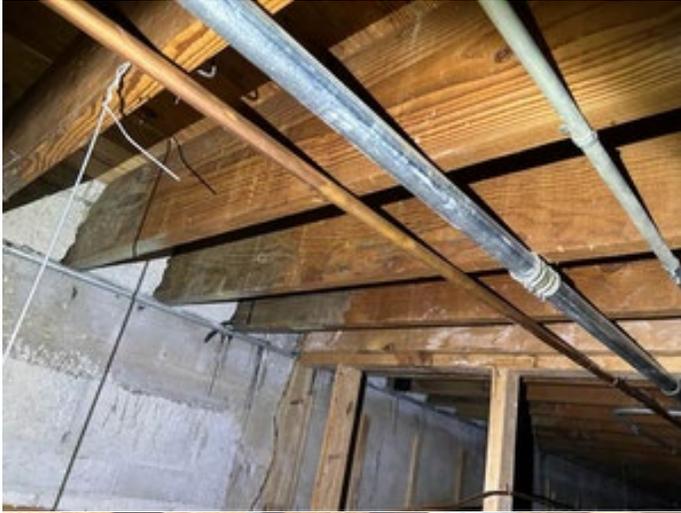
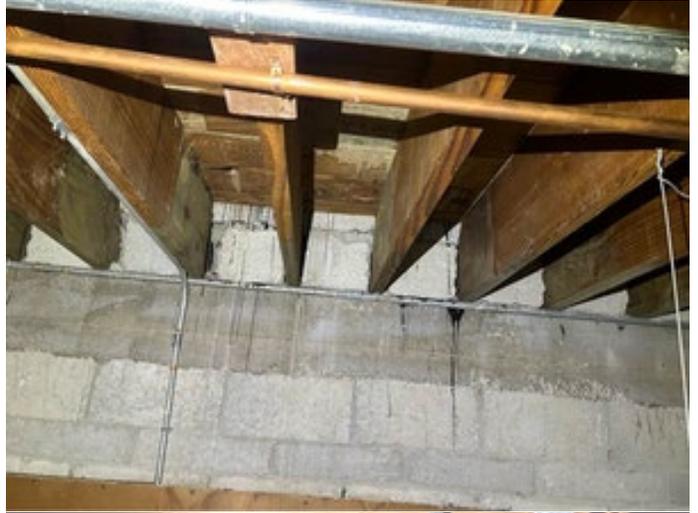
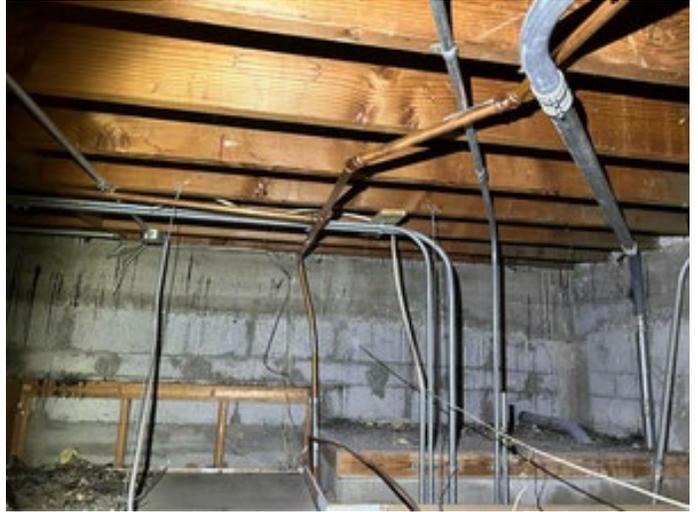
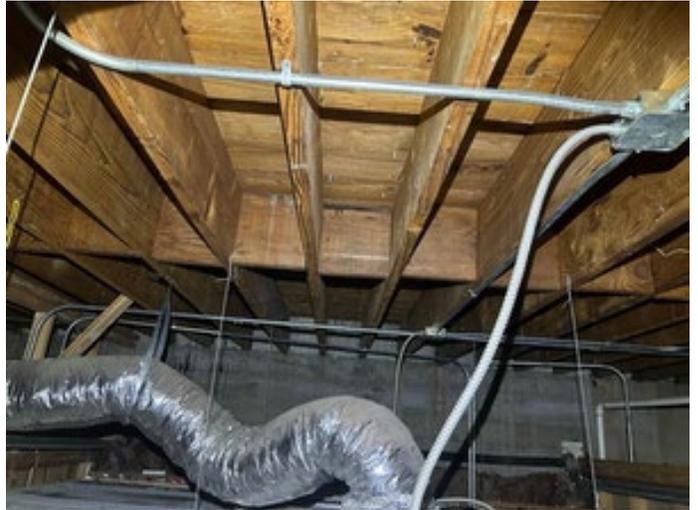
• **11-B3 – ROOF MEMBERS:**

b. Indicate the condition of the following:	PROVIDE PHOTO 11b
1. Walls:	
N/A	
2. Floors:	
N/A	
3. Roof member, roof trusses: Good	
Flat roof Modified TPO membrane supported over tongue and groove decking & 2x10 wood trusses spaced 16"	
O.C. embedded within reinforced concrete of the structure. - Good condition
