2 Coral Way

Electrical Safety Inspection
Project No.: S4210.01
Issued Date: June 4, 2025

Structural Safety Inspection
Project No.: S4210.01
Issued Date: March 24, 2025

Intertek understands that the City of Coral Gables sent a Notice of Hearing to the owner concerning the 25-year recertification of the building structure. This letter addresses your concern raised in the NOTICE OF UNSAFE STRUCTURE VIOLATION FOR FAILURE TO RECERTIFY AND NOTICE OF HEARING dated February 28, 2025.

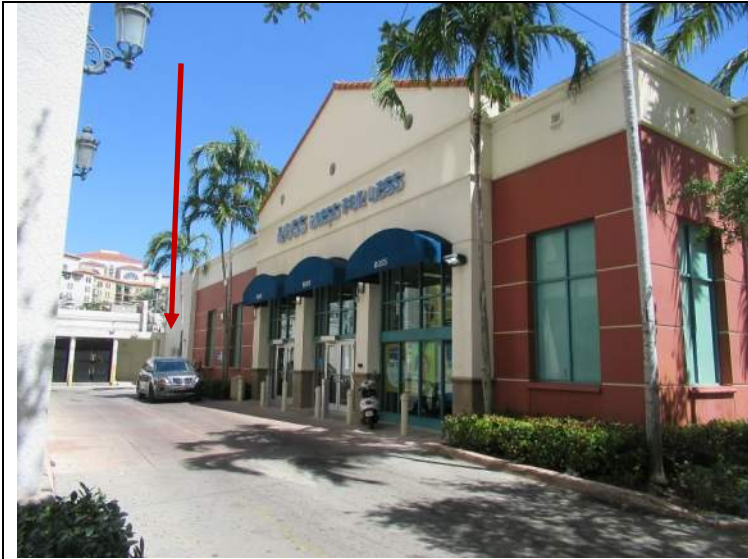
Photograph No. 1.

The west elevation of the Ross store showing the back SW entrances. The arrow indicates the electrical service location for the store.

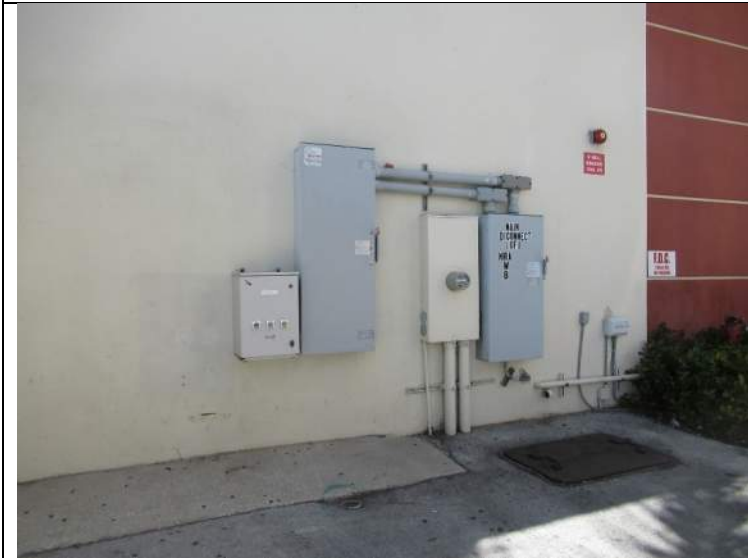
Photograph No. 2.

The service entrance to the store with service disconnect.

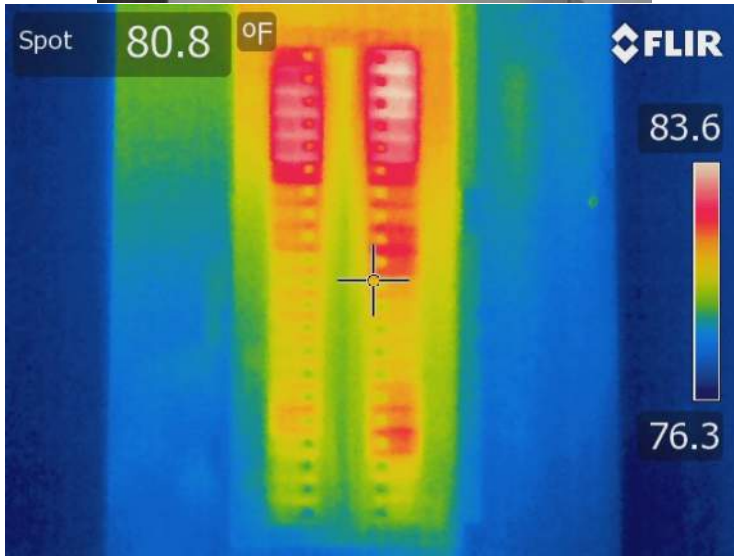
Photograph No. 4.

The HA subpanel is powered by the MDP.

The HA lighting sub-panel with maximum temperature at 83.6 degrees.

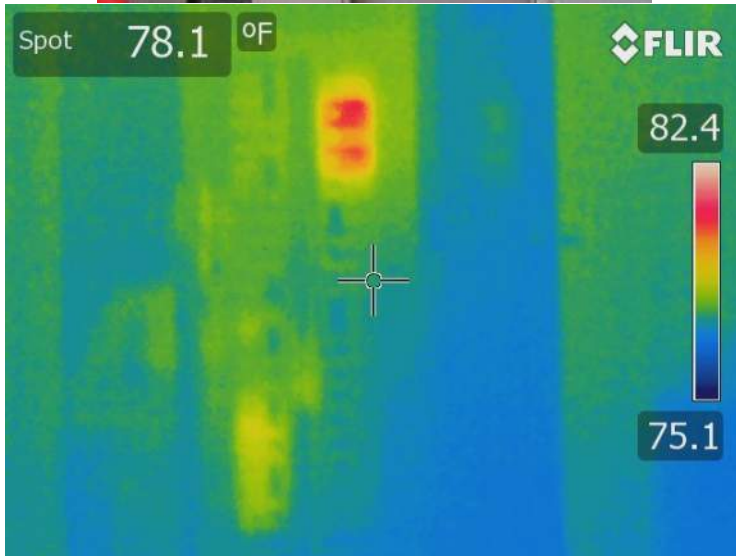
Photograph No. 5.

The AC subpanel is powered by the MDP.

The AC HVAC RTU sub-panel with maximum temperature at 82.4 degrees.

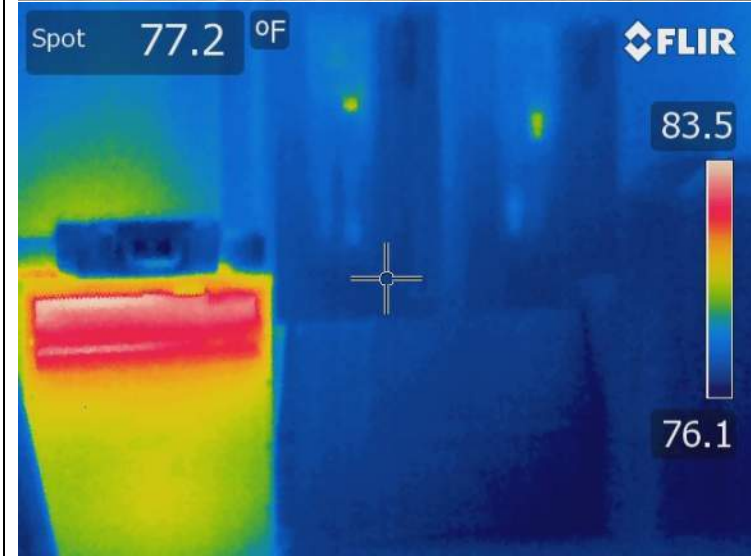
Photograph No. 6.

The transformer is powered by the MDP.

The 75 kva transformer stepping down 480Y277 to 208Y120 volts operating at 83.5 degrees vent temperature.

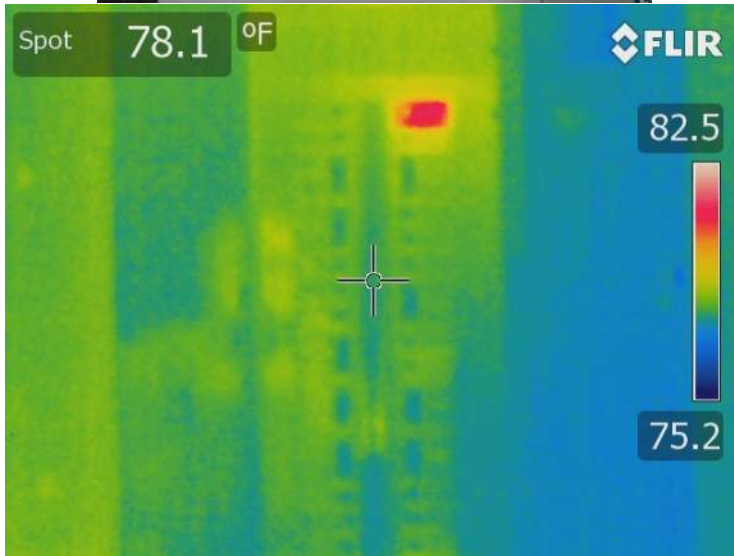
Photograph No. 7.

The LA subpanel is powered from the MDP to the 75 kva transformer.

The LA 208Y120 sub-panel with maximum temperature at 82.5 degrees.

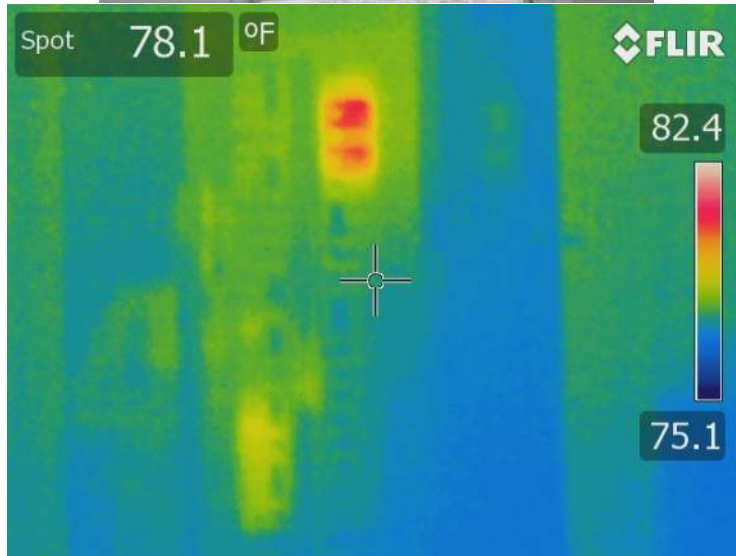
Photograph No. 8.

The LB subpanel is powered by the LA subpanel CB 38, 40, 42.

The LB 208Y120 sub-panel with maximum temperature at 82.4 degrees. The LB panel is supplied by the LA panels (CB 38, 40, & 42).

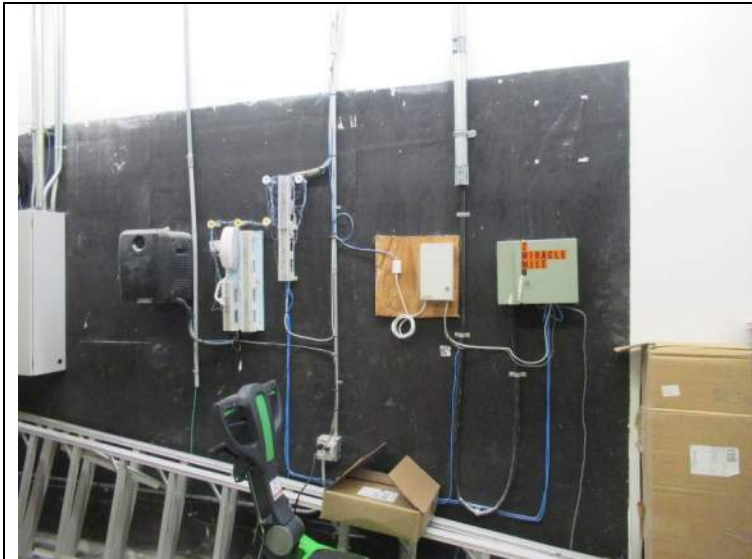
Photograph No. 13.

The telecommunication panels on the east wall of the electrical room.

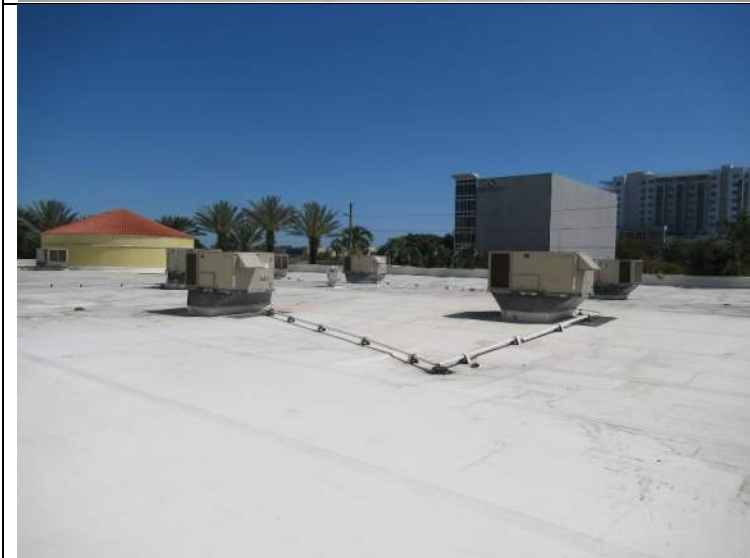
Photograph No. 16.

All the roof top HVAC units had internal electrical feed from the MDP or AC subpanel with integral service disconnect manufactured with the RTU.

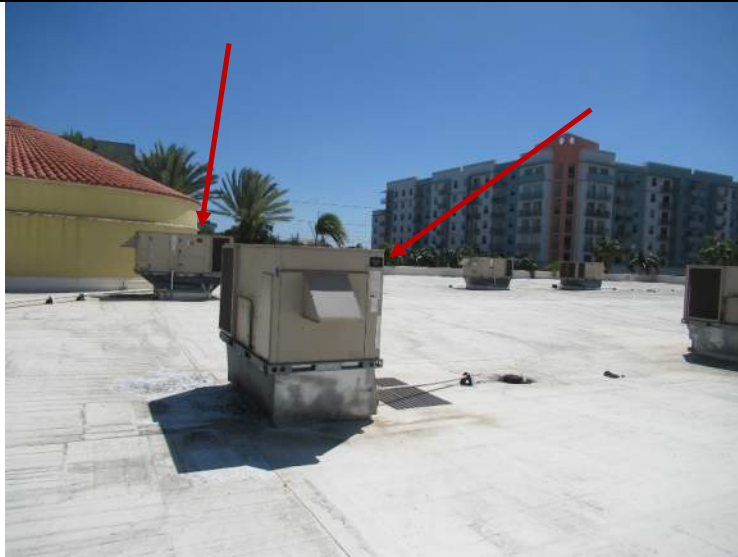
Photograph No. 17.

All the roof top HVAC units had proper identification labels on each RTU.

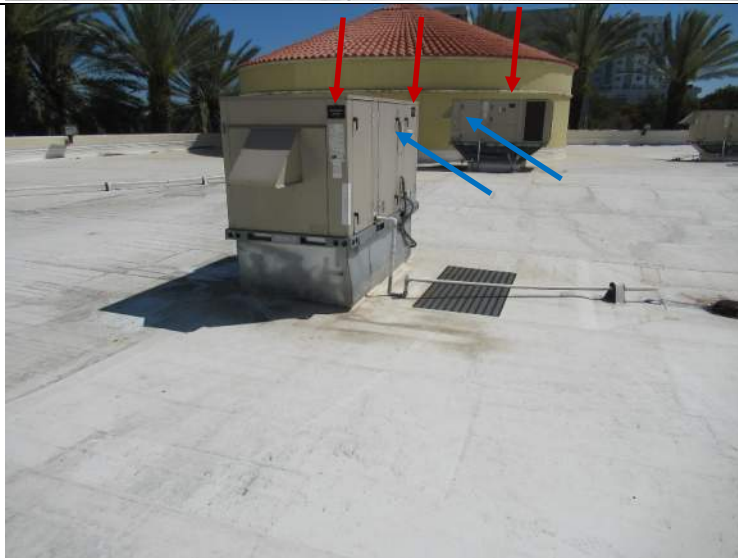
Photograph No. 18.

All the roof top HVAC units had proper identification labels on each RTU (red arrows). The HVAC units have integral service disconnect manufactured with the RTUs (blue arrows).

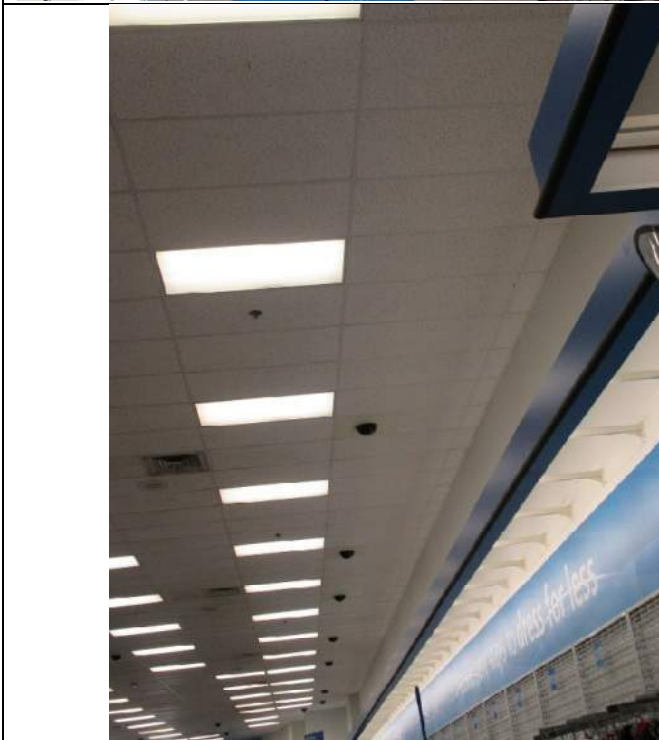
Photograph No. 28.

The 277-volt fluorescent store lights.

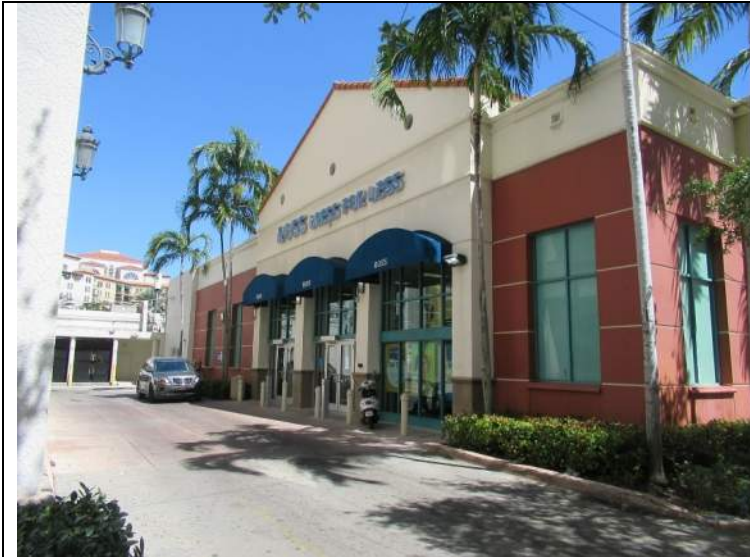
Photograph No. 1.

The west elevation of the Ross store showing the back SW entrances.

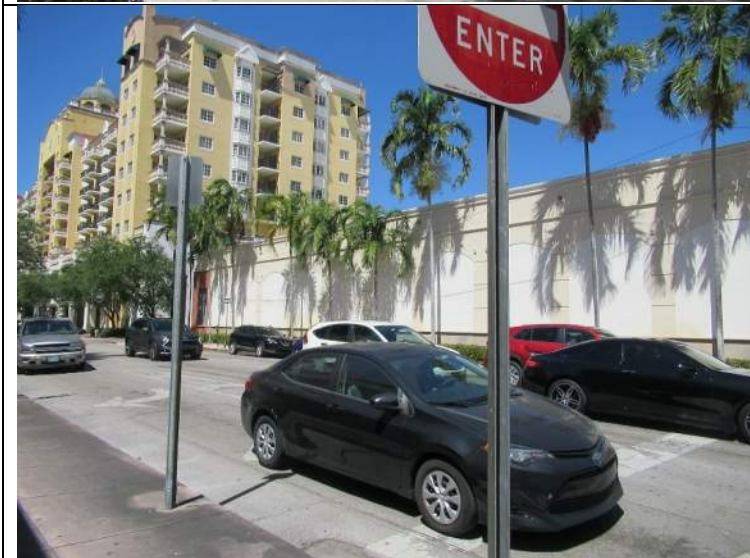
Photograph No. 2.

The south elevation of the Ross store along Andalsia Way.

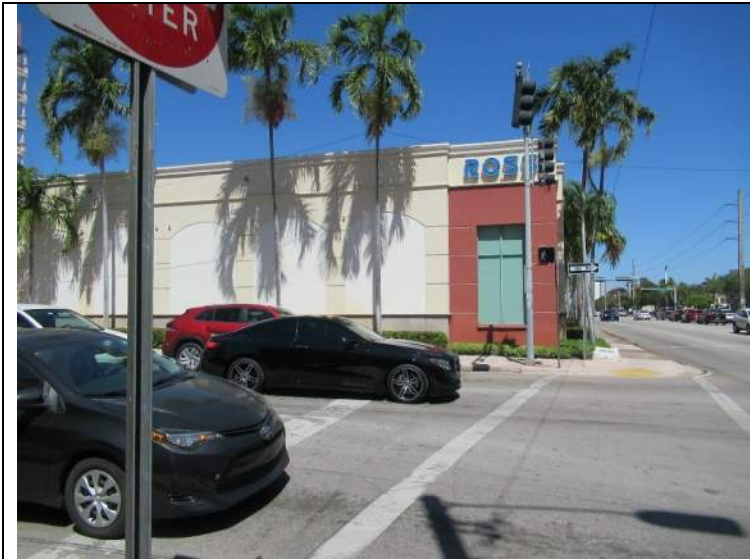
Photograph No. 3.

The southeast corner of the store showing an “obscured” storefront window that has a GWB board wall over it in the interior of the store.

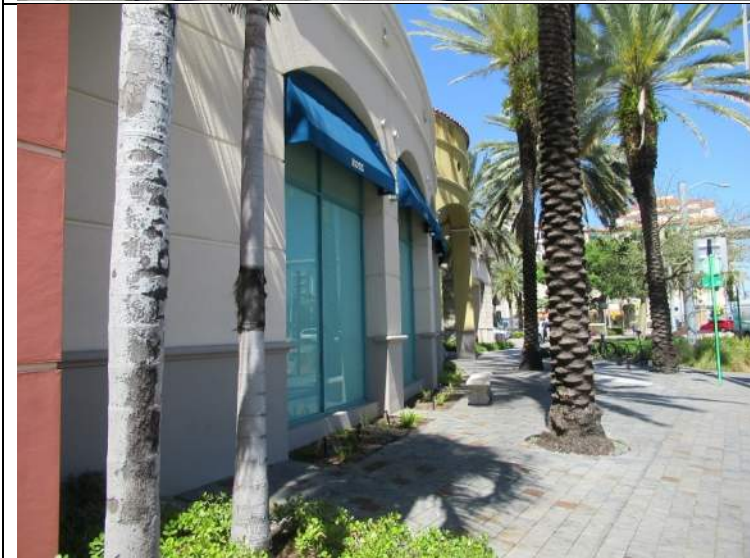
Photograph No. 4.

The front main (NE) rounded wall that is next to Coral Way and Douglas Road.

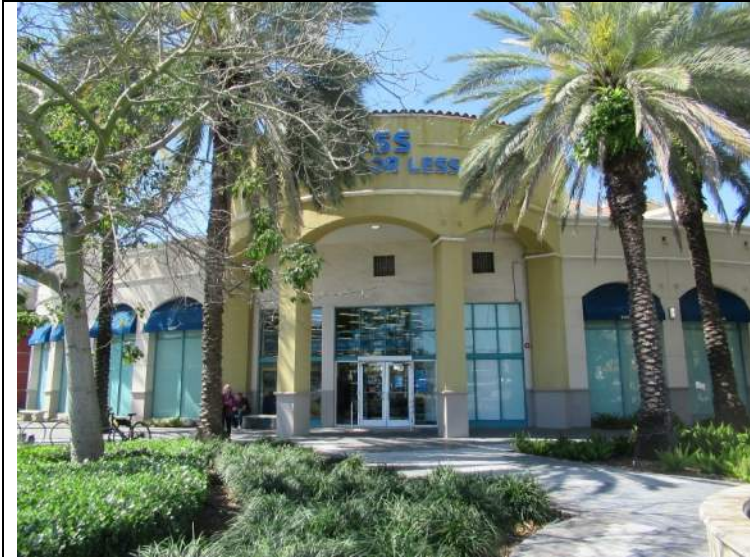
Photograph No. 5.

The front main (NE) rounded wall that is next to Coral Way and Douglas Road. The round silo roof feature is better shown in this picture.

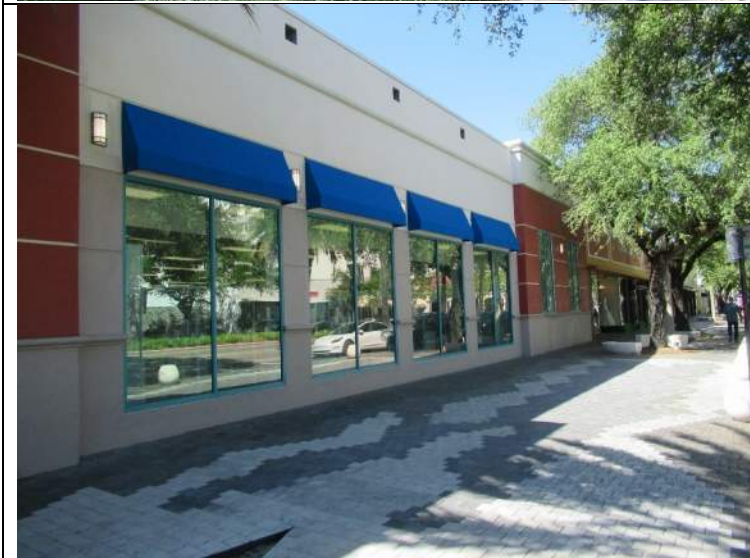
Photograph No. 6.

The north elevation looking west along Coral Way.

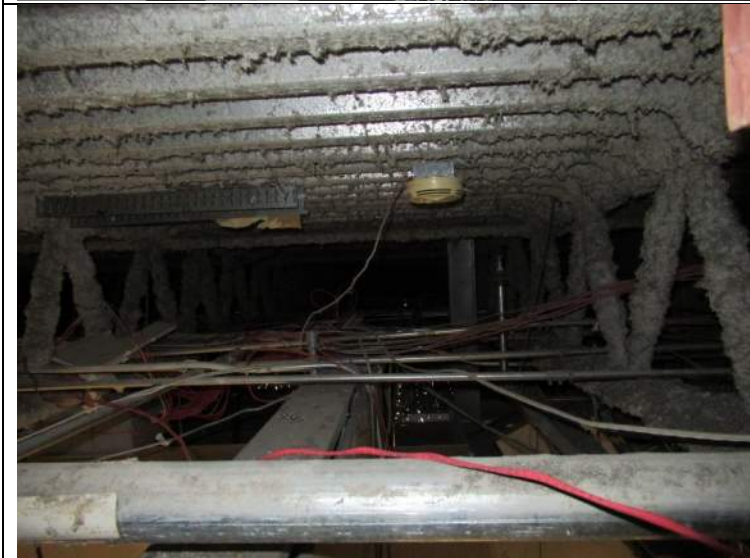
Photograph No. 8.

Typical roof structure bay between two (2) steel bar joists.

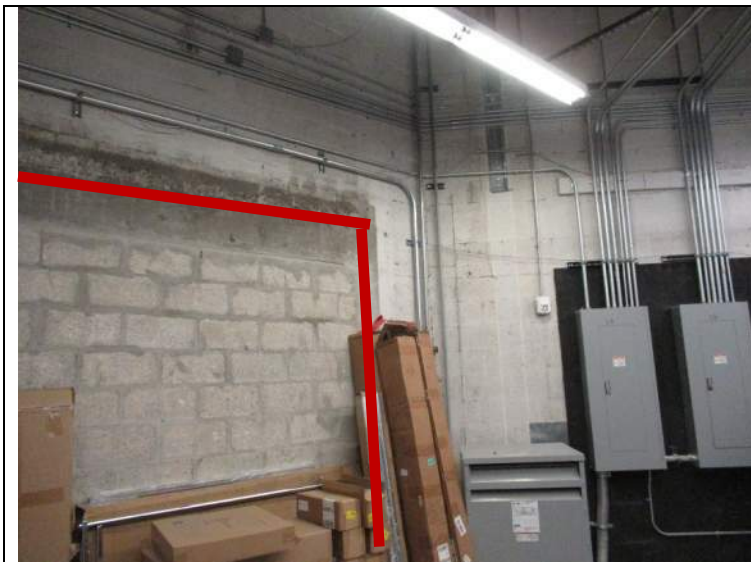
Photograph No. 9.

Former garage door opening for the store in the west wall. The other side is now an AT&T and public safety relay equipment locker.

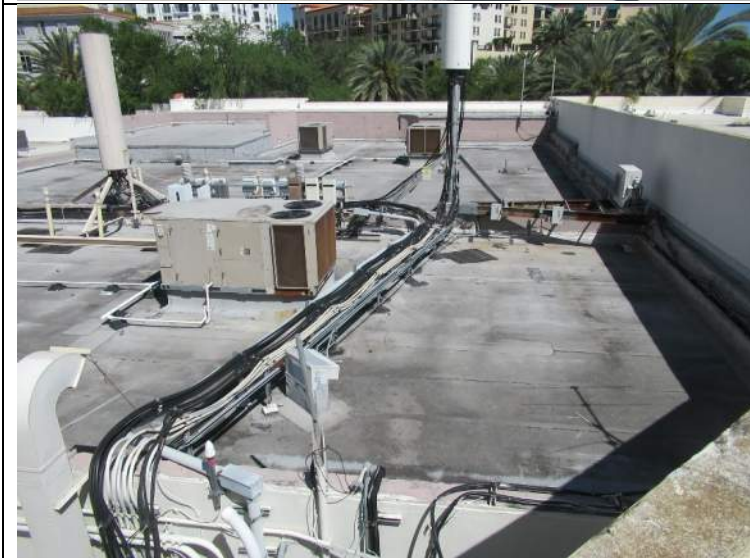
Photograph No. 14.

The zero property line walls between the Ross store property and the expansion space (lower roof) to the west. There are two independent walls on the property line. This view is looking north from the AT&T equipment locker of the building.

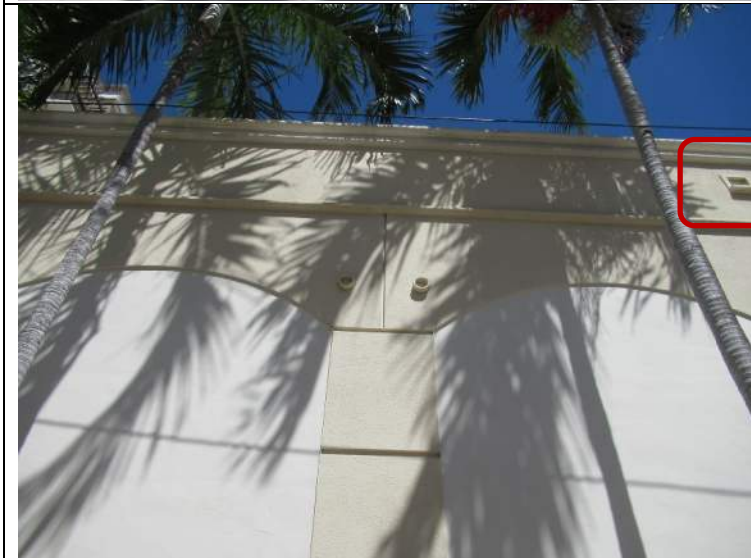
Photograph No. 15.

Typical west elevation wall showing the power meter and service disconnect, the obscured storefront windows, and stucco wall surfaces.

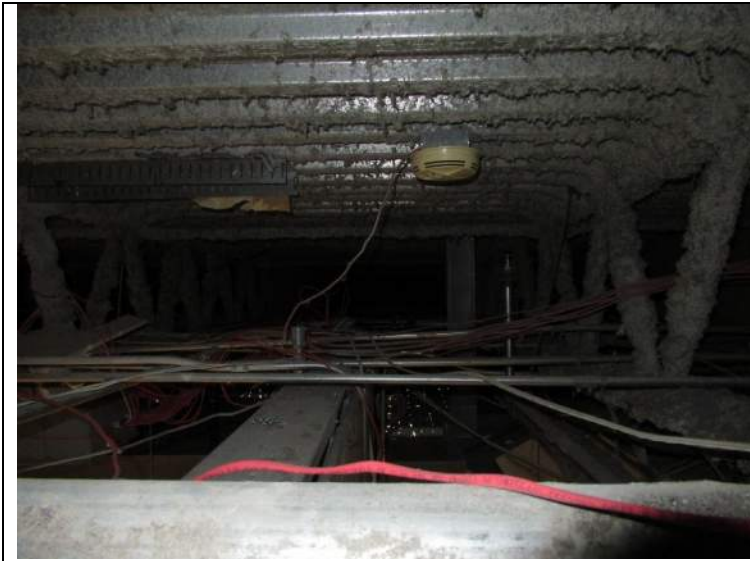
Photograph No. 22.

The fireproofed bar joist supporting the metal roof deck pan.

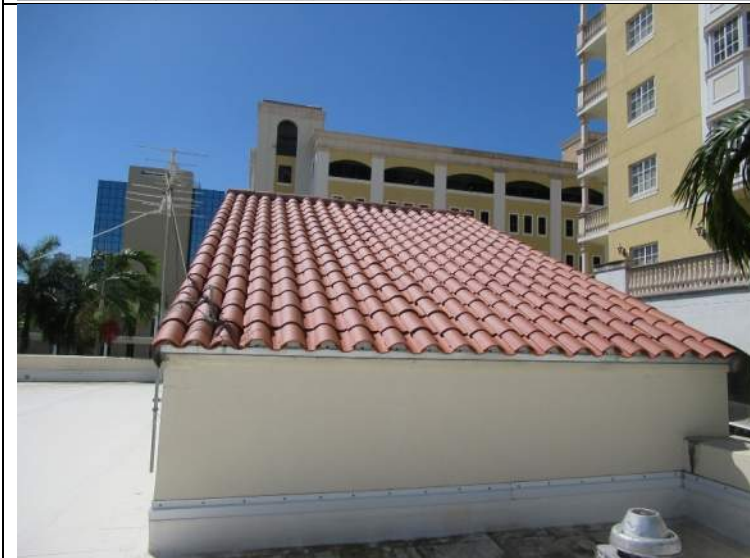
Photograph No. 29.

The gable roof structure above the roof in the SW corner of the store over the back entrances.

The roof drains need maintenance cleaning.

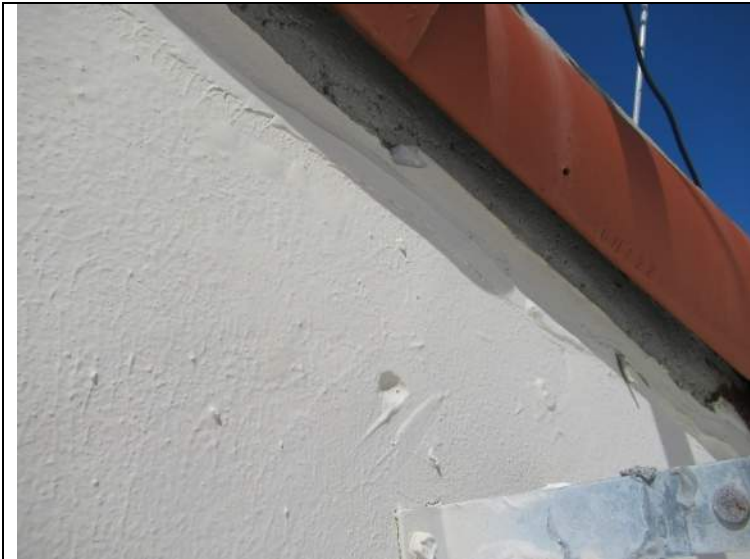
Photograph No. 30.

Closer picture of the gable roof structure with red terracotta barrel tile roof.

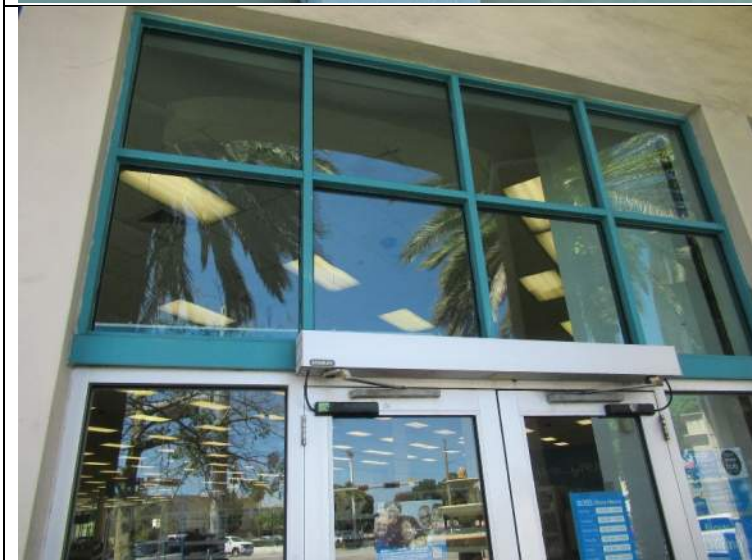
Photograph No. 35.

Chalking thumb prints in frame paint.

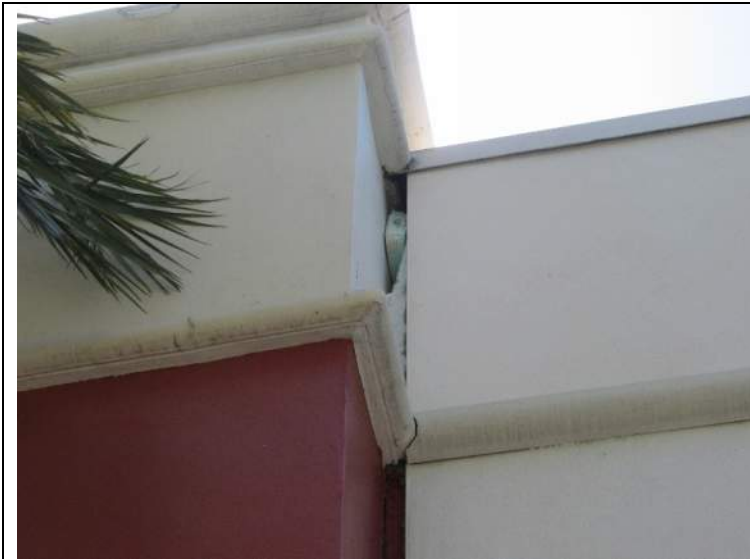
Photograph No. 40.

The zero lot line between the Ross store and the adjacent store to the west that Ross expanded into. The gap between the two zero lot line walls needs to be sealed off properly.

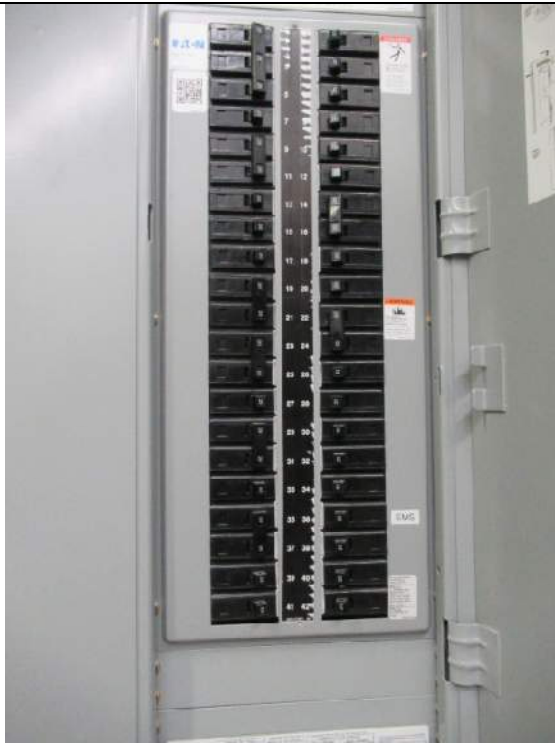
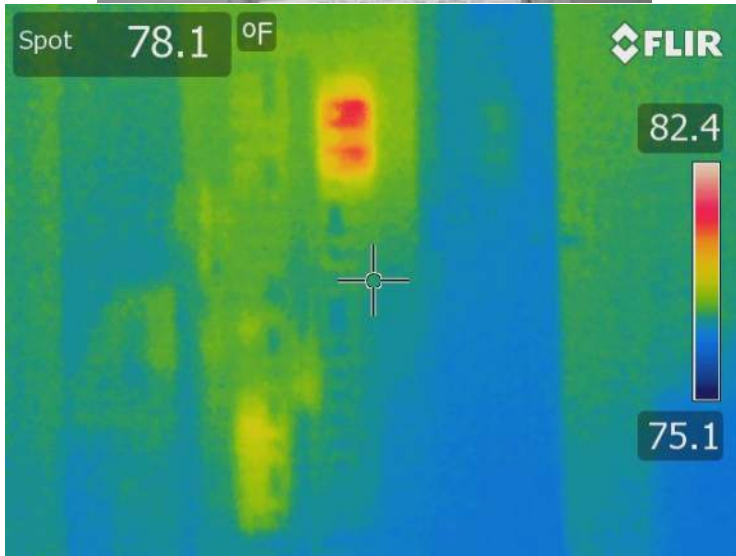
Photograph No. 49.

The LA 208Y120 sub-panel with maximum temperature at 82.5 degrees.
