**LISA H. HAMMER, RCA**  
*Horticultural Consultant*

March 31, 2025

RE: 737 Valencia Avenue  
Coral Gables, Florida 33134

We met at the above-referenced property on March 10, 2025, and again on March 26, 2025, where you requested that I evaluate the condition and relocation potential of six live oak trees (*Quercus virginiana*), #14, #20, #30, #41, #46 and #56, and one gumbo limbo tree (*Bursera simaruba*) #45, as shown on the Tree Survey/Disposition Plan you provided (de la Guardia Victoria Architects & Urbanists, Inc. Permit Set 11-25-24. Sheet LA-02). My report follows.

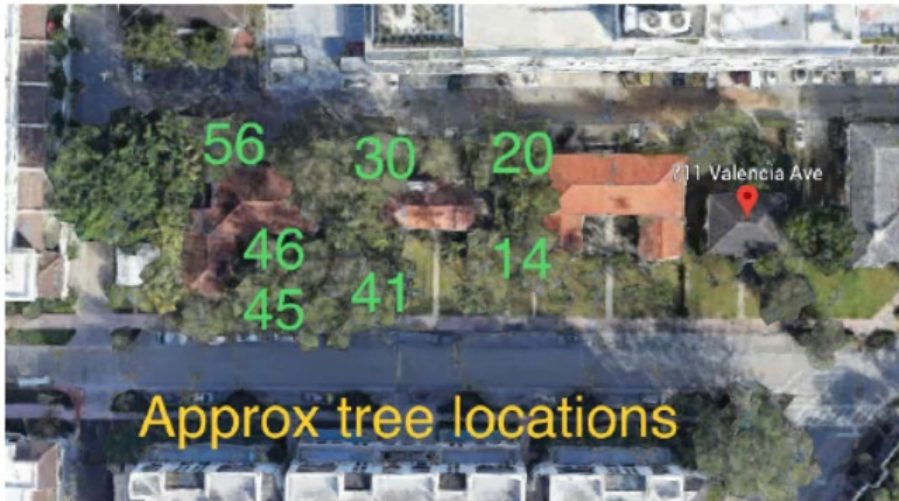
## SITE MAP – TREE LOCATIONS

The aerial photograph on the next page shows the condition of the property prior to demolition of the buildings, with the locations of the trees in question marked by tree number. Note their locations in between buildings and near sidewalks, streets, and alleys.

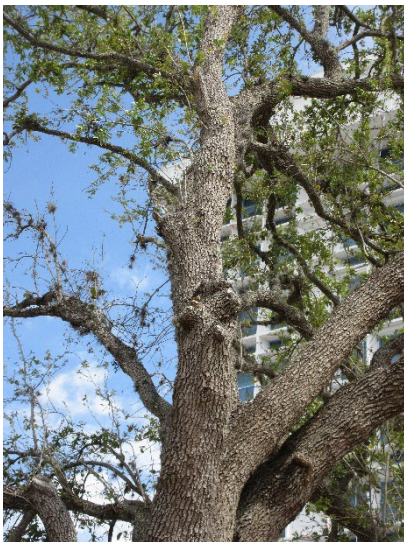
There are numerous dead branches and significant twig dieback.

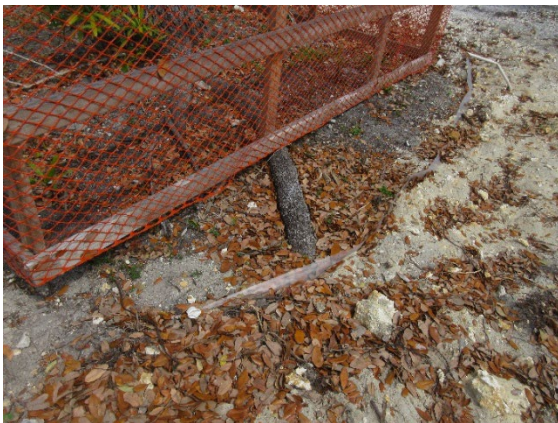
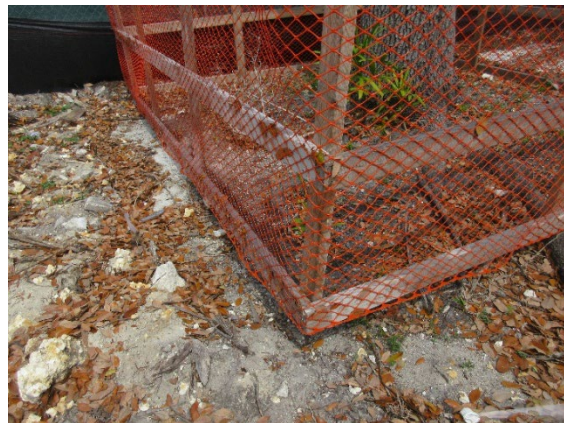
The tree was root-pruned on the south and west sides, reportedly done on January 6, 2025, and on the north and east sides on March 18, 2025. The root pruning cuts are approximately 12 to 15 feet in diameter.
