HISTORIC PRESERVATION BOARD PRESENTATION

NOVEMBER 20, 2025

CORAL GABLES CITY HALL

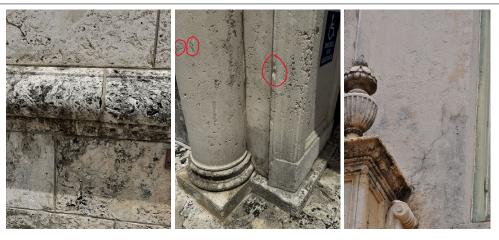
South Elevation Failures

- · Limestone
 - \circ $\;$ Cracking, spalling, incompatible patching at sill/anchors
- · Stucco
- Deterioration above cornices due to missing flashing
- Swirl marks from power-washing
- · Cast Stone
- Cracking
 Spalling
- Binder loss
- Corroded reinforcement and deteriorating balusters

- Remove incompatible limestone patches; repair with mortar or stone dutchmen
- Replace severely damaged limestone with matching new stone
- · Repoint all elevations
- $\circ\,$ Sound and repair stucco to matching original color, texture and finish
- Stabilize cast stone with crack injection, patching, and selective recasting
- $\circ\,$ Clean masonry gently; remove vegetation; apply new coatings
