# The Cla-Reina Hotel (La Palma Hotel)

City of Coral Gables Ad Valorem Tax Exemption Application

**MIAMI-DADE COUNTY  
HISTORIC PRESERVATION AD-VALOREM TAX EXEMPTION**

**PART 1 – PRECONSTRUCTION APPLICATION**

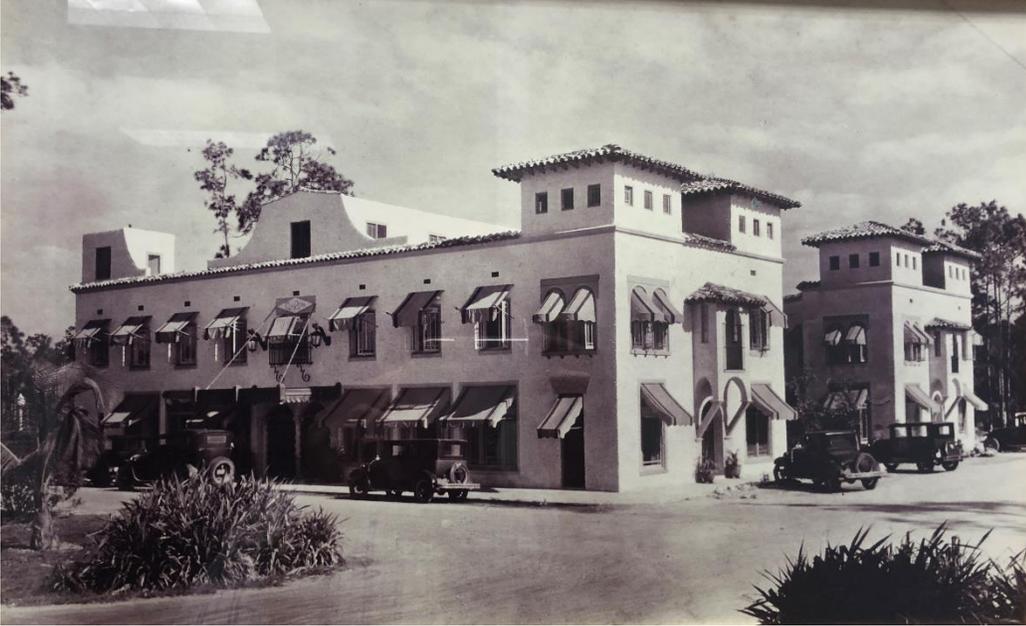
PHOTO 1.

Looking at the NW corner of the Cla-Reina Hotel, circa 1926. Note the central canopy suspended over the double arched entryway on the north façade.

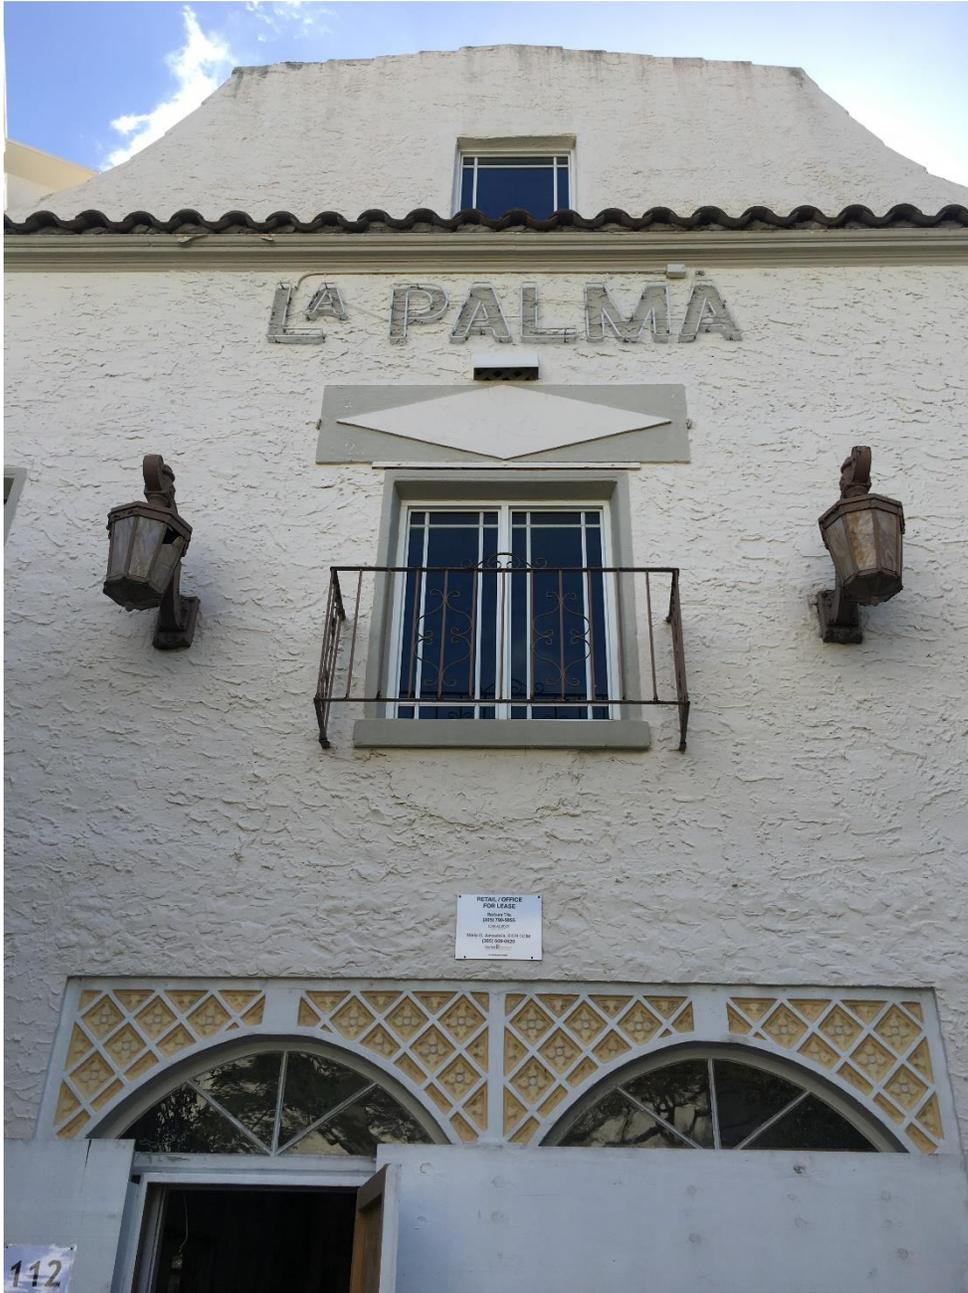
PHOTO 3.

The north façade of “La Palma” building.  
The semi-circular transoms with diamond pattern relief surrounds at the central entrance, original light fixtures flanking the second floor window.

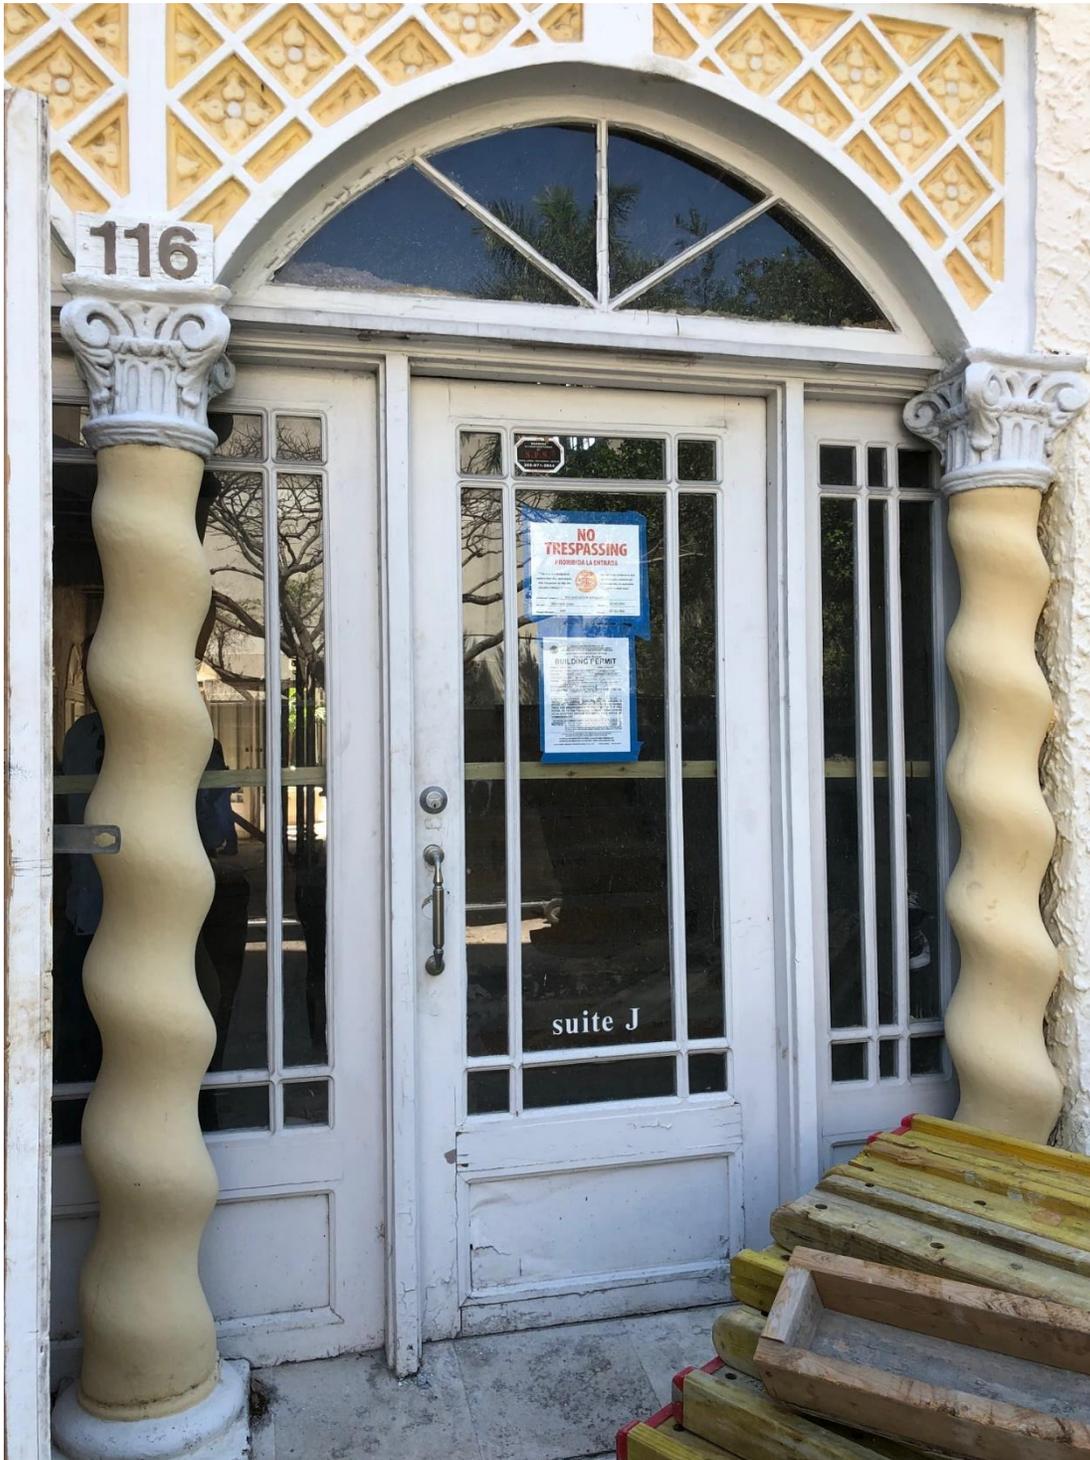
PHOTO 4.

The north façade of “La Palma” building.  
Detail of one of the arched entrances with twisted (Solomonic) columns.

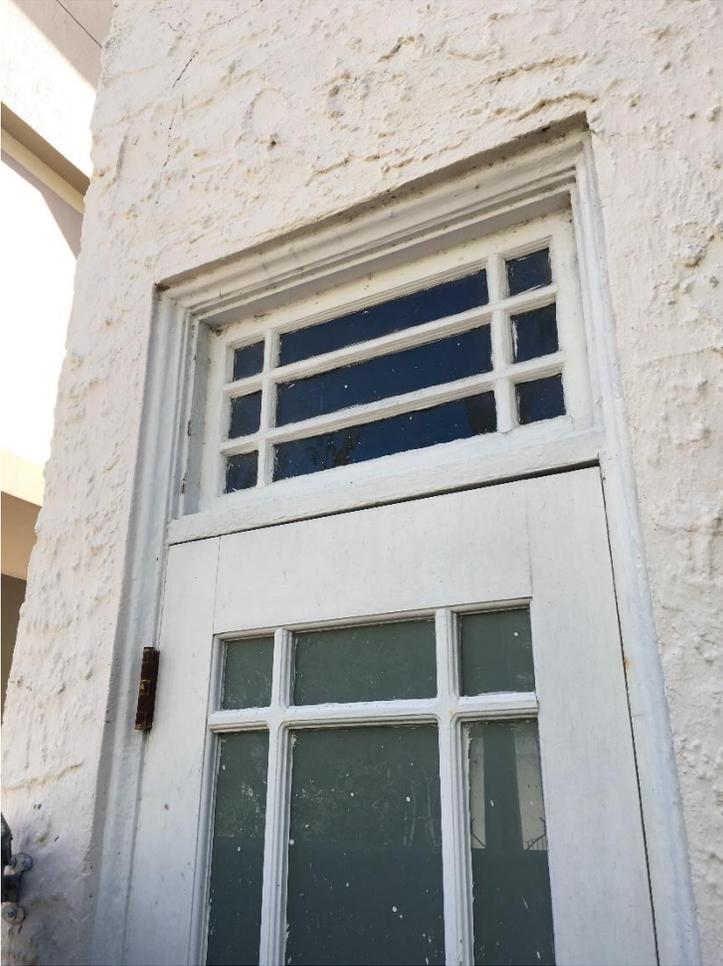
PHOTO 6.

The north façade of “La Palma” building, detail of a wood door and transom at the east end of the façade.

According to City of Coral Gables permit records, the windows were replaced in 1969 with aluminum awning windows.

Another renovation in the 1980s reintroduced wood windows on the first floor and aluminum impact on the second.

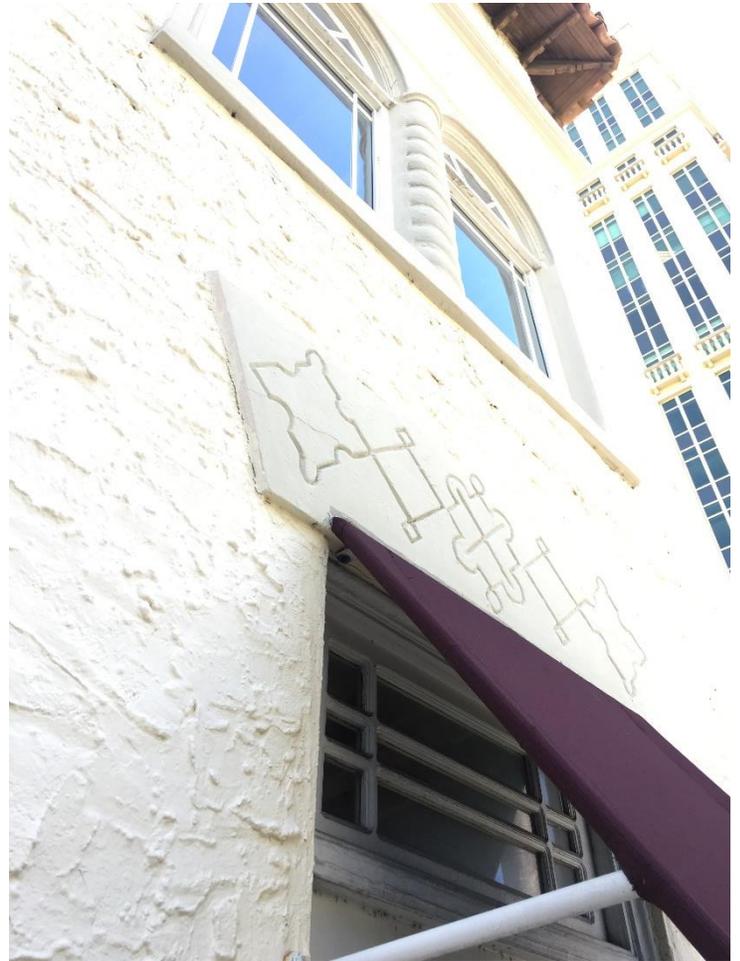
PHOTO 7.

The north façade of “La Palma” building, detail of a carved relief lintel over the transom at the west end of the façade.

A pair of windows with semi-circular transoms and separated by an engaged twisted column is at the second floor.

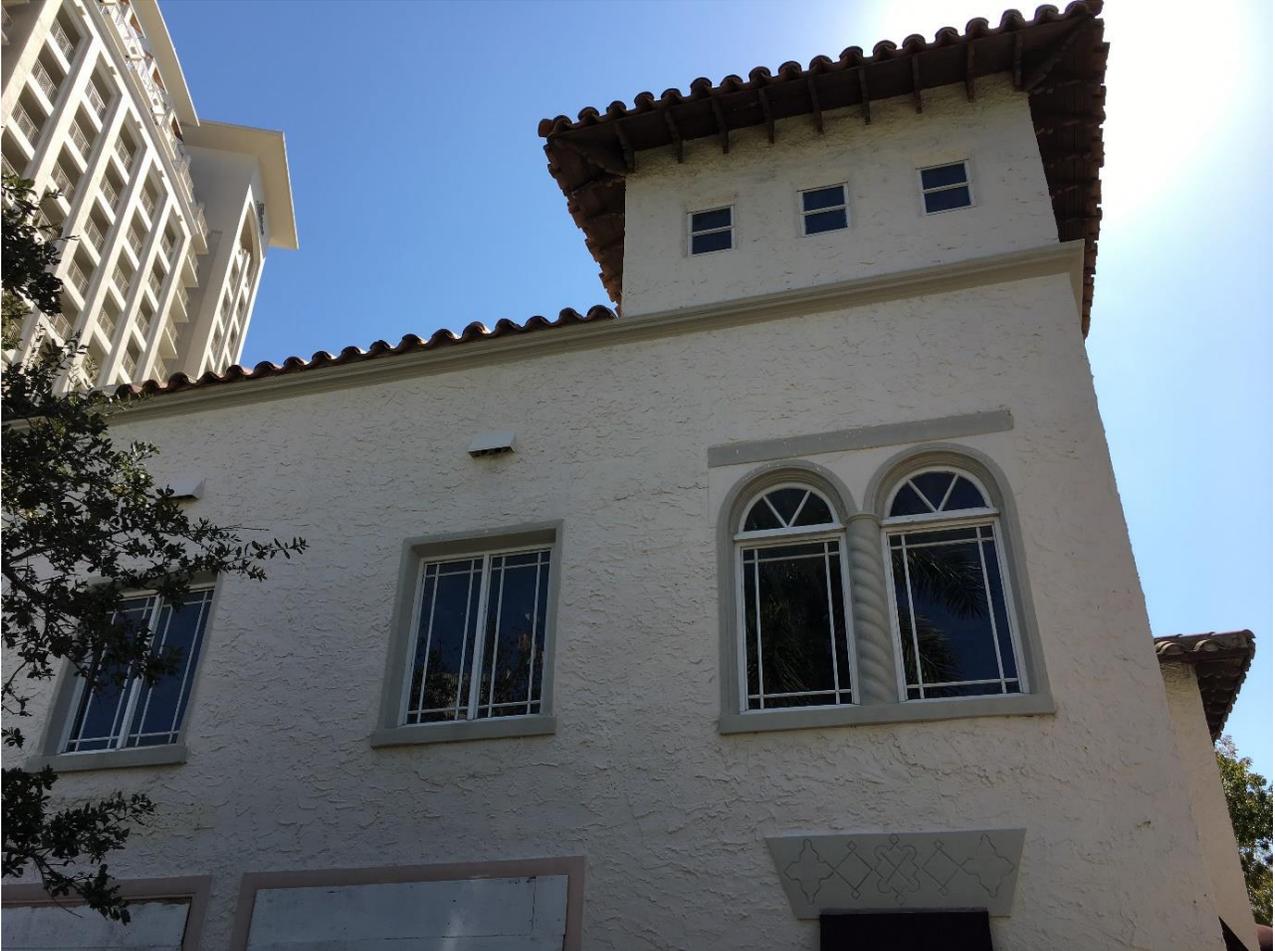
PHOTO 8.

The north façade of “La Palma” building, at the western end.

A pair of windows with semi-circular transoms and separated by an engaged twisted column is at the second floor.

One of the four third-floor “towers” topped by a pyramidal hipped roof covered with barrel tile.

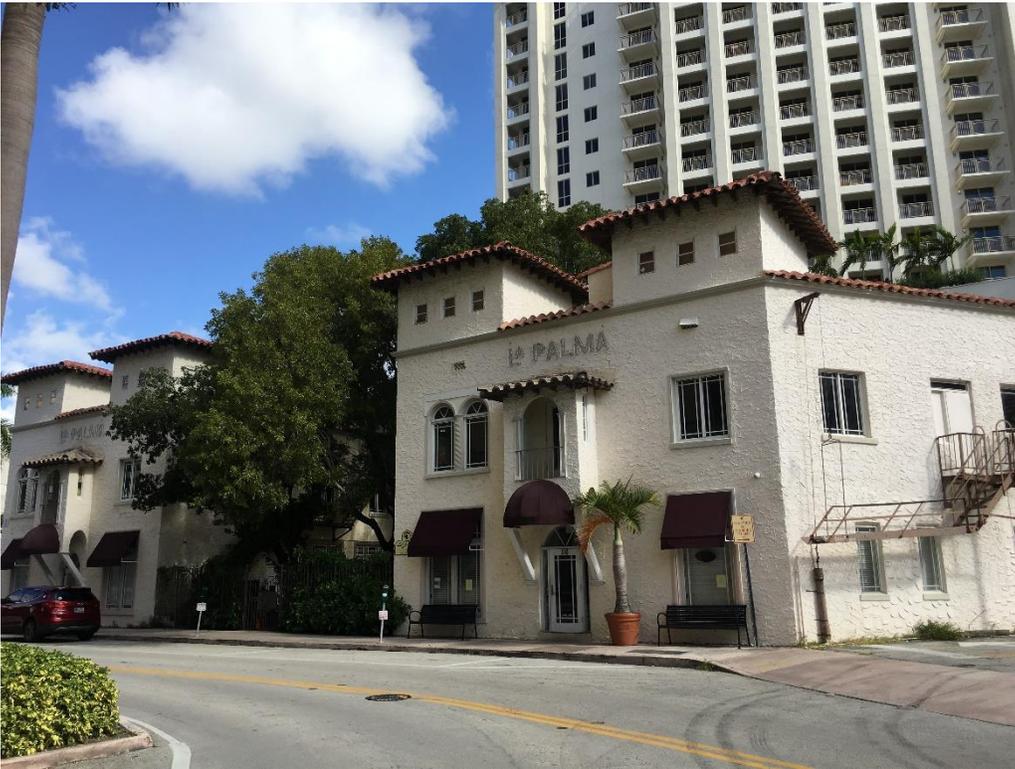
PHOTO 11.

The west facade of “La Palma” building.

Photo taken near the southern wing of the U-shaped building with interior courtyard.

One of the two exterior staircases can be seen on the southern façade.

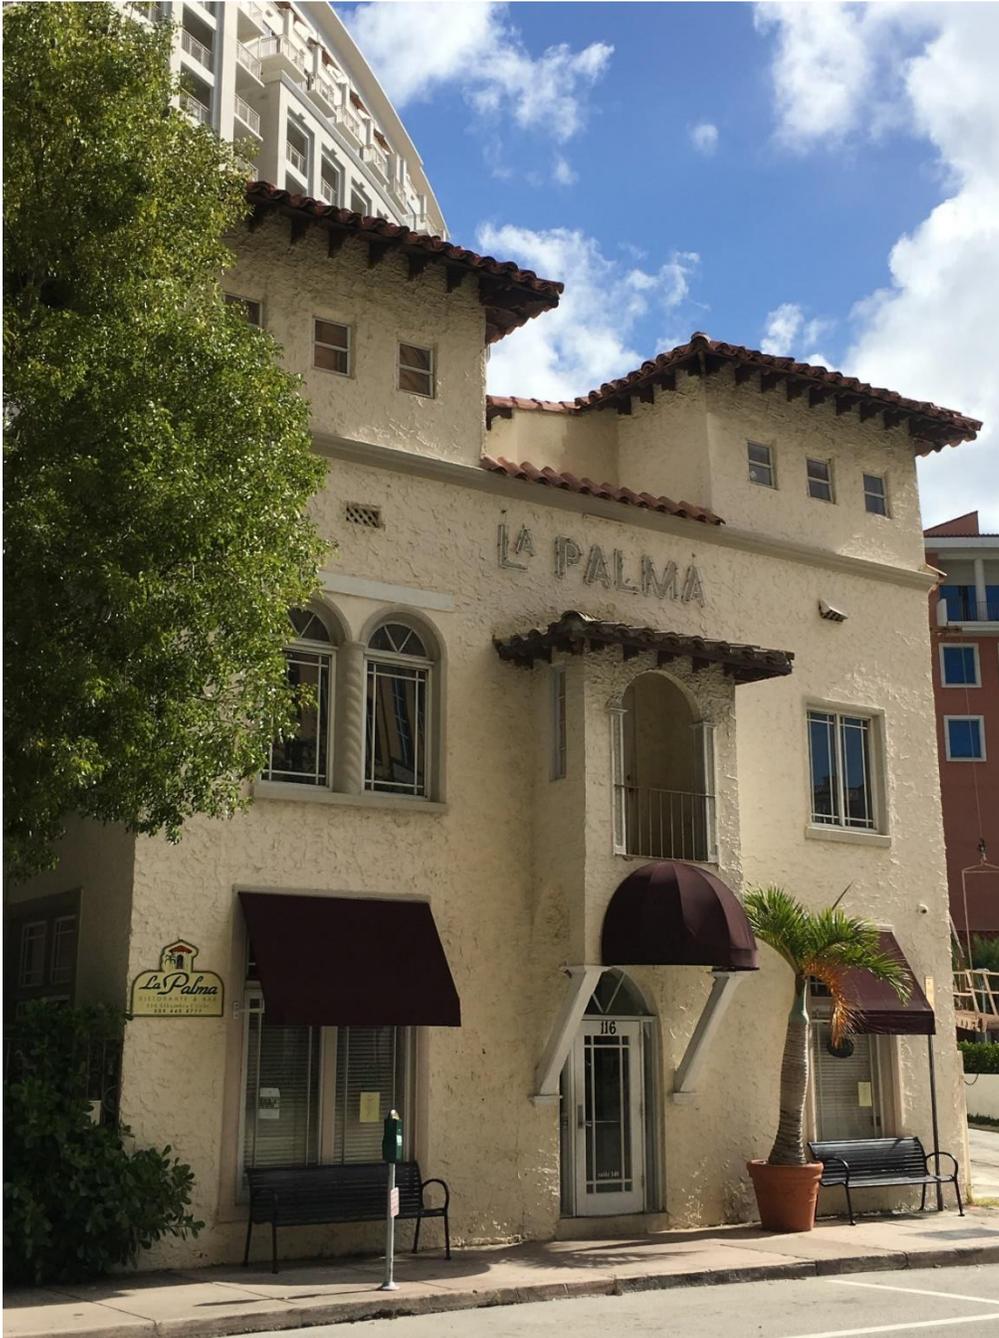
PHOTO 13.

On the west elevation, in the center of each wing of the building, there are two entryways that have a corbeled arch ceiling created from second floor balconies, supported by thick wood braces. Some stucco is damaged or missing, and the wood braces show some signs of cracking and splitting.

The west façade of the southern wing of the U-shaped building.  
Note the shallow, cantilevered, semi-enclosed bay balconies supported by thick wood brackets.

The existing entryway arches shall be repaired, with stucco replaced as needed. The wood brackets will be retained and restored.

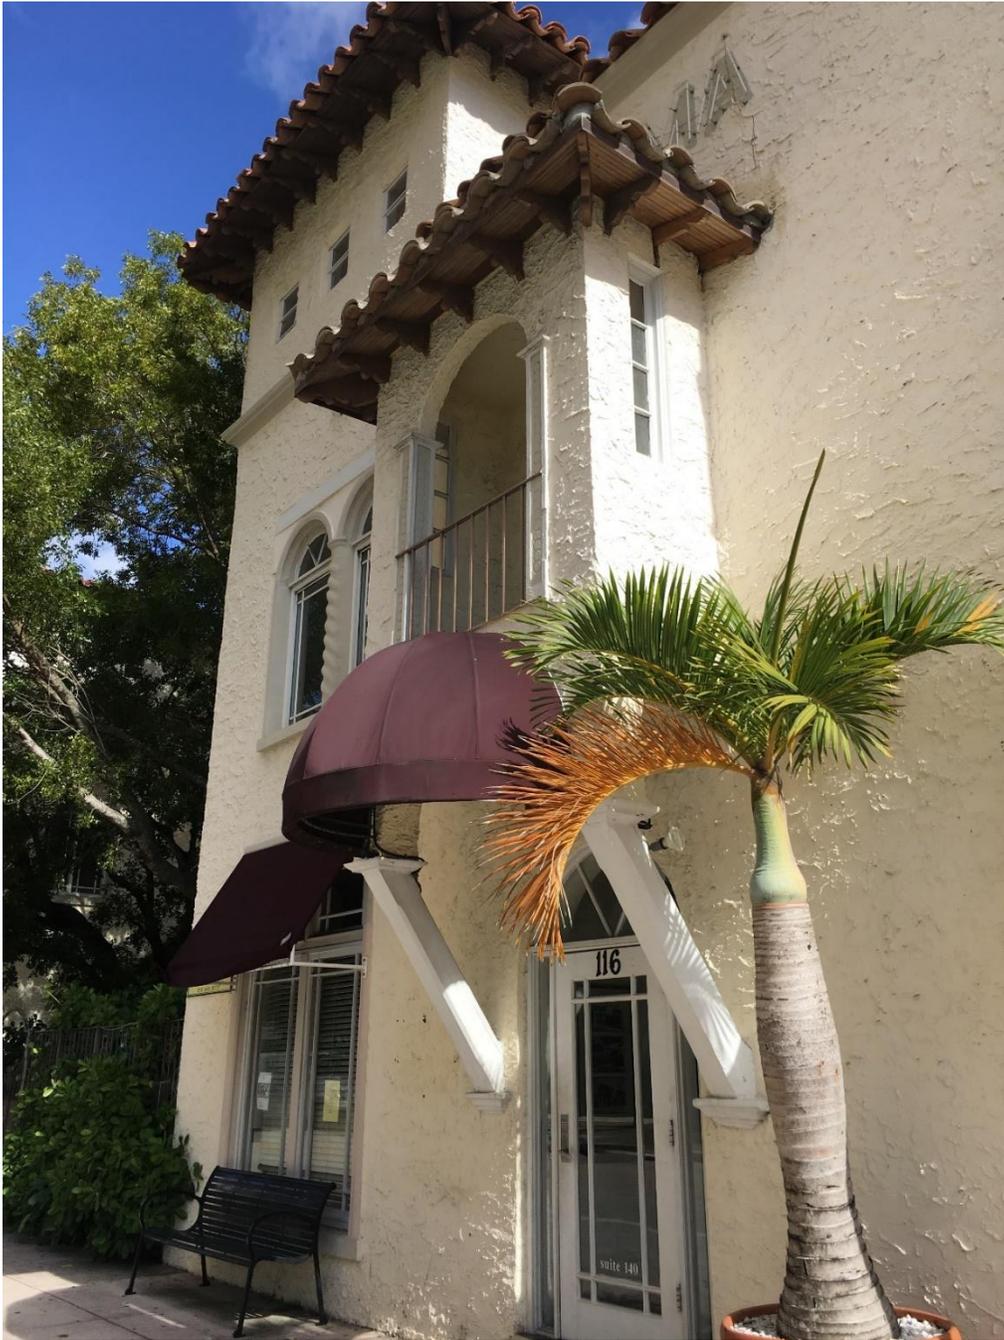
PHOTO 14.

The west façade of the southern wing of the U-shaped building.  
Note the shallow, cantilevered, semi-enclosed bay balconies supported by thick wood brackets, and the carved wood rafter tails under the eaves.

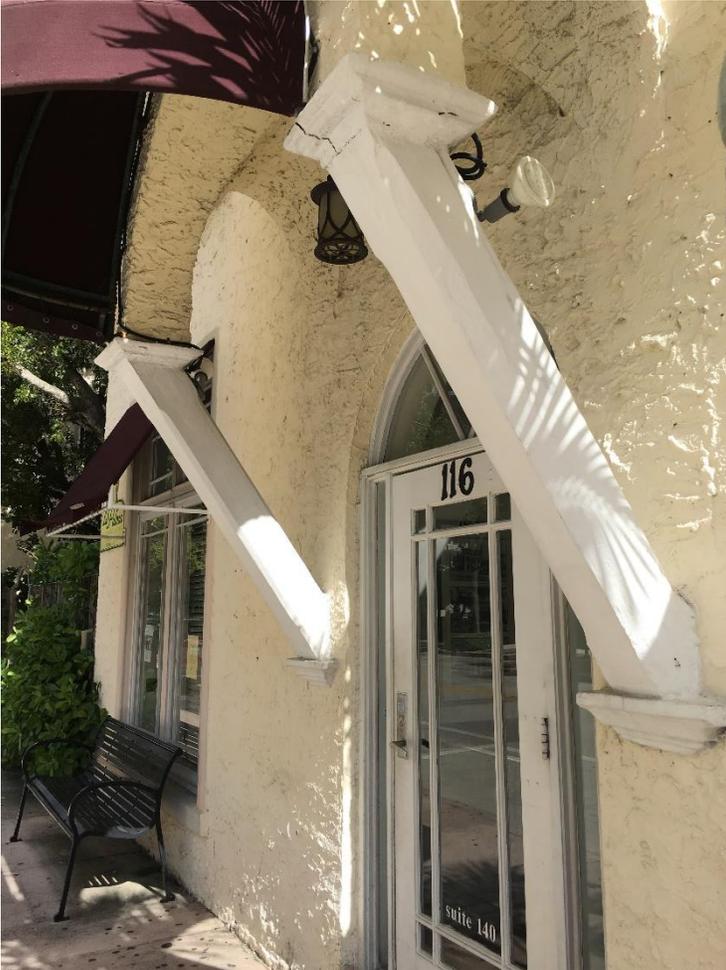
PHOTO 15.

The west façade of the southern wing of the U-shaped building, entrance doorway.

Note the shallow, cantilevered, semi-enclosed bay balconies supported by thick wood brackets, and cast iron light fixture.

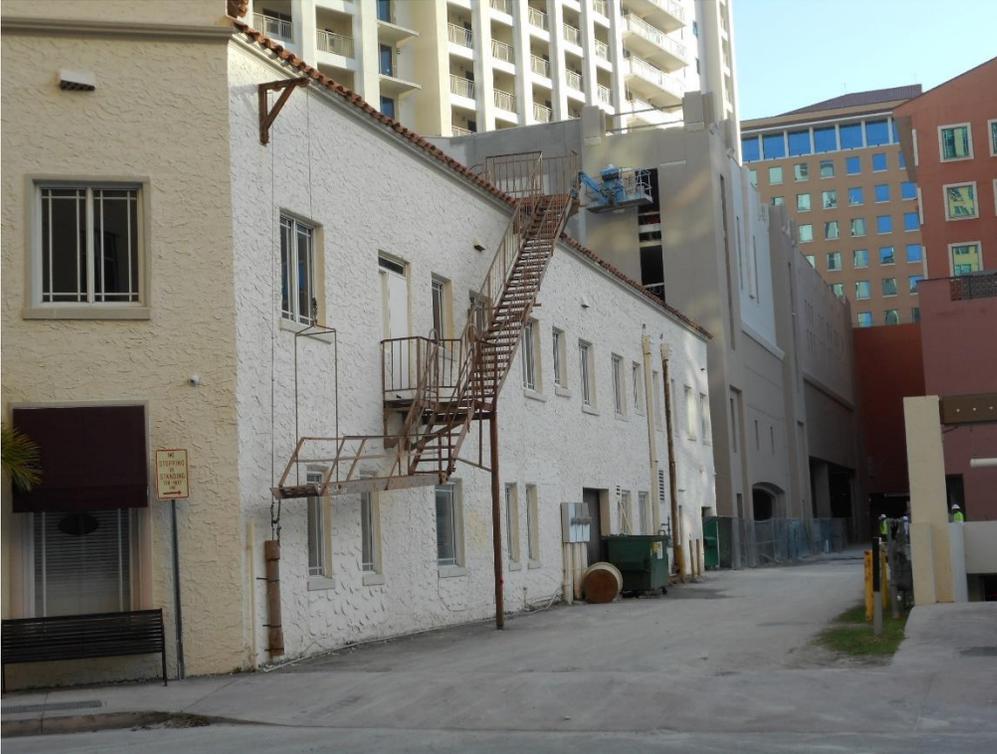
PHOTO 18.

South façade, looking east.

Note the exterior metal egress staircase, barrel tile on the flat roof coping.

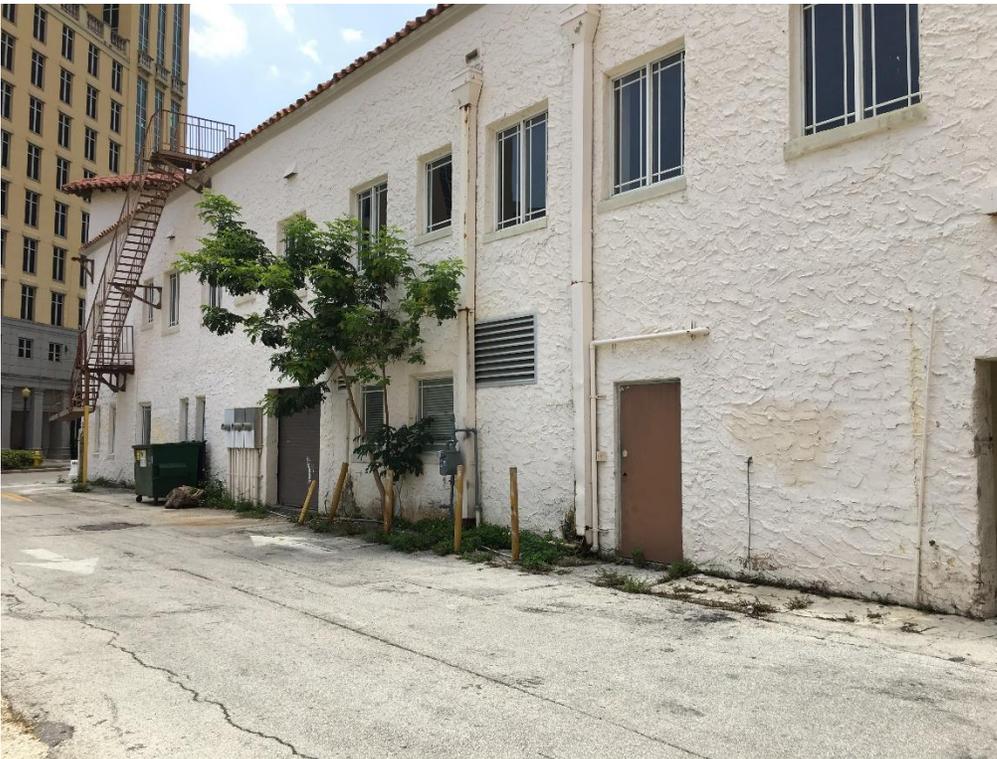
PHOTO 19.

South façade, looking west.

Note the exterior metal egress staircase, aluminum impact windows on second floor.

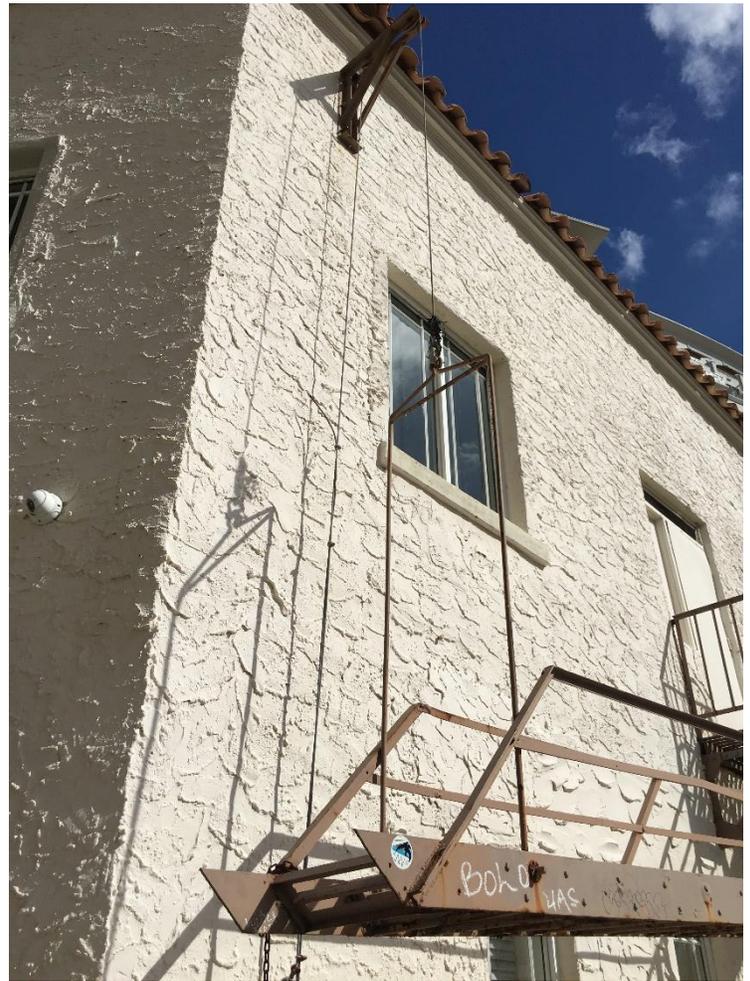
PHOTO 21.

The western end of the south façade.

Note the pulley system for the metal egress staircase.

The metal staircase on the exterior south elevation will be restored to the original operating condition. The metal staircase on the courtyard's south elevation used to have a landing at the rooftop level, but a wall with a window is now at the top of the staircase, where the landing used to be. Portions of this staircase will be restored so as to keep an original feature, but a portion will be closed off for use per fire code requirements.

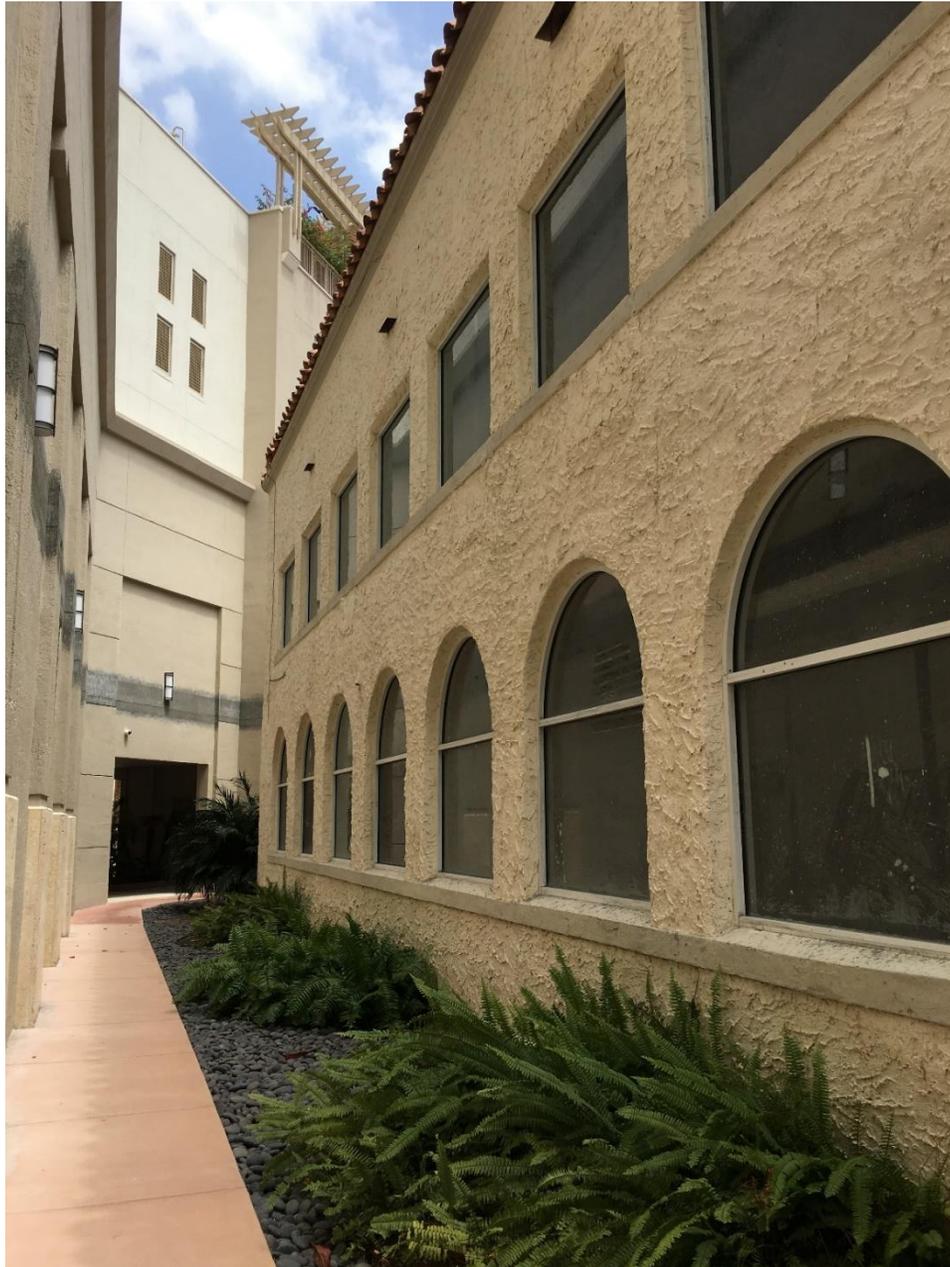
PHOTO 23.

The east façade, or “rear” of the building.  
The first floor arches were originally open, creating a colonnade, and providing an open walkway for the second floor, which has now also been enclosed.

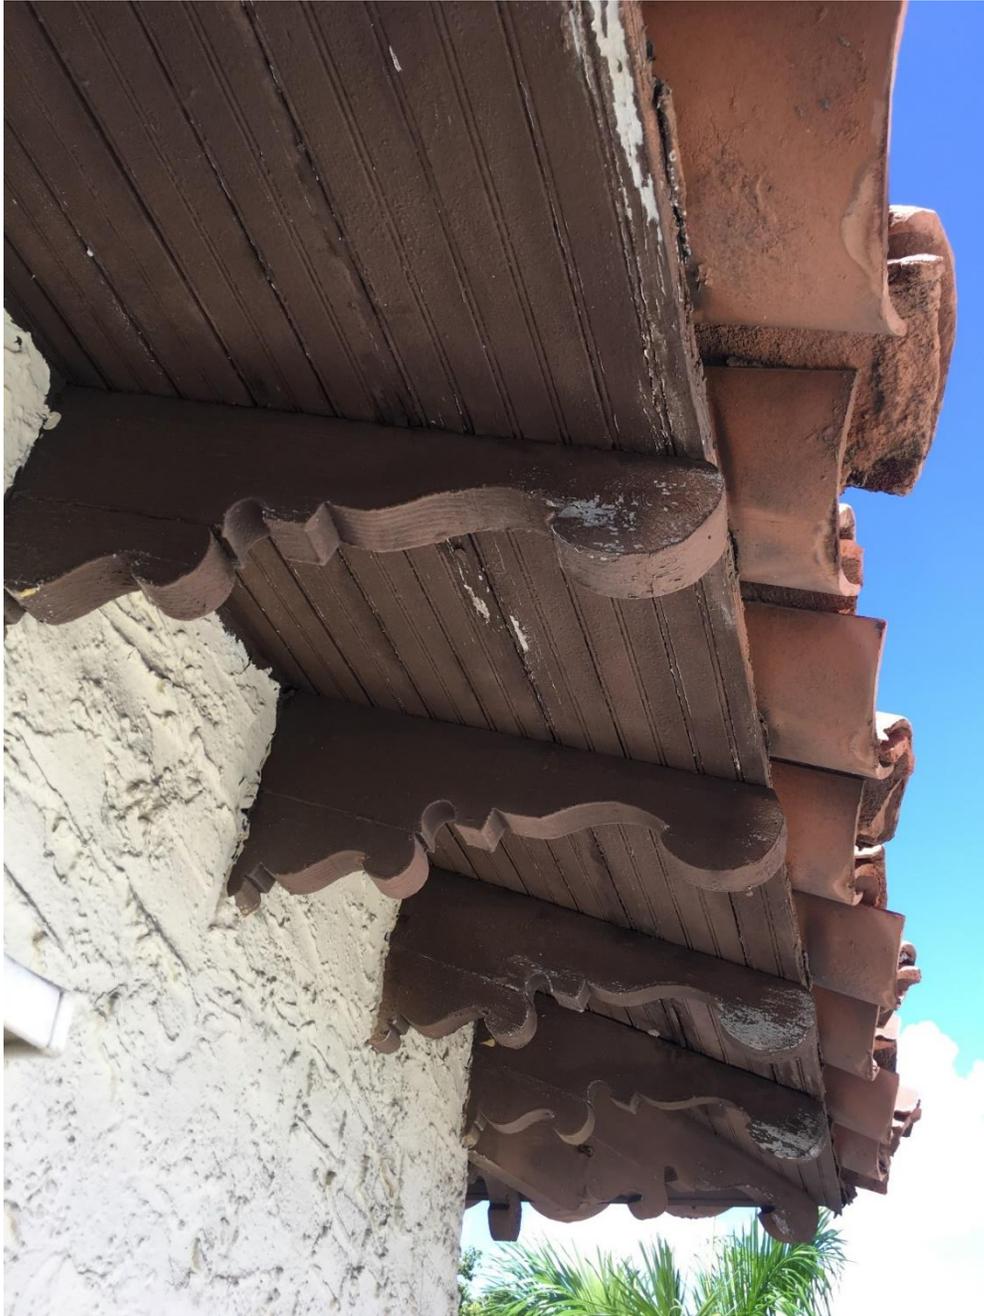
PHOTO 27.

Detail of the carved wood rafter tails underneath the eaves of the barrel tile roofs of the four third-floor towers.

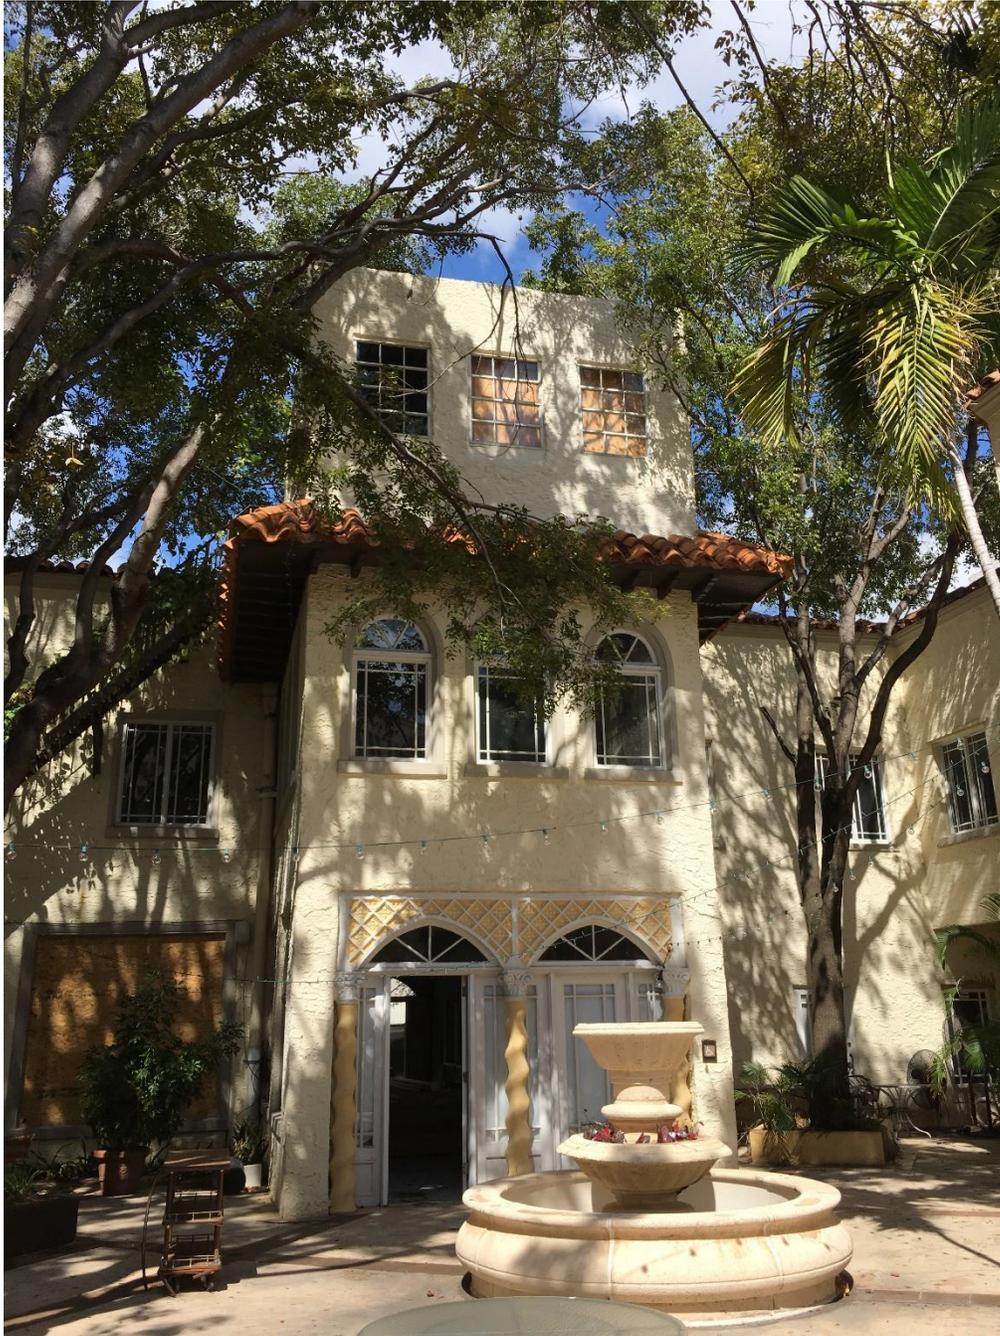
PHOTO 32.

The courtyard's north elevation, looking north. A central fountain in the courtyard is not a historic feature.

The projecting bay features arched double entryways, flanked by Solomonic columns. This used to be an open breezeway that transected the building when first constructed in 1924/1925.

It will not be functionally appropriate to completely reopen the lobby corridor as an open air space. However, a new frame-less impact door and window system will be designed and installed so as to try to replicate the feeling that the double arched entryway is leading into an open corridor. The same will be done on the courtyard end of the hallway. The existing doors will be removed and replaced with a new impact frameless door and window system. The arched windows that are a part of the east and west elevations on the projecting bay on the courtyard side currently have notable muntins dividing the lights and the transoms. These shall be replaced with single panes of glass to better replicate what the open-air corridor would have looked like. The original decorative precast cement reliefs in a diamond pattern that surround the corridor's arched entryways and that surround the arched windows in the projecting bay shall be retained and restored.

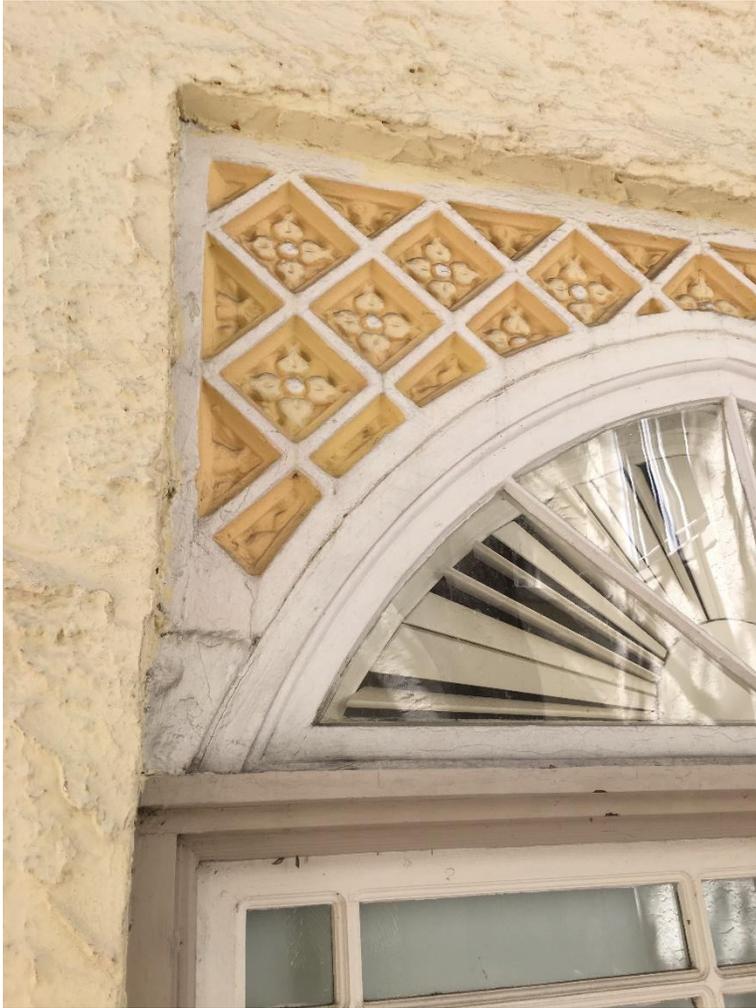
PHOTO 33.

Detail of entryway in the projecting bay of the courtyard's north façade.

The door and the semi-circular transom were introduced at a later date to enclose the open corridor.

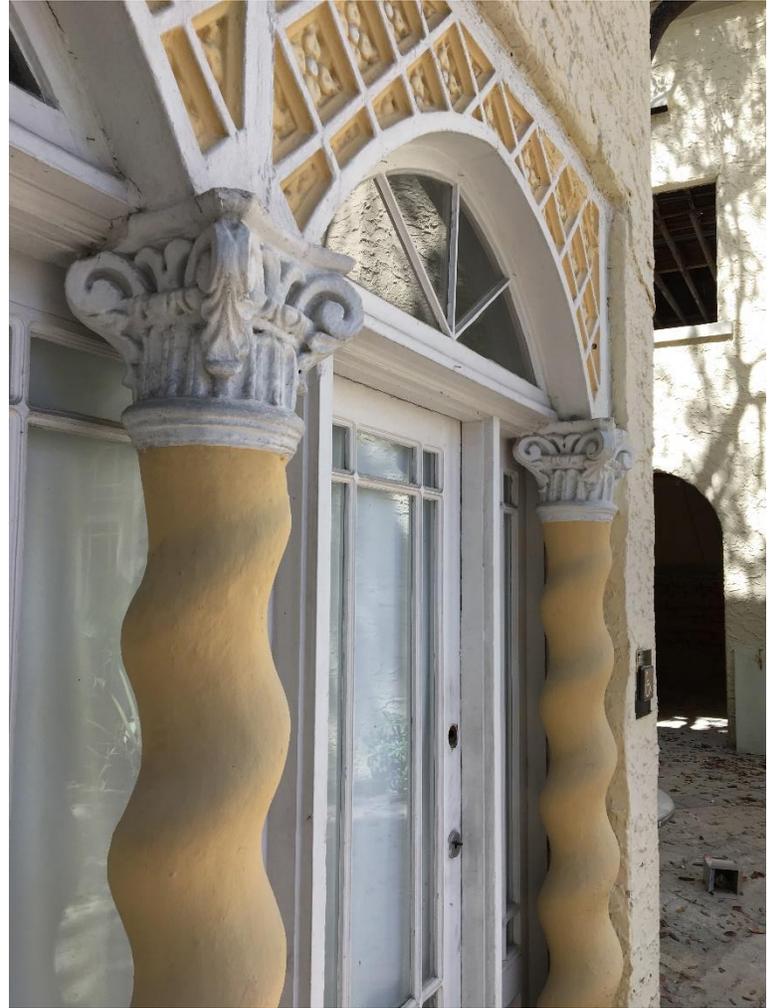
PHOTO 34.

Detail of entryway in the projecting bay of the courtyard's north façade.

Note the original Solomonic (twisted) columns with Corinthian capitals, spanned by the diamond-pattern relief insert with rosettes.

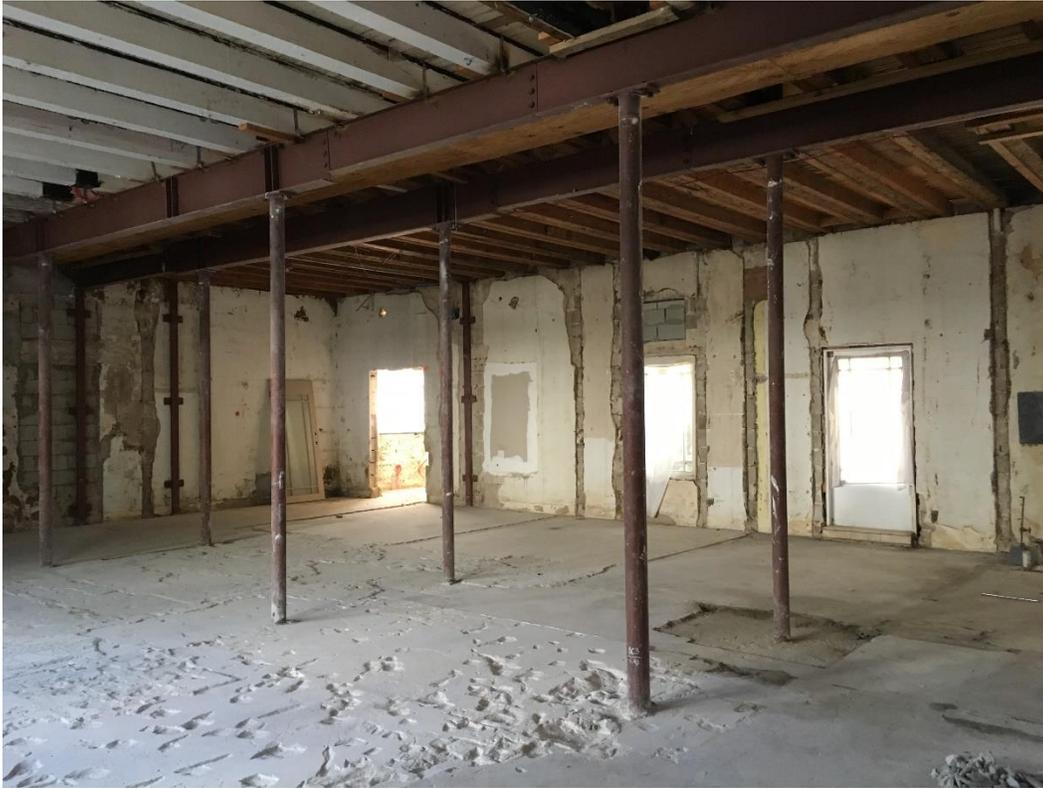
PHOTO 40.

1<sup>st</sup> floor interior, northwest corner of building looking southeast.

The building's northern and eastern wing were almost completely gutted by 2017, previous to the current owner's possession.

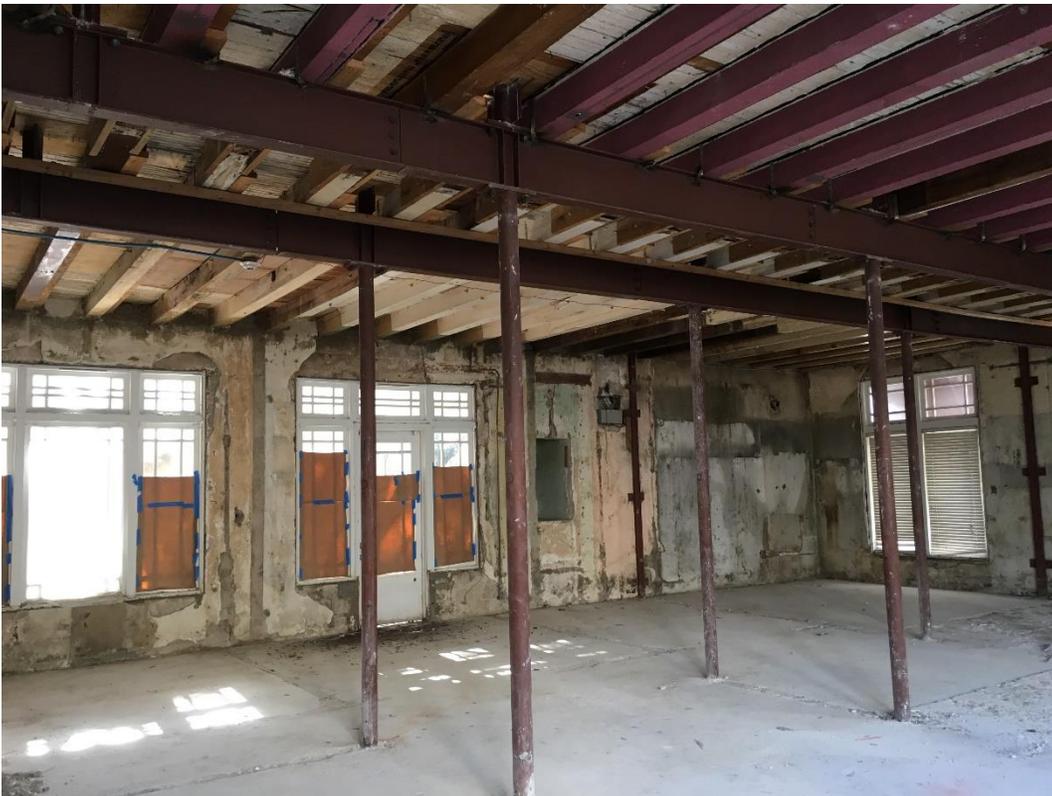
PHOTO 41.

1<sup>st</sup> floor interior, northwest corner of building looking southwest.

The building's northern and eastern wing were almost completely gutted by 2017, previous to the current owner's possession.

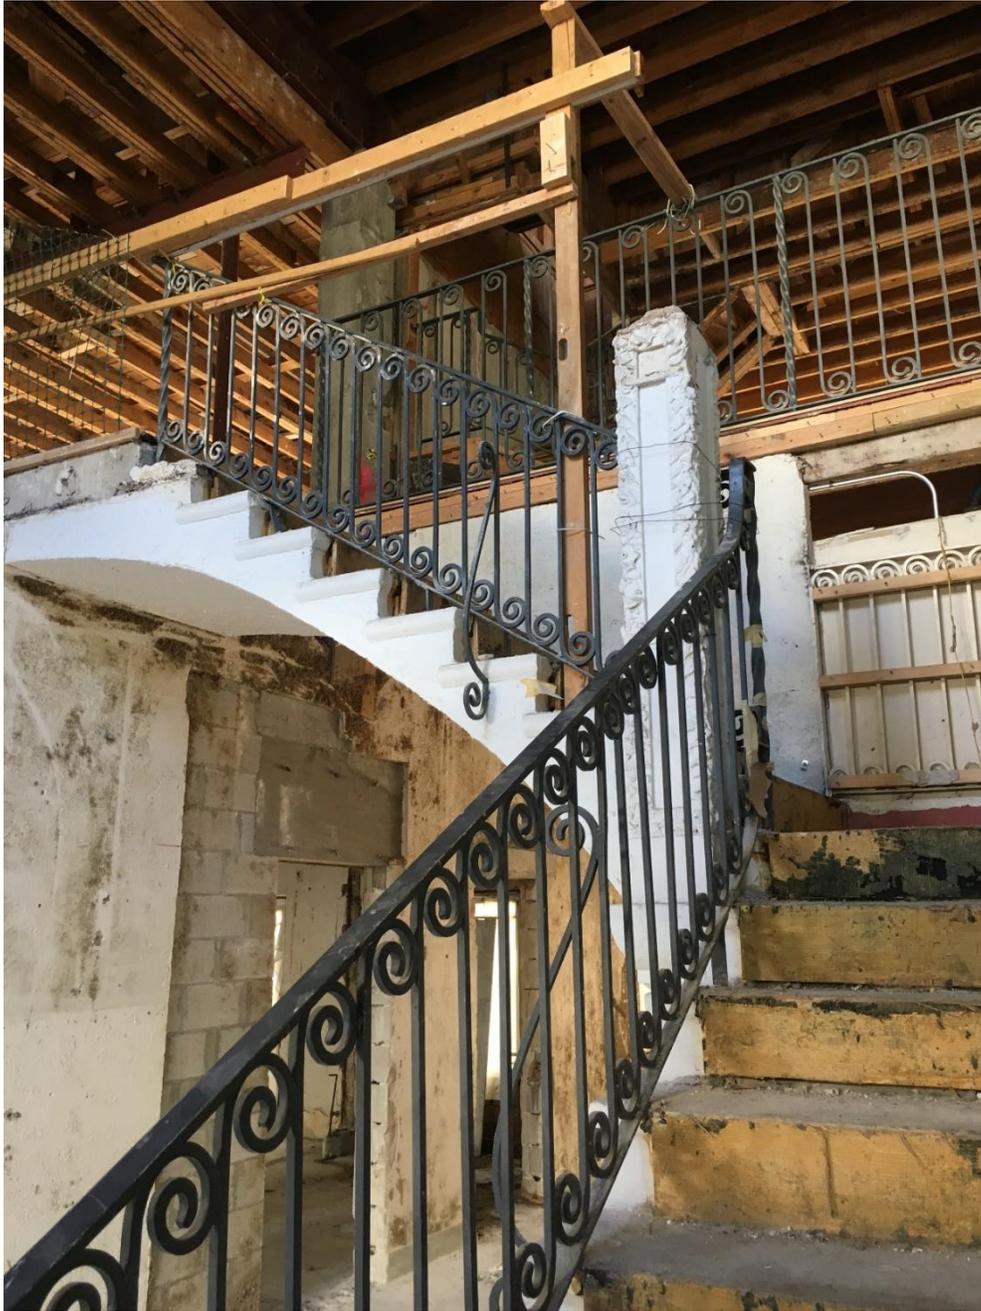
PHOTO 42.

1<sup>st</sup> floor interior, original staircase in lobby to second floor. Code-compliant railing a later addition.
