Big Ron's Tree Service

Arborist Report

Address: 5307 Orduna Drive Coral Gables Fl 33146

Date: January 15th, 2025

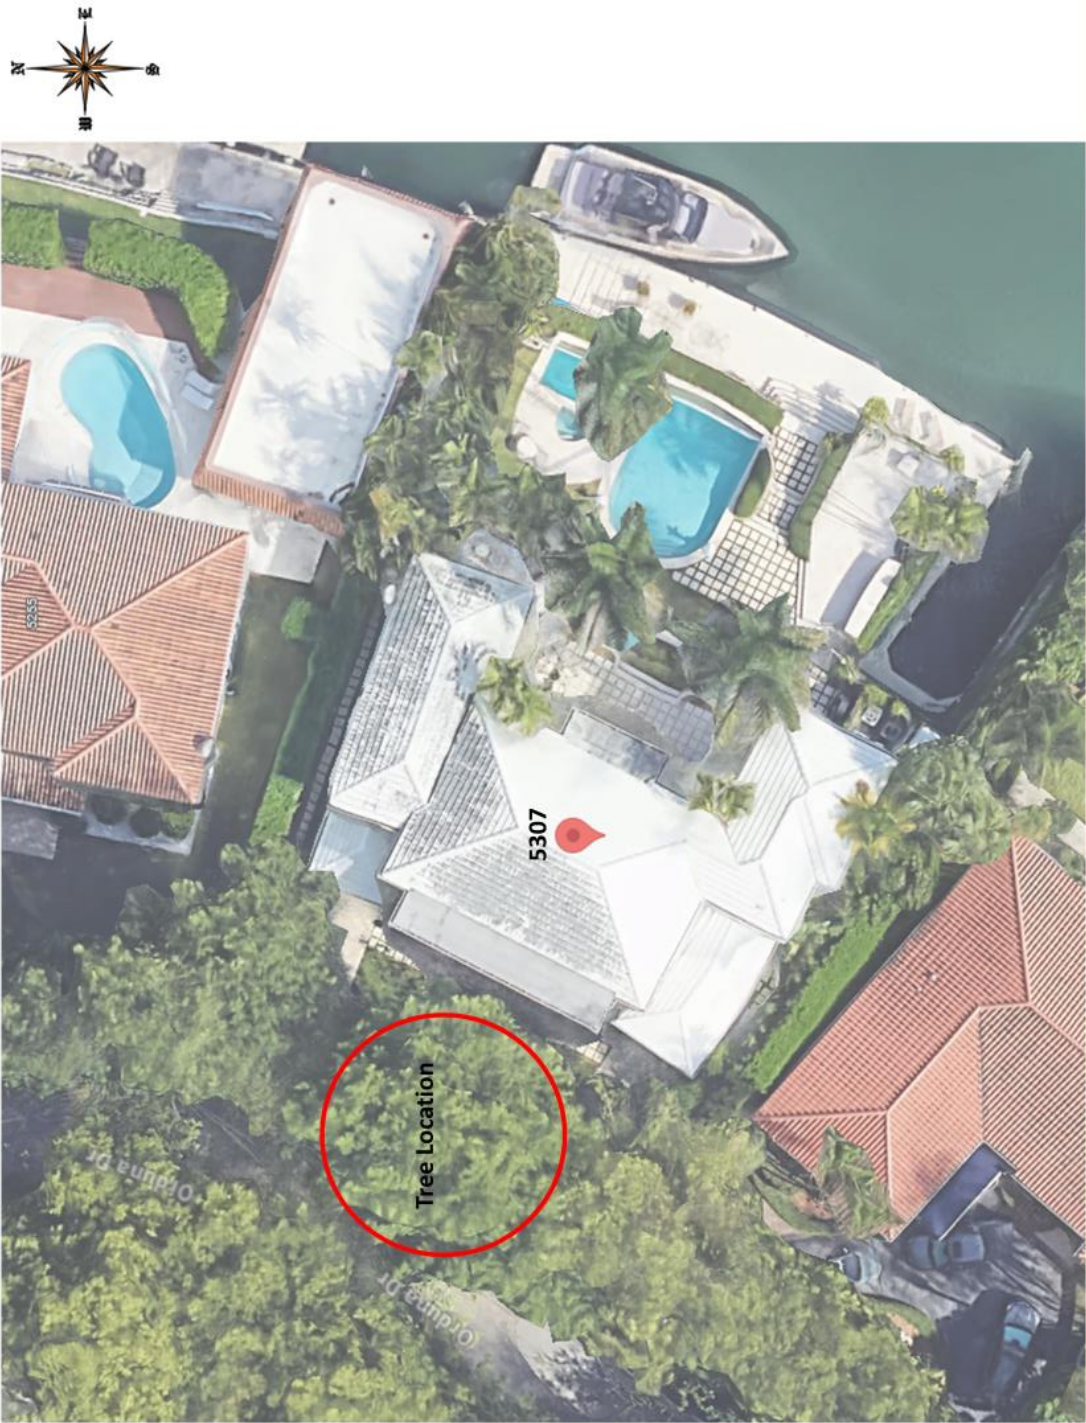
Tree Location

Though this tree was trimmed without a permit, it is still in fair condition. It appears that this tree was utility trimmed as well which usually leaves stubs.

This tree has been pruned without a permit as per the notice of violation. The tree was trimmed back from the property. Not all pruning cuts were done as per ANSI A-300 standards. The following restorative actions should be taken:

1. **Remove Stubs:** Stub cuts should be corrected, that is as per ANSI A-300 standards. This should be supervised by an ISA certified Arborist. In my professional opinion the tree stands a fair chance of recovery if the stubs are removed. Removing them will avoid the tree going into stress mode. I will also recommend the removal of the stubs below the Utility lines. See pic below. Though the client isn't at fault for this, there is a lot of adventitious growth on it and if left alone it will grow back faster than before and the utility company will improperly prune it again in the future, leading to additional unwanted stress to the tree.
2. **Follow-up Arborist assessment:** After 12 months an arborist assessment must be done to determine if the tree is healing and re-growing as it should, and its overall condition. No additional pruning should be done during the 12 month period.
