Jun 2, 2025

Please find below my Certified Arborist Report for 2 Southern Live Oak trees, *Quercus virginiana* in response to a notice of violation by the City of Coral Gables, case #:NOVI-25-05-10100 at 8245 Los Pinos Cir, Coral Gables, FL 33143.

SUMMARY

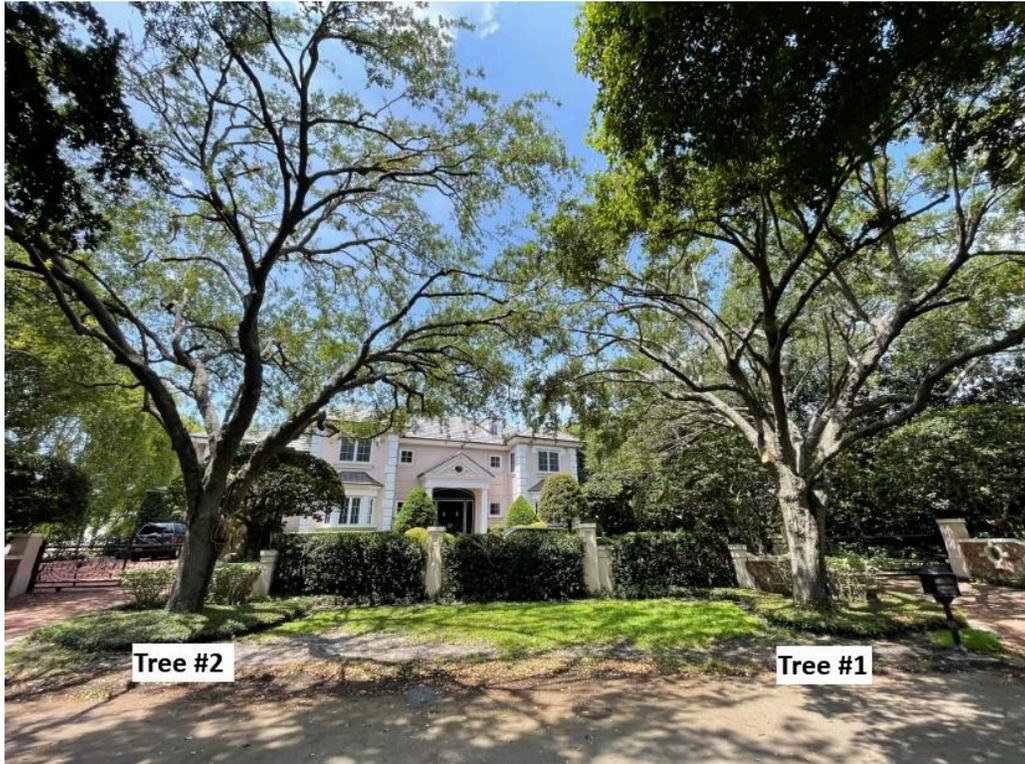
8245 Los Pinos Cir, Coral Gables, FL 33143 - Tree Table										
ID	Date	Common	Botanical	DBH *diameter at breast height (inches)	Height (feet)	Canopy Spread (feet)	Health	Disposition	Lat	Lon
1	6/2/25	Southern Live Oak	<i>Quercus virginiana</i>	21"	42'	54'	80% - Good	Remain	25.6954 1773	-80.263 78634
2	6/2/25	Southern Live Oak	<i>Quercus virginiana</i>	26"	41'	60'	80% - Good	Remain	25.6953 549	-80.263 66363

Defects and Conditions of Concern – Both trees have grown tall due to PHOTOTROPISM and give the appearance that they have been over raised and over pruned. However, due to the location of the trees and the adjacent surrounding trees, both live oaks have grown tall to compete for sunlight within the tree hammock. All that has been trimmed was deadwood and any epicormic growth that will not benefit the tree structurally.

Risk Mitigation Options – In regards to case #:NOVI-25-05-10100 at 8245 Los Pinos Cir, Coral Gables, FL 33143, the following canopy restoration plan is recommended. 1. Restore Canopy – For the first 2 to 3 years allow canopy to flush out as much auxiliary growth and sprouts in the canopy, no pruning is required in this phase. Once canopy has flushed out sufficiently, prune no more than 20% of these sprouts back to the collar or Parent Branch to allow Compartmentalization. When selecting the sprouts for removal the objective should be to restore a canopy that is promoting lateral branches and good taper. Two years after sprout management pruning, the next phase would be to subordinate any of the remaining auxiliary growth sprouts or sprouts from old pruning cuts that have dominated and are over-extended, and to cut back old pruning stubs back to ONLY unions of branches that are at least 1/3 in diameter of specific stub.
