# PROPERTY APPRAISER OF MIAMI-DADE COUNTY

| PROPERTY INFORMATION | |
|---|---|
| Property Address | 13637 DEERING BAY DR<br>CORAL GABLES, FL 33158-0000 |

**NOTICE OF UNSAFE STRUCTURE VIOLATION FOR FAILURE TO RECERTIFY  
AND NOTICE OF HEARING**

☒ Initial Inspection Report ☐ Amended Inspection Report after completion of repairs

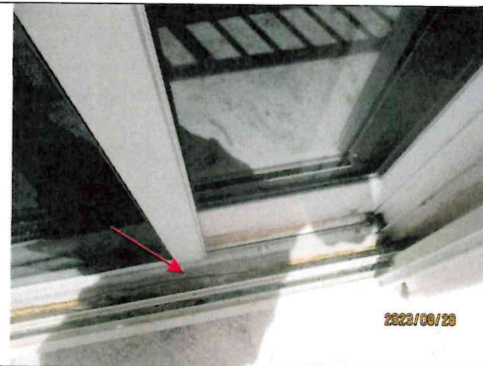
4. Water ponding was observed adjacent to the accordion shutters bottom track of Unit 294 and Unit 235. Refer to photographs #21 and #22.
5. A damaged soffit was observed on the roof of Unit 294. Refer to photograph #23.

*Photo-22: Water ponding adjacent to the shutter in the balcony of Unit 235.*
