HISTORIC PRESERVATION AD-VALOREM TAX EXEMPTION

PART 2 – REQUEST FOR REVIEW OF COMPLETED WORK

**Request for Completed Work
Ad-Valorem Application Package for:
Historical Restoration, Addition, and Alteration to:
(Submitted June 2, 2014)**

Olivera Residence

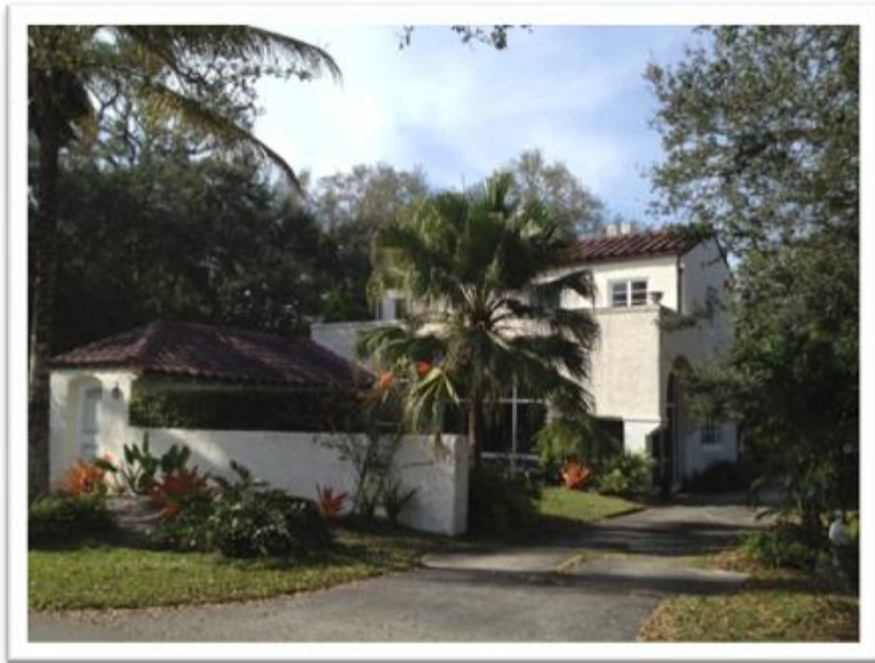
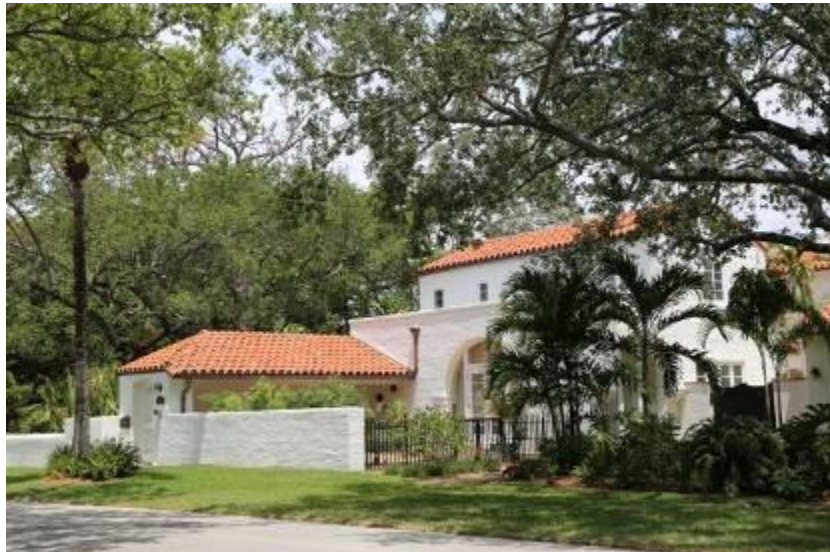
Photo Number: Image (Before)

Front Elevation

Describe Work and Impact on Existing Feature: New paint, new Landscape

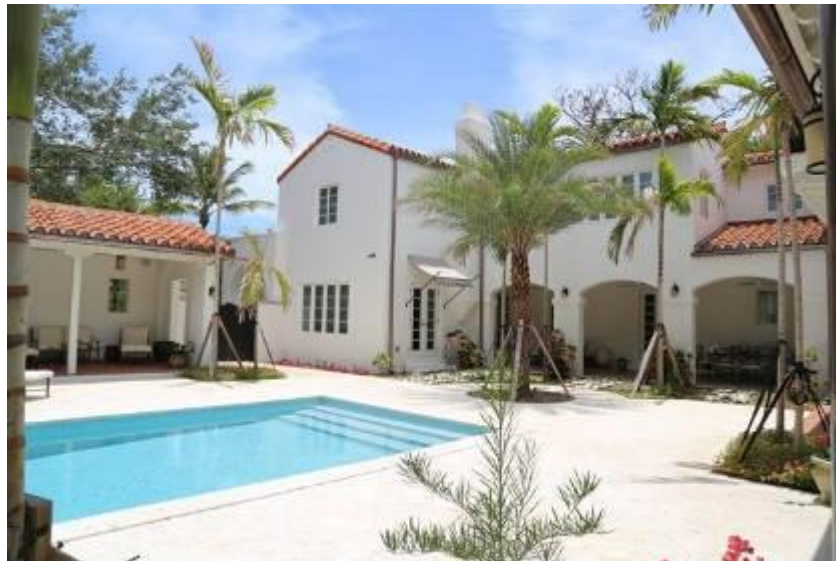
Photo Number: Image 3 (After)

Overall East Side Elevation

Describe Work and Impact on Existing Feature: New paint, new impact windows, new roof, remove windows at terrace and restore as open-air, and additional landscaping (Existing Structure to Remain)

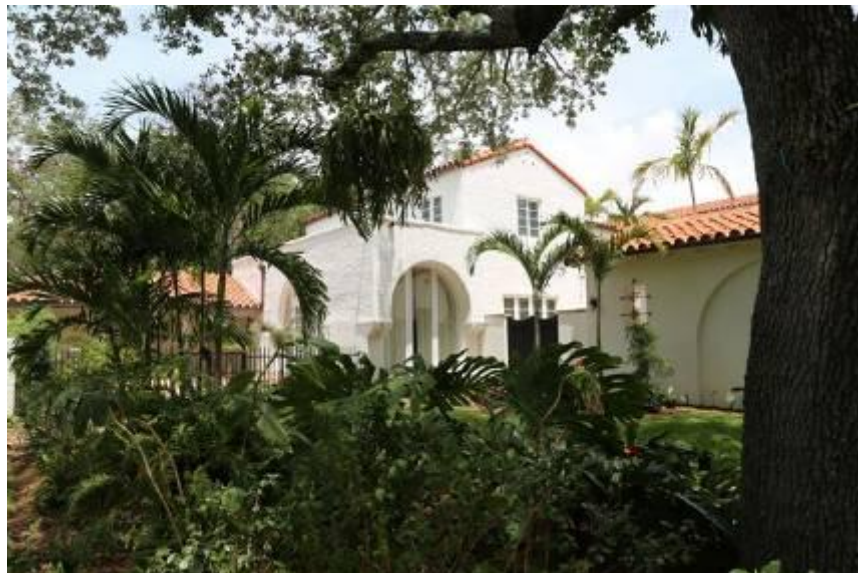
Photo Number: Image 4 (After)

Overall East Side Elevation

Describe Work and Impact on Existing Feature: New paint, new impact windows, new roof, and additional landscaping (Existing Structure to Remain)

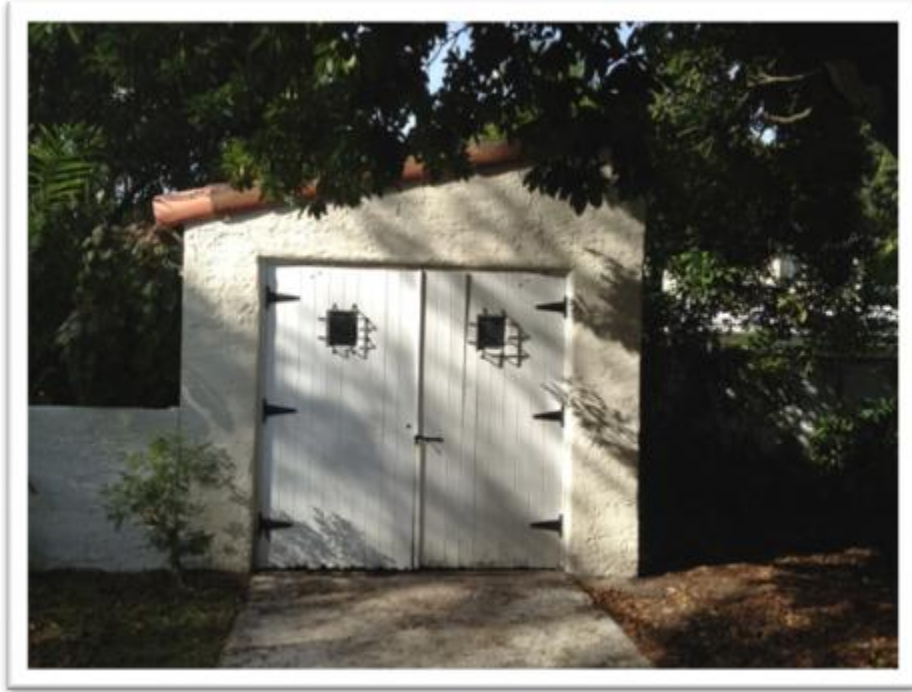
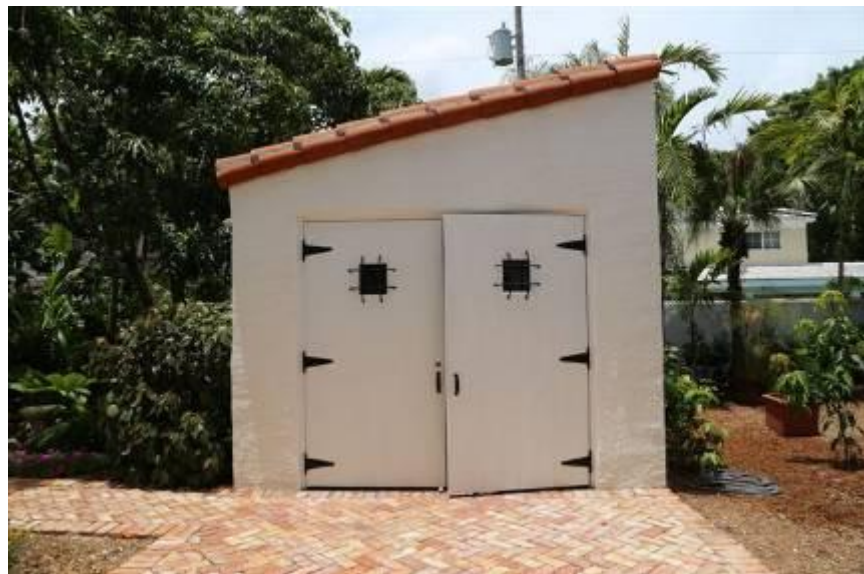
Photo Number: Image 5 (Before)

Garage

Describe Work and Impact on Existing Feature: Existing Garage to Remain, New Paint, New Roof, New Impact Windows, Existing Door & Hardware to Remain

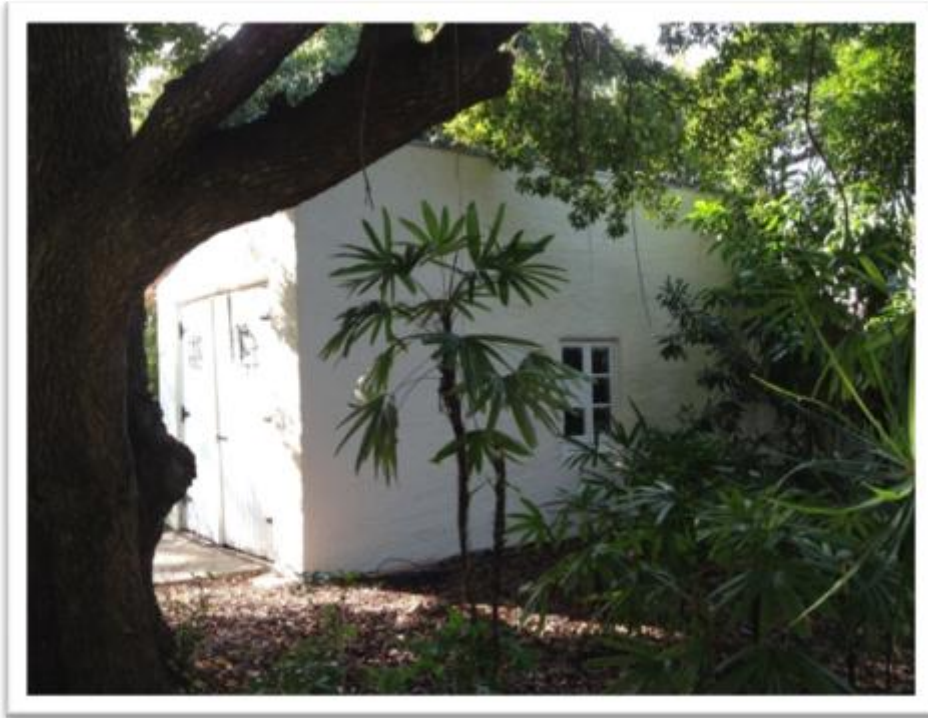
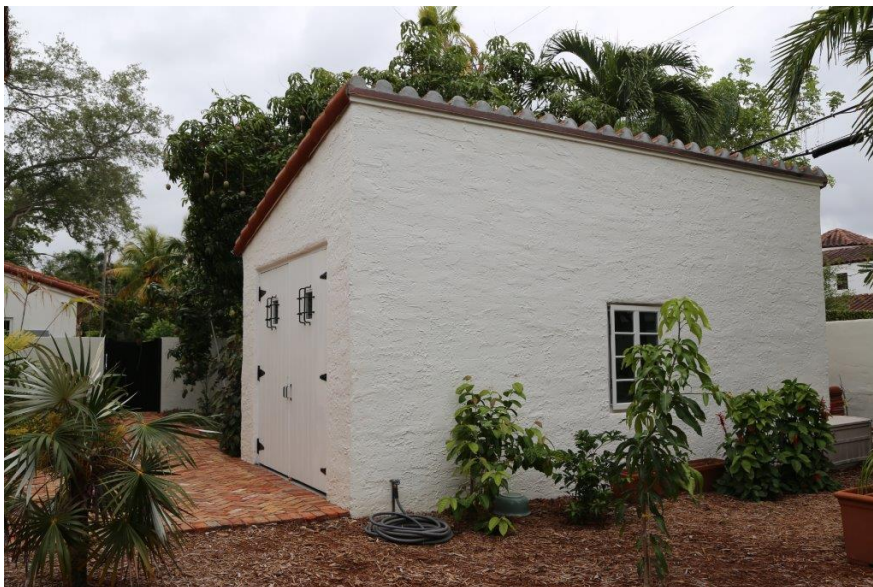
Photo Number: Image 6 (Before)

Garage from East Side

Describe Work and Impact on Existing Feature: Existing Garage to Remain, New Paint, New Roof, New Impact Windows, Existing Door & Hardware to Remain

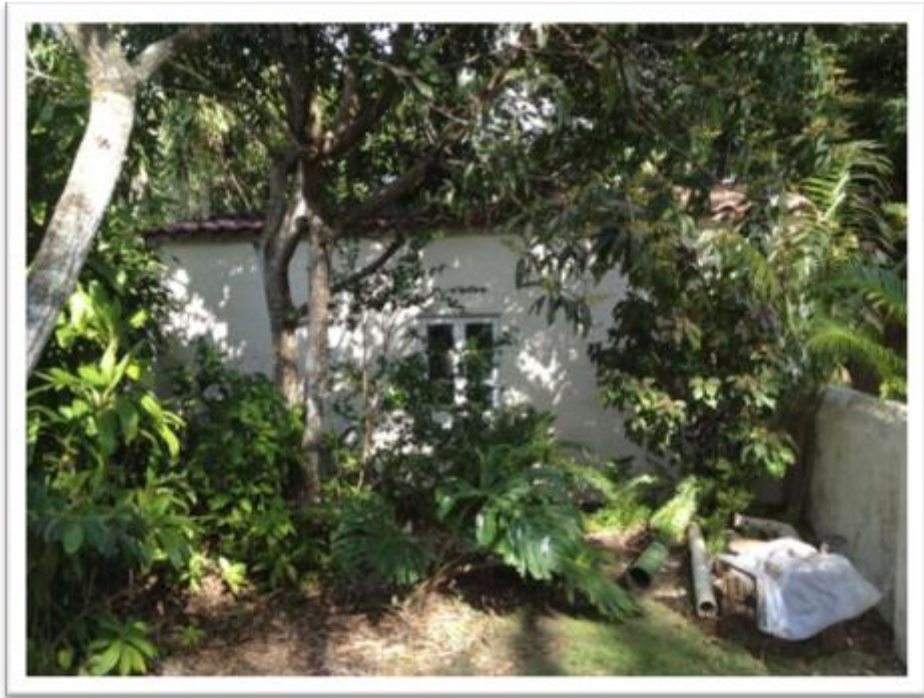
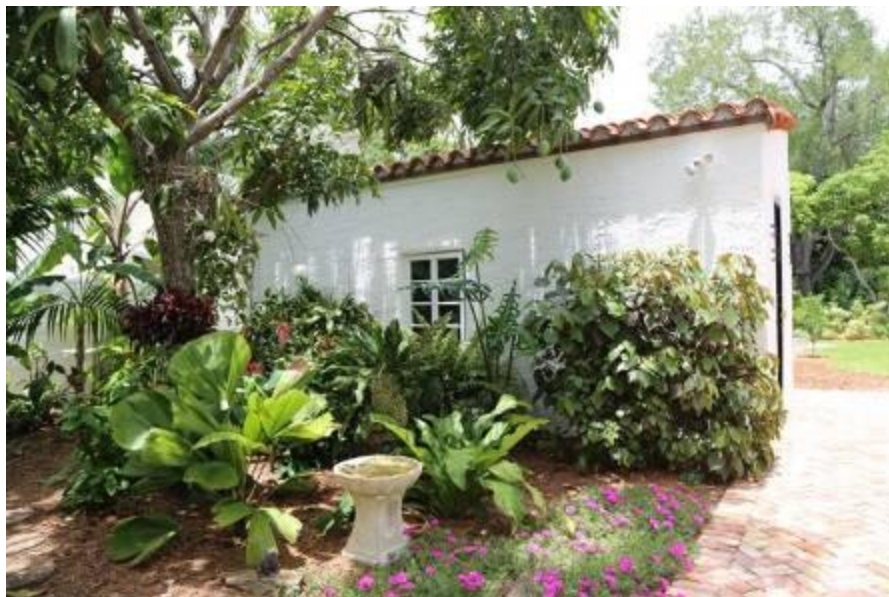
Photo Number: Image 7 (Before)

Garage View from Palmarito

Describe Work and Impact on Existing Feature: Existing Garage to Remain, New Paint, New Roof, New Impact Windows, Existing Door & Hardware to Remain

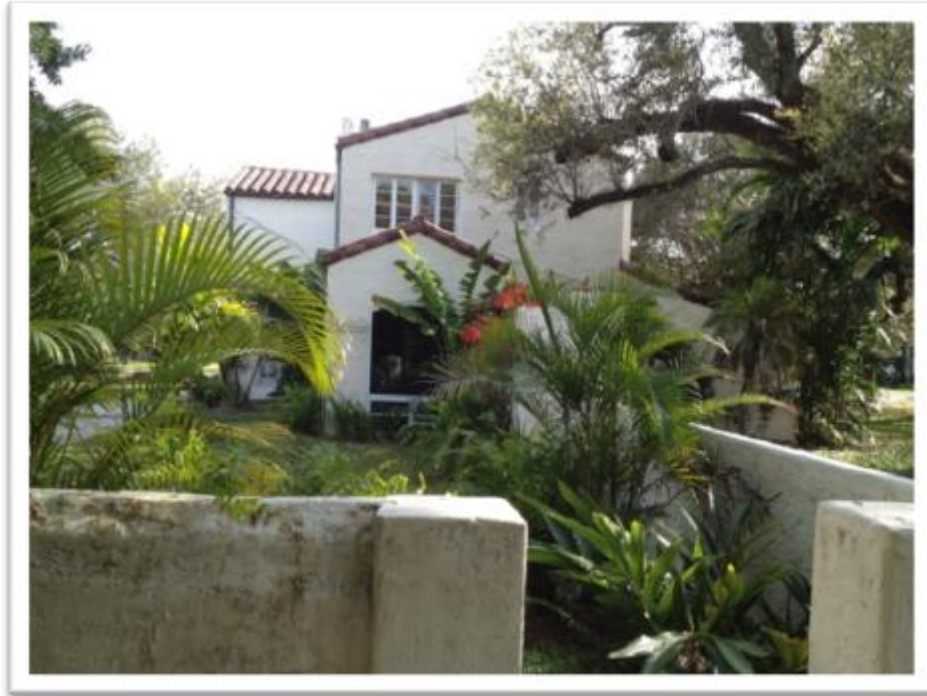
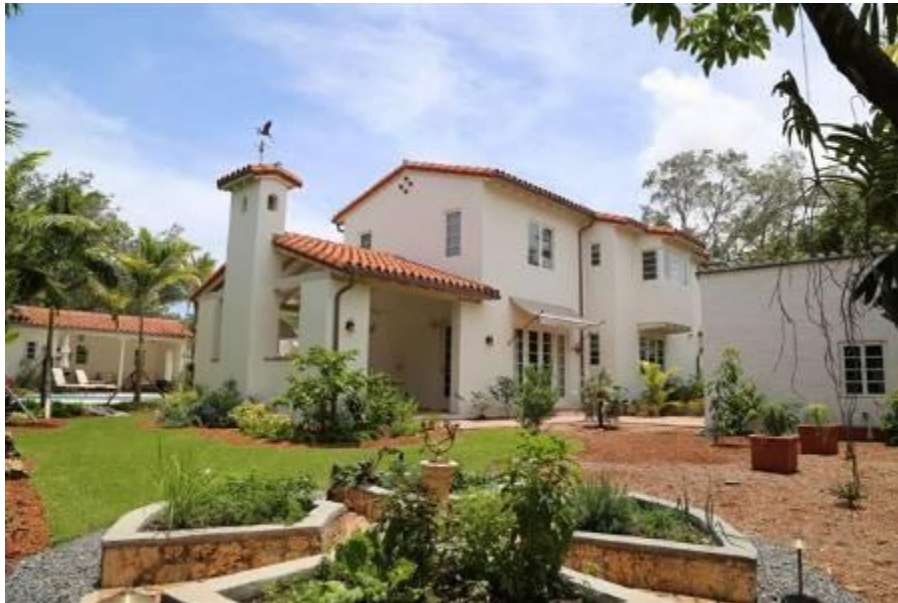
Photo Number: Image 8 (Before)

View from Garage of Rear Elevation

Describe Work and Impact on Existing Feature: Garden low wall to be removed, New paint, new impact windows, new roof, remove windows at terrace and restore as open-air and additional landscaping (Existing Structure to Remain)

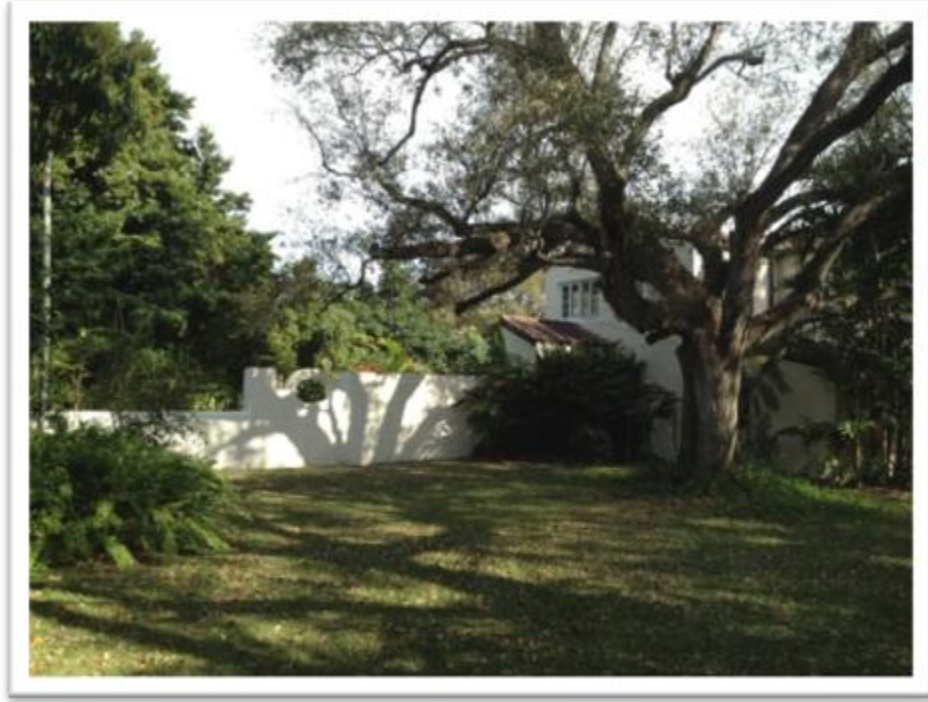
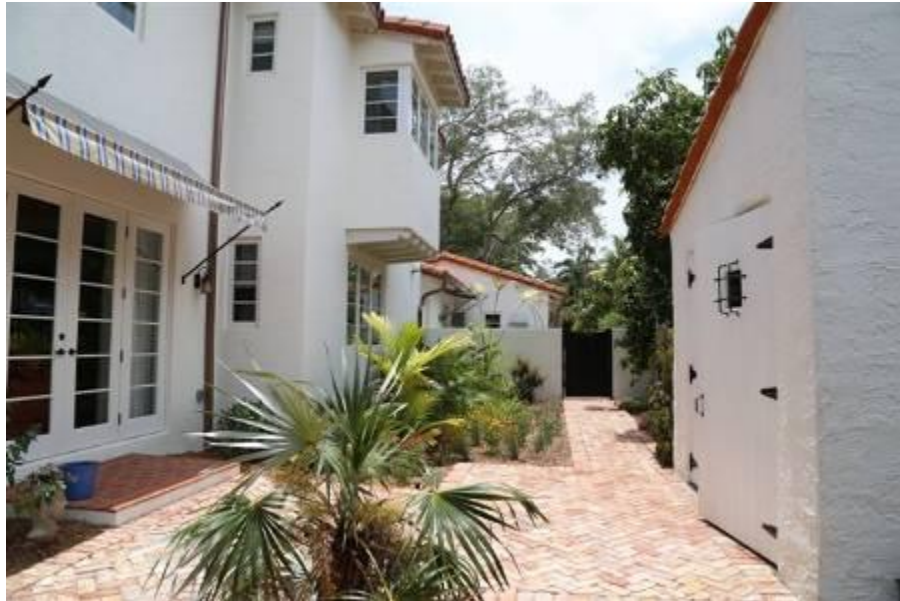
Photo Number: Image 9 (Before)

Rear Elevation View from Palmarito

Describe Work and Impact on Existing Feature: Garden low wall to be removed, New paint, new impact windows, new roof, and additional landscaping (Existing Structure to Remain)

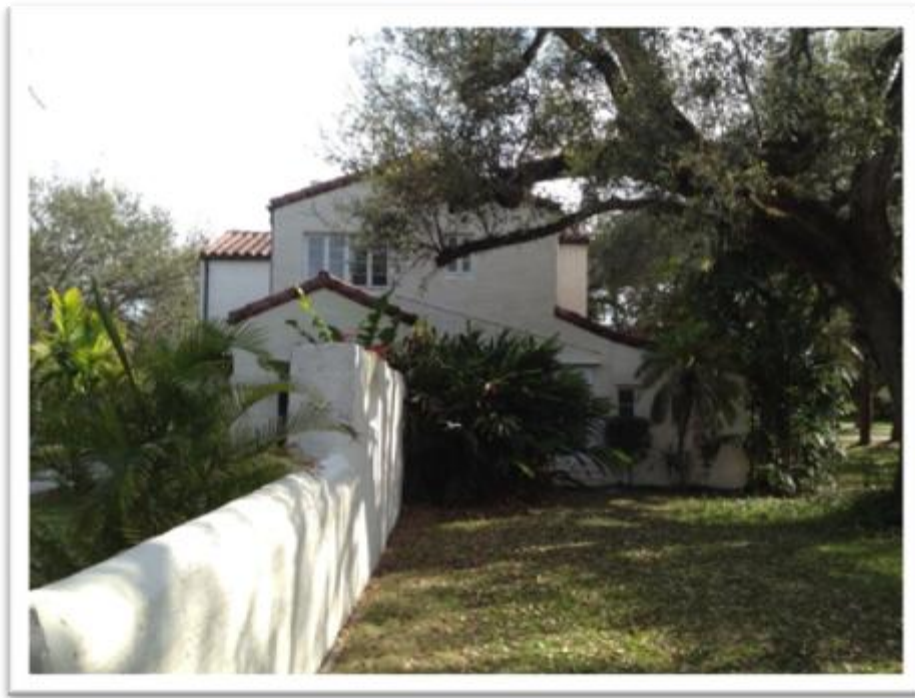
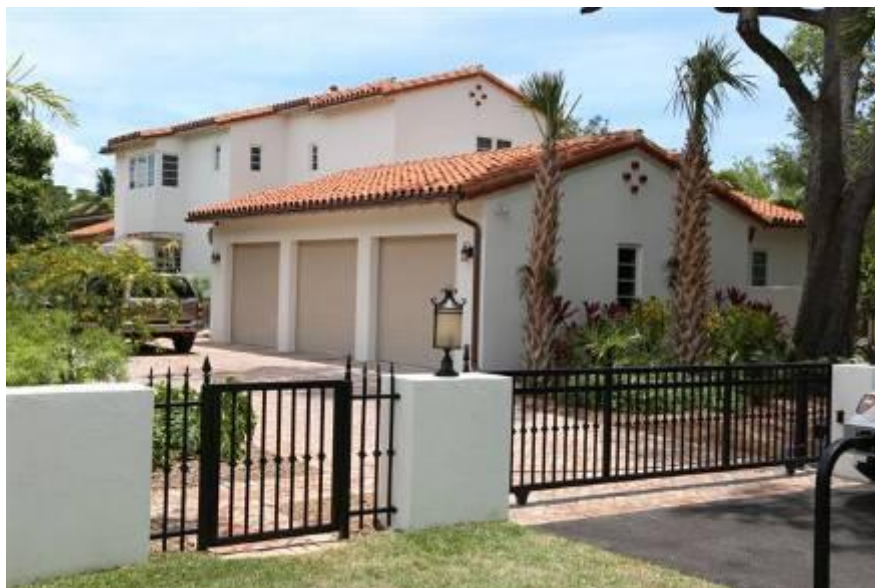
Photo Number: Image 10 (Before)

Rear Elevation

Describe Work and Impact on Existing Feature: Garden low wall to be removed, New paint, new impact windows, new roof, and additional landscaping (Existing Structure to Remain)

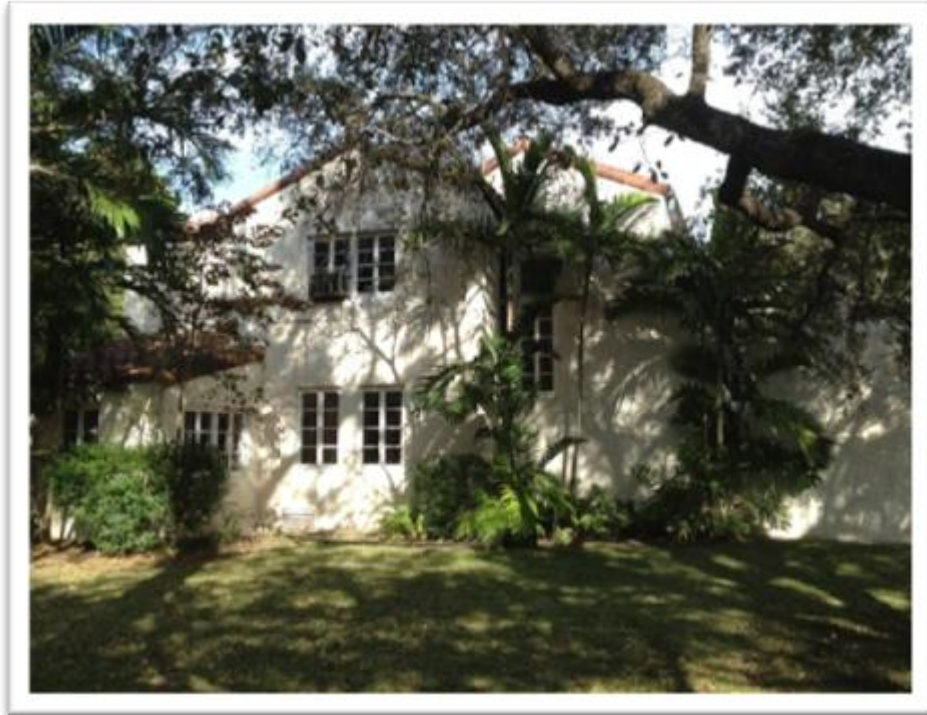
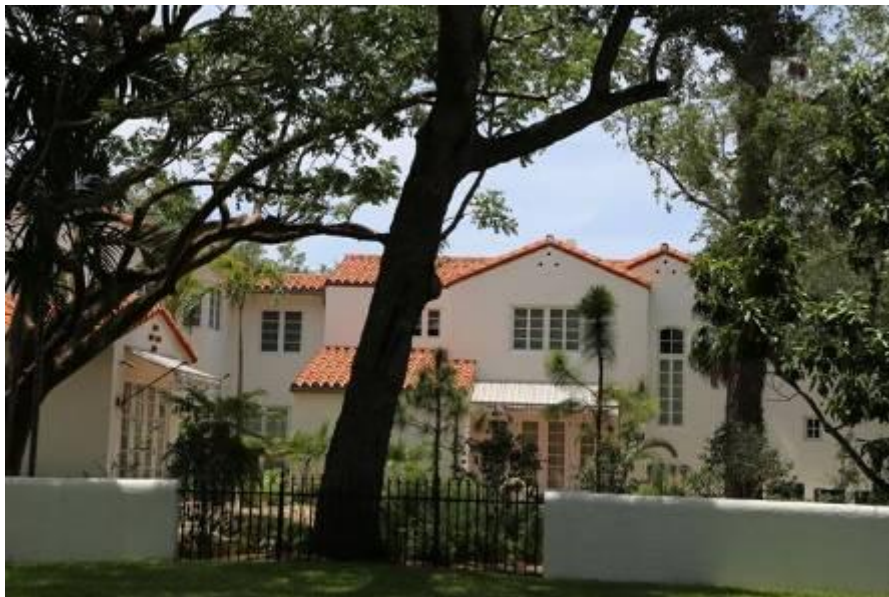
Photo Number: Image 11 (Before)

Side View from Palmarito

Describe Work and Impact on Existing Feature: One-Story structure to be removed, New paint, new impact windows, new roof, and additional landscaping (Existing Structure to Remain)

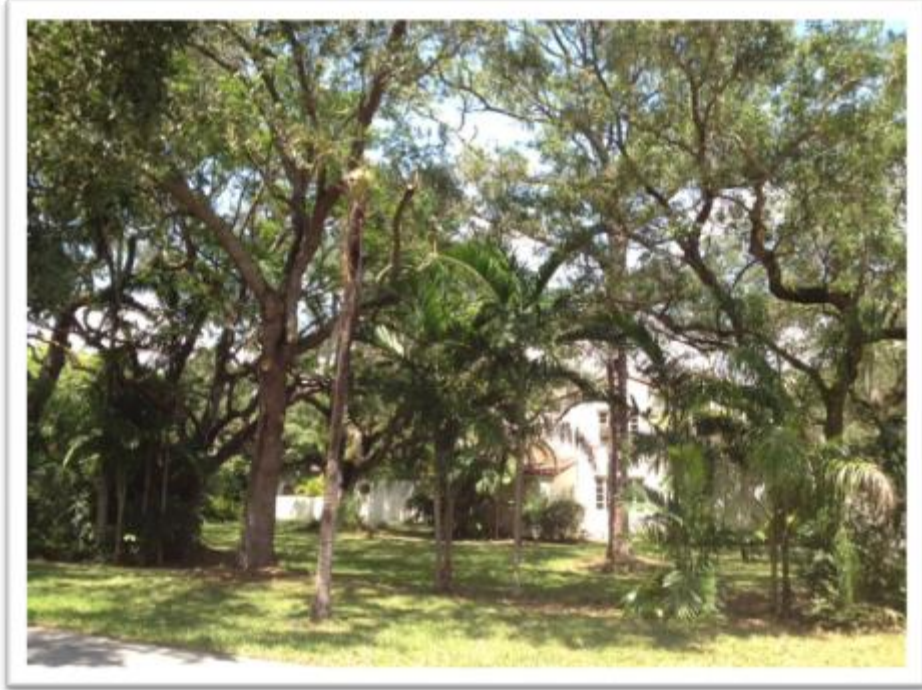
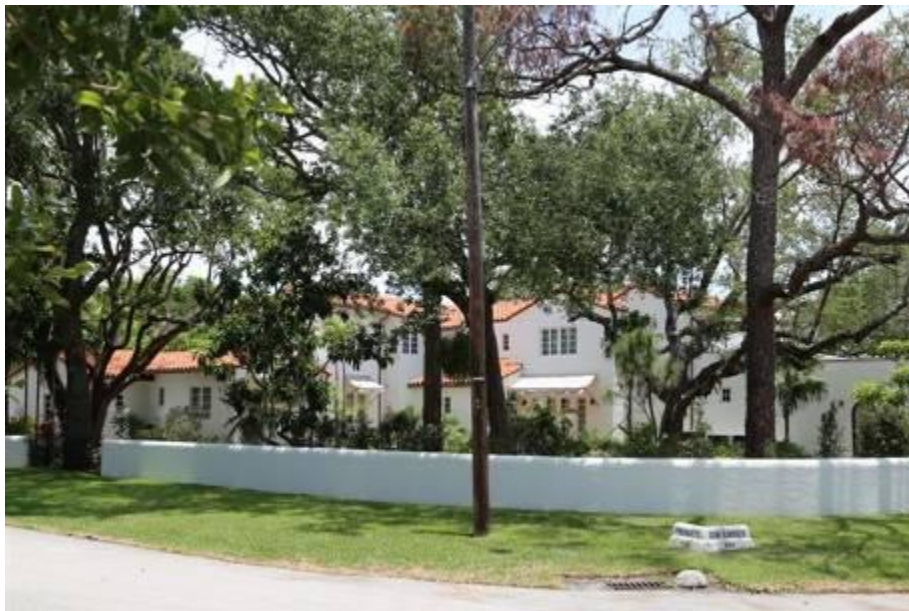
Photo Number: Image 12 (Before)

Side View from Palmarito

Describe Work and Impact on Existing Feature: One-Story structure to be removed, New paint, new impact windows, new roof, and additional landscaping (Existing Structure to Remain)

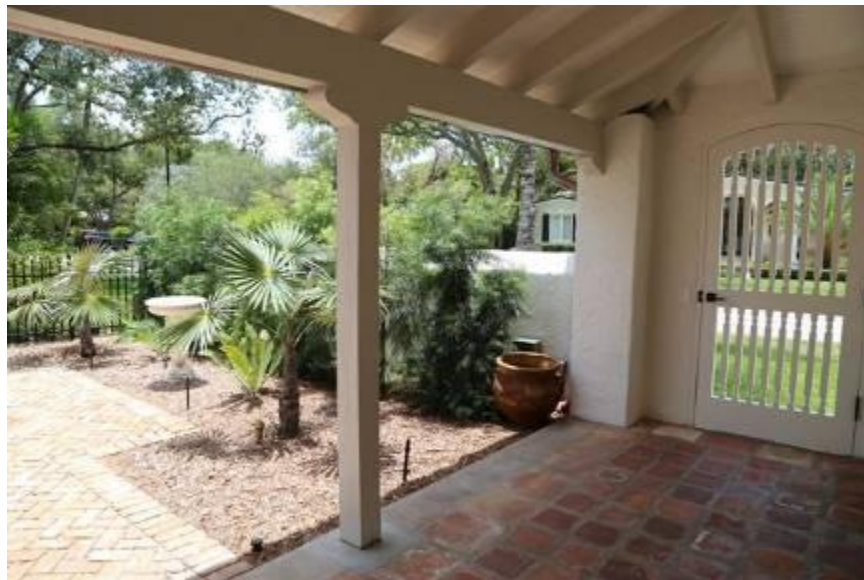
Photo Number: Image 13 (After)

Courtyard View

Describe Work and Impact on Existing Feature: New Paint, Repair Cracks in Existing Beam/Column as needed, Clean & Seal Existing Floor Tiles, and new Landscape

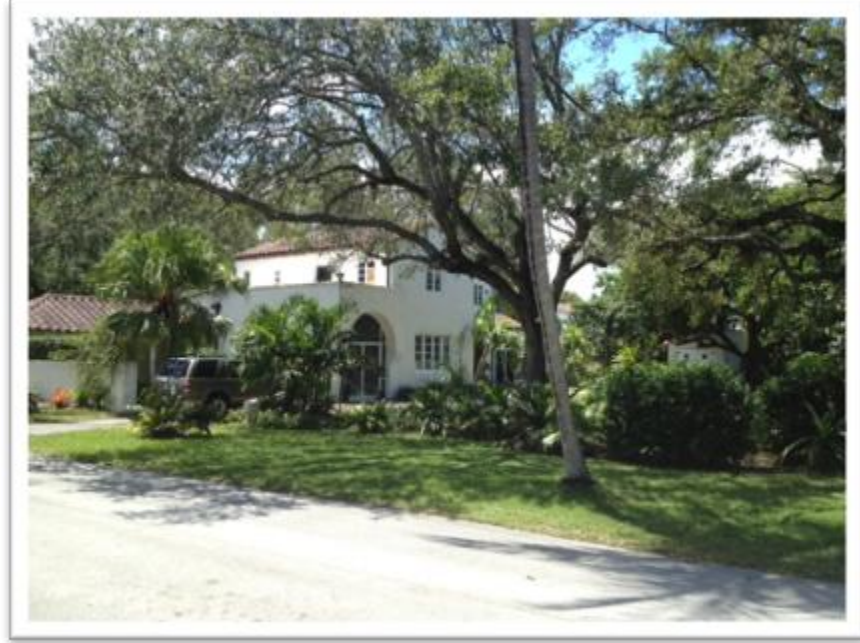
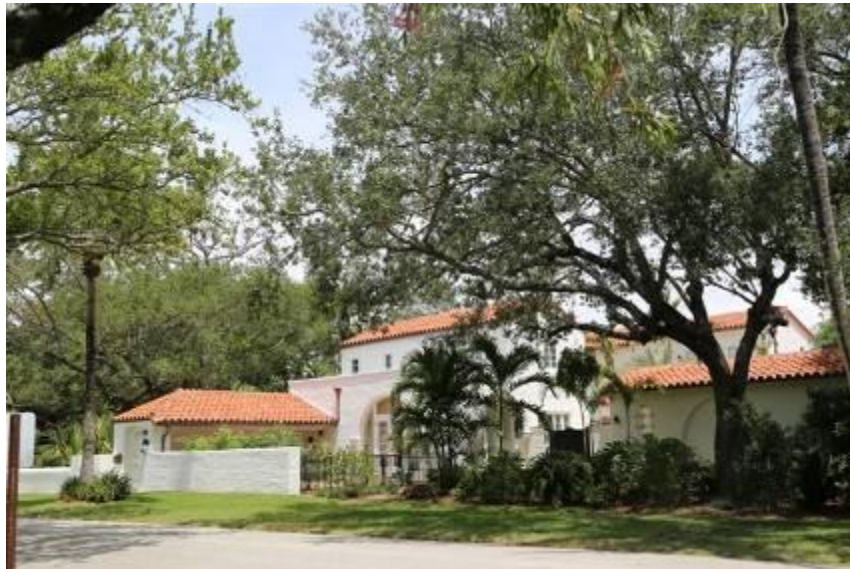
Photo Number: Image 18 (Before)

View of SE Corner

Describe Work and Impact on Existing Feature: New paint, new impact windows, new roof, and additional landscaping (Existing Structure to Remain)

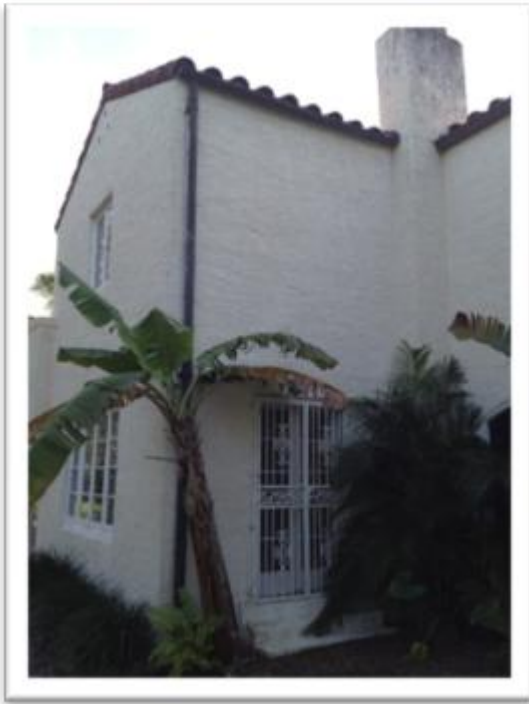
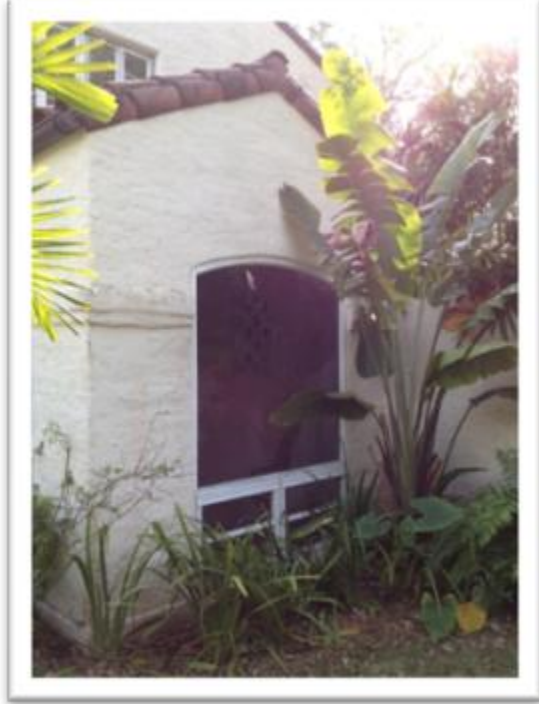
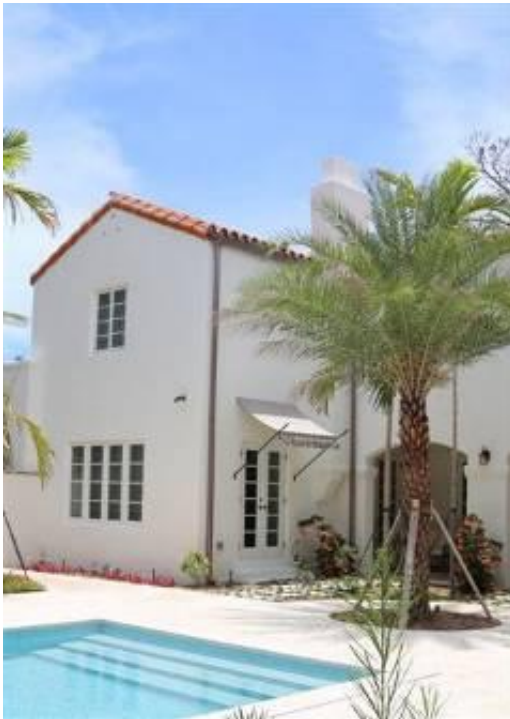
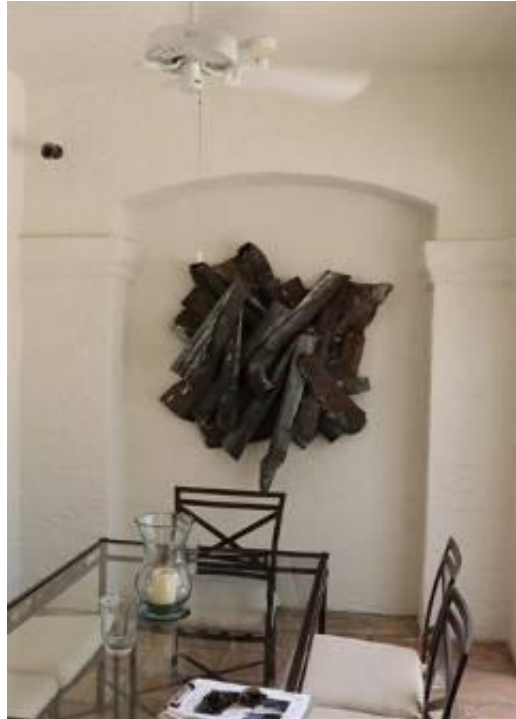
Photo Number: Image 19 & 20 (Before)

View of Living Room from Rear & Porch from Rear

Describe Work and Impact on Existing Feature: New paint, new impact windows, new roof, (Existing Structure to Remain)

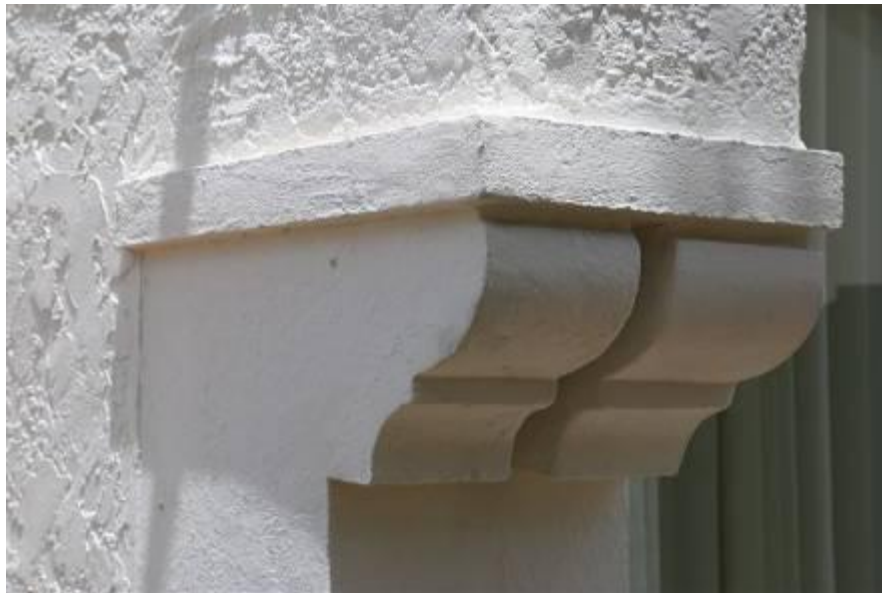
Photo Number: Image 21 (After)

Plan Number: **Stucco Detail View of Porch Column Capitals**

Describe Work and Impact on Existing Feature: Repair stucco cracks at Column Capital, New Paint

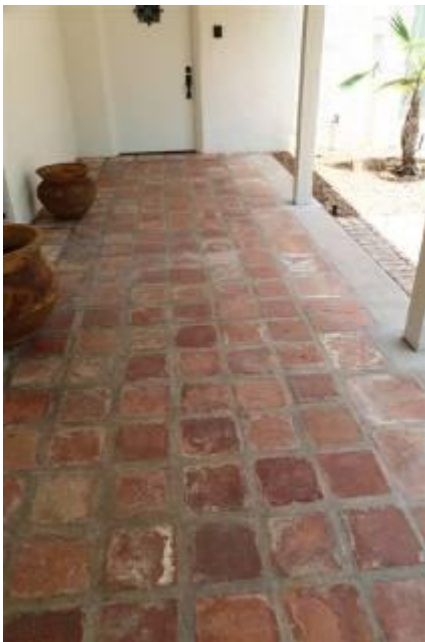
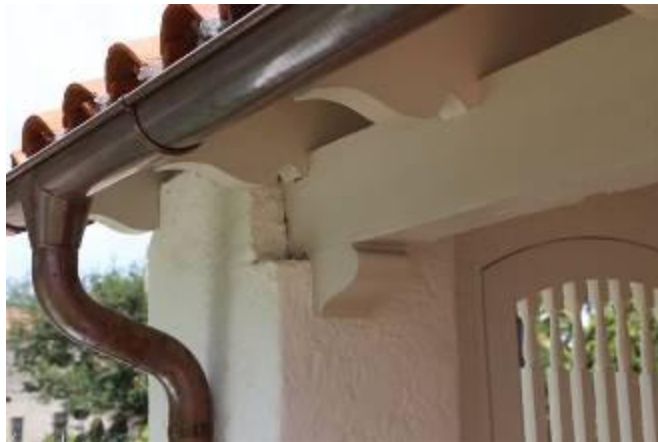
Photo Number: Image 24 & 25 (After)

Detail View of Floor Tile at Courtyard, View of Beam & Outriggers at Courtyard

Describe Work and Impact on Existing Feature: Clean and Repair visible cracks in wood beam, New Paint

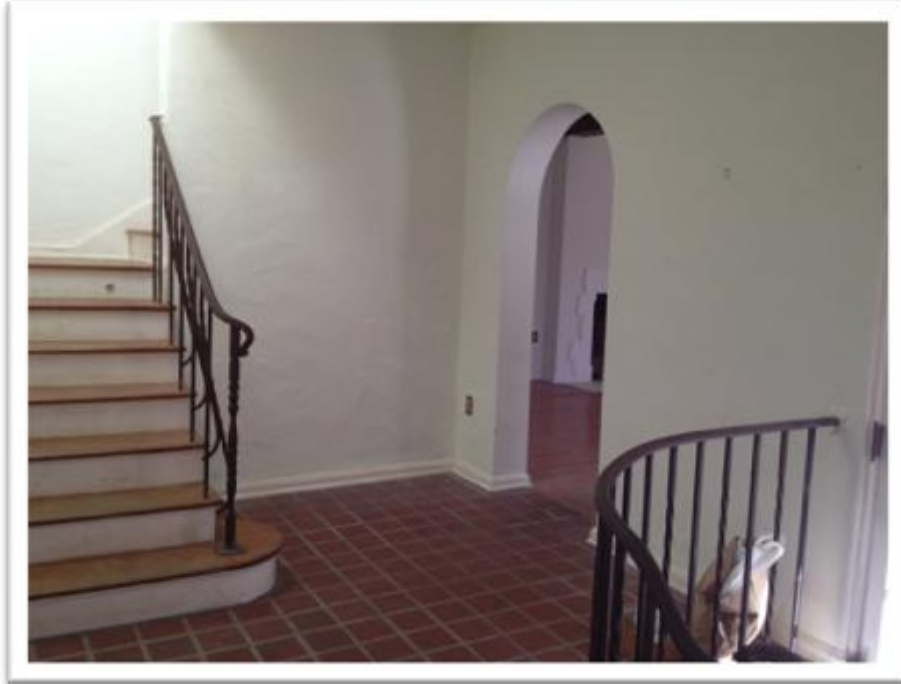
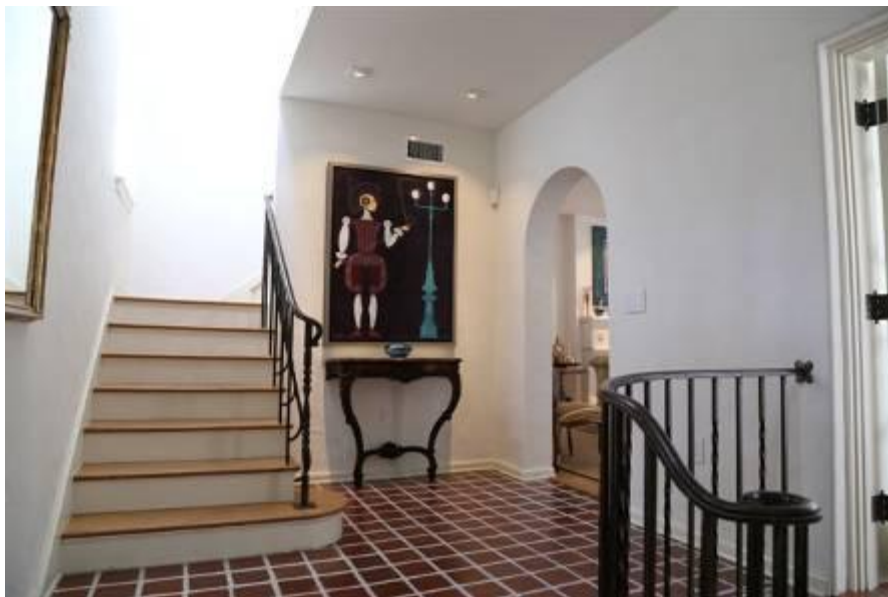
Photo Number: Image 26 (Before)

Entry Foyer

Describe Work and Impact on Existing Feature: New Paint, Existing Flooring and Rail to be restored

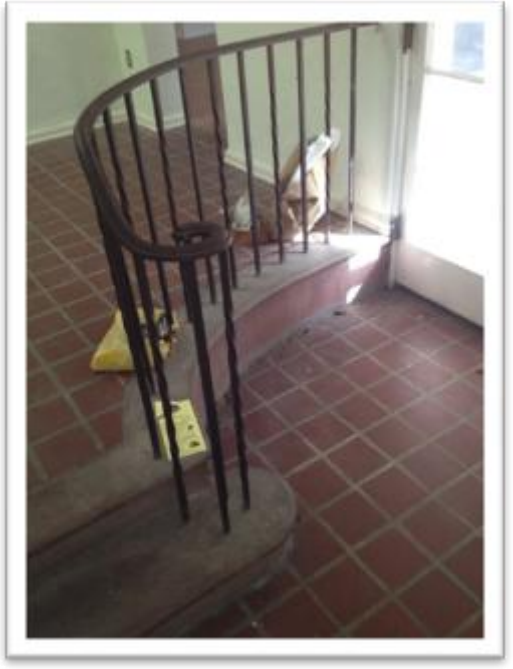
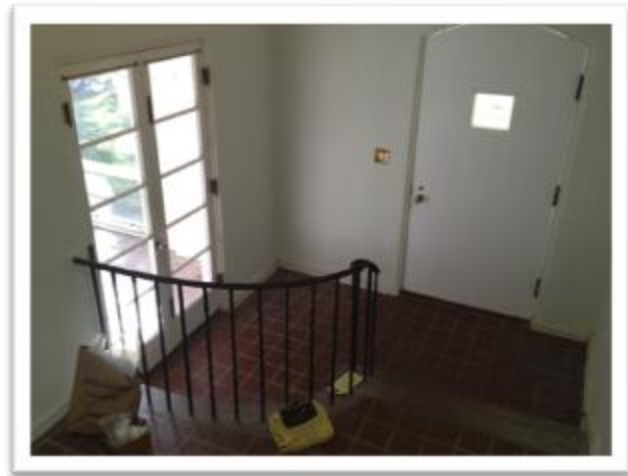
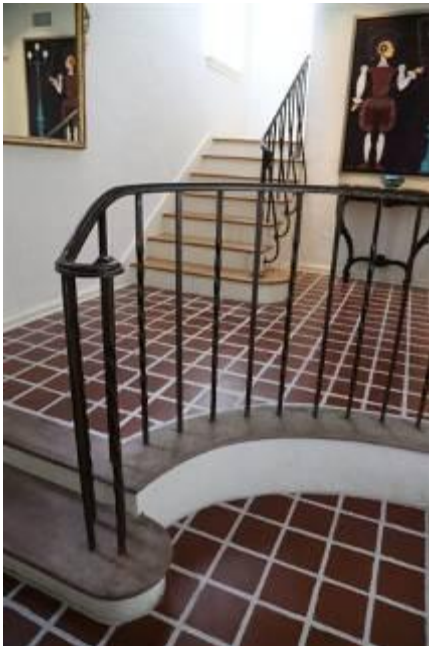
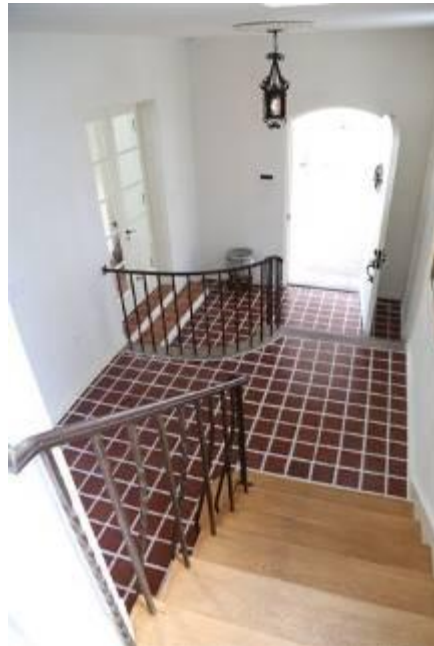
Photo Number: Image 27 & 28 (Before)

Entry Foyer

Describe Work and Impact on Existing Feature: New Paint, Existing Flooring and Rail to be restored

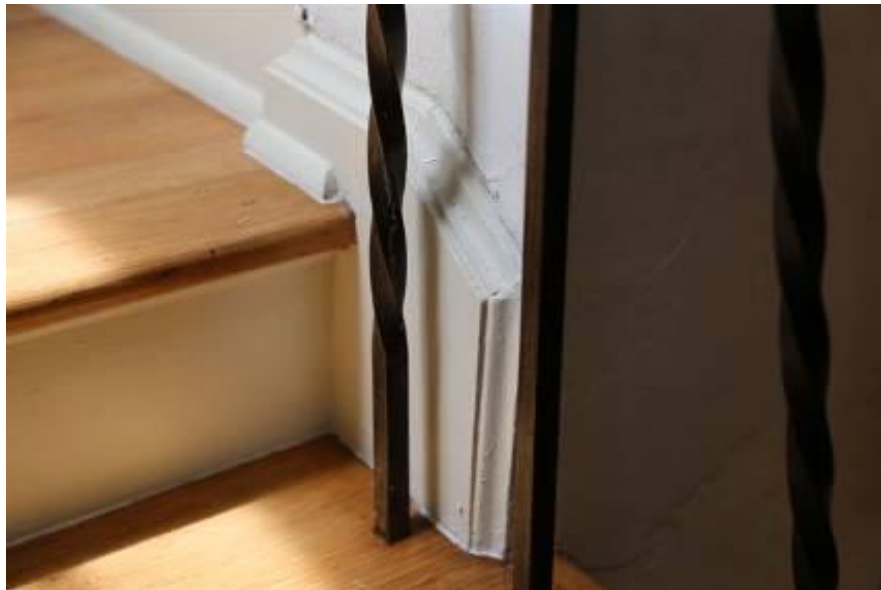
Photo Number: Image 29 (After)

Existing Wood Treads & Iron Rails

Describe Work and Impact on Existing Feature: Refinish Existing Wood Treads, Railings

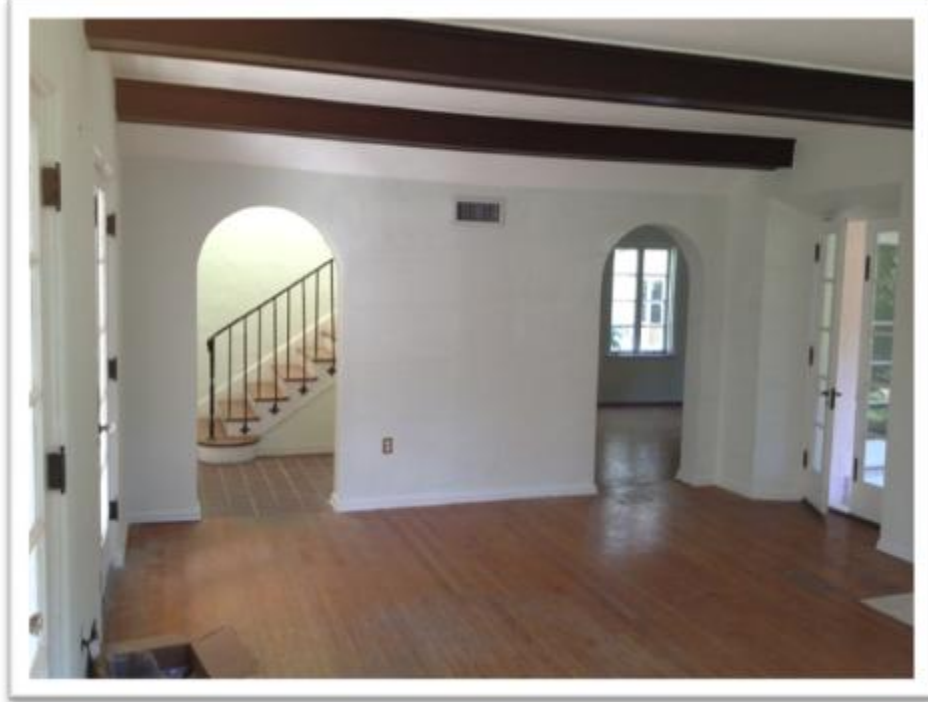
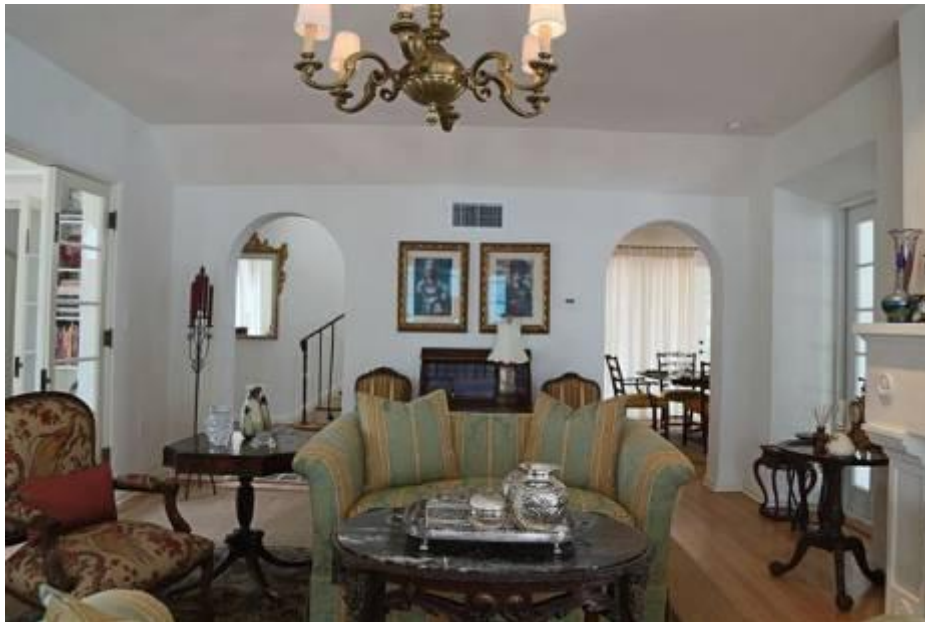
Photo Number: Image 31 (Before)

Existing Living Room

Describe Work and Impact on Existing Feature: Refinish Existing Wood Floors, New Paint

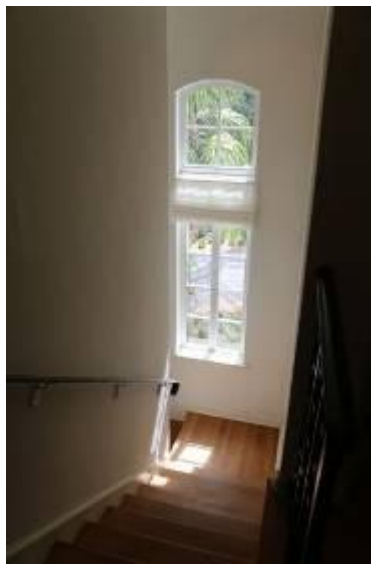
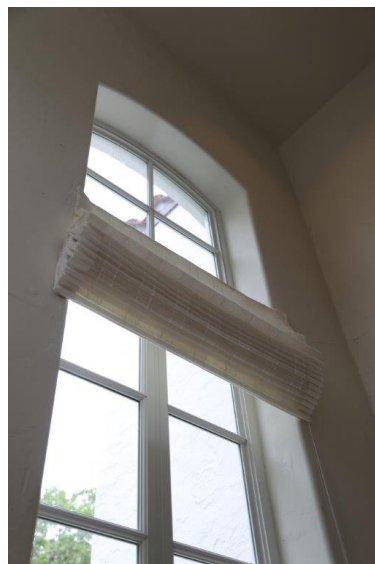
Photo Number: Image 34 & 35 (After)

Existing Staircase

Describe Work and Impact on Existing Feature: Refinish Wood Floors, Paint Handrails, New Paint, Replace window with impact rated window

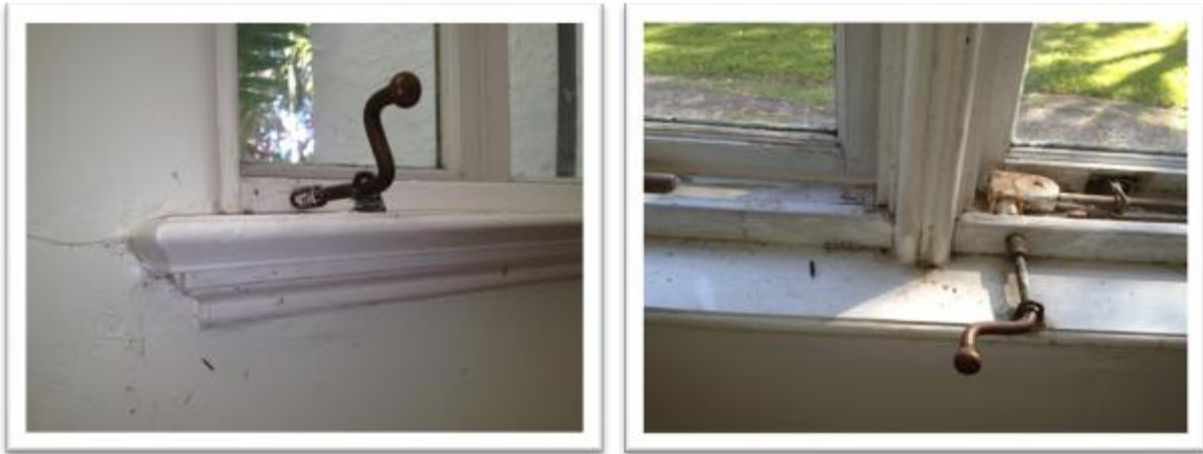
Photo Number: Image 37 & 38 (Before)

Existing Window Sill

Describe Work and Impact on Existing Feature: Replace with New Impact-Rated Window, Decorative Wood Sill to Remain

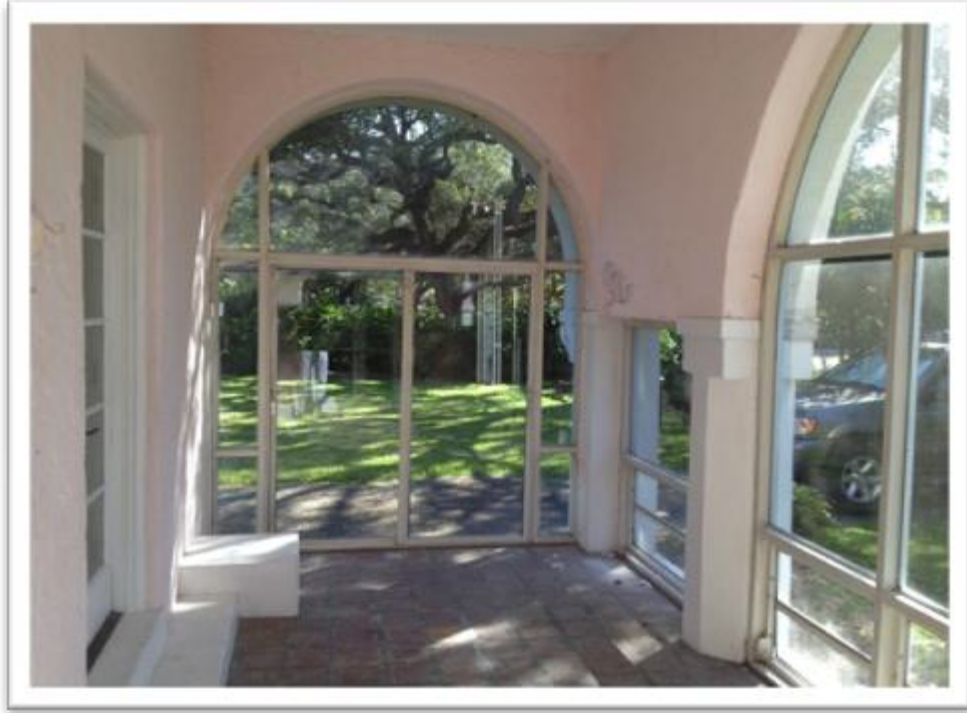
Photo Number: Image 39 (Before)

Sunroom

Describe Work and Impact on Existing Feature: New Impact Doors and Windows, new paint

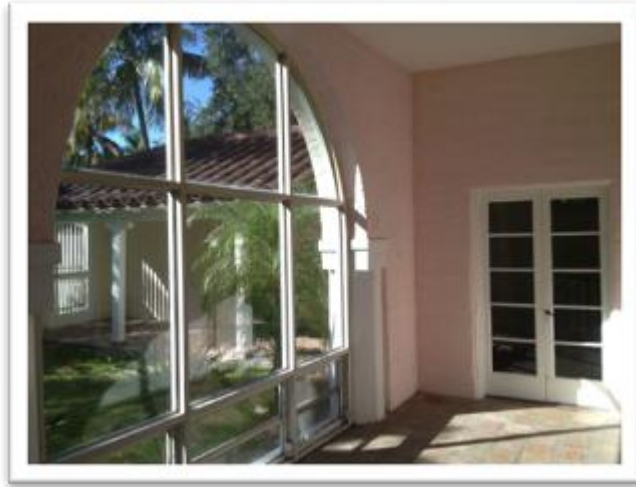
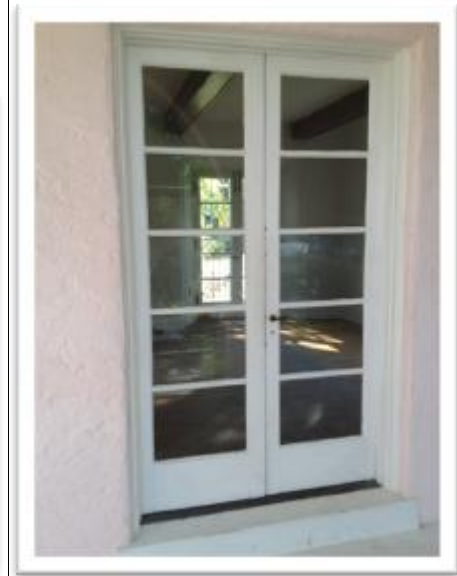
Photo Number: Image 40 & 41 (Before)

Sunroom

Describe Work and Impact on Existing Feature: New Impact-Rated window, new paint, Interior doors to remain
