HISTORIC PRESERVATION AD-VALOREM TAX EXEMPTION

PART 2 – REQUEST FOR REVIEW OF COMPLETED WORK

**Request for Completed Work
Ad-Valorem Application Package for:
Historical Restoration, Addition, and Alteration to:
(Submitted June 2, 2014)**

Olivera Residence

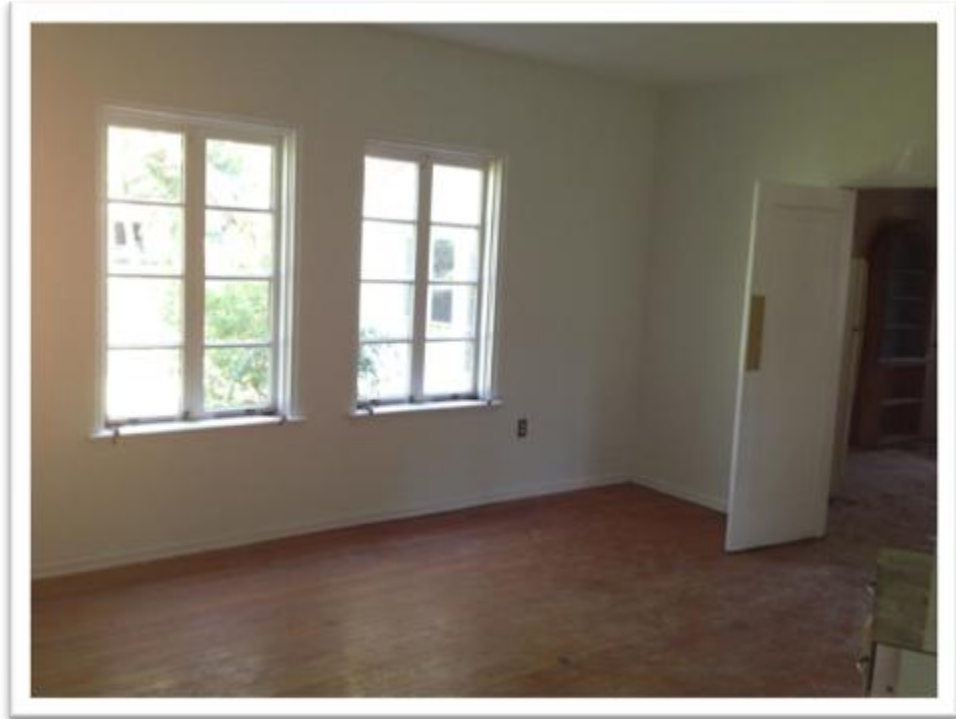
Photo Number: Image 42 (Before)

Existing Dining Room

Describe Work and Impact on Existing Feature: Refinish existing wood floor, new paint, new impact windows

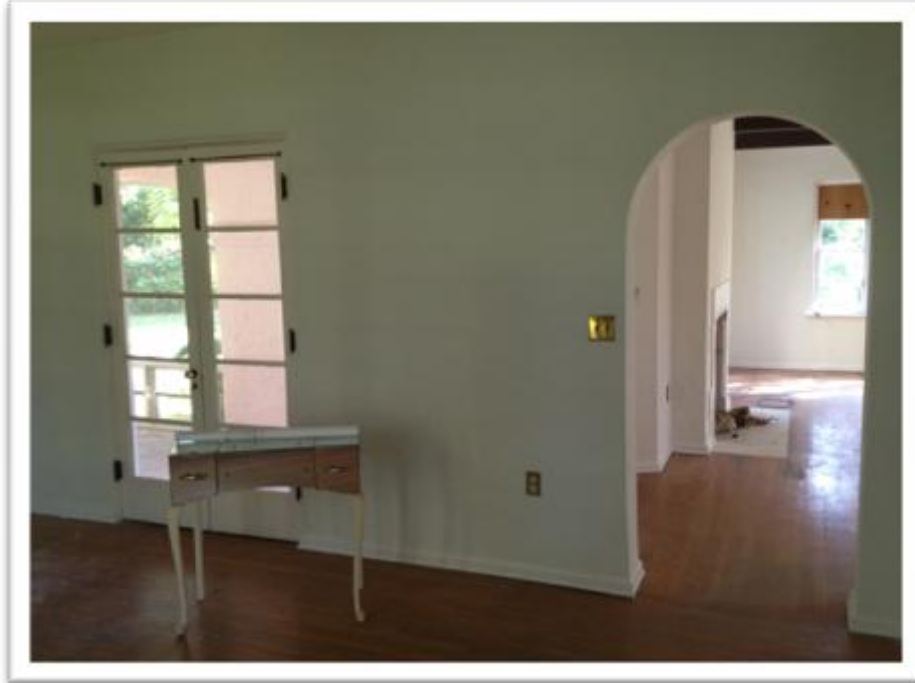
Photo Number: Image 43 (Before)

Existing Dining Room

Describe Work and Impact on Existing Feature: Refinish existing wood floor, new paint, new impact windows

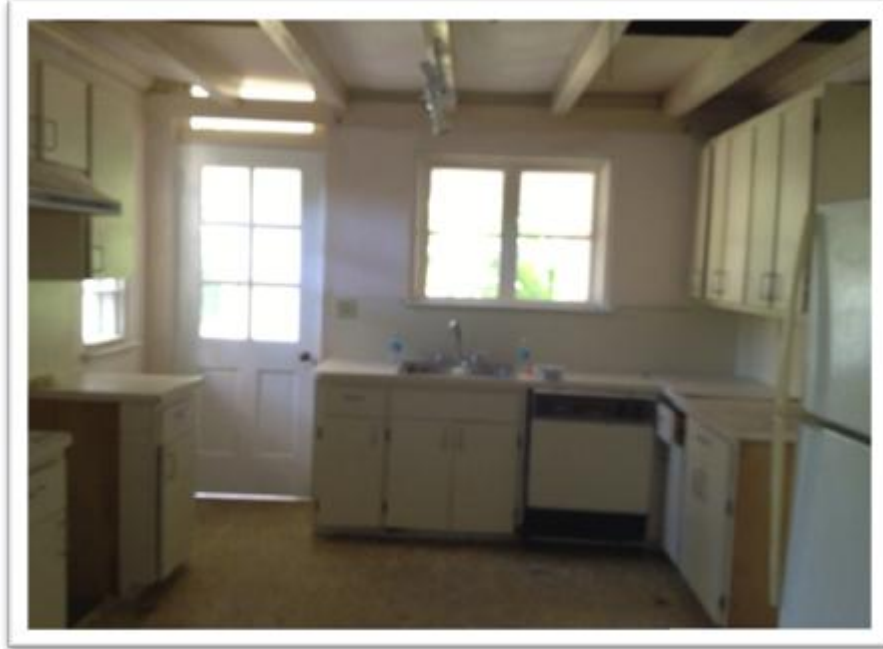
Photo Number: Image 44 (Before)

Existing Kitchen

Describe Work and Impact on Existing Feature: Remove Existing Cabinets, Flooring, area to be converted to new Butler's Pantry

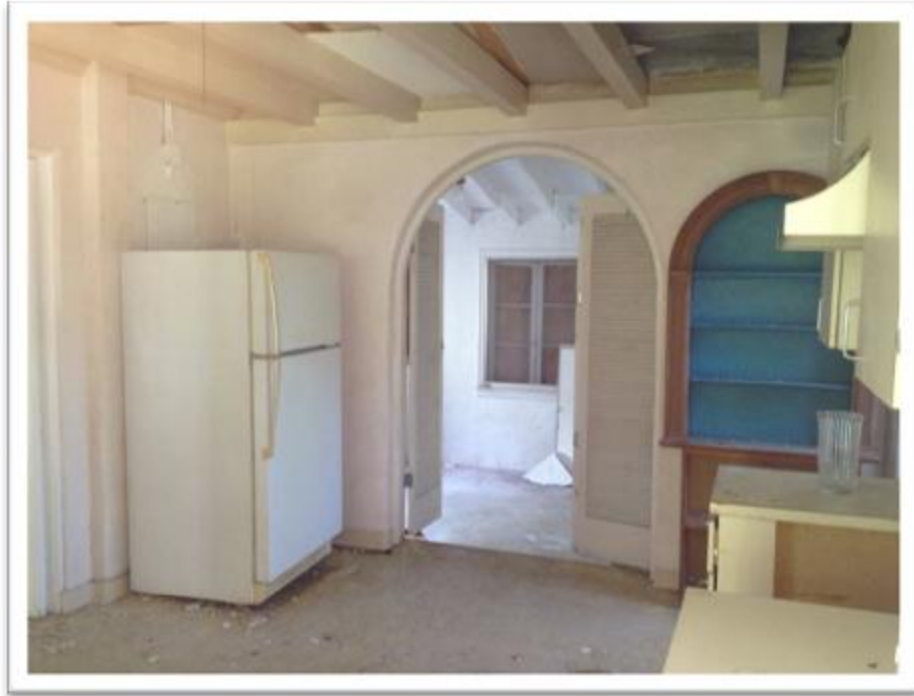
Photo Number: Image 45 (Before)

Existing Kitchen

Describe Work and Impact on Existing Feature: Remove Existing Cabinets, Flooring, area to be converted to new Butler's Pantry

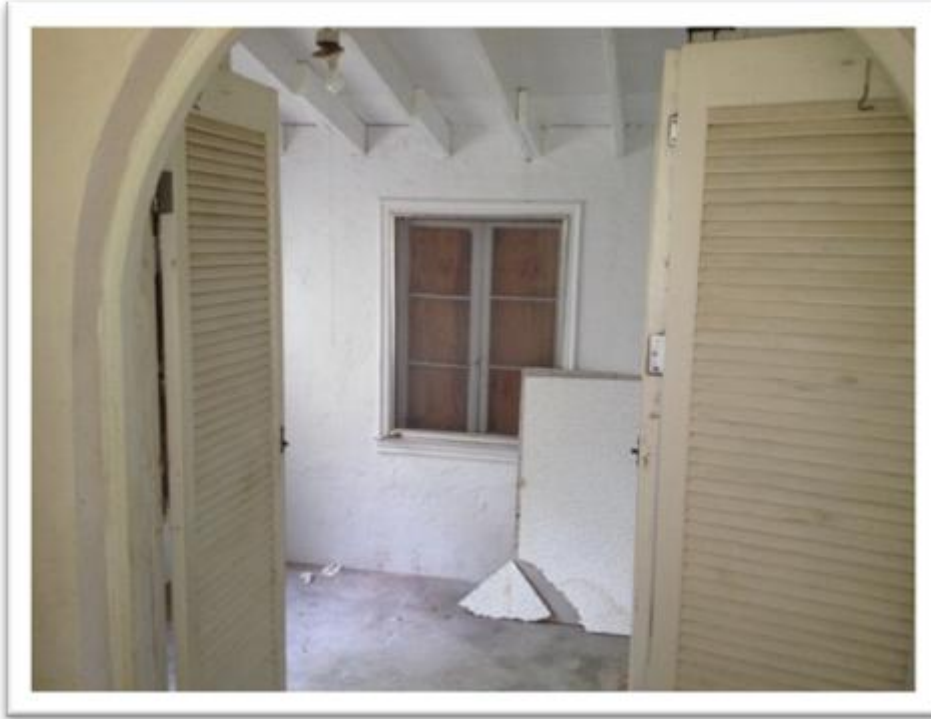
Photo Number: Image 46 (Before)

Existing Laundry

Describe Work and Impact on Existing Feature: Complete Demo of Existing Structure

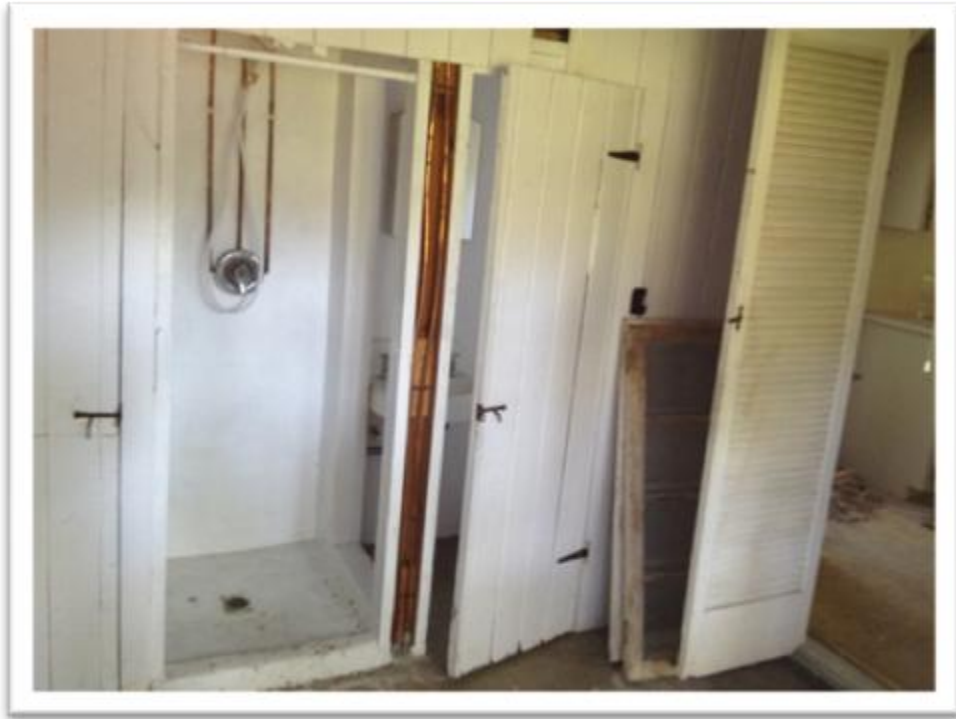
Photo Number: Image 47 (Before)

Existing Laundry

Describe Work and Impact on Existing Feature: Complete Demo of Existing Structure

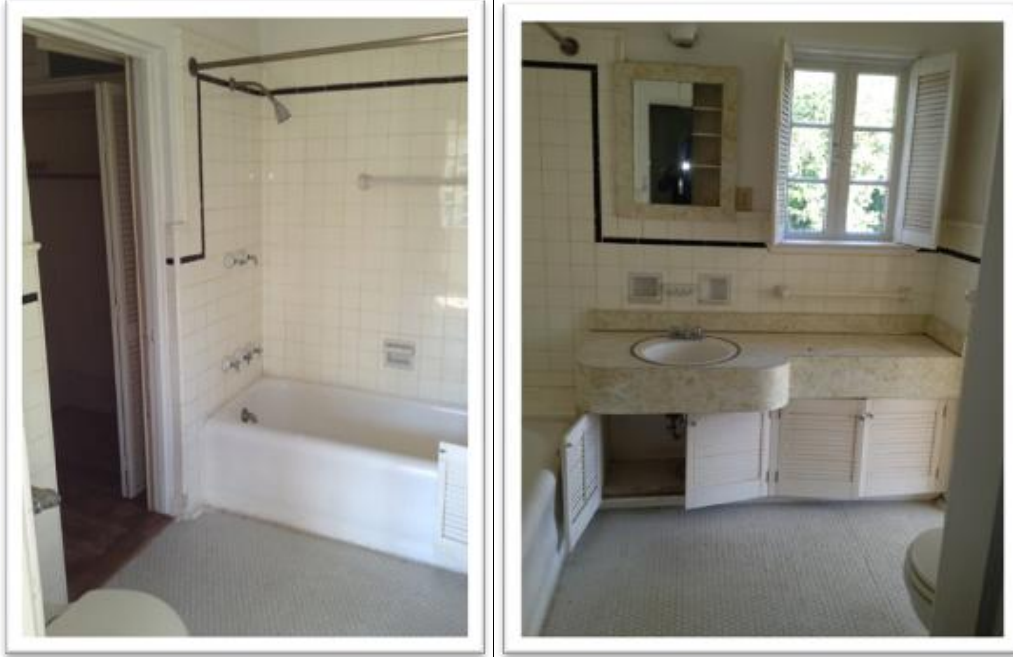
Photo Number: Image 48 & 49 (Before)

Existing Bathroom#1

Describe Work and Impact on Existing Feature: New Plumbing Fixtures, New Tile, New Lighting and New impact rated window

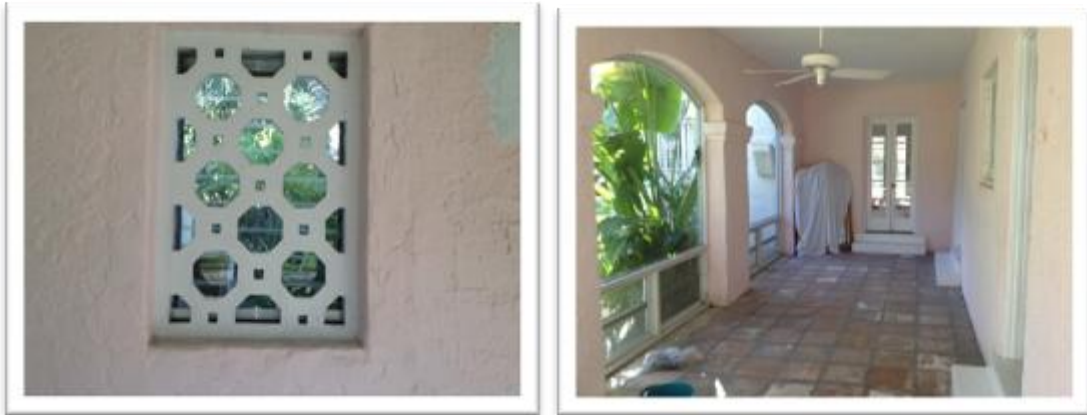
Photo Number: Image 51 & 52 (Before)

Existing Enclosed Side Terrace

Describe Work and Impact on Existing Feature: Windows to be removed and terrace to be open (non a/c), new paint finish, new fans, floors to be cleaned and resealed, existing stucco vent to be removed and resued

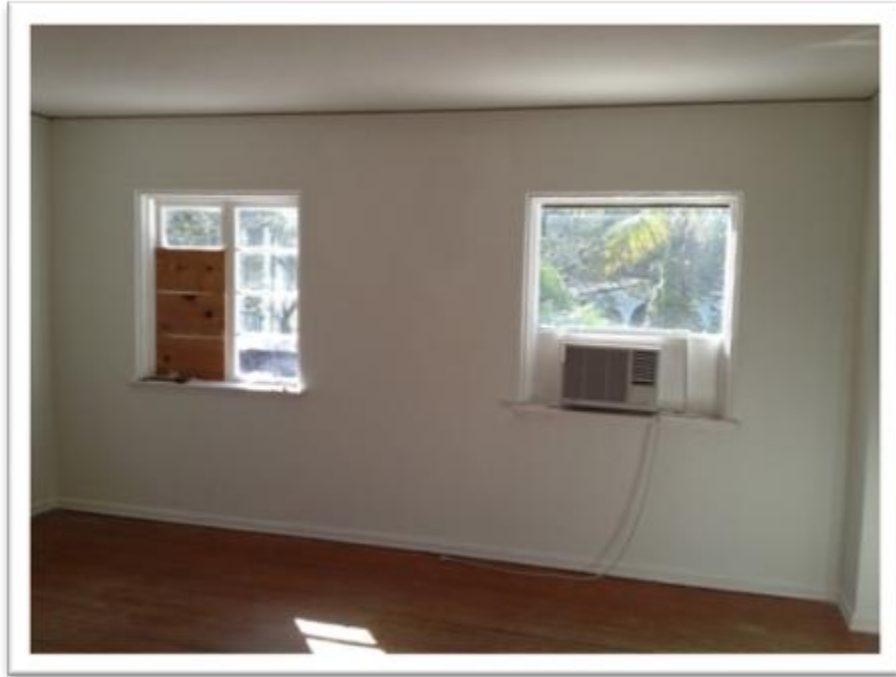
Photo Number: Image 53 (Before)

Existing Bedroom #2

Describe Work and Impact on Existing Feature: Remove wall A/C, New paint finish, floors to be refinished, new impact windows

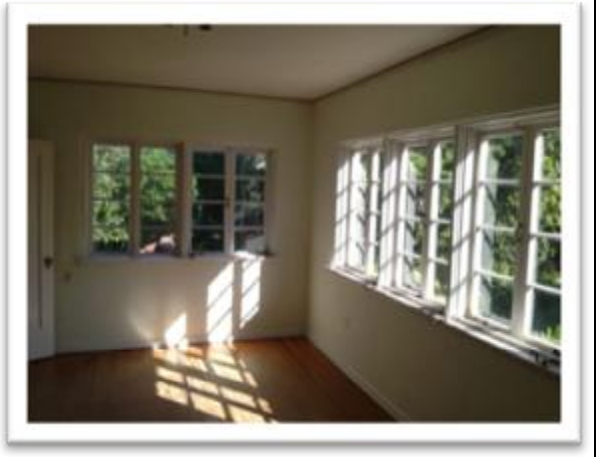
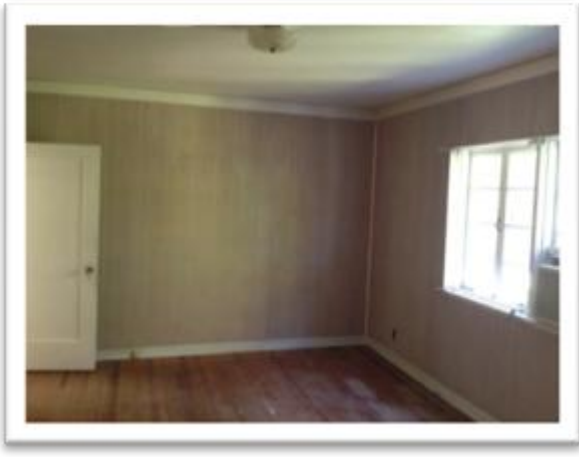
Photo Number: Image 54 (Before)

Existing Bedroom #3

Describe Work and Impact on Existing Feature: Remove wall A/C, New paint finish, floors to be refinished, new impact windows

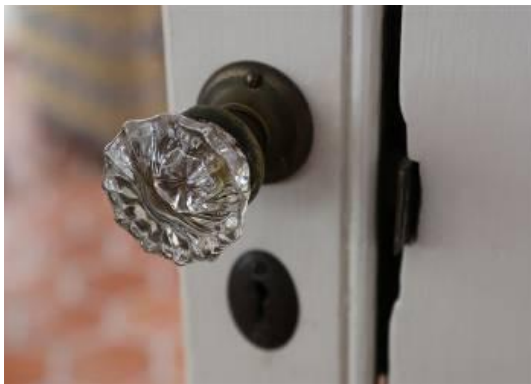
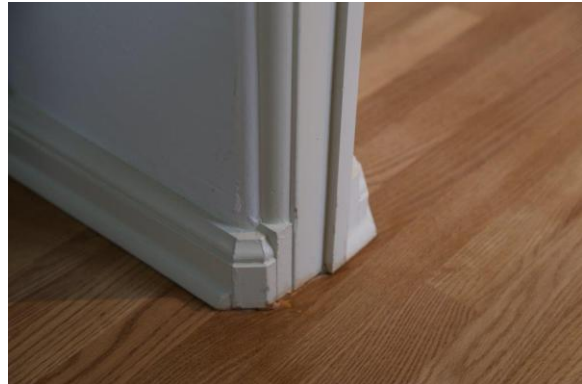
Photo Number: Image 55 & 56 (After)

Door Hardware, Baseboards

Describe Work and Impact on Existing Feature: Existing hardware and baseboards to remain, repair as needed

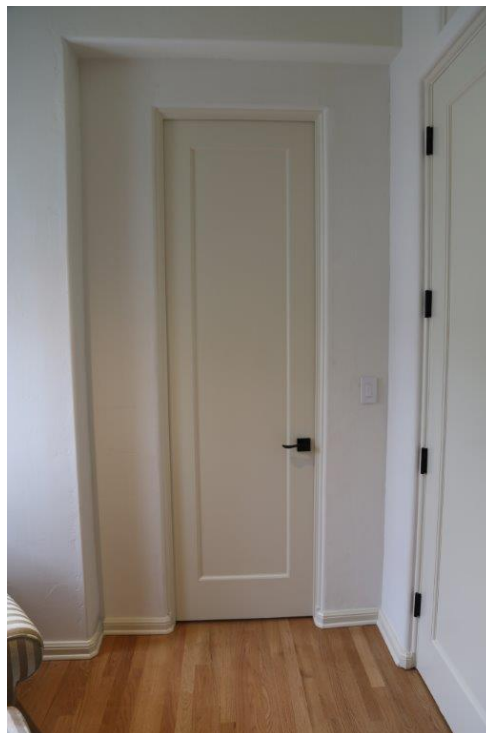
Photo Number: Image 57 (After)

Existing Door

Describe Work and Impact on Existing Feature: Existing hardware and interior door to remain, repair as needed

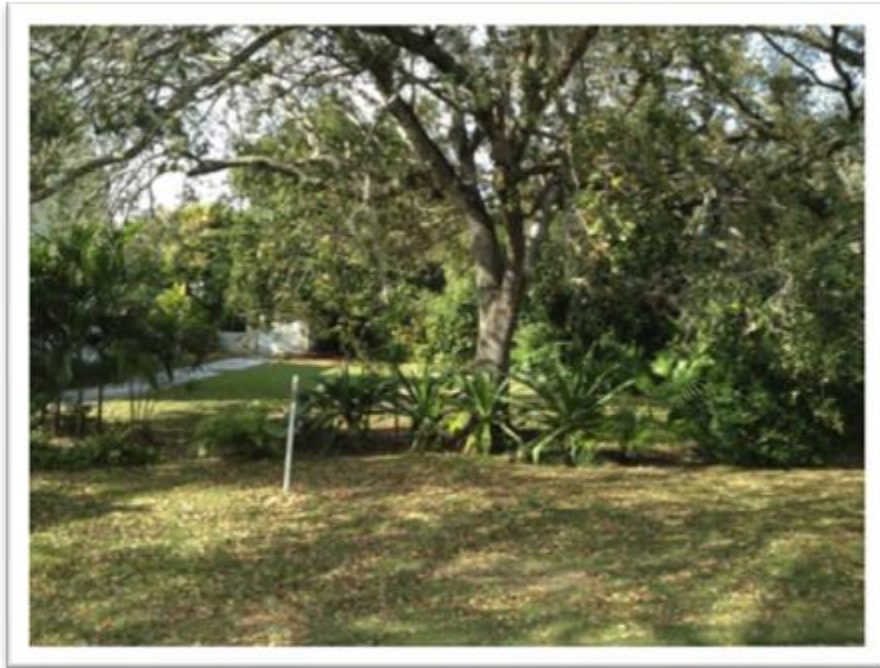
Photo Number: Image 58 (Before)

East Side Yard

Describe Work and Impact on Existing Feature: New Low wall at perimeter, new landscaping

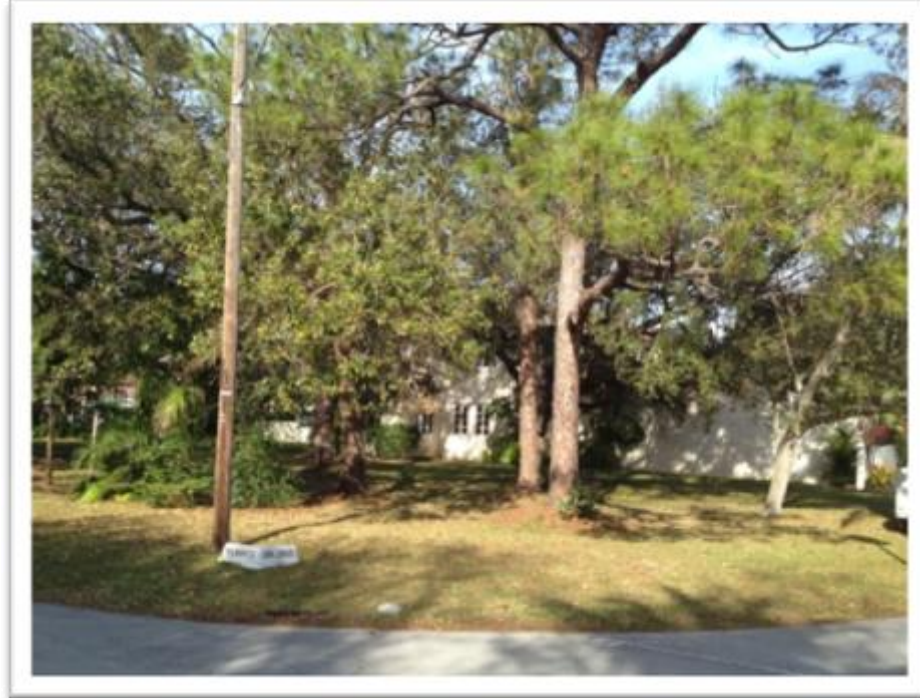
Photo Number: Image 59 (Before)

View of Yard from Intersection

Describe Work and Impact on Existing Feature: New Low wall at perimeter, new landscaping

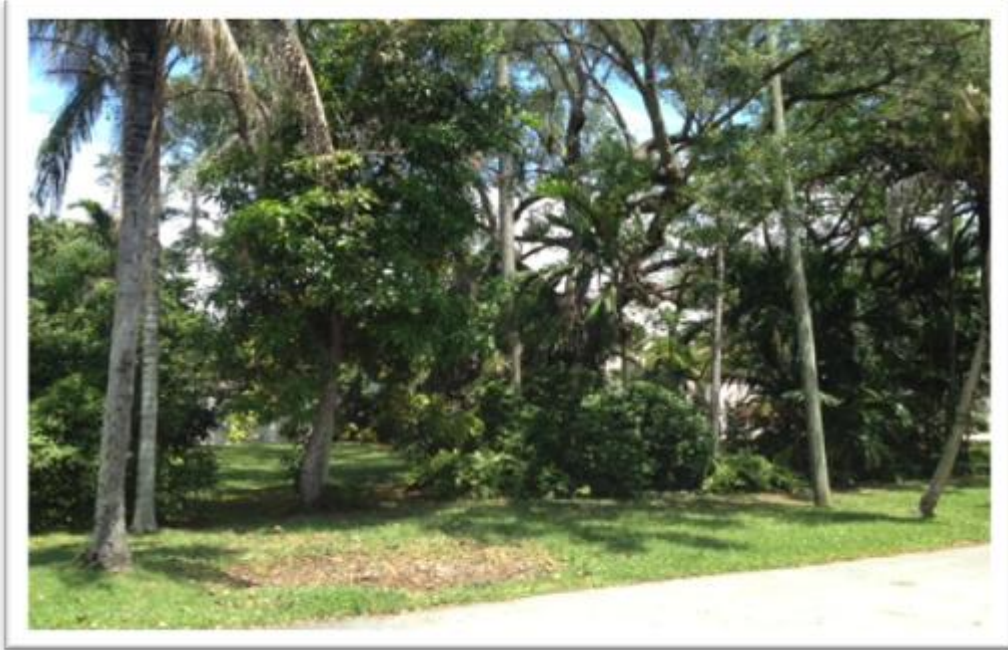
Photo Number: Image 60 (Before)

Northwest Corner View

Describe Work and Impact on Existing Feature: New Low wall at perimeters, new driveway, new landscaping
