**Almeria Park Condominium  
357 Almeria Avenue  
Coral Gables, FL 33134**

## **Testing Report**

**Raul Schwerdt, P.E.  
RAS Engineers and Consultants, Inc.**

**Re: Moisture Scanning and Stucco Testing**

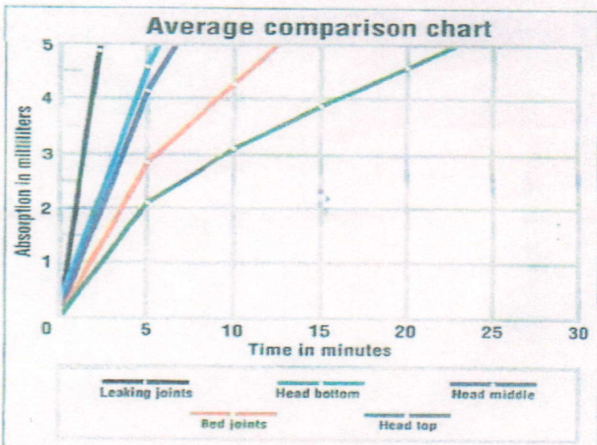
No.	Location	Absorption (millimeters)	Time (minutes)	Surface Condition
1	A	0	5	Good
2	B	0	5	Good
3	C	0	5	Good
4	D	5	5	Good
5	E	0	5	Good
6	F	0	5	Good
7	G	5	5	Good
8	H	0	5	Good
9	I	0	5	Good

Figure 2. Absorption graphs show the volume of water absorbed in milliliters versus time. The more permeable the masonry, the faster 5 ml of water will be absorbed.

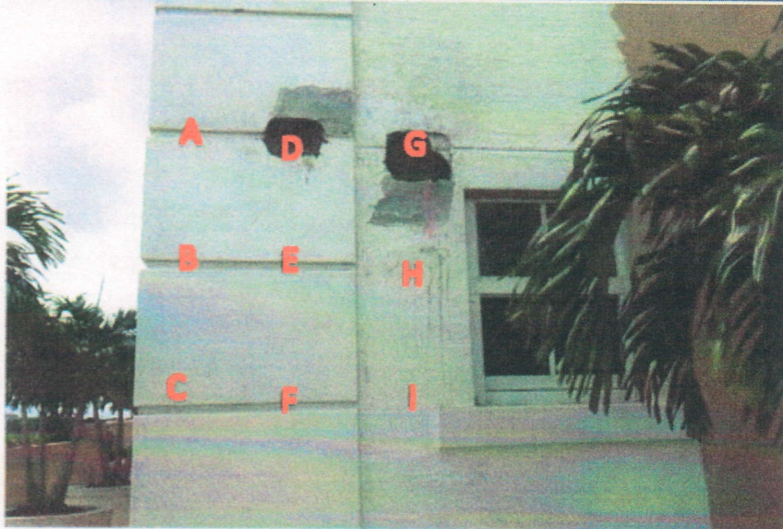
We conclude that the water is penetrating through the exterior stucco. In order to know more specific details, the applied white coating has to be removed by heavy pressure cleaning to expose the stucco's surface. Thereafter, we propose to test the permeability of the surface in different spots, scan the thickness of the stucco and layers, echo sound testing, and survey the thickness of the original coatings on the wall panes, columns, and the reveals on the wall. We suspect those reveals are one of the sources of the leak.

Specifications for Repairs

1. Cut 8" horizontal strip of stucco, four inches over and below the reveal groove. Extend the cut where indicated in the picture to reach the concrete block.
2. Remove stucco entirely and the plastic reveal form.
3. After opening, call the engineer for inspection.
4. Repair large cracks if necessary by injecting epoxy. Assume 3 LF for bidding, final quantities will be determined by the engineer after demolition.
5. Apply bonding to the masonry block, and one coat of stucco, maximum 5/8" thick.
6. Next day apply second coat of stucco. Make a reveal on the surface matching existing dimension, by pushing wood shim on the fresh stucco. Note the reveal on the column must be larger than the one on the wall.
7. Wait for a couple of days and apply sealer on the new stucco.
8. Call Engineer for final water deluge testing before applying two coats of painting and approval of the work.
